## TECHNICAL MEMO

Date: October 30, 2017  
To: Mary Ann King, Trout Unlimited  
From: Lauren Hammack, Prunuske Chatham, Inc.  
Subject: Mill Creek Dam Fish Passage Monitoring – Post-construction

### Introduction

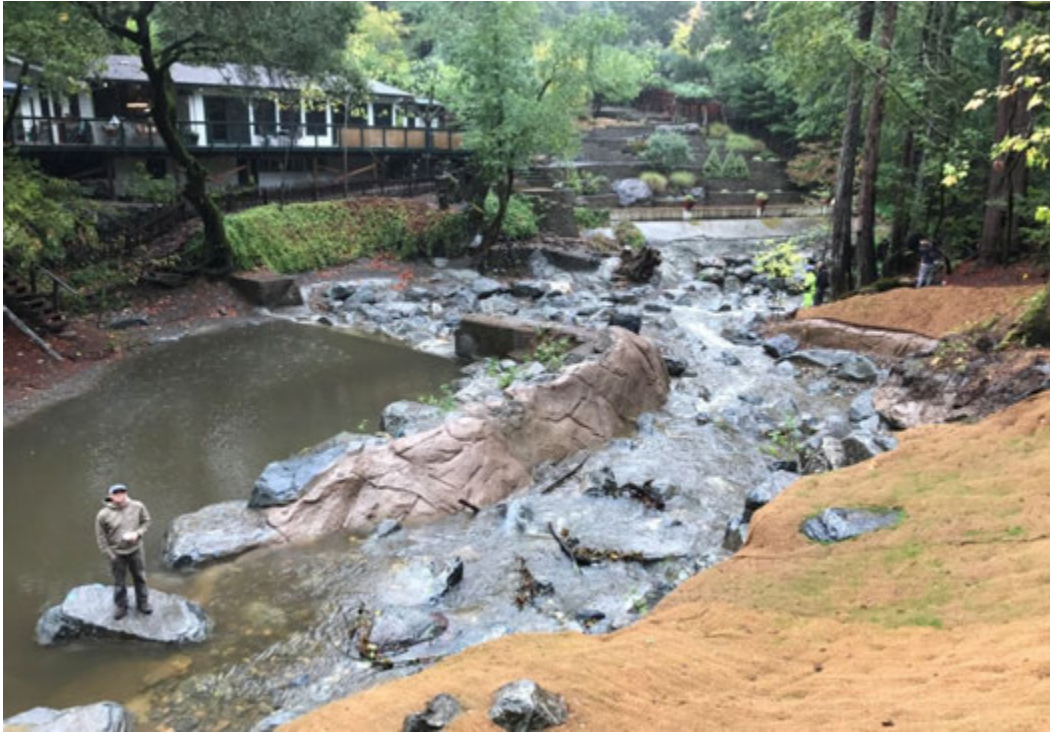
*Figure 1. View of Mill Creek Dam Fish Passage Project less than one month after construction completion (looking downstream). Constructed side channel with 3% slope is in the foreground with pre-existing dam and the main channel roughened ramp in center of photo.*

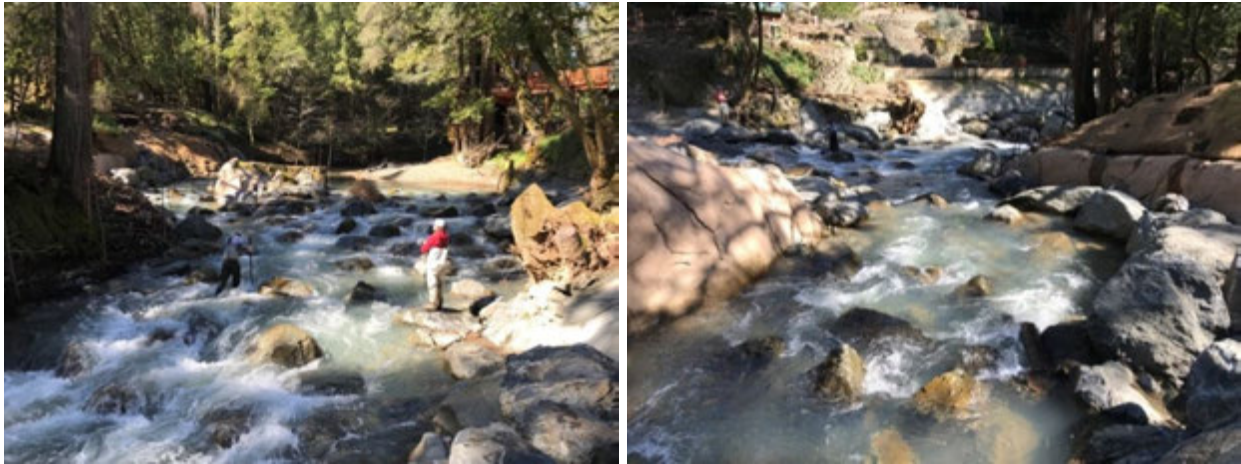
*Figure 4. The site during the mid-range flow on March 1, 2017. Left: Looking upstream at the confluence cross section ( $Q_{total}=63$  cfs). Right: Looking downstream at the side channel cross section ( $Q=21$  cfs).*

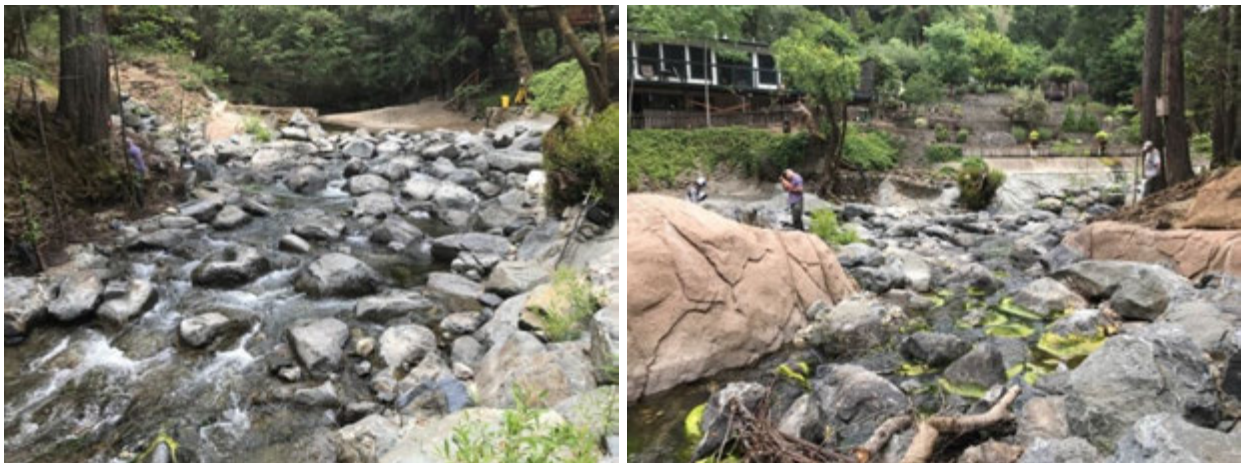
*Figure 5. The site during low flow on May 30, 2017. Left: Looking upstream at the confluence cross section ( $Q_{total}=7$  cfs). Right: Looking downstream at the side channel cross section ( $Q=1$  cfs).*

<sup>1</sup> Note: This proportioning of the discharge during low flows—majority of flow going down main channel—is not how the project was designed. A landowner adjacent to the Project dammed the side channel inlet, forcing the majority of flows down the main channel. Under design conditions the ratio of side to main channel flow would have been reversed with the majority of flow going down the side channel. Also, a small landslide blocked the right side of the side channel inlet, which reduced the proportion of flow going down the side channel during higher flows (i.e. ratio documented in early 2017 does not match the design ratio shown in Table 1).

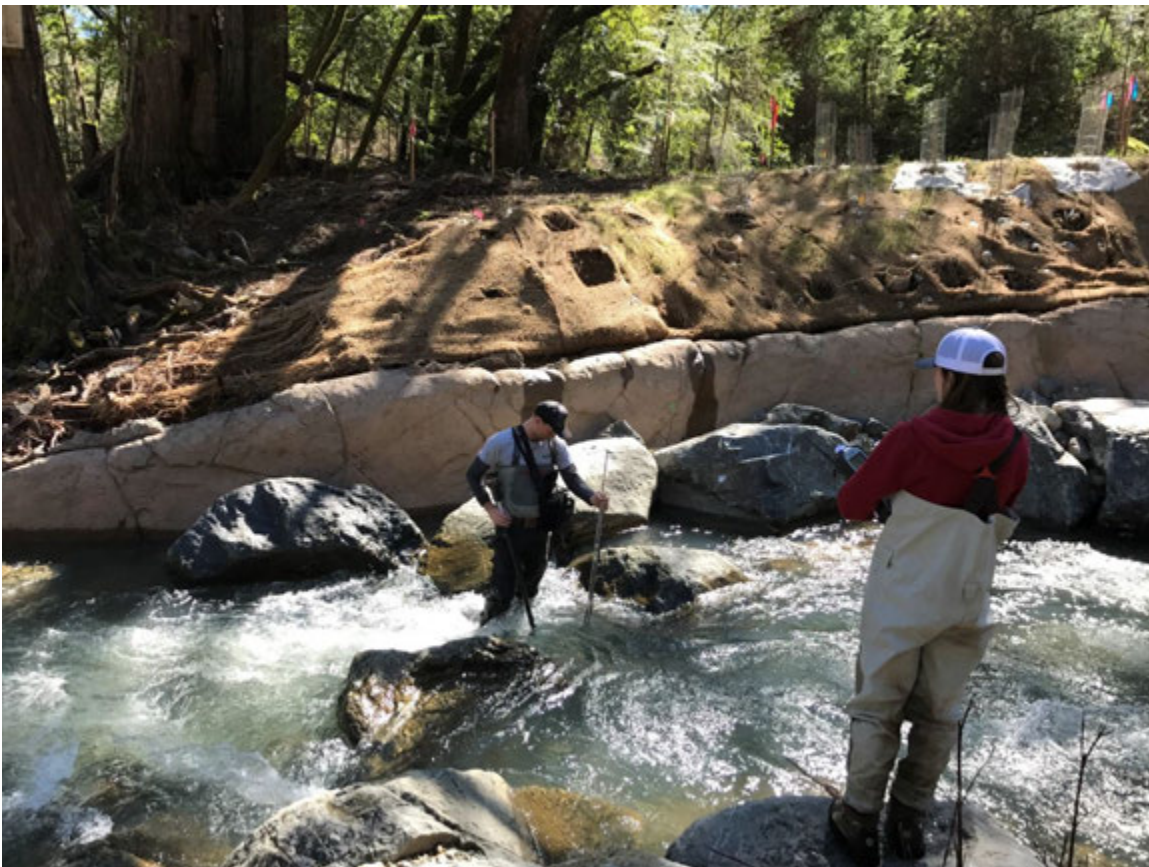
The profile graphs (Figure 7 and Figure 8) show that point specific velocities vary from near 0 fps to over 4 fps in both the main and side channels, which is due to the chute-pool nature of the bed form and flow patterns. Channel slope does not appear to significantly influence velocity. Velocities at or above 6 fps were measured in the 6% and 8% sloped sections, while the 3% side channel's maximum measured velocity was 4.5 fps. The profile points were taken to represent a fairly straight-line swim path for adult fish to take near the center of the channel. The profile data does not represent the path a juvenile fish would likely take if migrating upstream. Velocities near the channel margins are typically much lower than the center channel, as shown in the cross section plots (Figure 9). The cross-channel velocity variation is similar in scale to the longitudinal variation. However, multiple locations at each cross section had velocities within the preferred range for juvenile coho and had zones of calm water. The zones of calm or low velocity waters are larger in extent in the 3% side channel (Figure 10) than they are in the main channel where the slopes are 6-8% (Figure 11).

*Figure 10. Representative flow pattern and zones within the side channel on March 1, 2017. Note short chutes with large flatwater pool features and slow zones behind boulders.*

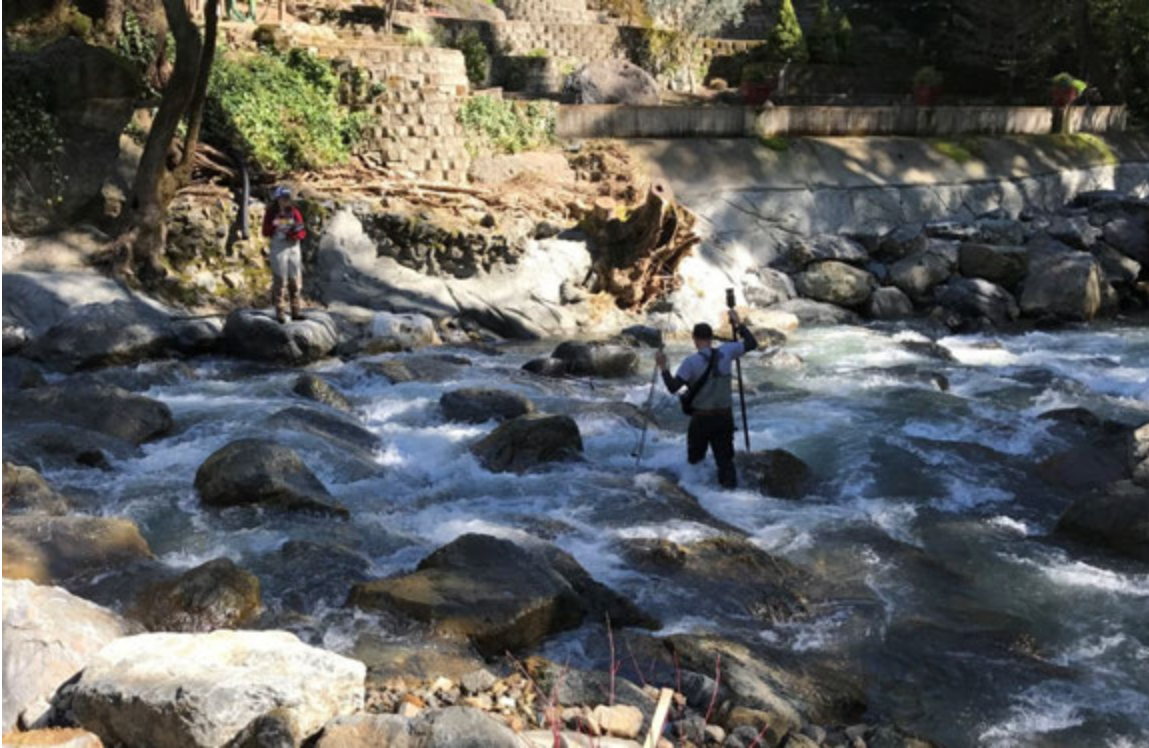
*Figure 11. Representative flow and swim conditions in the main channel on March 1, 2017. Note that calm flow zones appear to be smaller and less connected than those in the side channel.*

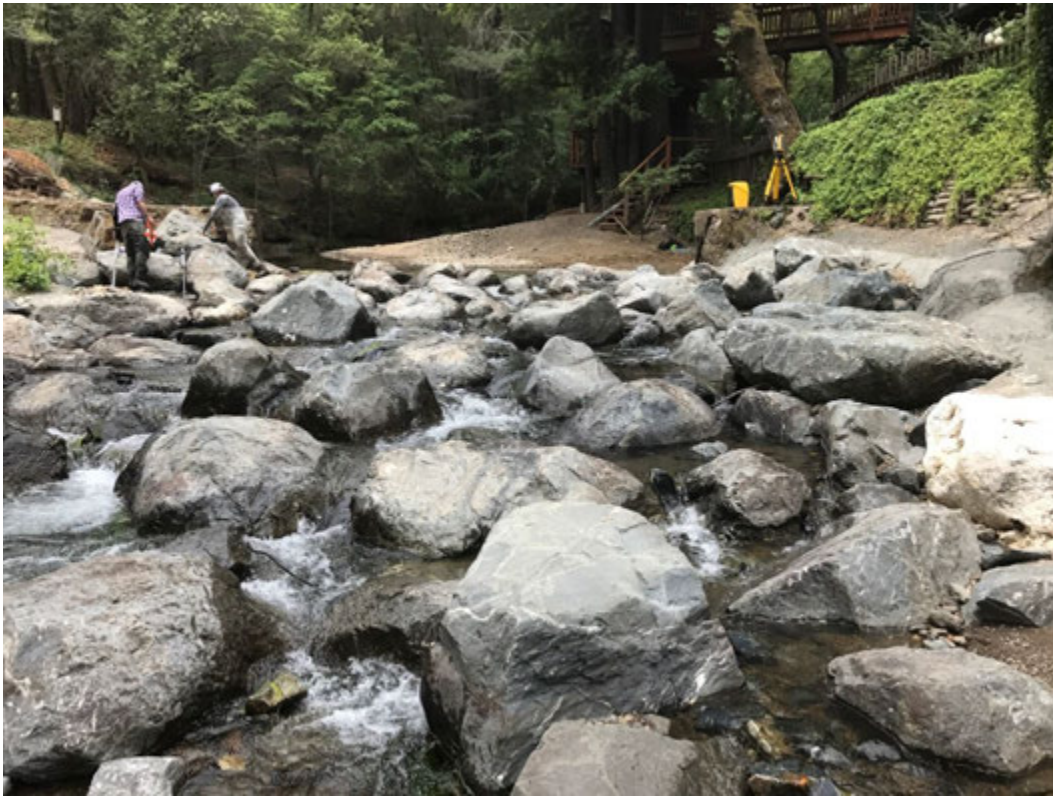
Based on the cross section velocity and depth data it is expected that juvenile coho and steelhead can navigate the Project and migrate upstream between early spring storm events and when flows recede in the late spring through early summer (see 2017 hydrograph, Figure 6). The side channel provides abundant low velocity and calm water zones with gravel and meandering flow paths between the boulders. The main channel, with its steeper slope, has less defined flow paths and calm-water resting zones. In the main channel below the dam the interstitial gravel and cobble was largely scoured out, which left small drops and chutes between the boulders that may make navigating the main channel more difficult for juvenile coho (Figure 15).

*Figure 15. Flow conditions and paths in the main channel during low flow conditions on May 30, 2017. Flow is 6 cfs. Note the drops and chutes between the boulders.*
