**Final Supplemental Watershed Plan No. 1 - Environmental  
Assessment**

**Central Sonoma Watershed - Matanzas Creek Dam Rehabilitation Project**  
**Sonoma County, California**

**Appendix D - TM006 - Spillway Stability and Integrity Analysis**

## **TM006 – Spillway Stability and Integrity Analysis**

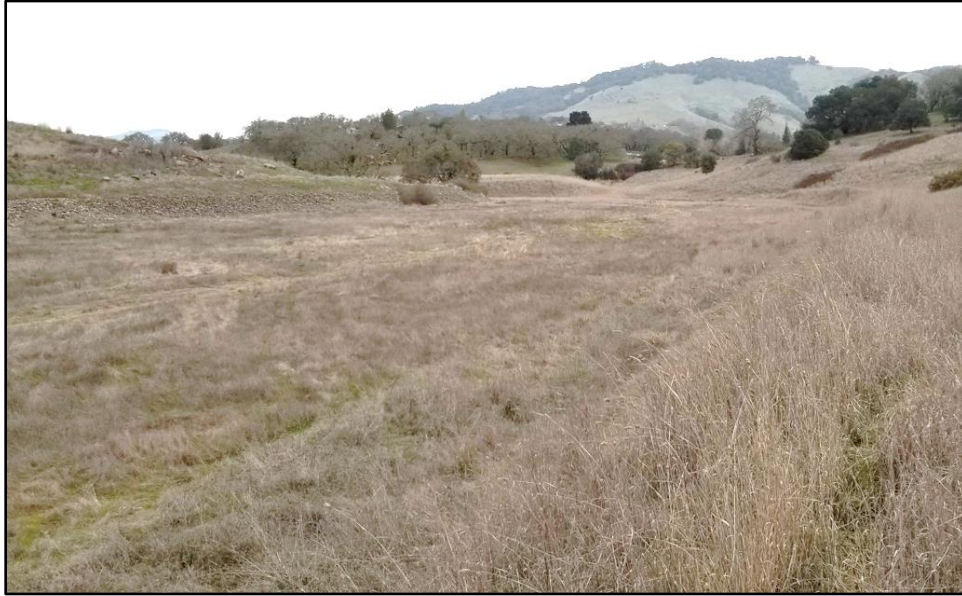
**Figure 4-1. Upper section of auxiliary spillway (view is looking north towards downstream channel)**

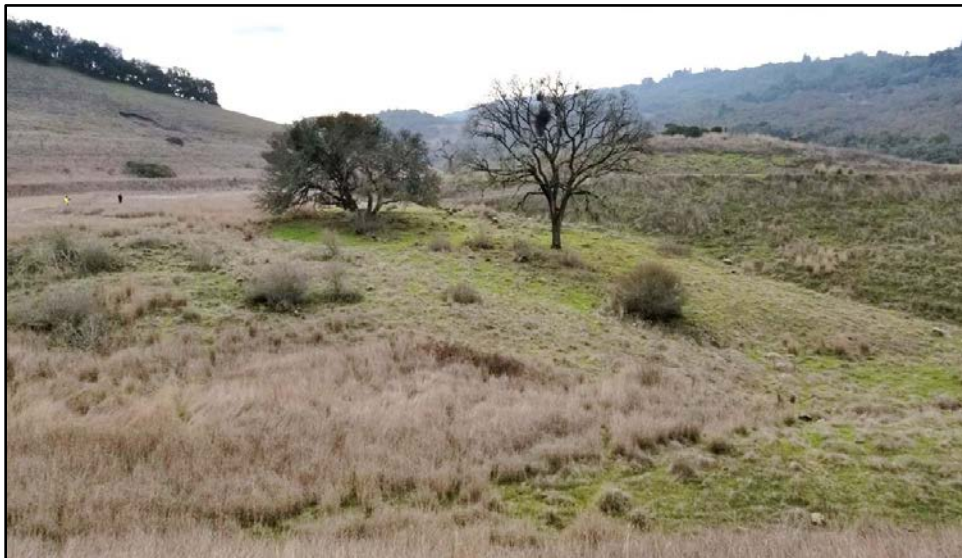
**Figure 4-2. Middle section of auxiliary spillway (view is looking south towards upstream channel)**

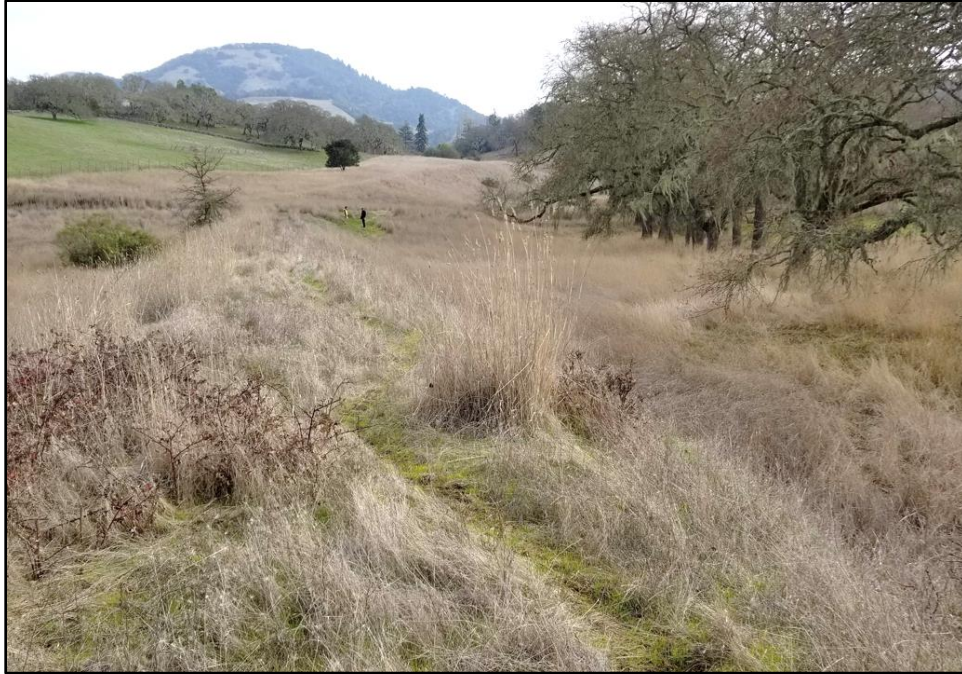
**Figure 4-3. Lower section of auxiliary spillway (view is looking east towards upstream channel; photo is taken from top of constructed dike)**

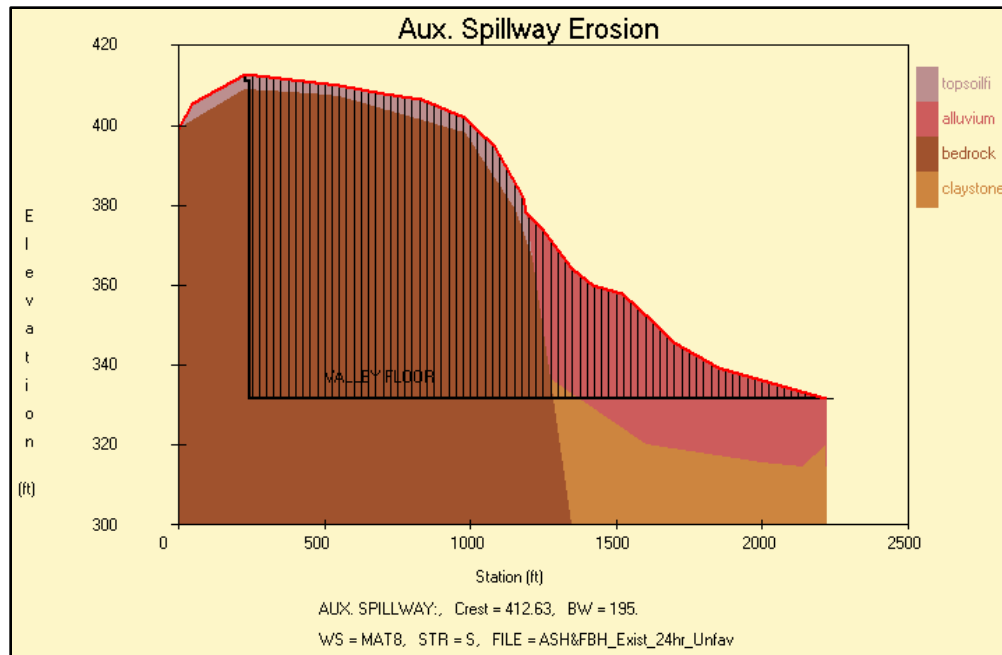
The SITES integrity analysis evaluates the erosion process in a spillway over the course of a 6-hour or 24-hour FBH storm event. This typically results in stepped, incremental eroded spillway material in the analyses. As observed in the Figures 3-4 and 3-5 however, this is not the case for the SITES evaluation of Matanzas Creek Dam. Given the spillway profile, materials parameters, and hydrologic storms, SITES resulted in a several headcuts that merge together which resulted in an abrupt drop in the spillway (70+

**Figure 4-4. SITES integrity evaluation of 24-hr FBH (unfavorable conditions): Breached**

feet). This type of headcut is unlikely as such a large drop may likely cause other geotechnical and geological failures. Modeling the erodibility and the integrity of the spillway during the 24-hour FBH with additional software (i.e. 1D modeling, 2D modeling, or computational fluid mechanics) is recommended to further analyze the results produced by SITES.

Based on the unfavorable material parameters used in the integrity analysis of the spillway, the existing spillway would breach during the 24-hour FBH storm event. Proposed alternatives presented in the Plan-EA should mitigate the potential for significant headcutting leading to dam failure. This may include channel erosion protection, channel concrete lining, roller-compacted concrete lining, a cutoff wall, etc. Due to the uncertainty in the subsurface materials in the spillway, it is recommended to conduct additional geotechnical investigation and spillway integrity analyses. This additional data may conclude that there are no integrity issues in the spillway, and there is no need for spillway reinforcement, as mentioned previously.

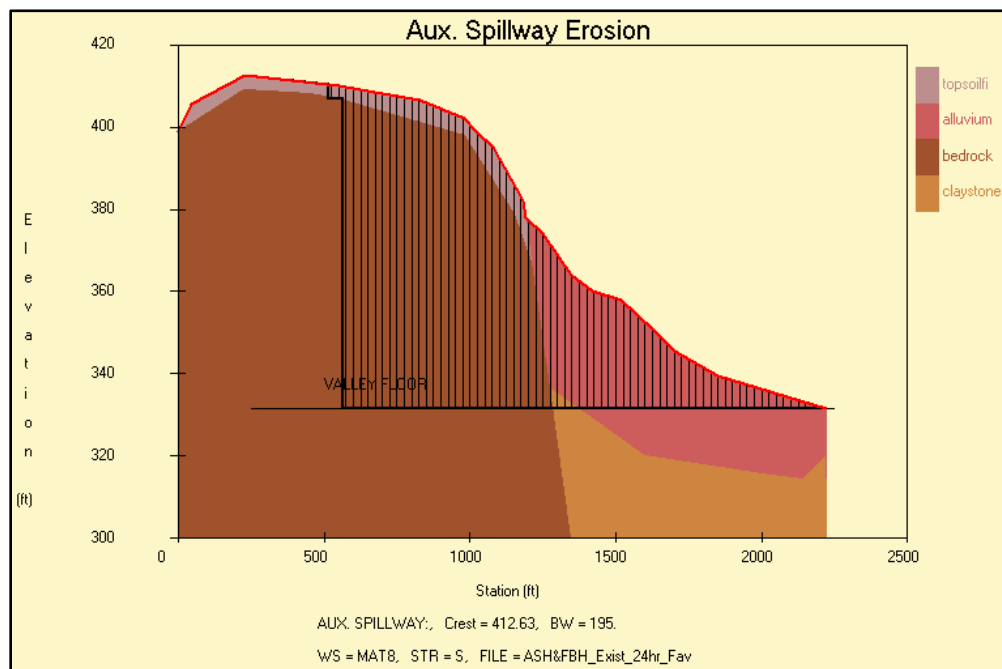
**Figure 4-5. SITES integrity evaluation of 24-hr FBH (favorable conditions): Not Breached – 283 feet remaining**

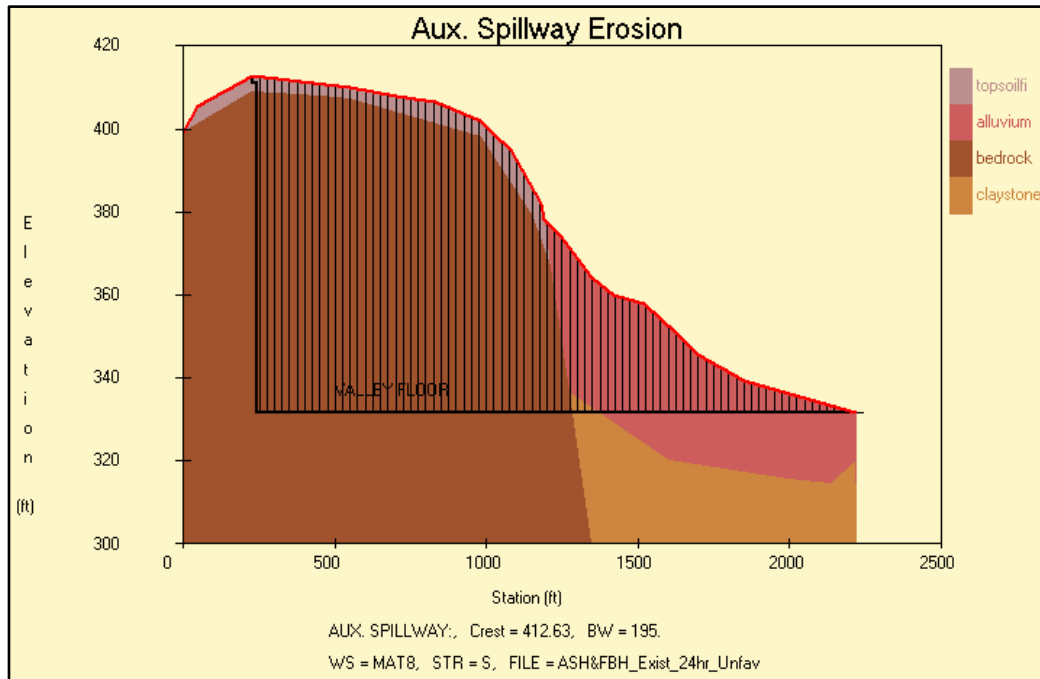
Figure 1. SITES integrity evaluation of 24-hr FBH (unfavorable conditions): Breached

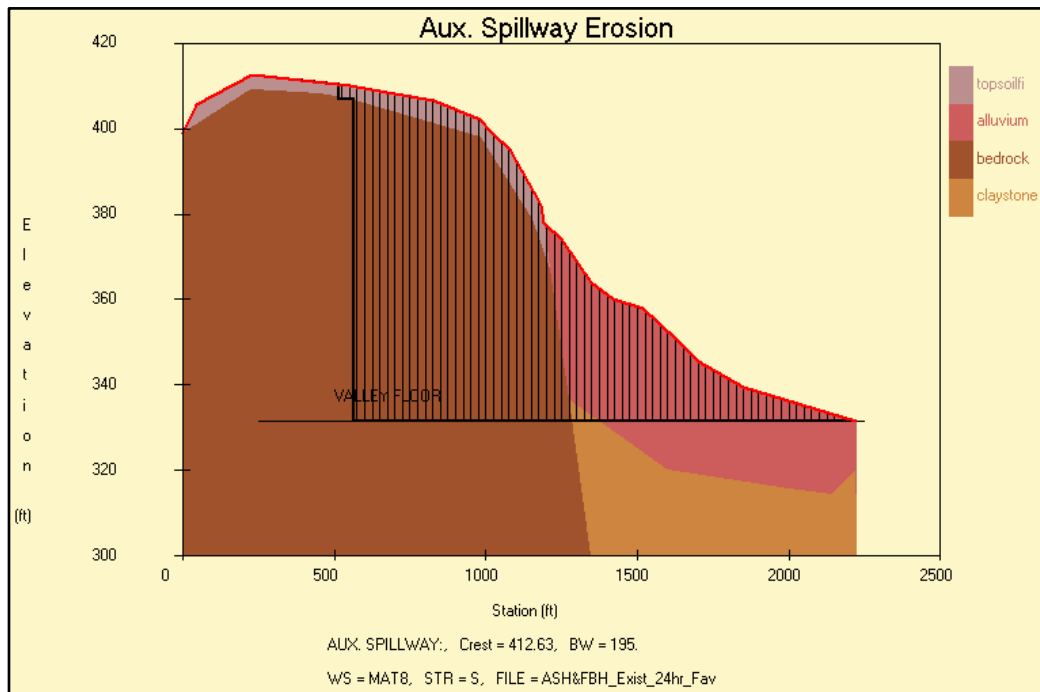
Figure 2. SITES integrity evaluation of 24-hr FBH (favorable conditions): Not breached – 283 feet remaining

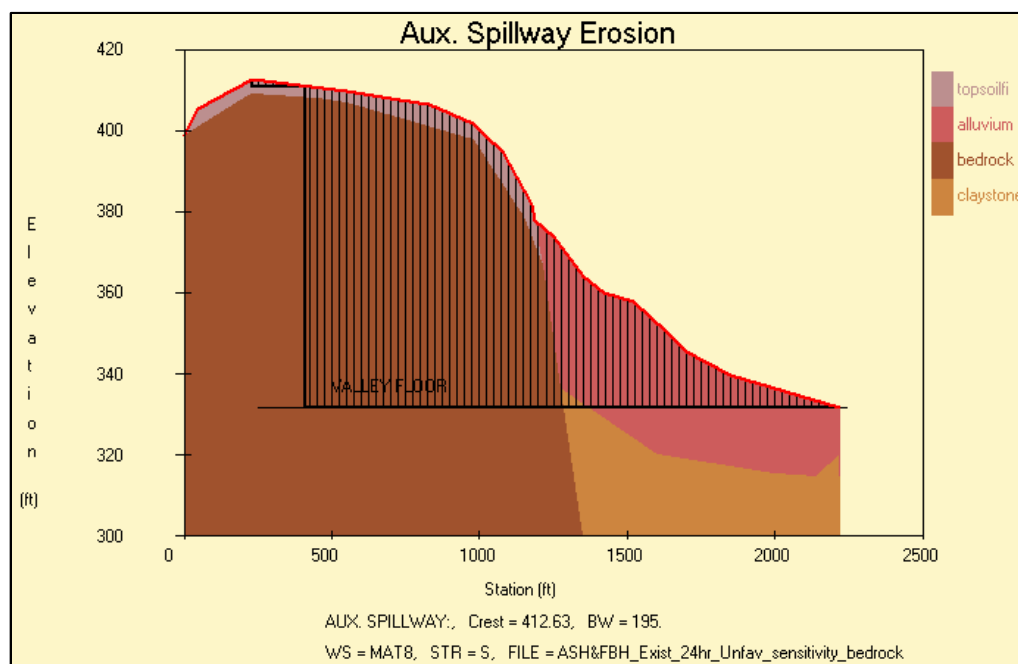
While these results suggest that the bedrock layer may affect the spillway integrity evaluation, it still results in spillway failure due to the unfavorable parameters in the topsoil layer. Also note that these results do not consider the concrete cutoff wall that is located at the auxiliary spillway crest. The concrete cutoff wall is 10 feet deep, which may prevent complete breach of the results shown in Figures 3 and 4. However, it is unknown if the concrete cutoff would fail should the downstream soil be eroded away (it may not have strength to bear soil pressure on upstream side of wall).

Figure 3. Bedrock sensitivity analysis -  $K_h = 2$ : Breached (unfavorable topsoil failure)

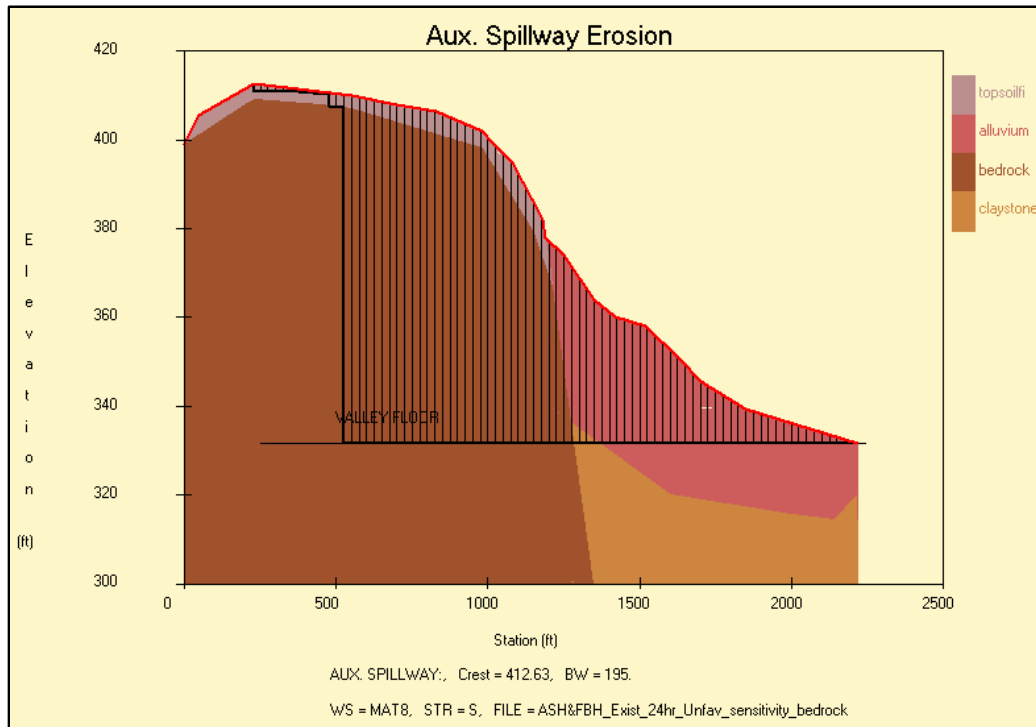
Figure 4. Bedrock sensitivity analysis –  $K_b = 20$ : Breached (unfavorable topsoil failure)

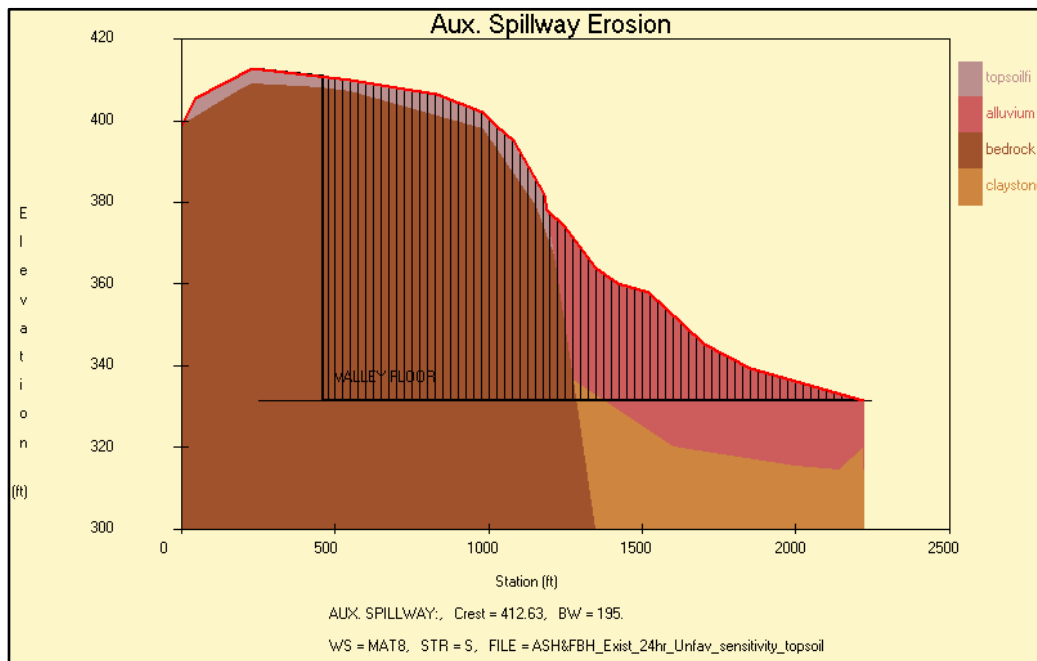
Figure 5. Topsoil sensitivity analysis: Not breached – 229 feet remaining

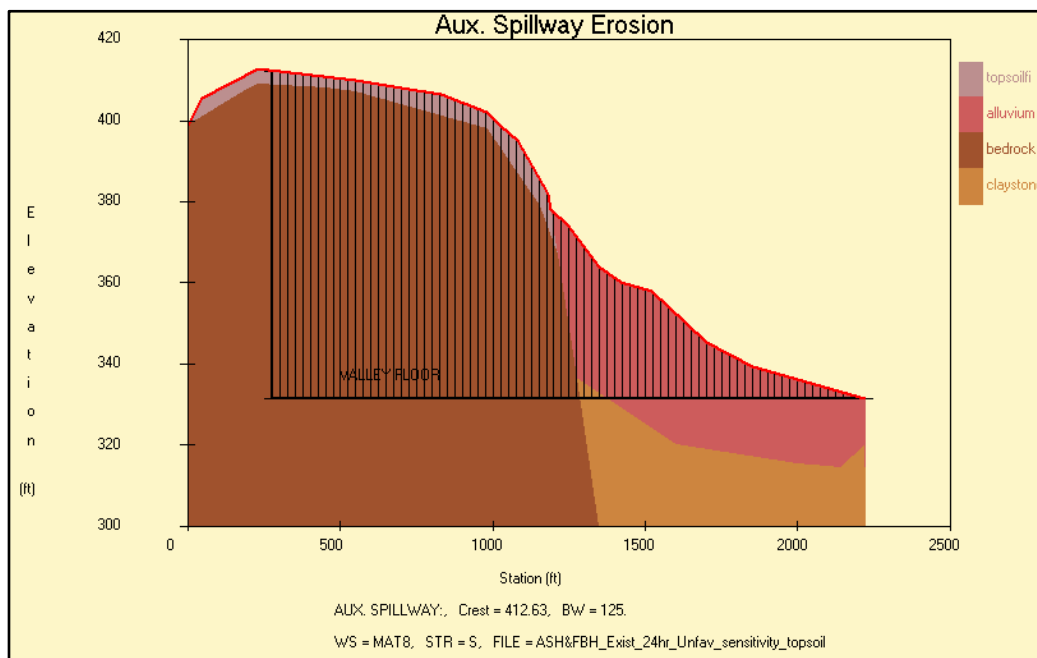
Assuming the same parameters described in the topsoil sensitivity analysis, it was found that the spillway width can be reduced to 125 feet and still pass the integrity analysis with approximately 47 feet remaining between the auxiliary spillway crest and the developed headcut (see Figure 6). This spillway width is significantly conservative considering the smallest width of the spillway is approximately 100 feet, and the average spillway width is 195 feet. A passing integrity analysis while assuming a width of 125 feet for the entire alignment of the spillway width suggests the outcome of the analysis is less sensitive to the width than it is to the topsoil characteristics.

Figure 6. Spillway width sensitivity analysis (125 feet width) = Not breached - 47 feet remaining

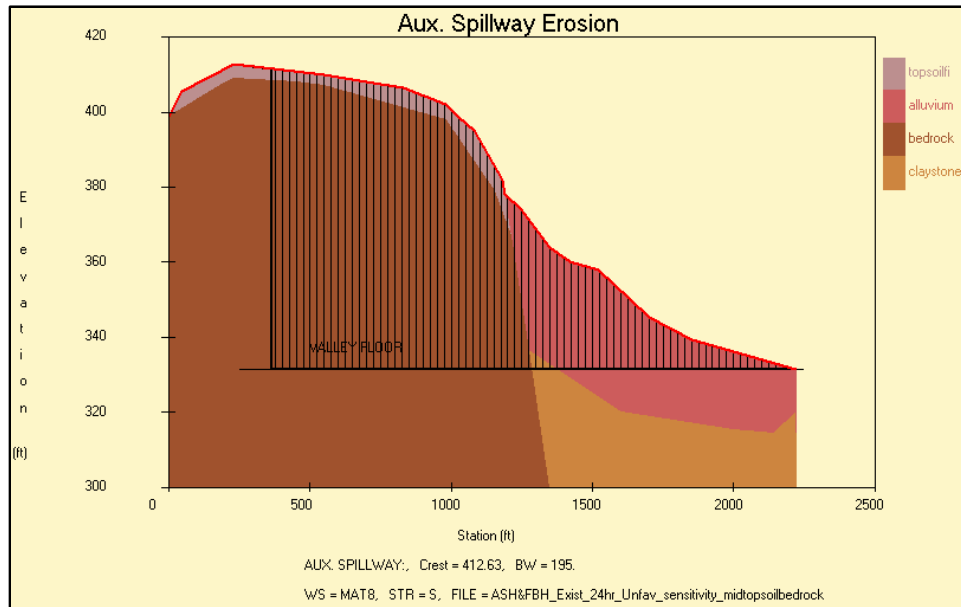
Thus far, the sensitivity analyses suggest that the topsoil layer is most influential on the SITES evaluation followed by the bedrock layer. Therefore, one last test was assuming the median or average unfavorable and favorable parameters for these two layers while assuming unfavorable parameters on the alluvium and claystone layers. As shown in Figure 7, the results show the spillway not breaching with 135 feet remaining.

Figure 7. Median parameters for topsoil and bedrock: Not breached - 135 feet remaining
