Sonoma
Water

Russian River Estuary Management Project 2018 Review and 2019 Update

AUGUST 28, 2019

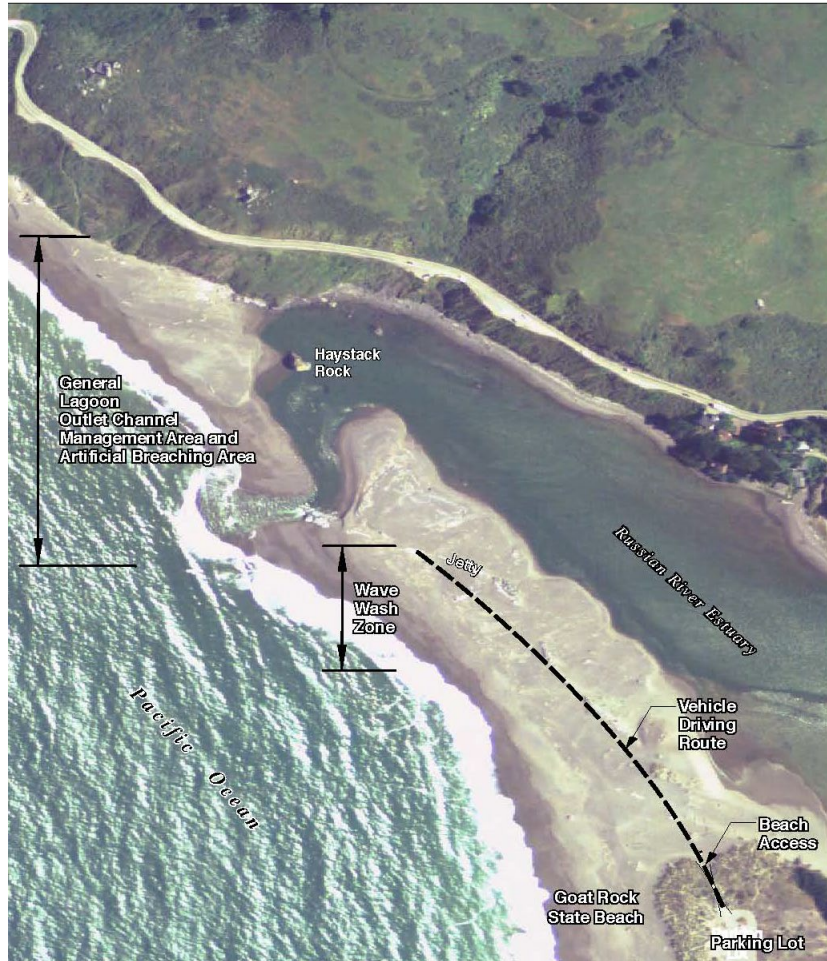
Beach Management Activities

Artificial breach

Outlet channel

- Lagoon Management Period (May 15 – October 15) – 0 closures
- Remainder of 2018 – 6 fall closures
 - 1 beach management event in December
- Inlet located at jetty groin through mgmt. season
- Swell wave events occurred in summer
- High flood water events occurred during December events

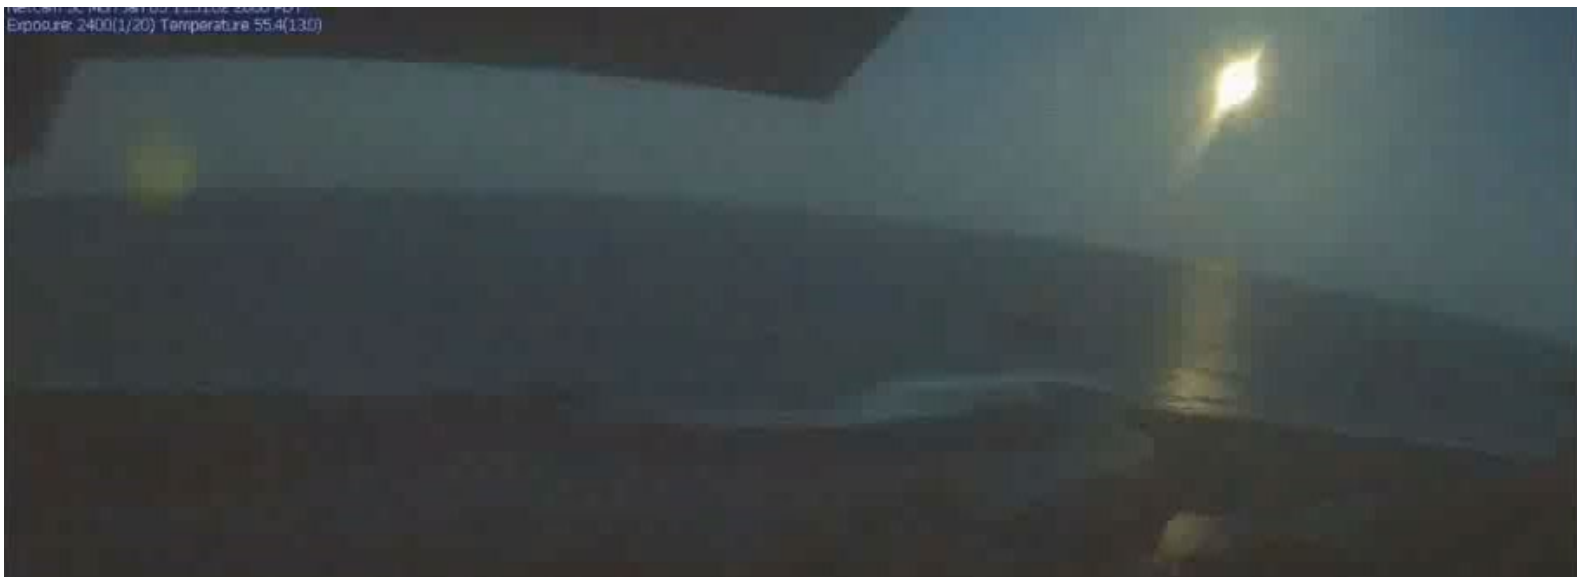
March 6, 2015 06:11:22

1. Apply insights from monitoring and scientific studies

Photos courtesy of Bodega Marine Lab
video created by ESA with funding from SCWA

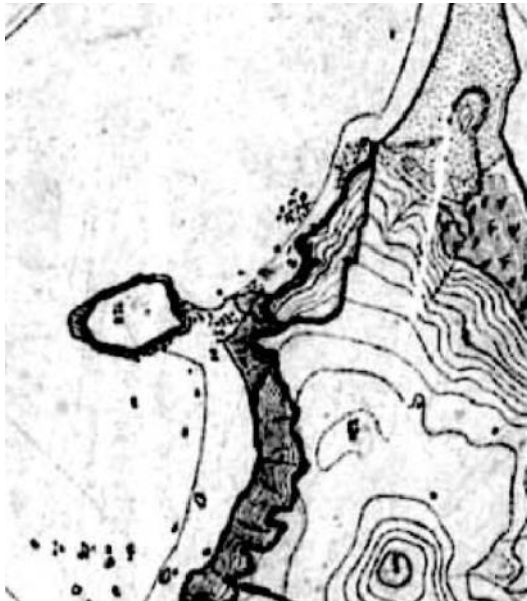
- Historic maps indicate that Goat Rock was only connected to the shore by a tombolo (low-lying sand spit) prior to jetty construction.
- Shoreline **accretion** of 1.5 ft/yr on GRSB since 1930.
- Shoreline **erosion** of 0.8 ft/yr at neighboring beach to the south since 1930.

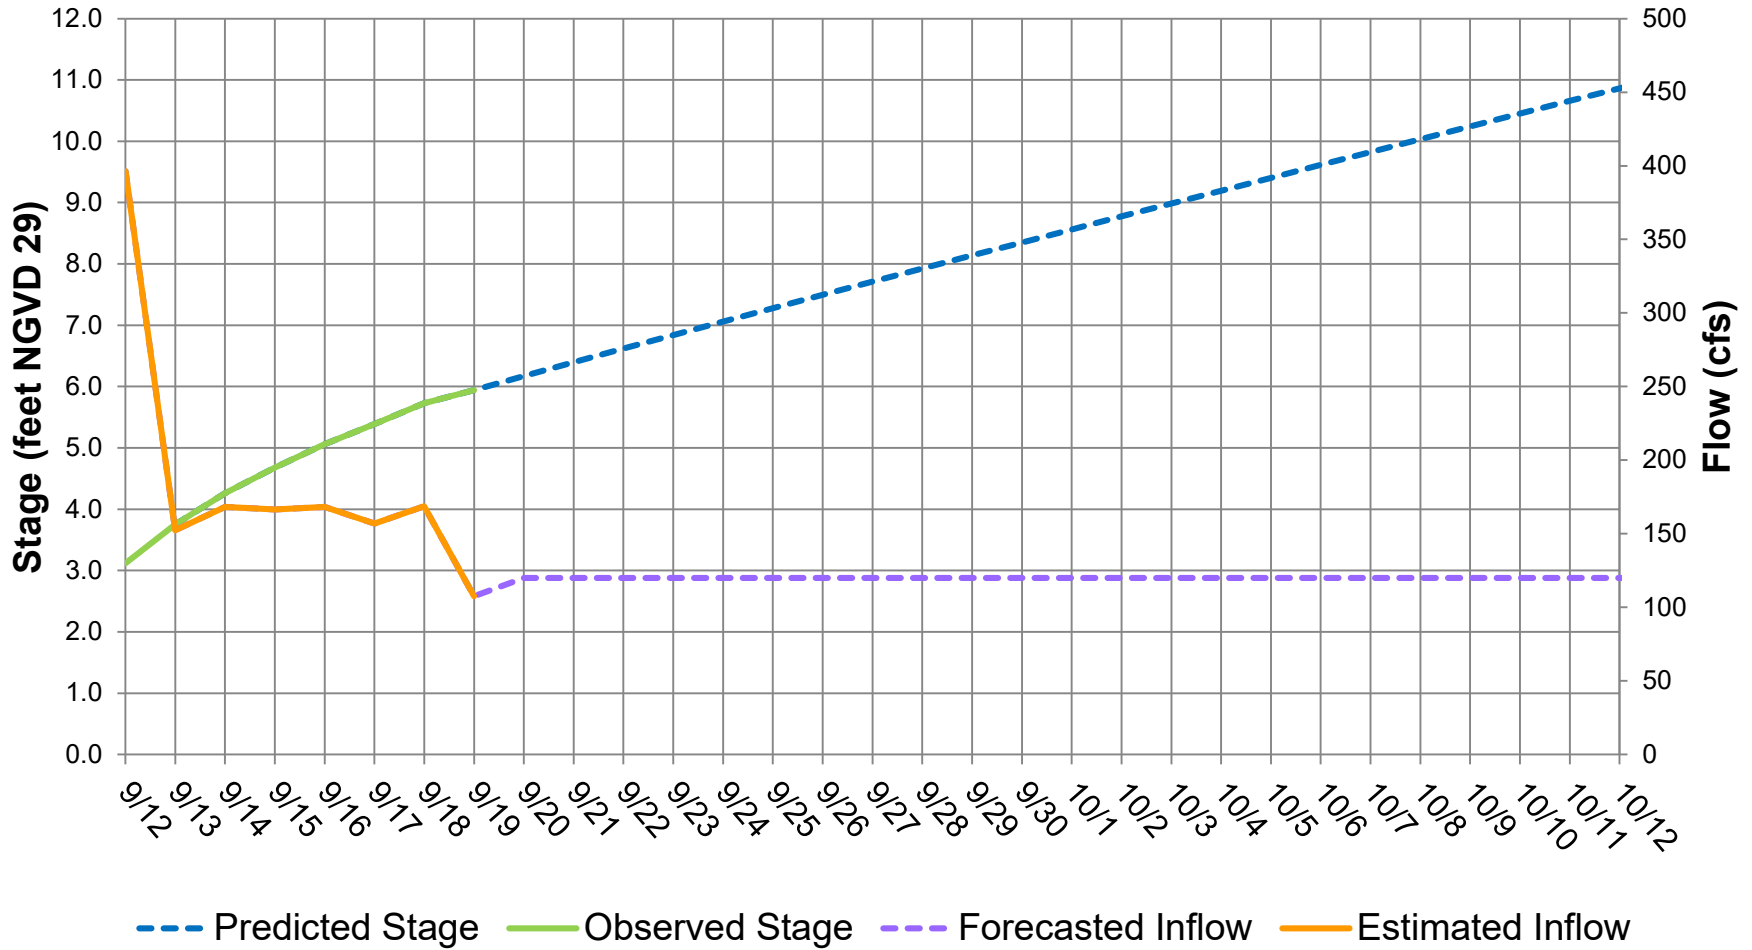
2. Use predictive tools to anticipate outcomes

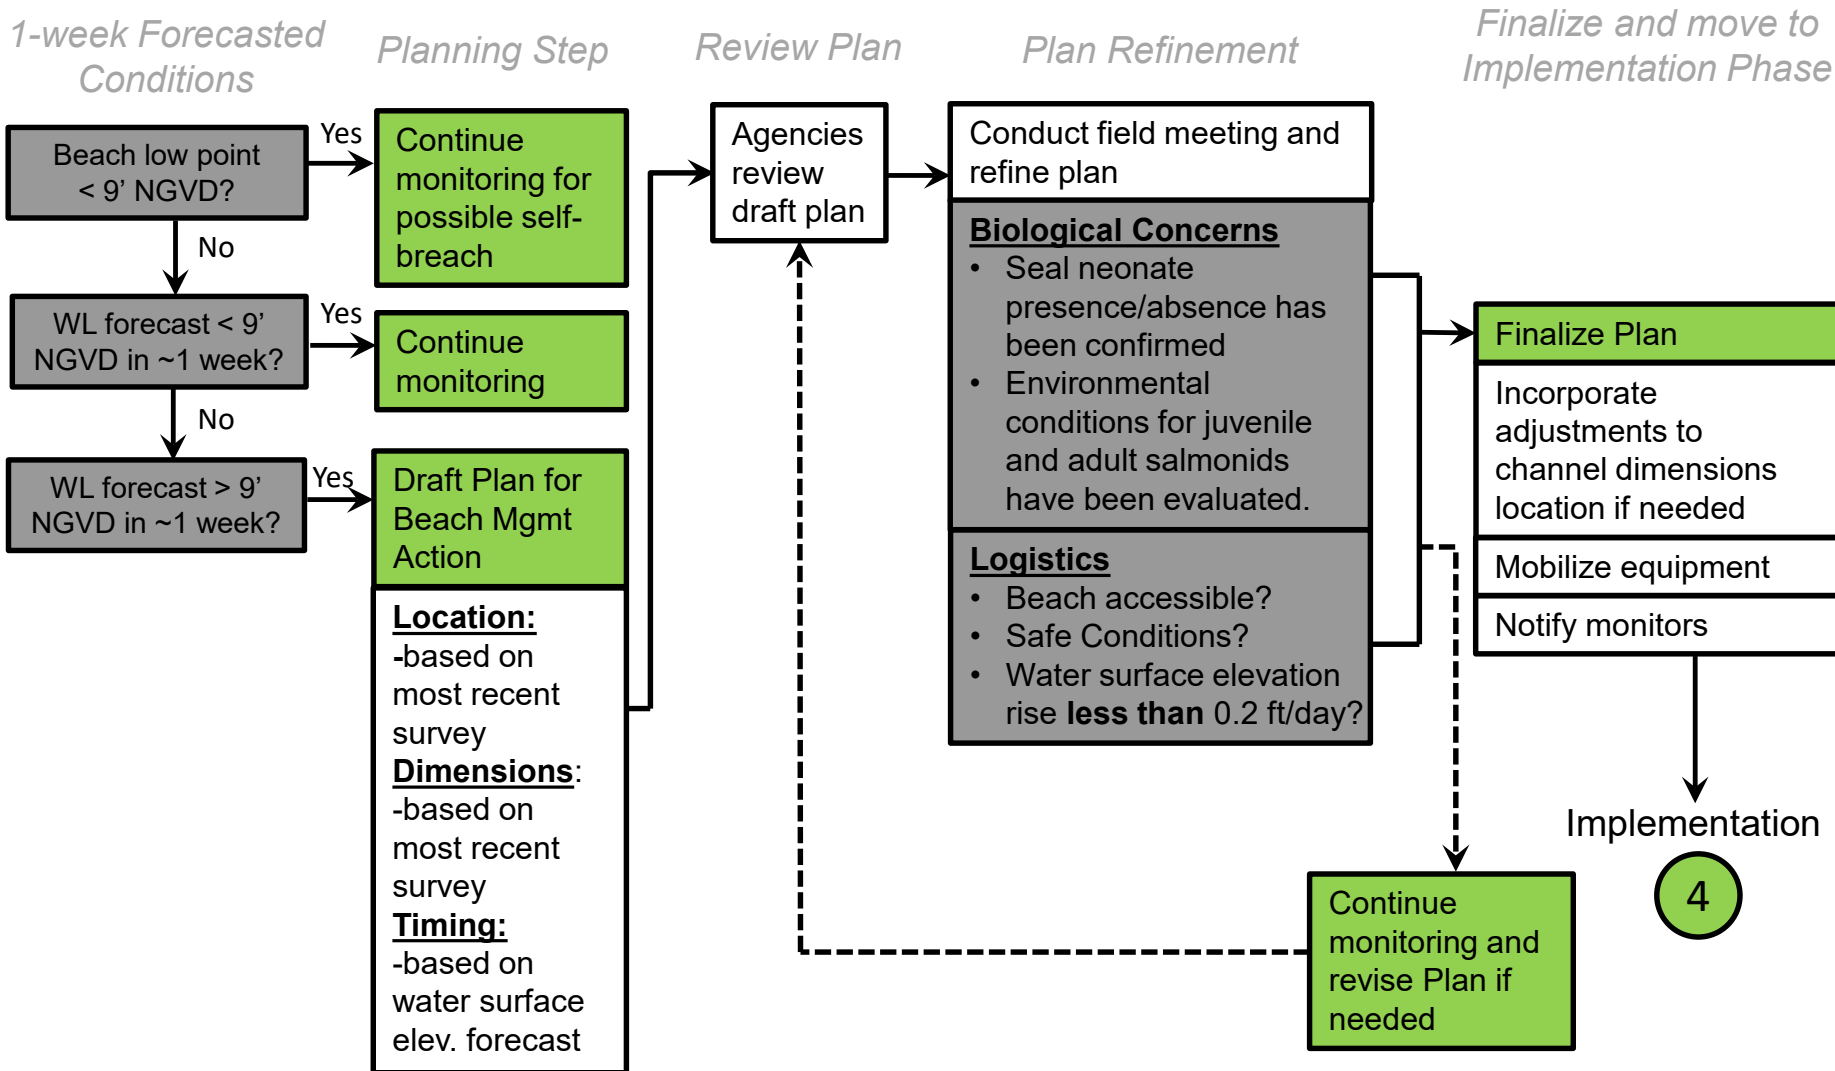
4. Clarify the decision process

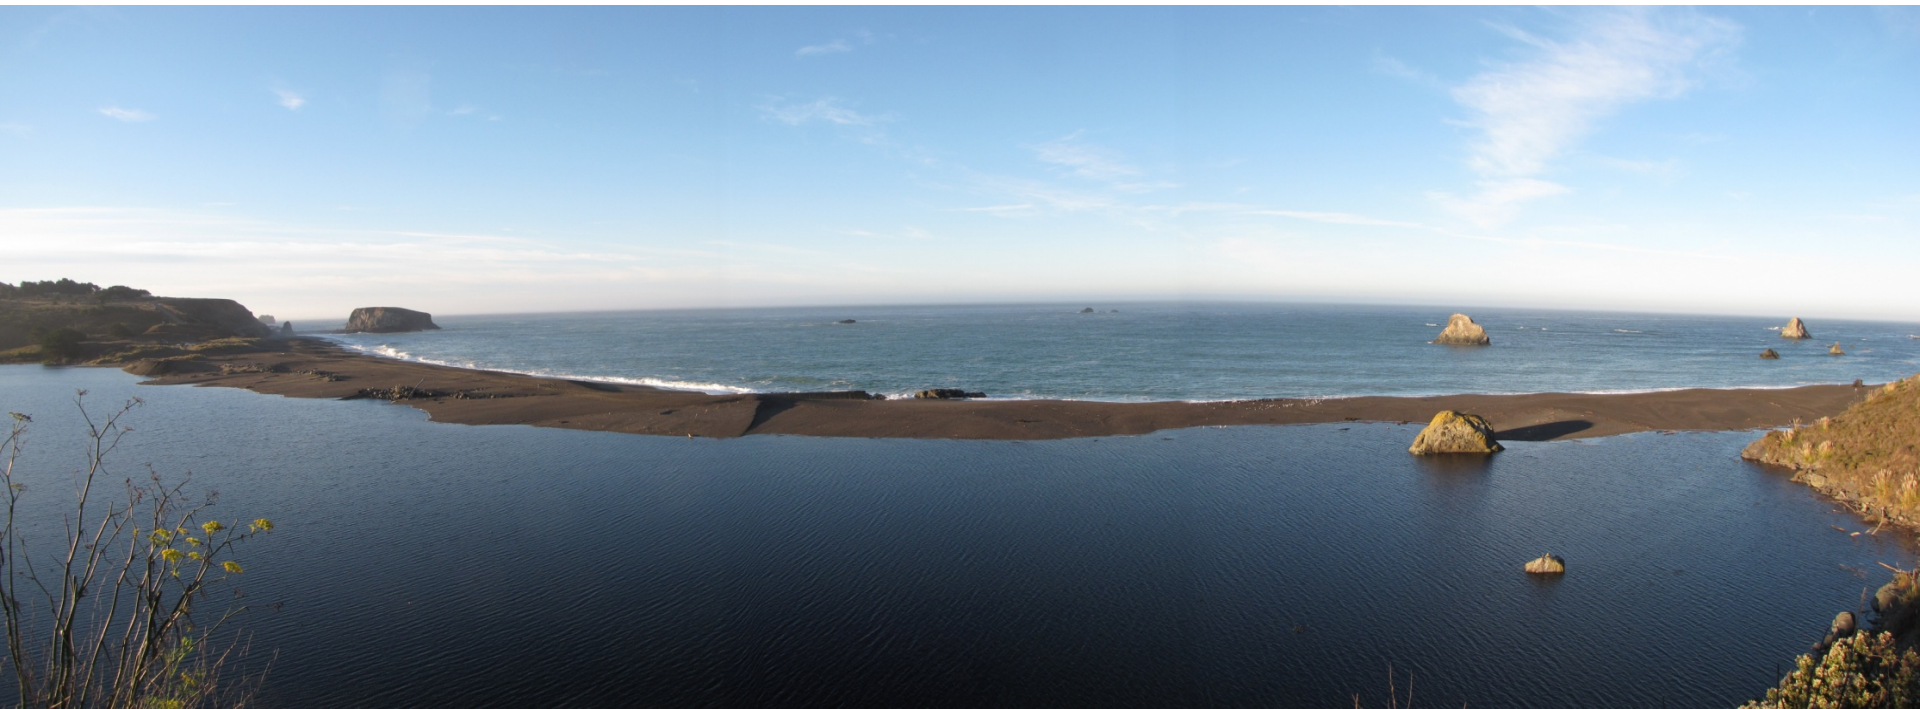
- Open river mouth
 - Tidal, cold seawater, daily exchange
- Outlet channel
 - Lagoon, increase volume of fresh or brackish water

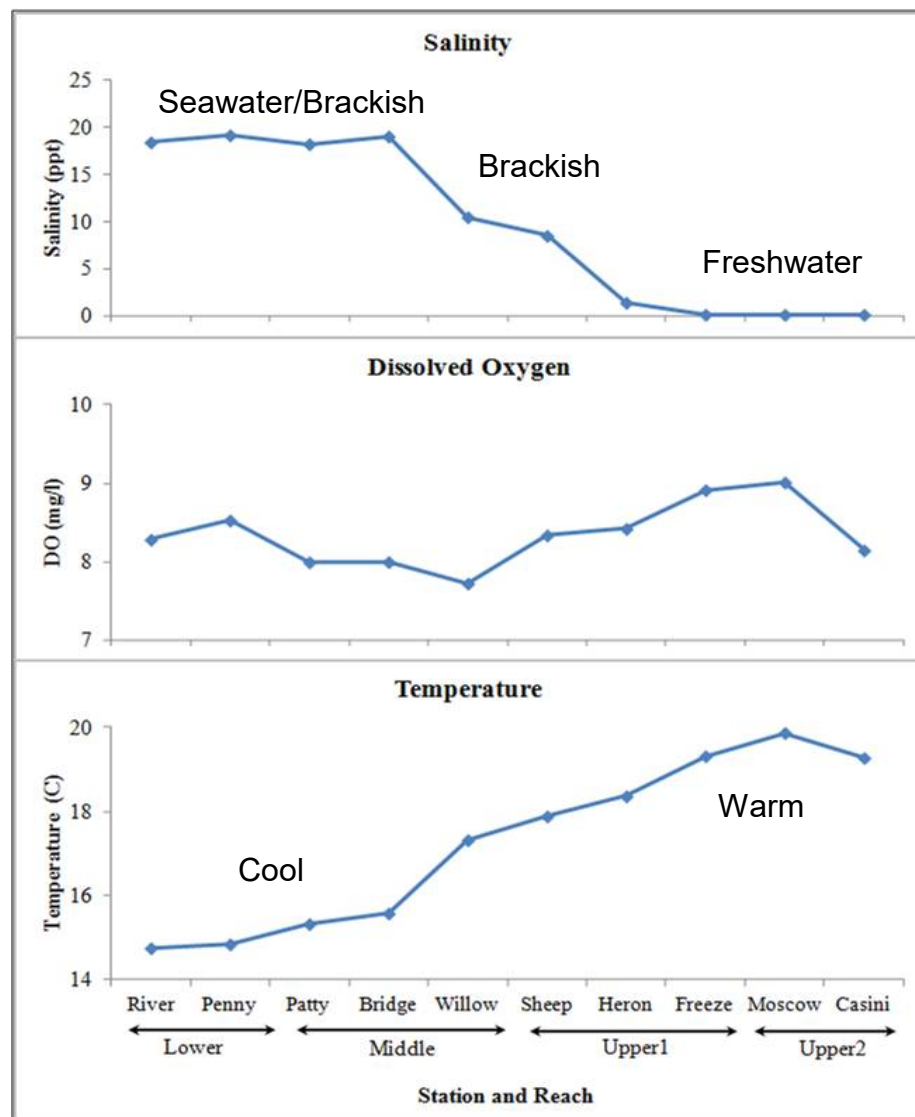
- Longitudinal salinity gradient
- Stratified water column
- Tidal vs Lagoon

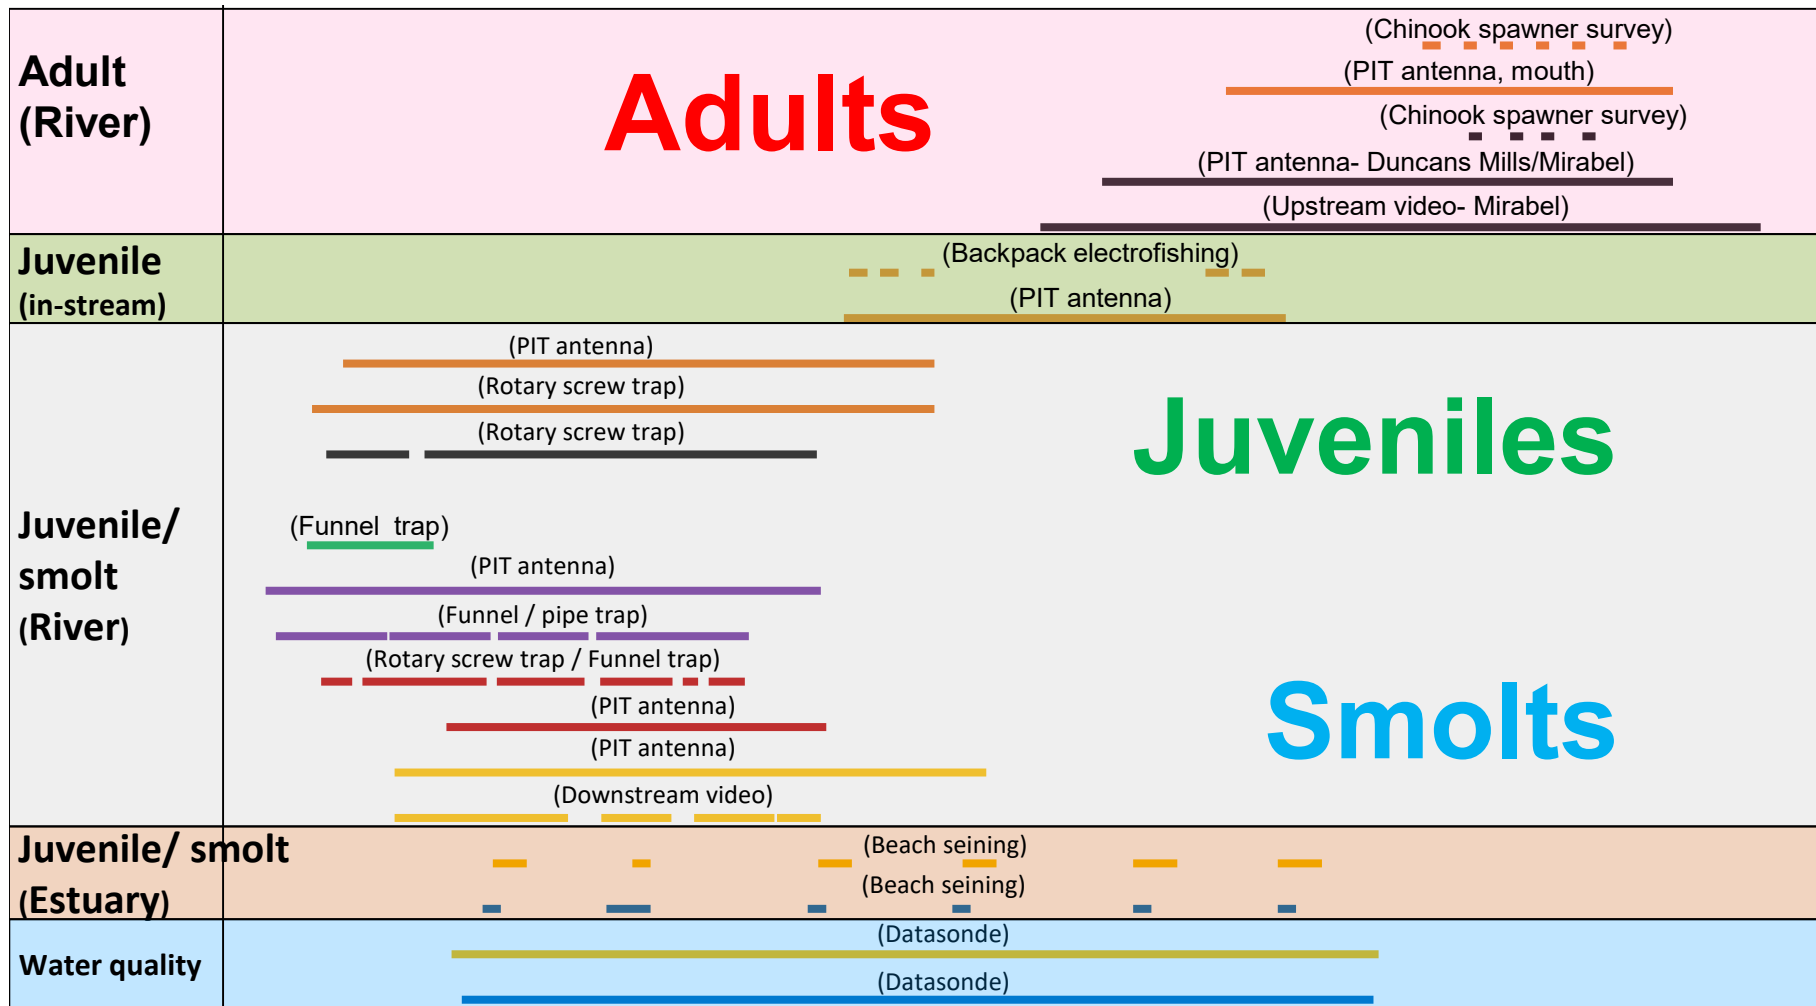
Monitoring Timing and Life Stage

1-Apr 1-May 1-Jun 1-Jul 1-Aug 1-Sep 1-Oct 1-Nov 1-Dec 1-Jan

— Lower estuary — Upper estuary — Austin Creek — Dutch Bill Creek — Mark West Creek — Mainstem — Dry Creek

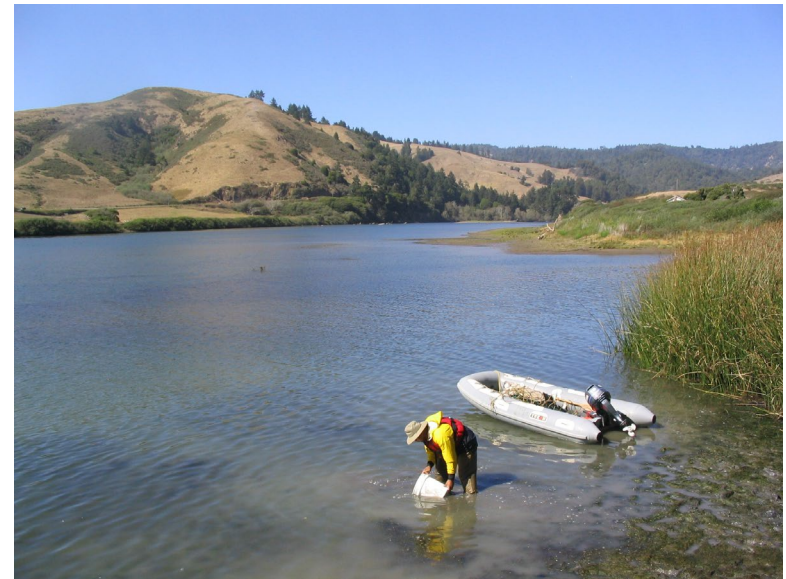
Estuary Reaches & Seine Stations

- Study Area
 - River mouth to Duncans Mills (6 miles)
- Studies began in 2003
- Survey Period: May-Oct
- Fish sampling
 - Beach seine
 - PIT tag steelhead

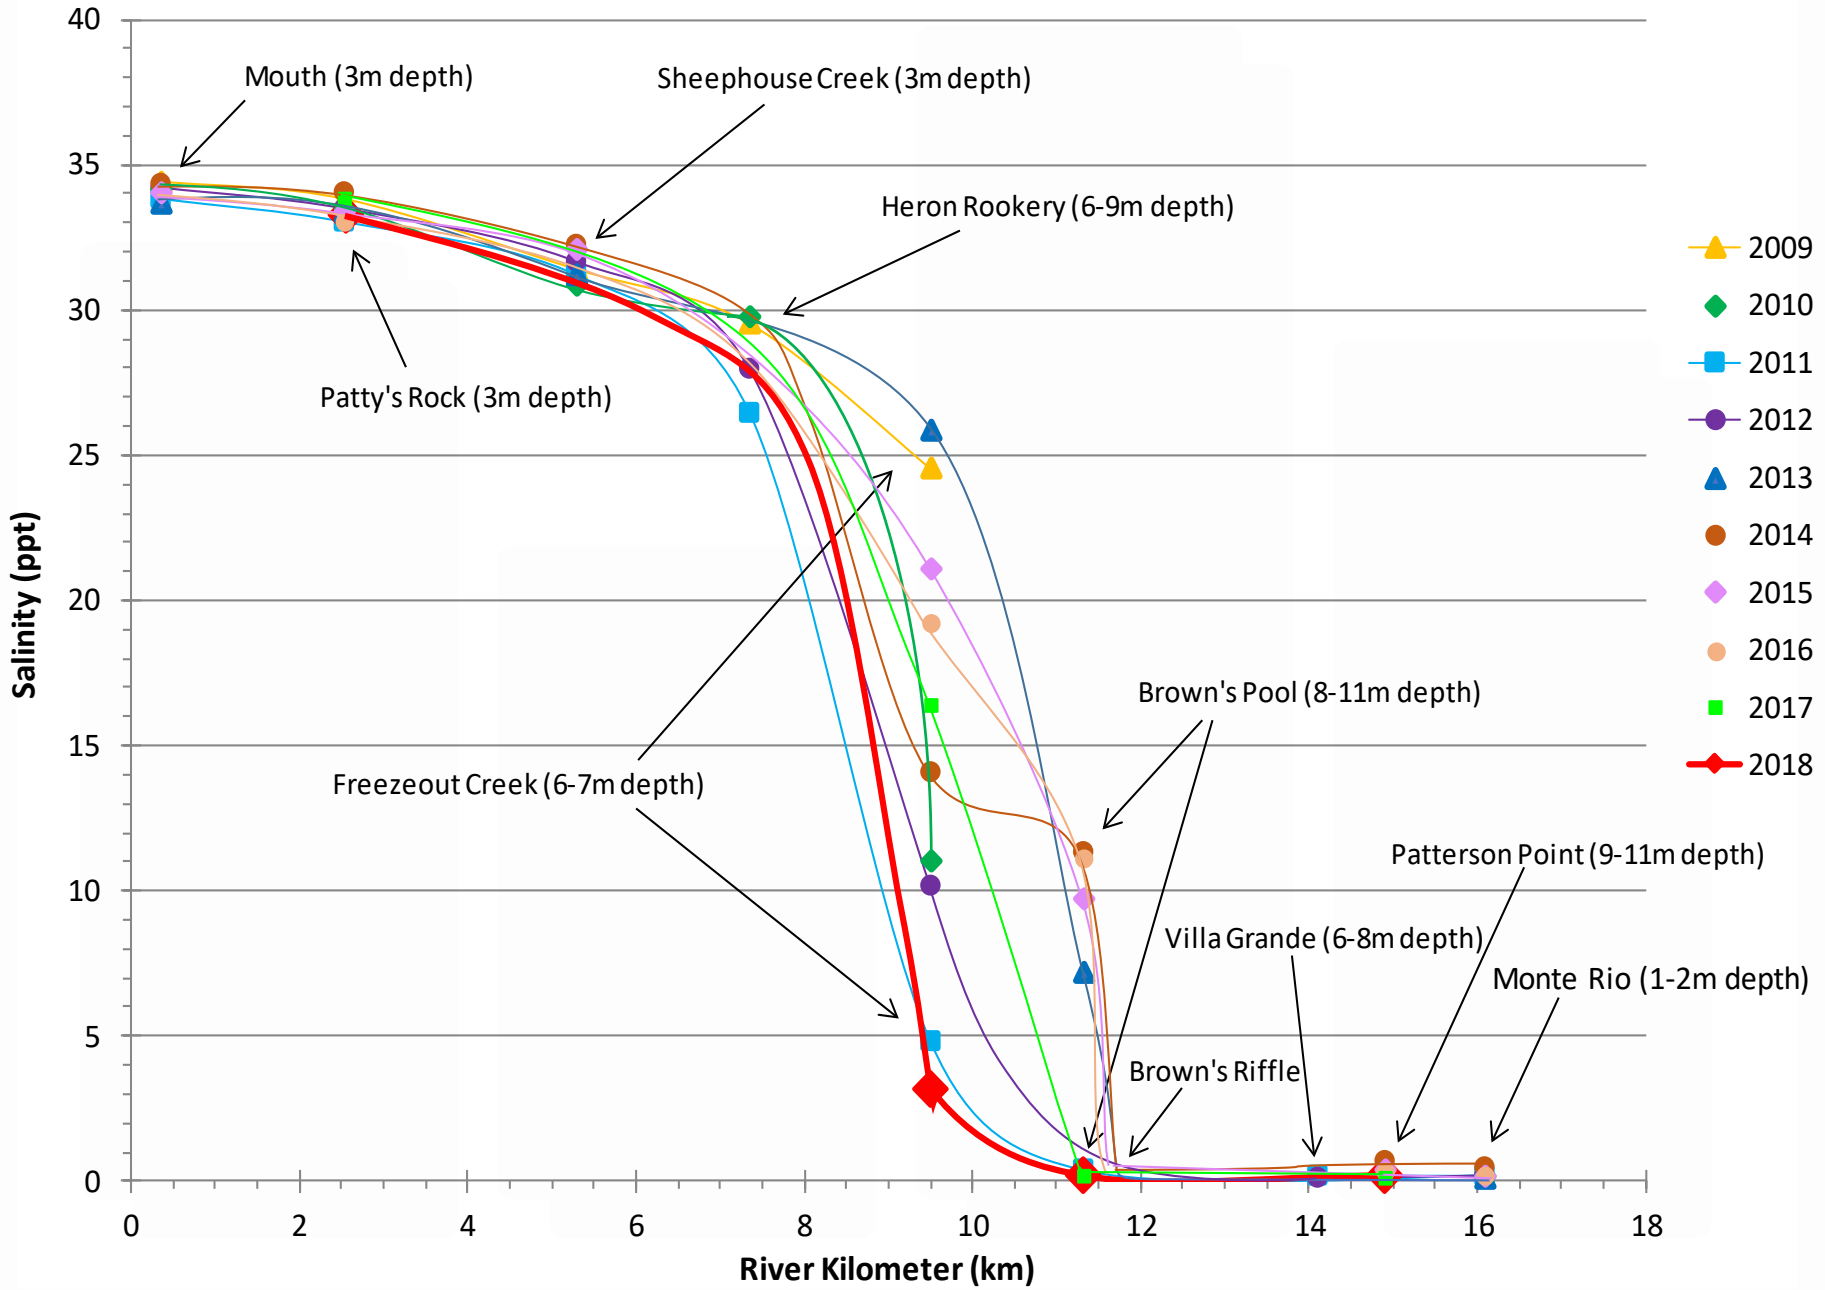
Maximum Annual Observed Salinity by Russian River Estuary Monitoring Station

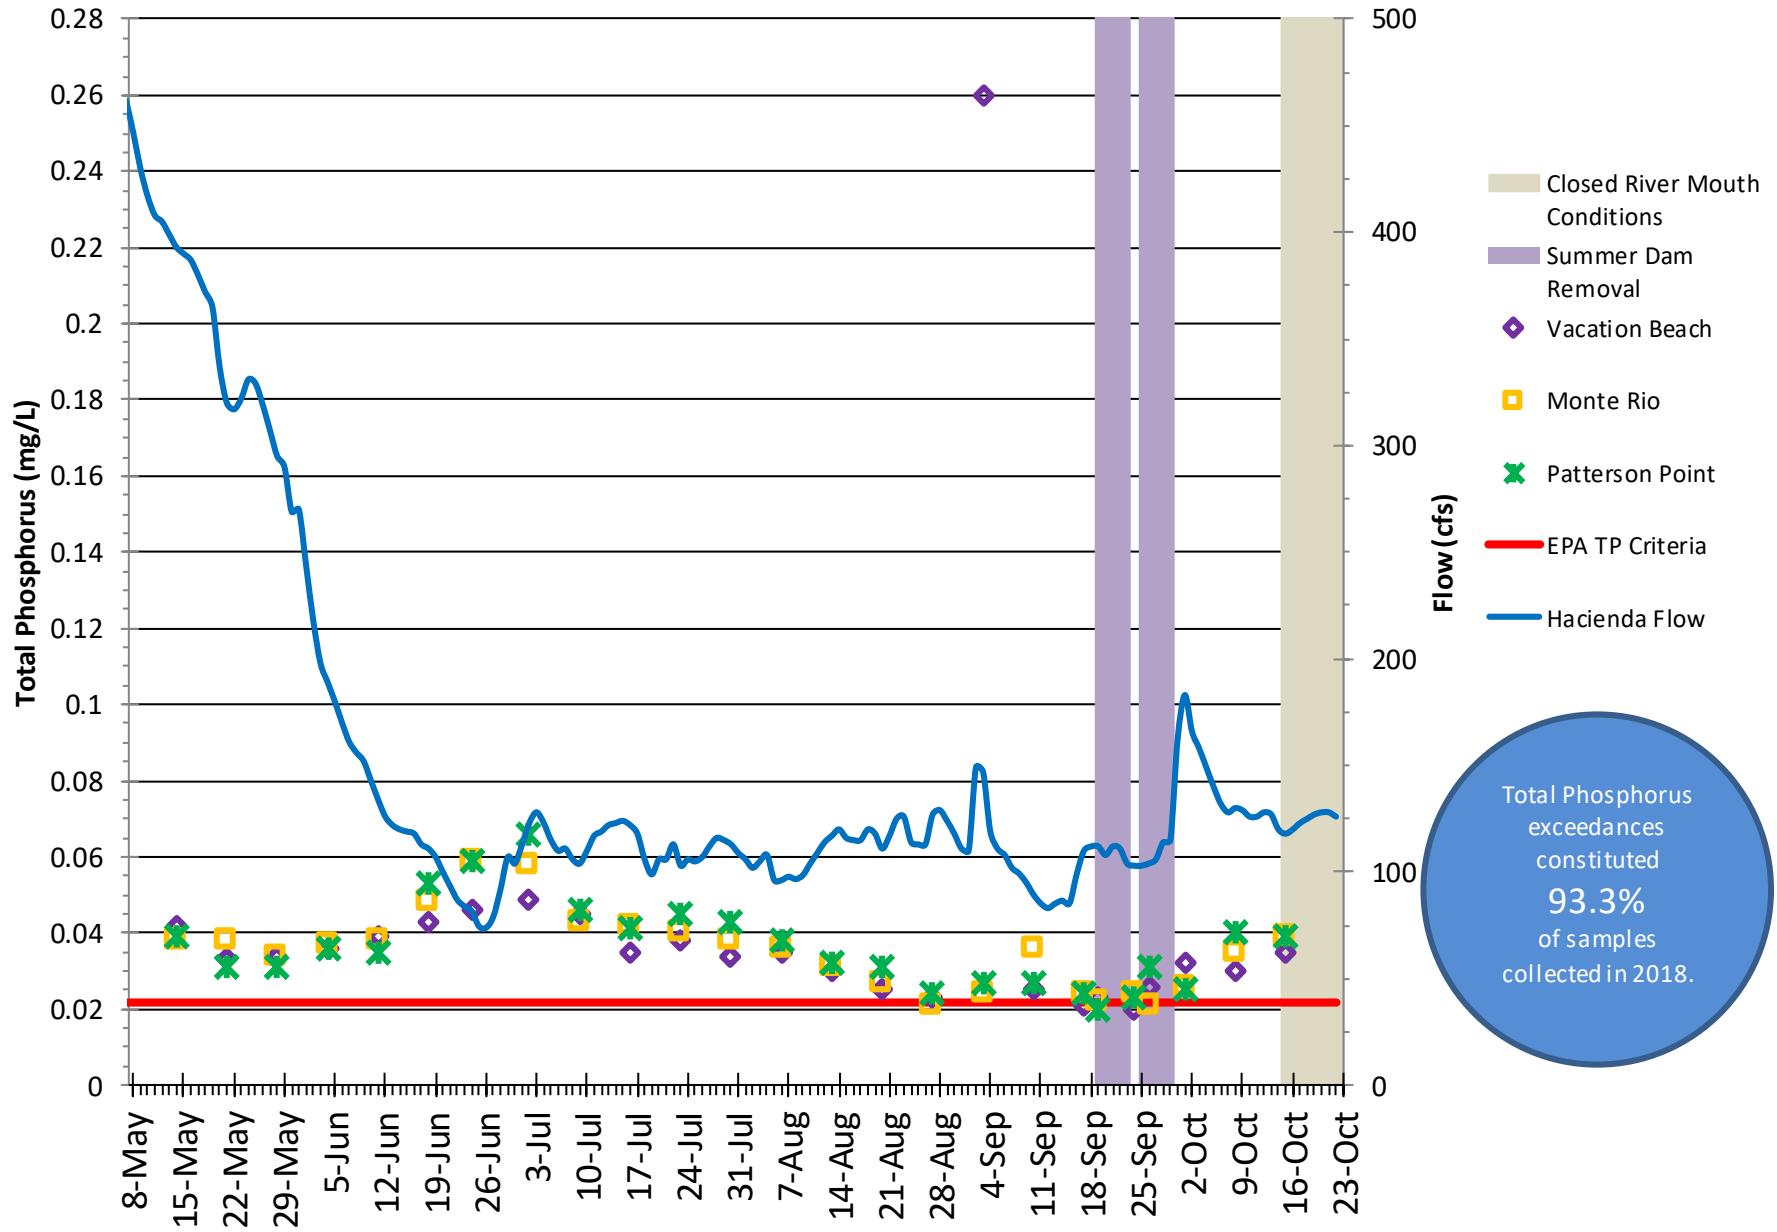
Total Phosphorus - Lower Russian River and Estuary - 2018

Total Phosphorus exceedances constituted 93.3% of samples collected in 2018.

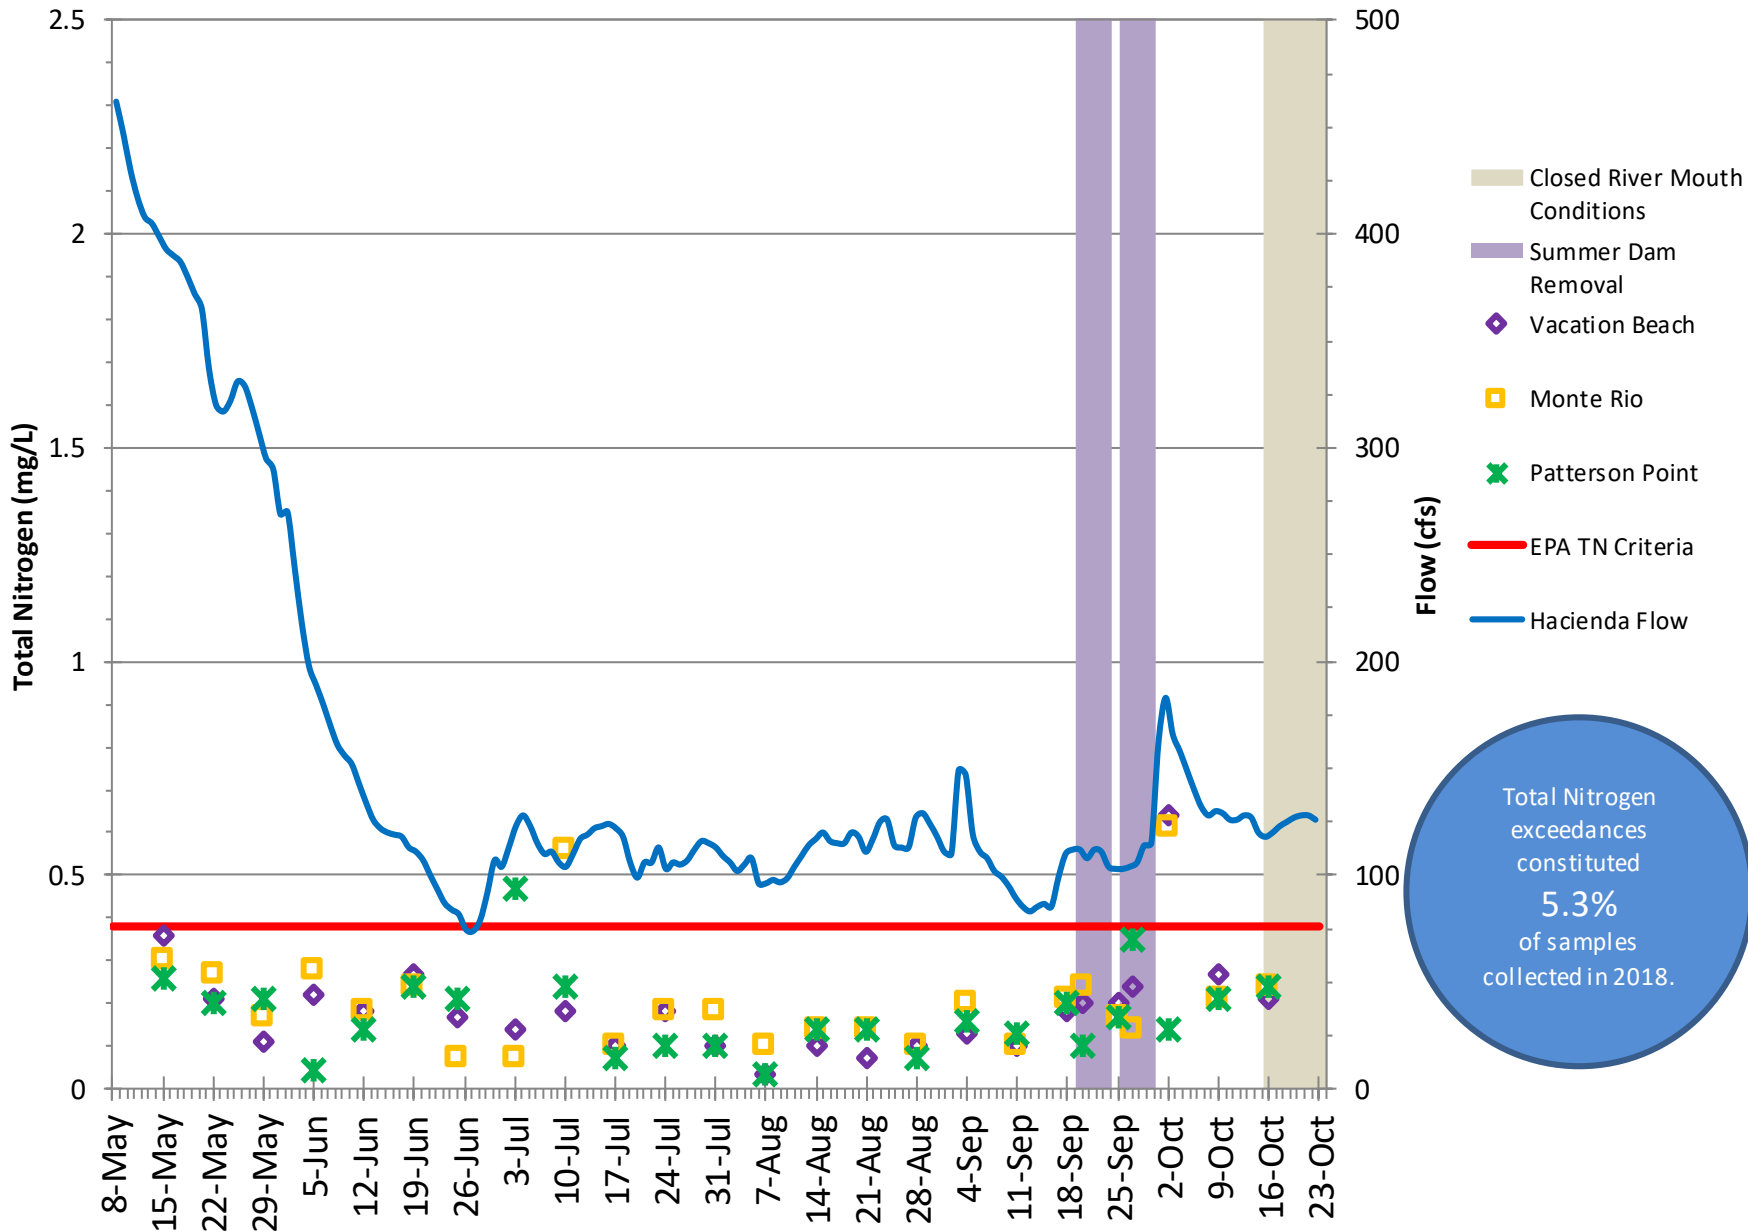
Total Nitrogen - Lower Russian River and Estuary - 2018

Total Nitrogen exceedances constituted 5.3% of samples collected in 2018.

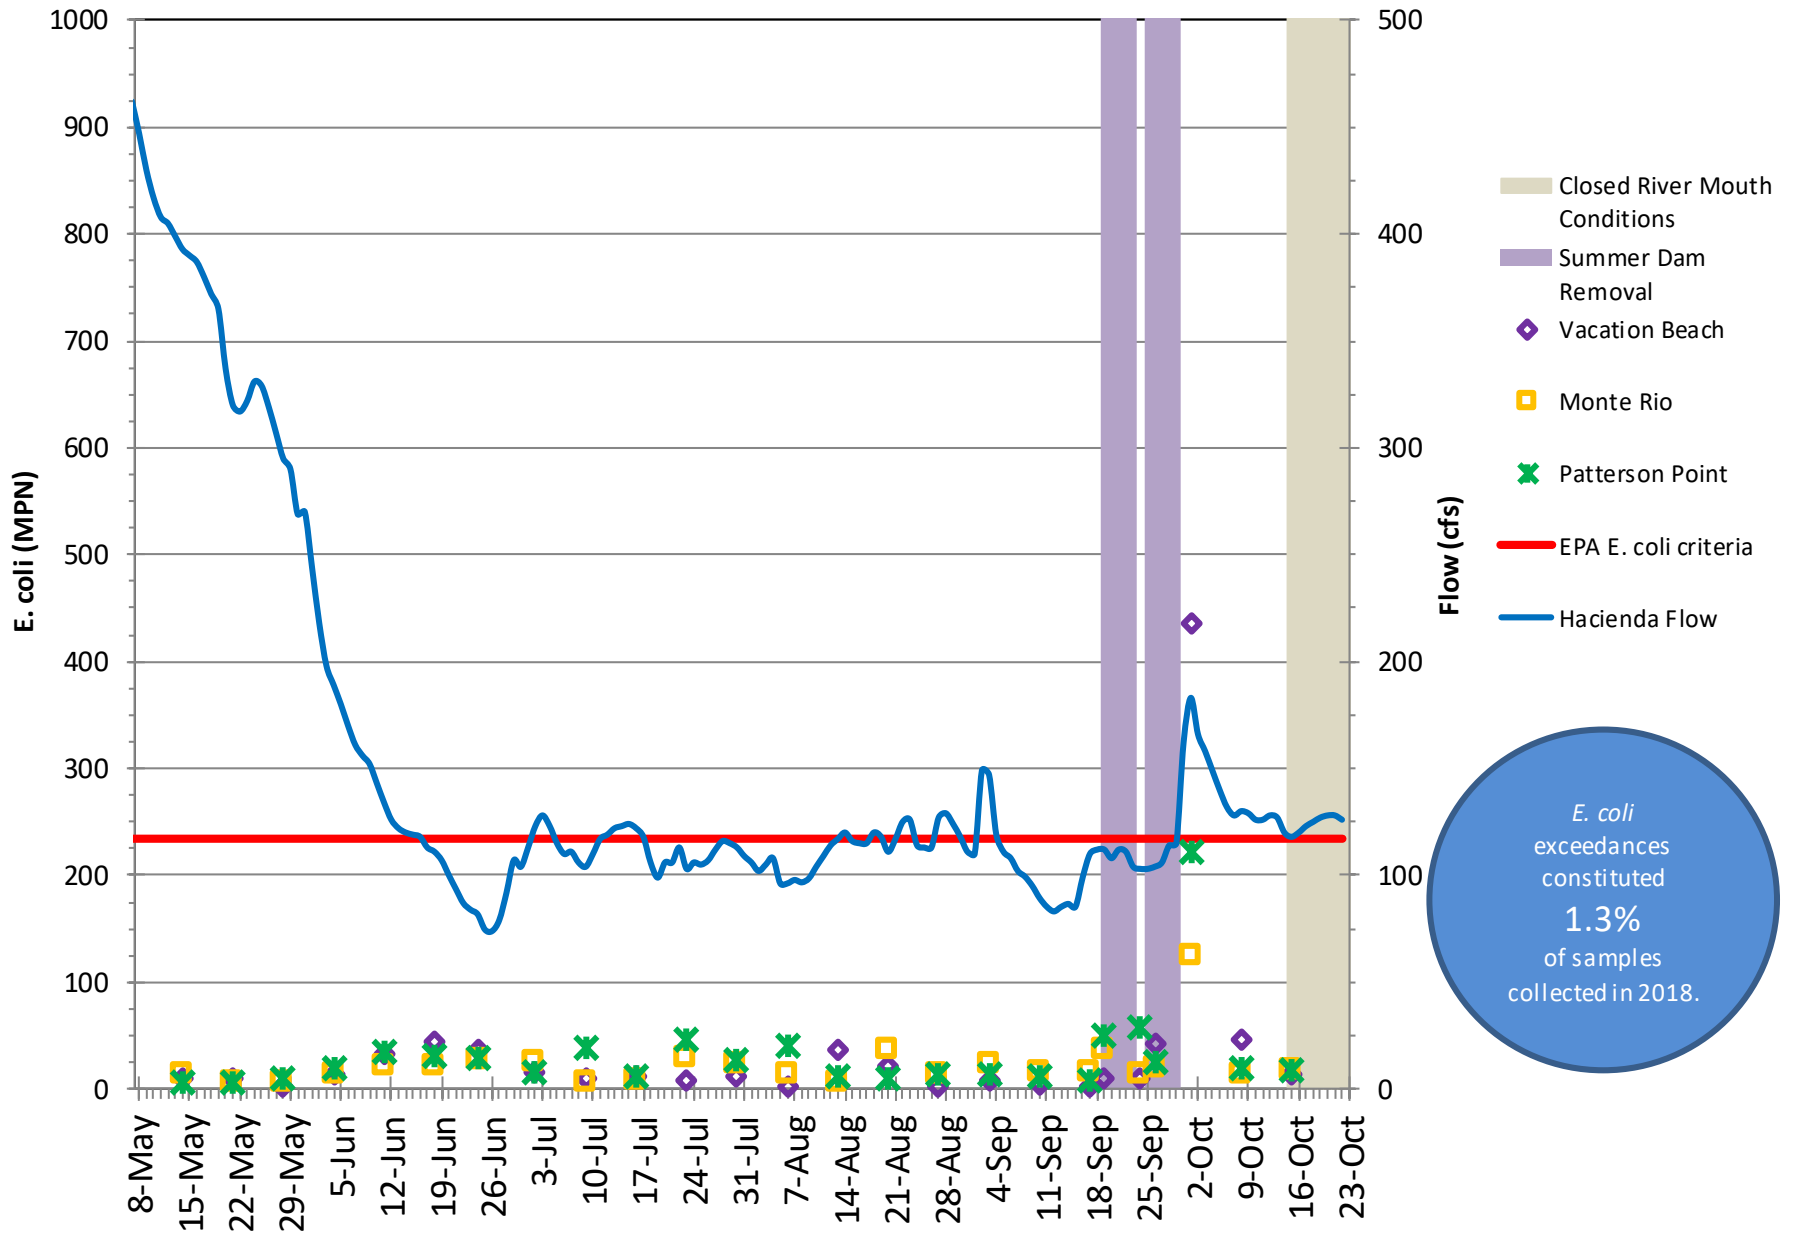
E. coli - Lower Russian River and Estuary - 2018

Estuary Monitoring Season	<i>Escherichia coli</i> (<i>E. coli</i>) Percentage Exceedance
2009	0
2010	N/A
2011	0
2012	0
2013	1.0
2014	6.3
2015	1.9
2016	2.2
2017	1.3
2018	1.3

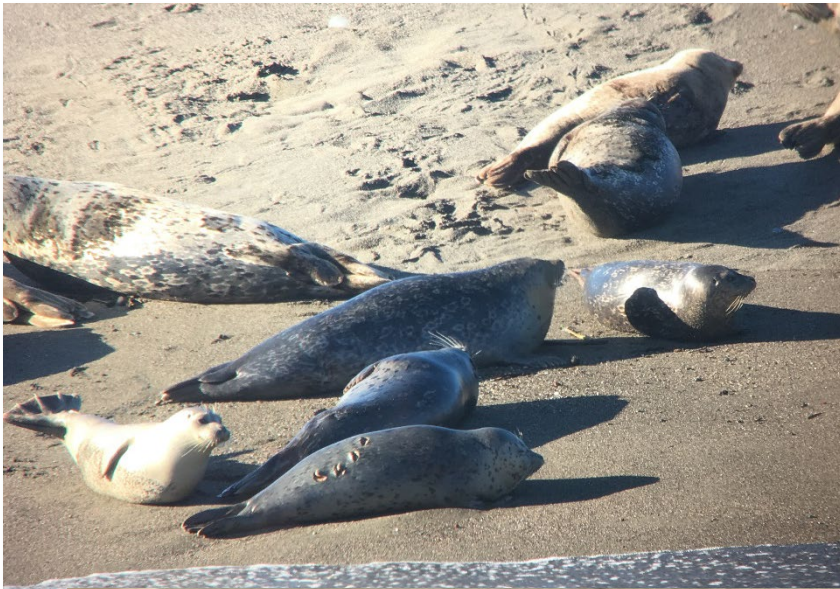
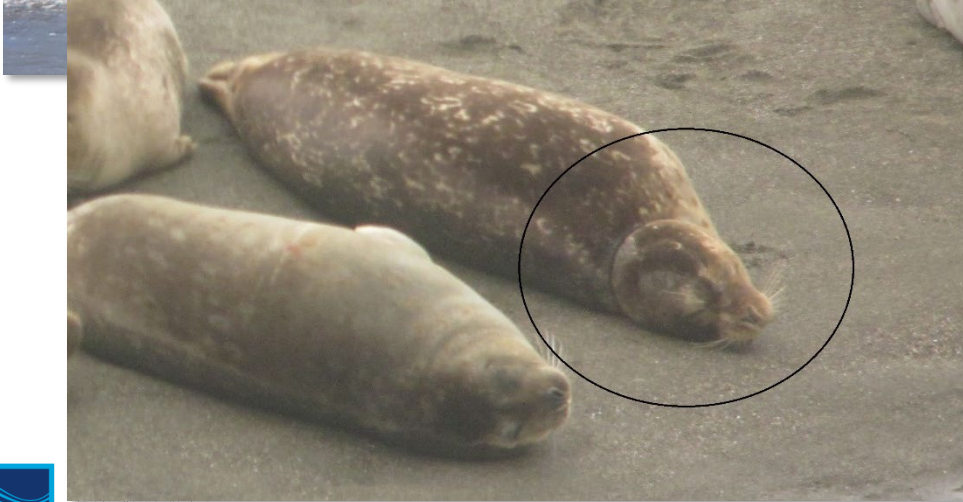
Report injured pinnipeds

SONOMA COUNTY WATER AGENCY - PINNIPED INJURY/MORTALITY REPORT

Initial Observation
Date: 10/16/14
Common name: harbor seal genus: Phoca species: vitalina
First observed: beach/land floating swimming
Condition: alive fresh dead moderate decomposition advanced decomposition mummified/skeletal
 whole carcass partial carcass
Morphological data
Sex: male female unknown
Age class: adult sub-adult yearling pup unknown
Standard length: _____ cm actual estimate
(standard length = measured tip of nose to tip of tail with tape held body, not curvilinear length)

Nature of injury or mortality: Related to SCWA activity human caused (non SCWA) animal caused unknown
Note: in most cases unless you observe the injury or mortality event you will not be able to determine the cause
Description of incident including exact location and potential cause of injury/mortality:
apparent shark bite located on left side pelvic region - size of bite equivalent to V size of seal's rear flipper
