**RUSSIAN RIVER ESTUARY  
ADAPTIVE BEACH MANAGEMENT PLAN  
2022**

May 23, 2022

**ESA REF. # DW01958**

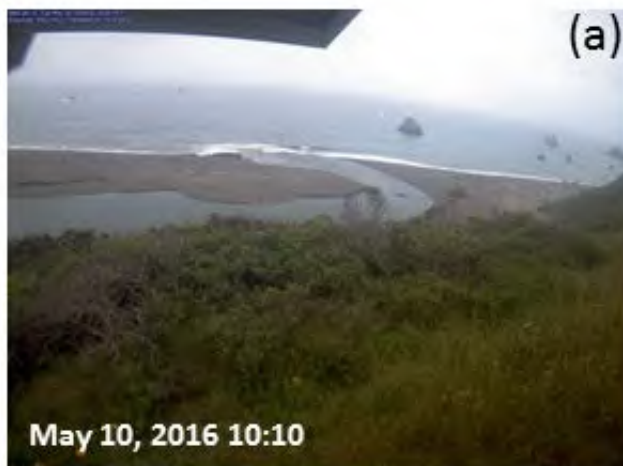
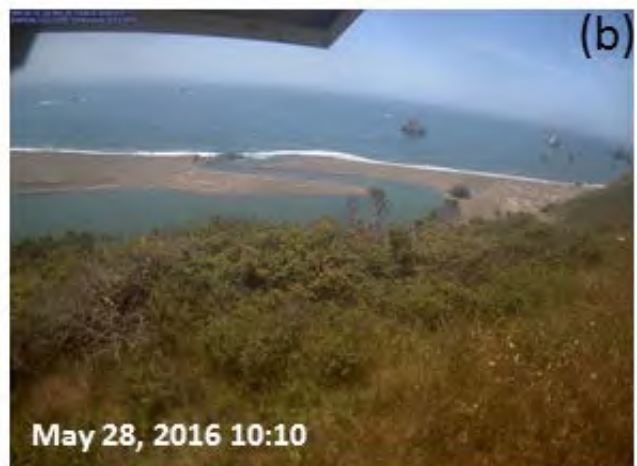
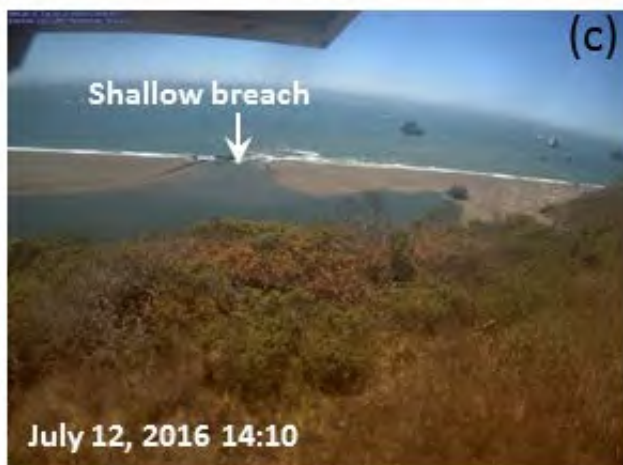
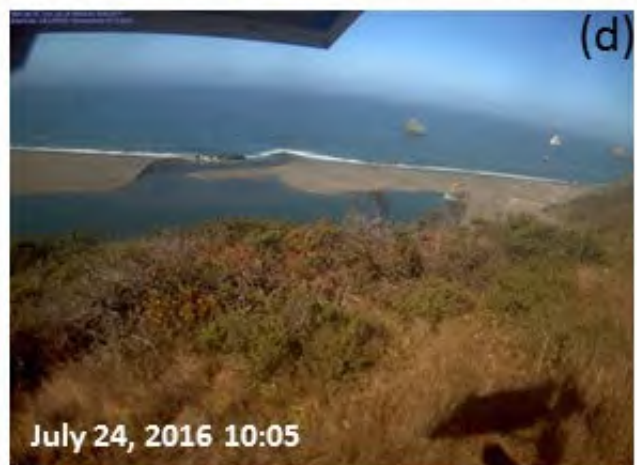
Russian River camera photographs showing some of the muted tidal conditions observed in 2016.

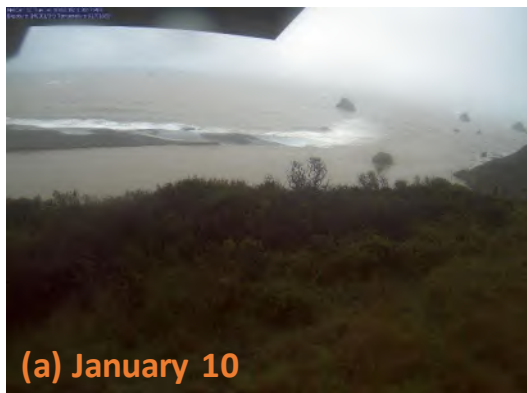
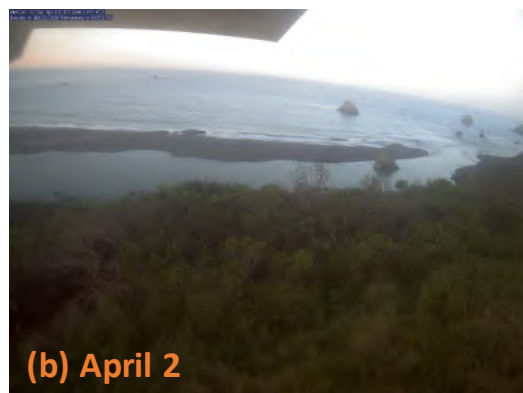
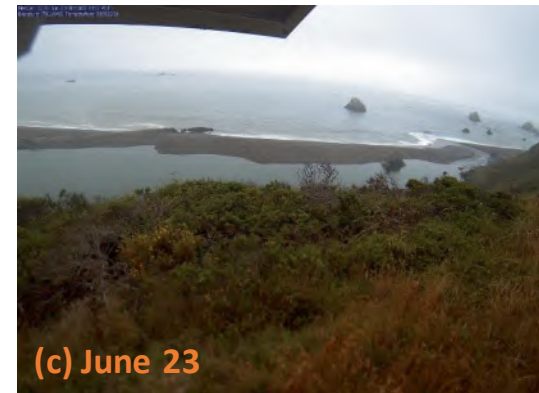
(a) Russian River during fluvial flooding on January 10<sup>th</sup>, 2017, (b) During moderate discharge conditions on April 2<sup>nd</sup>, 2017, and (c) during natural perched conditions on June 23<sup>rd</sup>, 2017.

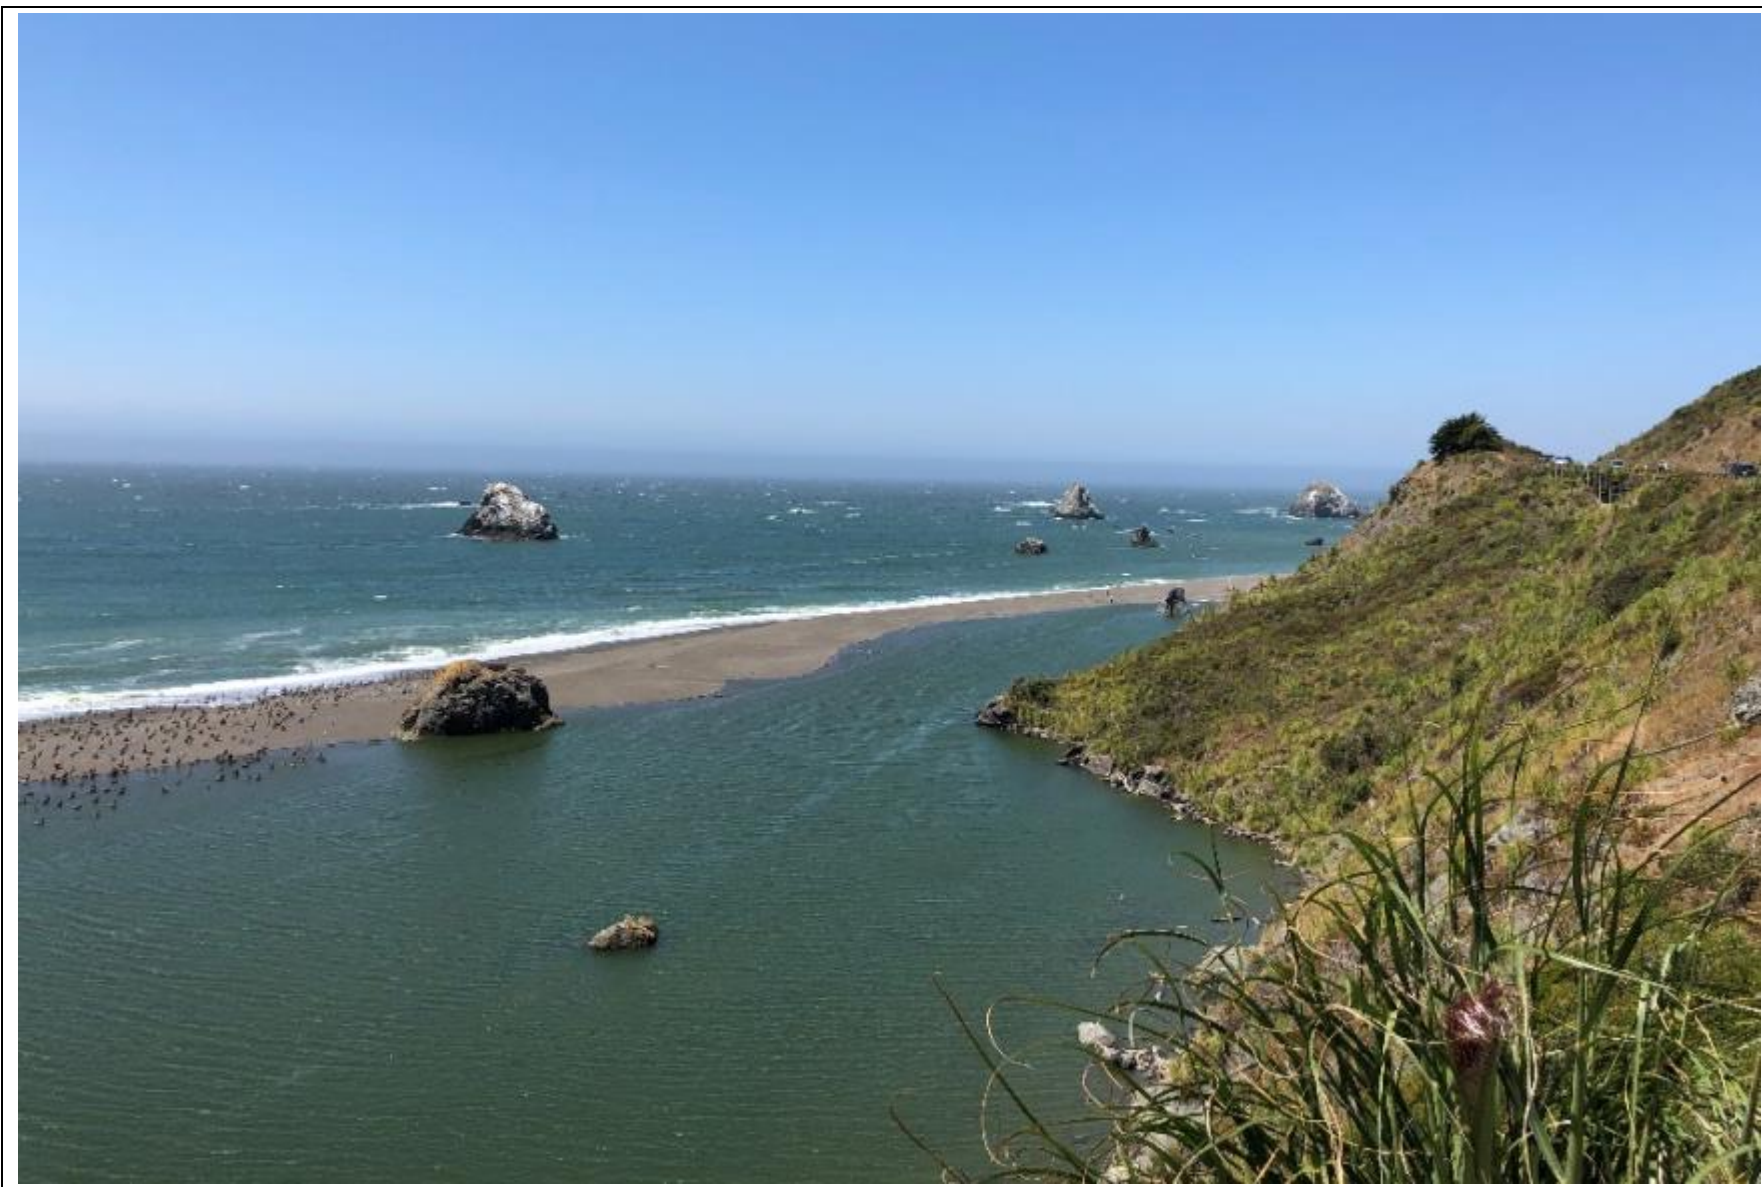
Condition of the beach on July 29<sup>th</sup>, 2019.
