# Appendix 4.1

**RUSSIAN RIVER ESTUARY OUTLET CHANNEL  
ADAPTIVE MANAGEMENT PLAN  
2016**

October 24, 2016

**ESA REF. # DW01958**

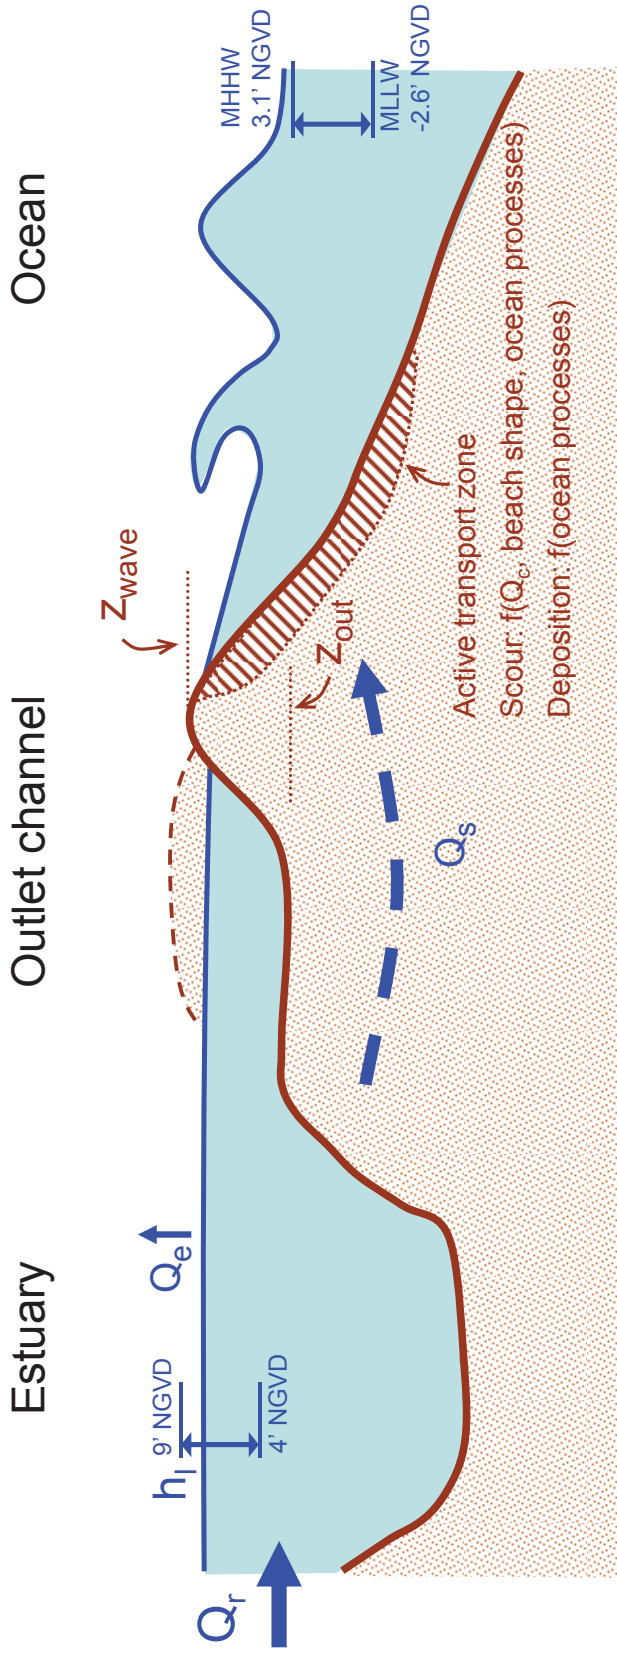
Parameters

- $Z_{out}$  = target channel bed elevation
- $Z_{wave}$  = wave runup elevation;  $f(\text{wave conditions, ocean water level, channel location})$

The breach failure considered as part of the conceptual model and shown in Figure 4 is breaching that occurs when the outlet channel is operating according to the target conditions described above. Breaching is likely to result from two processes, high discharge which scours the channel bed or seepage-induced bed mobilization. Self or artificial breaching after a closure event are not discussed in this section because it is assumed that management actions would be enacted to return the outlet channel to target conditions prior to either of these breach mechanisms occurring. Additionally, breaching by wave overtopping or strong river discharge are not considered because these processes are associated with winter storm events, which are rare during the management period.

A second possible mechanism of breaching is seepage-induced sand mobilization, represented in Figure 4 as an arrow associated with  $Q_s$ . If seepage rates are sufficiently large, the movement of water through the sand can mobilize sand particles where the seepage flow daylight at the ground surface. Piping of groundwater along preferred pathways, which may exist within or adjacent to the jetty, might encourage this process by increasing flow rates through portions of the beach. Although seepage failure has not been observed at the Russian River estuary, it has been observed at other estuaries including Crissy Field (Battalio et al 2006) and others (Kraus et al 2002). Seepage failure may simultaneously accompany other breach mechanisms and hence be difficult to identify on its

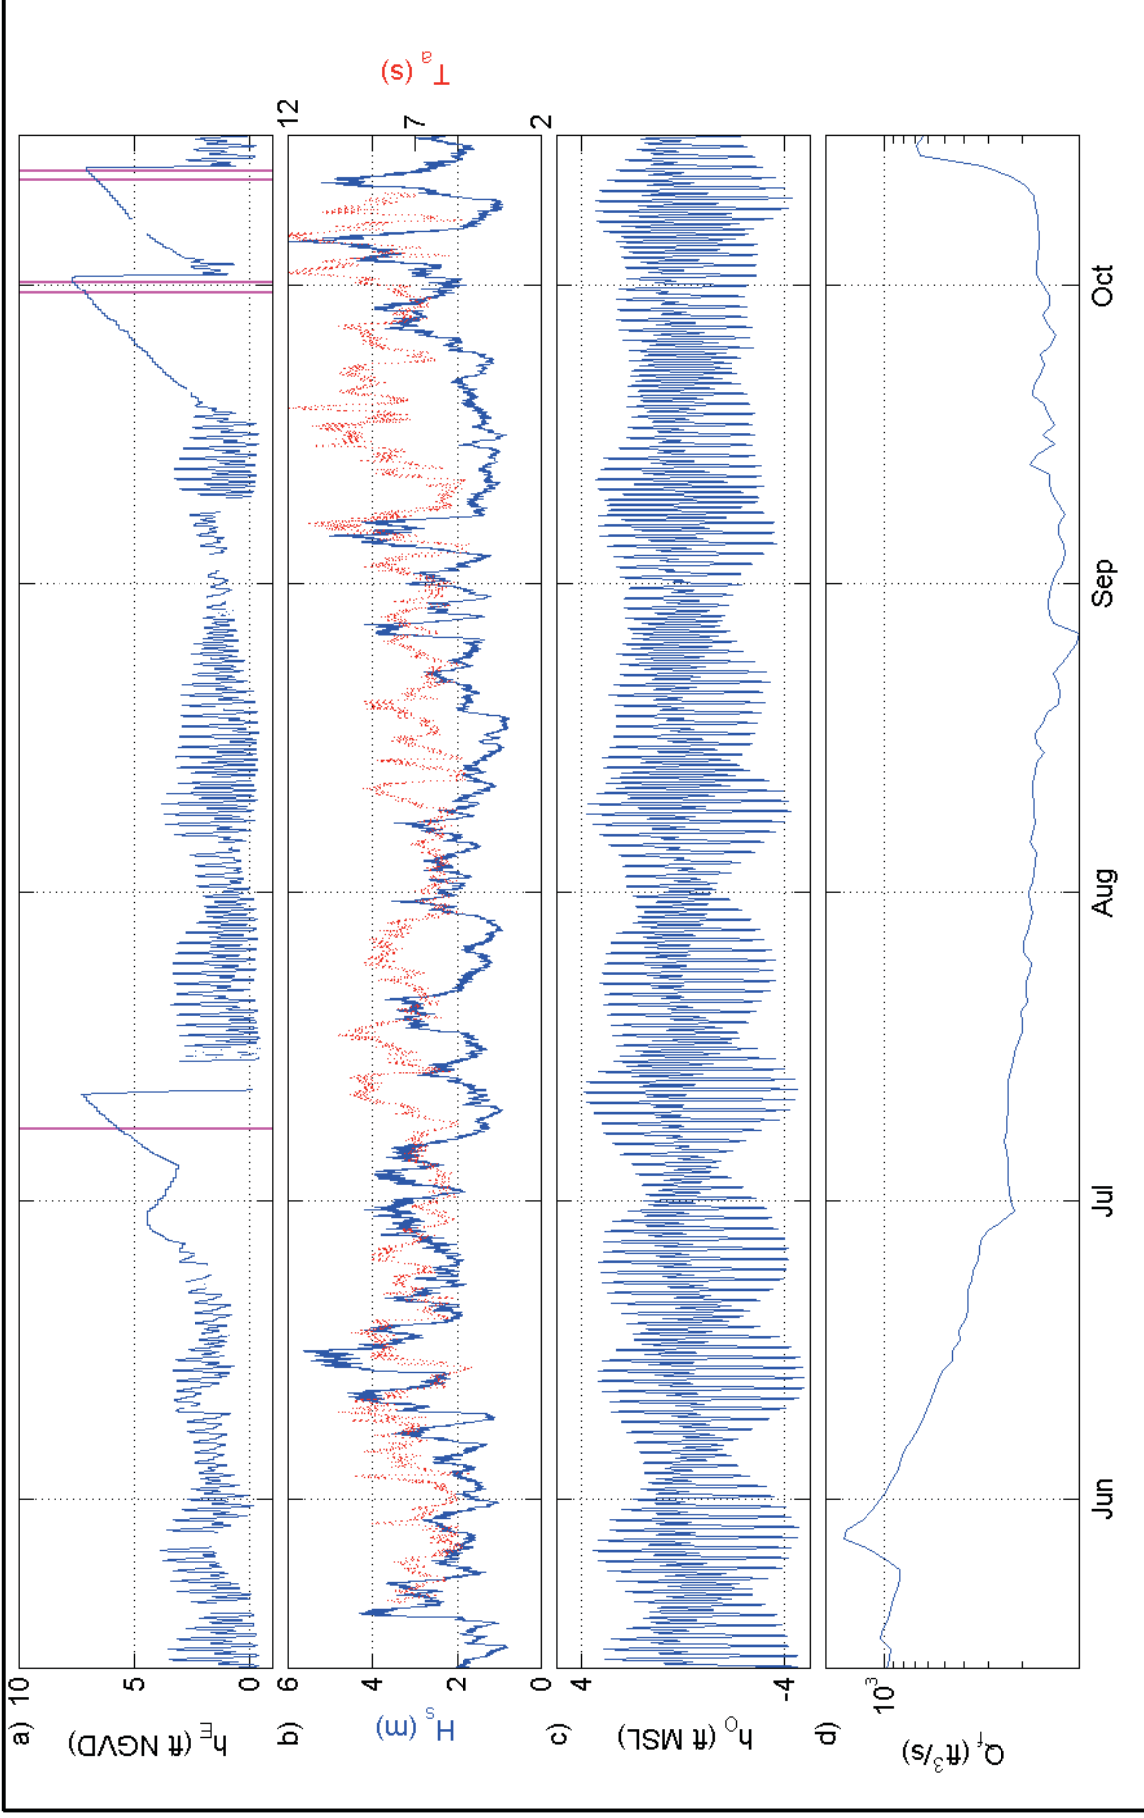
Figure 1  
 Russian River Estuary Outlet Channel Management Plan  
 Estuary and Ocean Conditions, May 15 - October 15 2010

Sources:  
 a)  $h_e$  = estuary water level (SCWA); pink bar = mmgt action  
 b)  $H_s$  = sig. wave height;  $T_s$  = avg. wave period (CDIP, Pt. Reyes, #029)  
 c)  $h_o$  = ocean water level (NOAA, Pt. Reyes #9415020)  
 d)  $Q_r$  = river discharge (USGS, Guerneville #11467000)

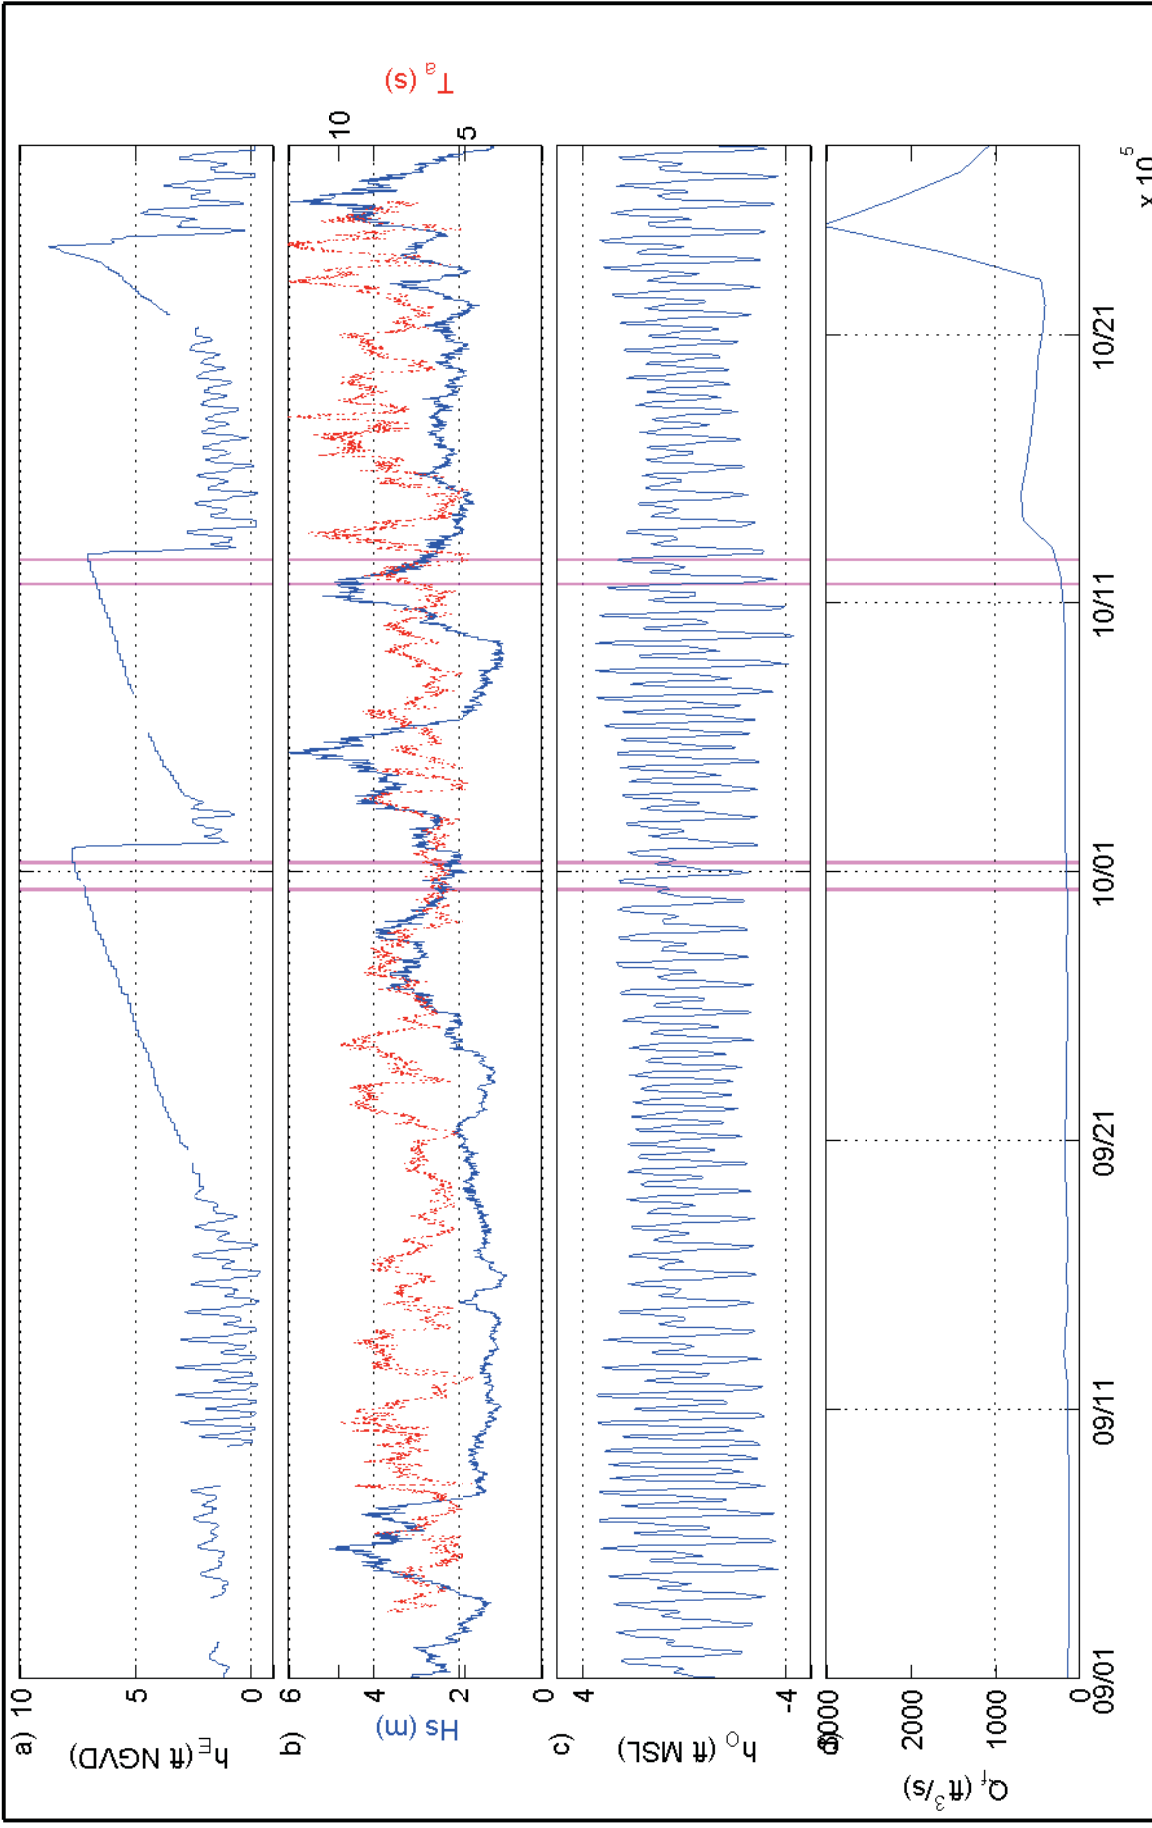
Figure 6  
 Russian River Estuary Outlet Channel Management Plan  
 Estuary and Ocean Conditions, September - October 2010

Sources:  
 a)  $h^E$  = estuary water level (SCWA); pink bar = mnngt action  
 b)  $H_s$  = sig. wave height;  $T_s$  = avg. wave period (CDIP, Pt. Reyes, #029)  
 c)  $h^o$  = ocean water level (NOAA, Pt. Reyes #9415020)  
 d)  $Q_r$  = river discharge (USGS, Guerneville #11467000)

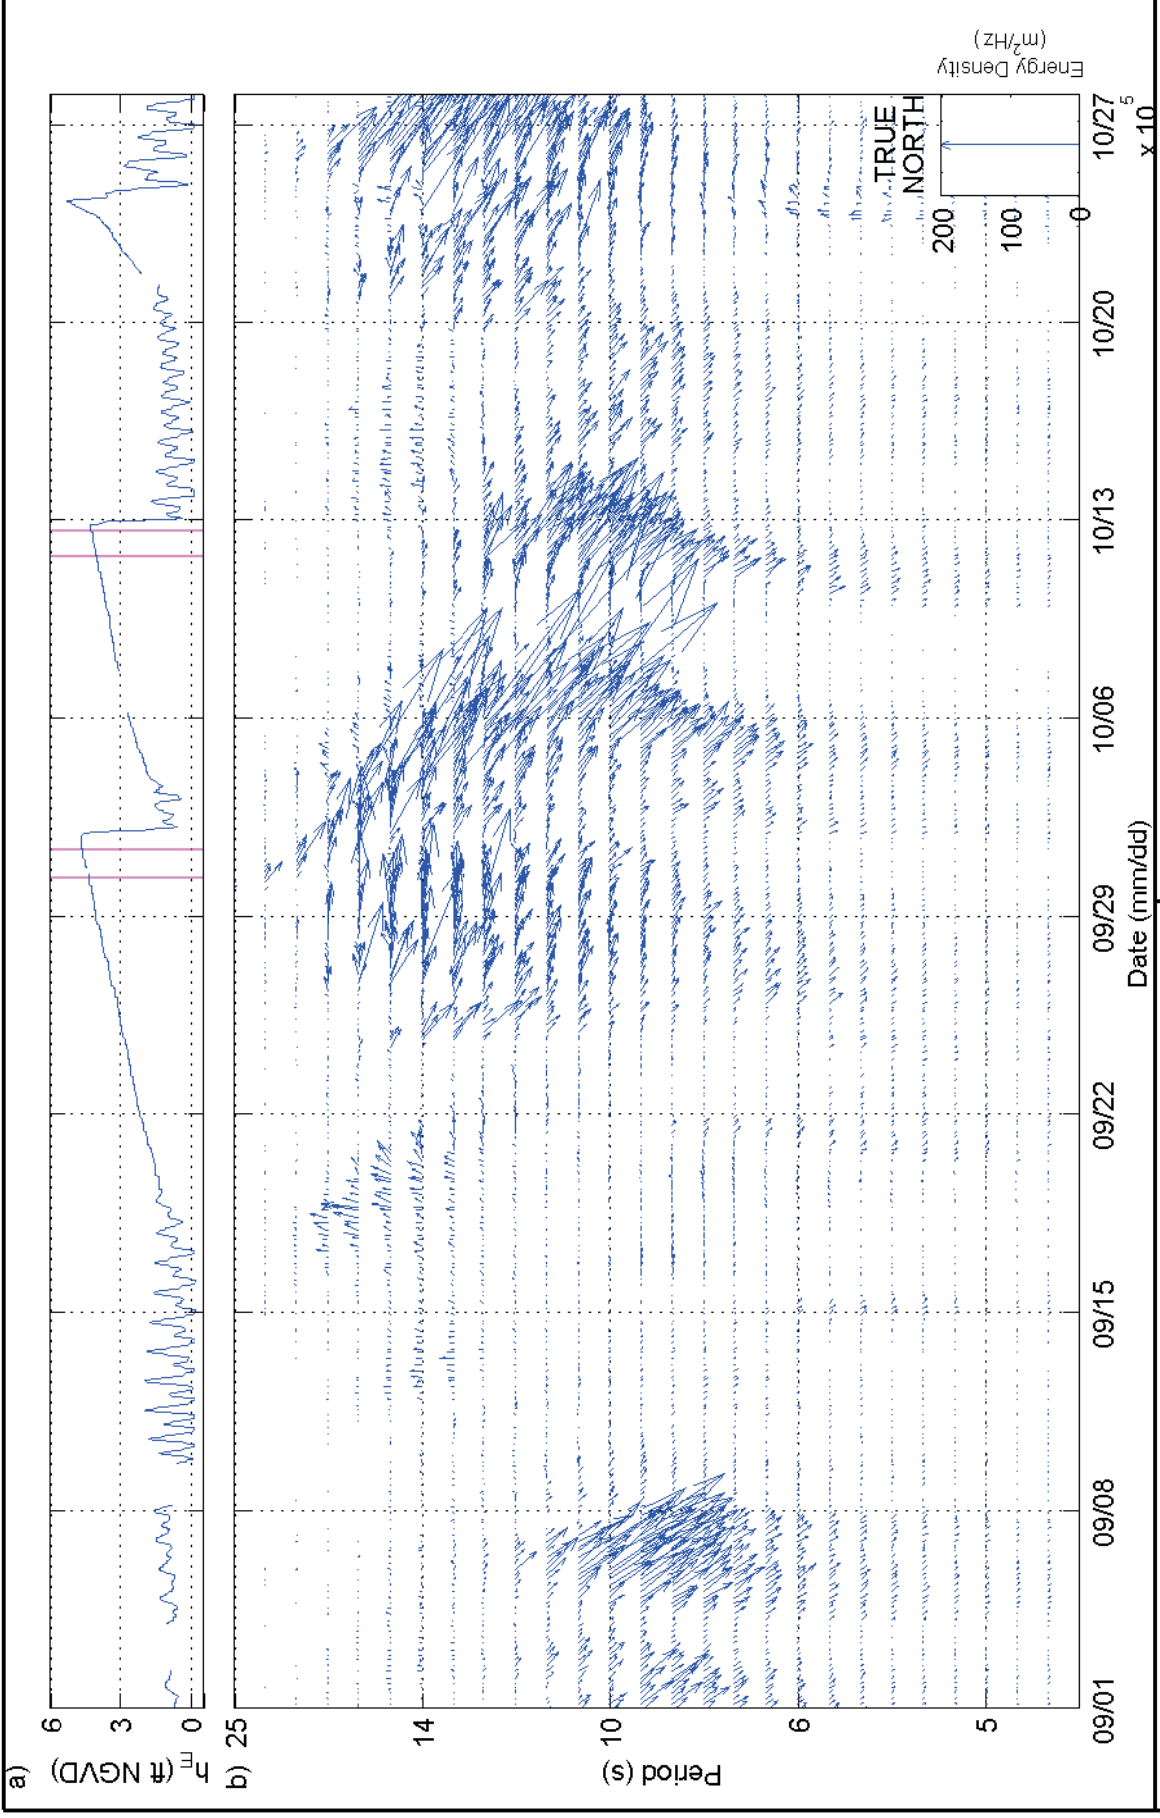
Figure 7  
 Russian River Estuary Outlet Channel Management Plan  
 Estuary Water Level and Wave Energy/Direction Spectrum  
 September-October 2010

Sources:  
 a)  $h_E$  = estuary water level (SCWA); pink bar = mnngt action  
 b) Wave magnitude and direction (CDIP, Pt. Reyes, #029)

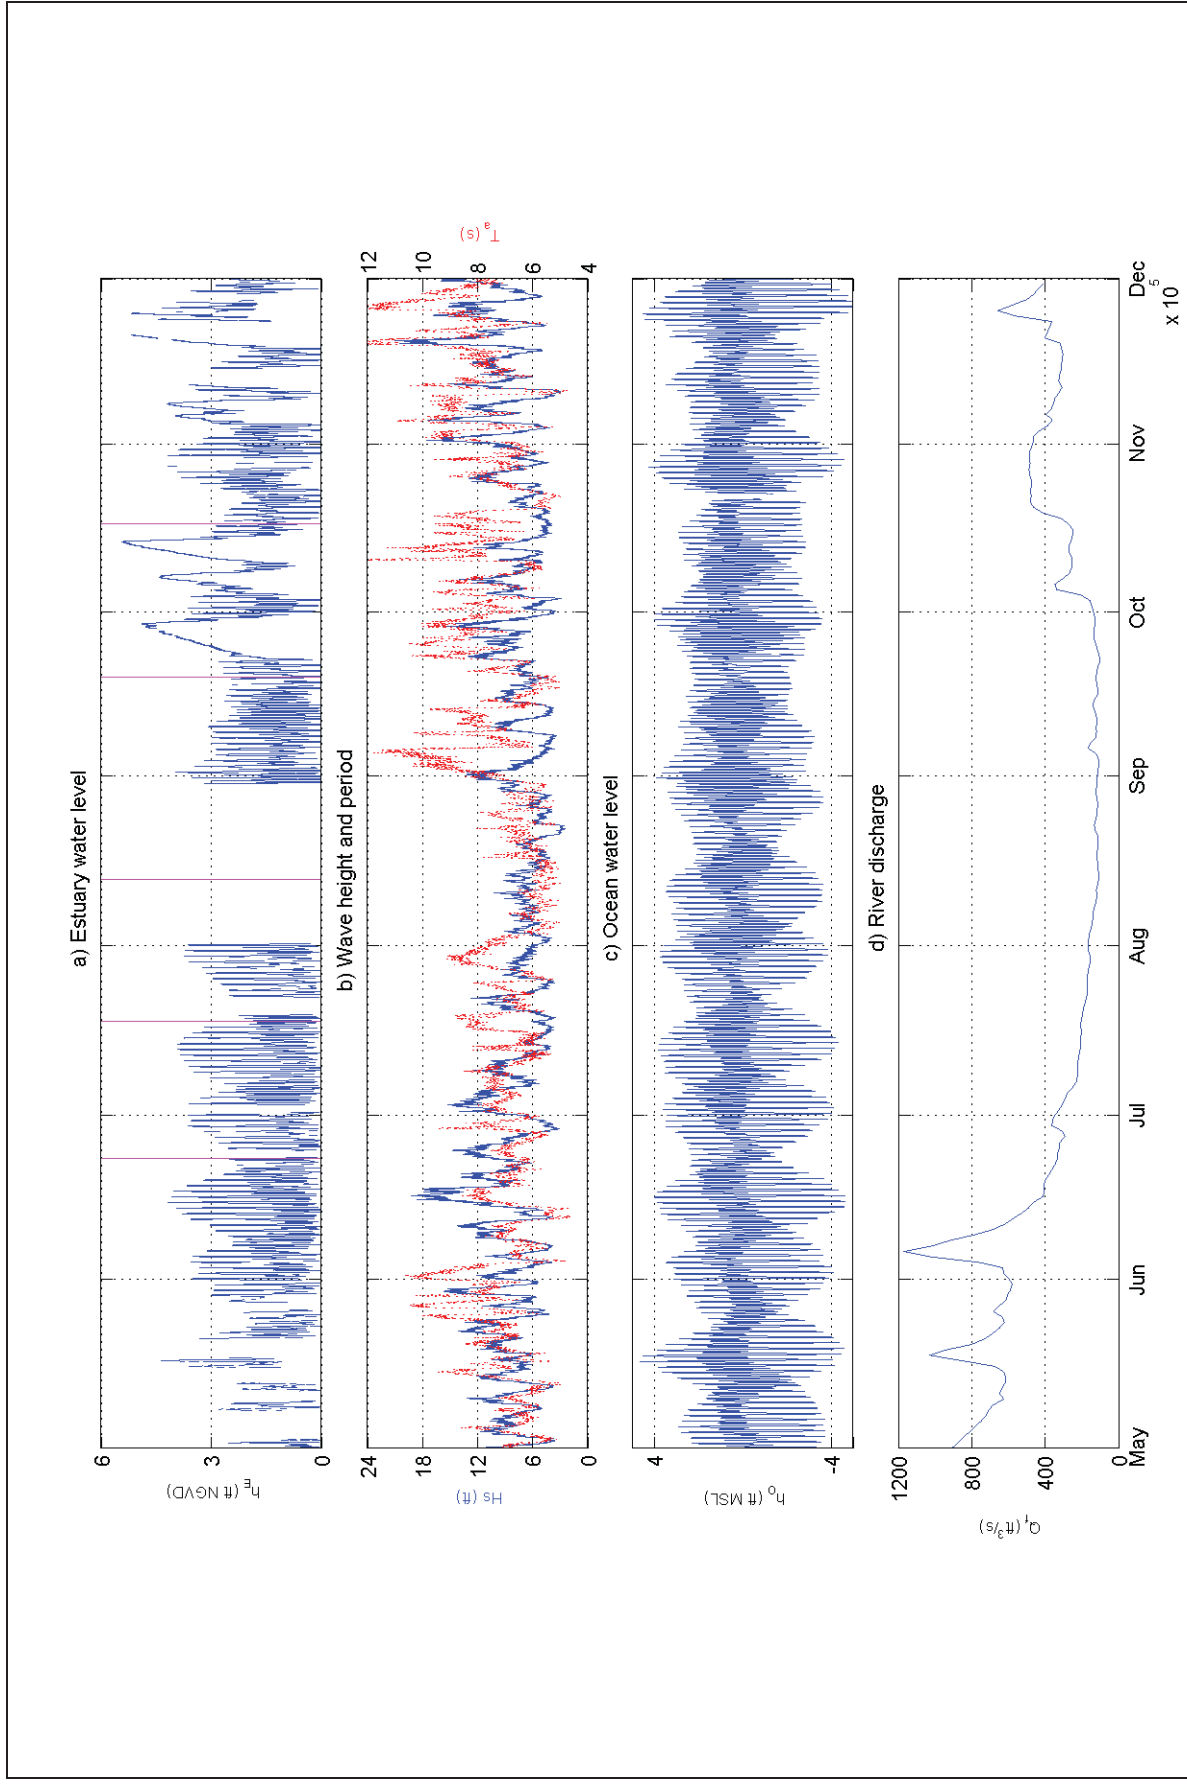
**Figure 1**  
**Estuary, Ocean, and River Conditions**  
**May - November 2011**

a)  $h_E$ =estuary water level (SCWA); pink bar = beach survey  
 b)  $H_s$ =sig. wave height;  $T_a$ =avg. wave period (CDIP, Pt. Reyes, #029)  
 c)  $h_o$ =ocean water level (NOAA, Pt. Reyes #9415020)  
 d)  $Q_r$ =river discharge (USGS, Guerneville #11467000)

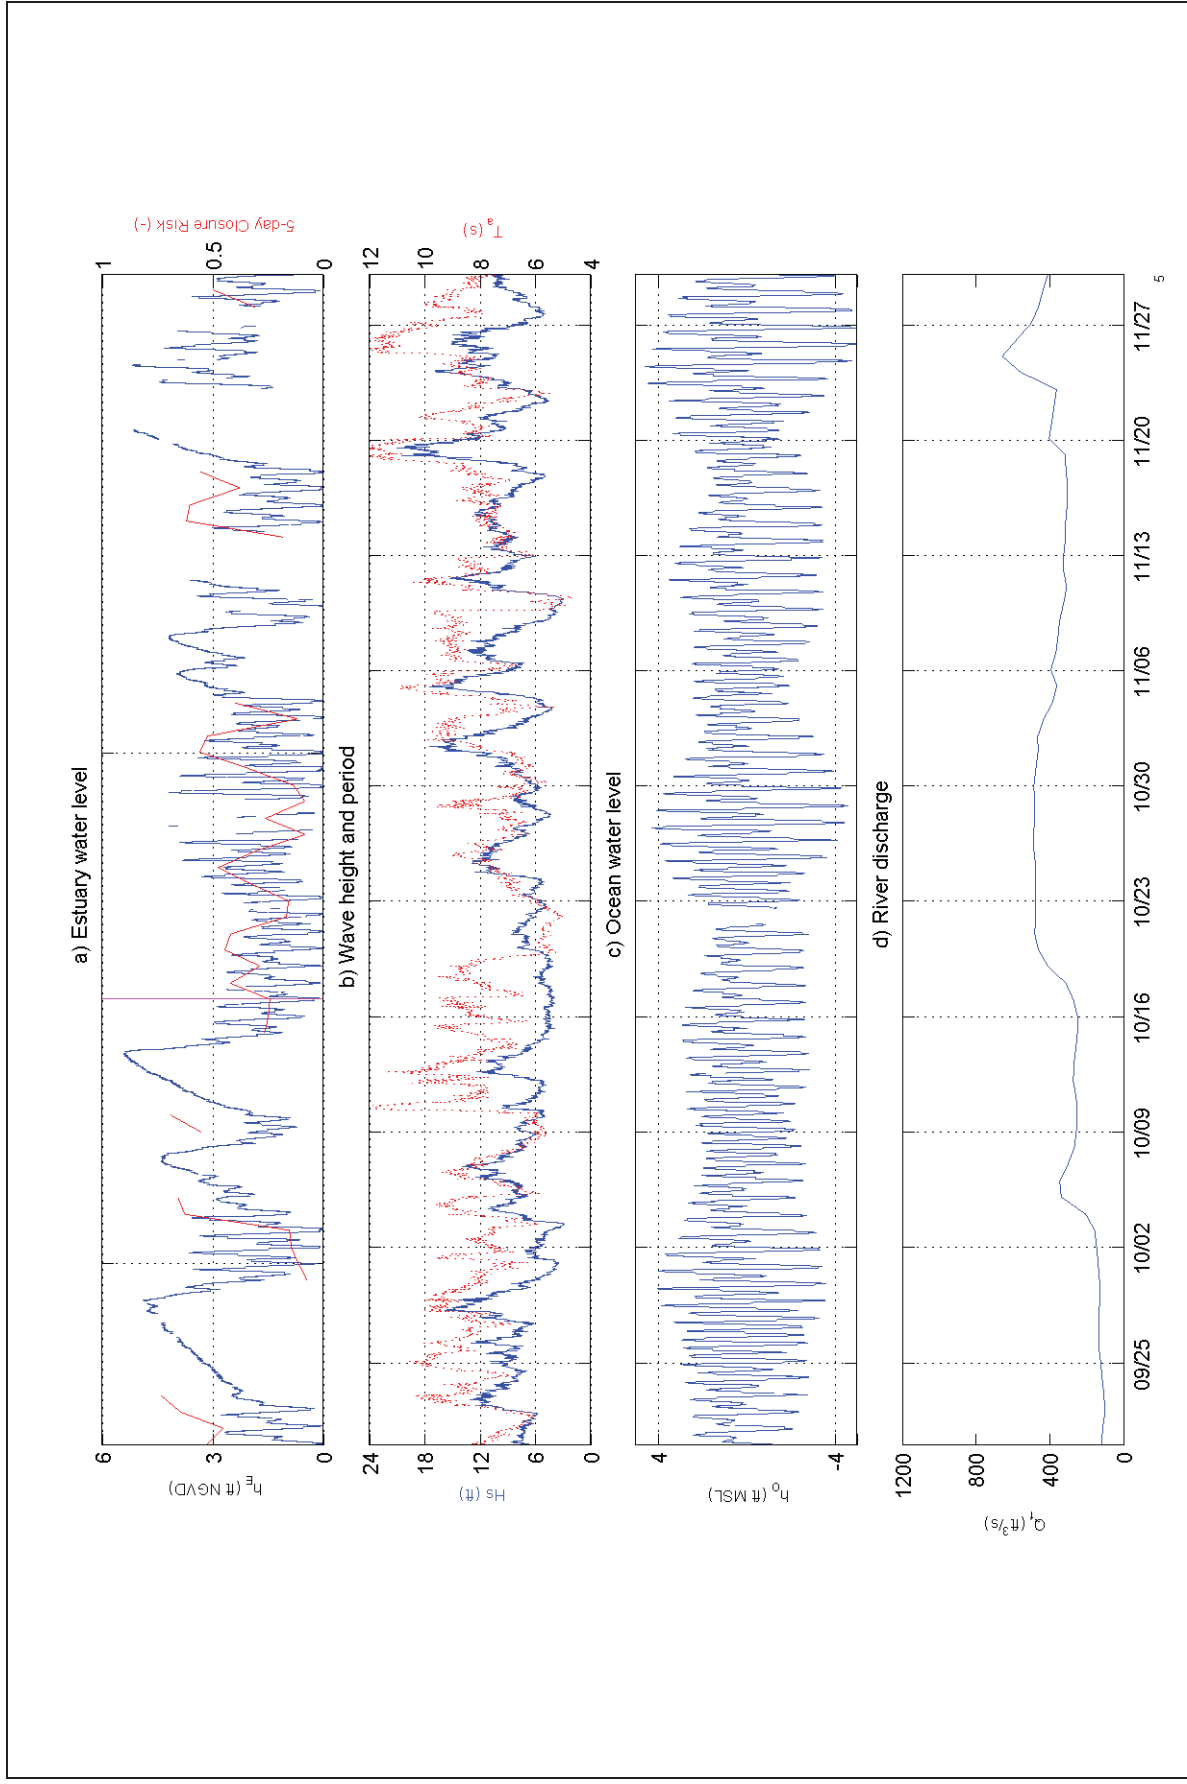
**Figure 2**  
**Estuary, Ocean, and River Conditions**  
**September - November 2011**

a)  $h_E$ =estuary water level (SCWA); pink bar = beach survey  
 b)  $H_s$ =sig. wave height;  $T_a$ =avg. wave period (CDIP, Pt. Reyes, #029)  
 c)  $h_o$ =ocean water level (NOAA, Pt. Reyes #9415020)  
 d)  $Q_r$ =river discharge (USGS, Guerneville #11467000)

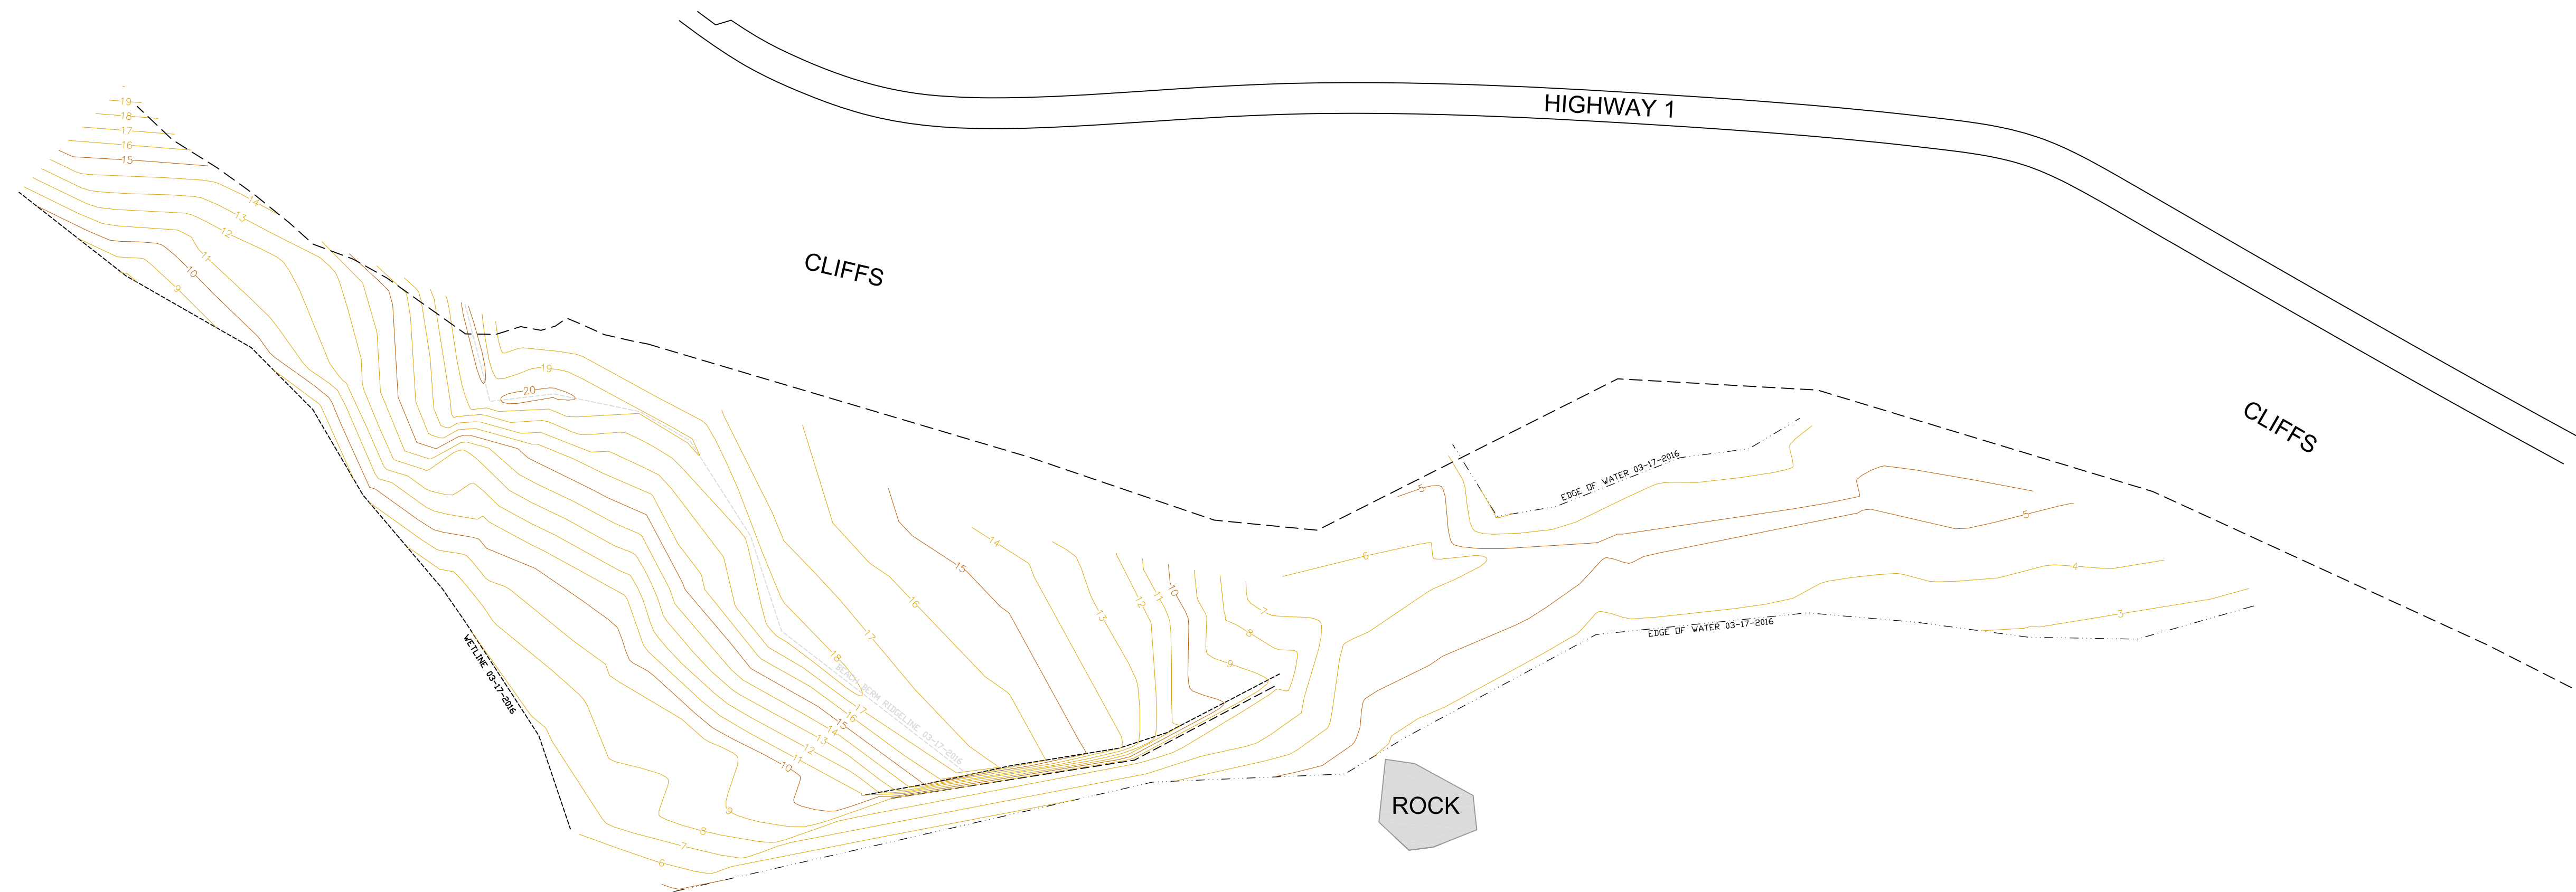
SCALE: AS NOTED	APPROVED DEPUTY CHIEF ENGR:	RUSSIAN RIVER INSTREAM FLOW RESTORATION (RRIFR) PROGRAM MONTHLY SURVEY OF BEACH TOPOGRAPHY AND OUTLET CHANNEL: Feb. 18, 2016	
				DATE: AS NOTED	SUBMITTED		
				DRAWN: EKM	DESIGNED		
				CHECKED: JRM			
NO.	DATE	BY		FILE NAME:		DRAWING NUMBER	SHEET NO. 1 OF 1

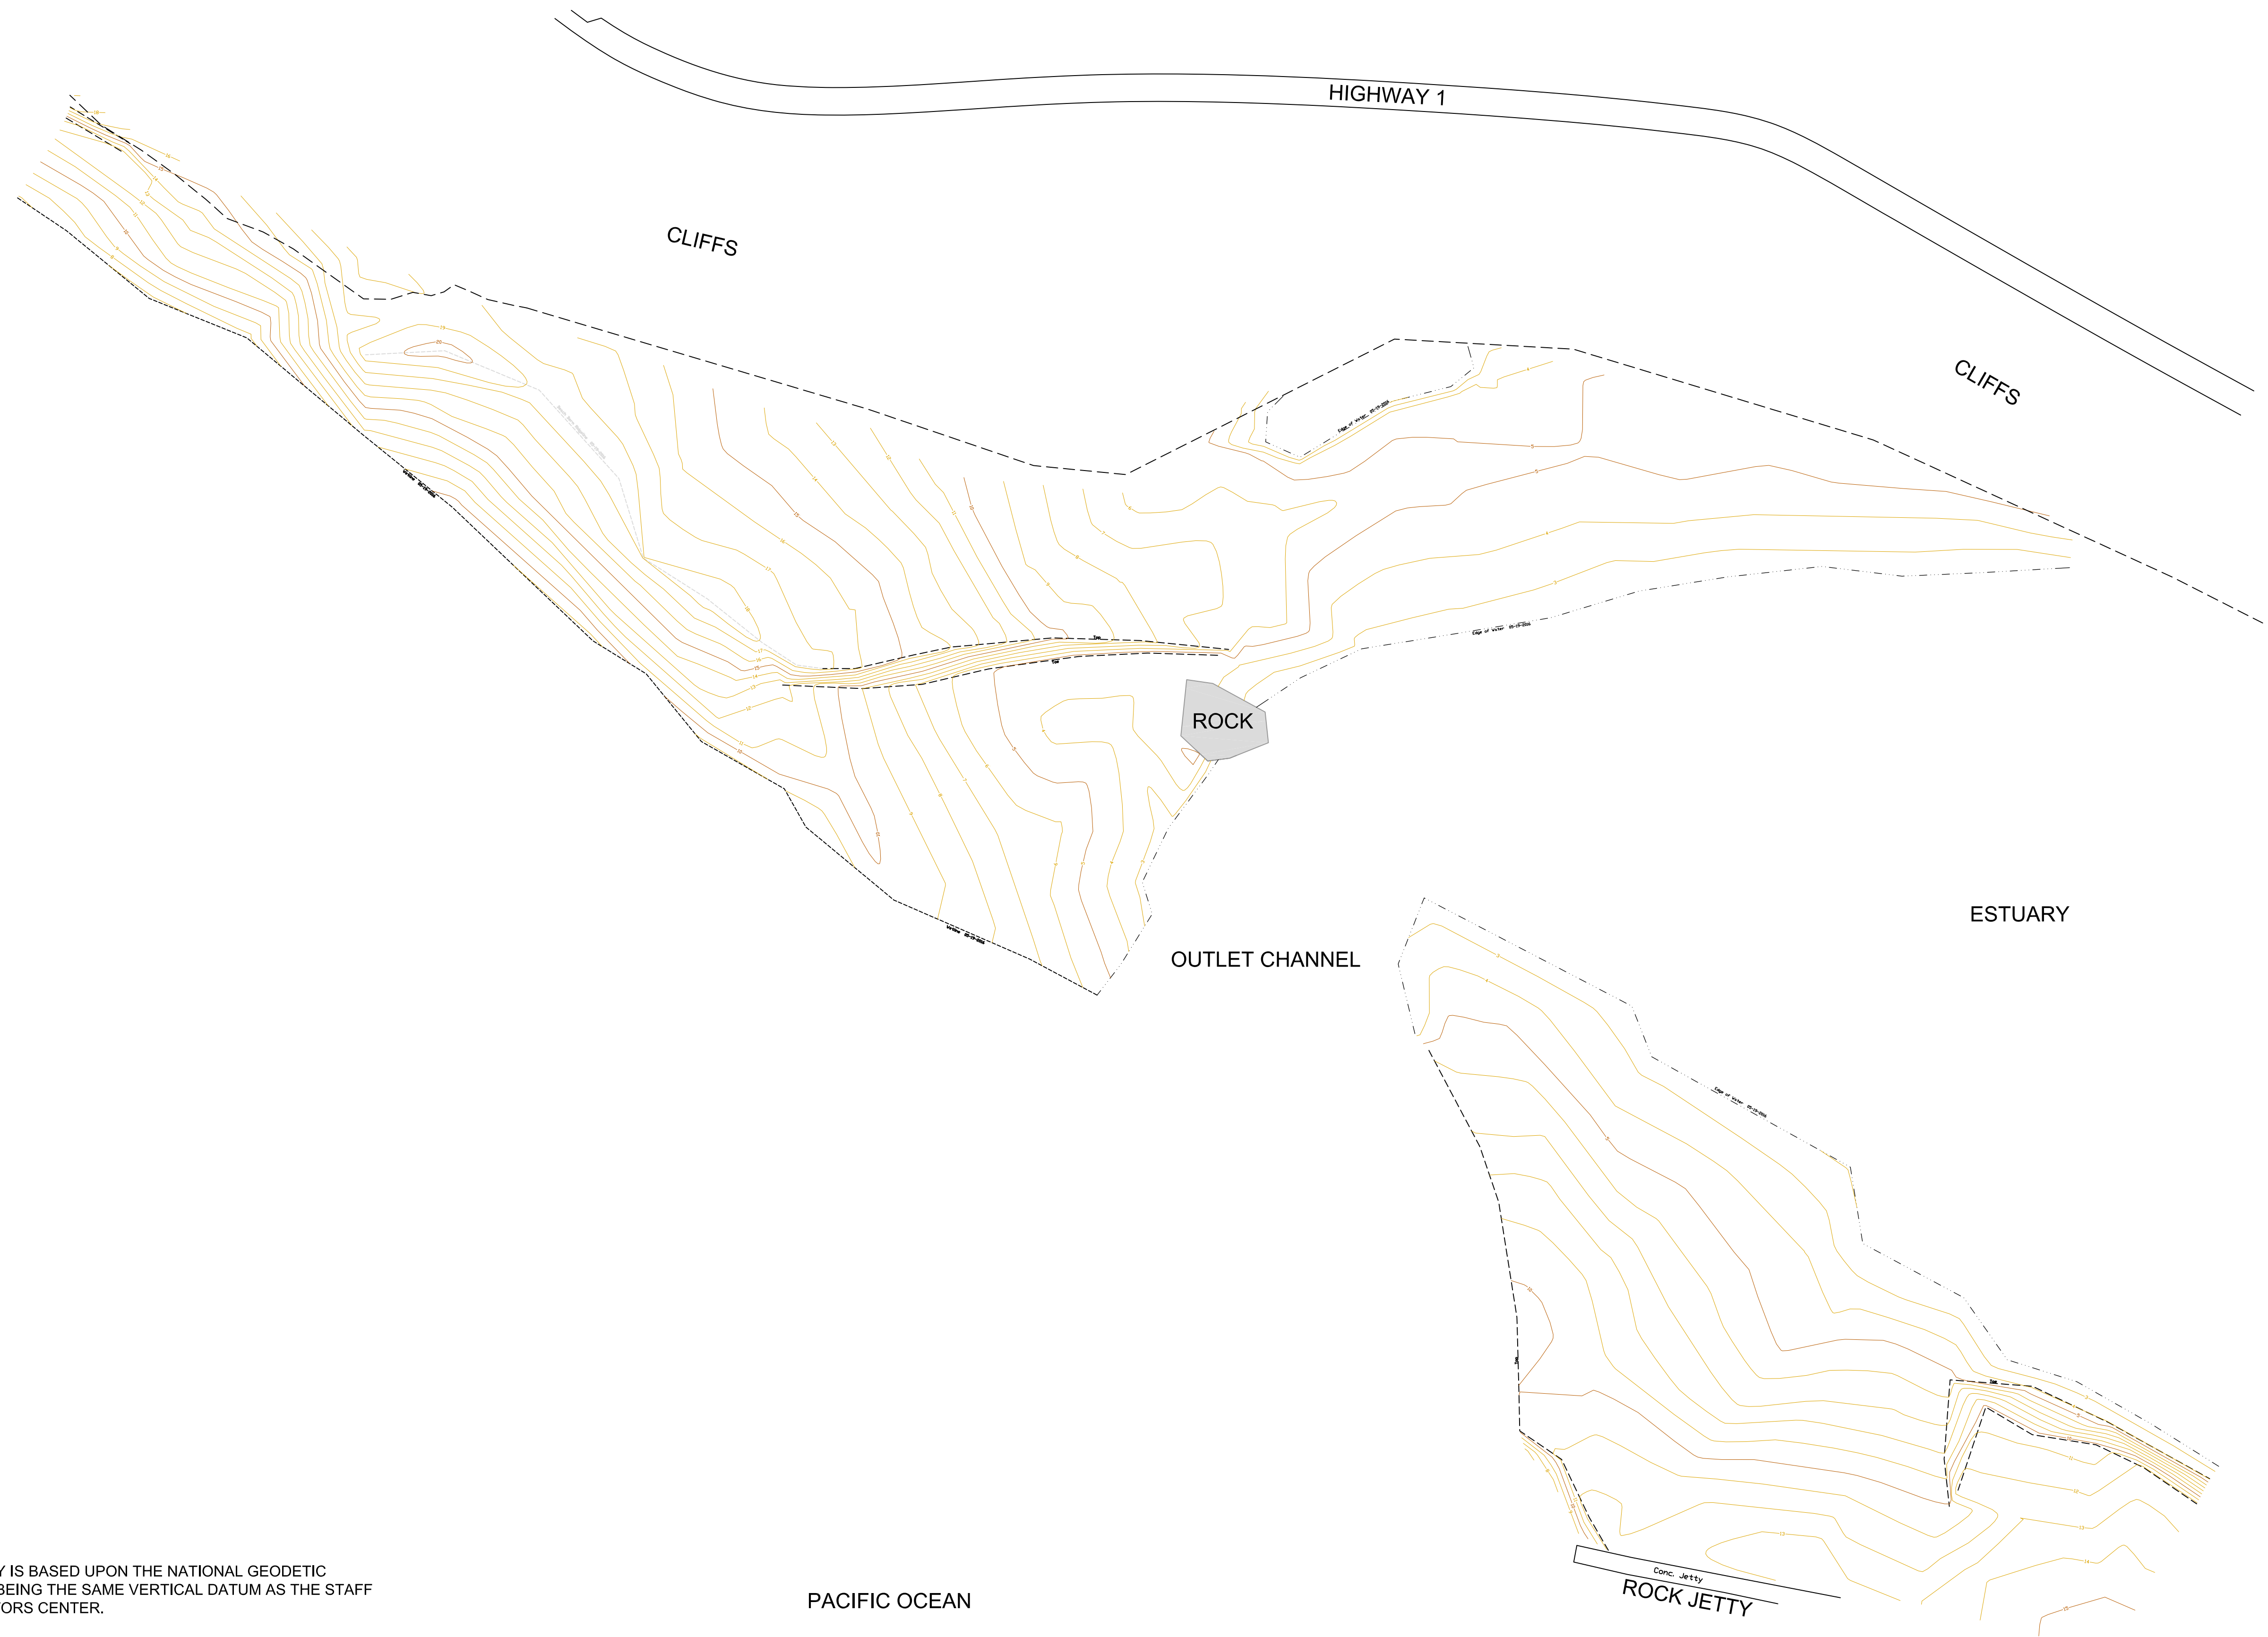
SCALE: AS NOTED	APPROVED DEPUTY CHIEF ENGR:	RUSSIAN RIVER INSTREAM FLOW RESTORATION (RRIFR) PROGRAM MONTHLY SURVEY OF BEACH TOPOGRAPHY AND OUTLET CHANNEL: Mar. 17, 2016	
				DATE: AS NOTED	SUBMITTED		
				DRAWN: EKM	DESIGNED		
				CHECKED: JRM			
NO.	DATE	BY		FILE NAME:		DRAWING NUMBER	SHEET NO. 1 OF 1

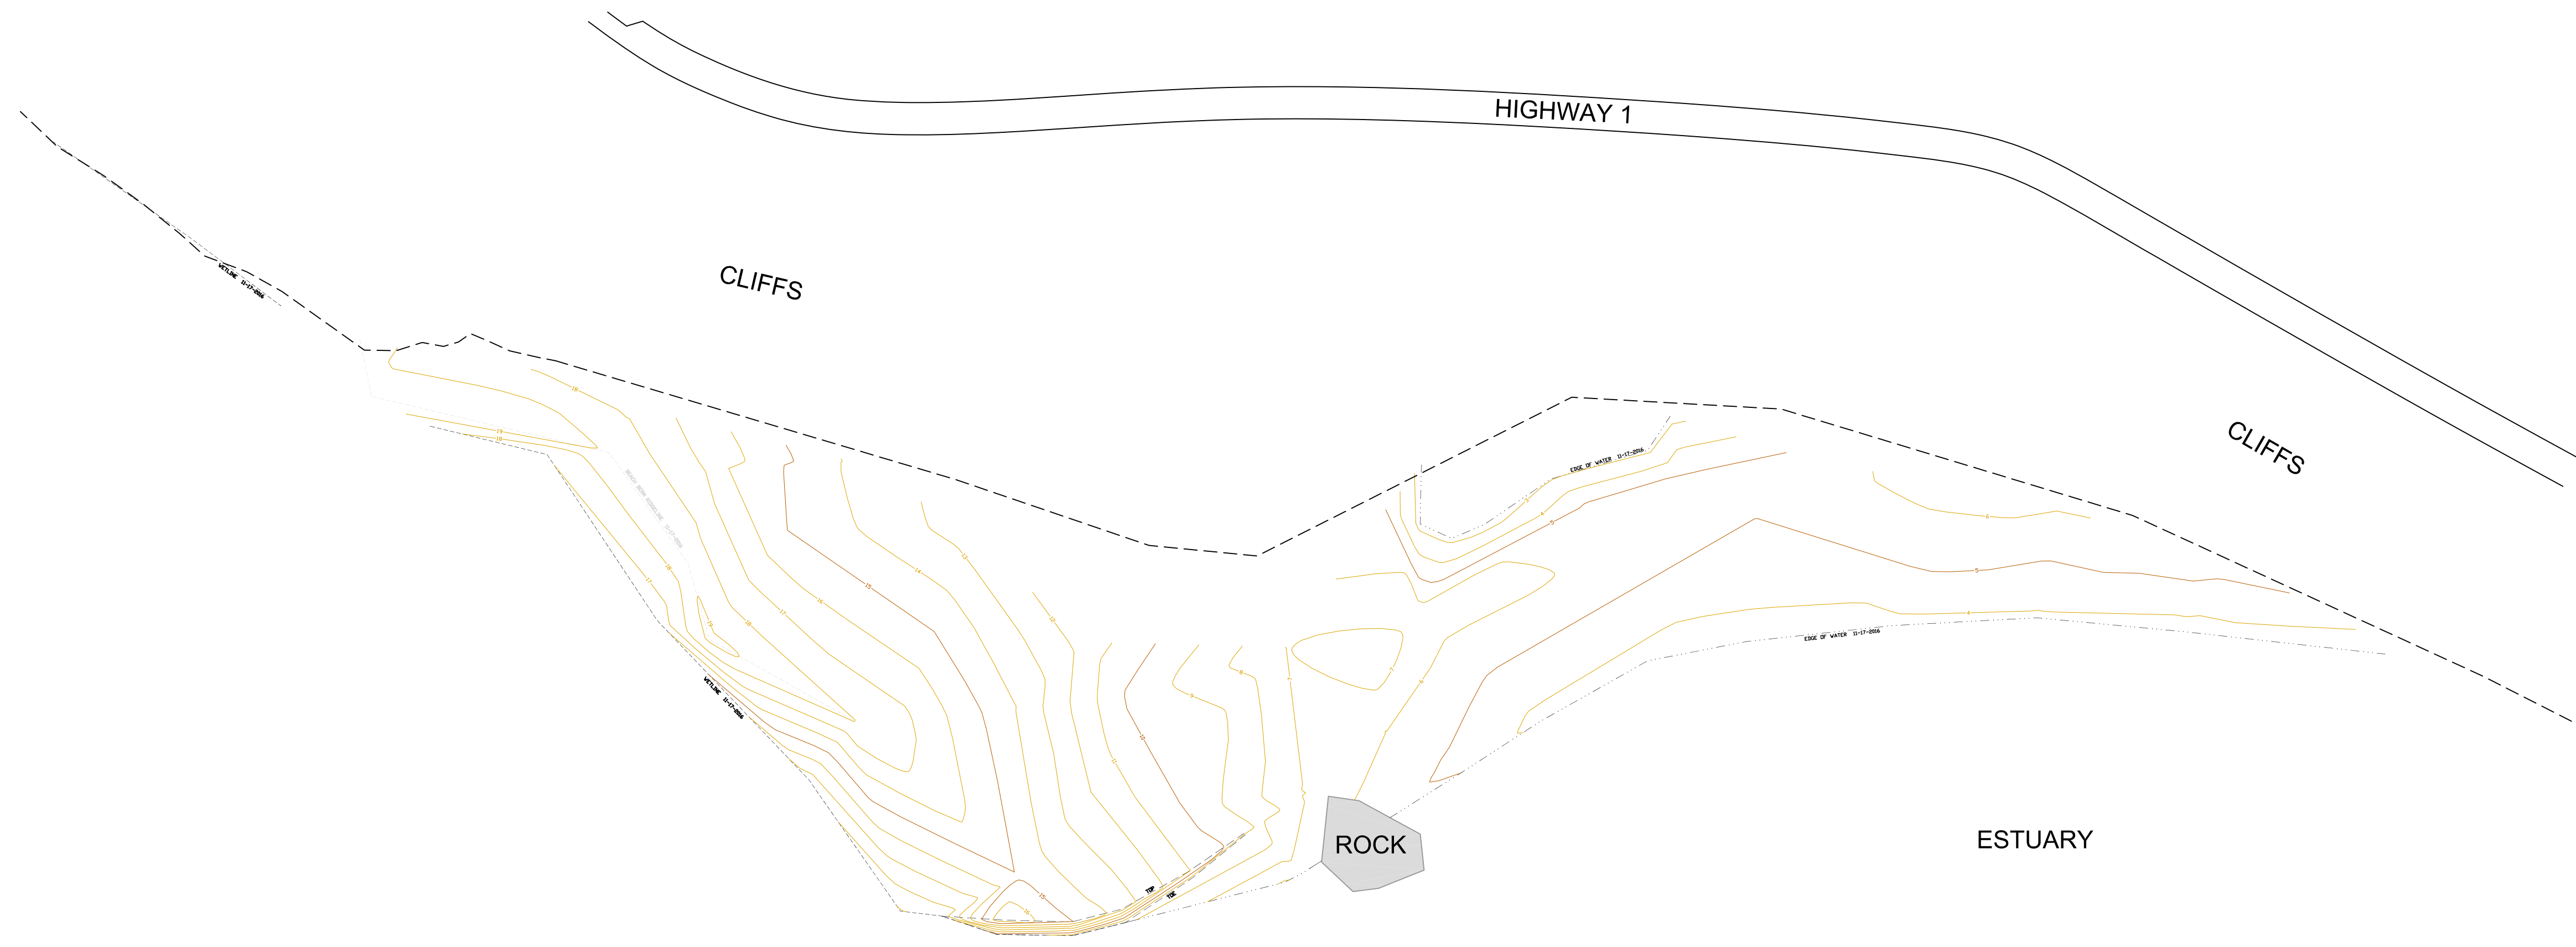
SCALE: AS NOTED	APPROVED DEPUTY CHIEF ENGR:	RUSSIAN RIVER INSTREAM FLOW RESTORATION (RRIFR) PROGRAM MONTHLY SURVEY OF BEACH TOPOGRAPHY AND OUTLET CHANNEL: Oct. 26, 2016	
				DATE: AS NOTED	SUBMITTED		
				DRAWN: EKM	DESIGNED		
				CHECKED: JRM			FILE NAME: CONTRACT NO. XXX
NO.	DATE	BY		DRAWING NUMBER		SHEET NO. 1 OF 1

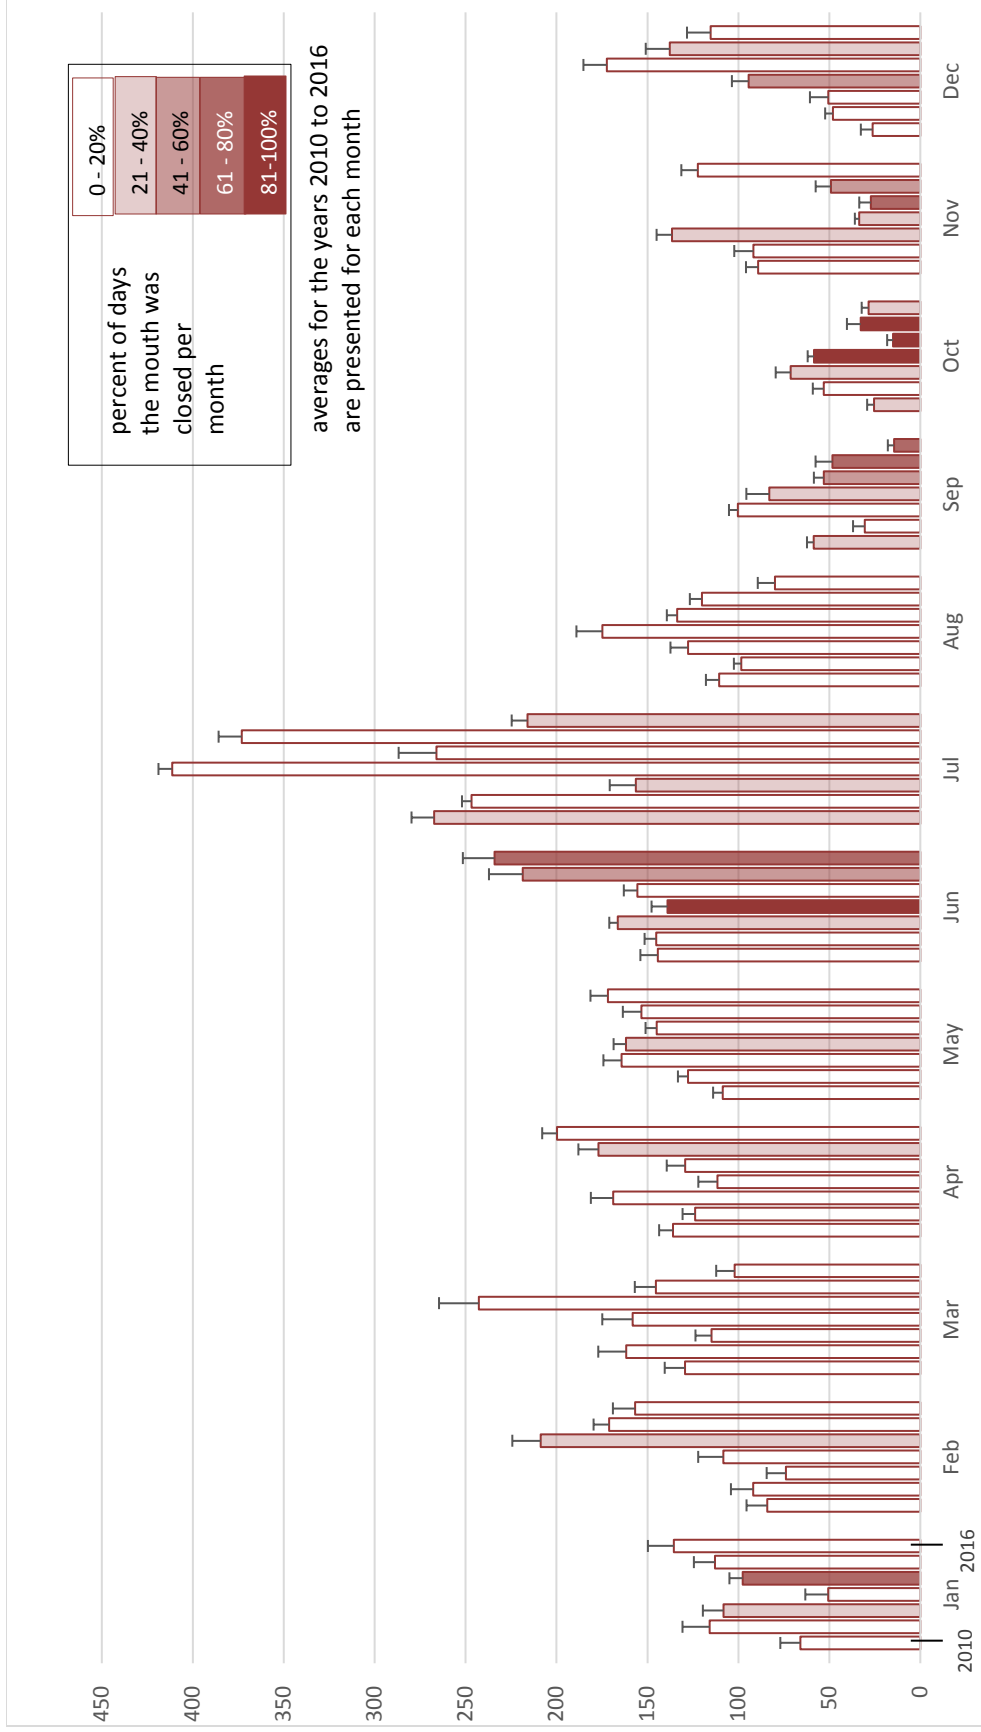
Figure 2. The average number of harbor seals hauled out at the Jenner haul-out (Russian River mouth at Goat Rock State Beach) as counted during baseline surveys for each year (January 2010 – December 2016) categorized by month. Error bars represent standard error.
