# Appendix 4.1

**RUSSIAN RIVER ESTUARY OUTLET CHANNEL  
ADAPTIVE MANAGEMENT PLAN  
2016**

October 24, 2016

**ESA REF. # DW01958**

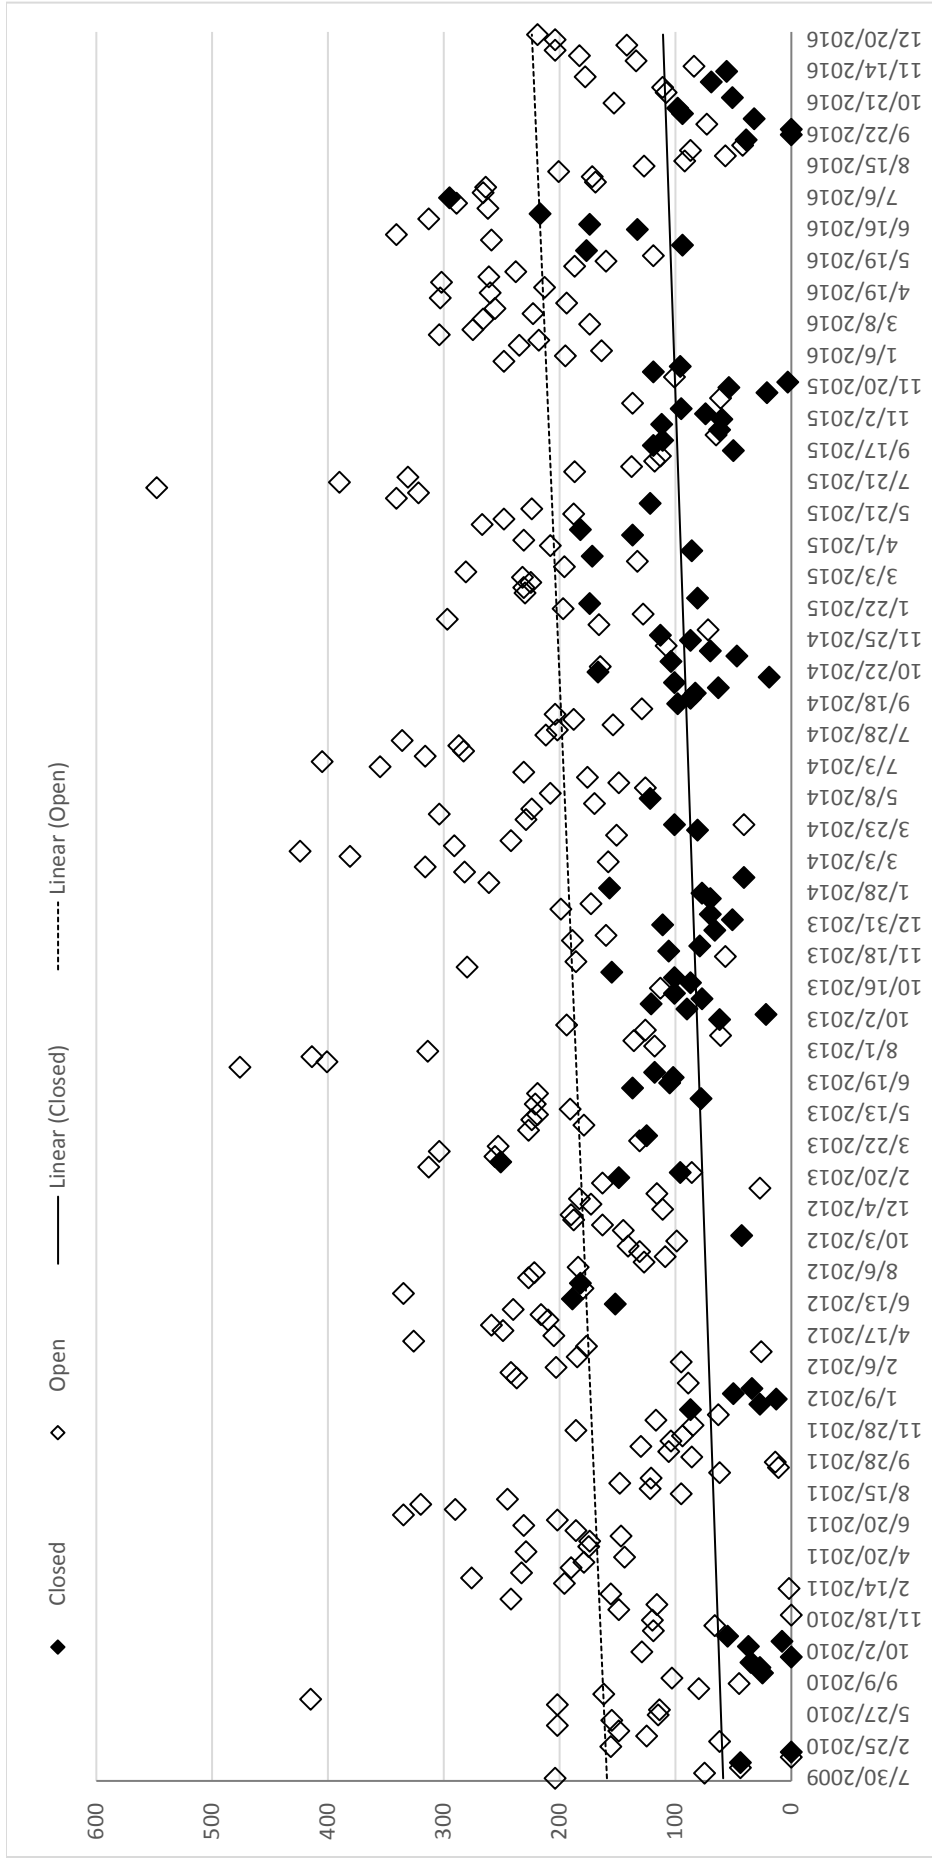
Figure 3. Maximum number of harbor seals counted during all pinniped surveys at the Jenner haul-out (Russian River mouth at Goat Rock State Beach) from July 2009 to December 2016. Open diamonds represent counts in mouth open conditions and black filled diamonds represent counts during mouth closed conditions.

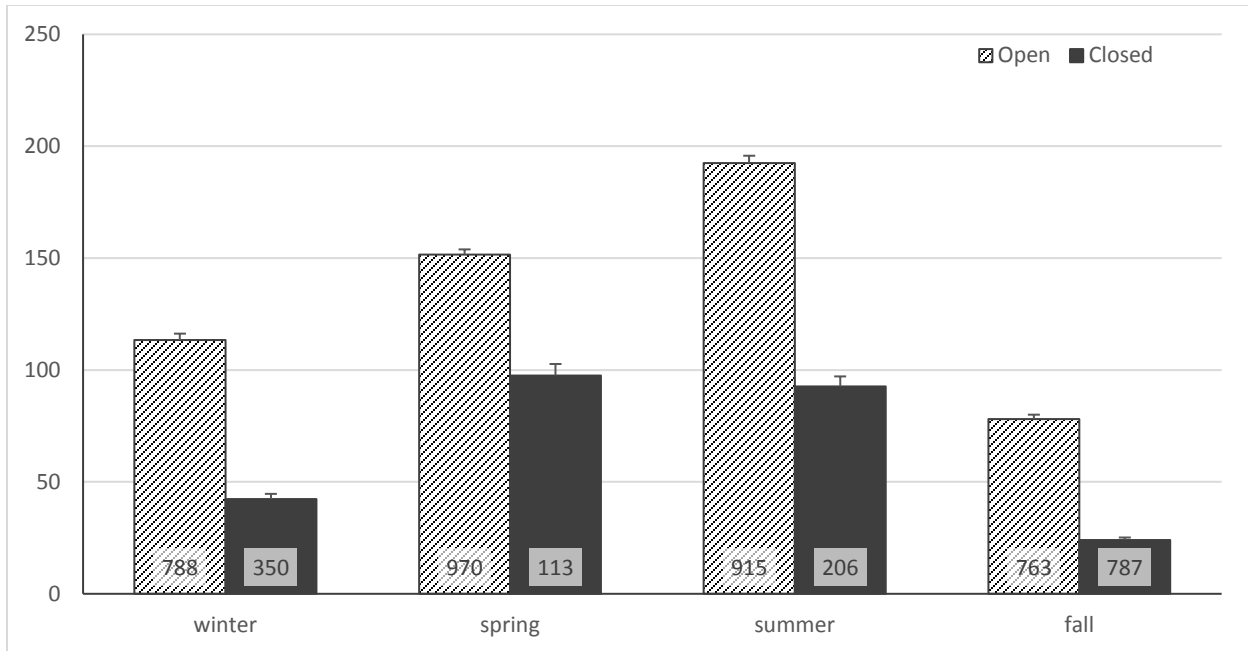
**Figure 4. Average number of harbor seals at the Jenner haul-out for all surveys from July 2009 to December 2016 for mouth open and mouth closed conditions by season. Seasons were defined as: winter = December – February; spring = March – May; summer = June – August; fall = September – November.**

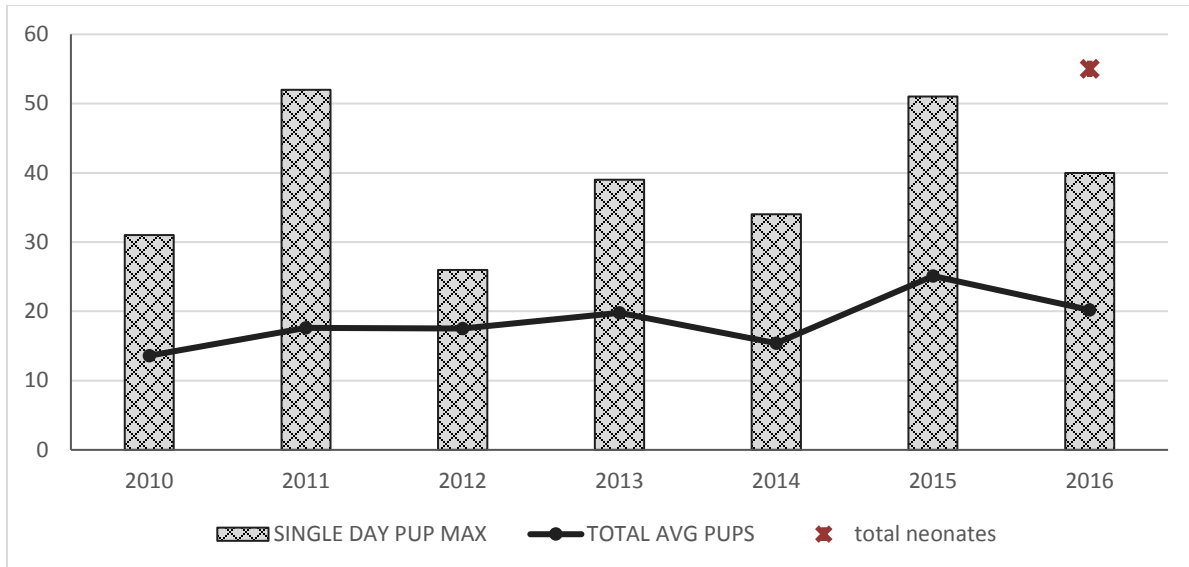
**Figure 5. Number of harbor seal pups observed at the Jenner haul-out (Russian River mouth at Goat Rock State Beach) by year. 2016 was the first year births could be estimated using the total number of neonates observed.**
