# Russian River Biological Opinion Status and Data Report

Year 2017 - 2018

**Sonoma  
Water**

**June 2020**

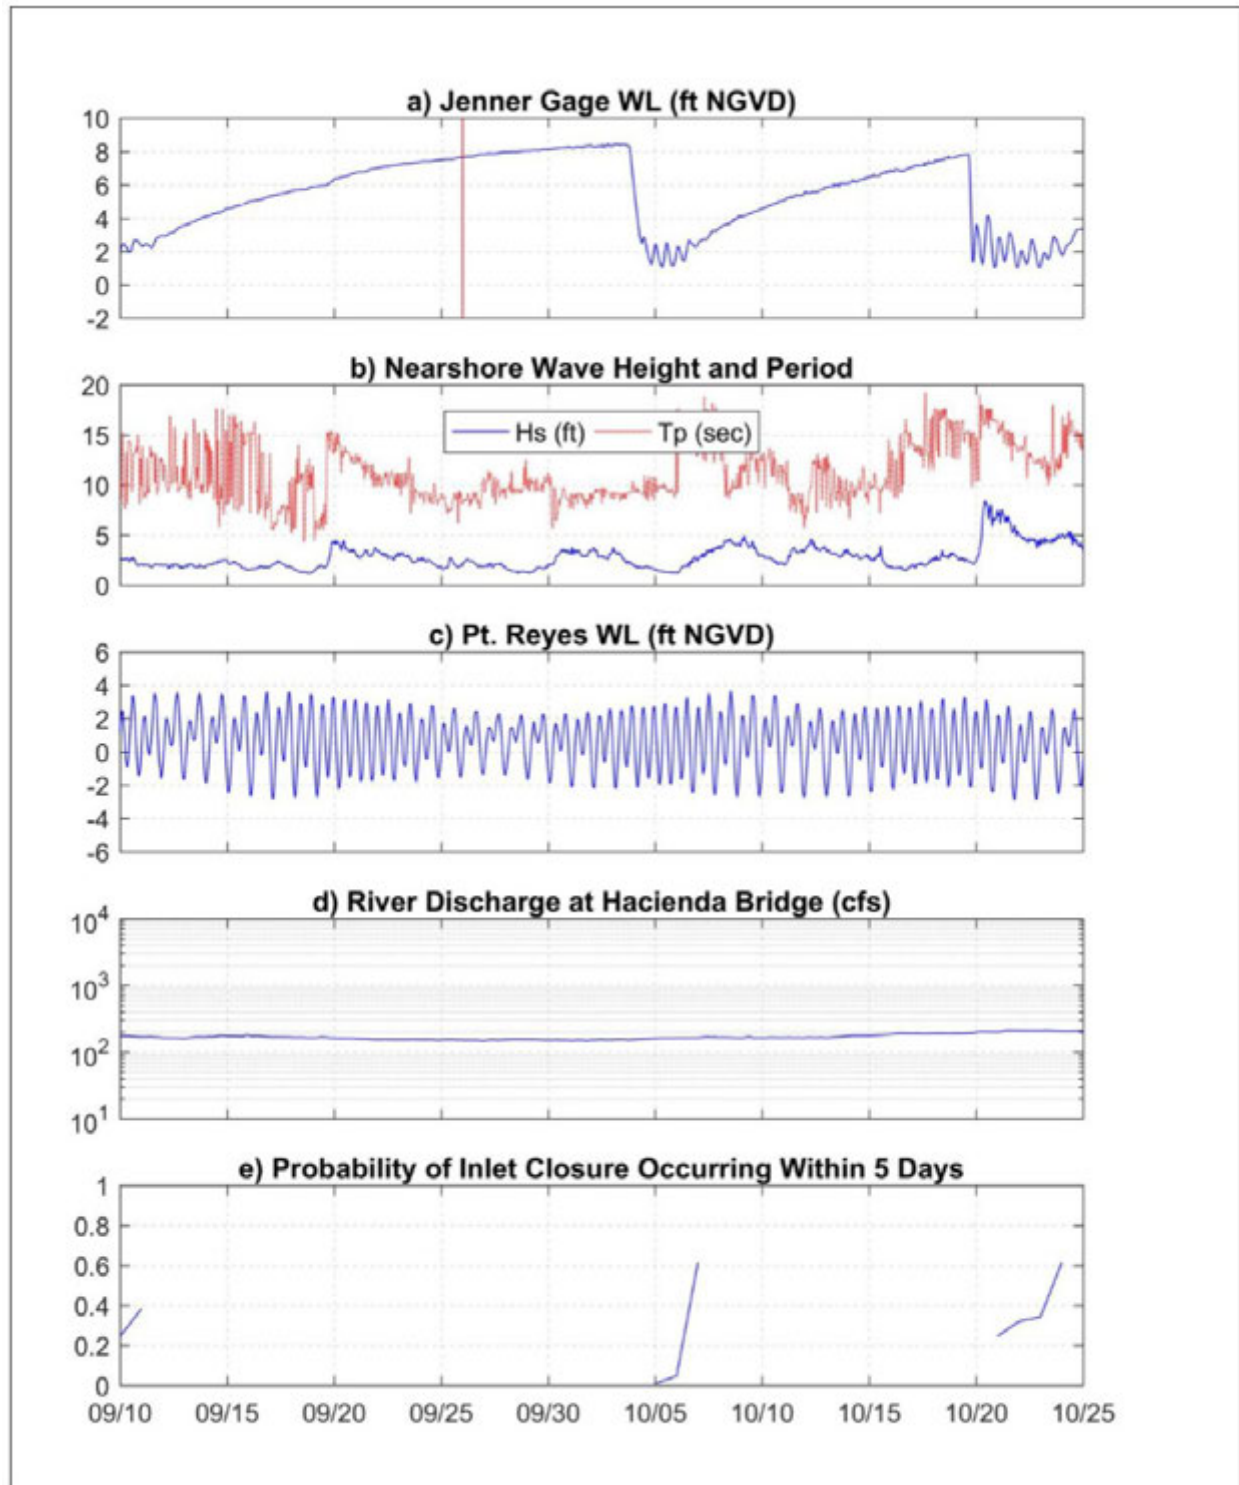
Figure 4.3. Estuary, Ocean, and River Conditions Compared with Closure Probability: September – October 2017.

Swell wave conditions were present throughout September, and the river mouth closed again on September 12 (Figure 4.3). Unlike the August event, long-period waves were consistently present, allowing the barrier beach to widen and creating safer conditions for equipment to reach the site. River inflows remained steady at 150-180 cfs. Sonoma Water implemented an outlet channel on September 28 at 10:55 am. The outlet channel was again located about 1,000 feet north of the jetty, where an outlet channel had naturally occurred in June. Compared to the July implementation, this channel was longer and wider, with a length of 150 feet and a width of 50 feet. The invert elevation was also higher, at 8.3 ft NGVD, which was approximately 0.3 feet above the lagoon water surface elevation at the time the channel was constructed. The plan was to allow lagoon water levels to increase to the outlet channel's elevation, at which time the outlet channel would allow lagoon water to flow out into the ocean to reduce the chance of flooding and prolong the freshwater/brackish water conditions for salmon rearing habitat, up until just below the flood stage of 9 ft NGVD. Just as water levels reached the elevation of the outlet channel, the mouth breached on October 3. A photograph taken from the Highway 1 overlook indicates a narrow (<10 ft wide) and lower elevation channel located within the full outlet channel, which suggests that the narrower channel may have been excavated by beachgoers (Figure 4.7). Unfortunately, this possible interference obfuscates the potential performance of excavating an outlet channel above existing lagoon water levels.

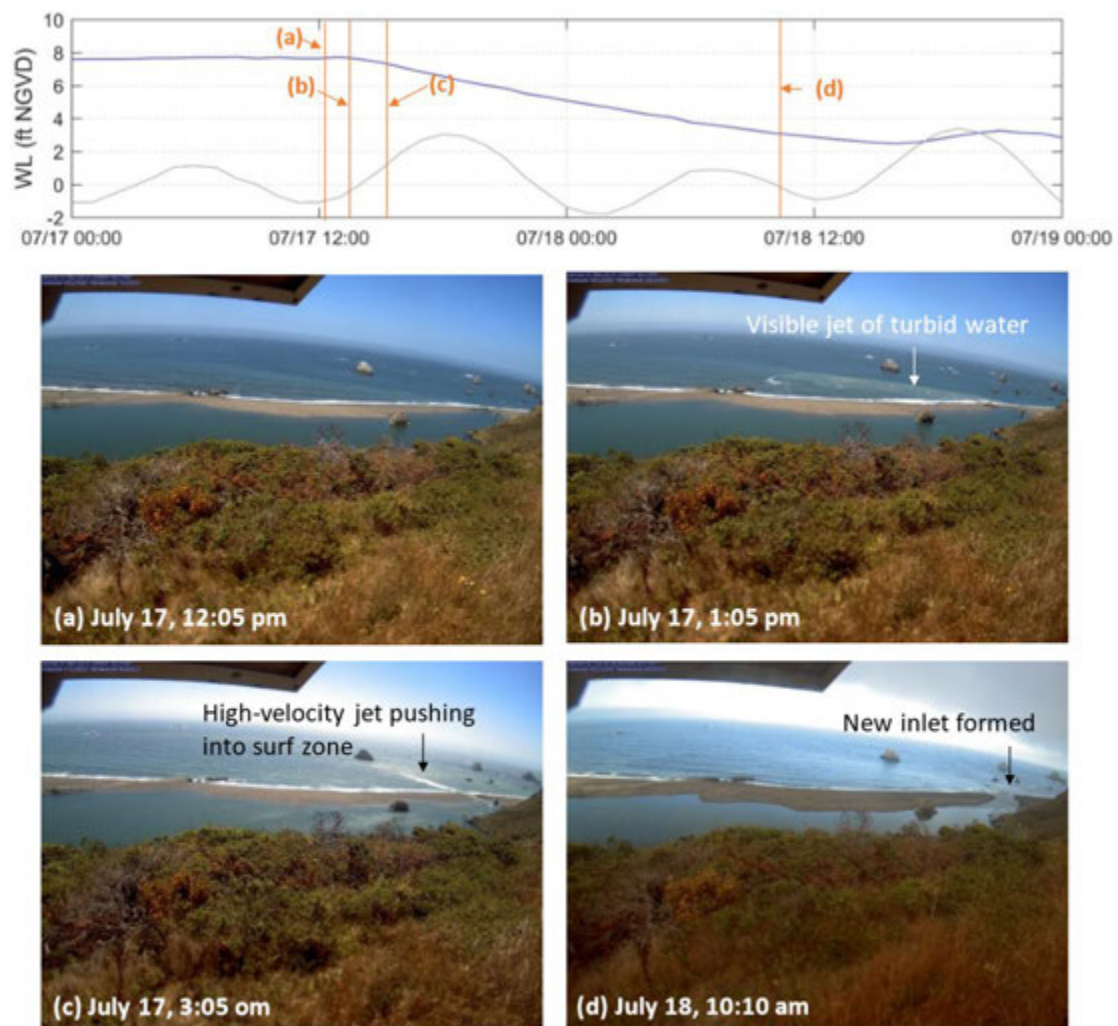
Figure 4.5. Sequence of photographs depicting the July 17, 2017, outlet channel implementation.

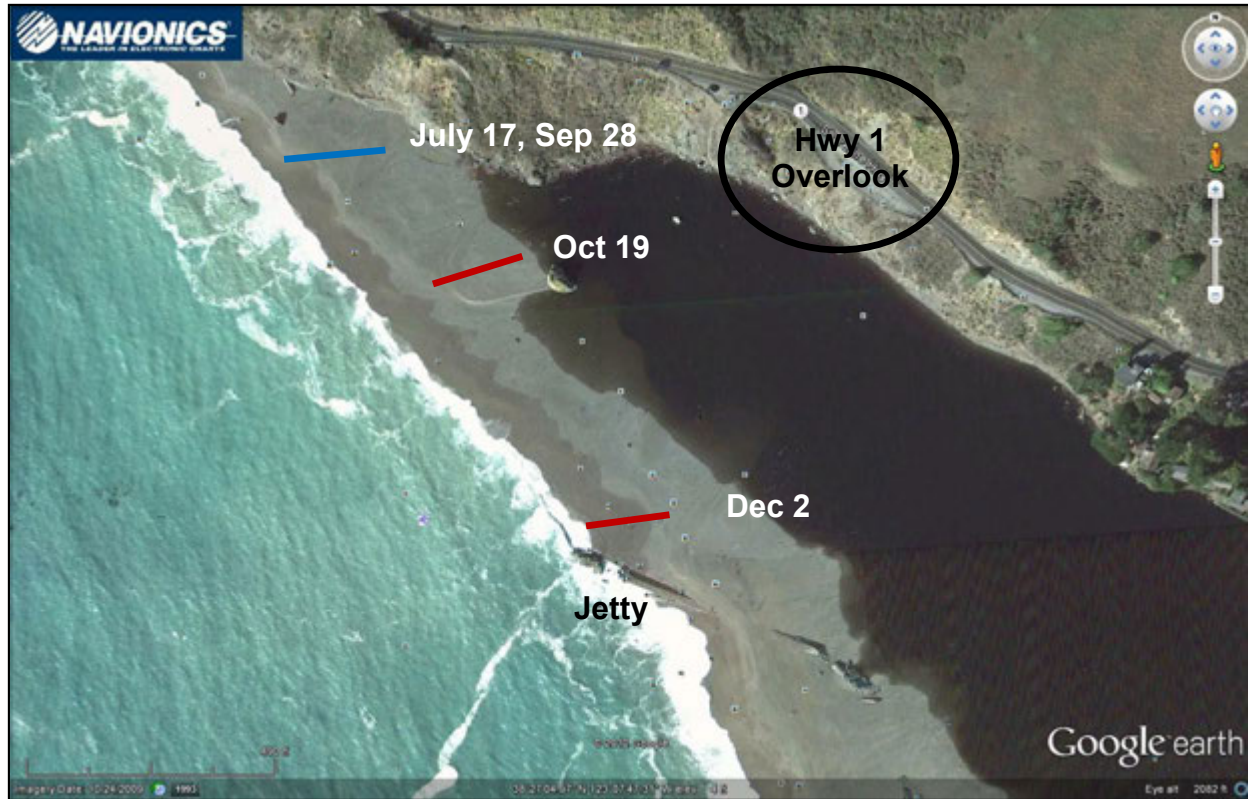
Figure 4.6. Locations of beach management activities in 2017 at the Russian River mouth, Goat Rock State Beach. Lines crossing the barrier beach are pilot channels for artificial breaching (red) and outlet channels to form a lagoon (blue). Self-breach events are not shown.

Outside of the management season, there were four mouth closures in 2017. Sonoma Water artificially breached the barrier beach at the Russian River mouth outside the lagoon management period twice in 2017 (Table 4.1; Figure 4.6). Time series photographs of the December 2 event are shown in Figure 4.8. The breaching events were necessary to minimize flood risk to low-lying structures, which occurs at or above an elevation of approximately 9 feet NGVD at the Jenner gage located at State Parks' Jenner visitor center. The December 2 breaching event was a result of closure of the river mouth on November 29. Water surface elevations

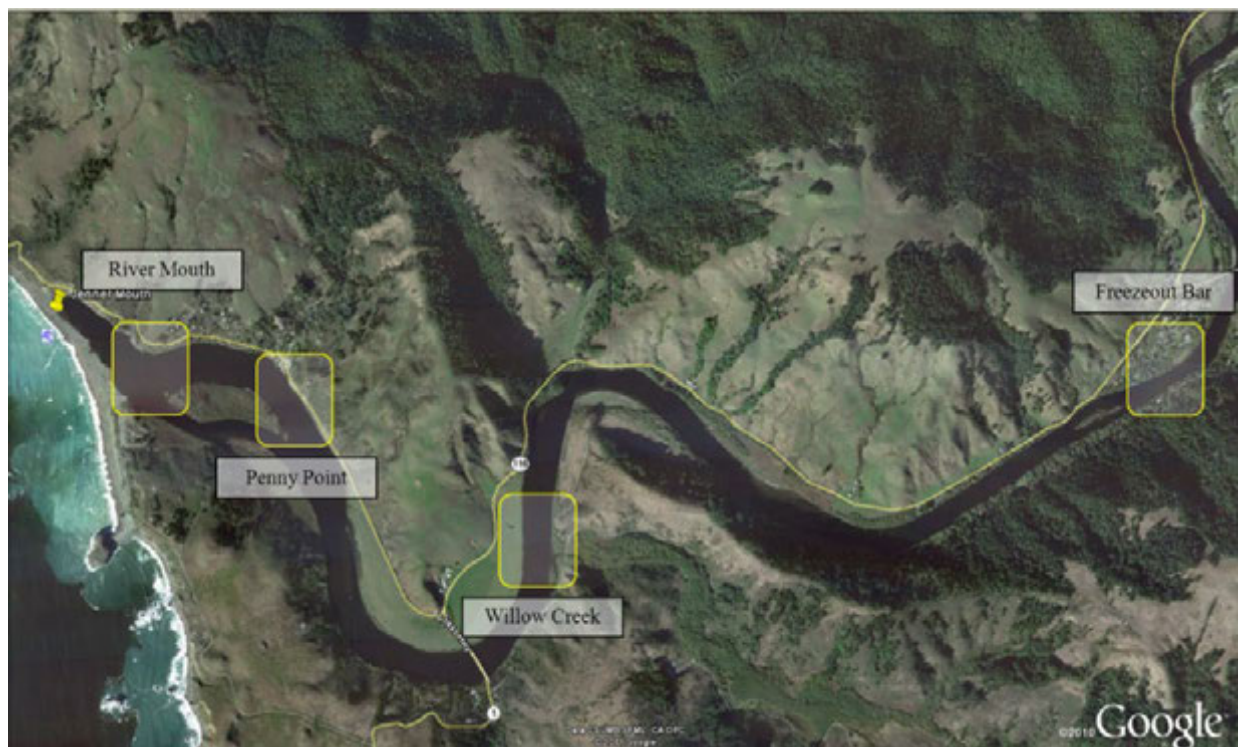
**Figure 4.3.2 . Distribution of juvenile salmonid prey resource availability in three reaches of the Russian River Estuary.**

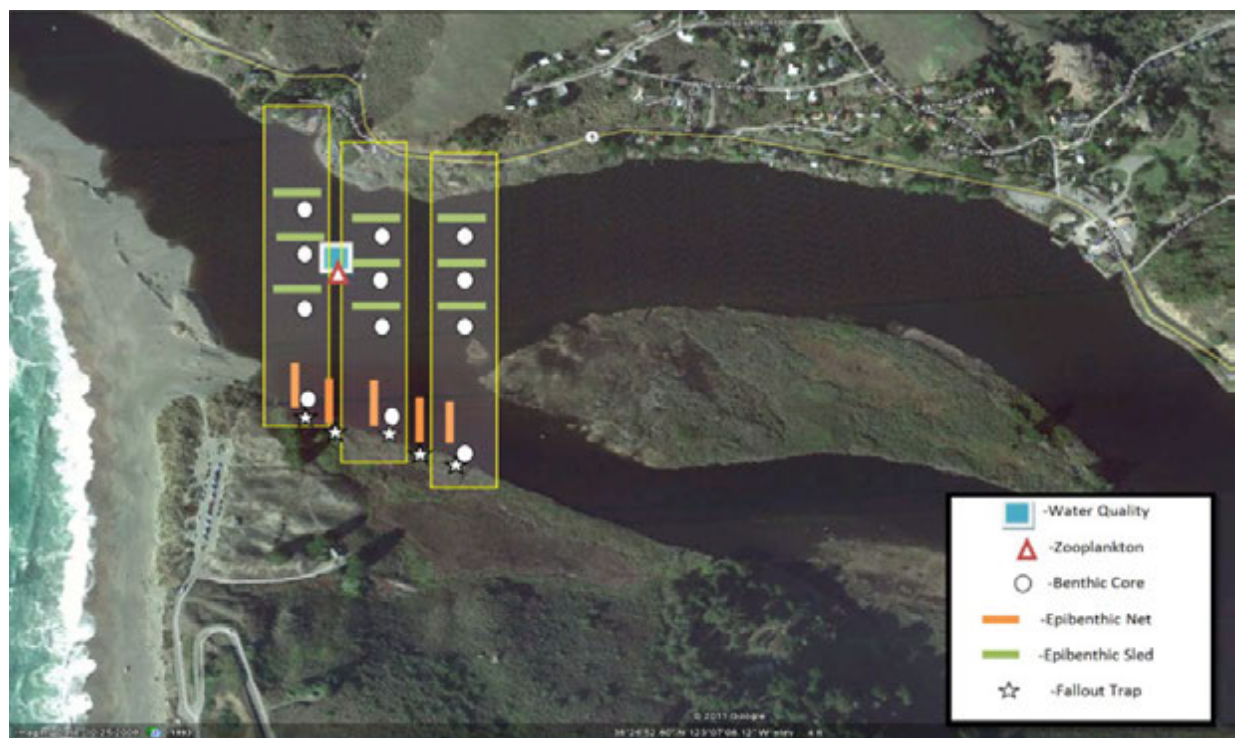
**Figure 4.3.3. Distribution of juvenile salmonid prey availability sampling transects and techniques at the River Mouth site in the Russian River Estuary.**

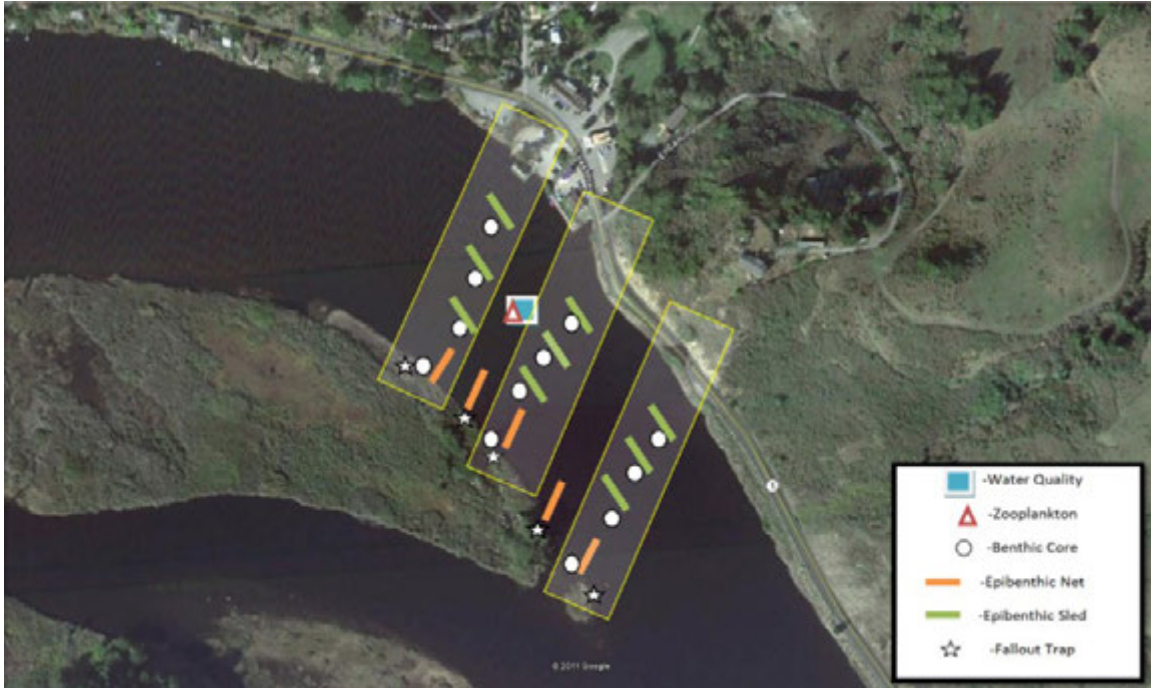
**Figure 4.3.4. Distribution of juvenile salmonid prey availability sampling transects and techniques at the Penny Point site in the Russian River Estuary.**

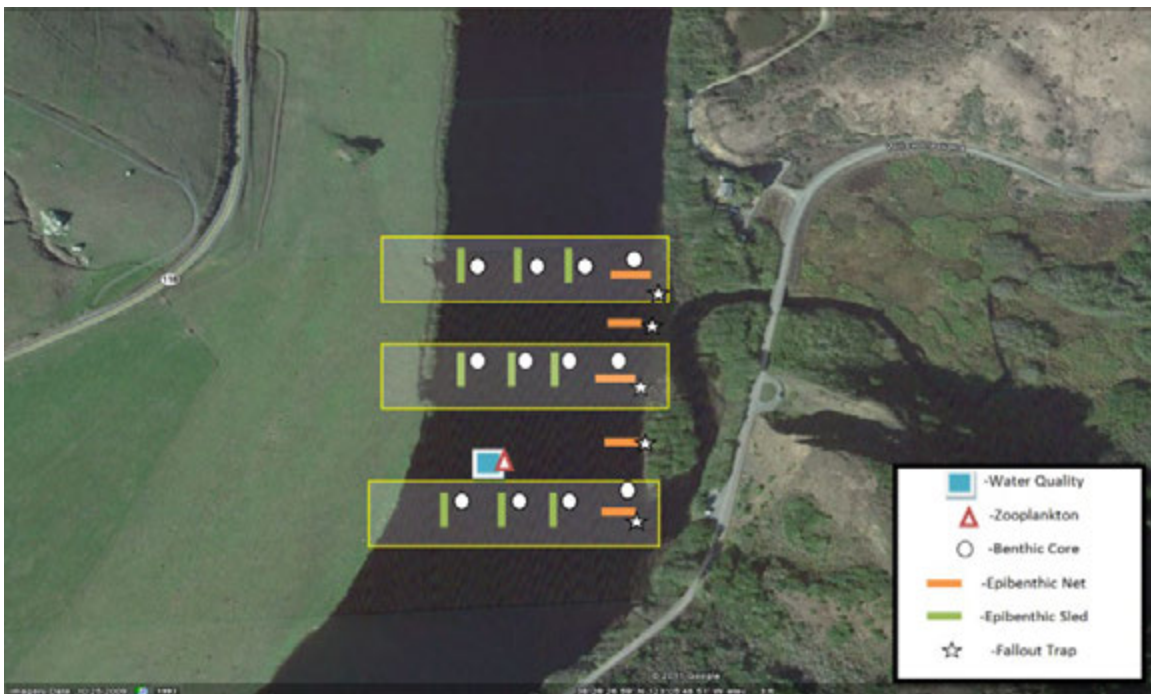
**Figure 4.3.5. Distribution of juvenile salmonid prey availability sampling transects and techniques at the Willow Creek site in the Russian River Estuary.**

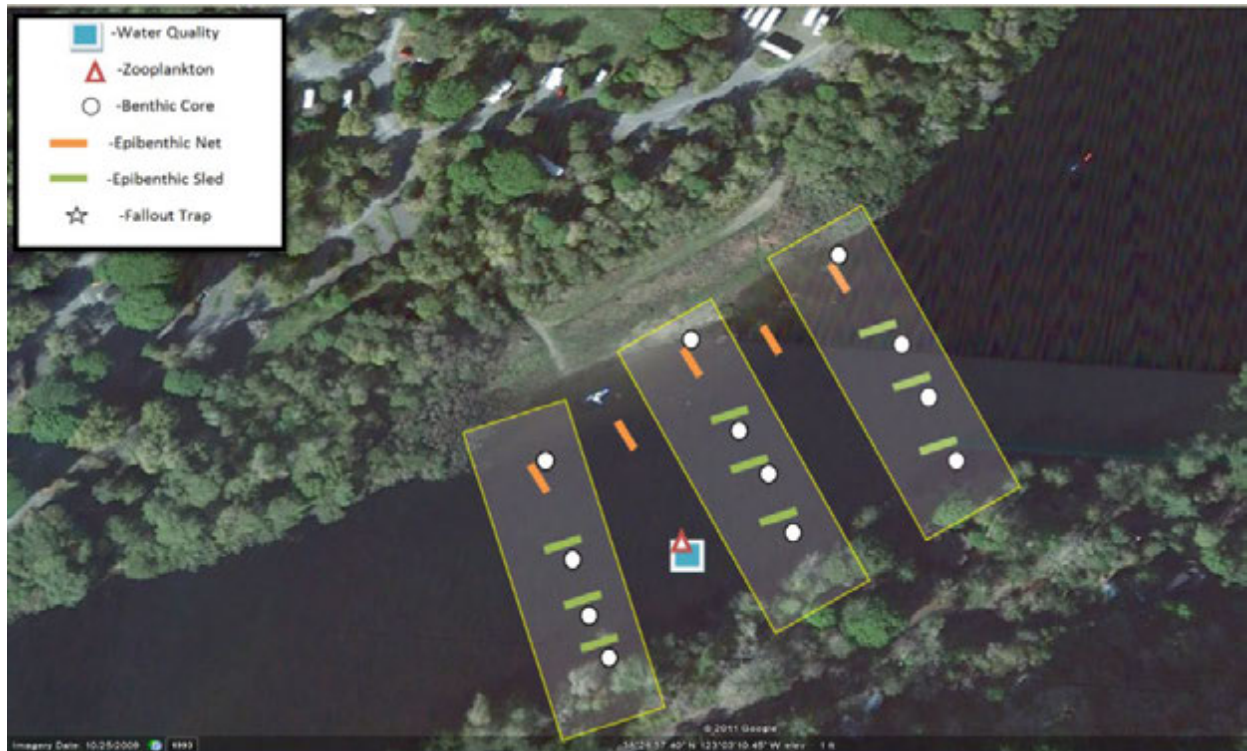
**Figure 4.3.6. Distribution of juvenile salmonid prey availability sampling transects and techniques at the Freezeout Bar site in the Russian River Estuary.**

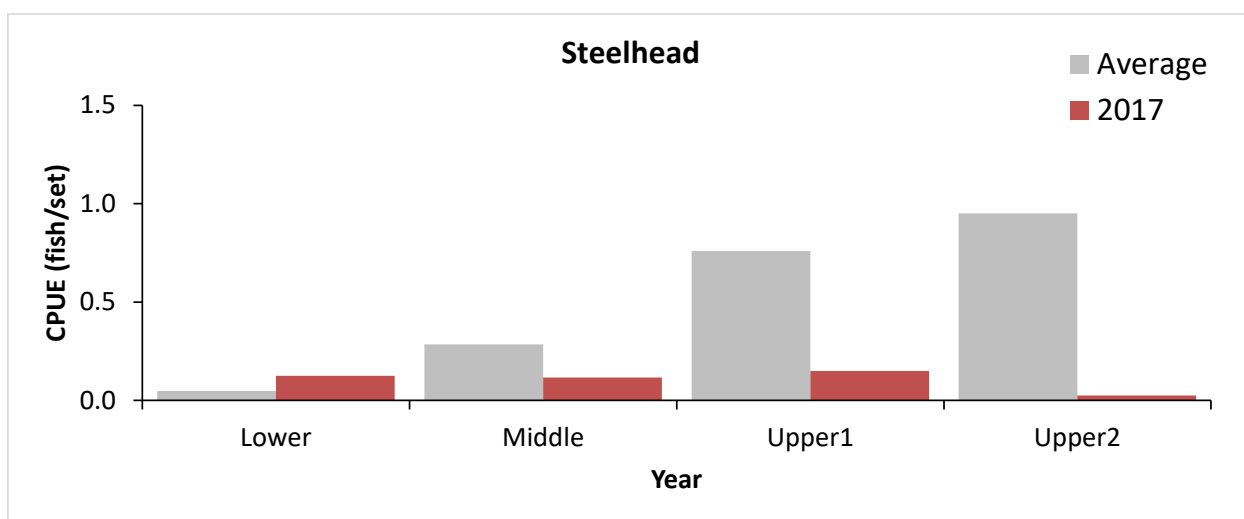
**Figure 4.4.6. Distribution of juvenile steelhead in the Russian River Estuary, 2004-2017. Fish were sampled by beach seine consisting of 96 to 300 sets annually. No surveys were conducted in the Upper2 Sub-Reach (Casini Ranch and Moscow Bridge stations) from 2004 to 2009. Data from 2004 to 2015 were averaged.**

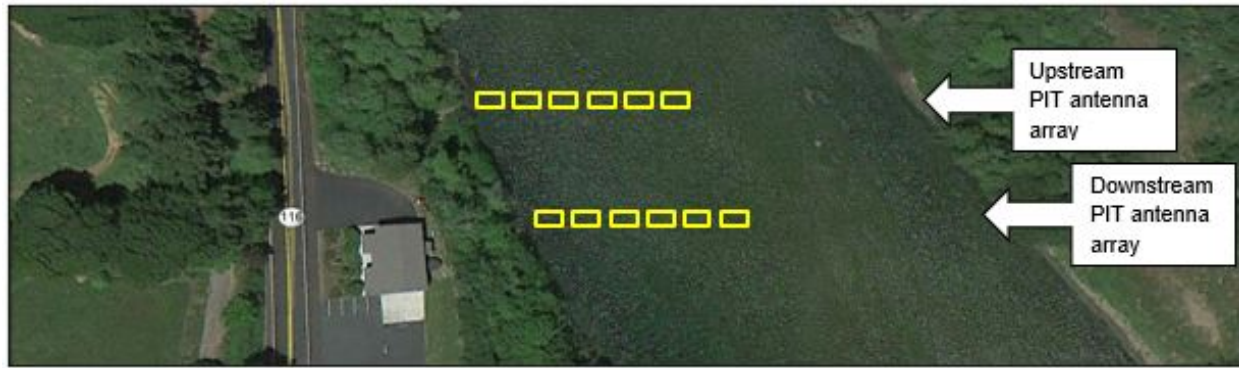
**Figure 4.5.2. Flat plate antenna arrays at Duncans Mills (rkm 10.44 and 10.46). Rectangles represent individual flat plate antennas.**

Two antenna arrays with multiple flat plate antennas (antennas designed to lay flat on the stream bottom) were installed in the upper Russian River estuary near the town of Duncans Mills (river km 10.44, 10.46) to detect PIT-tagged fish entering the estuary (Figure 4.5.2). Generally, 12 antennas were operated continuously throughout the year. The orientation of the antennas consisted of 2 rows of antennas with one row slightly upstream of the other. Each row contained 6 antennas placed side by side starting at the West river bank and extending out into the channel. However, these antennas were damaged in the winter of 2017 and not operational until after the end of the 2017 downstream migrant trapping season.

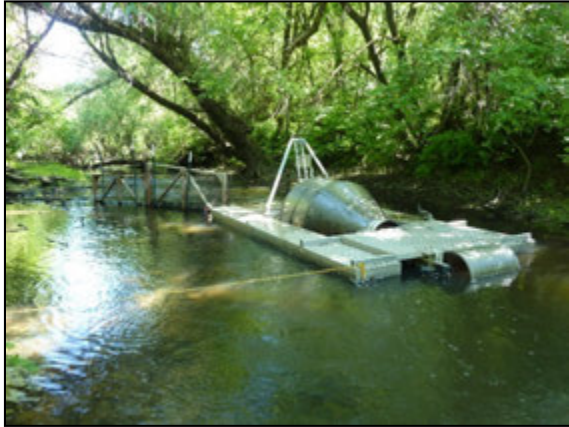
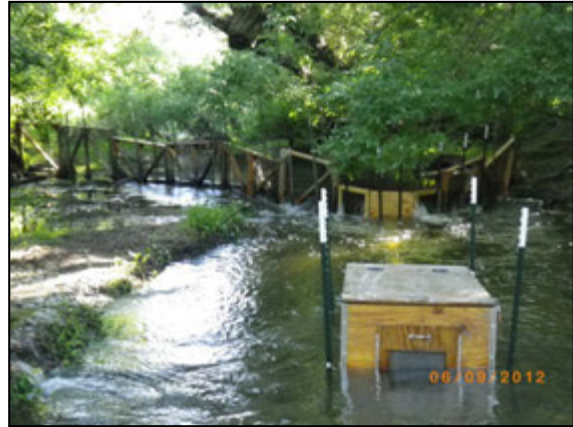
Mark West Creek: Rotary screw trap (fished 4/28-5/24) switched to pipe trap (fished 5/25-6/20).

**Figure 4.5.3. Photographs of downstream migrant traps operated by Sonoma Water (Mark West, Dutch Bill and Austin Creeks). See Chapter 5 of this report for details regarding operation of the Dry Creek trap.**

Following consultation with NMFS and CDFW, Sonoma Water identified three lower River tributaries (Mark West Creek, Dutch Bill Creek and Austin Creek, Figure 4.5.1) in which to operate fish traps as a way to supplement data collected from the Duncans Mills PIT antenna array and during sampling by beach seining throughout the estuary. Sonoma Water operated three types of downstream migrant traps in 2017: rotary screw trap, funnel trap and pipe trap depending on the stream, water depth, and velocity (Figure 4.5.3). Fish traps were checked daily by Sonoma Water staff during the trapping season (March through July). Captured fish were enumerated and identified to species and life stage at all traps. All PIT-tagged fish were measured for fork length ( $\pm 1$  mm) and weighed ( $\pm 0.1$  g). Additionally, a subset of all non-PIT-tagged individuals were measured and weighed each day. PIT tags were implanted in the majority of steelhead YOY and parr captured that were  $\geq 60$  mm in fork length.

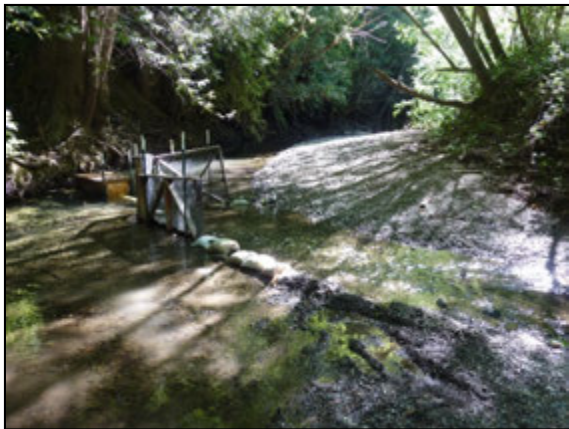
Dutch Bill Creek: Funnel net (3/30-5/15) switched to a pipe trap (fished 5/16-6/27).

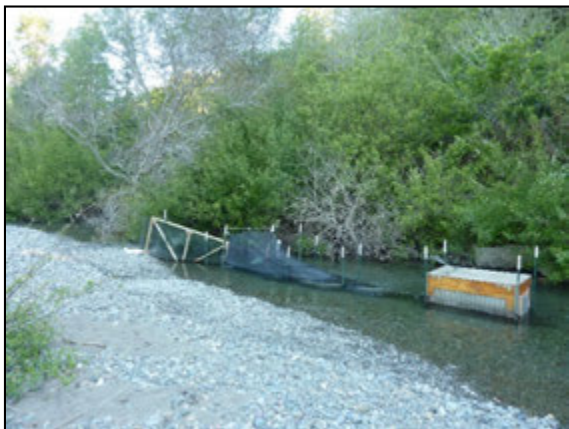
Austin Creek: Rotary screw trap (fished 4/25-5/23) switched to a funnel trap (fished 5/24-6/27).

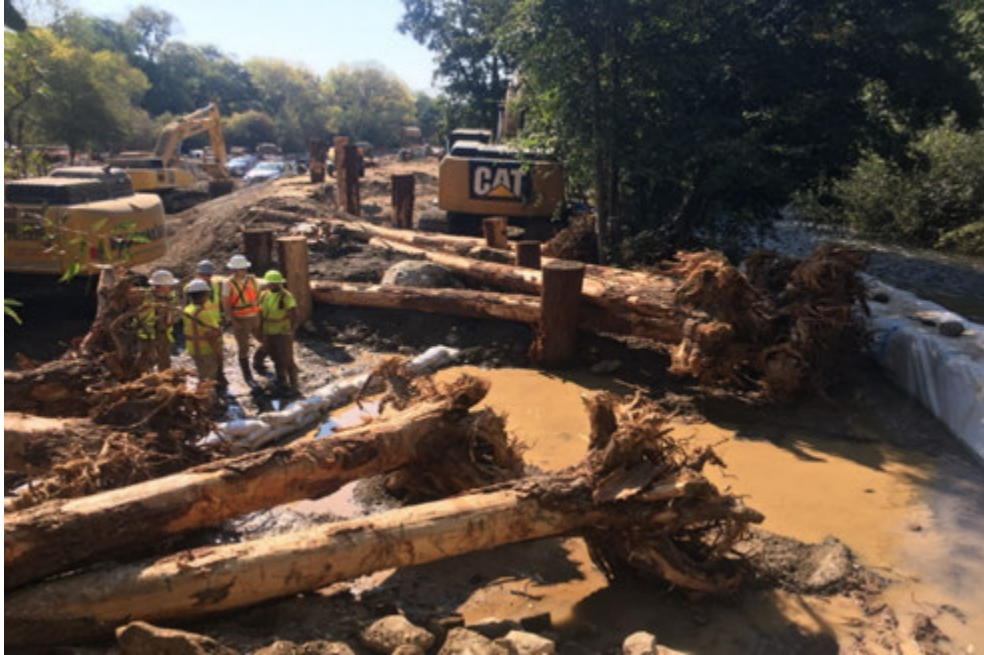
**Photo 5.1.1. Dry Creek Habitat Enhancement Project Phase 2, Part 1. New side channel inlet under construction at the Truett Hurst site (Reach 8). Mainstem of Dry Creek (looking downstream) can be seen at the right hand side of the photo. August 2016.**

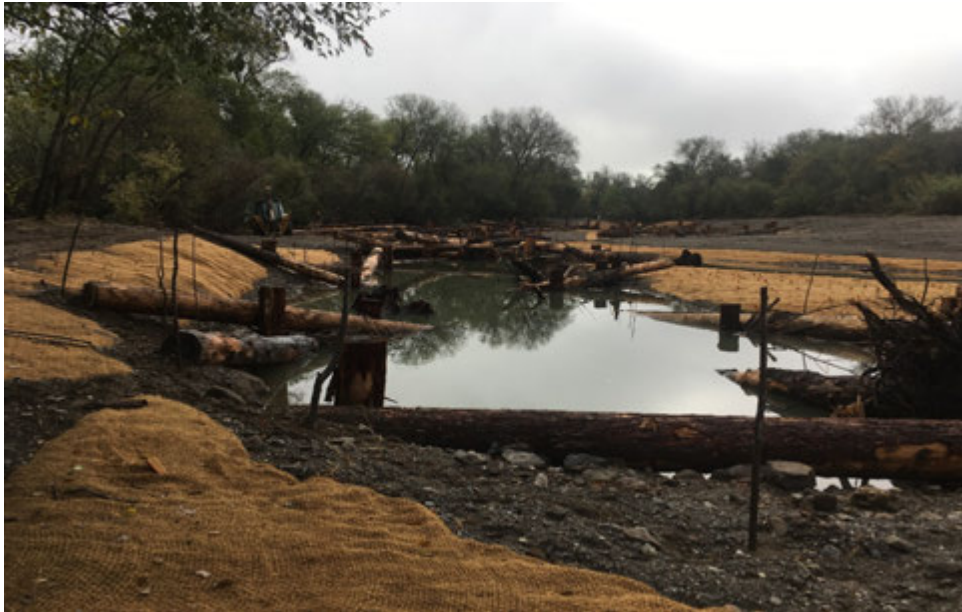
**Photo 5.1.2. Dry Creek Habitat Enhancement Project Phase 2, Part 1. New side channel backwater feature recently constructed at the Truett Hurst site (Reach 8). October 2016.**

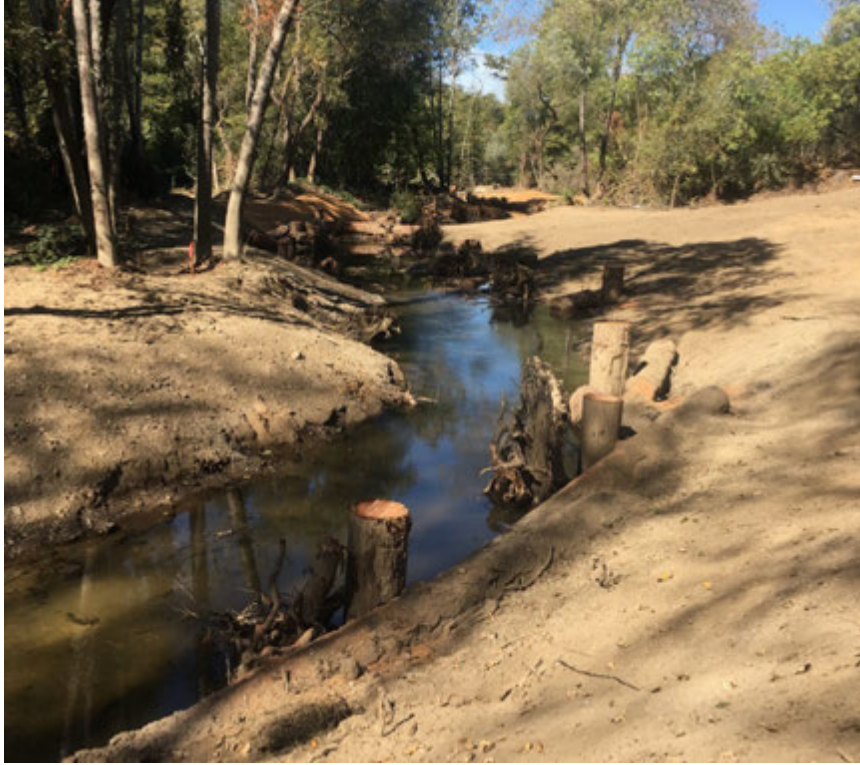
**Photo 5.1.3. Dry Creek Habitat Enhancement Project Phase 3, Part 1. New side channel feature recently constructed at the Geyser Peak site (Reach 2). October 2016.**

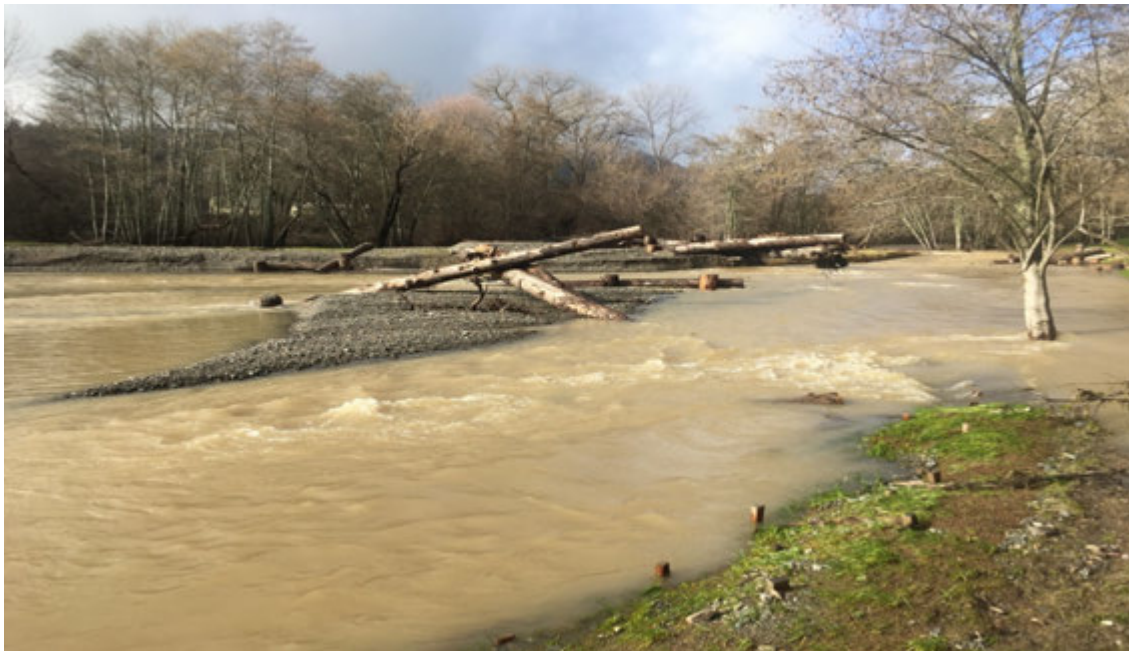
**Photo 5.1.4. Dry Creek Habitat Enhancement Project Phase 2, Part 1. High flow event through the recently completed new side channel at the Truett Hurst site (Reach 8). January 2017.**

Between the 2016 and 2017 construction seasons, high flow events significantly altered some of the new habitat features that were construction in 2016 at both the Phase 2, Part 1 and Phase 3, Part 1 sites. Sonoma Water worked with its design team and the resource agencies on adapted designs for both of these project areas. The remaining portions of the Phase 2, Part 1

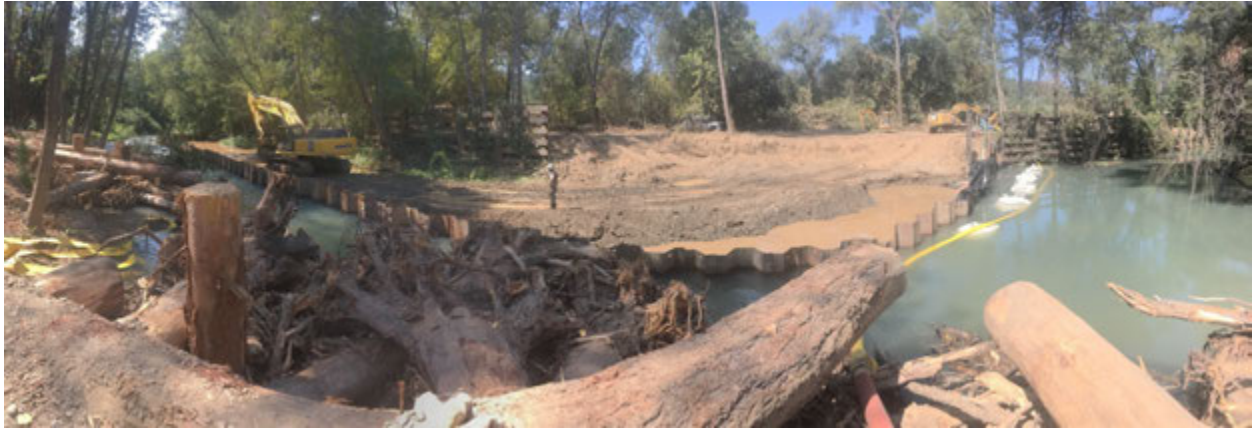
**Photo 5.1.5. Dry Creek Habitat Enhancement Project Phase 2, Part 1. Construction of new habitat features at the Carlson Lonestar site (Reach 8). August 2017.**

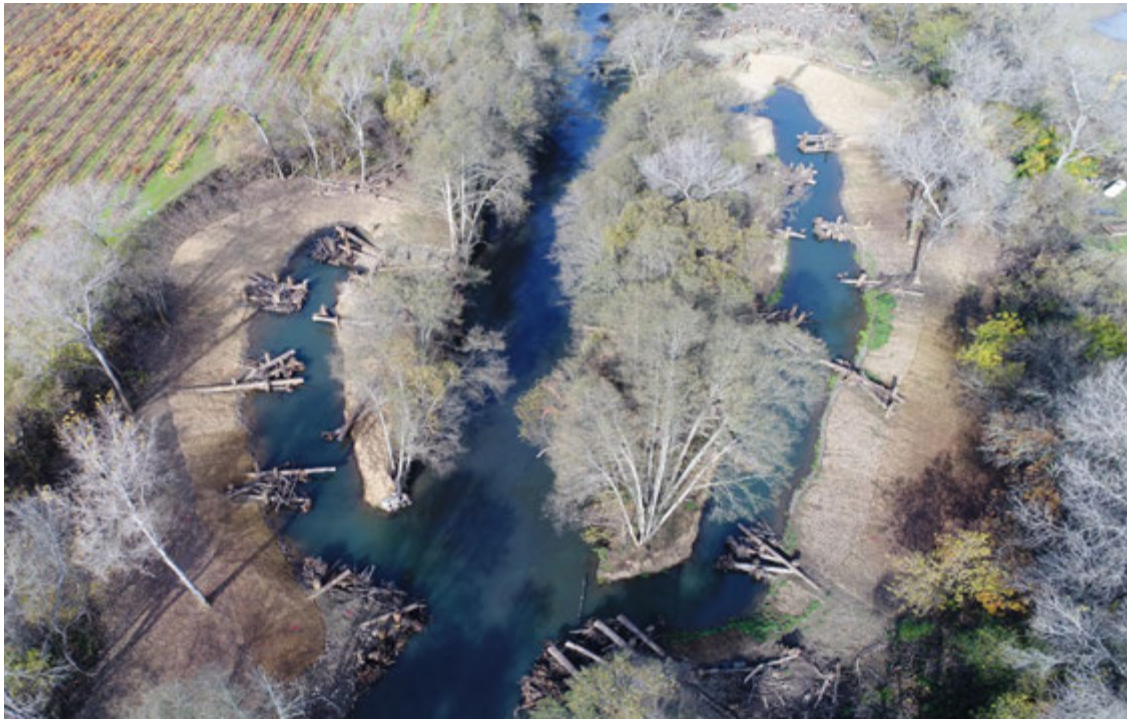
**Photo 5.1.6. Dry Creek Habitat Enhancement Project Phase 2, Part 1. Completed construction of new habitat features at the Carlson Lonestar site (Reach 8). Site “A” (Carlson) on Right, Site “B” (Lonestar) on Left. November 2017.**

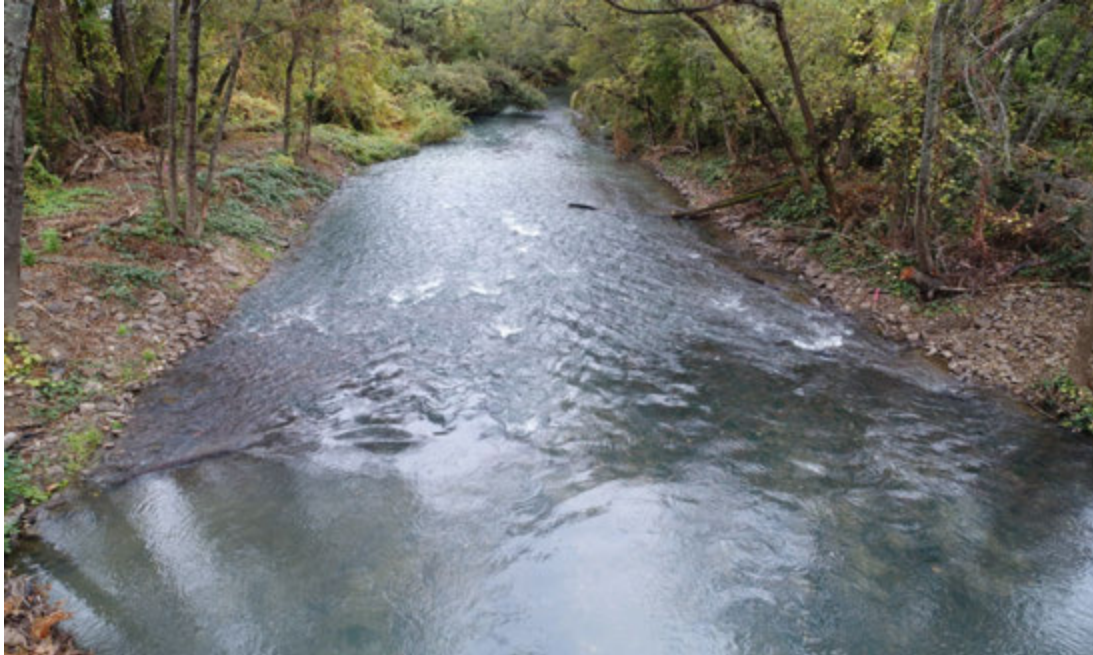
**Photo 5.1.7. Dry Creek Habitat Enhancement Project Phase 2, Part 1. Newly constructed riffle at the downstream end of the Carlson Lonestar sites (Reach 8). September 2017.**

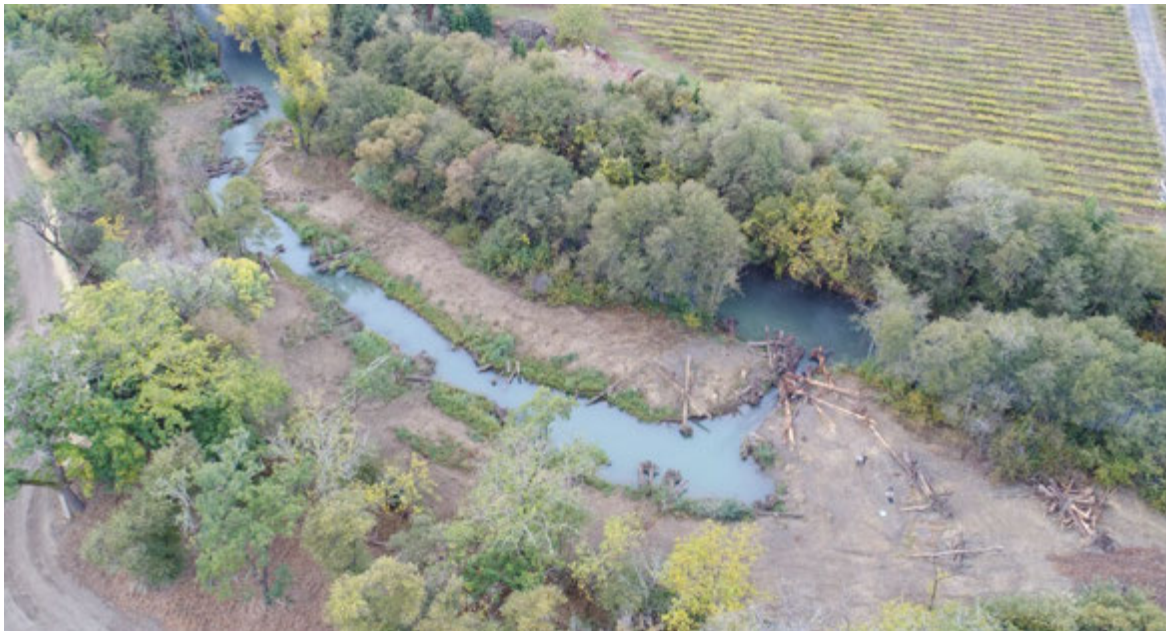
**Photo 5.1.8. Dry Creek Habitat Enhancement Project Phase 2, Part 1. Newly constructed side channel at the Meyer site (Reach 8, Site "C"). This site was constructed in 2016 and repaired in 2017. November 2017.**

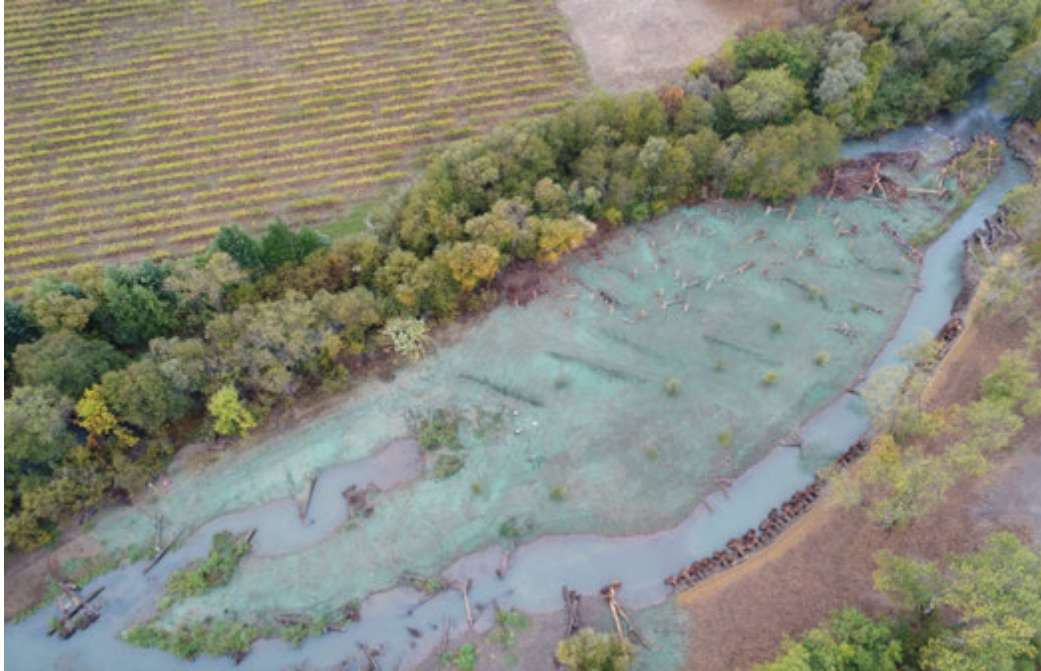
**Photo 5.1.9. Dry Creek Habitat Enhancement Project Phase 2, Part 1. Newly constructed side channel and alcove at the Truett Hurst site (Reach 8, Site “D”). This site was constructed in 2016 and repaired in 2017. November 2017.**

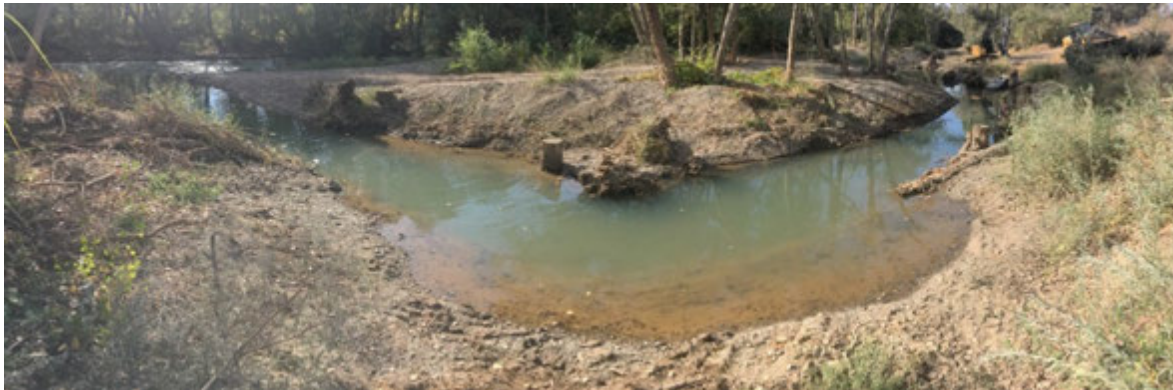
**Photo 5.1.10. Dry Creek Habitat Enhancement Project Phase 3, Part 1. Newly constructed side channel at the Geyser Peak site (Reach 2). This site was constructed in 2016 and repaired in 2017. October 2017.**

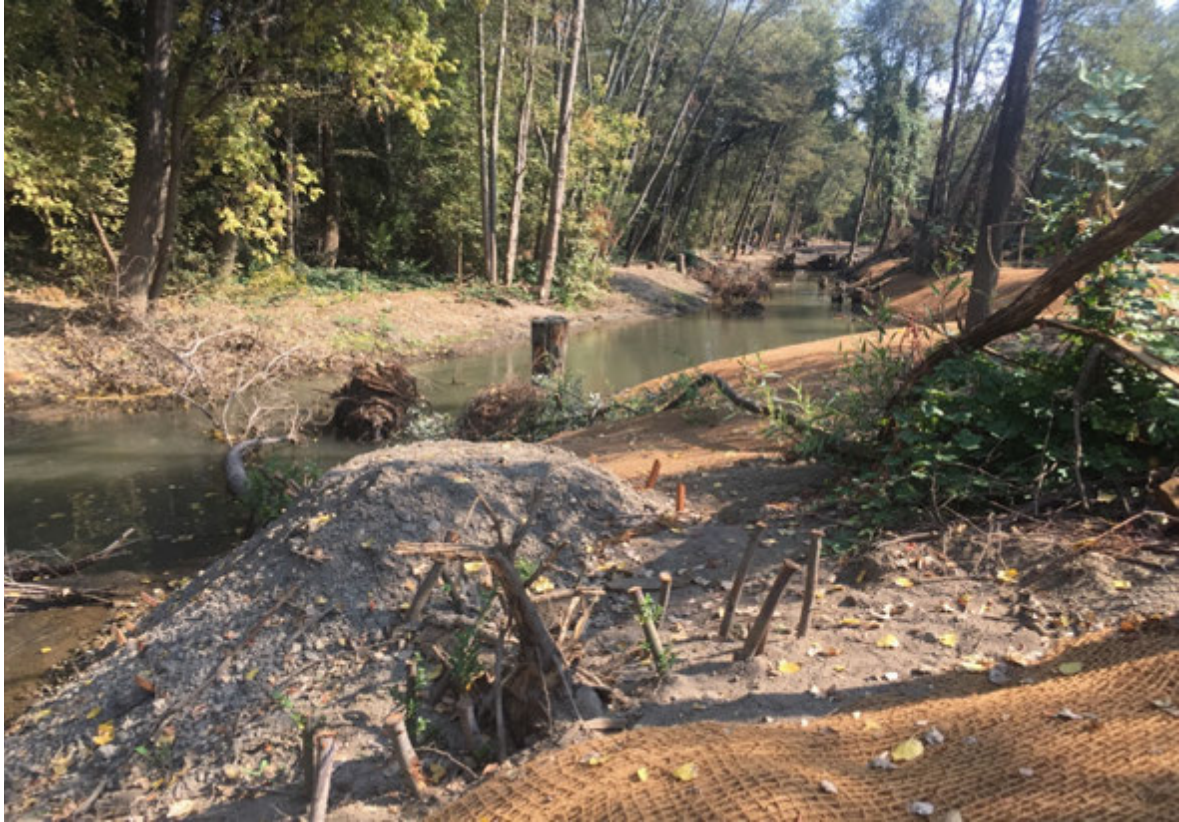
**Photo 5.1.11. Dry Creek Habitat Enhancement Project Phase 3, Part 1. Newly constructed side channel at the City of Healdsburg Yard site (Reach 2). This site was constructed in 2017. September 2017.**

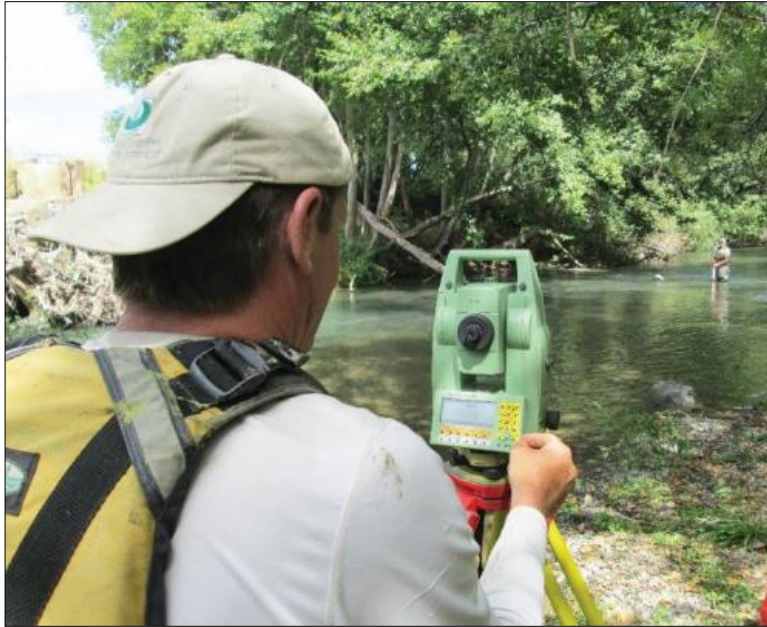
**Figure 5.2.1. Dry Creek effectiveness monitoring.** At each data point, we collected geographic location (latitude, longitude, elevation), and water depth and velocity by aiming the total station at a USGS topset rod fit with a survey prism and a flow meter

Field crews collected water depth and velocity at points across the streambed using handheld flow meters and a total station. At each point, we collected geographic location (latitude, longitude, elevation), and water depth and velocity by aiming the total station at a USGS topset rod fit with a survey prism and a flow meter (Figure 5.2.1). The technique allowed simultaneous collection of spatially accurate topographic and hydraulic data (water depth and velocity) that enabled comparison to future conditions. Field crews focused point collection on breaks in slope and breaks in water velocity, and at a minimum collected points at the top of each bank, water surface elevation, toe of bank, thalweg, and at least two points between toe of bank and thalweg.

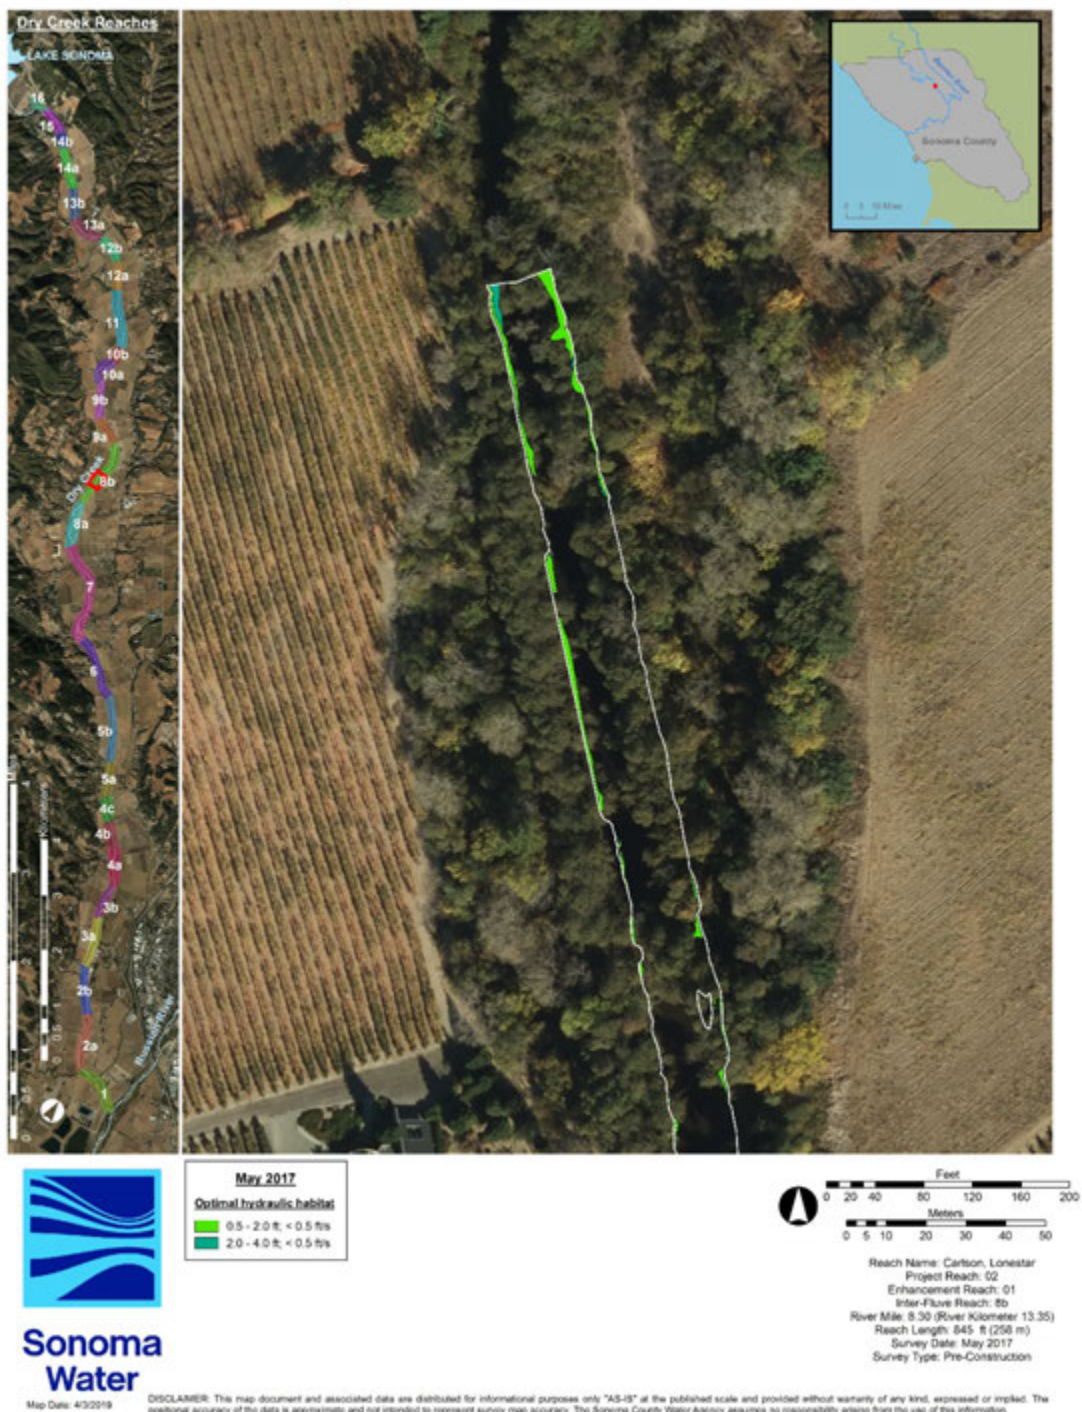
Figure 5.2.5. Optimal hydraulic habitat for fry (<0.5 ft/s, 0.5-2.0 ft) and parr (<0.5 ft/s, 2.0-4.0 ft) within the Carlson, Lonestar enhancement reach, May 2017.
