# Russian River Biological Opinion Status and Data Report

Year 2017 - 2018

**Sonoma  
Water**

**June 2020**

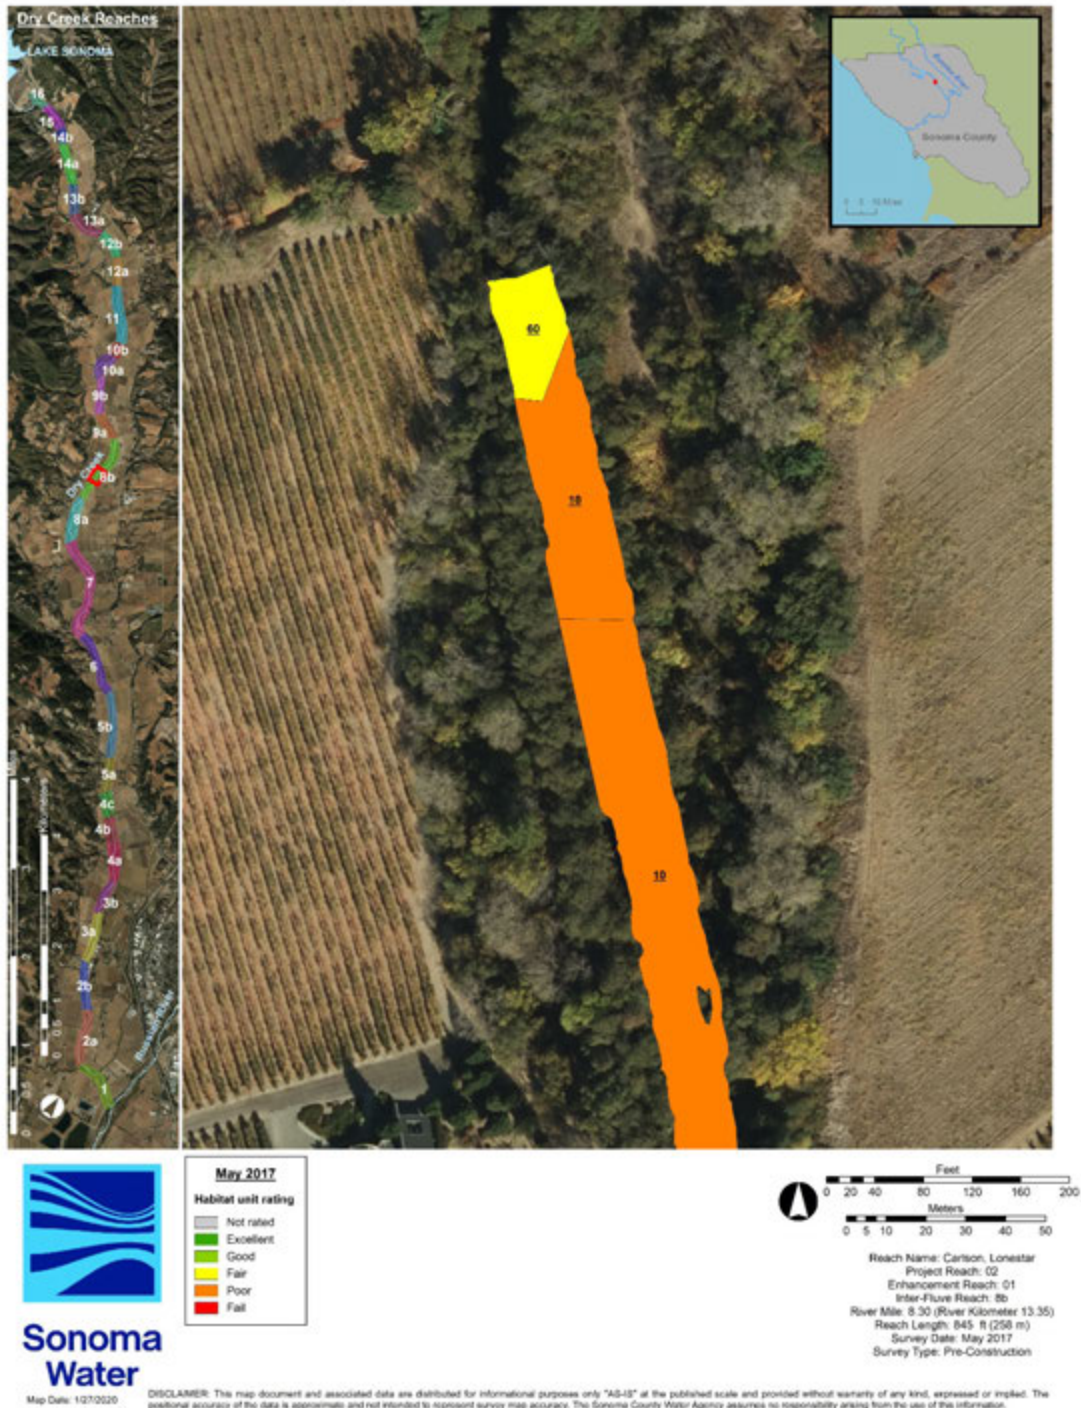
Figure 5.2.8. Habitat unit ratings for the Carlson, Lonestar enhancement reach, May 2017.

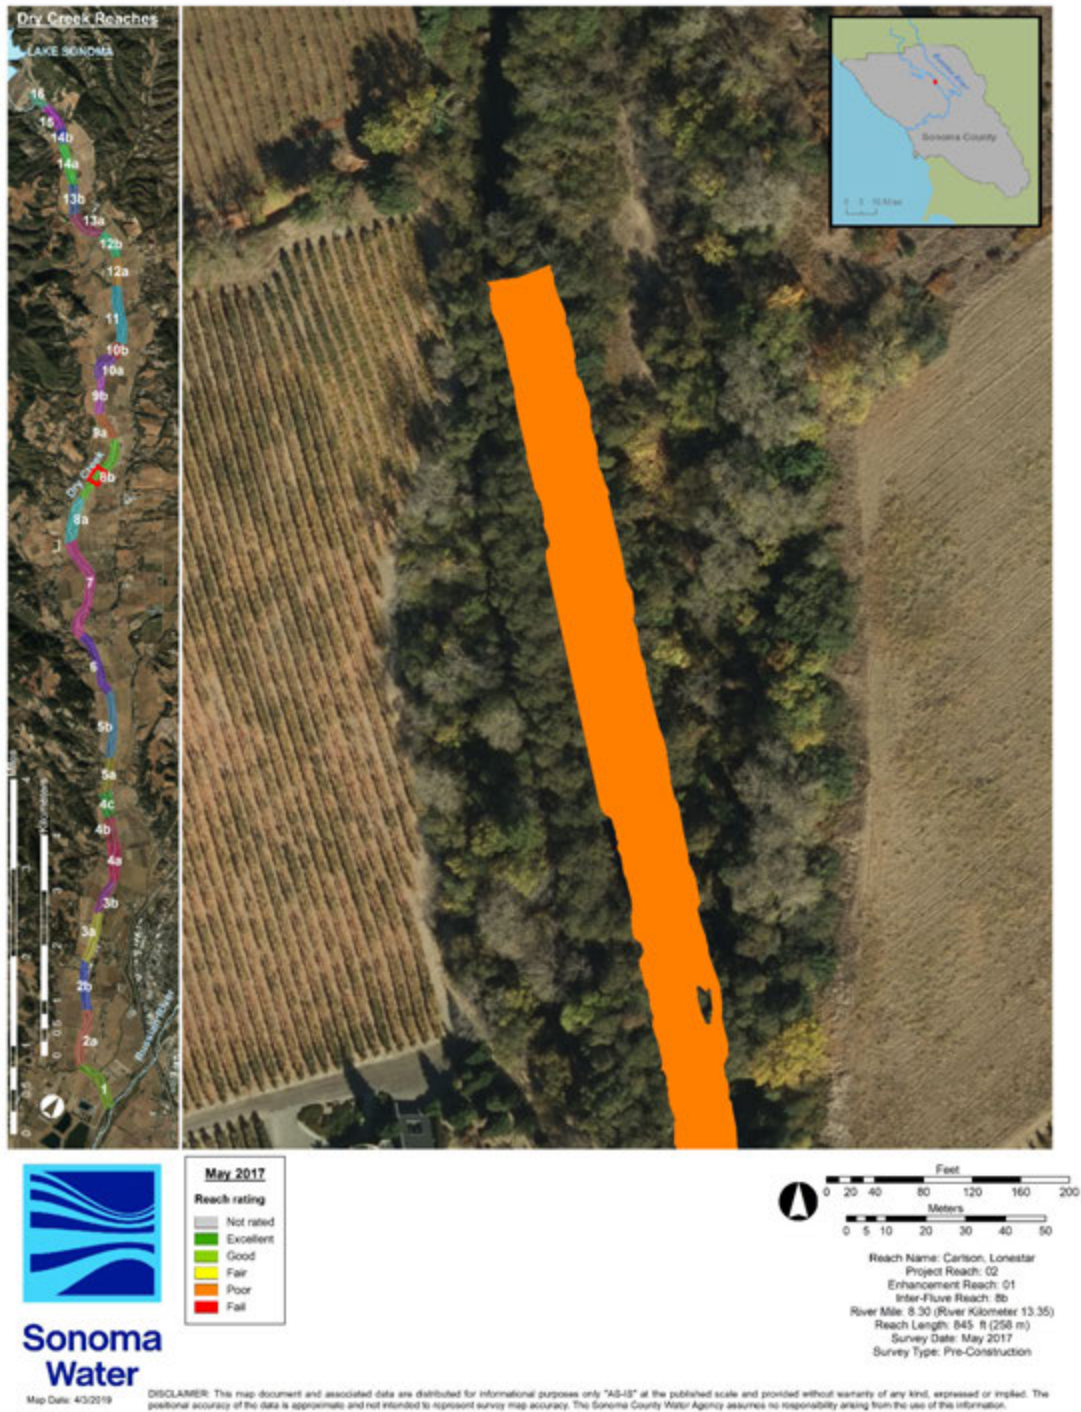
Figure 5.2.9. Pre-enhancement site and reach rating for the Carlson, Lonestar enhancement reach May 2017.

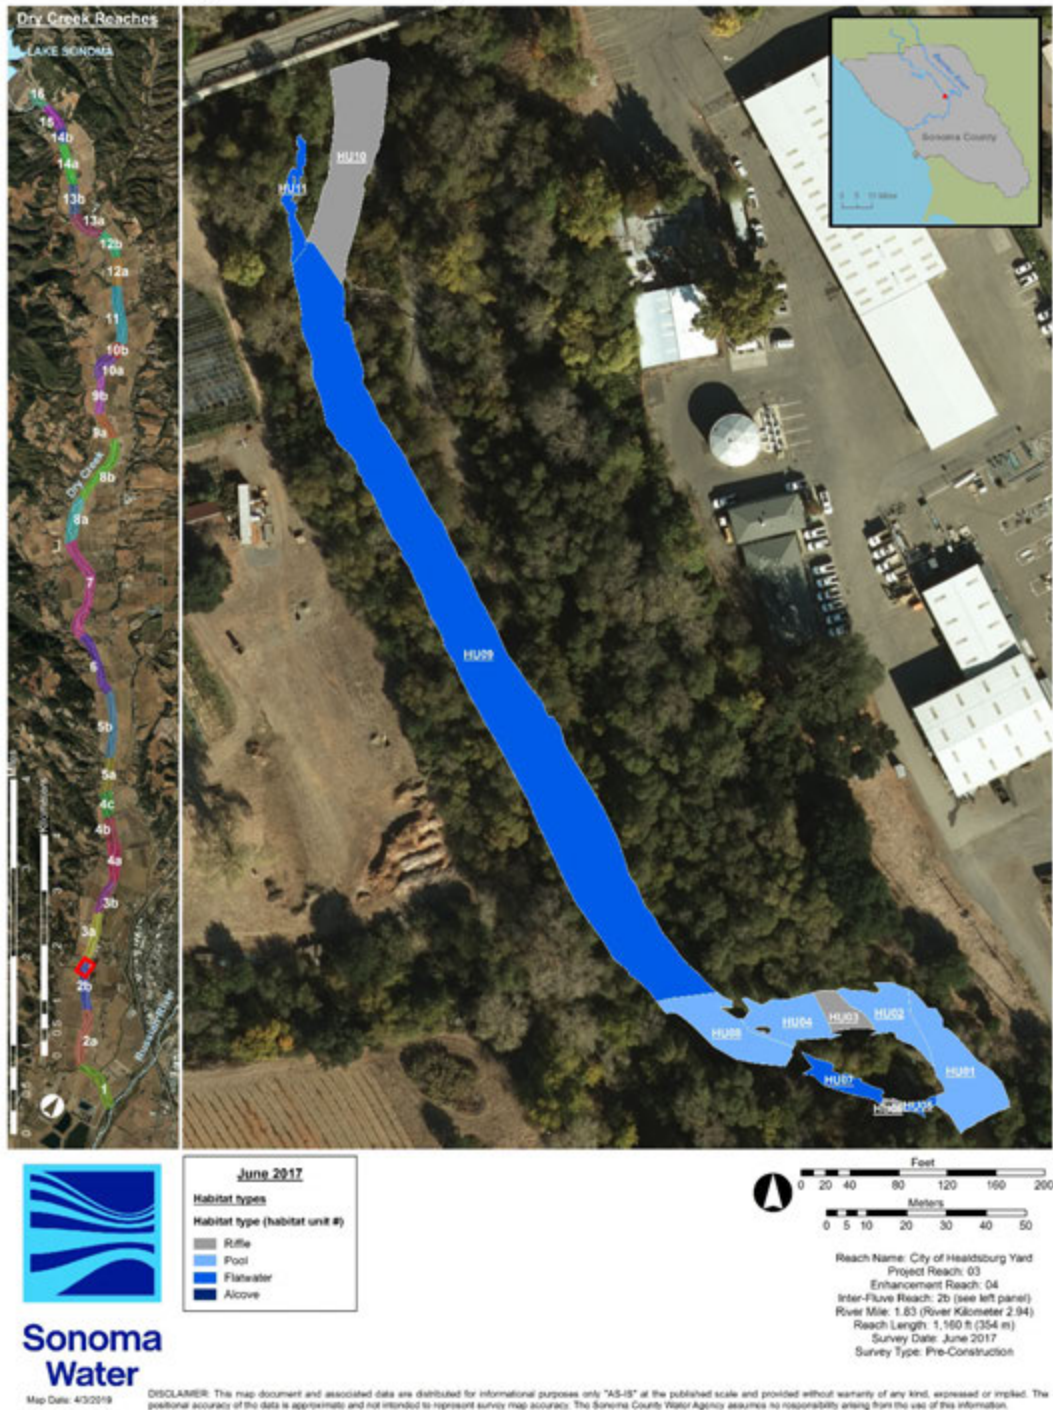
Figure 5.2.11. Habitat unit number and type within the City of Healdsburg Yard enhancement reach, June 2017.

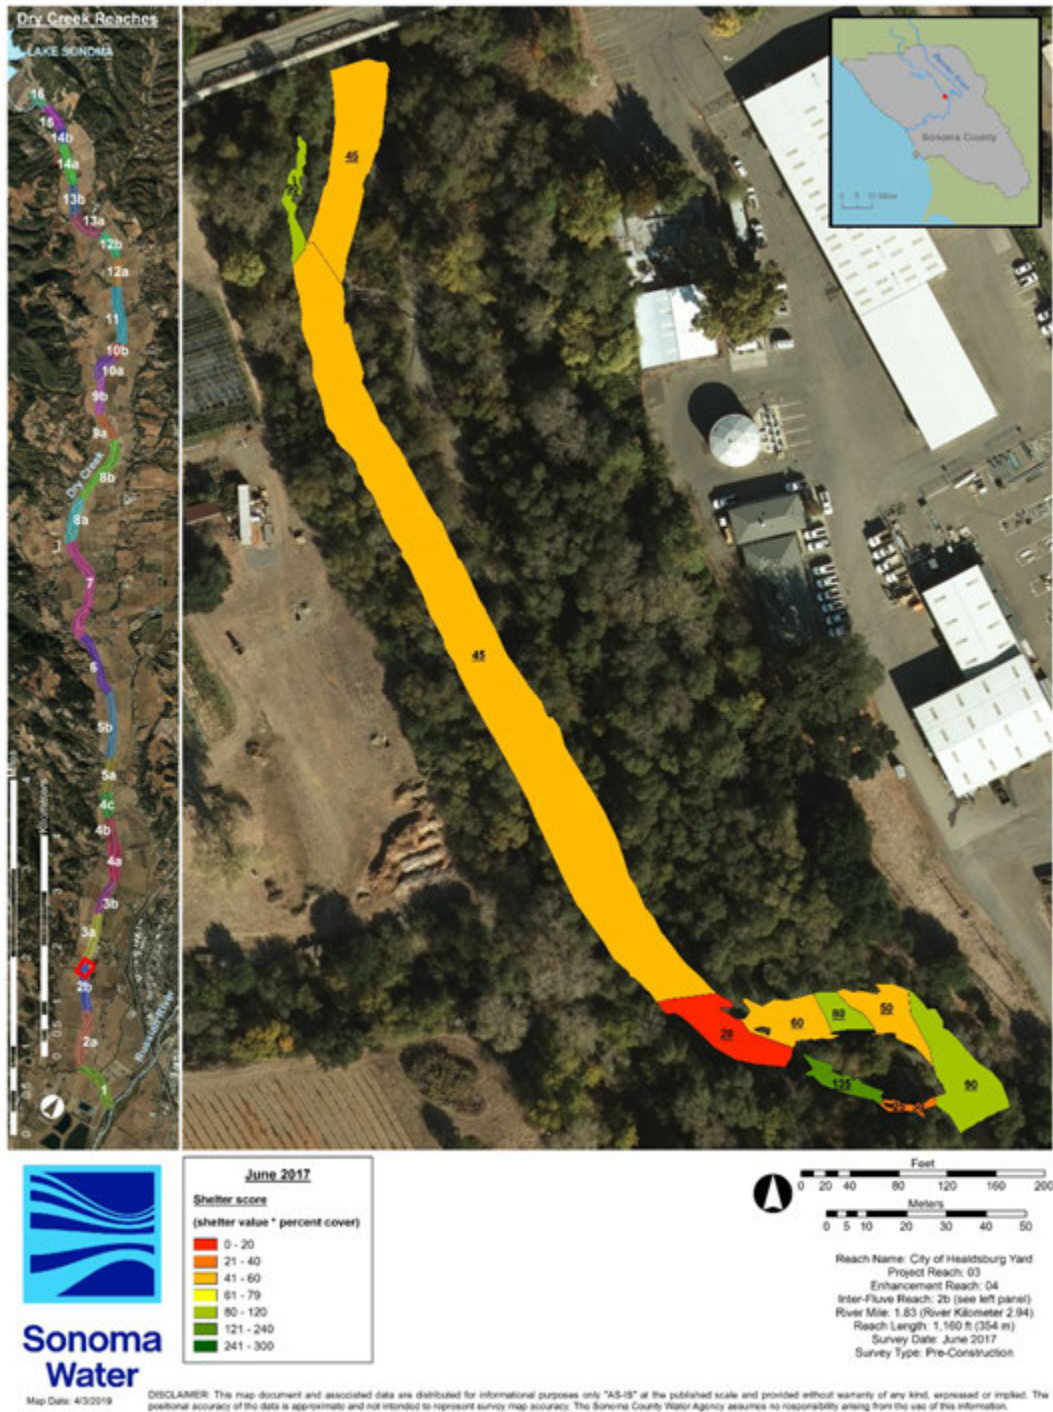
Figure 5.2.12. Habitat unit shelter values within the City of Healdsburg Yard enhancement reach, June 2017.

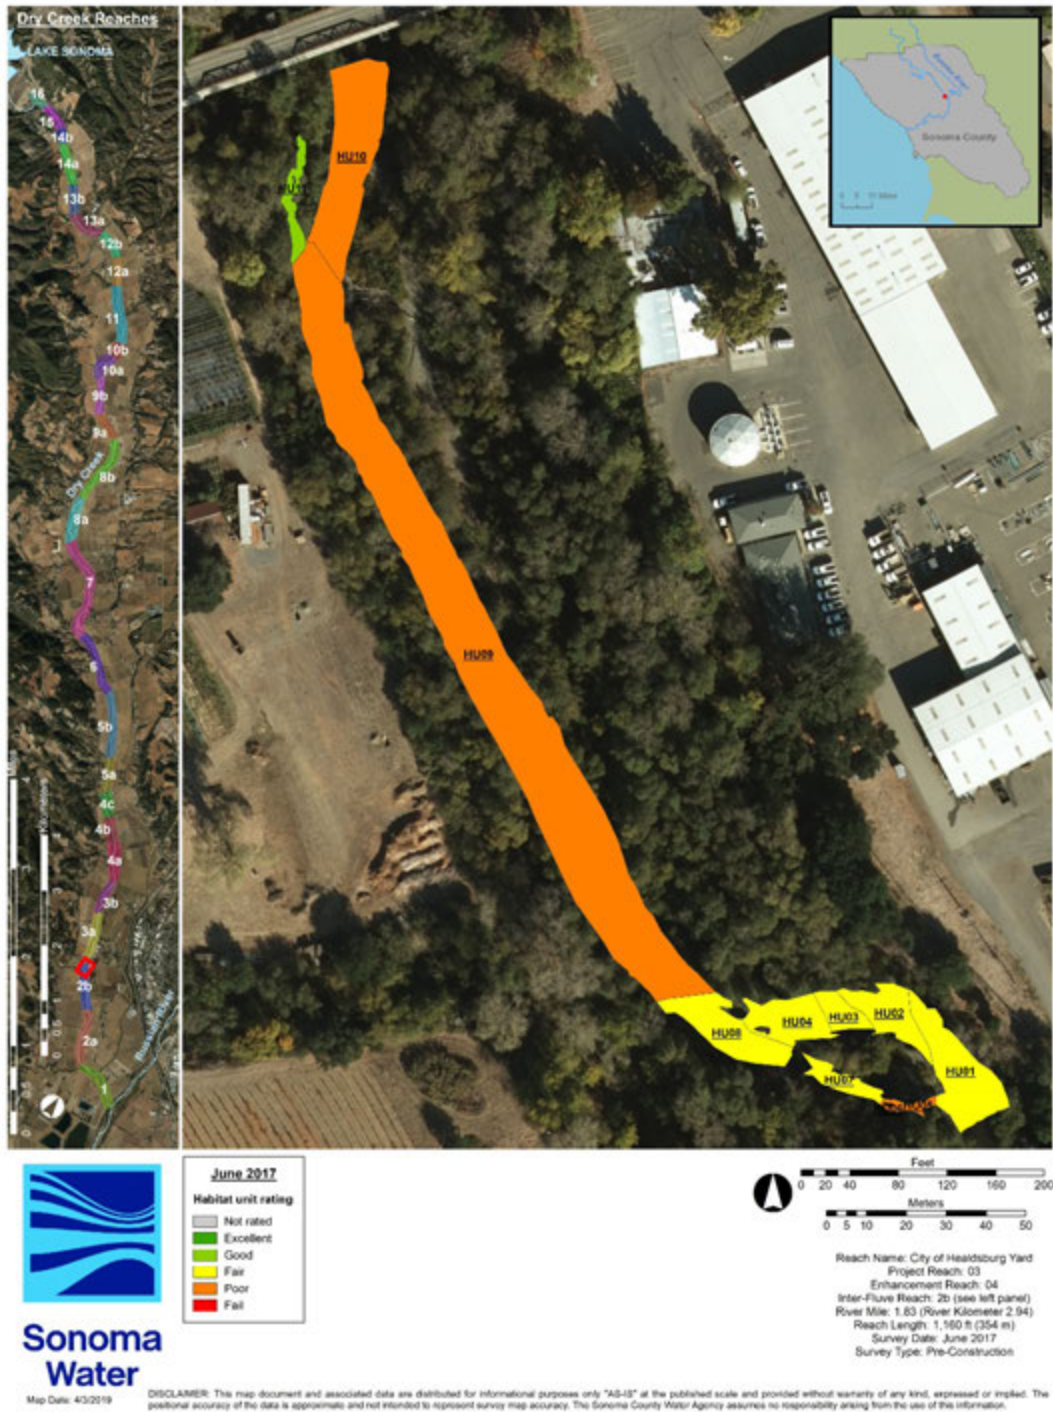
Figure 5.2.13. Habitat unit ratings for the City of Healdsburg Yard enhancement reach, June 2017.

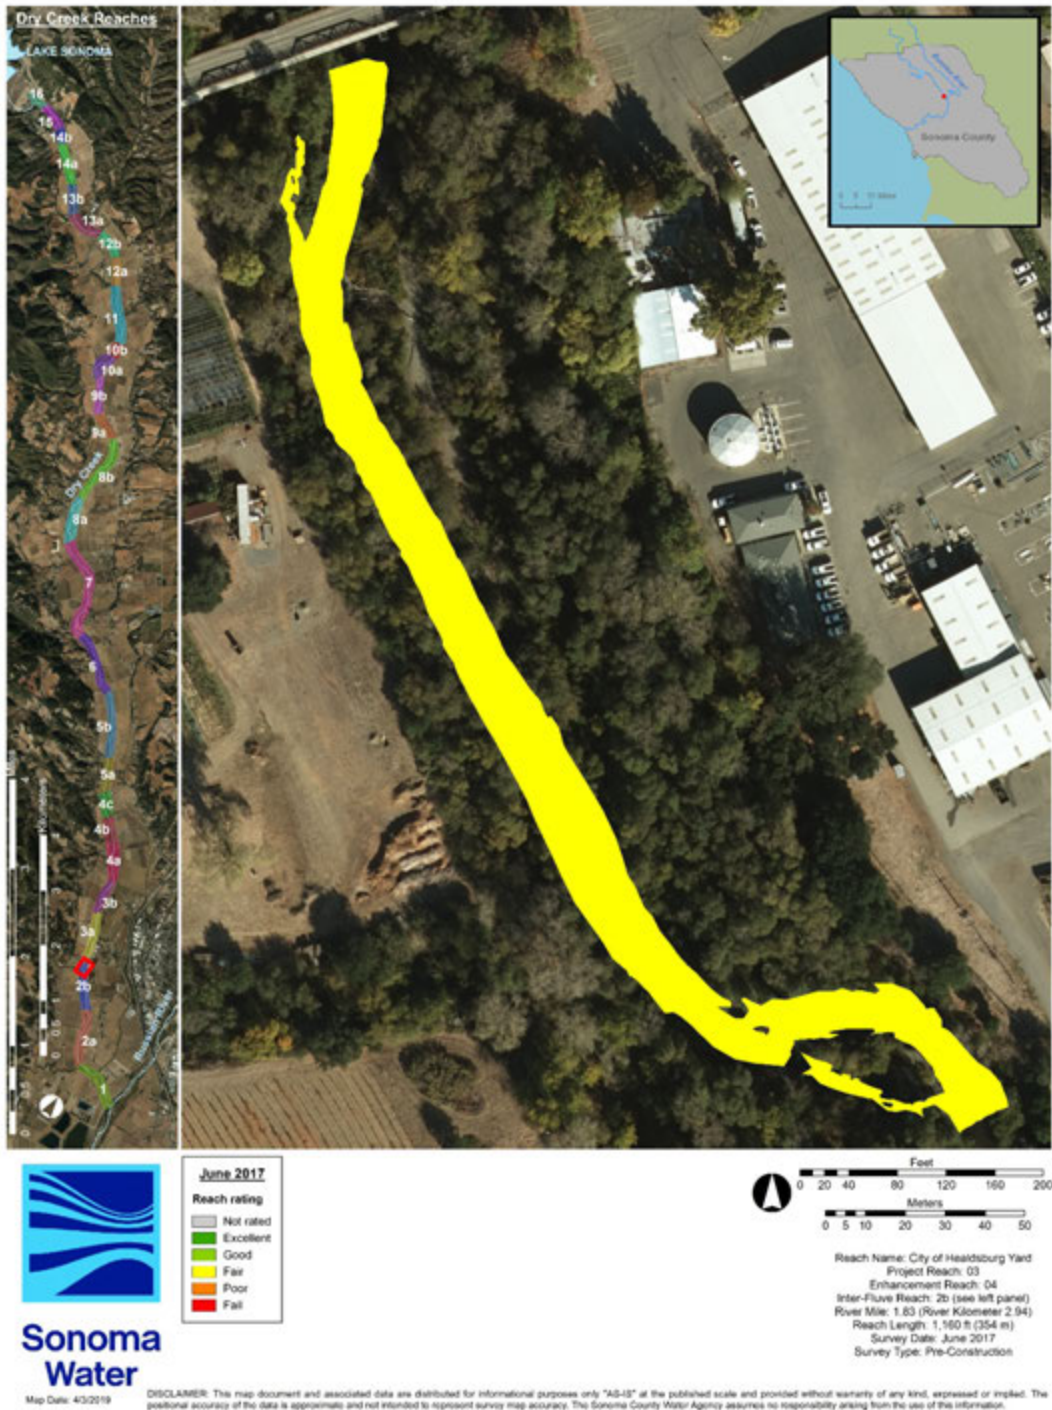
Figure 5.2.14. Pre-enhancement site and reach rating for the City of Healdsburg Yard enhancement reach June 2017.

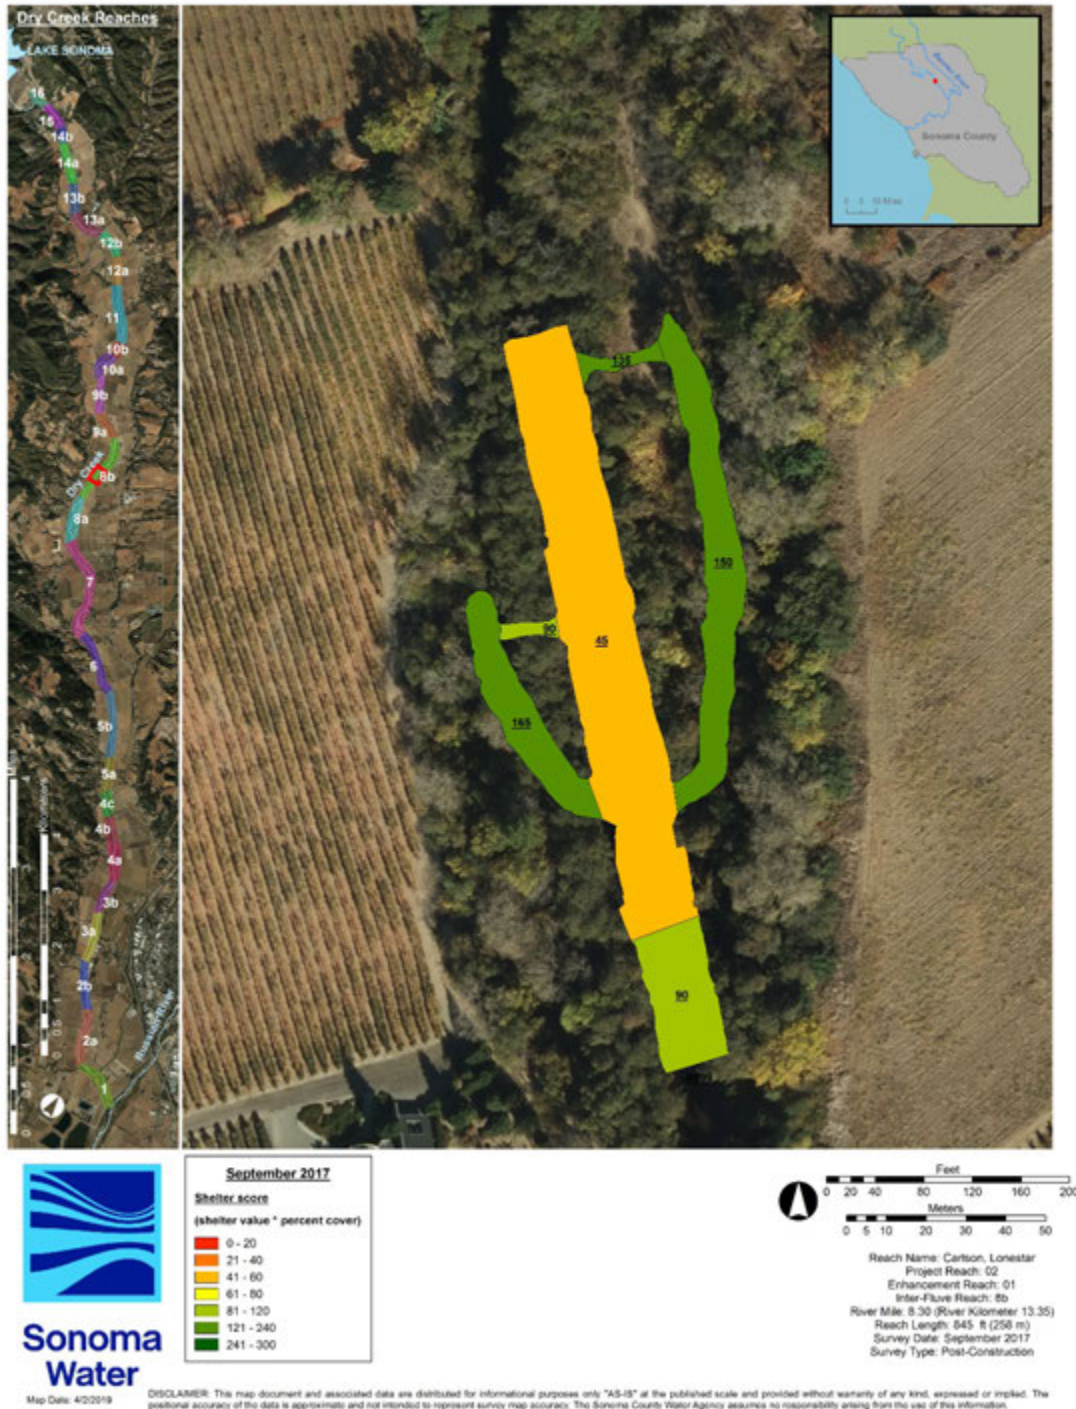
Figure 5.2.17. Habitat unit shelter values within the Carlson, Lonestar enhancement reach, September 2017.

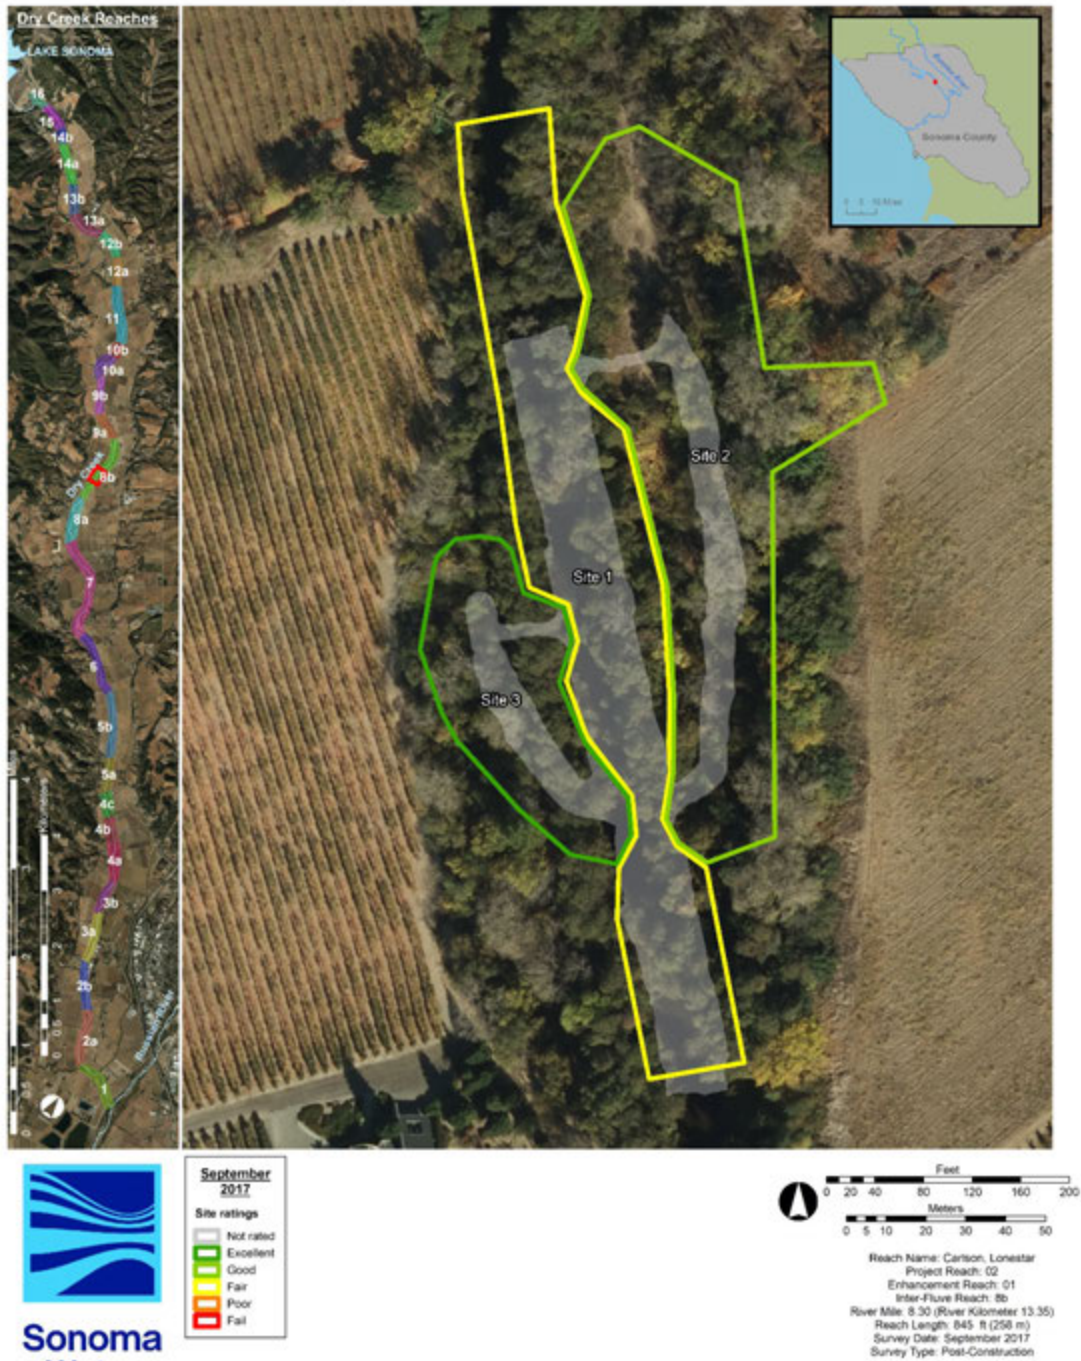
Figure 5.2.21. Post enhancement site ratings for the Carlson, Lonestar enhancement reach, September 2017.

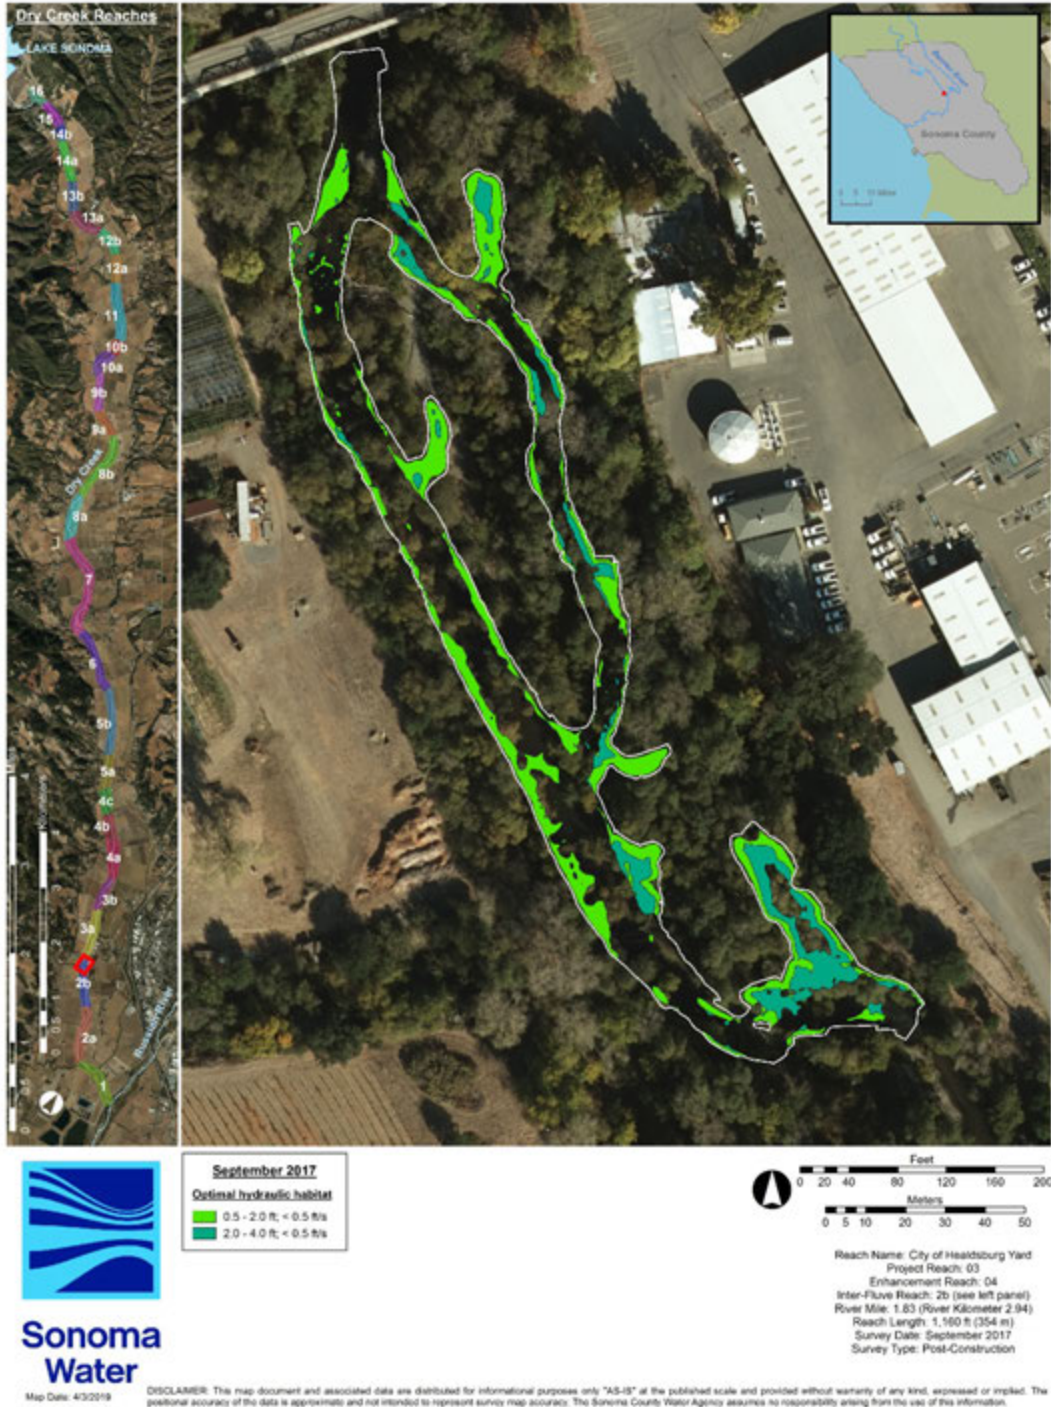
Figure 5.2.23. Optimal hydraulic habitat for fry (<0.5 ft/s, 0.5-2.0 ft) and parr (<0.5 ft/s, 2.0-4.0 ft) within the City of Healdsburg Yard enhancement reach, September 2017.

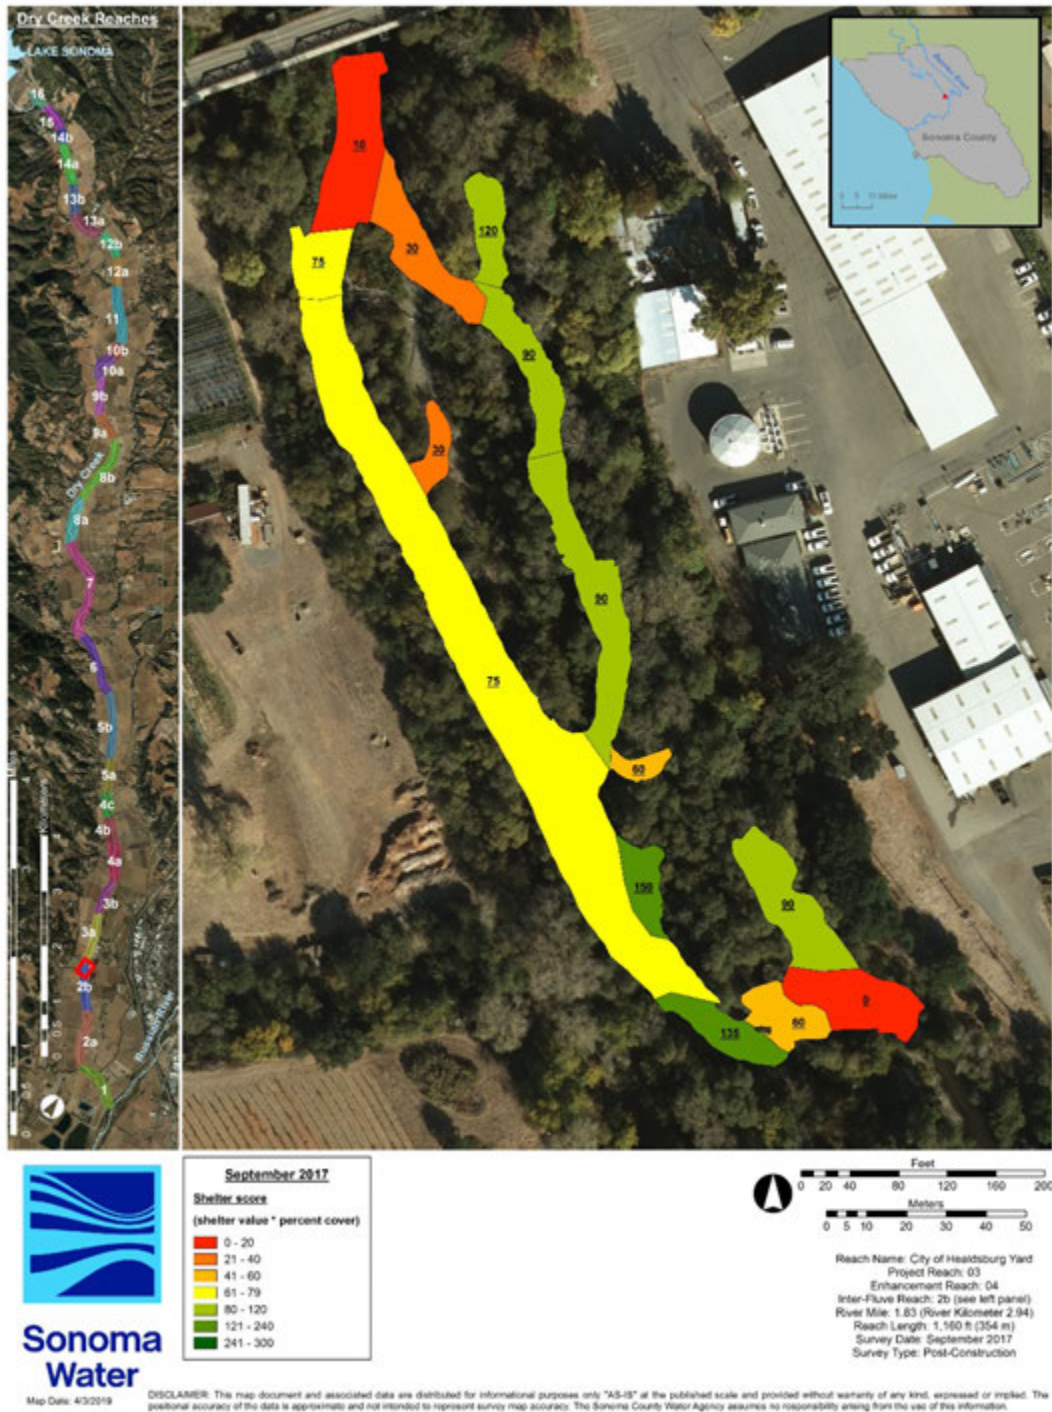
Figure 5.2.25. Habitat unit shelter values within the City of Healdsburg Yard enhancement reach, September 2017.

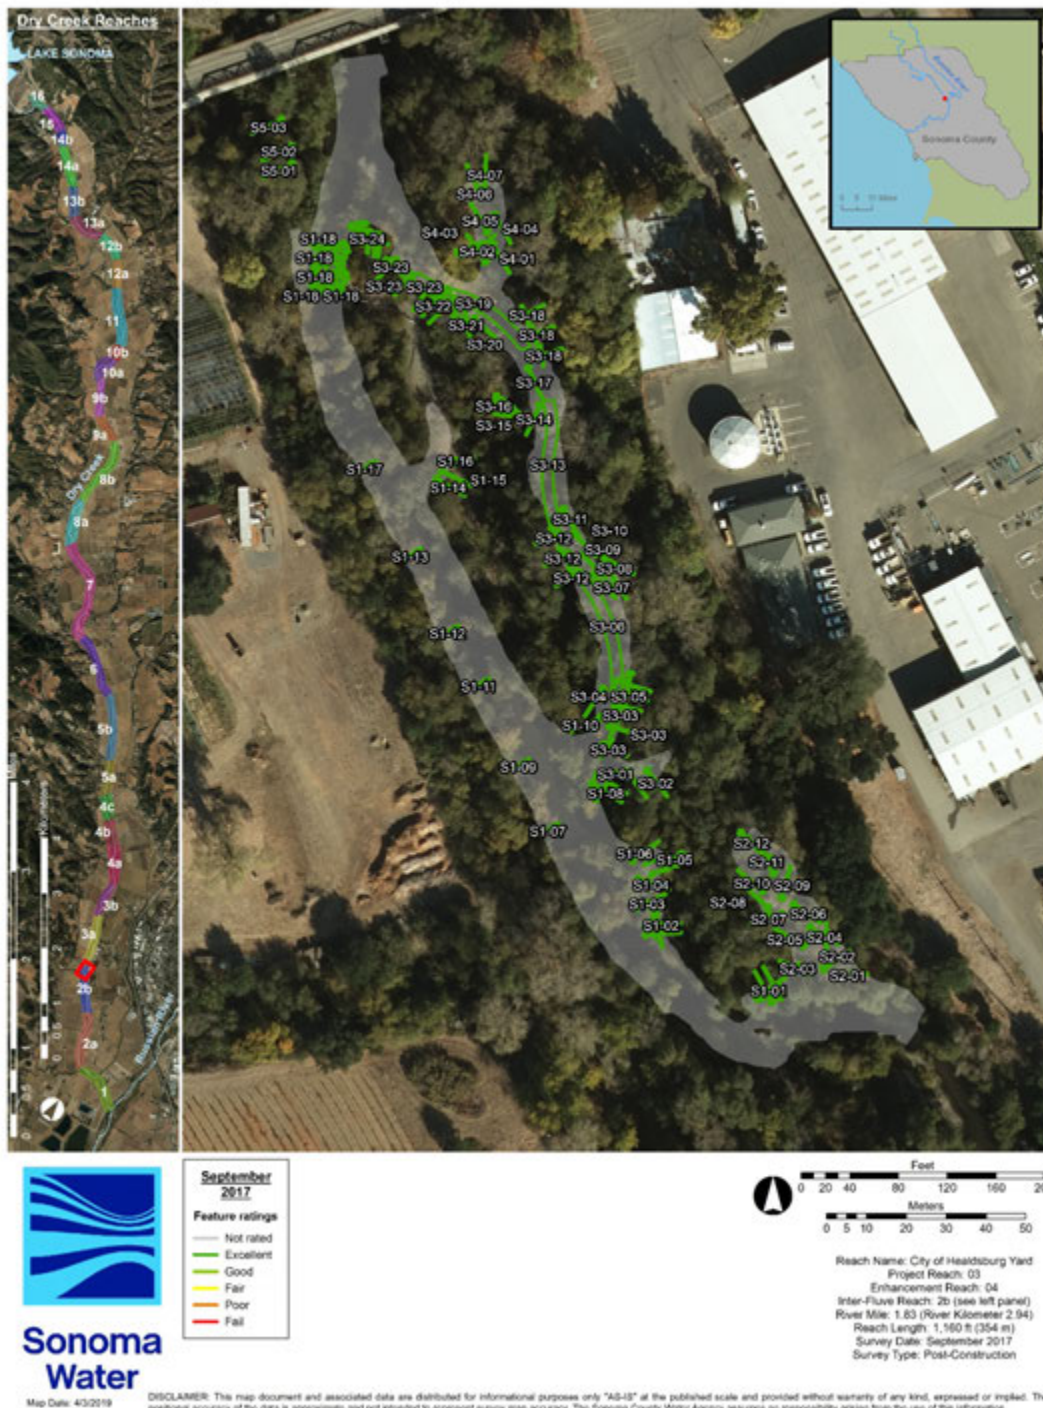
Figure 5.2.27. Feature ratings for the City of Healdsburg Yard enhancement reach, September 2017.

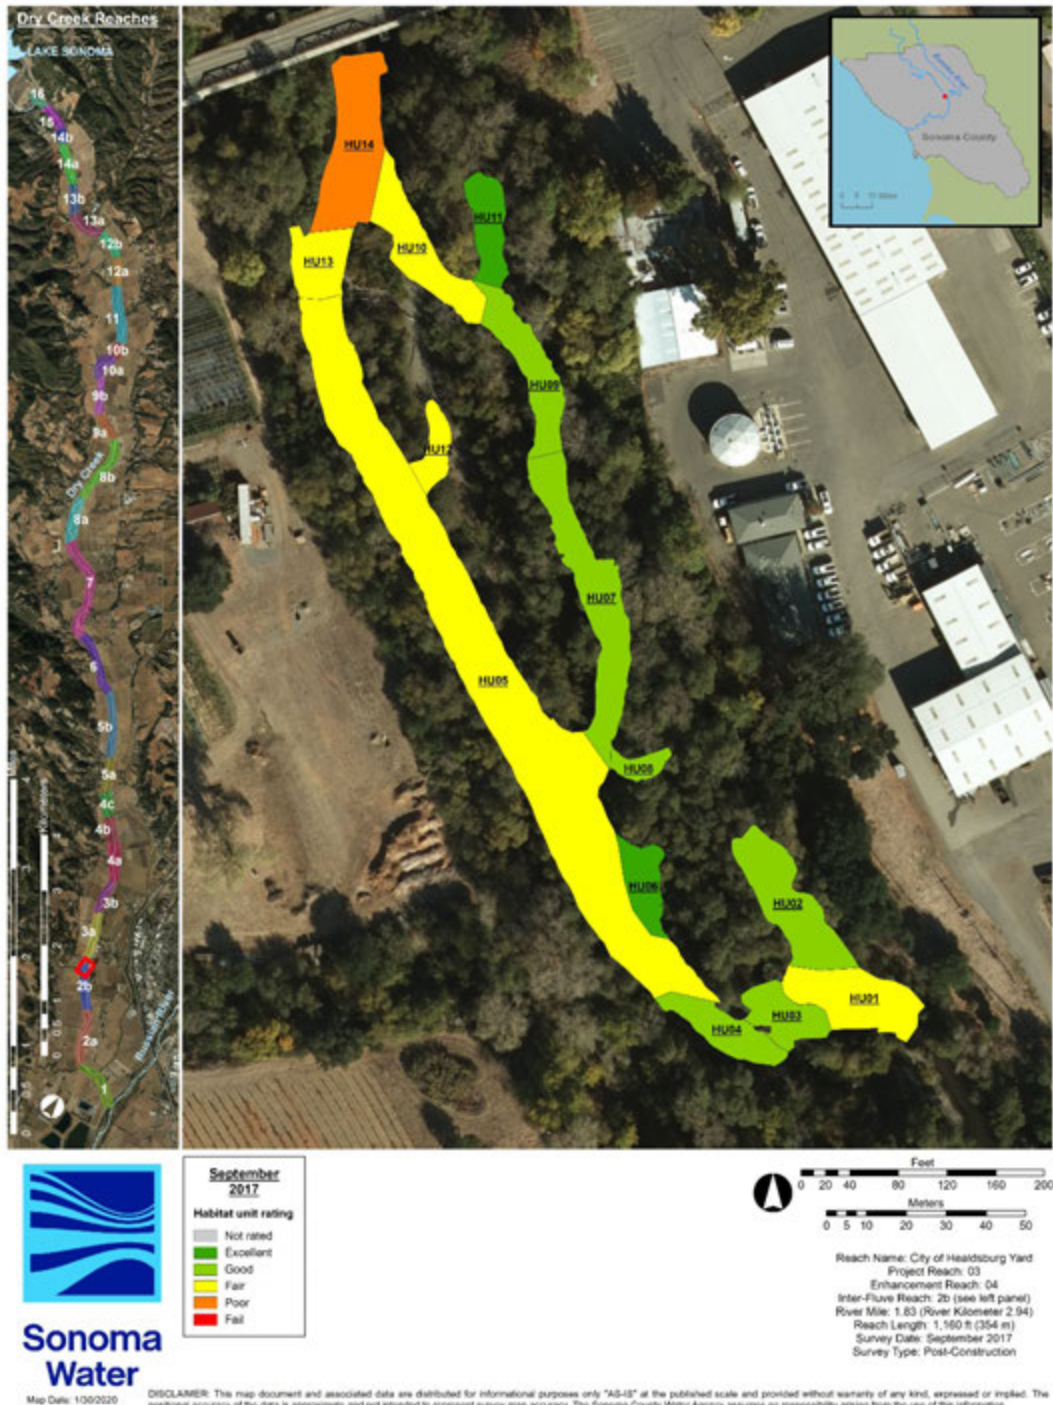
Figure 5.2.28. Habitat unit ratings for the City of Healdsburg Yard enhancement reach, September 2017.

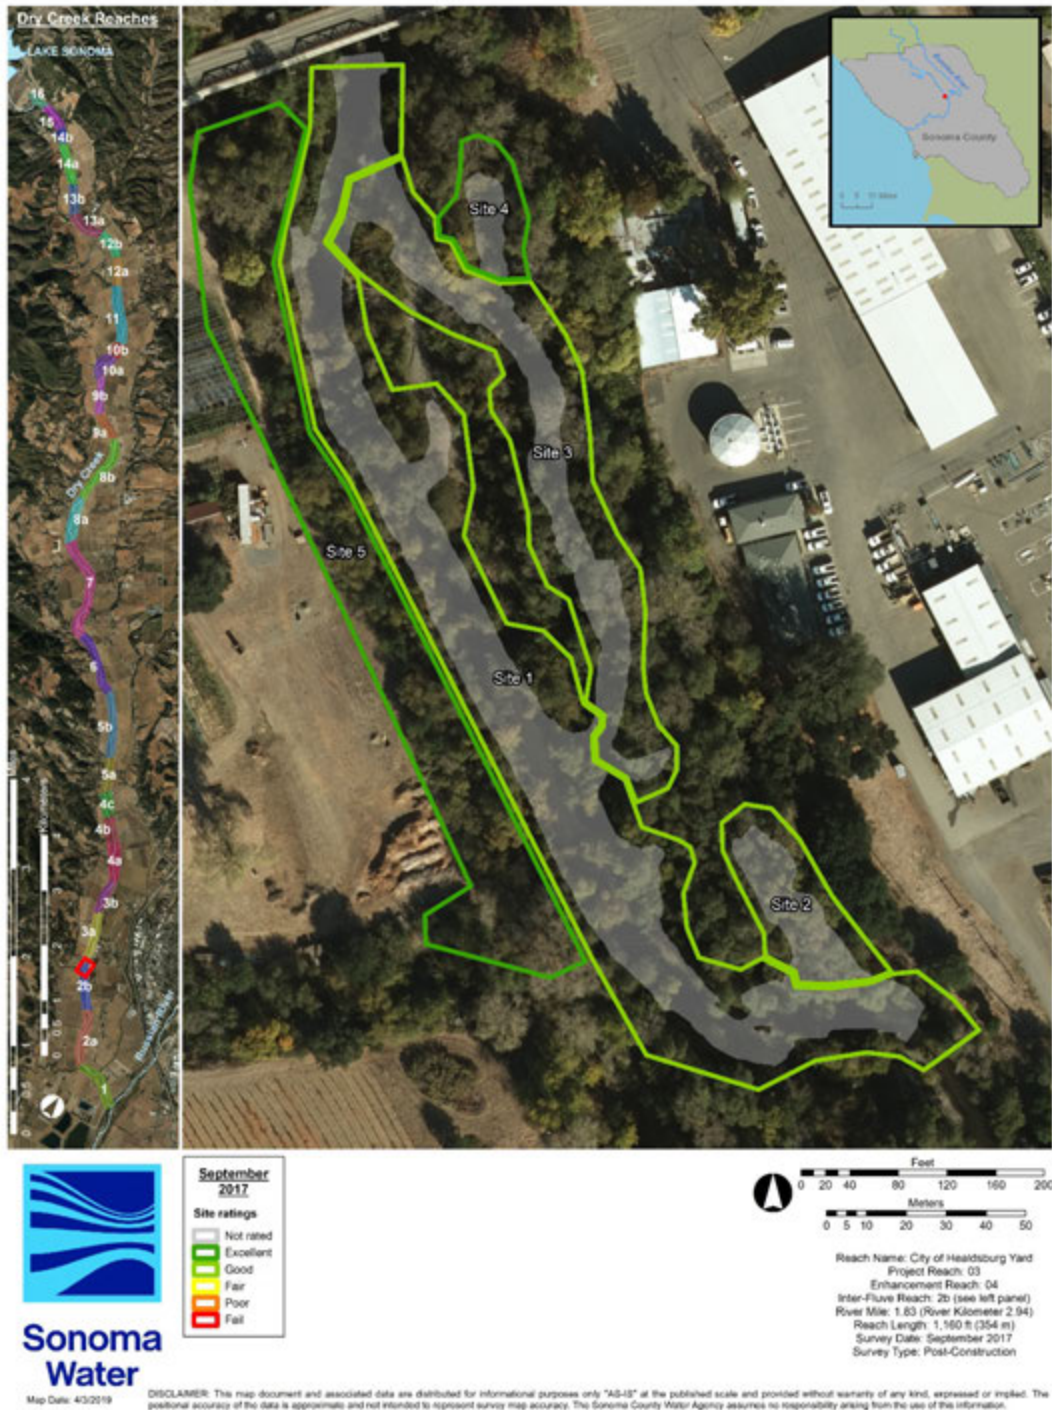
Figure 5.2.29. Post enhancement site ratings for the City of Healdsburg Yard enhancement reach, September 2017.

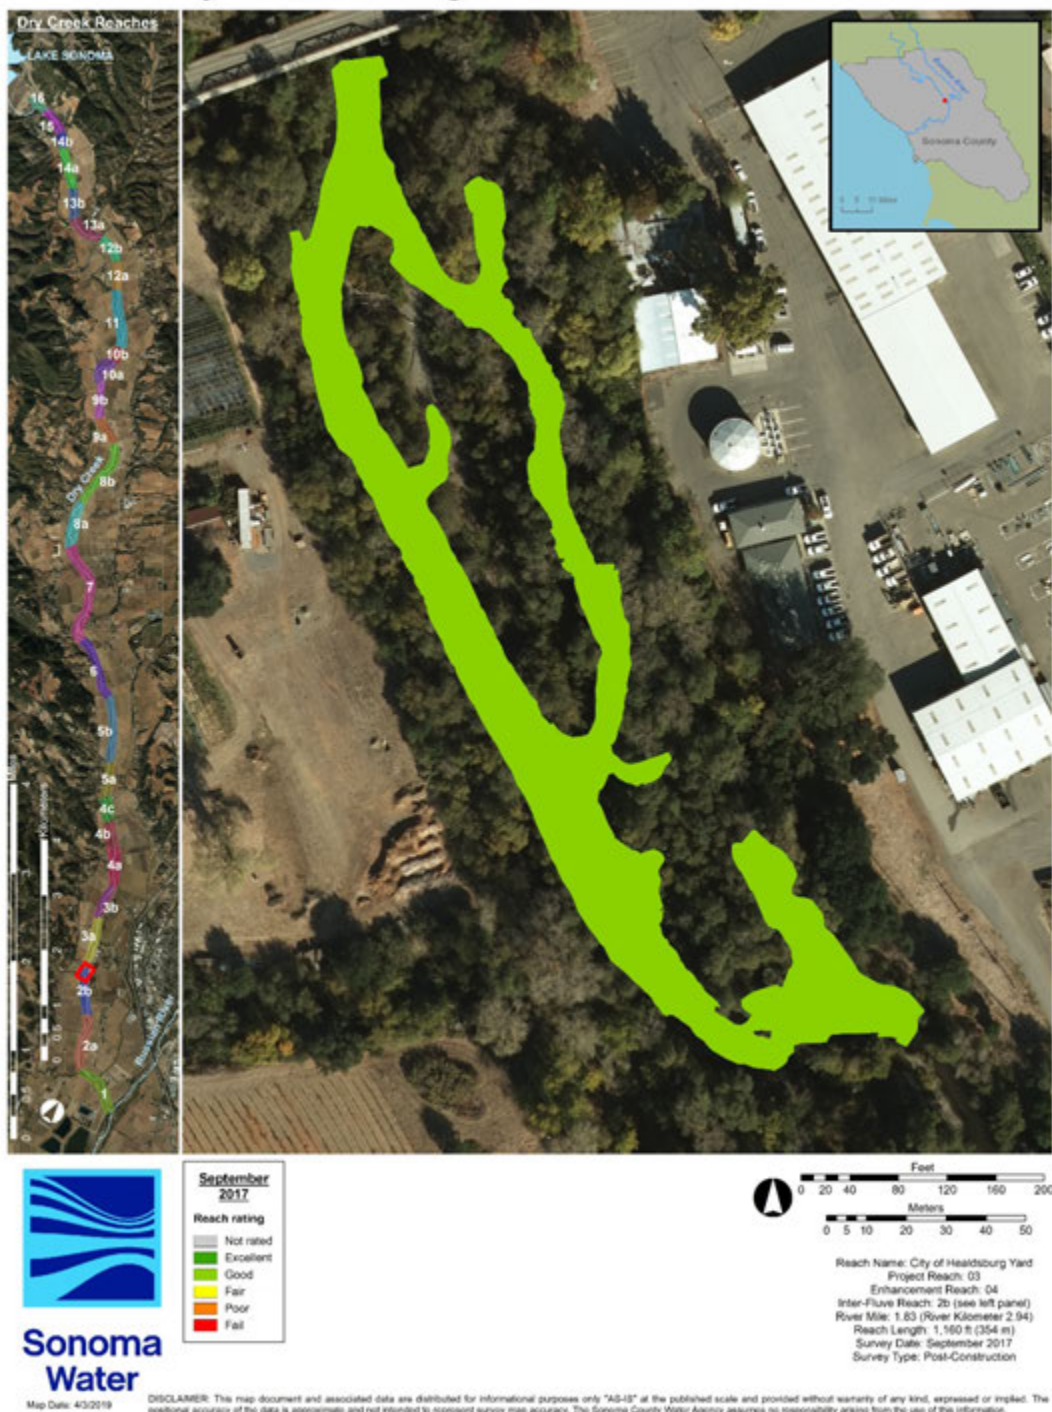
Figure 5.2.30. Post-enhancement reach rating for the City of Healdsburg Yard enhancement reach, September 2017.

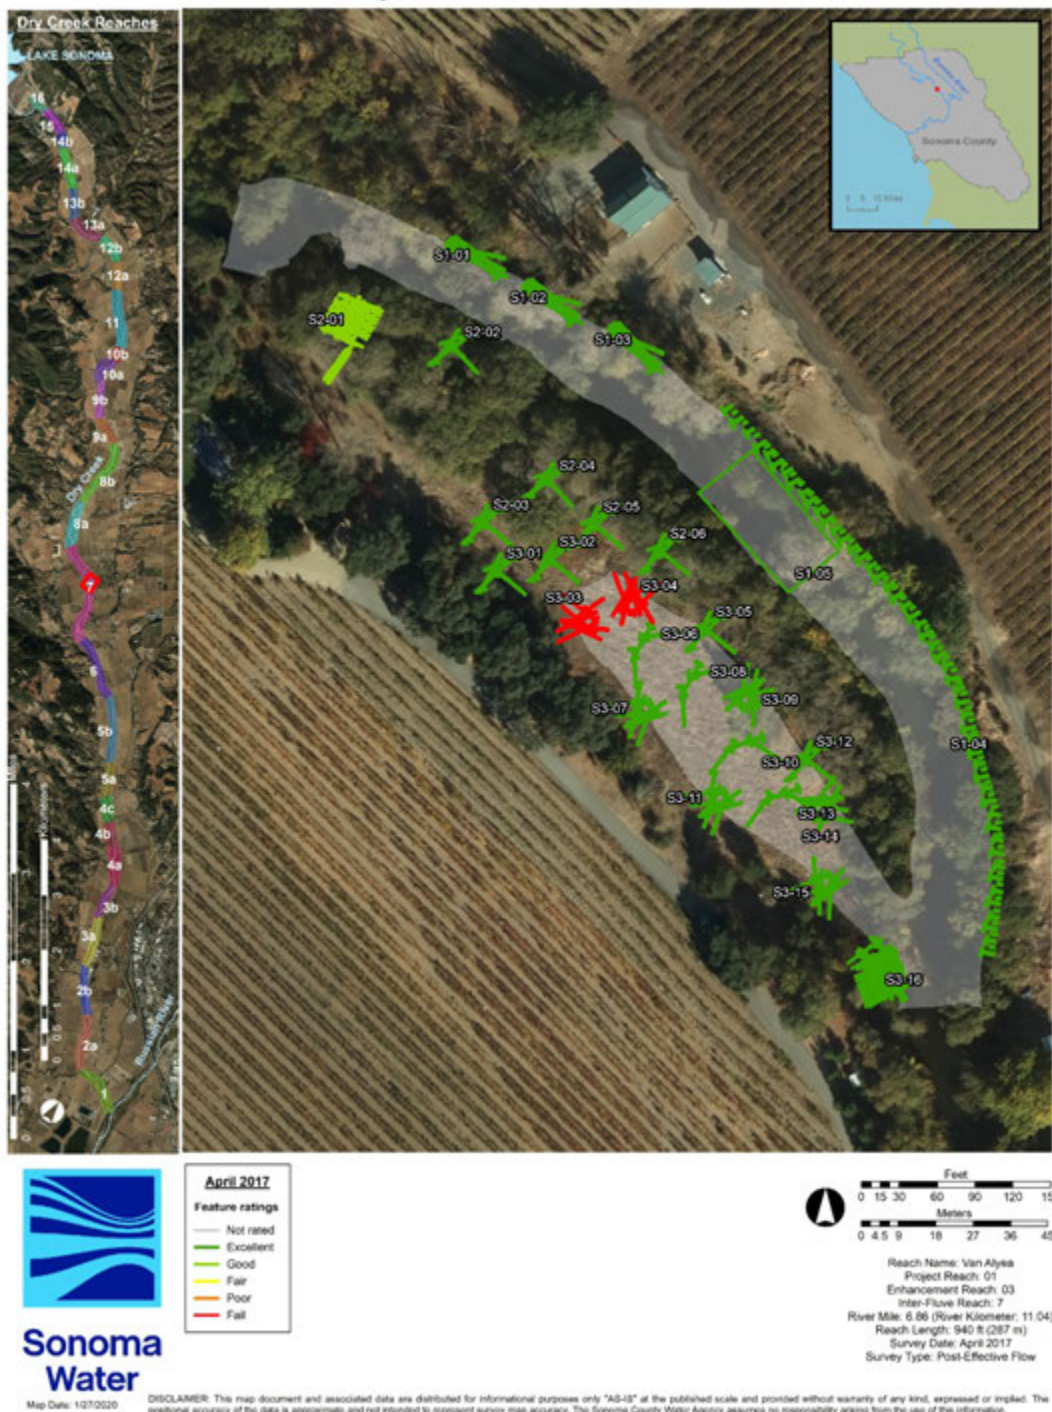
Figure 5.2.51. Feature ratings for the Van Alyea enhancement reach, April 2017.
