# Russian River Biological Opinion Status and Data Report

Year 2017 - 2018

**Sonoma  
Water**

**June 2020**

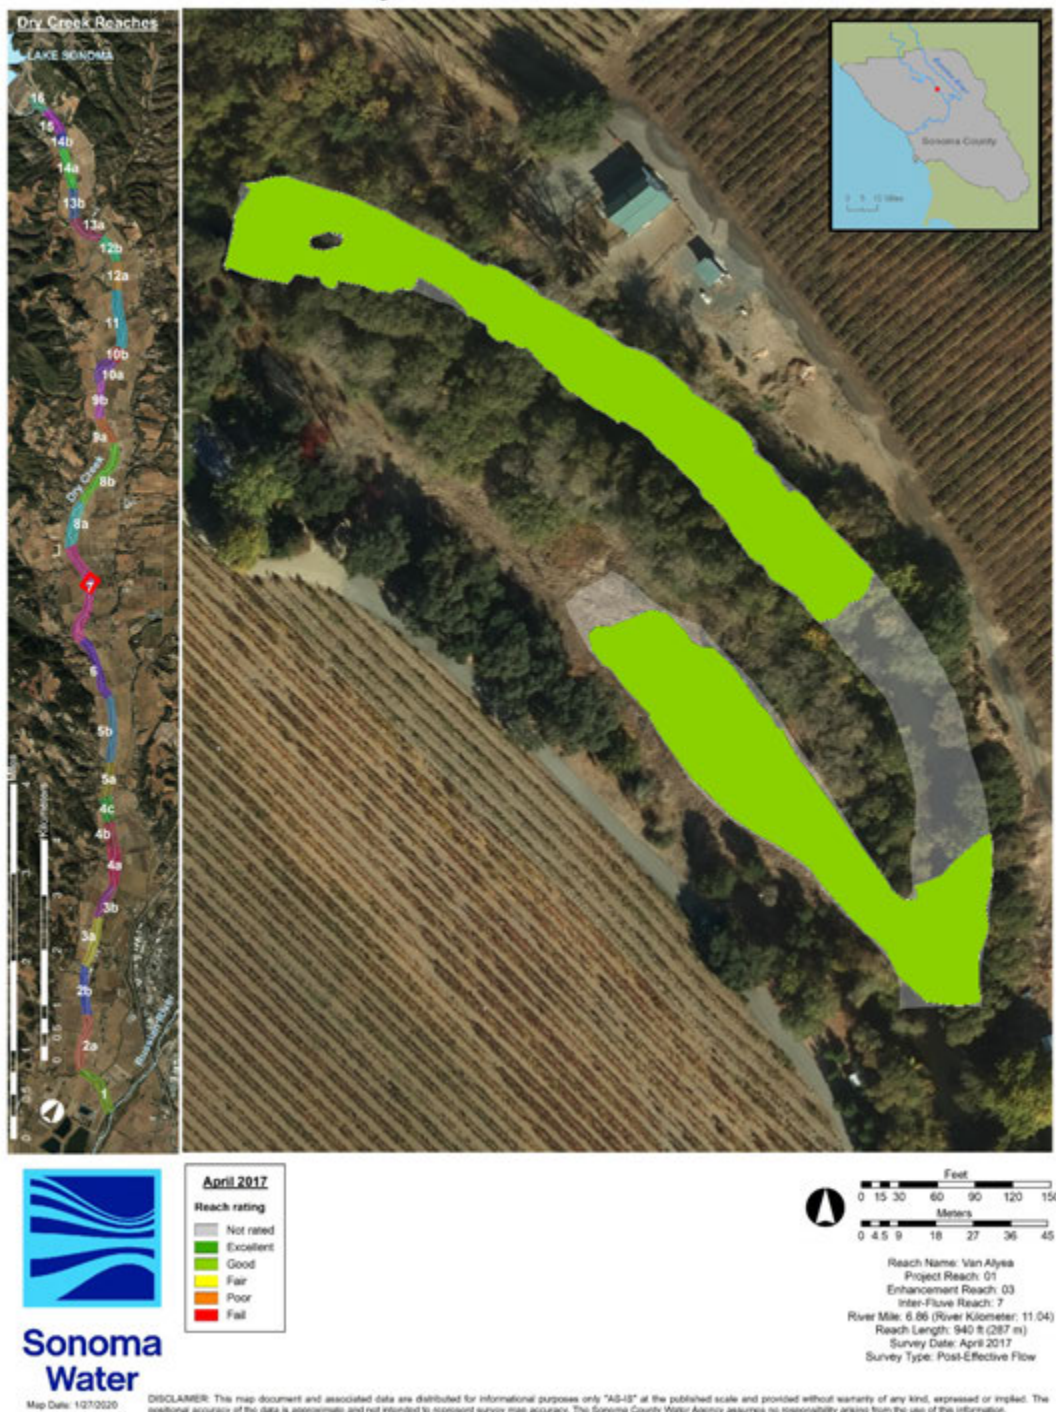
Figure 5.2.54. Post-effective flow reach rating for the Van Alyea enhancement reach, April 2017.

Sonoma Water monitored the post-effective flow condition of the Van Alyea enhancement reach in April 2017. The monitored portion of the reach covered 60,316 ft<sup>2</sup> within main channel and alcove areas, with 35% of the total meeting optimal depth and velocity criteria (Table 5.2.36, Figure 5.2.47). Previous effectiveness monitoring in August 2015 recorded 24,463 ft<sup>2</sup> of alcove area, but aggradation, likely from recent large storms in winter 2016/2017, reduced April 2017 alcove area to 20,545 ft<sup>2</sup>. The August 2015 effectiveness monitoring survey also recorded a greater area of main channel (51,995 ft<sup>2</sup>) than recorded in April 2017 (39,771 ft<sup>2</sup>) as crews could not survey a portion of the channel due to excessive depth (> 4 ft) (Figure 5.2.47). Still, 50% of the alcove area remaining in April 2017 met optimal depth and velocity criteria compared to 34% last observed in August 2015 (Table 5.2.36). Eight habitat units composed the enhancement reach post effective flow 2017, with a pool to riffle ratio of 3:1 (3.00) and an average shelter score of 64 (Table 5.2.37, Figure 5.2.48, Figure 5.2.49). Four habitat units met or exceeded the optimum shelter value of 80. The enhancement reach comprised three enhancement sites (one main channel, one alcove, one bank site; Table 5.2.38, Figure 5.2.50,) that all received good to excellent site average feature ratings and fair to good site average habitat unit ratings (Table 5.2.38, Figure 5.2.51, Figure 5.2.52). All three enhancement sites received good qualitative ratings and similar numerical scores (Table 5.2.38, Figure 5.2.53). Overall, Van Alyea enhancement reach received a good effectiveness monitoring score (Table 5.2.38, Figure 5.2.54; see Appendix 5.1 for measured values, scores, and ratings).

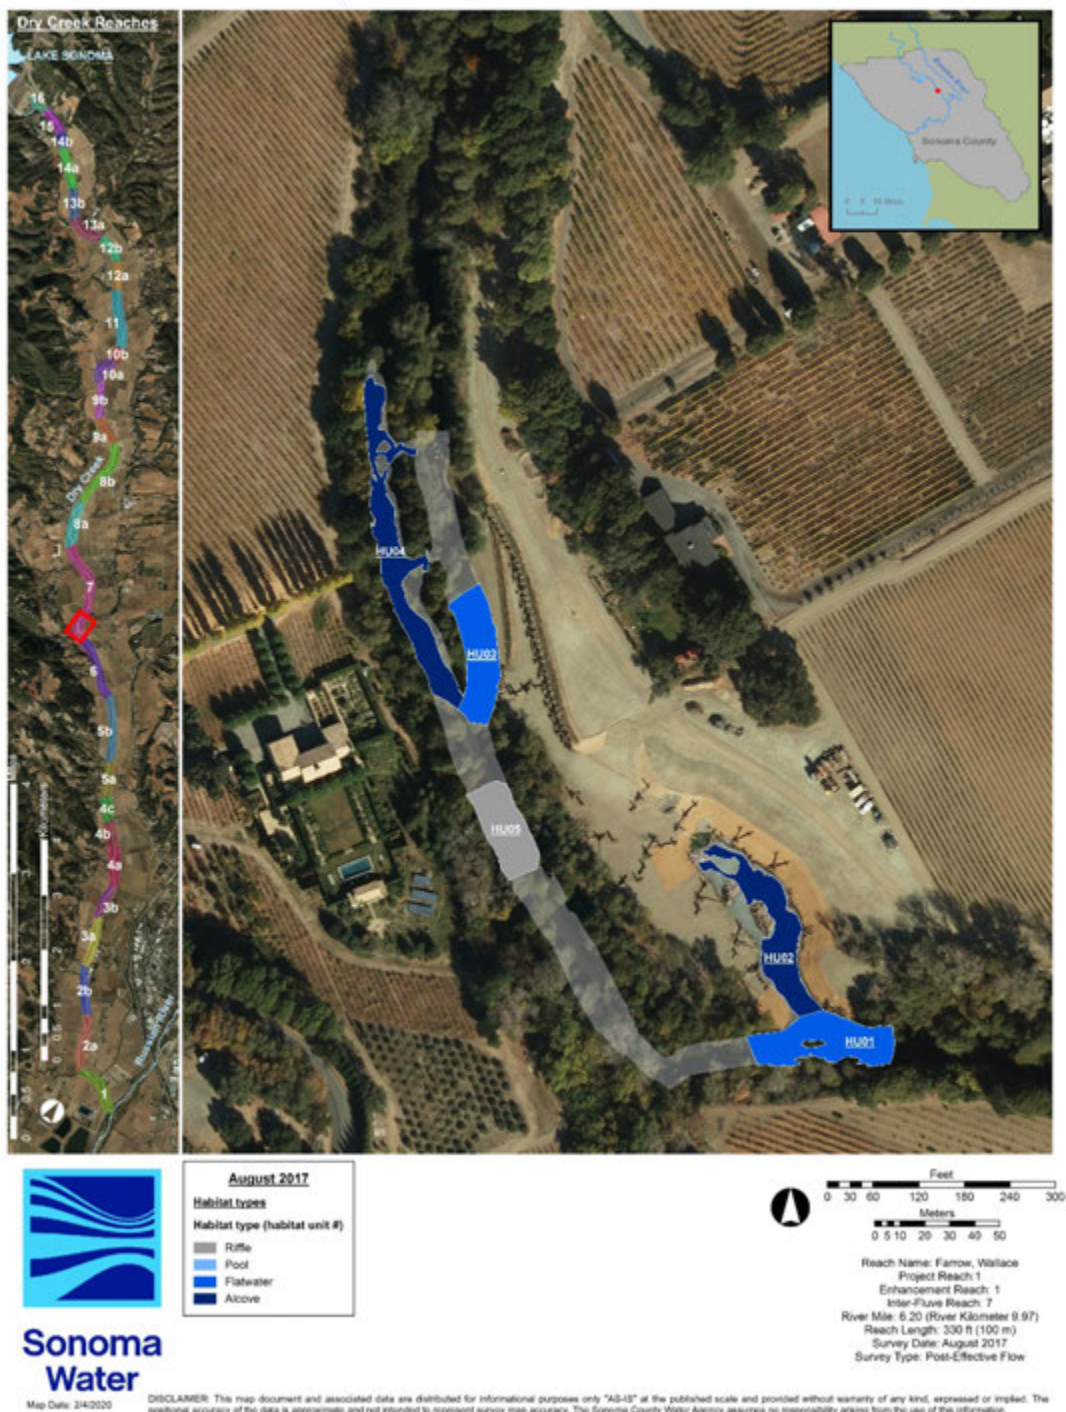
Figure 5.2.56. Habitat unit number and type within the Farrow, Wallace enhancement reach, August 2017.

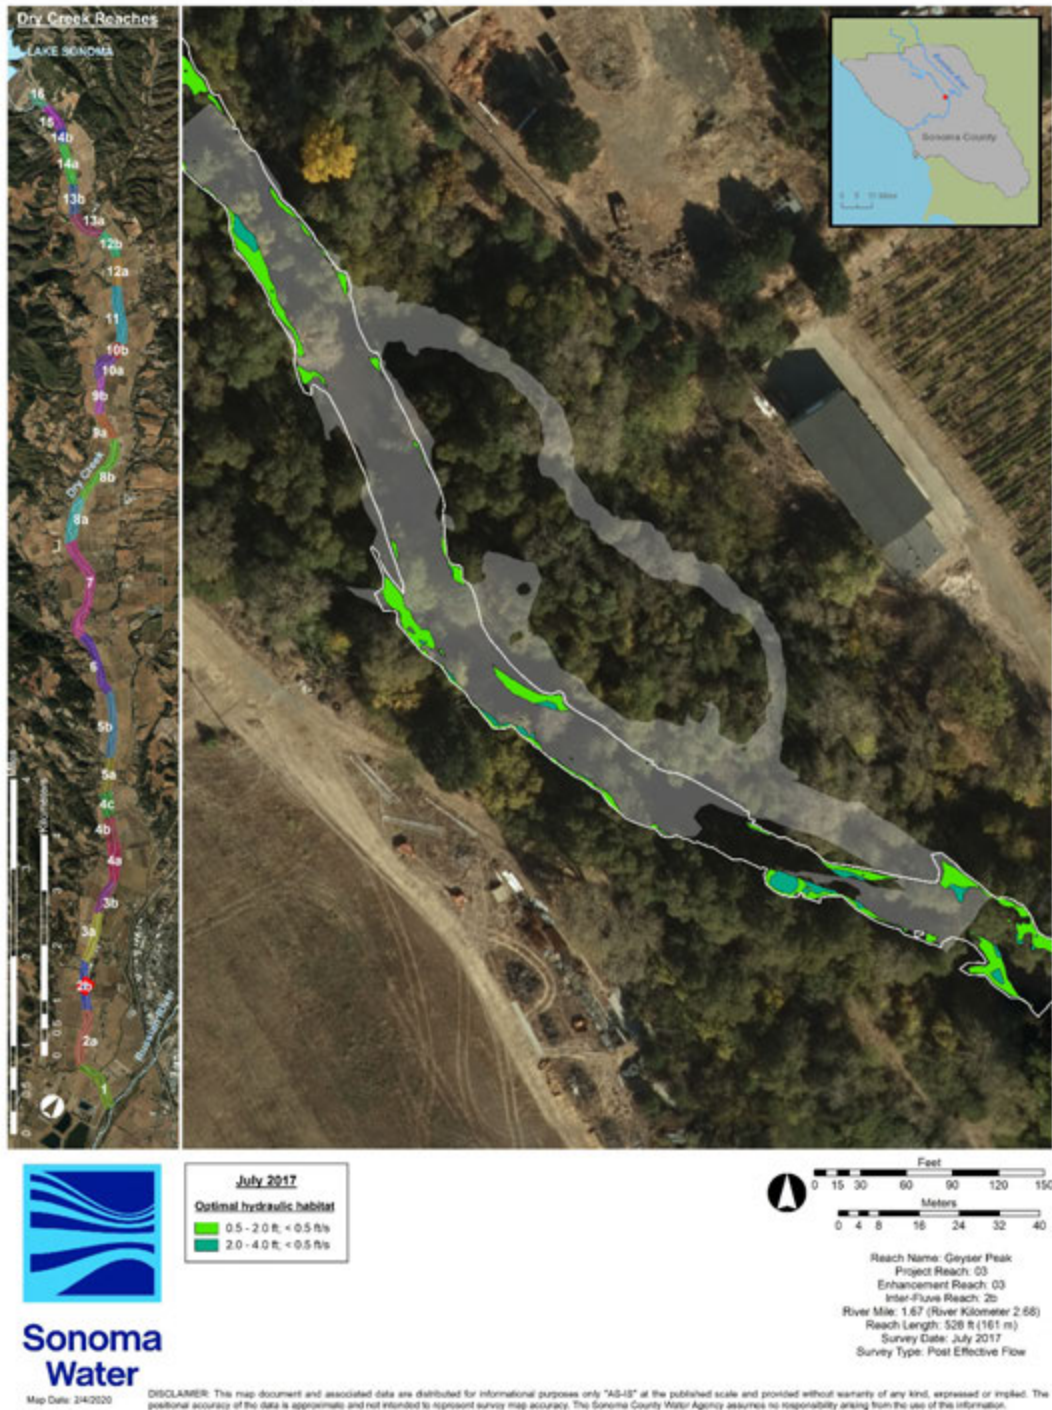
Figure 5.2.63. Optimal hydraulic habitat for fry (<0.5 ft/s, 0.5-2.0 ft) and parr (<0.5 ft/s, 2.0-4.0 ft) within the Geyser Peak enhancement reach, July 2017.

Geyser Peak Post-effective flow July 2017	Wetted area (ft <sup>2</sup> )	Optimal depth (ft <sup>2</sup> )			Optimal velocity (ft <sup>2</sup> )	Optimal habitat (ft <sup>2</sup> )		
		0.5 – 2.0 ft	2.0 – 4.0 ft	Total		0.5 – 2.0 ft < 0.5 ft/s	2.0 – 4.0 ft < 0.5 ft/s	Total
Main channel area	43,334	30,162	6,799	36,961	10,478	4,910	1,207	6,117
Off channel area	0	0	0	0	0	0	0	0
<b>Total area</b>	<b>43,334</b>	<b>30,162</b>	<b>6,799</b>	<b>36,961</b>	<b>10,478</b>	<b>4,910</b>	<b>1,207</b>	<b>6,117</b>
Main channel % of wetted area	100%	70%	16%	85%	24%	11%	3%	14%
Off channel % of wetted area	0%	0%	0%	0%	0%	0%	0%	0%
<b>Total % of wetted area</b>	<b>100%</b>	<b>70%</b>	<b>16%</b>	<b>85%</b>	<b>24%</b>	<b>11%</b>	<b>3%</b>	<b>14%</b>

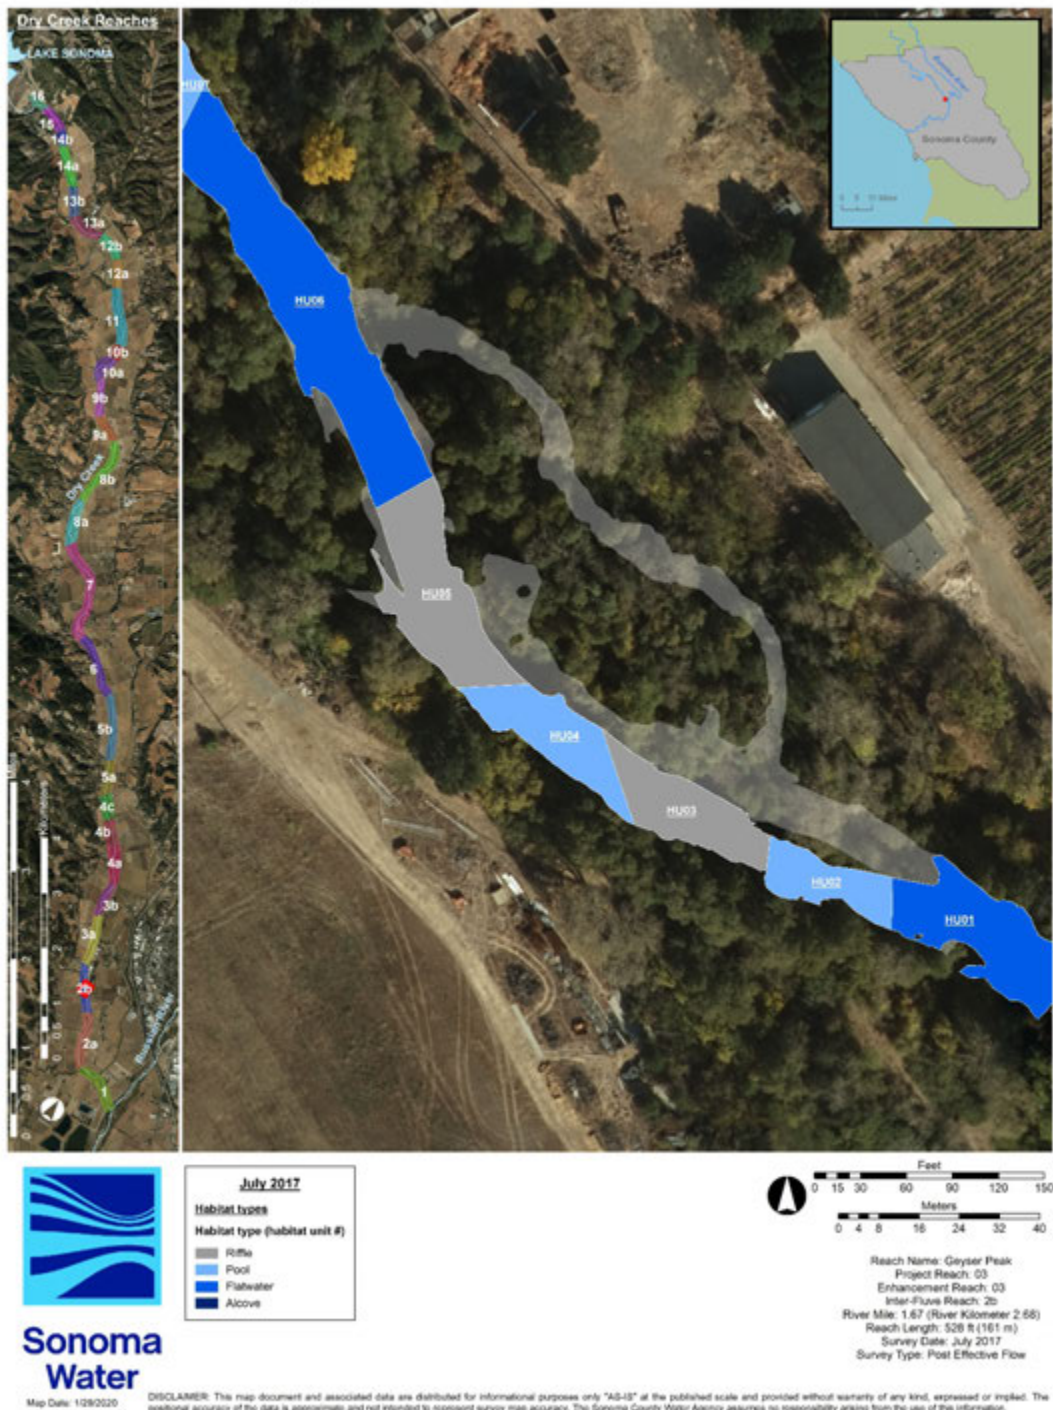
Figure 5.2.64. Habitat unit number and type within the Geyser Peak enhancement reach, July 2017.

<b>Habitat Unit #</b>	<b>Habitat Type</b>	<b>Shelter Value</b>	<b>Percent Cover</b>	<b>Shelter Score</b>
HU01	Flatwater	3	35	105
HU02	Pool	3	20	60
HU03	Riffle	1	10	10
HU04	Pool	3	30	90
HU05	Riffle	2	25	50
HU06	Flatwater	3	30	90
HU07	Pool	3	15	45
HU08	Riffle	1	10	10
HU09	Pool	3	35	105
<b>Pool: riffle</b>	<b>4:3 (1.33)</b>			<b>Avg = 63</b>

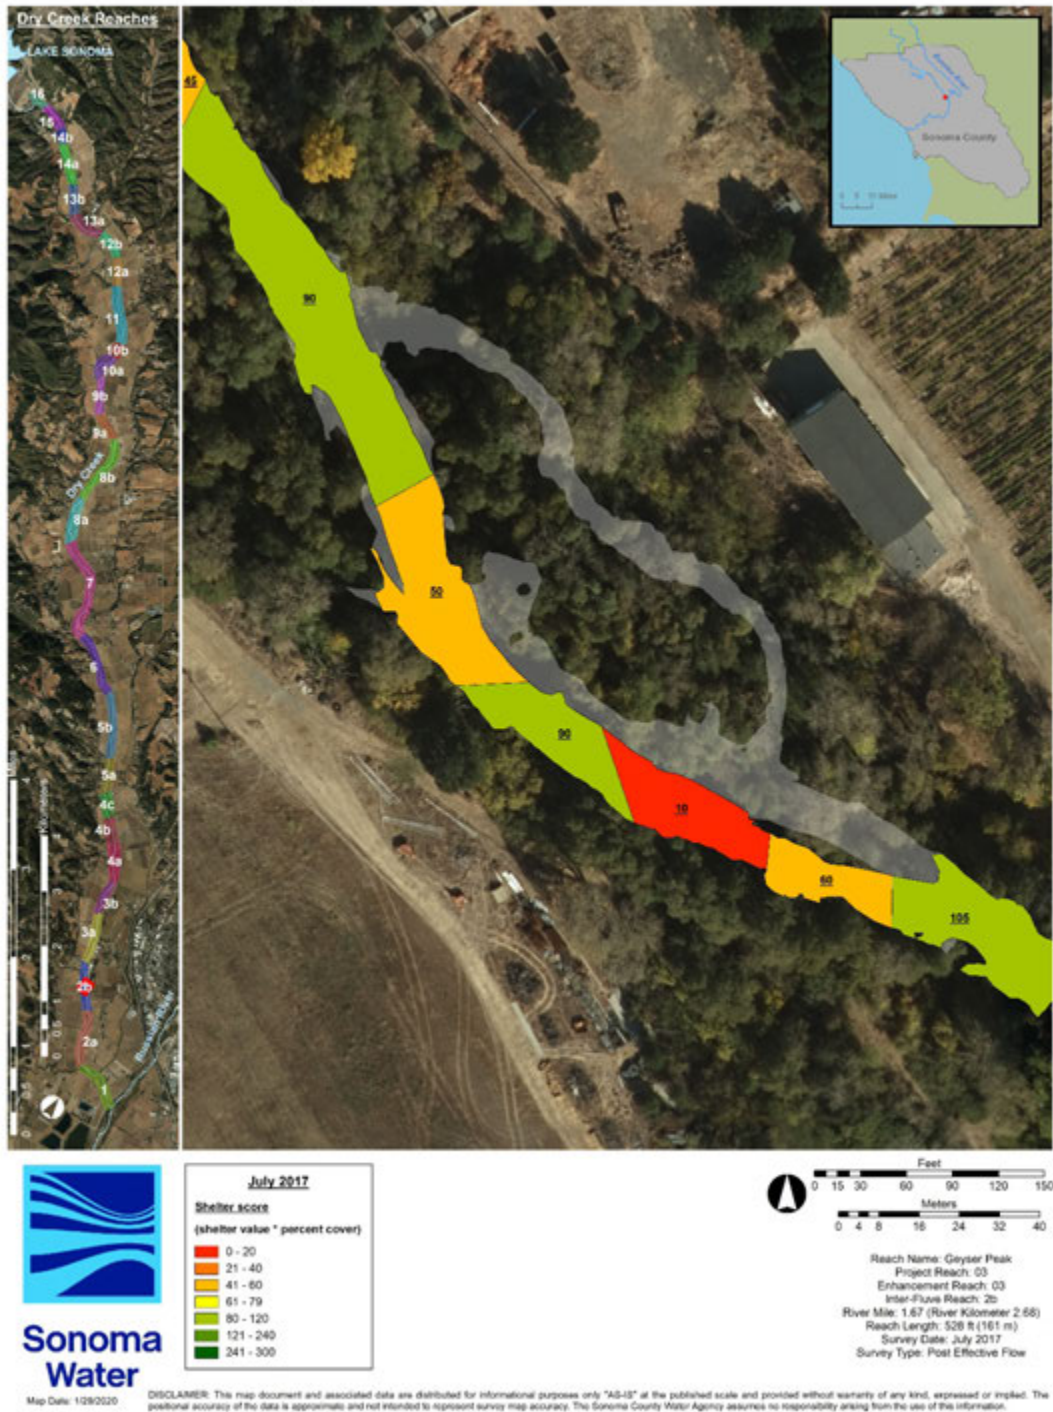
Figure 5.2.65. Habitat unit shelter scores within the Geyser Peak enhancement reach, July 2017.

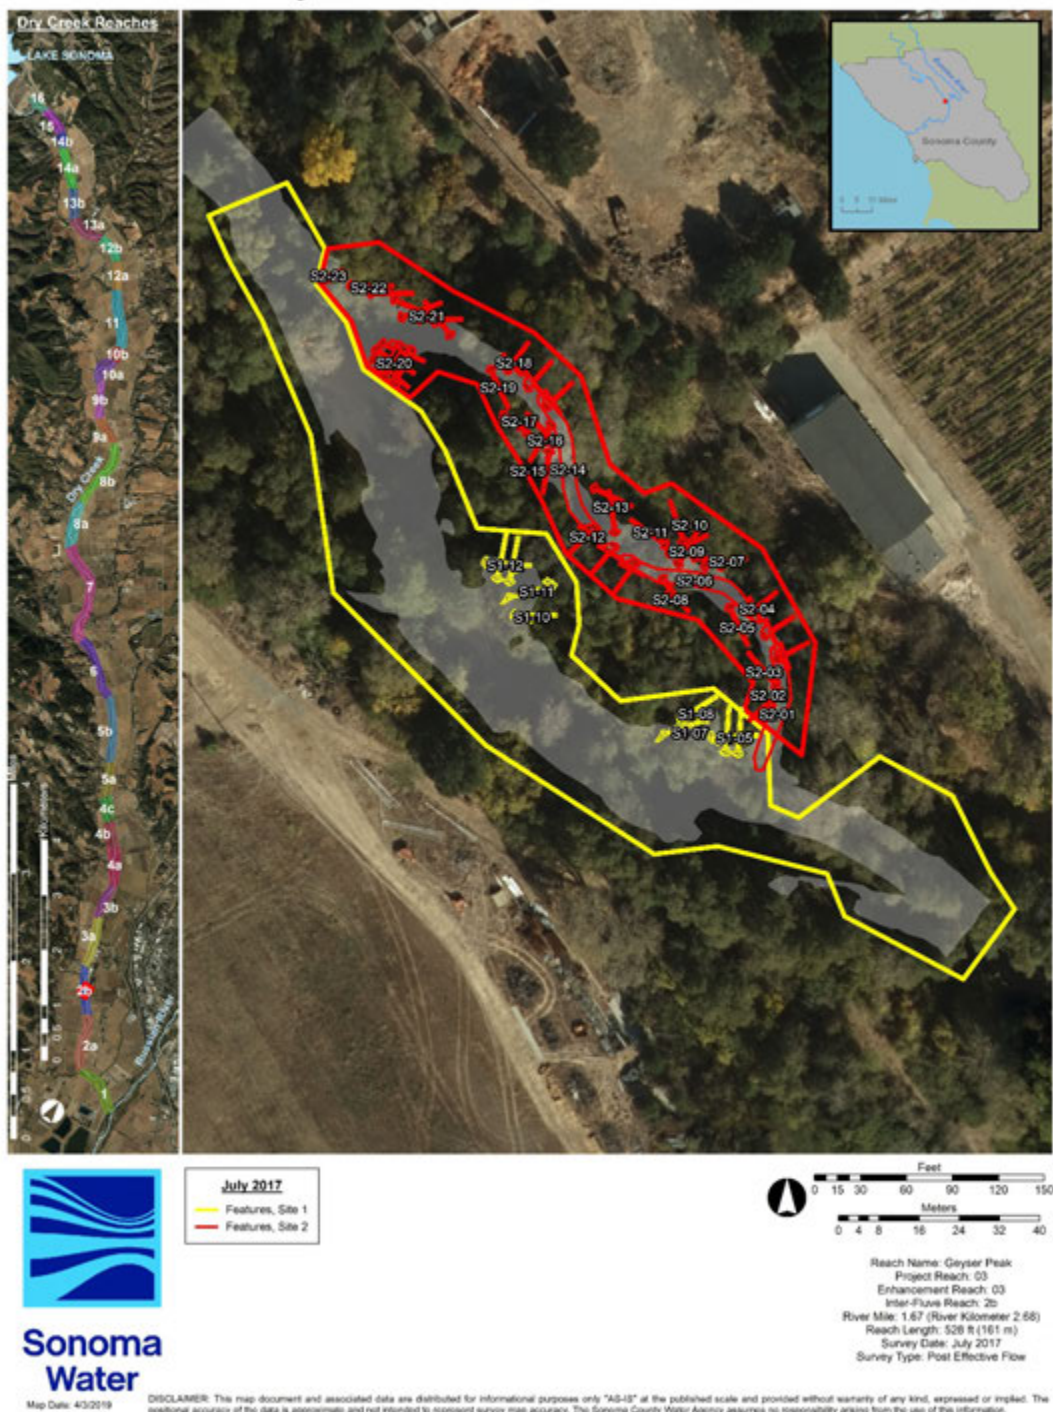
Figure 5.2.66. Enhancement sites and features within the Geyser Peak enhancement reach, July 2017.

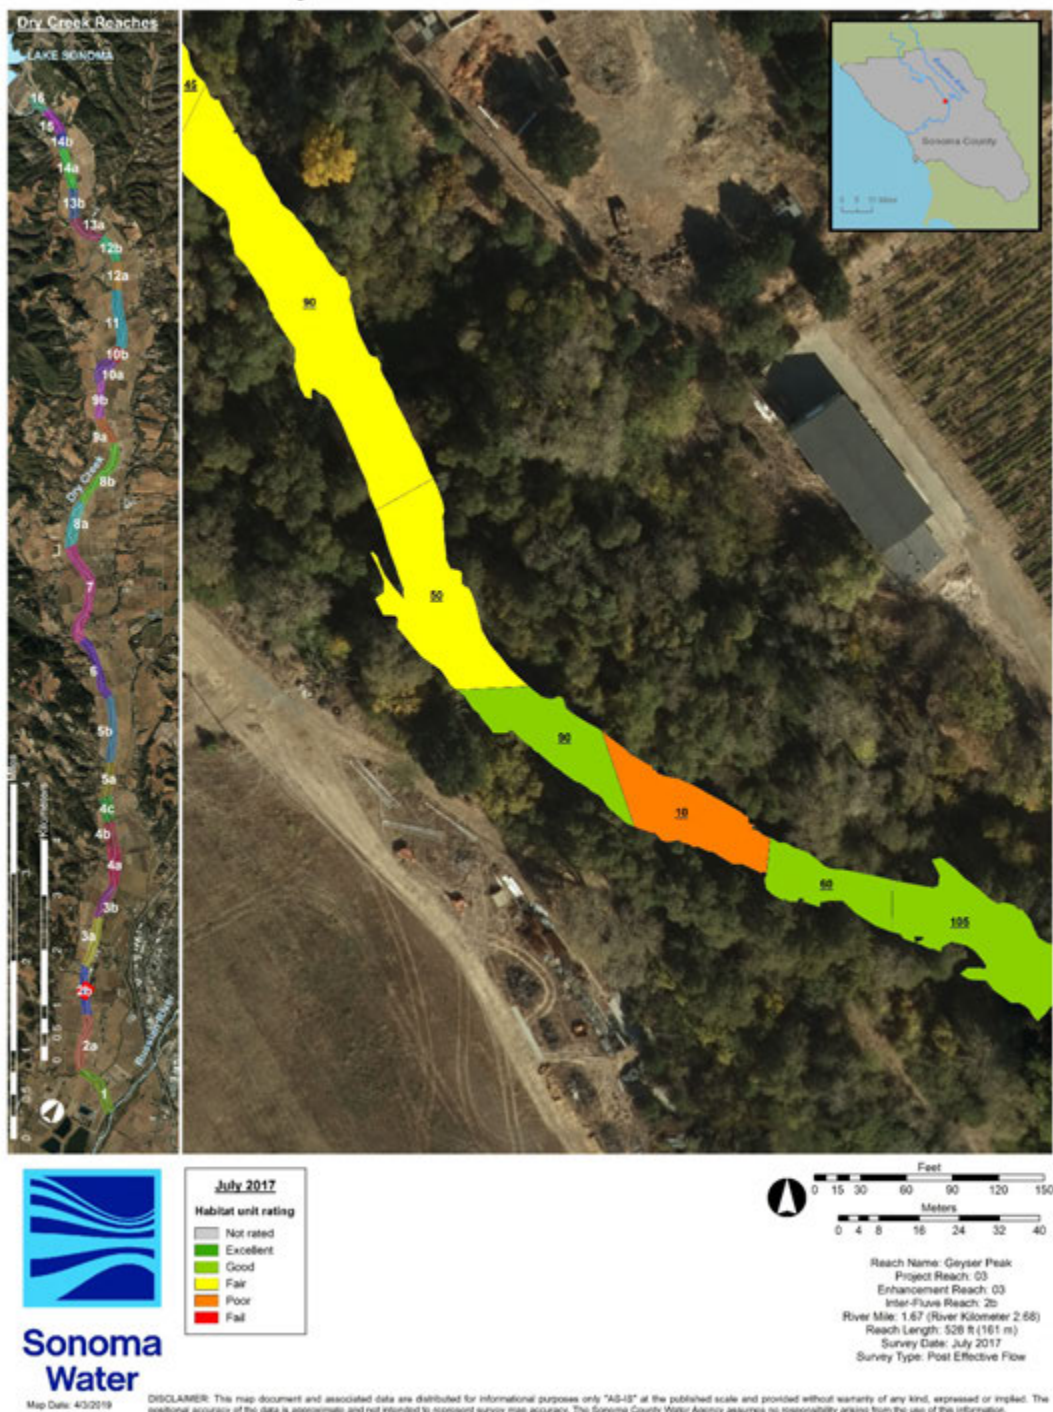
Figure 5.2.68. Post-effective flow habitat unit rating for the Geyser Peak enhancement reach, July 2017.

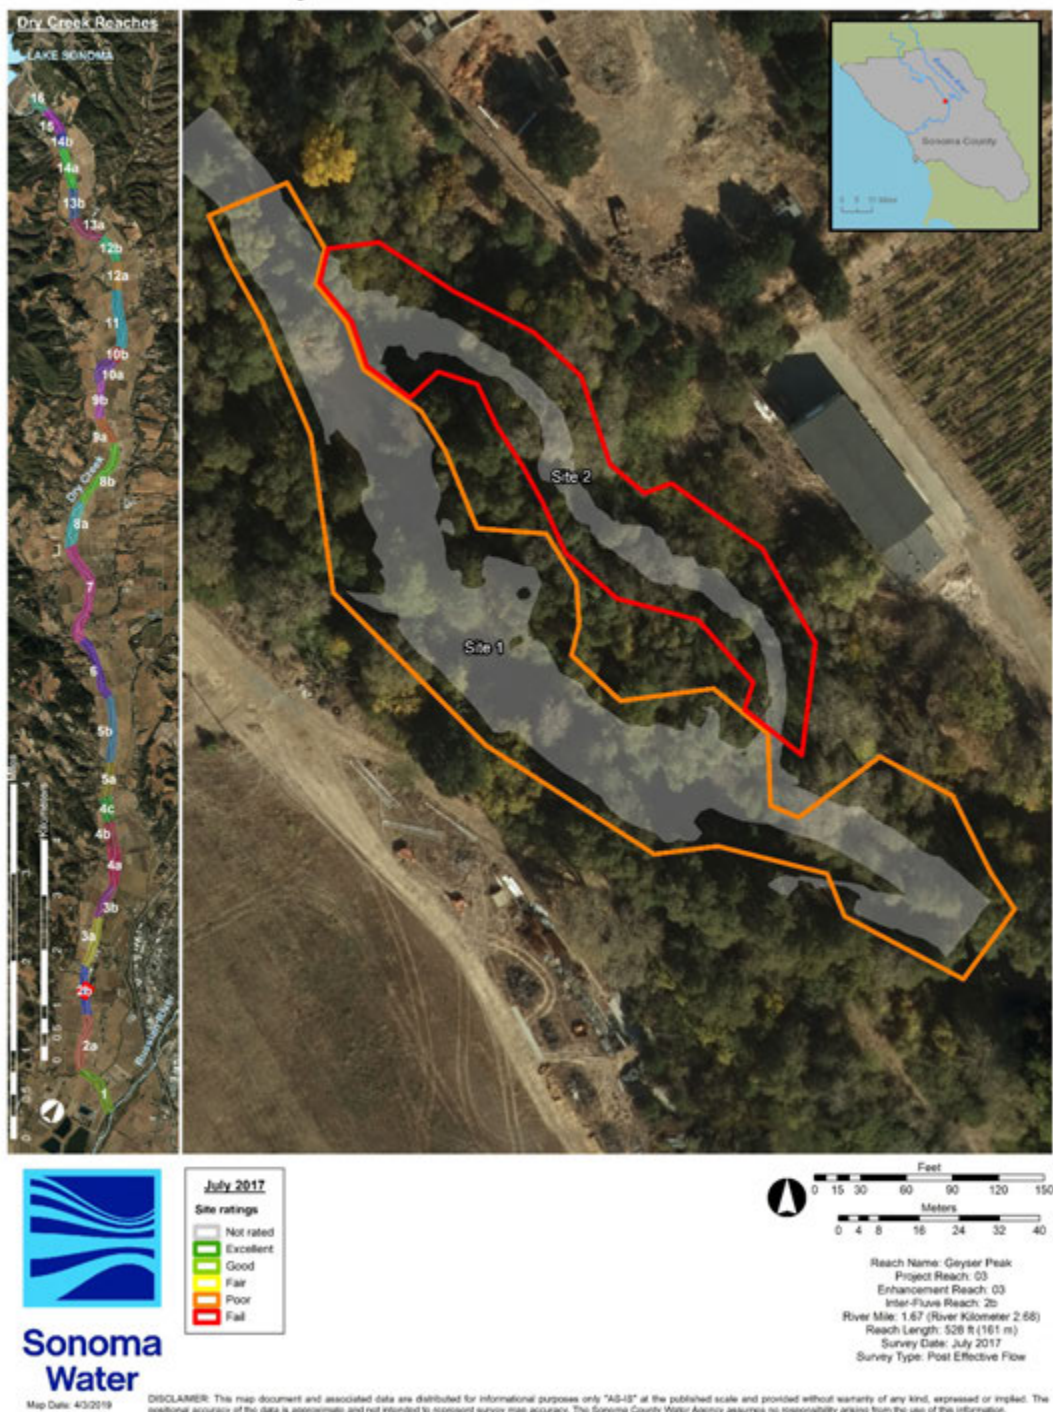
Figure 5.2.69. Post-effective flow site ratings for the Geyser Peak enhancement reach, July 2017.

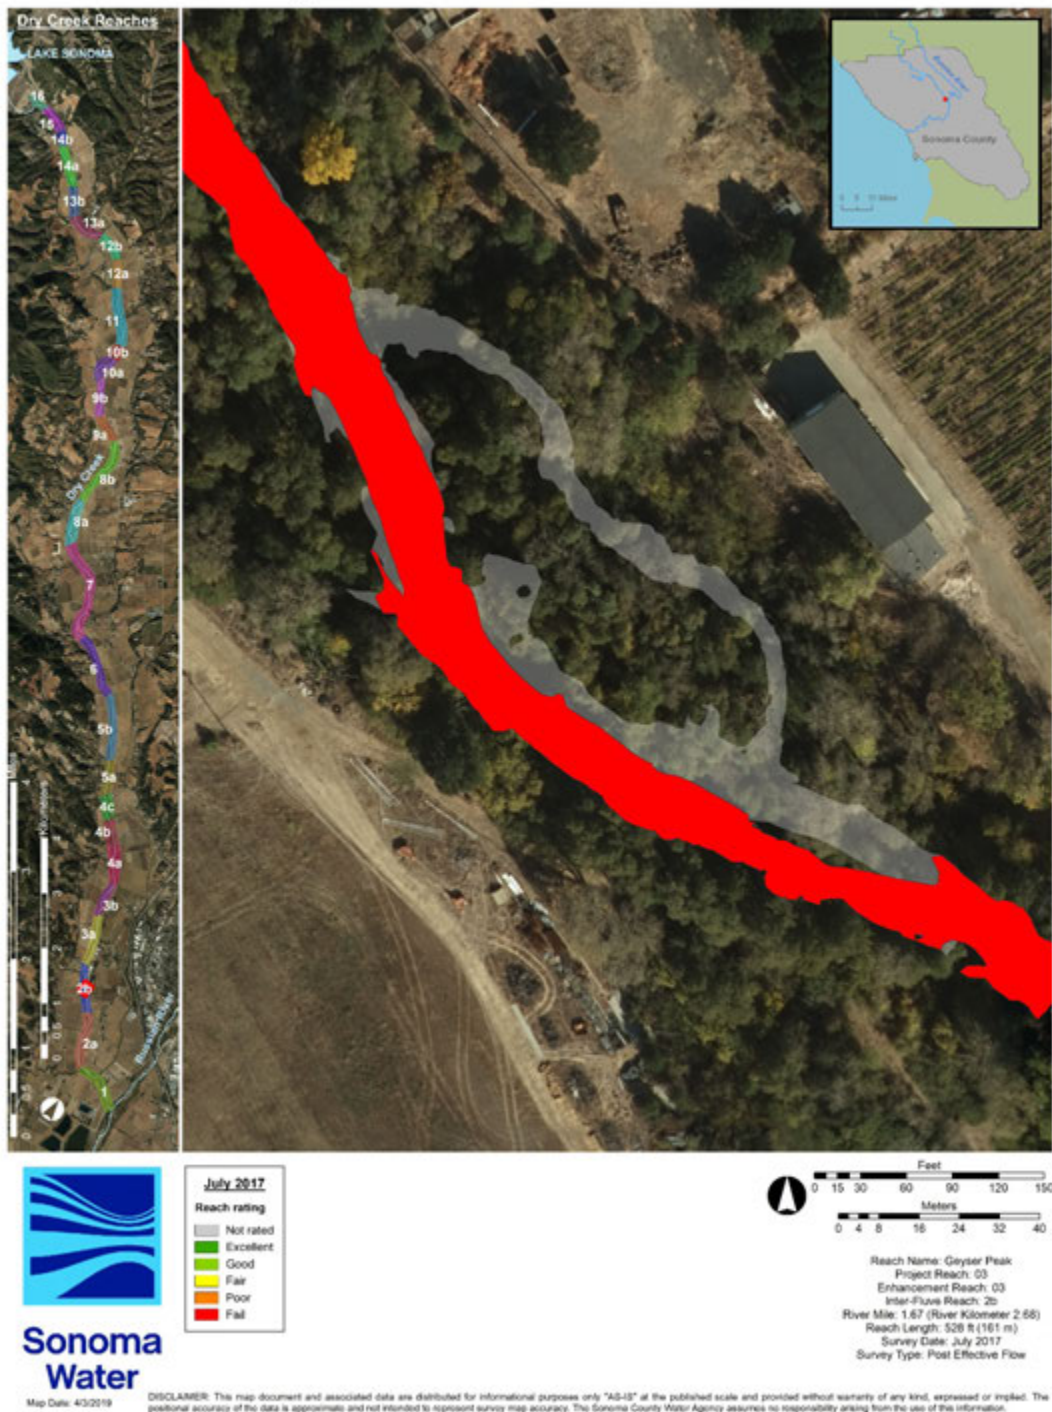
Figure 5.2.70. Post-effective flow reach rating for the Geyser Peak enhancement reach, July 2017.

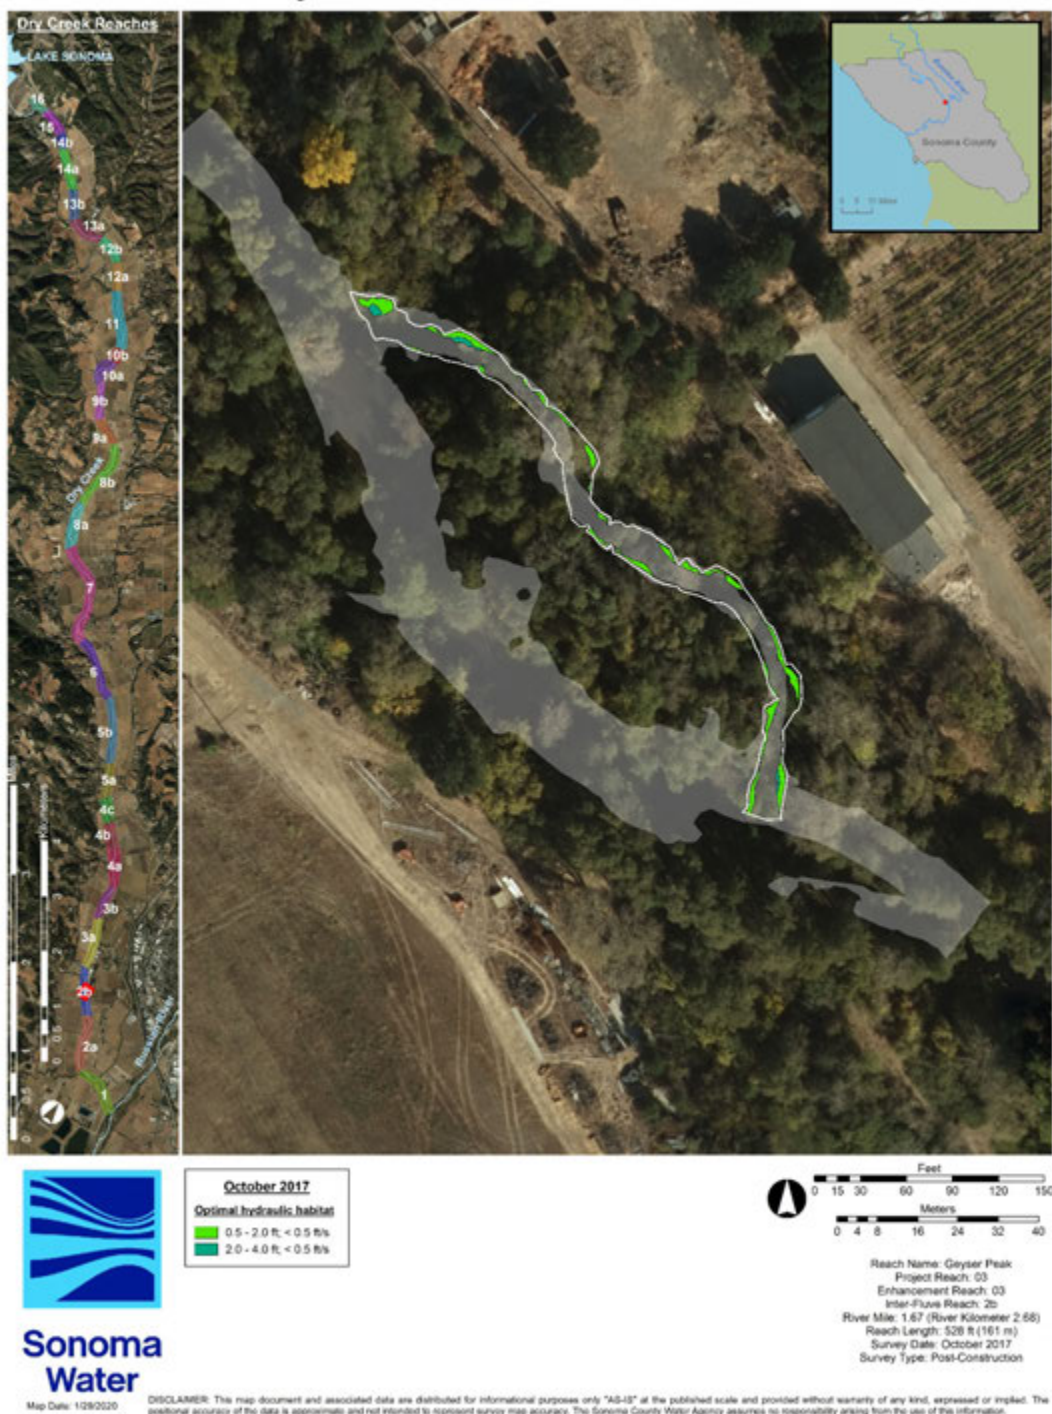
Figure 5.2.87. Optimal hydraulic habitat for fry (<0.5 ft/s, 0.5-2.0 ft) and parr (<0.5 ft/s, 2.0-4.0 ft) within the Geyser Peak enhancement reach, October 2017.

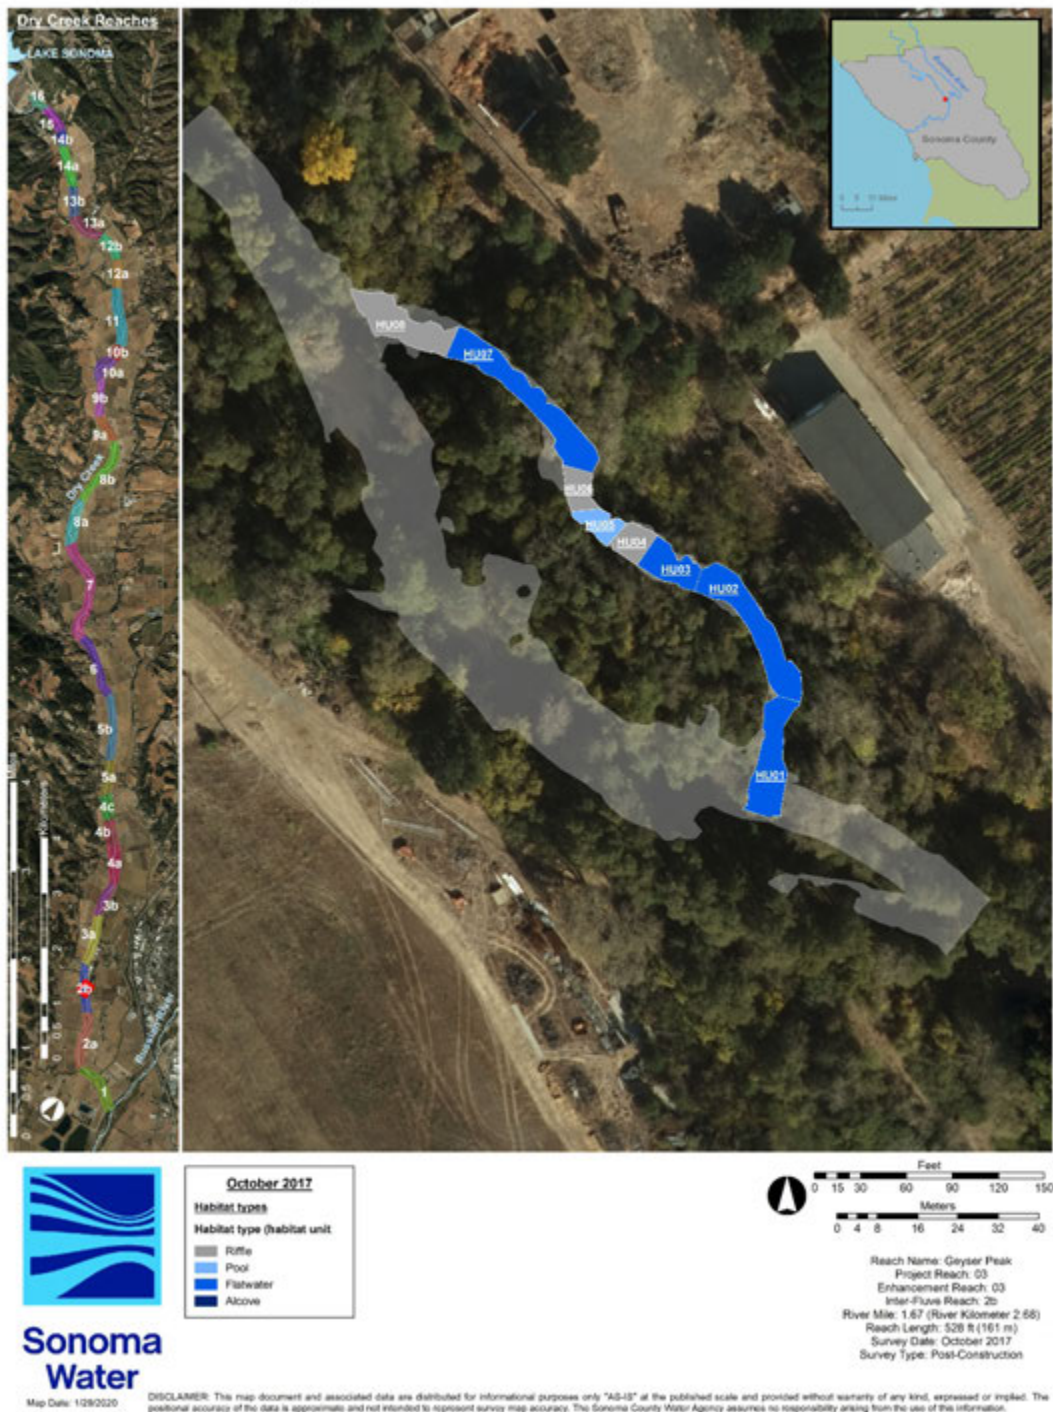
Figure 5.2.88. Habitat unit number and type within the Geyser Peak enhancement reach, October 2017.

Habitat Unit #	Habitat Type	Shelter Value	Percent Cover	Shelter Score
HU01	Flatwater	2	0	0
HU02	Flatwater	3	15	45
HU03	Flatwater	3	10	30
HU04	Riffle	3	10	30
HU05	Pool	3	15	45
HU06	Riffle	2	20	40
HU07	Flatwater	3	15	45
HU08	Riffle	3	0	0
<b>Pool: riffle</b>	<b>1:3 (0.33)</b>			<b>Avg = 29</b>

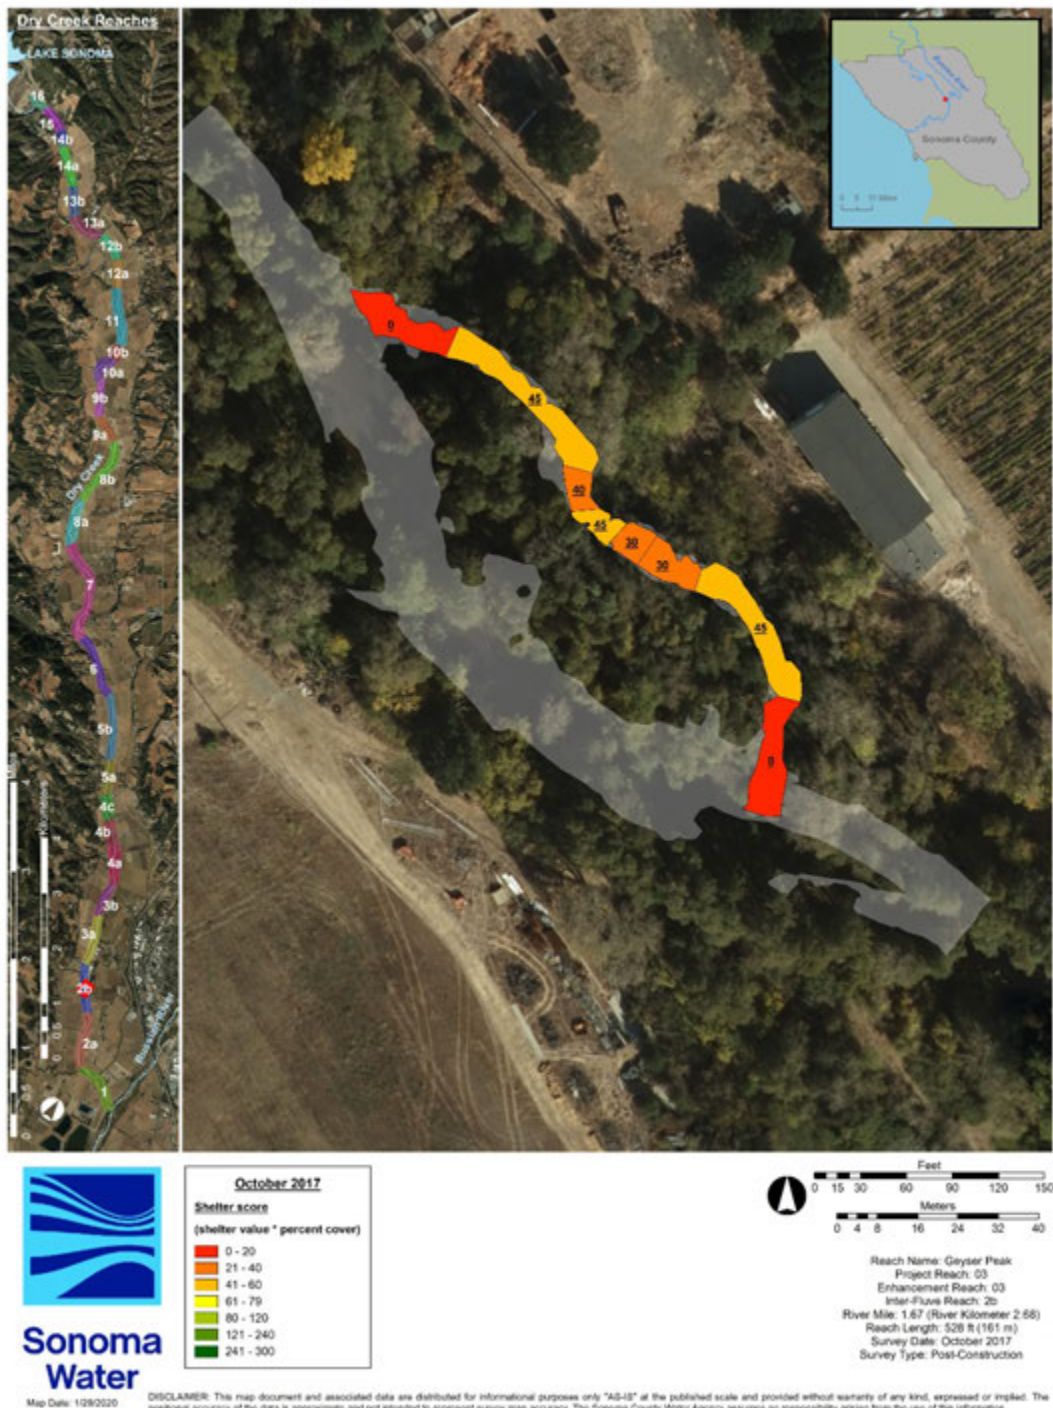
Figure 5.2.89. Habitat unit shelter scores within the Geyser Peak enhancement reach, October 2017.

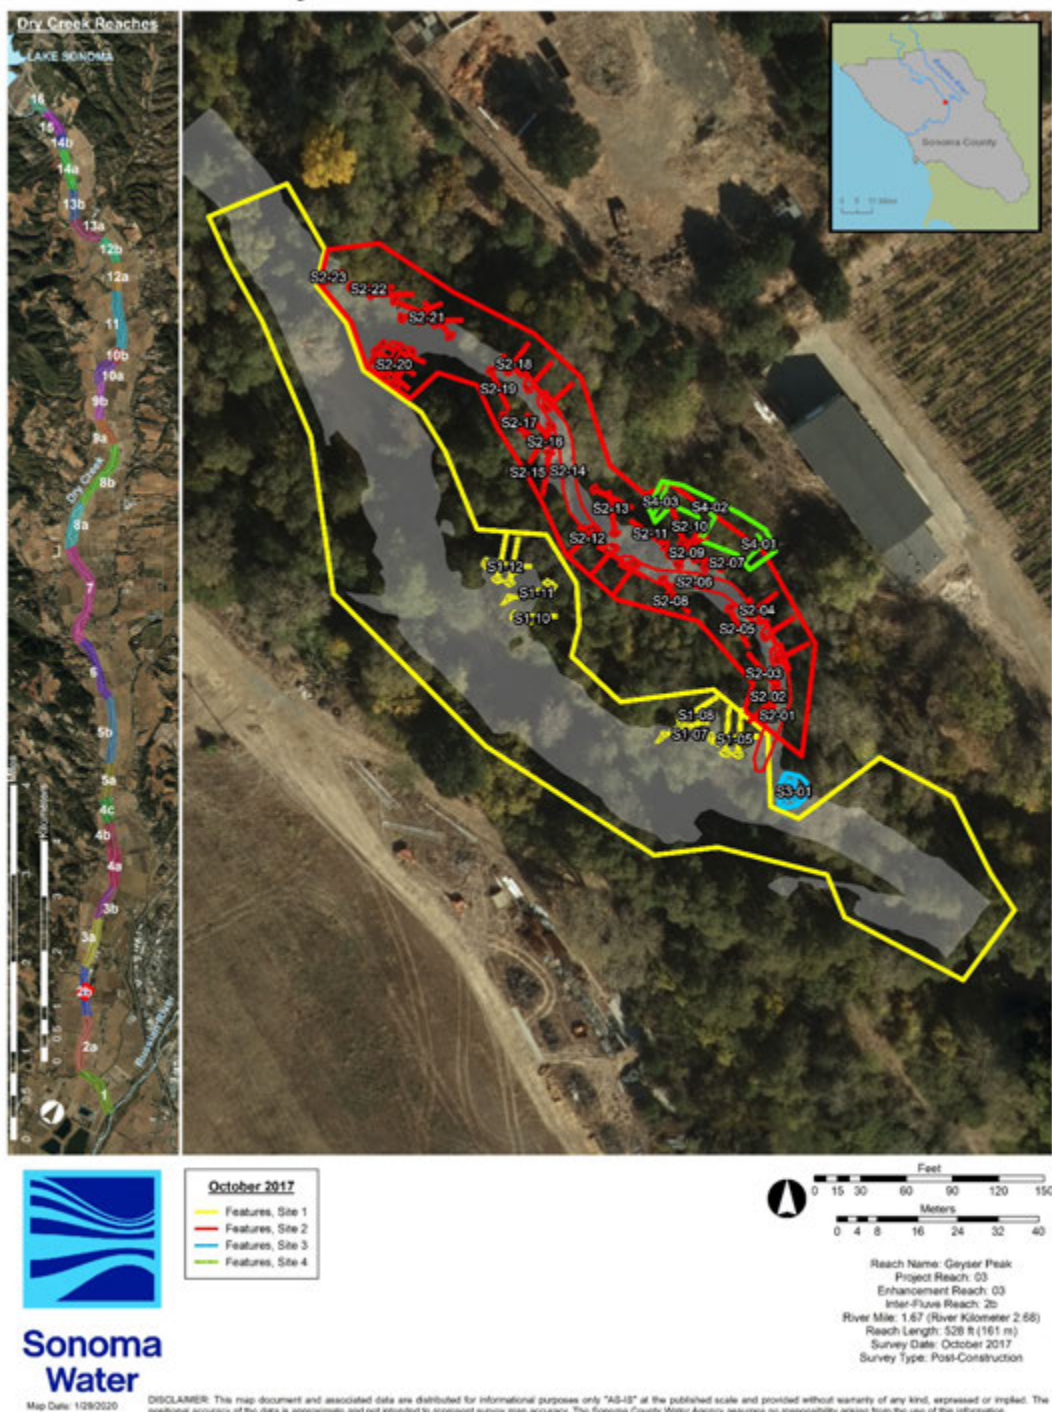
Figure 5.2.90. Enhancement sites and features within the Geyser Peak enhancement reach, October 2017.

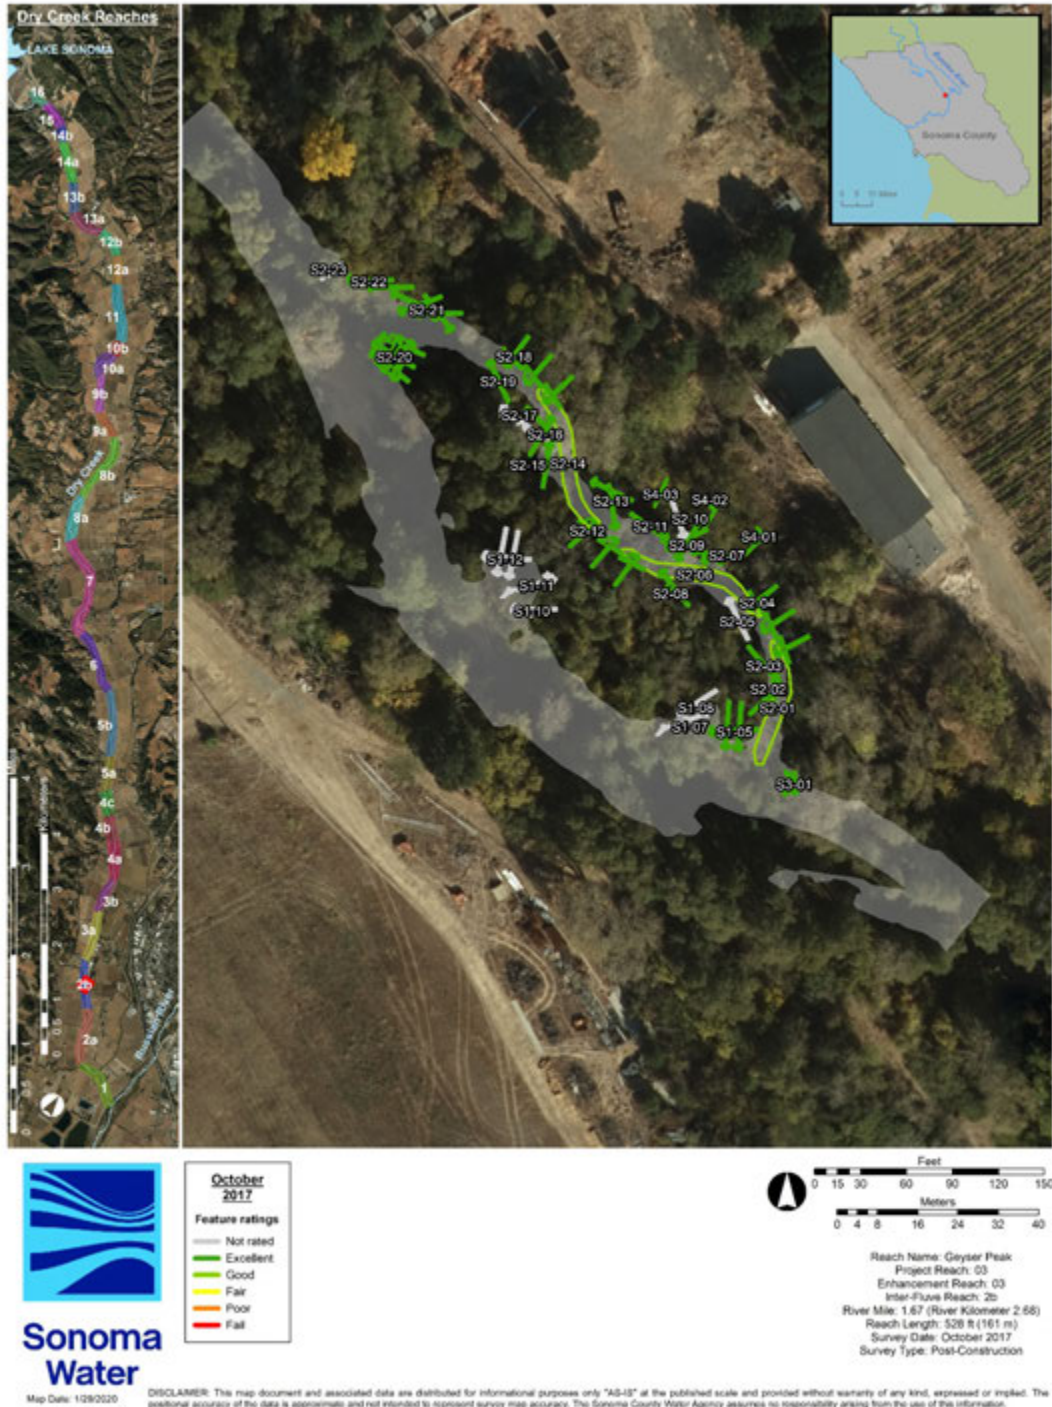
Figure 5.2.91. Feature ratings for the Geyser Peak enhancement reach, October 2017.
