# Russian River Biological Opinion Status and Data Report

Year 2017 - 2018

**Sonoma  
Water**

**June 2020**

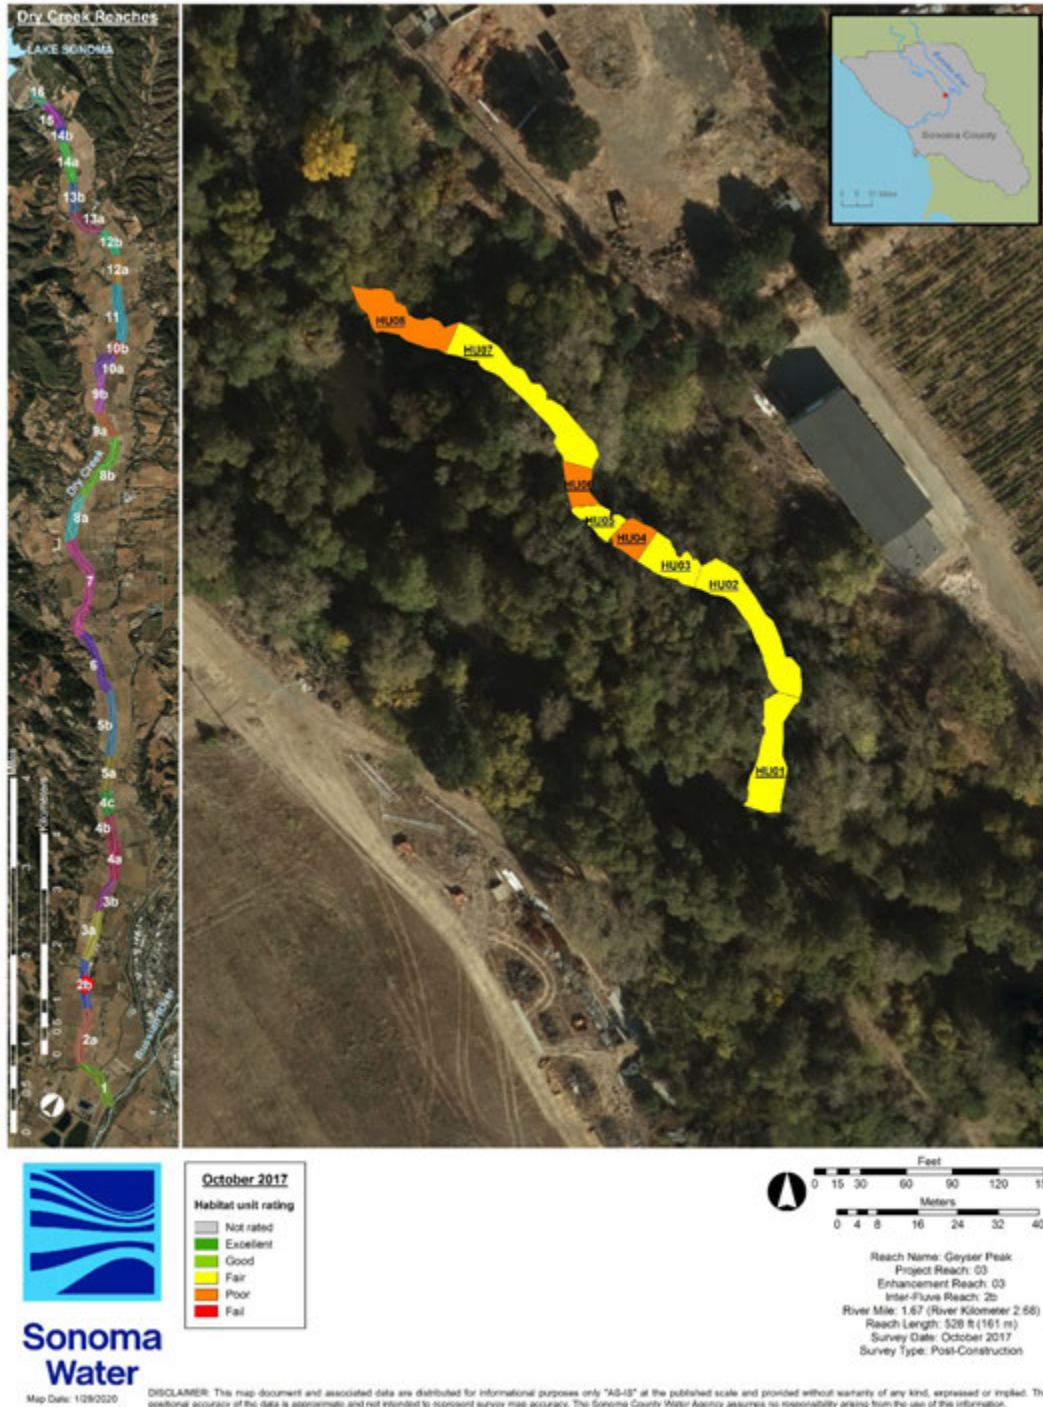
Figure 5.2.92. Post-repair habitat unit rating for the Geyser Peak enhancement reach, October 2017.

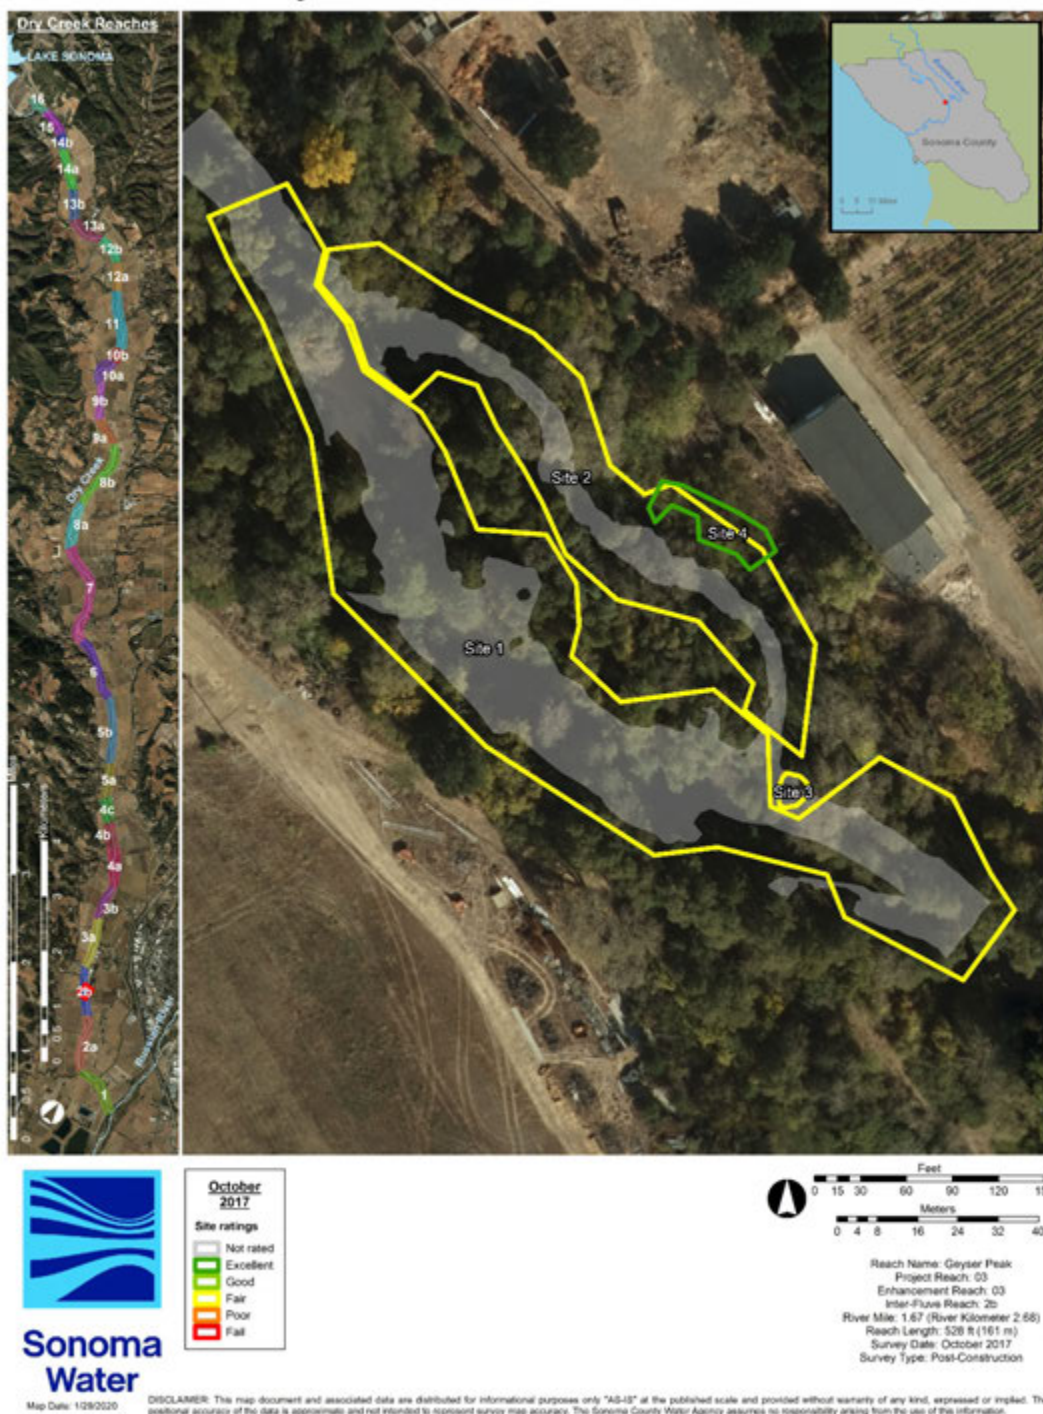
Figure 5.2.93. Post-repair site ratings for the Geyser Peak enhancement reach, October 2017.

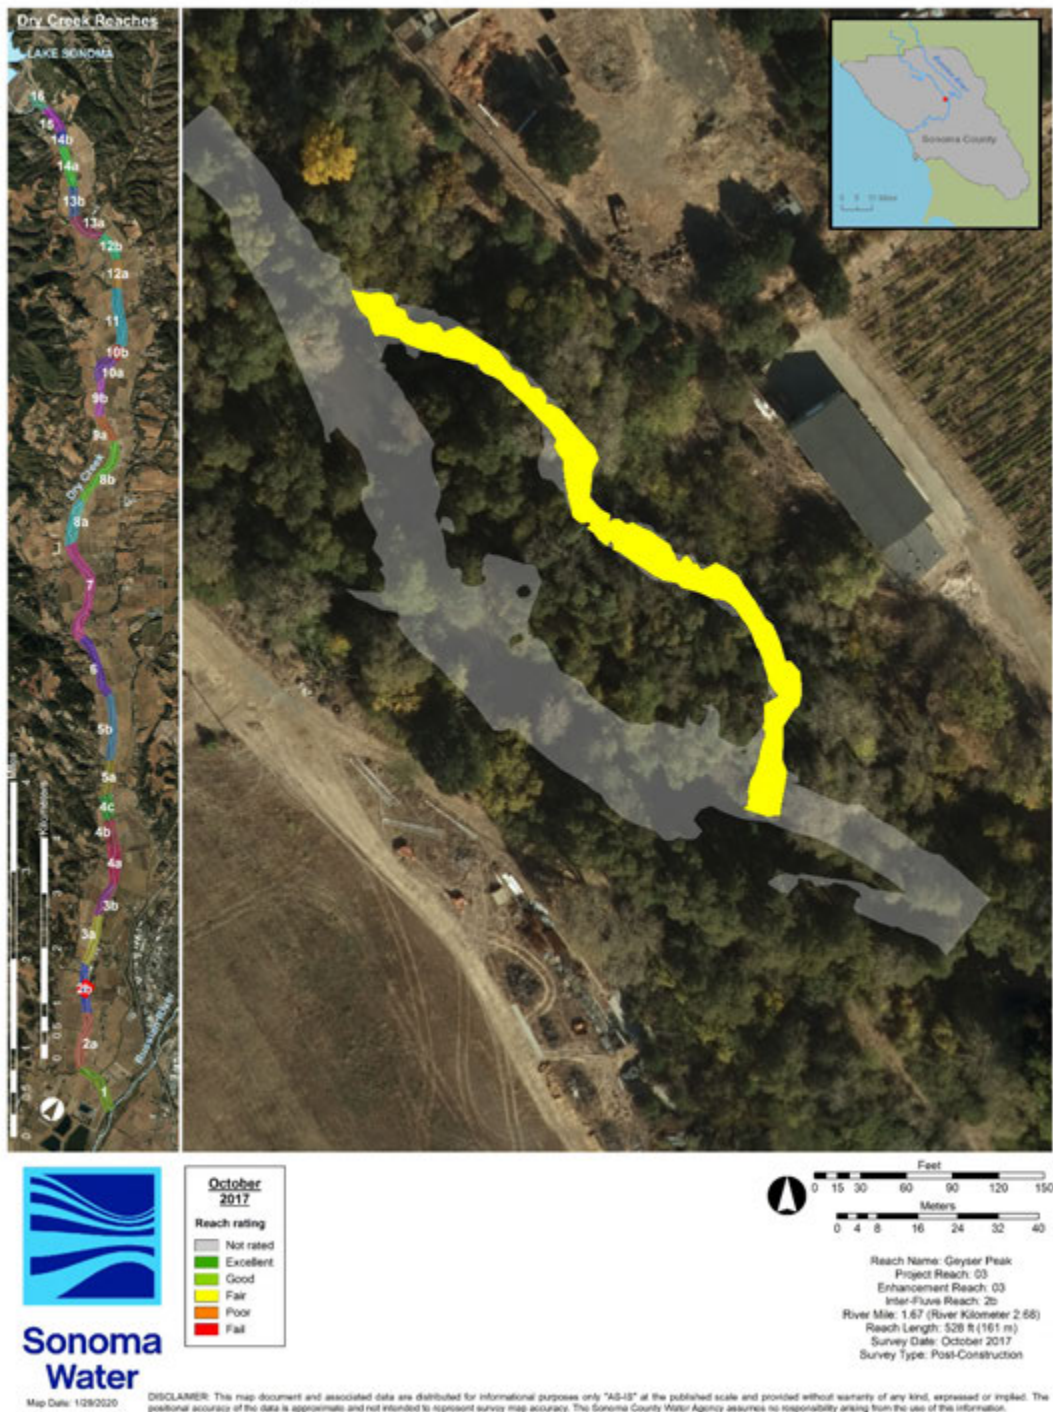
Figure 5.2.94. Post-repair reach rating for the Geyser Peak enhancement reach, October 2017.

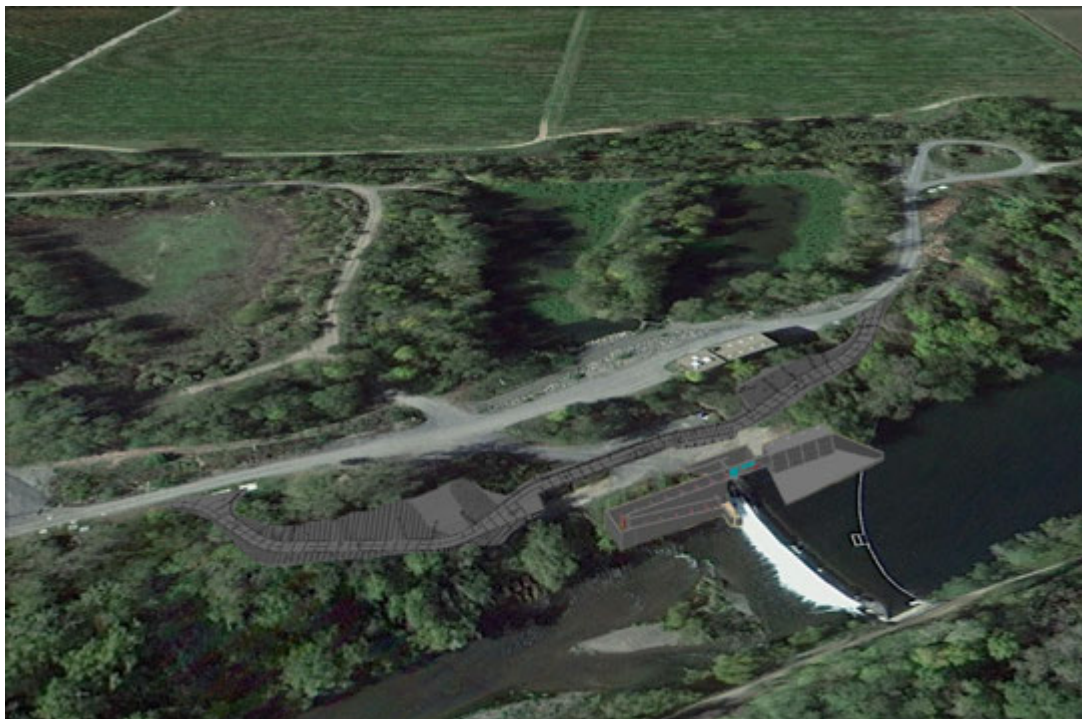
Figure 8.2. Artist rendering of new fish screen and fishway structure at Mirabel.

The CEQA document for the project provided a discussion of potential environmental impacts related to the construction, operation, and maintenance of the proposed fish screen and fish ladder modifications. Project construction activities require isolating the work area from the active flow of the Russian River, demolishing the existing fish screen/intake and fish ladder structures on the western bank of the Russian River, and constructing the new fish screen and fish ladder structures. The new facilities will extend approximately 40 feet farther upstream and approximately 100 feet farther downstream than the existing facilities. This larger footprint is necessary to meet contemporary fish screen and fish passage design criteria. Figure 8.1 shows a plan view of the project design. Figure 8.2 shows a conceptual design drawing of the project components.
