**RUSSIAN RIVER ESTUARY OUTLET CHANNEL  
ADAPTIVE MANAGEMENT PLAN  
2017**

Sonoma County Water Agency

ESA

May 30, 2017

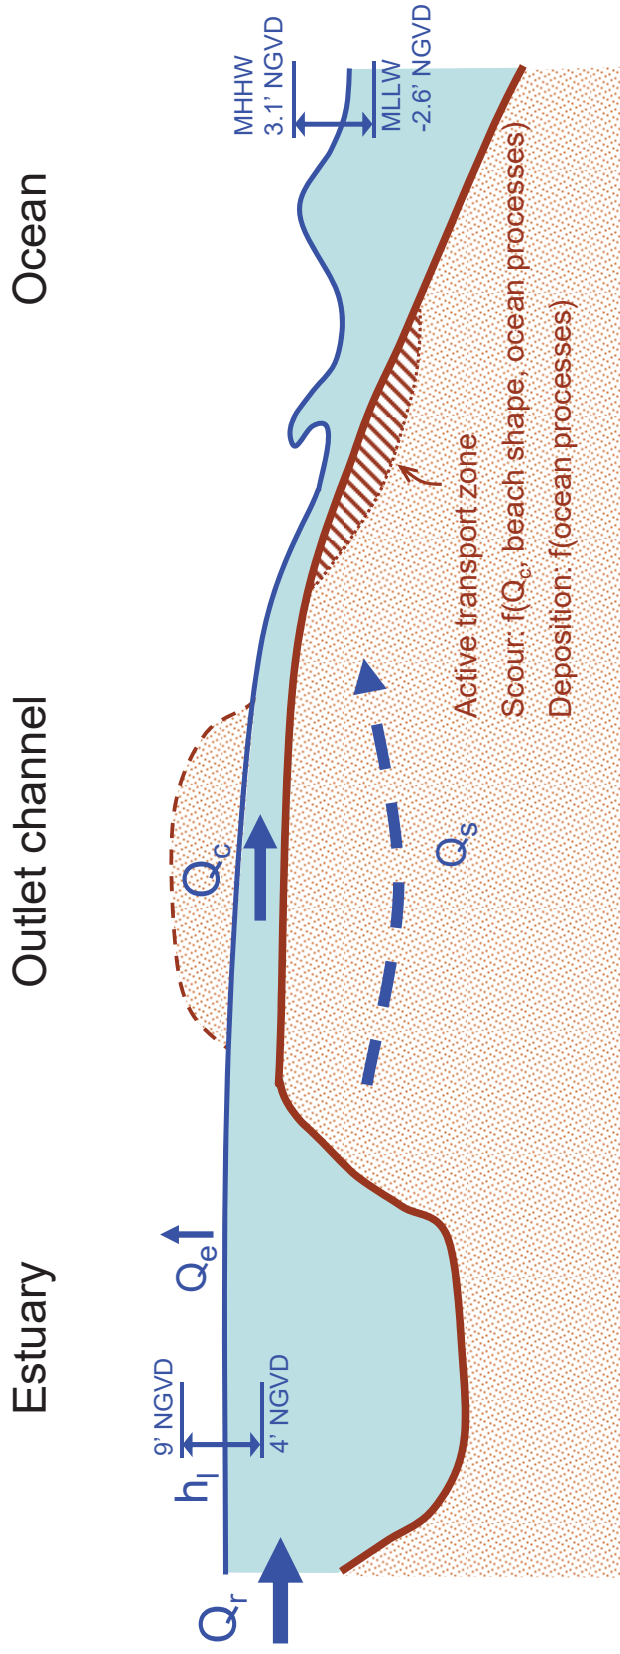
<i>figure 2</i>	
<i>Russian River Estuary Outlet Channel Management Plan</i>	
Conceptual model – Target conditions	
PWA Ref# 1958.01

Parameters

$h_l$ =lagoon water level

- $Z_{out}$  = target channel bed elevation
- $Z_{wave}$  = wave runup elevation;  $f(\text{wave conditions, ocean water level, channel location})$

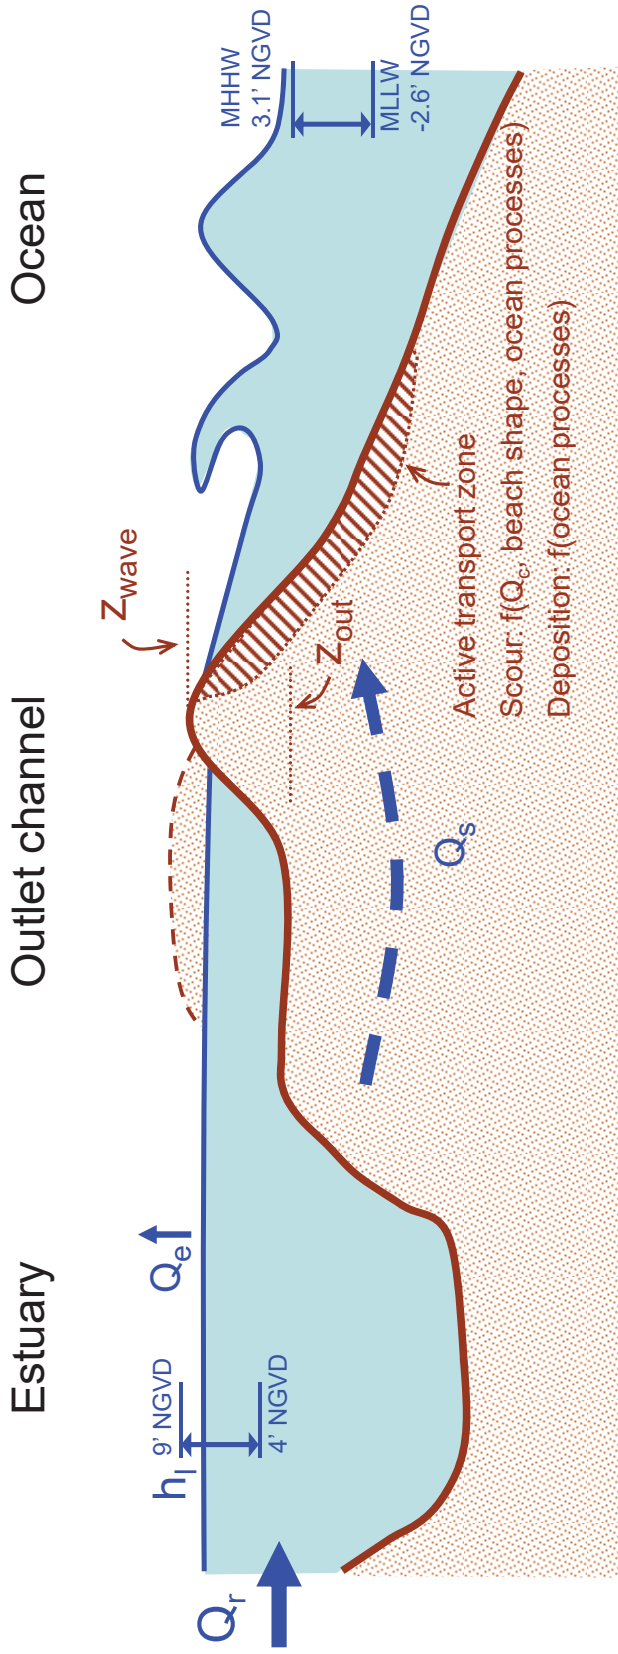
The conceptual model for target outlet conditions is shown in Figure 2. Ideally, the outlet channel conveys water from the estuary to the ocean so that estuary can be maintained in a non-tidal state during the management period. A key performance criterion of this non-tidal state is that the water levels in the estuary ( $h_1$ ) fall within the range of 4 to 9 ft NGVD, with elevations above 7 ft NGVD preferred. The estuary water level will not be managed directly, e.g. by pumping. Instead, it will be managed indirectly by management actions dictated by the Biological Opinion, the operation and maintenance of the outlet channel and the reduction of instream flow requirement.

Although sediment transport will be minimal within the outlet channel under target conditions, the channel's mouth will perpetually be an active transport zone. This portion of the channel, at its interface with the ocean, will be an active transport zone for two reasons. First, it lies within the surf zone and breaking waves move up and down its face in response to the tides and variations in wave

direction, magnitude, and period. Second, this wave action creates a slope on the order of 10:1, which is sufficiently steep that flows of nearly any magnitude from the outlet channel will accelerate to above the scour velocity threshold. In order for the outlet channel to persist with this active transport zone at its mouth, this zone will have to experience minimal net sediment transport. In other words, tidal fluctuations in water level and variability in wave intensity will cause the locations of scour and deposition to shift at hourly timescales, but averaging across several tidal cycles, any sand lost by scour will be balanced by an equivalent amount of deposition. This active transport zone also plays a significant role in lateral migration of the existing channel mouth. This process is discussed in Section 4.4 on planform alignment.

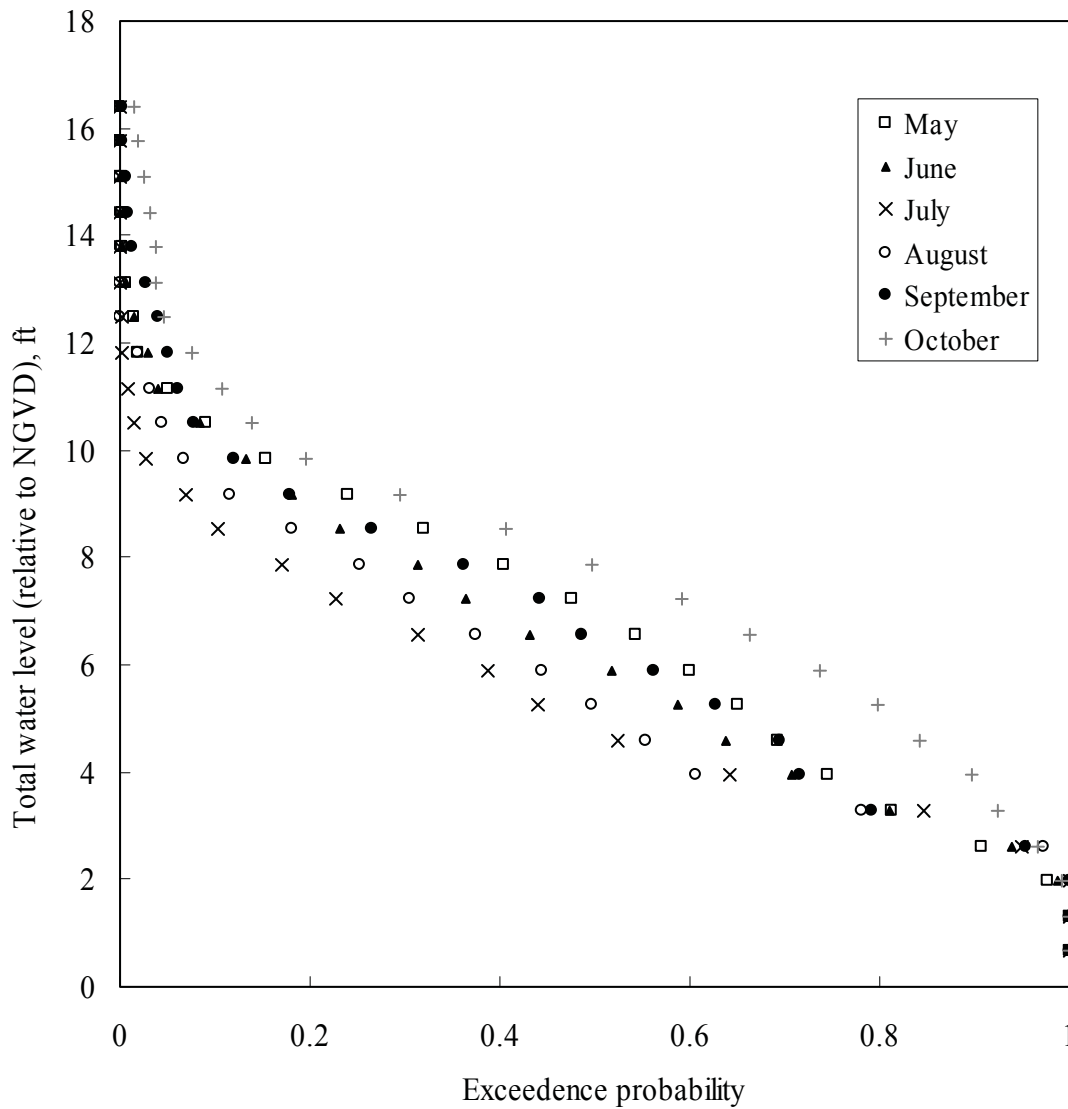
*figure 5*  
 Russian River Outlet Channel Management Plan

Source: D. Behrens (unpublished). Wave data from CDIP Point Reyes buoy.  
 Note: Total water level calculated as sum of daily higher high tide and wave runup elevation. Wave runup calculated from Stockdon et al (2006) using estimated de-shoaled deepwater equivalent wave heights.

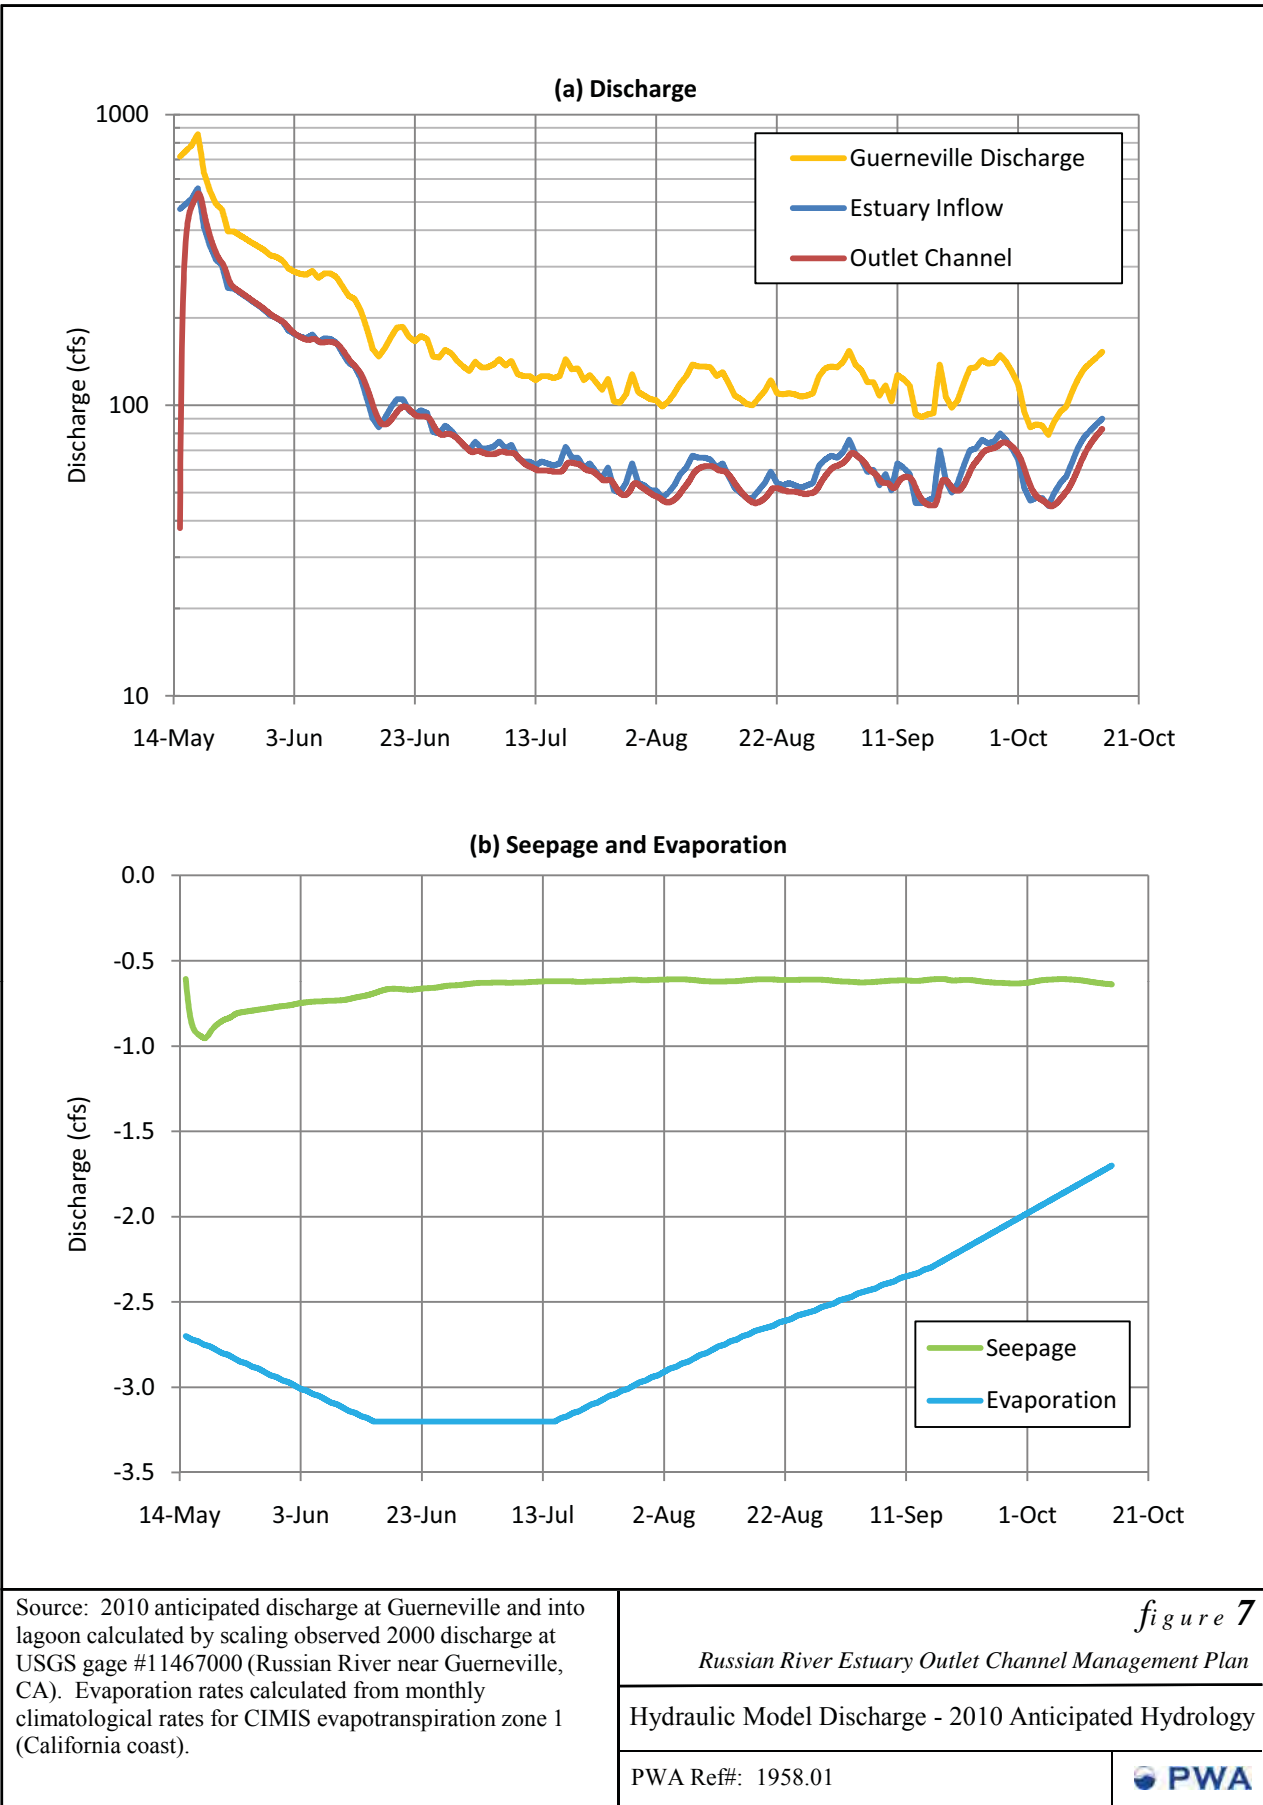
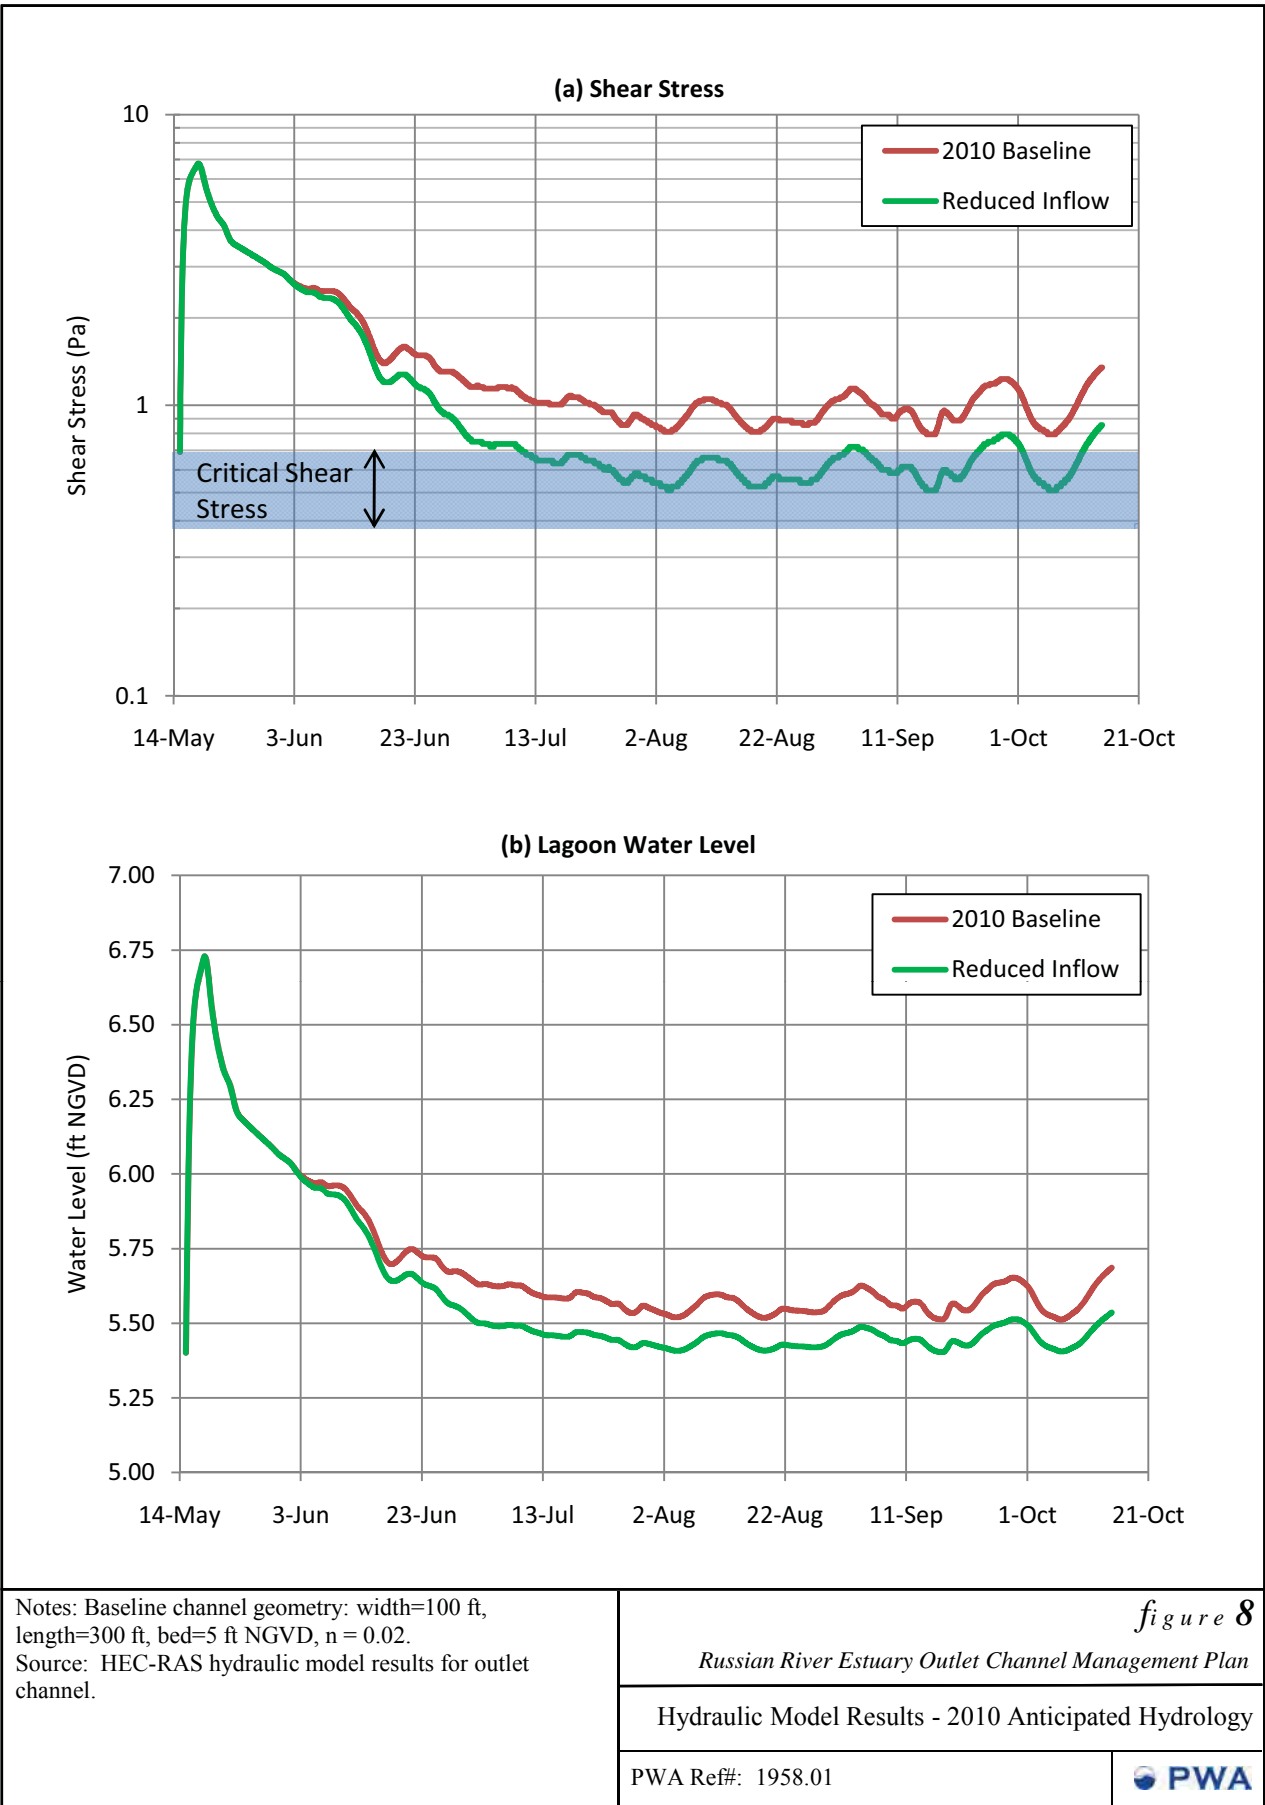
*figure 8*

Notes: Baseline channel geometry: width=100 ft, length=300 ft, bed=5 ft NGVD, n = 0.02.  
 Source: HEC-RAS hydraulic model results for outlet channel.

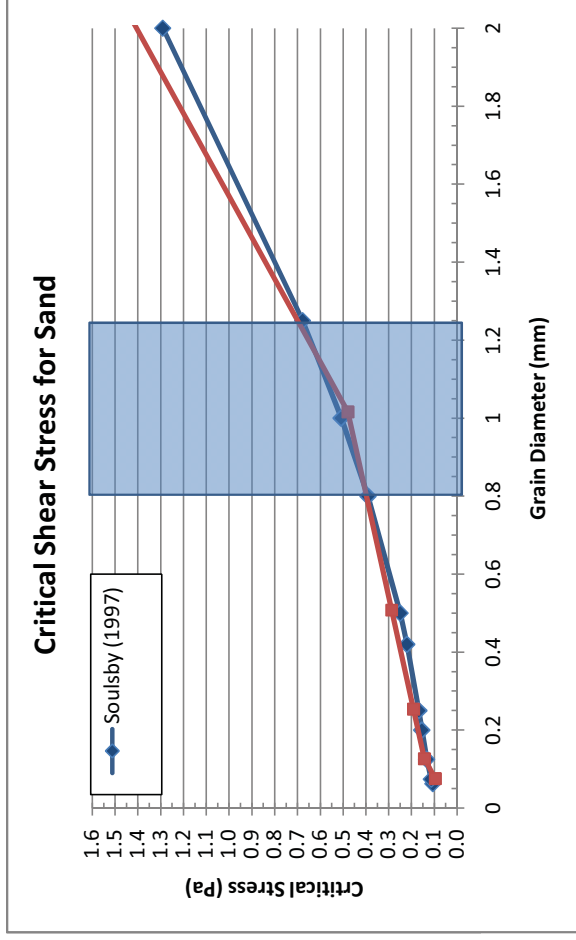
$$\theta_c = \frac{0.3}{1 + 1.2D_*} + 0.055[1 - \exp(-0.020D_*)]$$

$$\tau_c = \rho(s-1)gd\theta_c$$

Note: does not account for gravitational effects on sloping bed

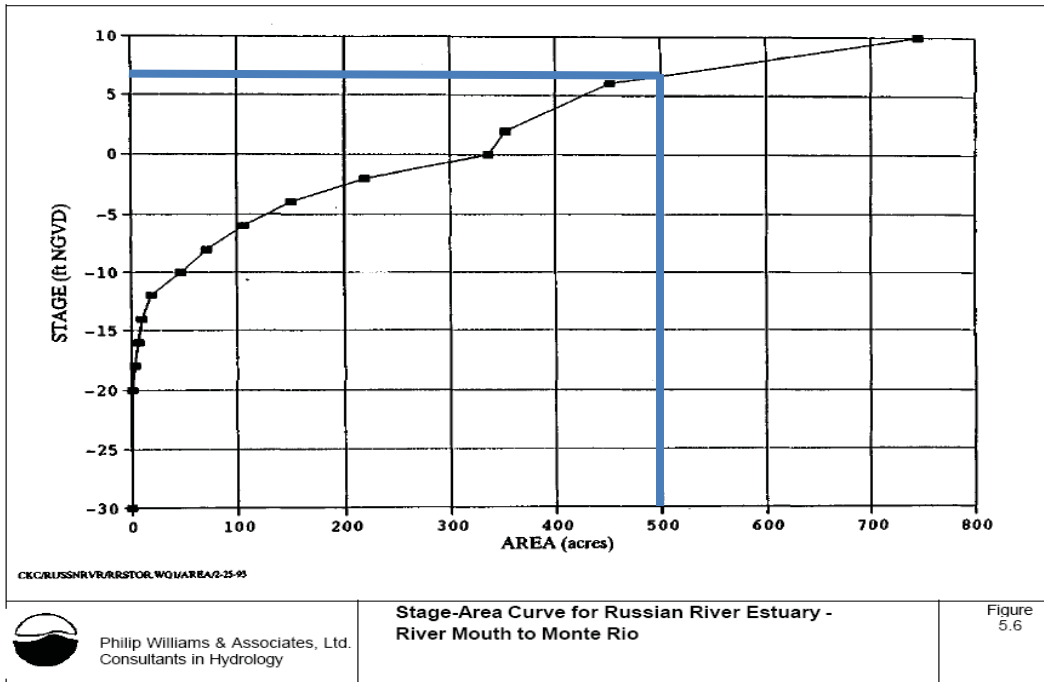
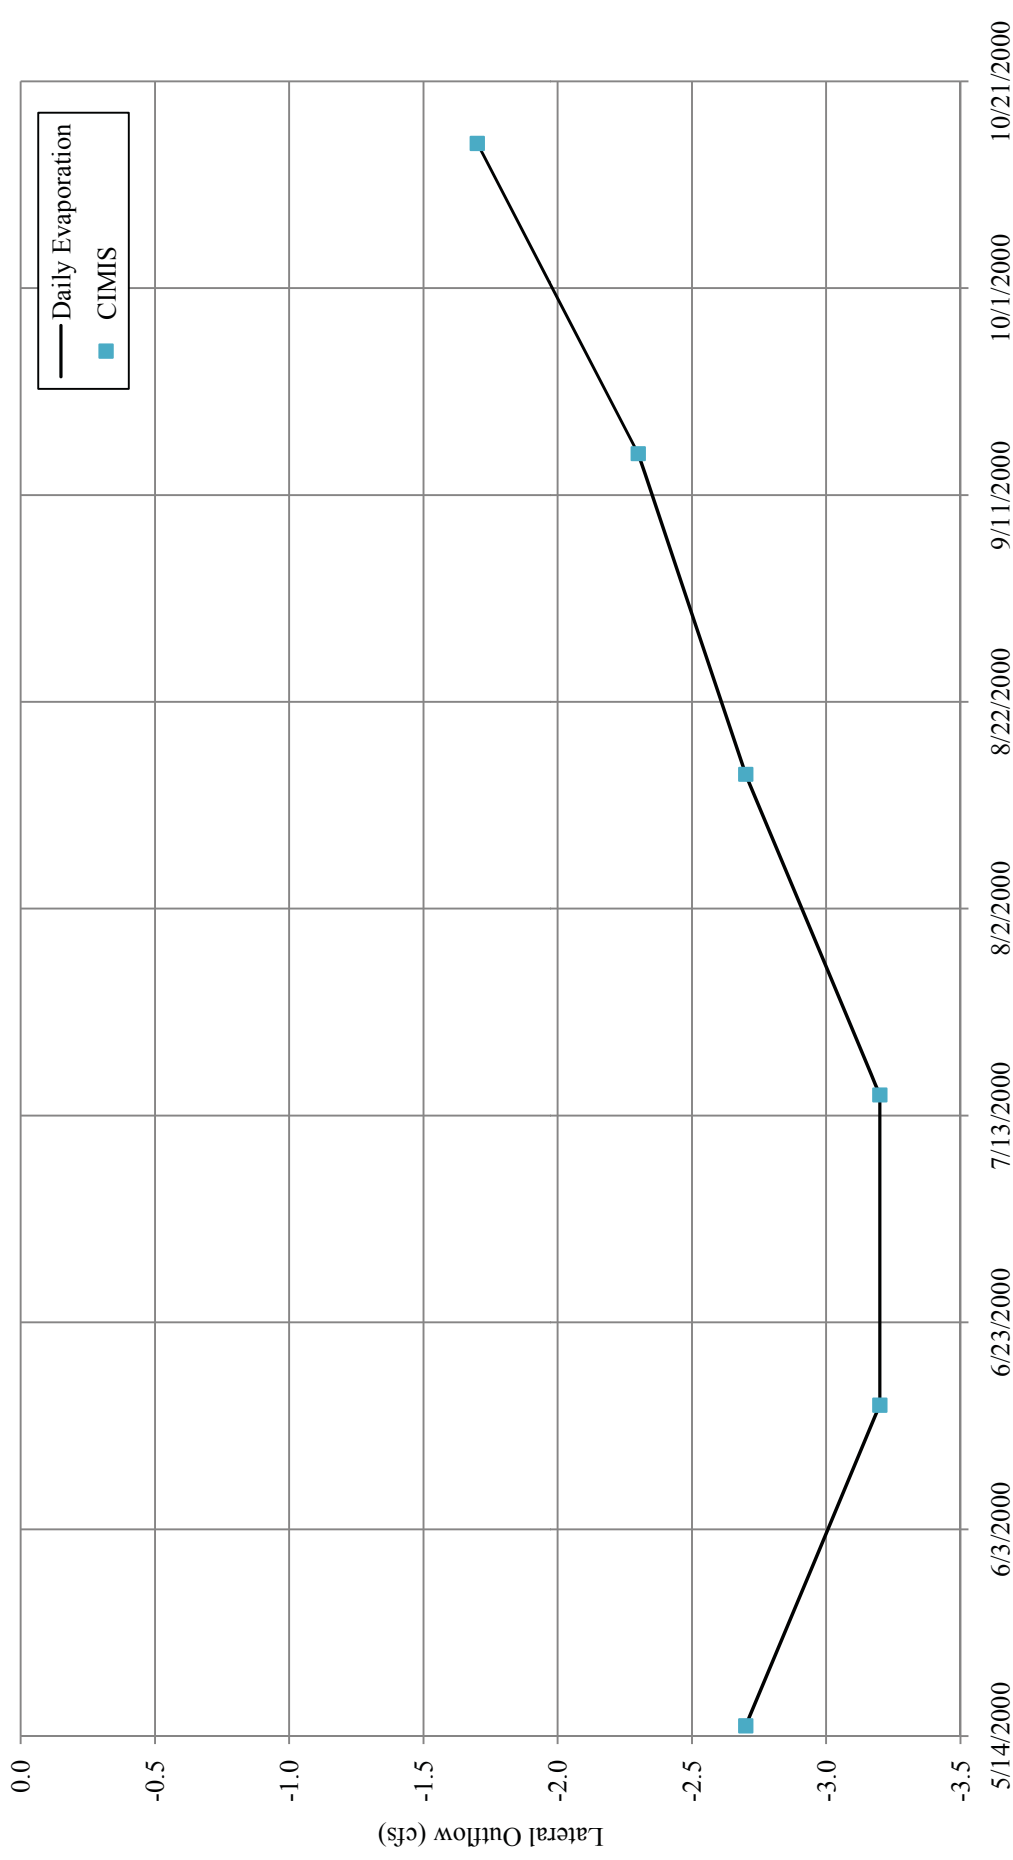
**Appendix A-3**  
*Russian River Estuary Outlet Channel Management Plan*

Notes: Daily evaporation rates for Russian River lagoon interpolated from CIMIS average monthly evapotranspiration statistics for Zone 1 (Coastal plains and heavy fog). Calculations assume lagoon surface area of 500 acres.

**HEC-RAS model evaporation boundary condition**

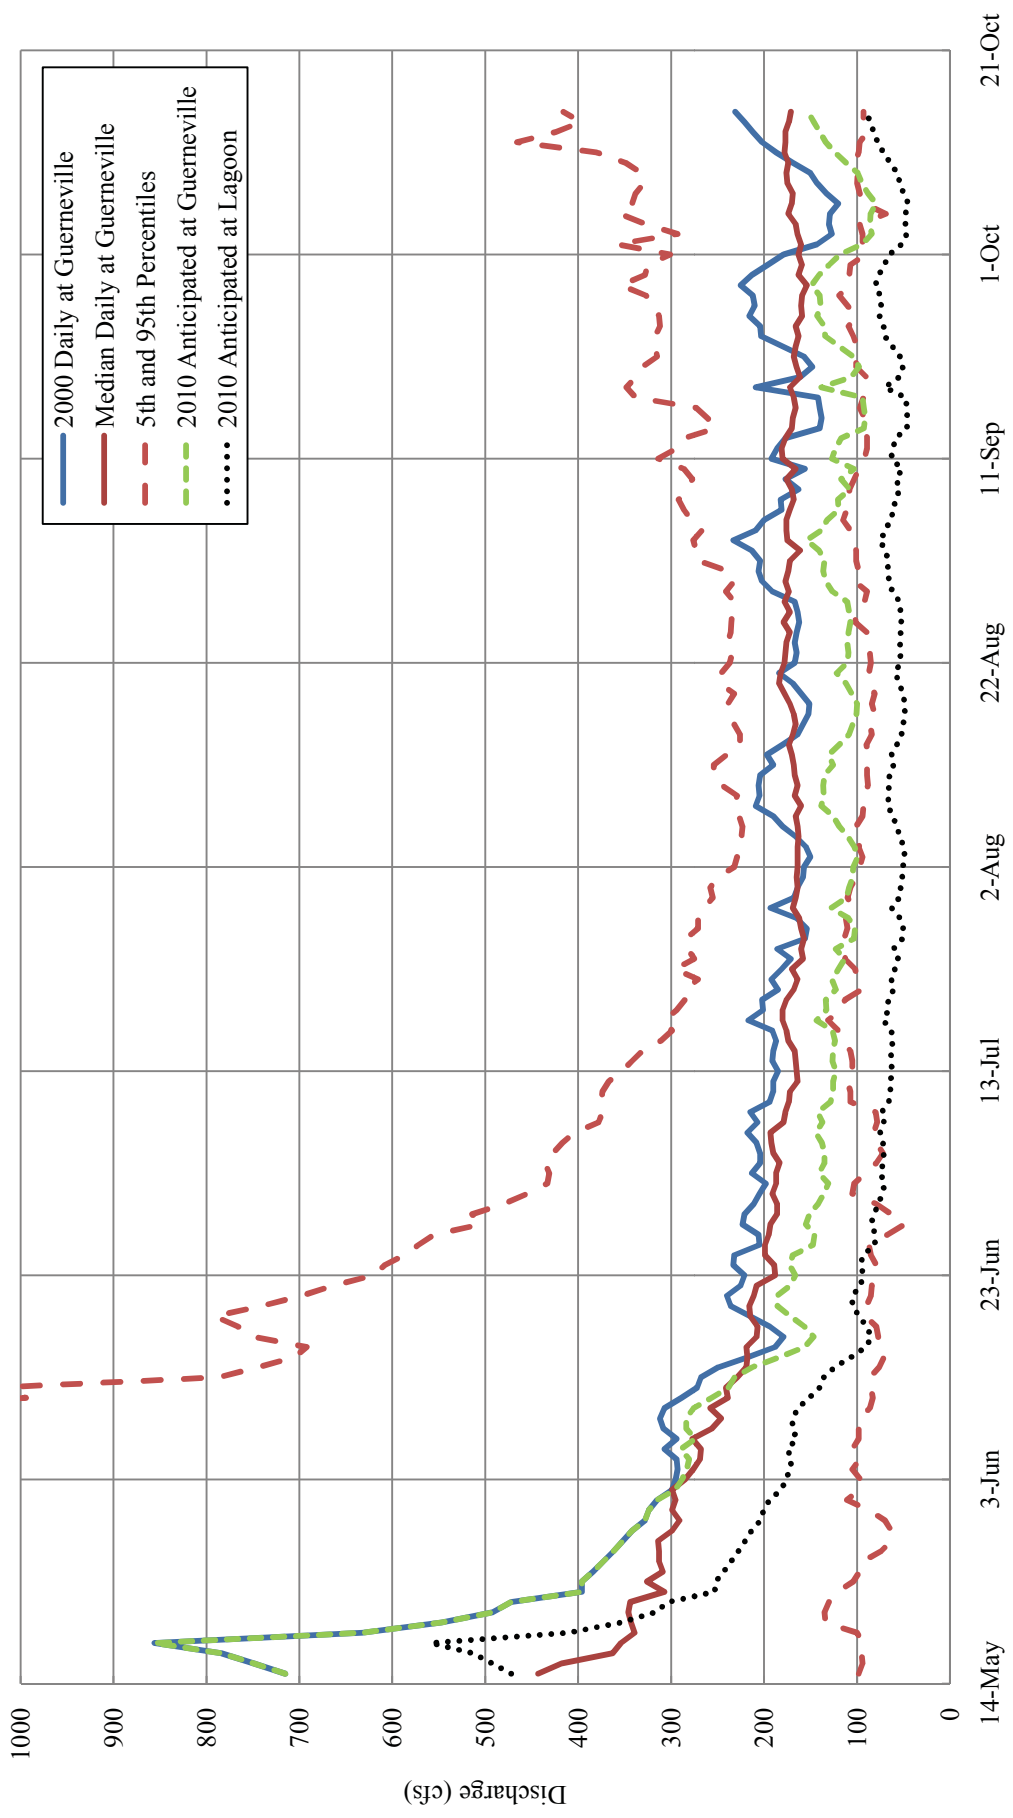
*Appendix A-6*  
 Russian River Estuary Outlet Channel Management Plan

Notes: Median daily discharge calculated from 1970-2008.  
 Source: USGS gage 11467000 (Russian River near Guerneville, CA). 2010 anticipated discharge at Guerneville calculated from 2000 discharge by scaling factor to obtain typical summertime flowrates of 120 cfs. 2010 anticipated lagoon inflow calculated based on calibrated seasonal losses from Guerneville to lagoon.

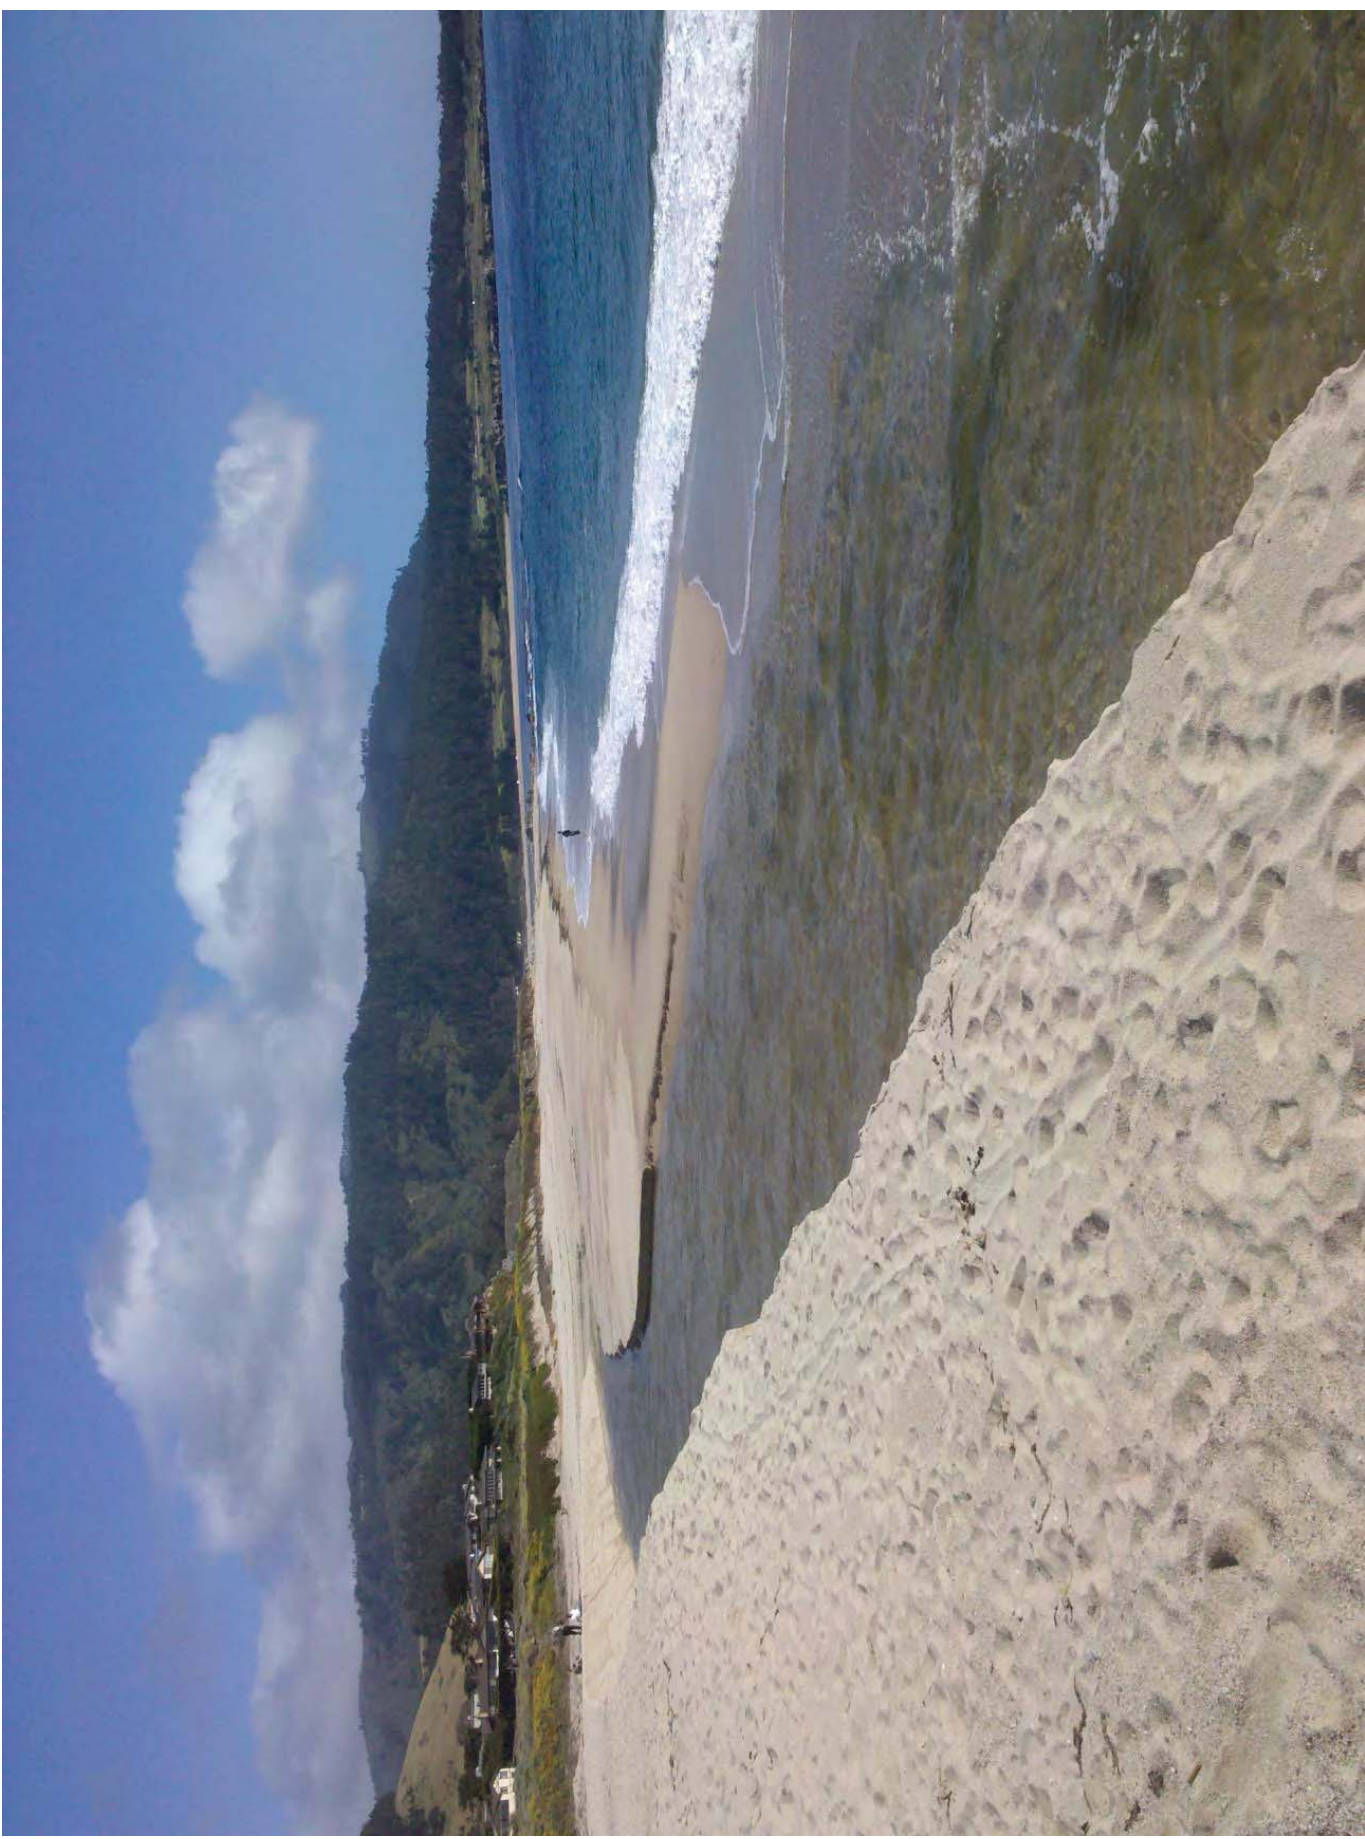
CARMEL, 6/9/2010

A short duration event of critically steep waves and beach building occurred along the California Coast the week of May 27<sup>th</sup> to June 3, 2010. Attached are photos of these river mouth beaches and the channels that resulted from that short duration beach building event. A WSE stage monitor in the Carmel lagoon recorded the effect on lagoon WSE, in which subsequent to the event and the lengthening of the channel, the WSE of the lagoon was maintained above the high tide level and tidal influence became muted. Photos included are of Carmel, San Lorenzo, Scott, Waddell, Pamponio and Navarro river beaches. A plot of the Carmel lagoon WSE for June 2010 can be viewed at <http://www.mpwmd.dst.ca.us/wrd/lagoon/webplots/2010/2010webplots.htm>

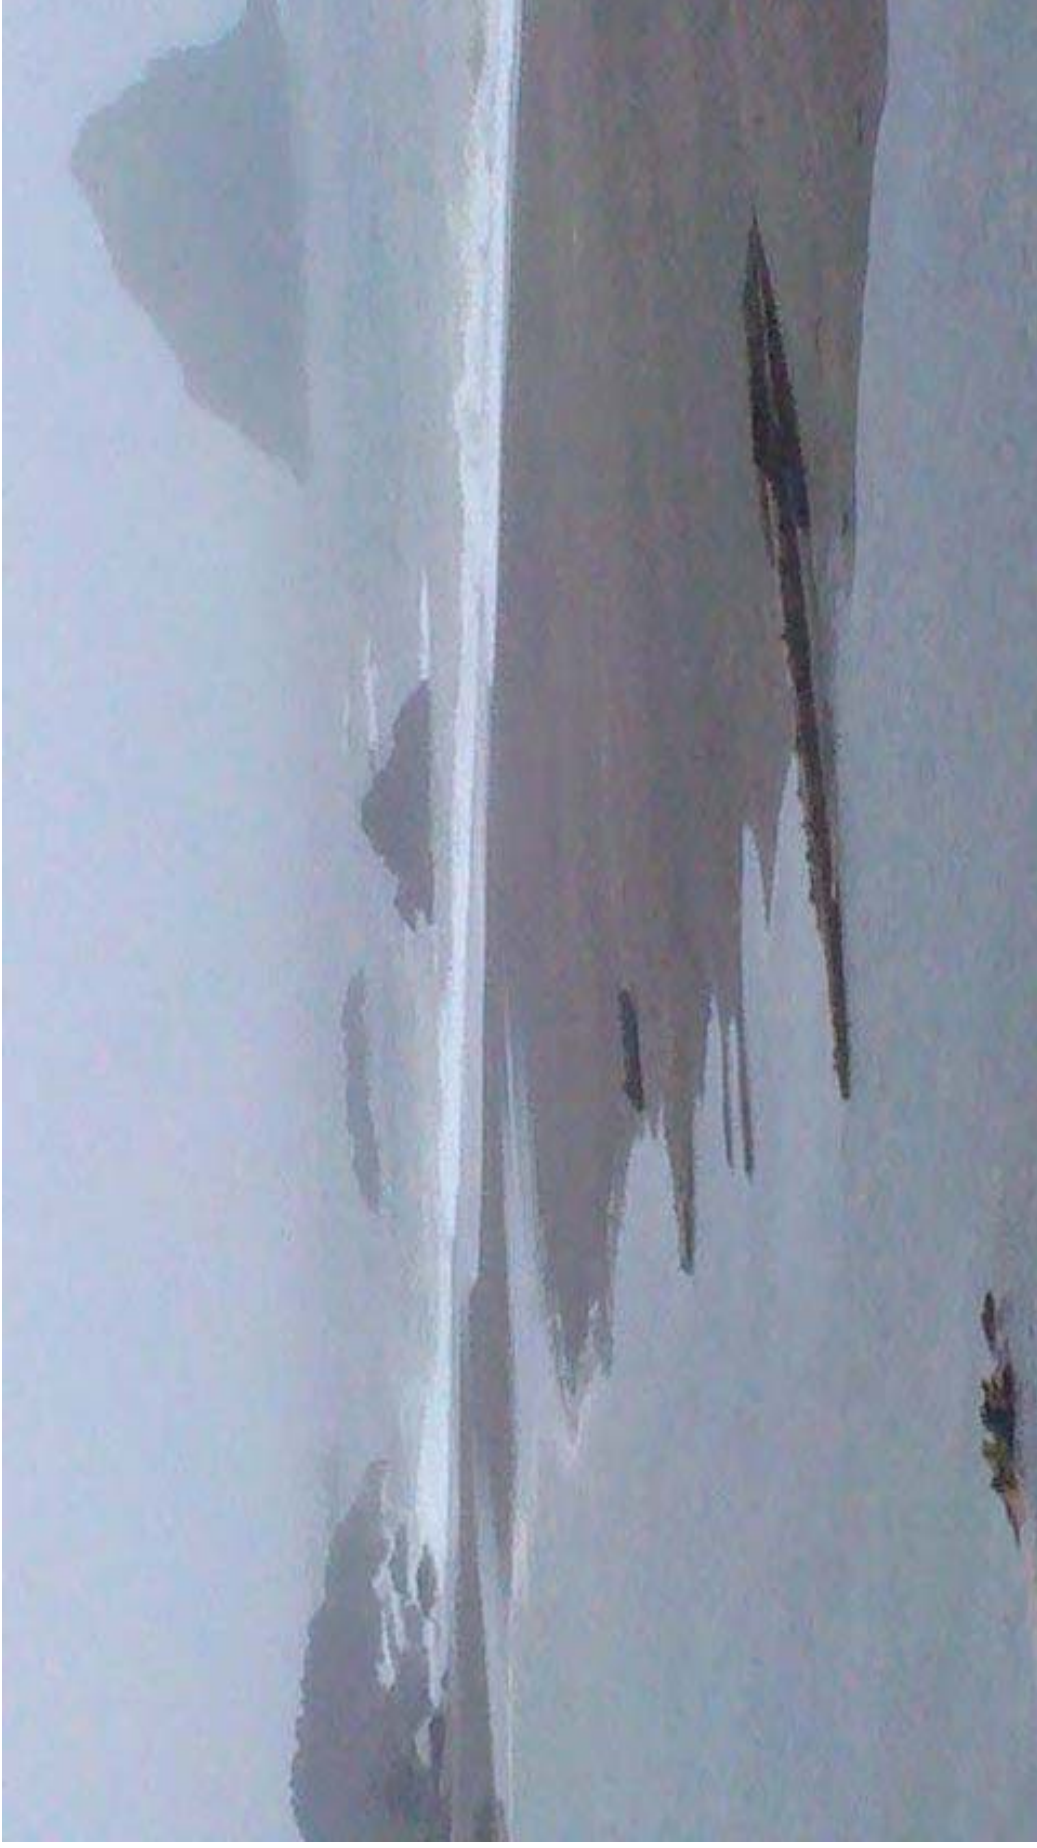
Navarro, 6/6/2010 (high tide-/Lagoon  
WSE ~ 6-7 feet NGVD estimated)

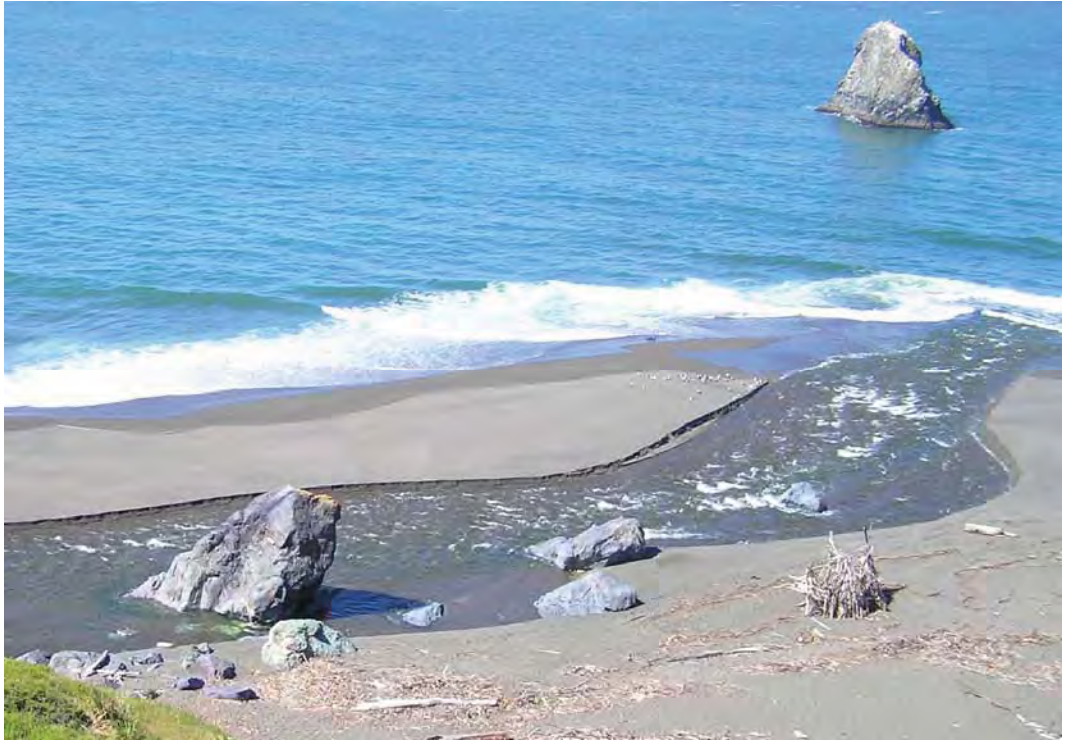
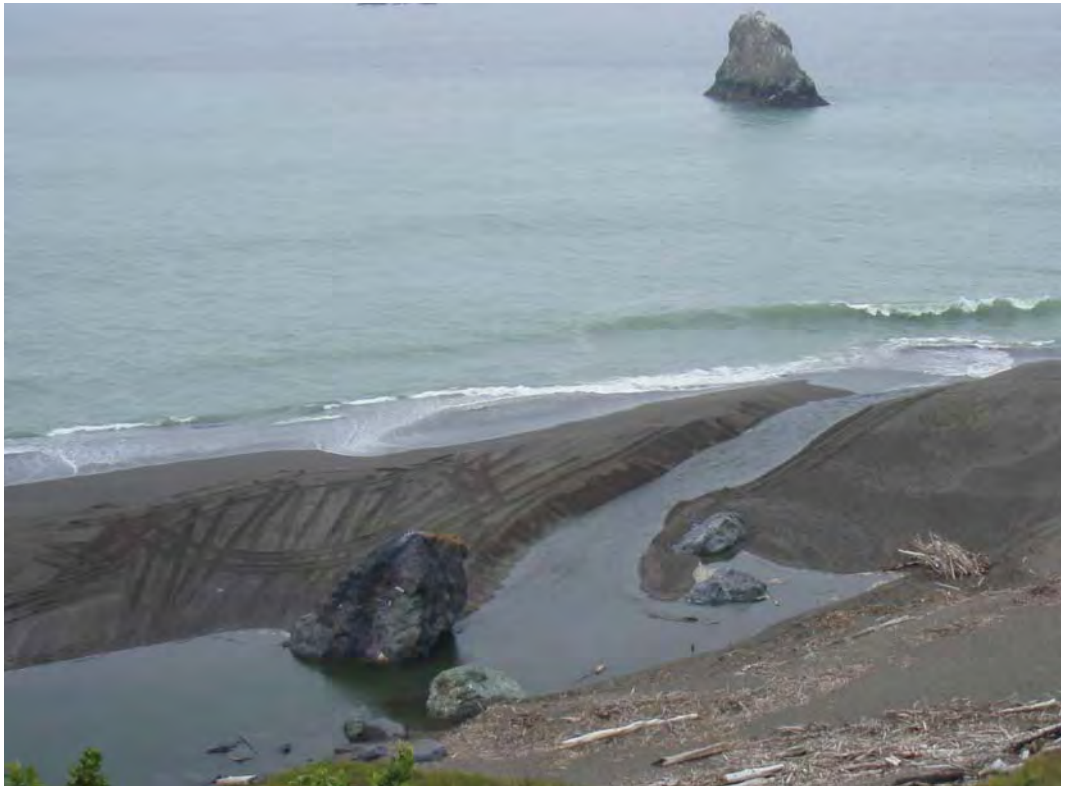
*figure 5*  
*Russian River Outlet Channel Adaptive Management Plan*

Source: C. Delaney, SCWA

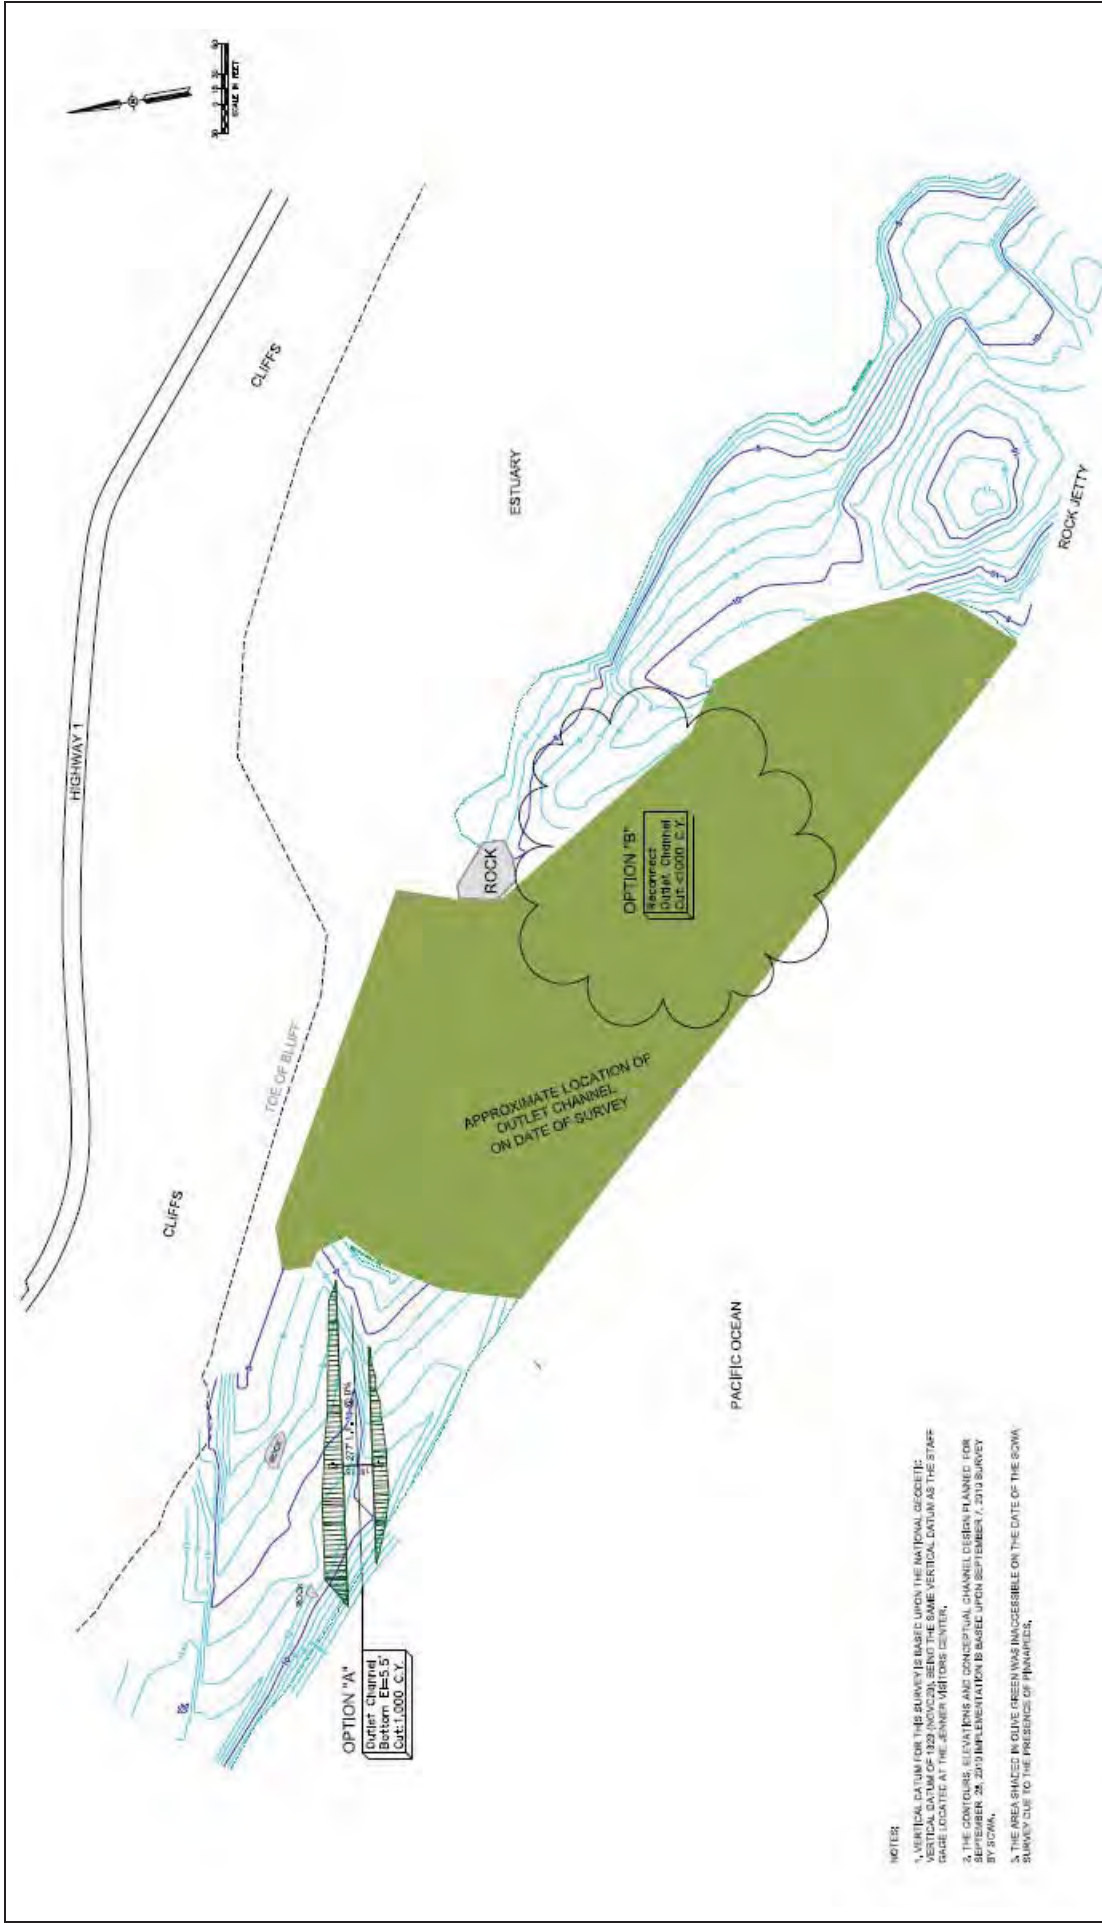
figure 8  
Russian River Outlet Channel Adaptive Management Plan  
Beach Topography and Management Options, September 2010

Source: SCWA
