**RUSSIAN RIVER ESTUARY OUTLET CHANNEL  
ADAPTIVE MANAGEMENT PLAN  
2017**

Sonoma County Water Agency

ESA

May 30, 2017

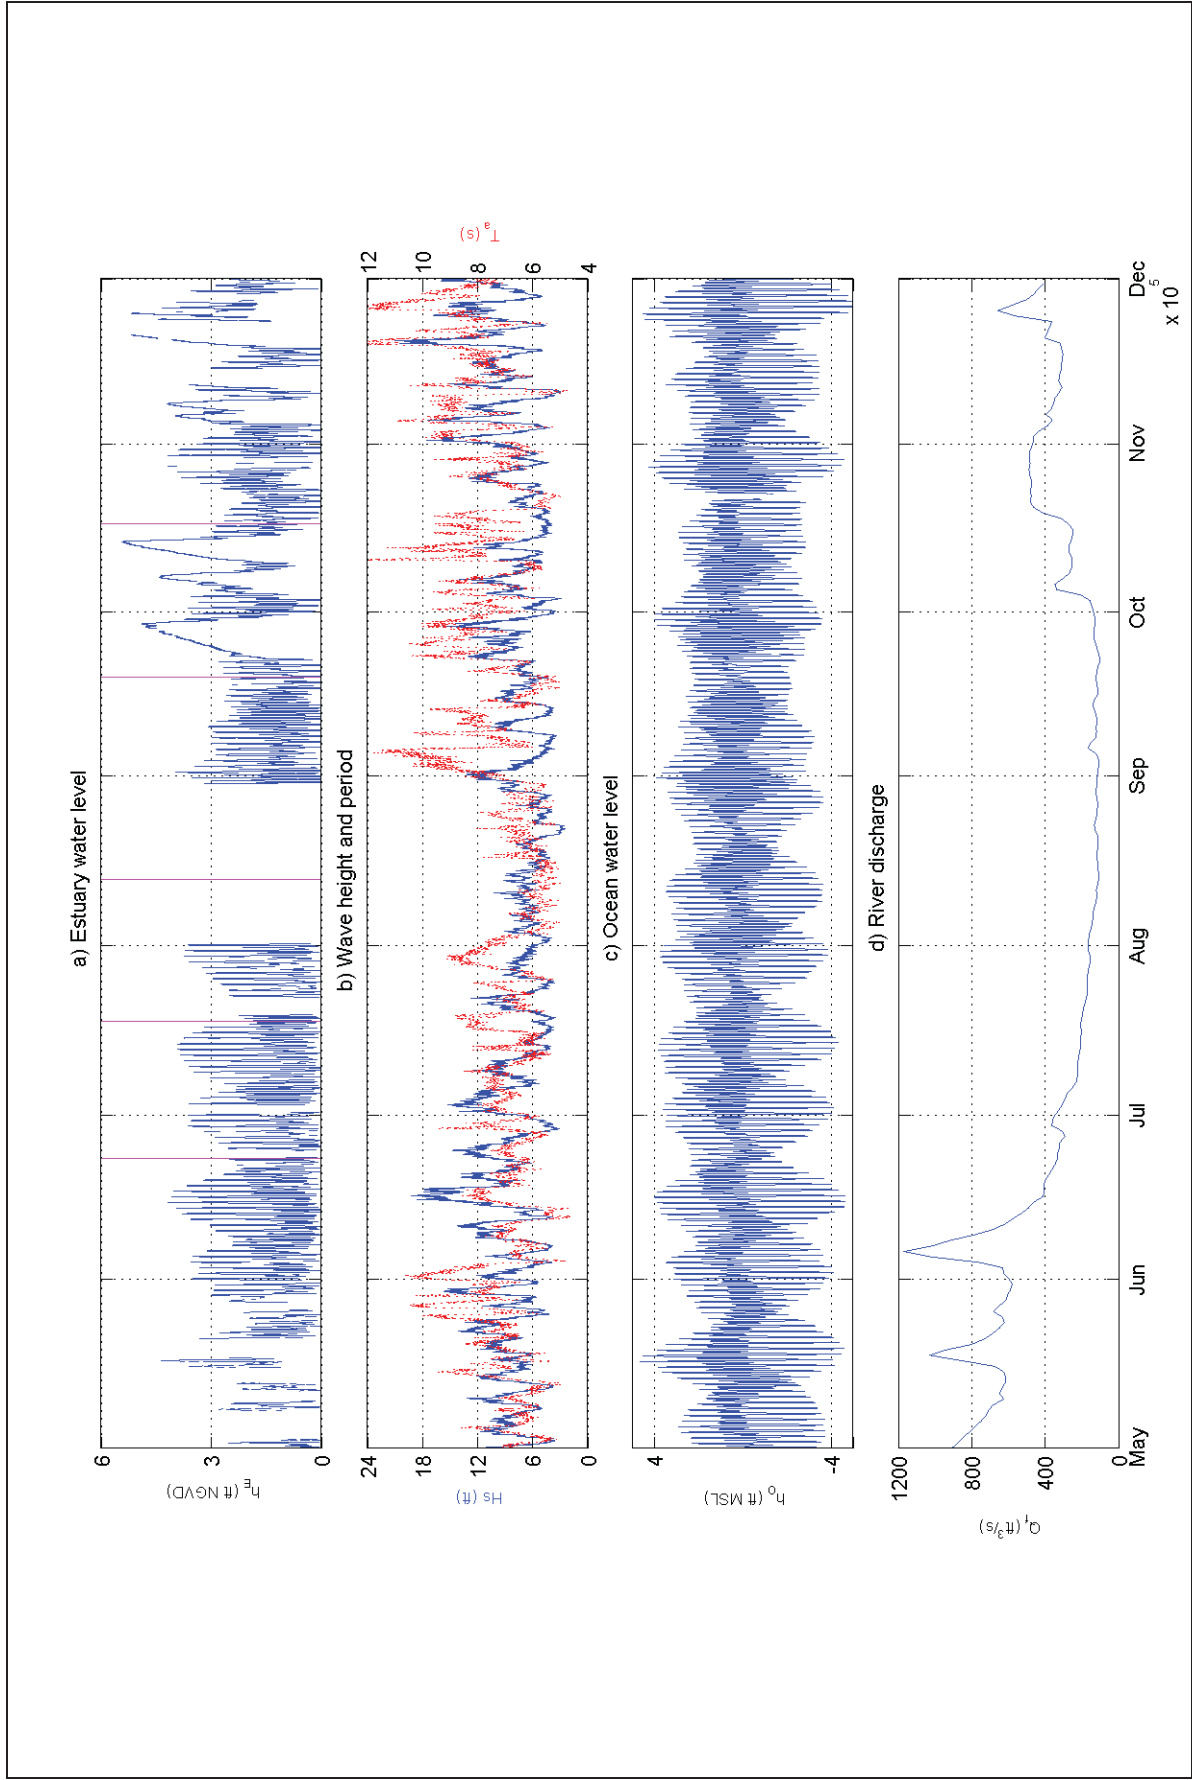
Russian River Estuary Outlet Channel Management Plan . DW01958  
**Figure 1**  
 Estuary, Ocean, and River Conditions  
 May - November 2011

SOURCE:  
 a)  $h_E$ =estuary water level (SCWA); pink bar = beach survey  
 b)  $H_s$ =sig. wave height;  $T_a$ =avg. wave period (CDIP, Pt. Reyes, #029)  
 c)  $h_o$ =ocean water level (NOAA, Pt. Reyes #9415020)  
 d)  $Q_r$ =river discharge (USGS, Guerneville #11467000)

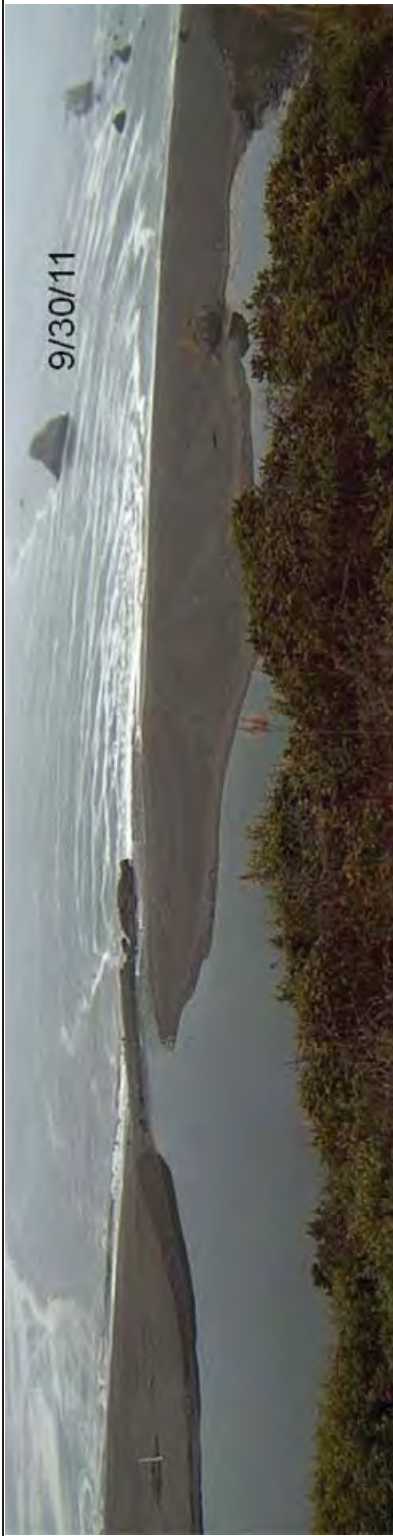
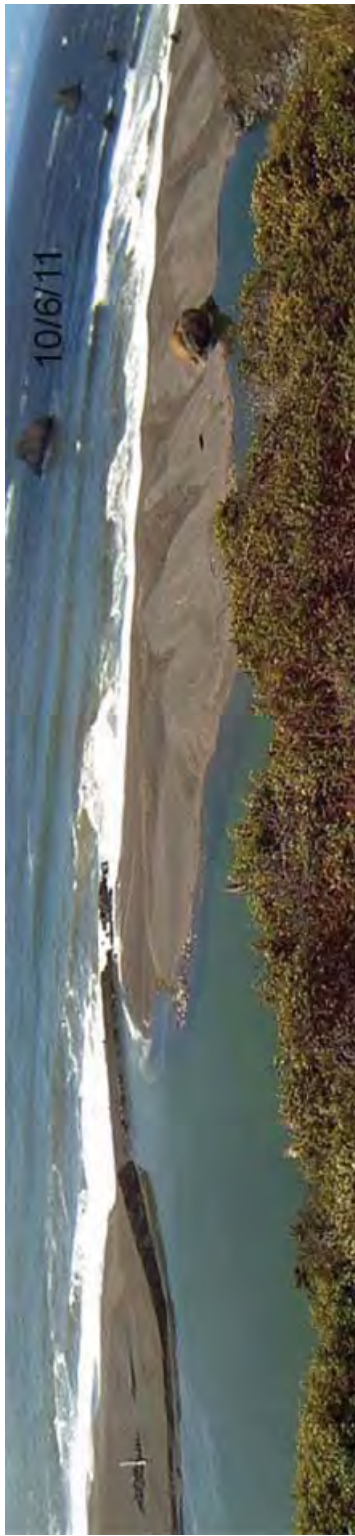
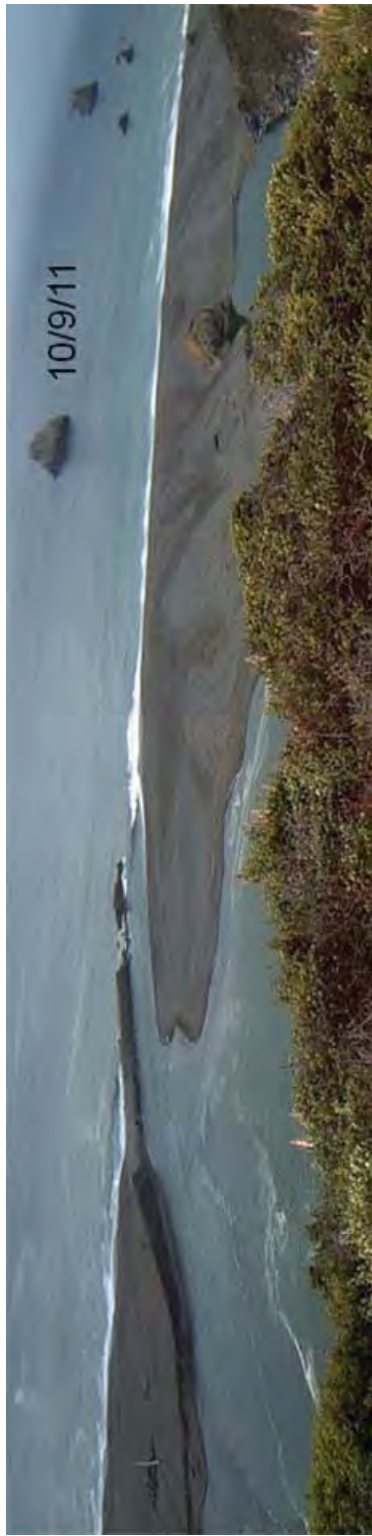
**Figure 2**  
**Estuary, Ocean, and River Conditions**  
**September - November 2011**

a)  $h_E$ =estuary water level (SCWA); pink bar = beach survey  
 b)  $H_s$ =sig. wave height;  $T_a$ =avg. wave period (CDIP, Pt. Reyes, #029)  
 c)  $h_o$ =ocean water level (NOAA, Pt. Reyes #9415020)  
 d)  $Q_r$ =river discharge (USGS, Guerneville #11467000)

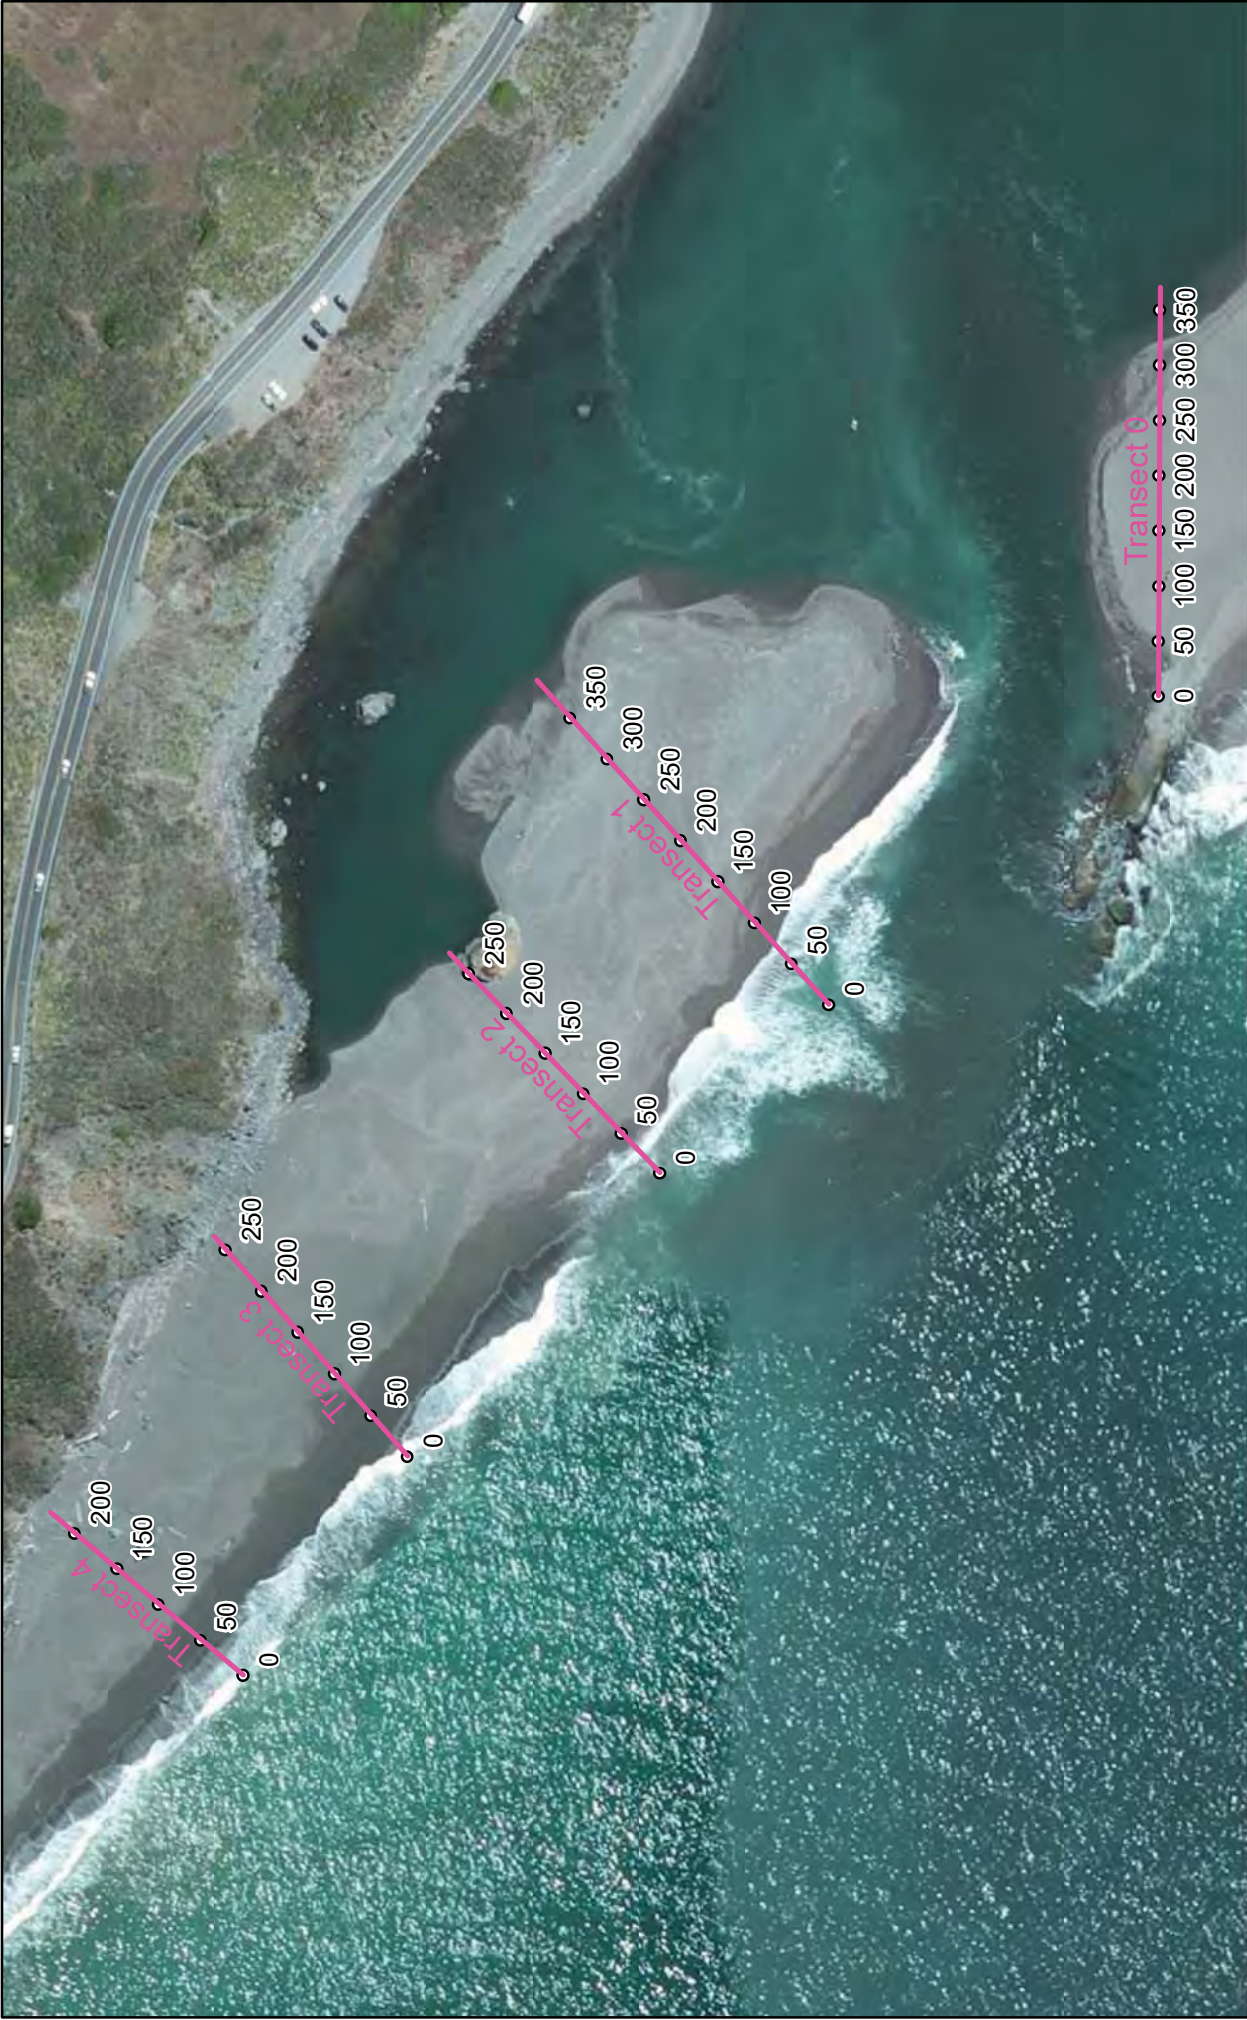
figure 5  
 Russian River Outlet  
 Channel Management Plan  
 Beach Topography Transect Locations  
 ESA PWA Ref# - DW01958  
 ESA PWA

Source: Sonoma County Water Agency survey data

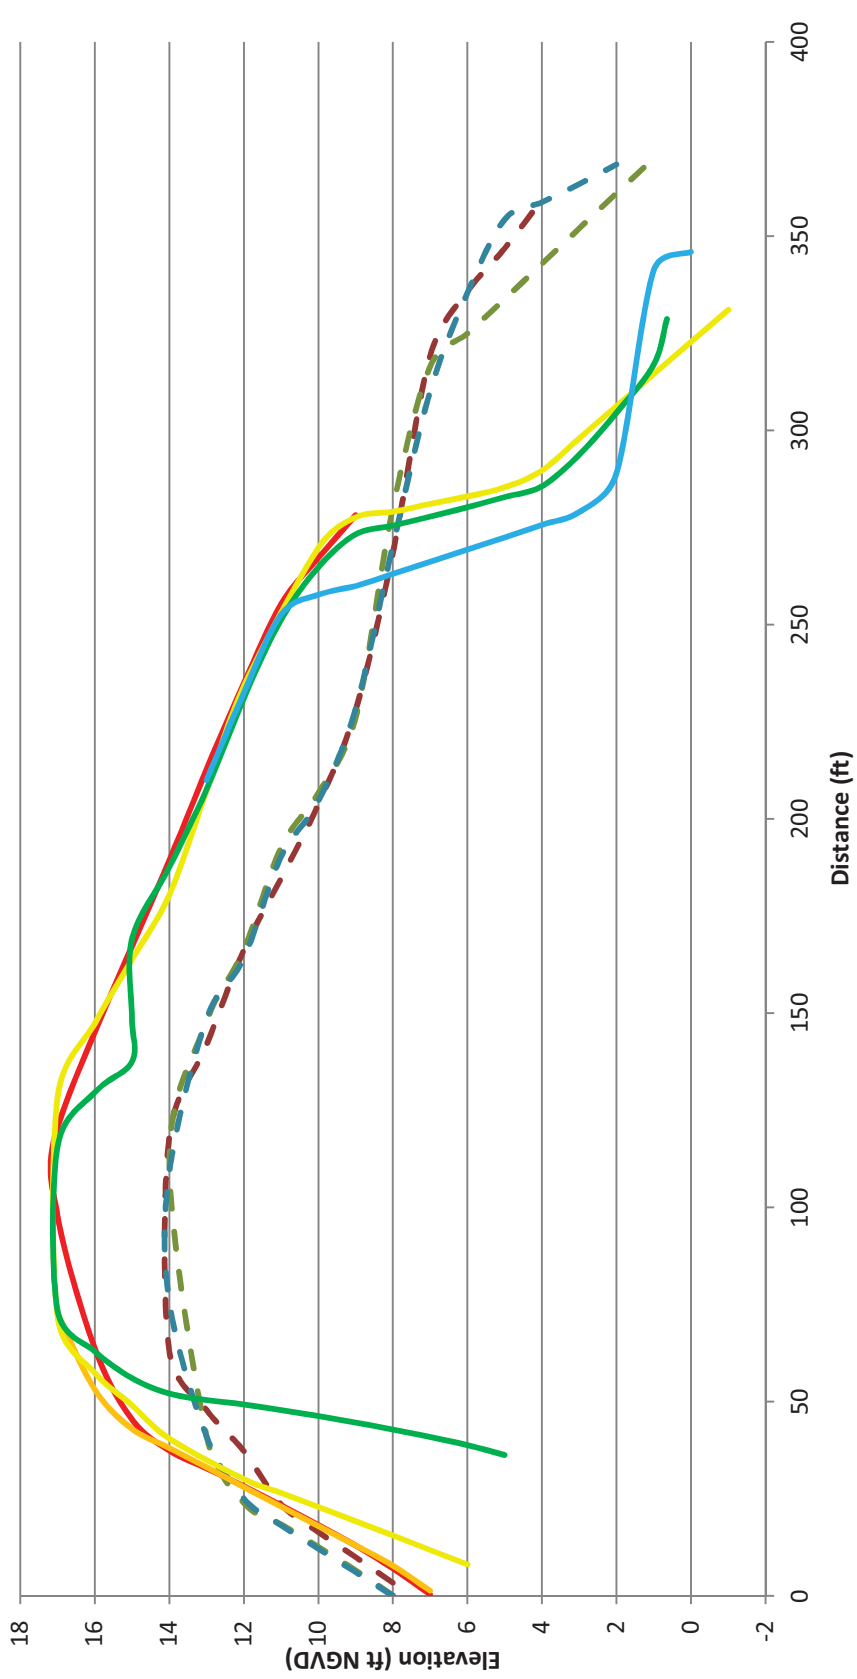
- - - 7/1/2010   
 - - - 8/3/2010   
 - - - 9/7/2010   
 — 5/31/2011   
 — 6/23/2011   
 — 7/18/2011   
 — 8/15/2011   
 — 9/19/2011

Source: Sonoma County Water Agency survey data

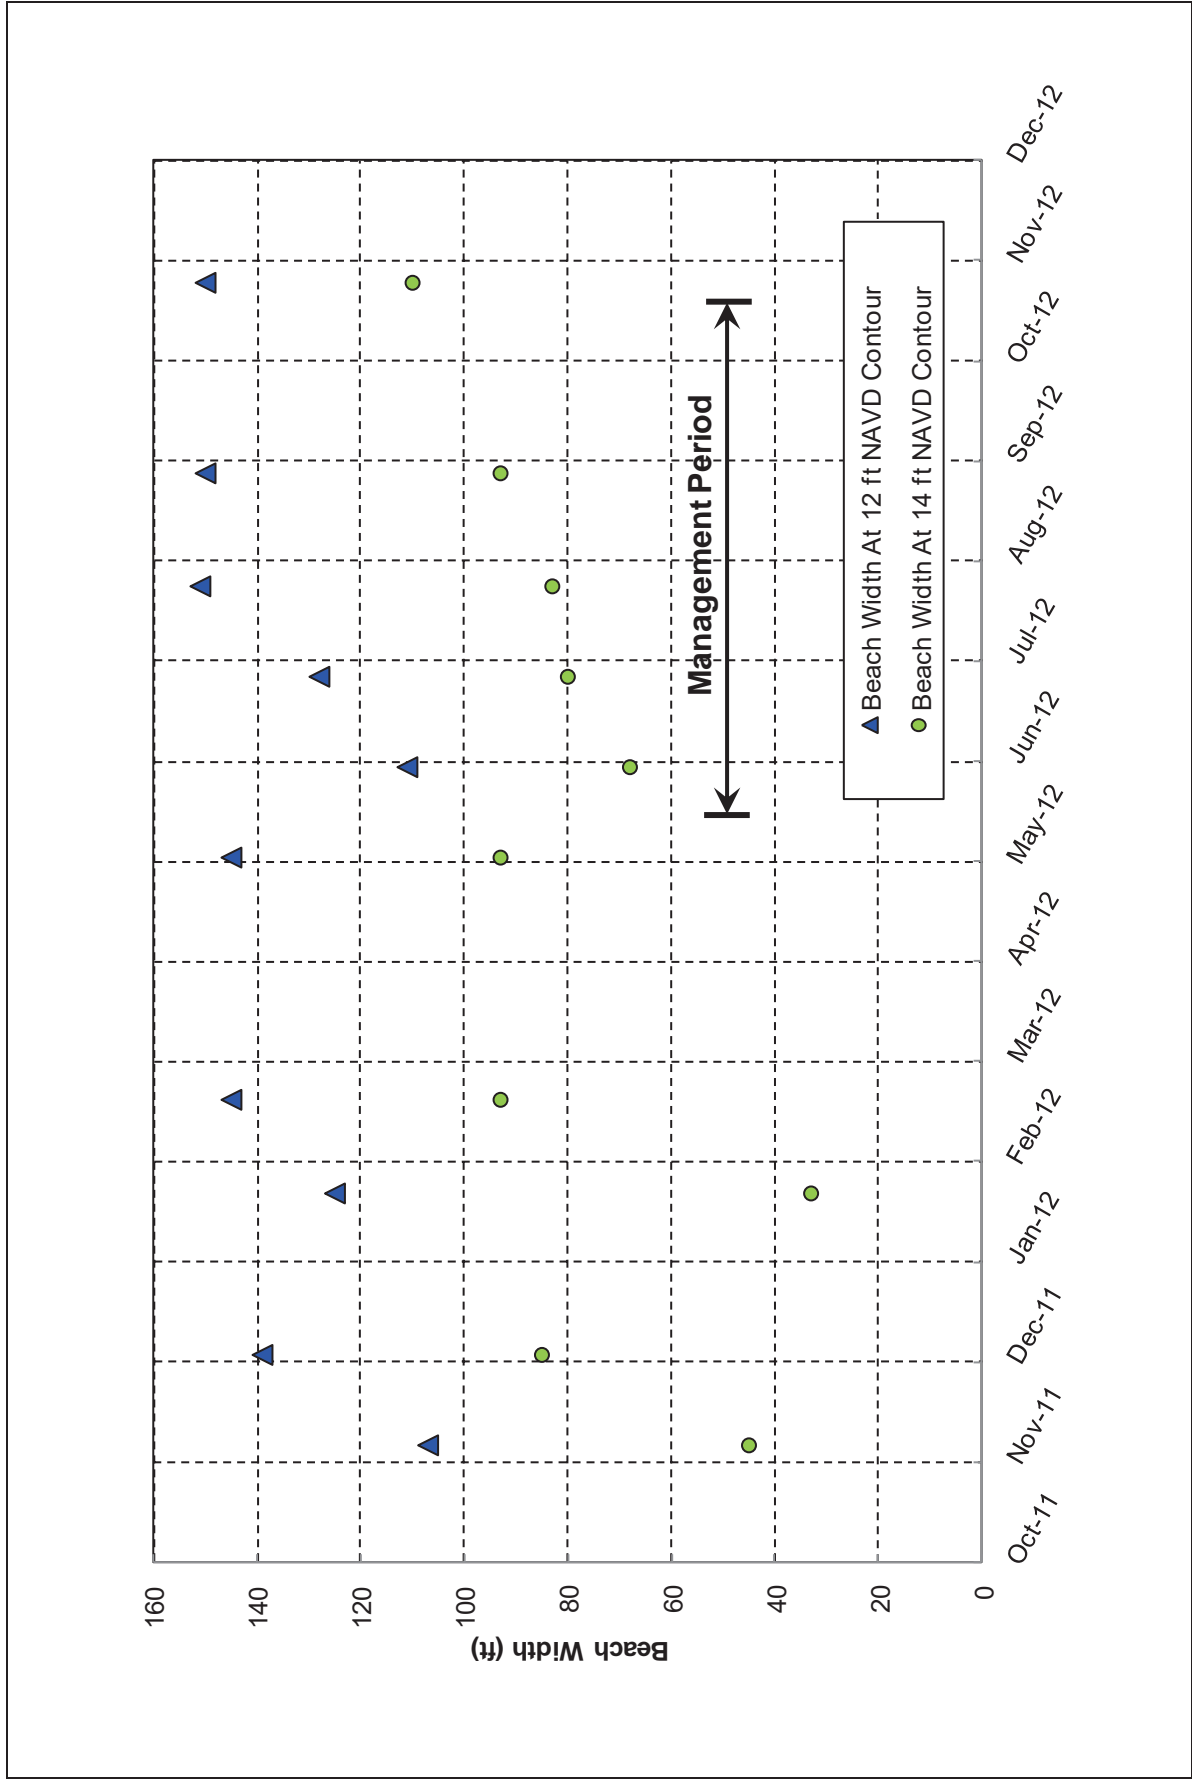
Russian River Estuary Outlet Channel Management Plan . D120709.00  
**Figure 13**  
 Beach width at Beach Transect ?

SOURCE: SC . survey data

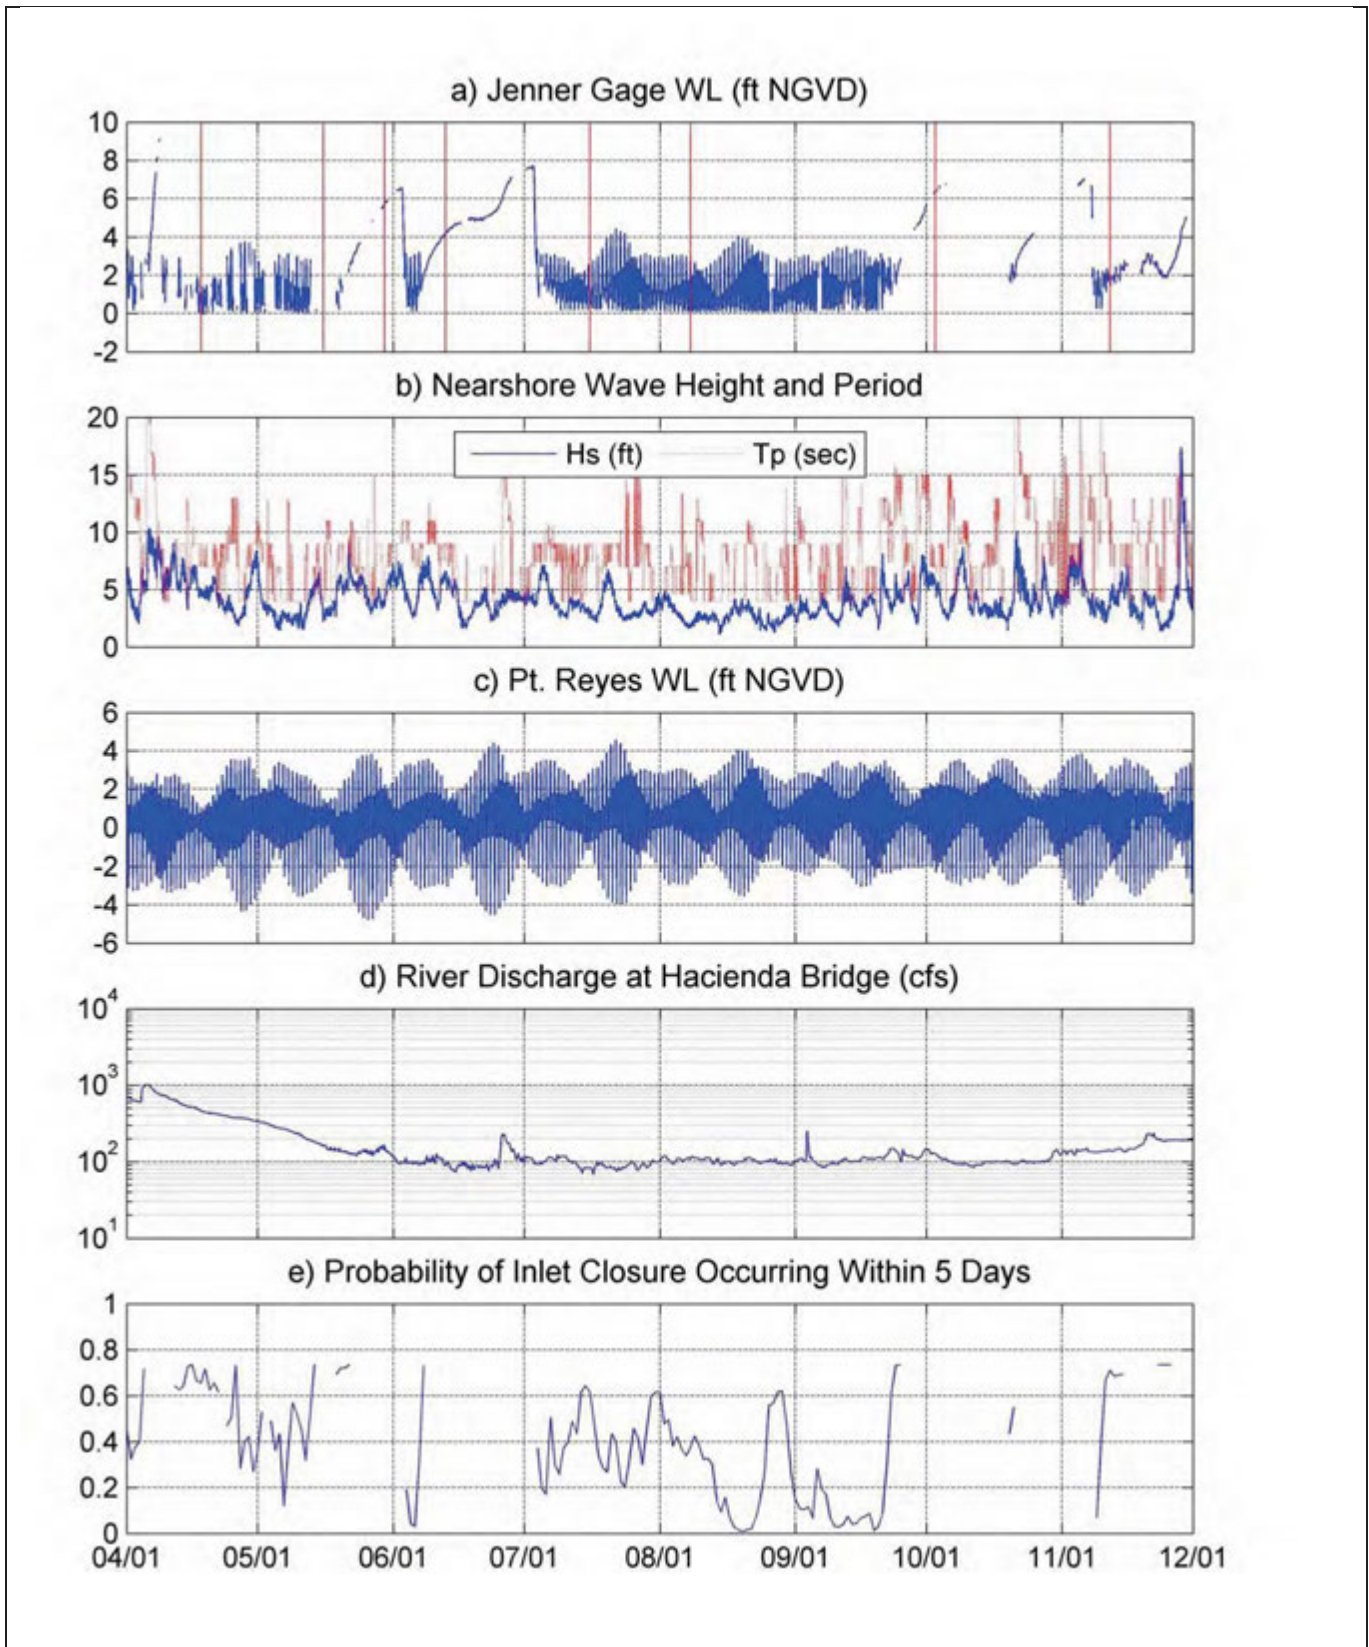
**Figure 2**  
 Estuary Ocean, and River Conditions Compared  
 with Closure Probability  
 May – July

a) Jenner gage water level provided by C...; red bar = beach survey  
 b) Nearshore wave height and period provided by NOAA  
 c) Pt. Reyes water level provided by NOAA  
 d) River discharge provided by USGS (Guerneville)  
 e) 5-day closure probability provided by B... et al.

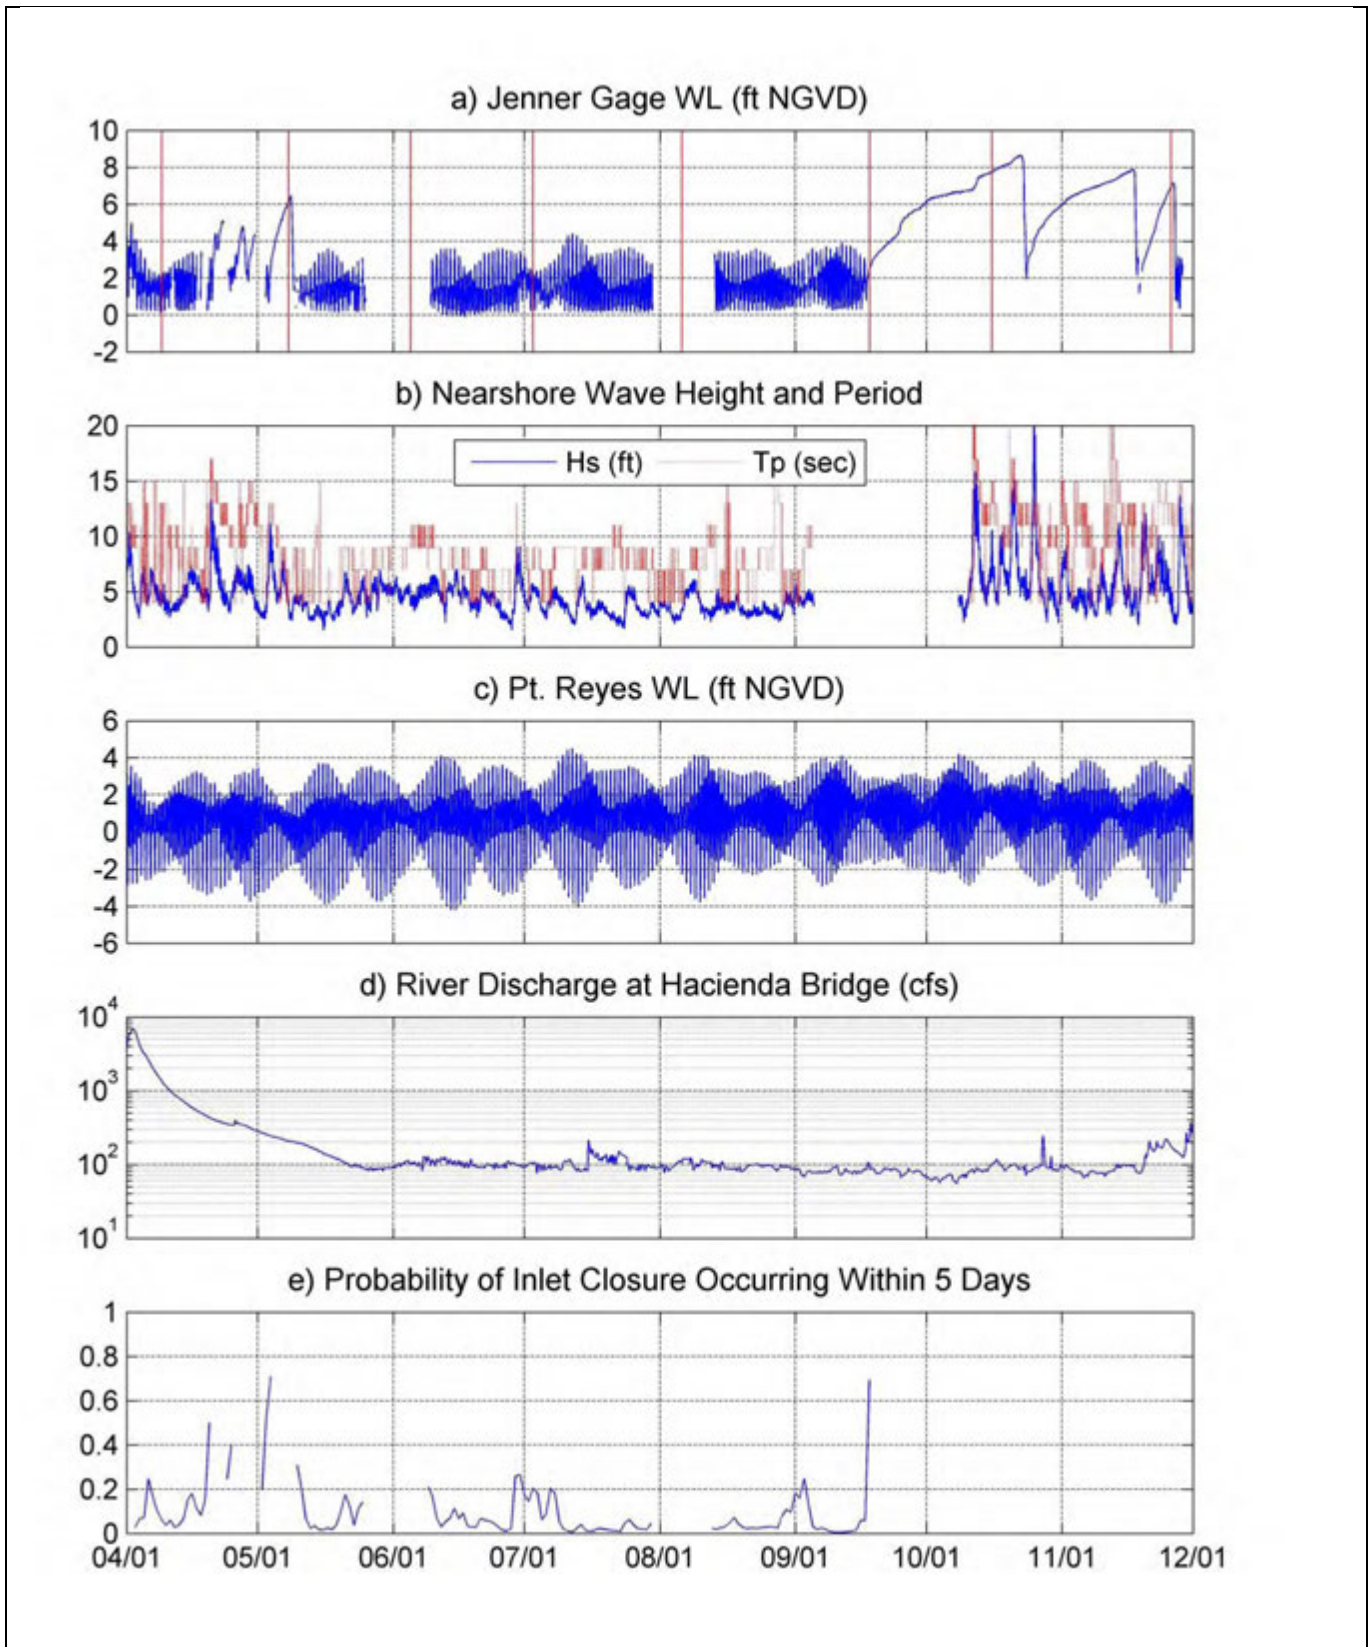
**Figure 1**  
 Estuary, Ocean, and River Conditions Compared  
 with Closure Probability:  
 April – November 2014

- a) Jenner gage water level provided by SCWA; red bar = beach survey
- b)  $H_s$  = sig. wave height;  $T_p$  = peak wave period (CDIP, Pt. Reyes, #029)
- c) Ocean water level provided by NOAA (Pt. Reyes #9415020)
- d) River discharge provided by USGS (Guerneville #11467000)
- e) Five-day closure probability provided after Behrens et al. (2013)

Time series of estuary water levels, as well as the key forcing factors (waves, tides, and riverine discharge), are shown in Figure 1 for the entire management period. The lagoon water level time series (Figure 1a) summarizes the closure events at the beginning of the management period, as well as the subsequent tidal conditions and later closure events in fall. As shown in Figure 1d, discharge was low for most of the management period, dropping from 7,000 ft<sup>3</sup>/s on April 2<sup>nd</sup> to below 100 ft<sup>3</sup>/s on May 21<sup>st</sup>. In mid-July, flows briefly reached 200 ft<sup>3</sup>/s and remained above 100 ft<sup>3</sup>/s for about a week. Afterwards, flows slowly declined until they reached a minimum of 55 ft<sup>3</sup>/s on October 7<sup>th</sup>. As in prior years, wave energy was minimal in much of the management period. A late season swell event ( $H_s > 8$  ft,  $T_p > 14$ s) occurred in late June, and may have led to the

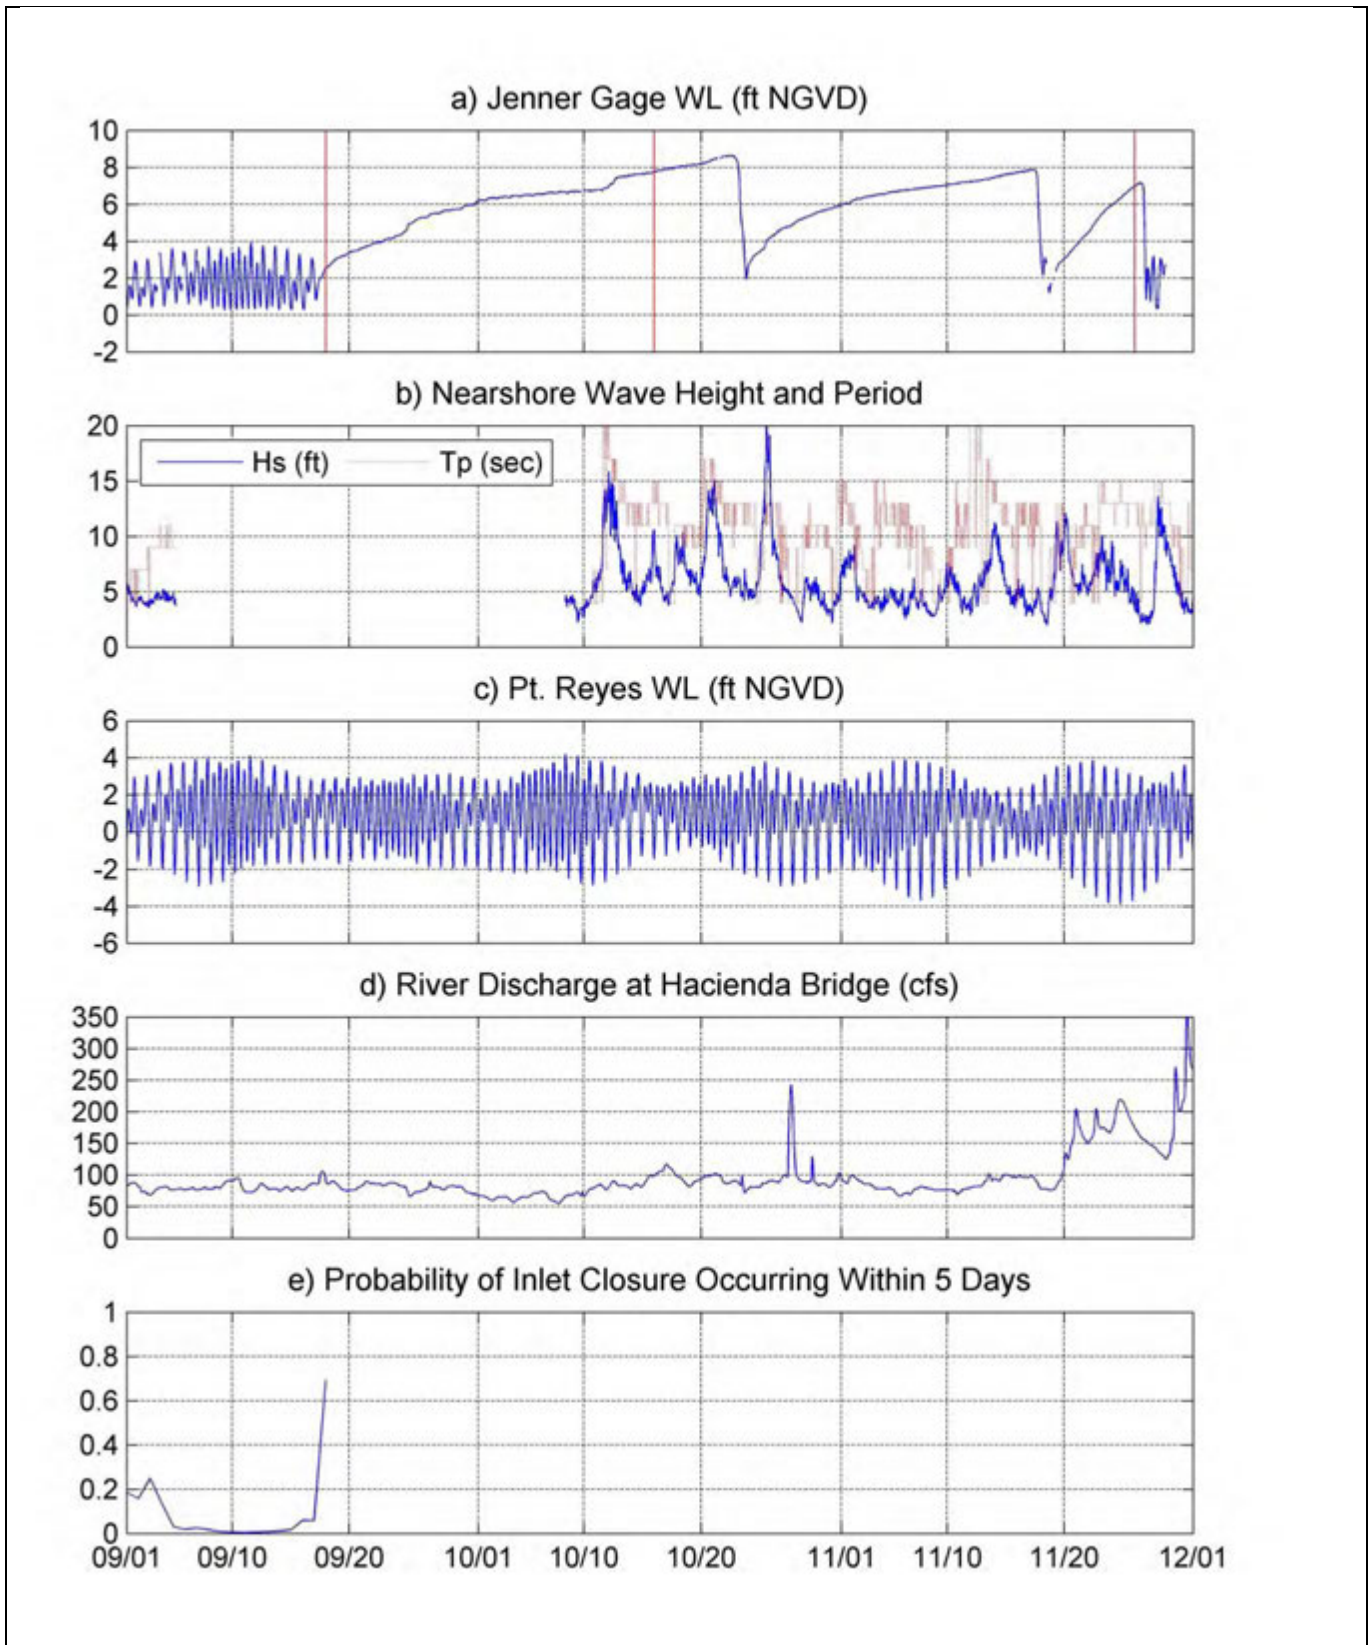
- a) Jenner gage water level provided by SCWA; red bar = beach survey
- b)  $H_s$  = sig. wave height;  $T_p$  = peak wave period (CDIP, Pt. Reyes, #029)
- c) Ocean water level provided by NOAA (Pt. Reyes #9415020)
- d) River discharge provided by USGS (Guerneville #11467000)
- e) Five-day closure probability provided after Behrens et al. (2013)

The conditions leading to inlet closure were consistent with the existing conceptual model described in Section 4 of the Management Plan. All closure events coincided with either moderately high waves ( $H_s > 6$  ft) having periods greater than 10 s, or with neap oceanic tide ranges of less than approximately 5 ft, with the exception of the September closure event, when nearshore waves could not be estimated. Moderately high waves coincided with the closure events in April and May. The September closure event occurred during a neap tide. The artificial breach events that occurred on October 22<sup>nd</sup> and November 17<sup>th</sup> were coincident with neap tides and large to moderate waves, and were followed by closure within less than one day. The artificial breach event on November 26<sup>th</sup> happened during a spring tide, and was not followed by closure. The persistent closure conditions from September through November are examined in more detail in Figure 2.

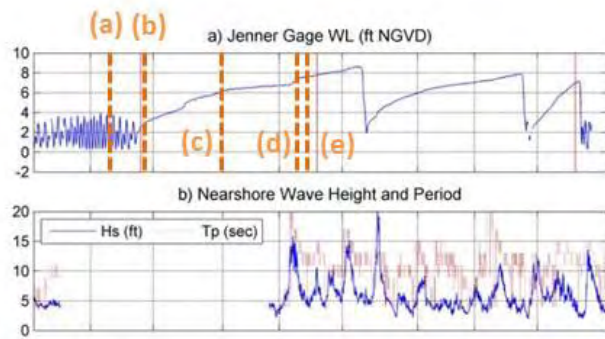
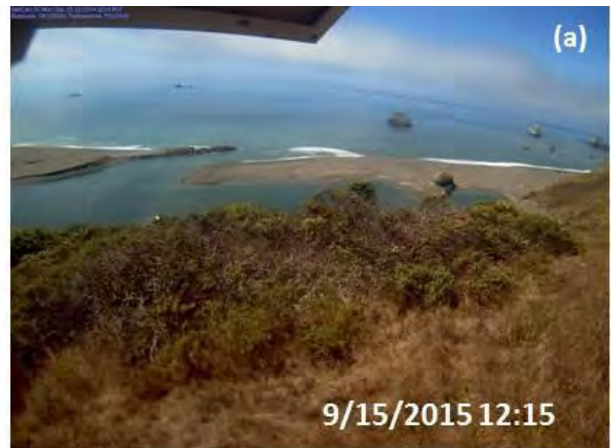
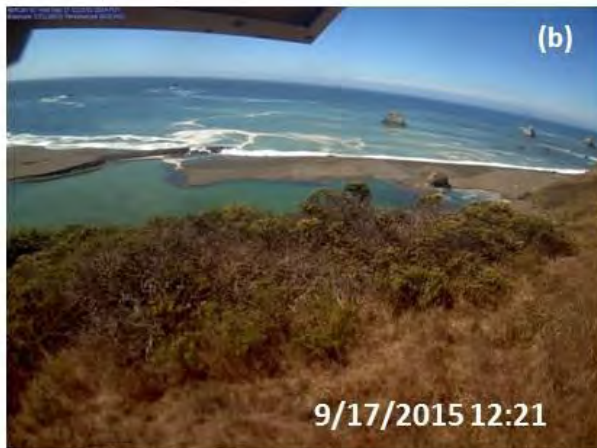
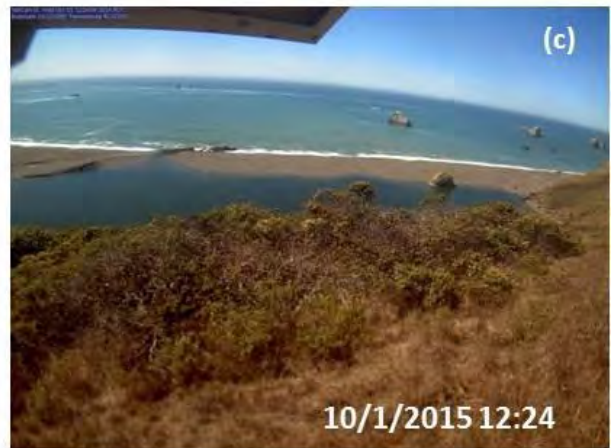
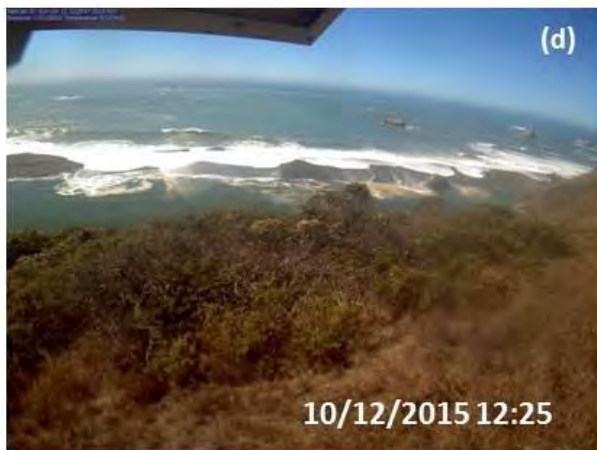
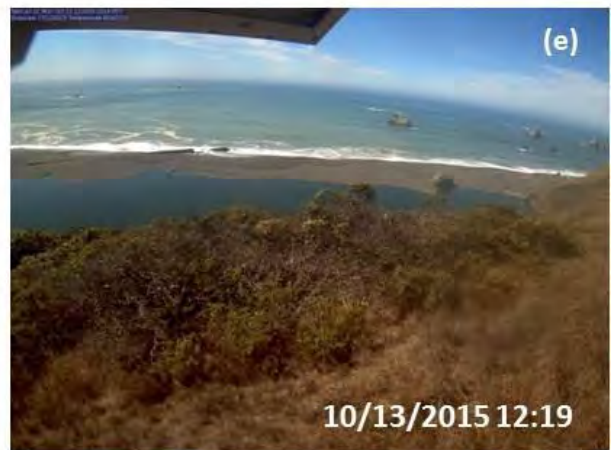
**Figure 3**

Russian River camera photographs showing some of the key morphologic influences during the September-October 2014 closure event.

40 ft. Nearshore waves could not be estimated for the week of closure, but are likely to have played a role, since waves generally begin to increase in energy in September. Neap tide conditions were present during the week of closure, with the oceanic tide range measured at approximately 4 feet (Figure 2c). Figure 3d shows extensive wave overwash surging over the beach berm and into the lagoon.

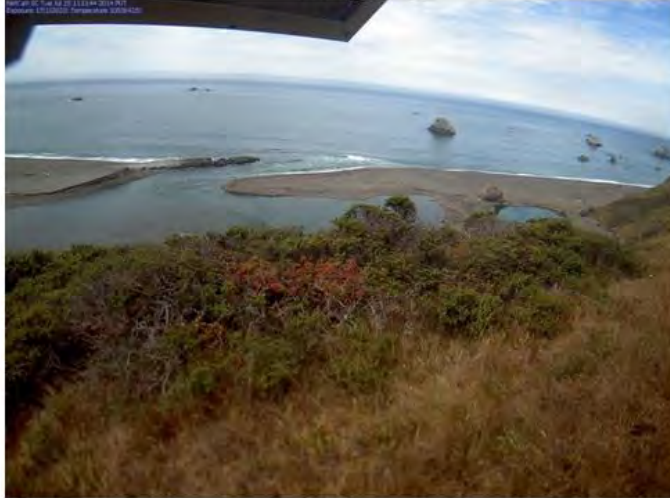
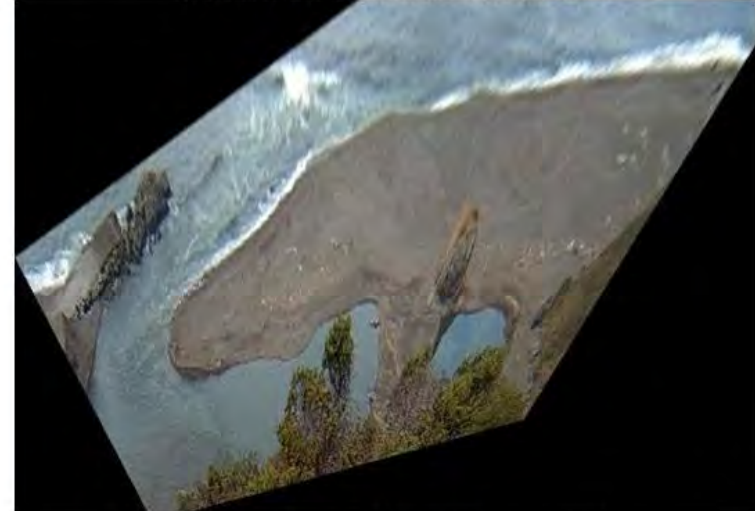
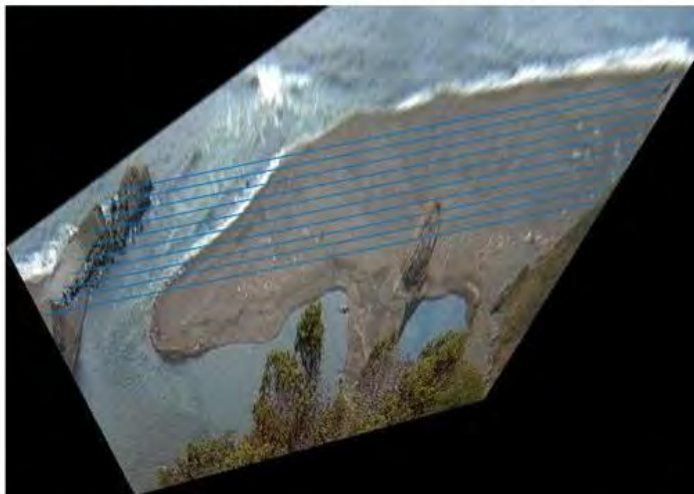
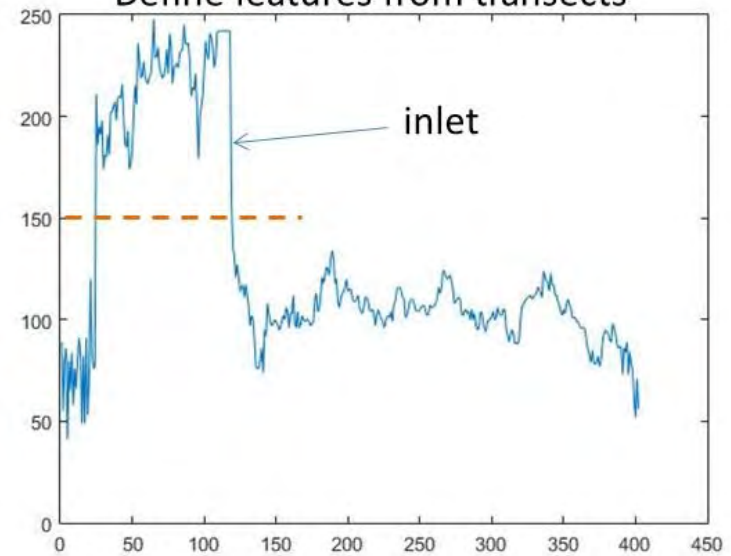
Original

Geometric transformation

Processing with transects

Define features from transects
