**RUSSIAN RIVER ESTUARY OUTLET CHANNEL  
ADAPTIVE MANAGEMENT PLAN  
2017**

Sonoma County Water Agency

ESA

May 30, 2017

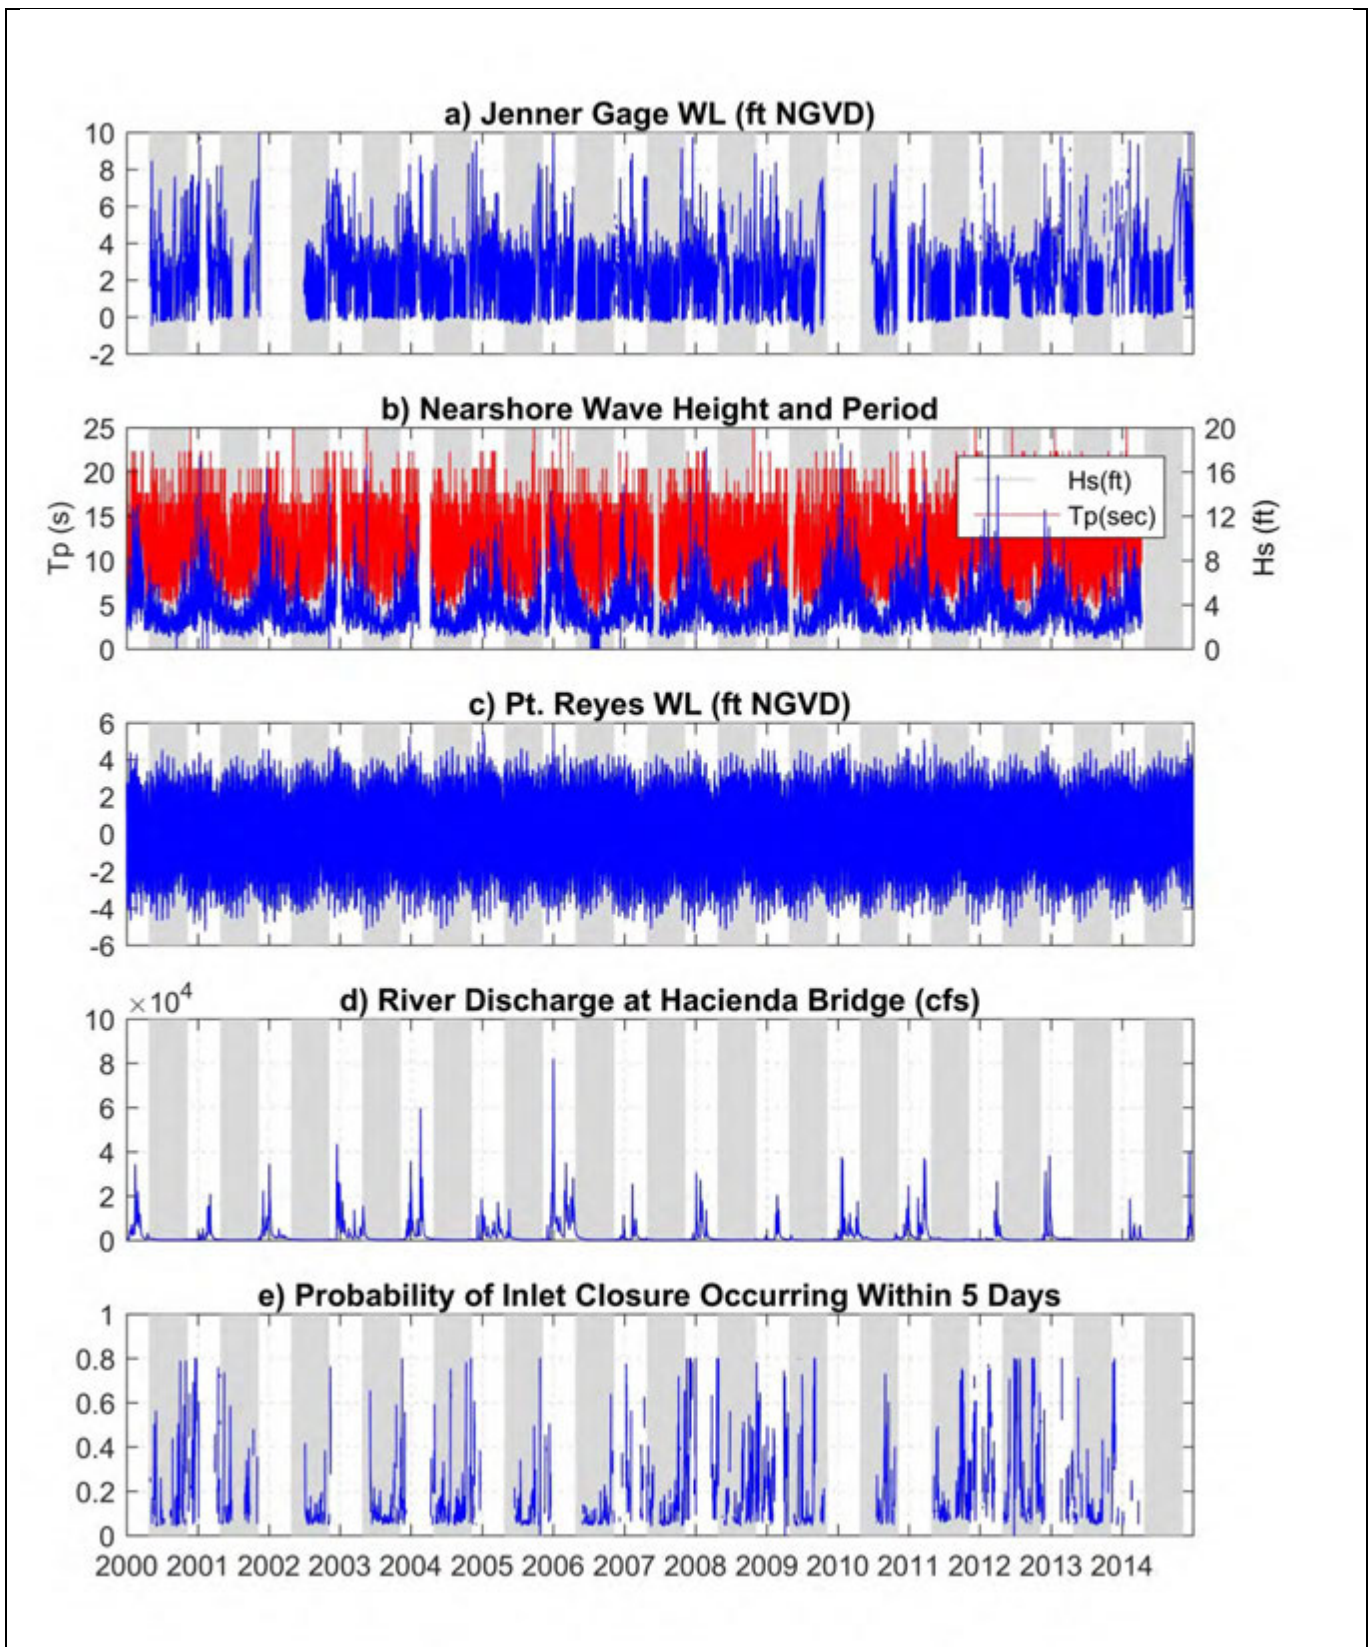
**Figure 3**  
 Estuary, Ocean, and River Conditions Compared  
 with Closure Probability:  
 2000-2014.

- a) Jenner gage water level provided by SCWA; red bar = beach survey
- b)  $H_s$  = sig. wave height;  $T_p$ =peak wave period (CDIP, Pt. Reyes, #029)
- c) Ocean water level provided by NOAA (Pt. Reyes #9415020)
- d) River discharge provided by USGS (Guerneville #11467000)
- e) Five-day closure probability provided after Behrens et al. (2013)

NOTE: grey bands represent management period of May 15-October 15

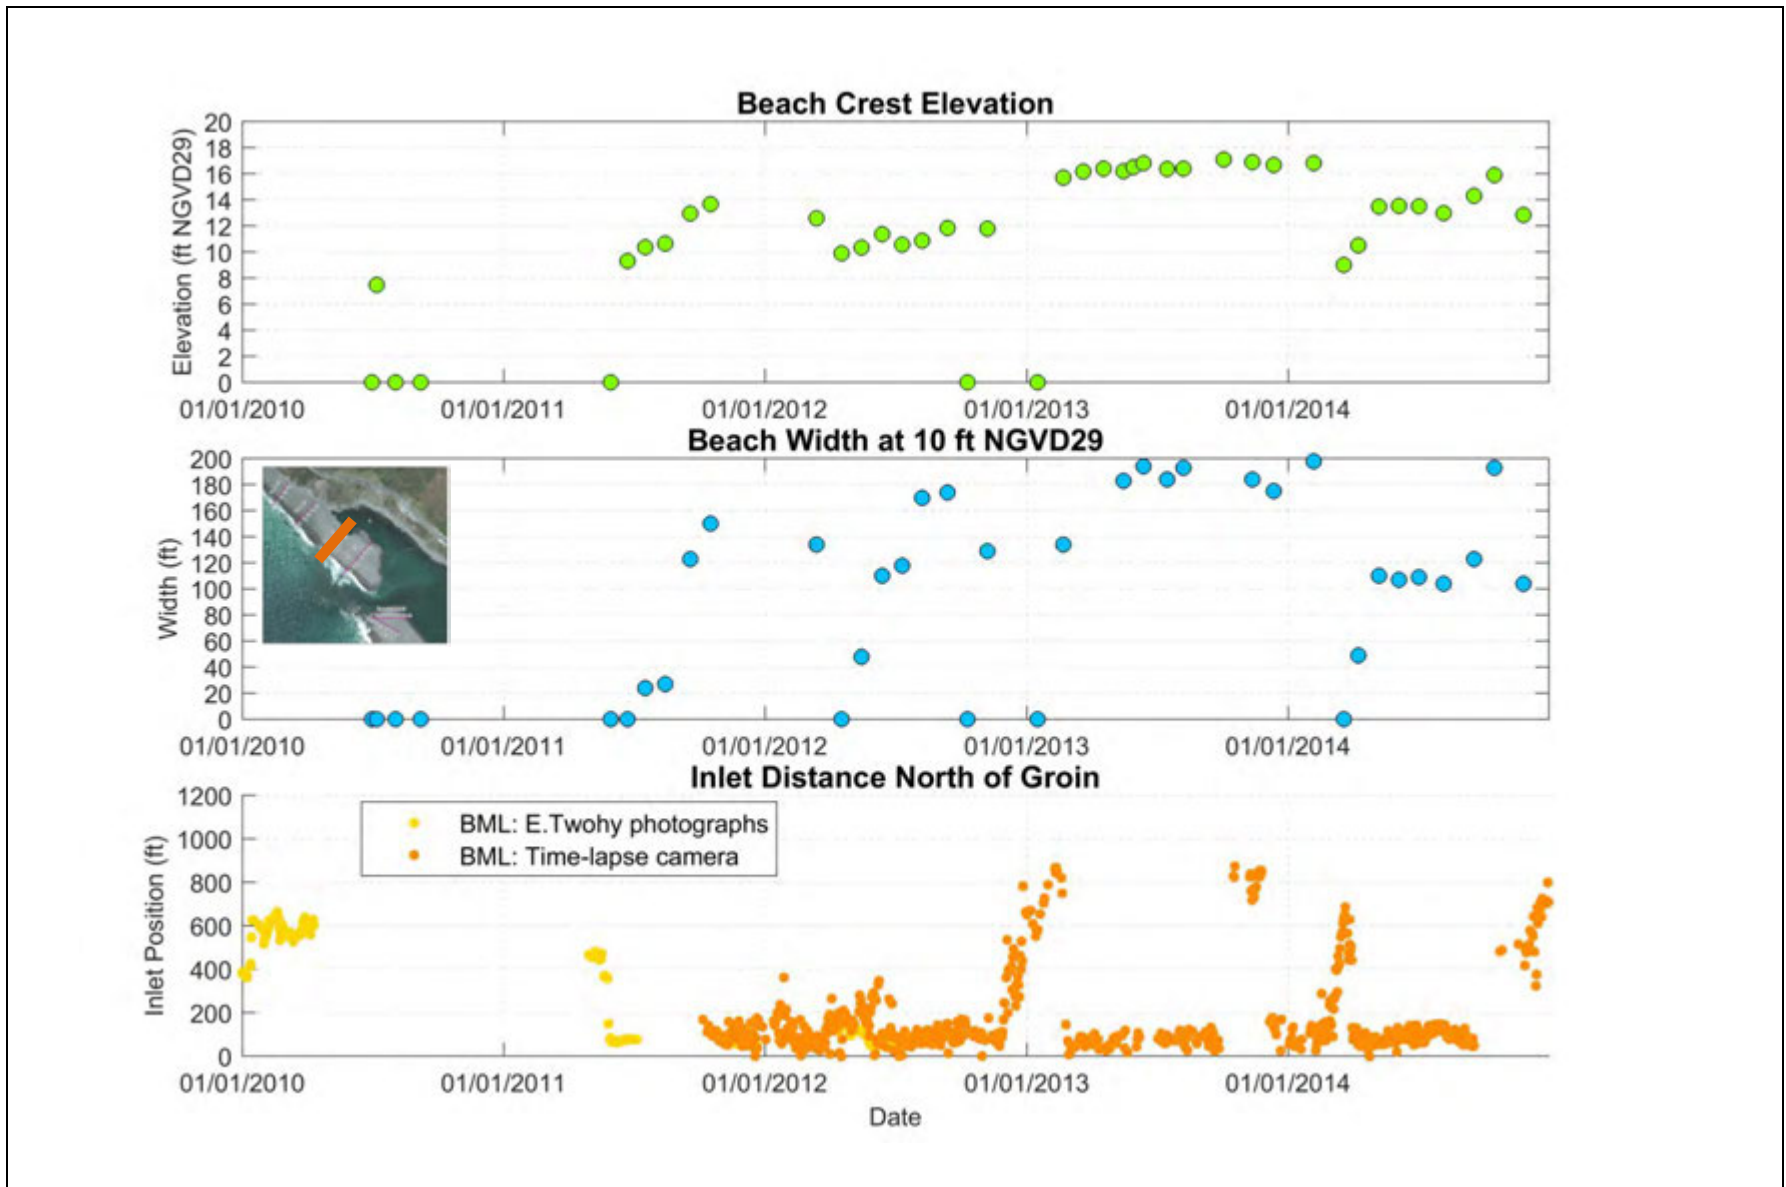
**Figure 7**  
 Summary of **(top)** monthly beach crest and **(middle)** beach width at Transect 2, measured from Water Agency surveys, compared with **(bottom)** Mouth position.

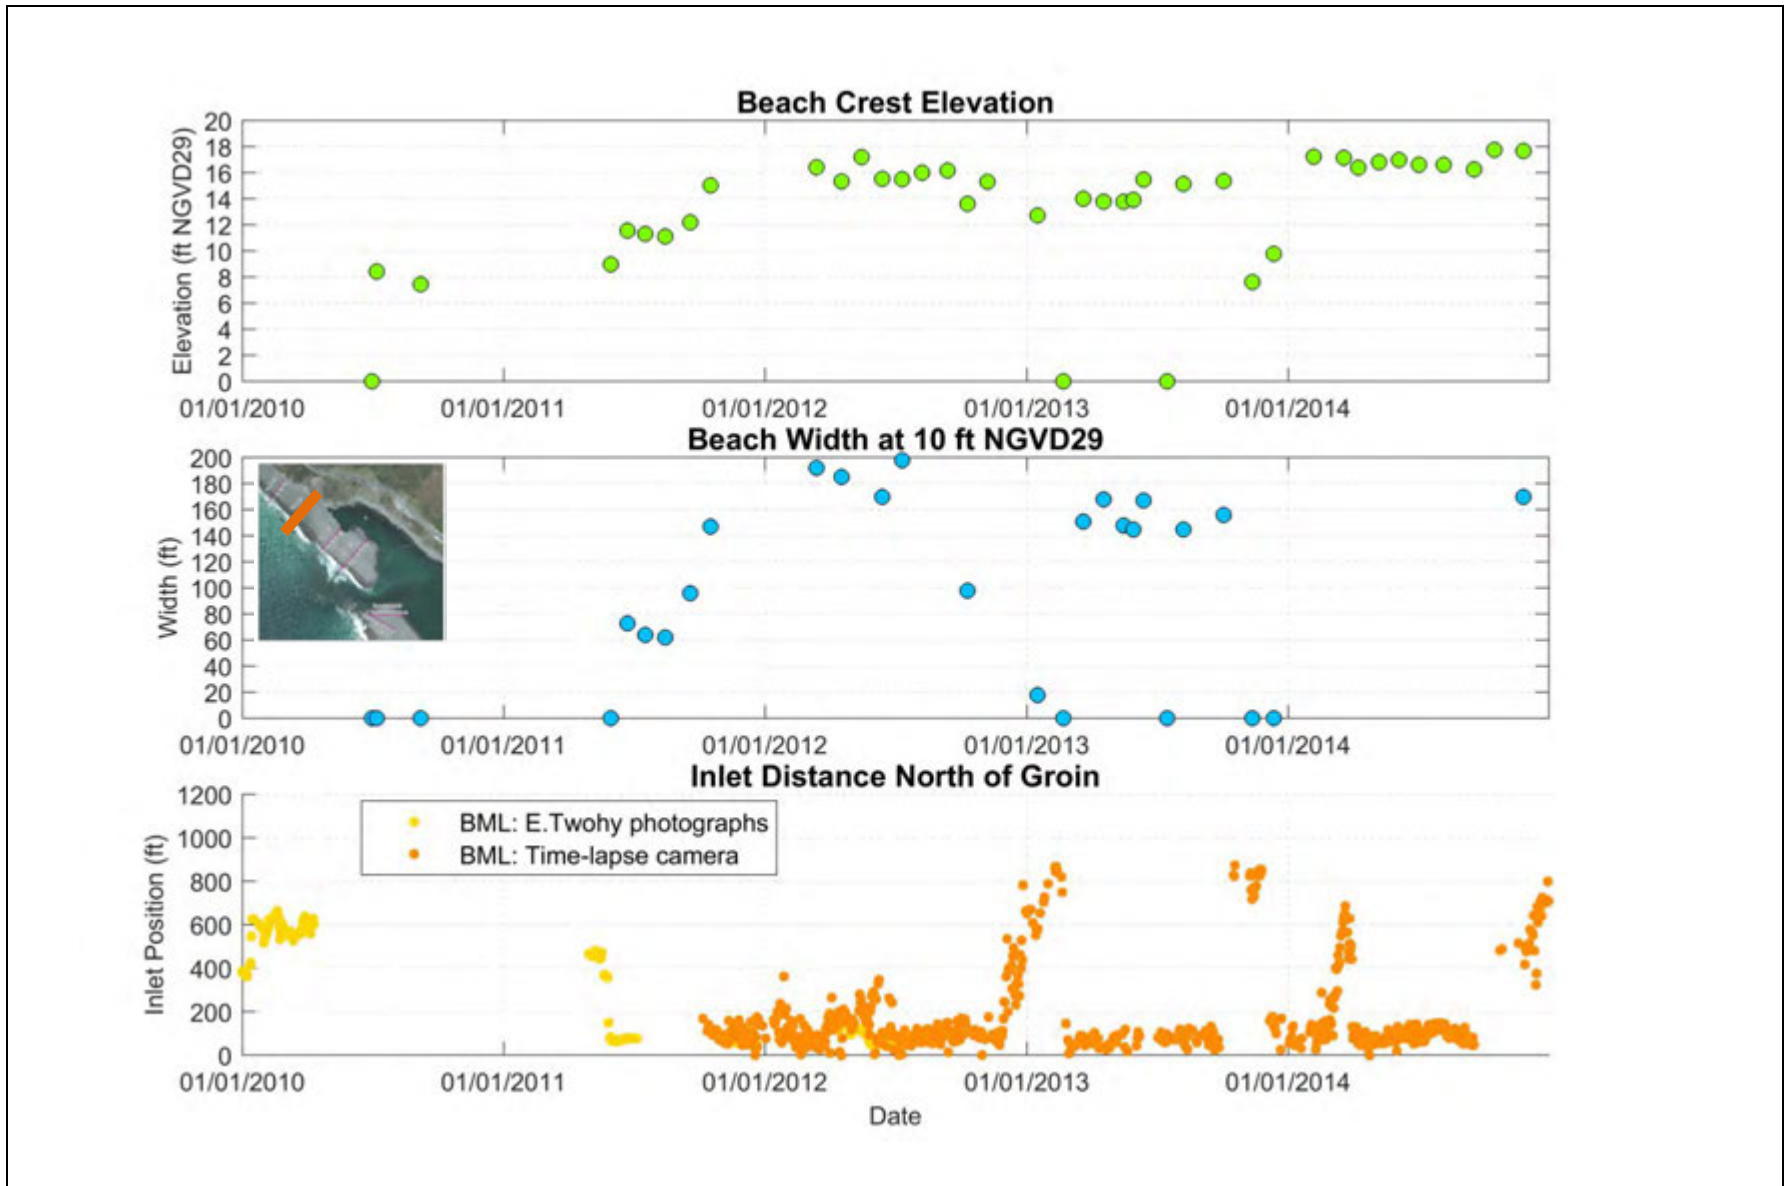
**Figure 8**  
 Summary of **(top)** monthly beach crest and **(middle)** beach width at Transect 3, measured from Water Agency surveys, compared with **(bottom)** Mouth position.

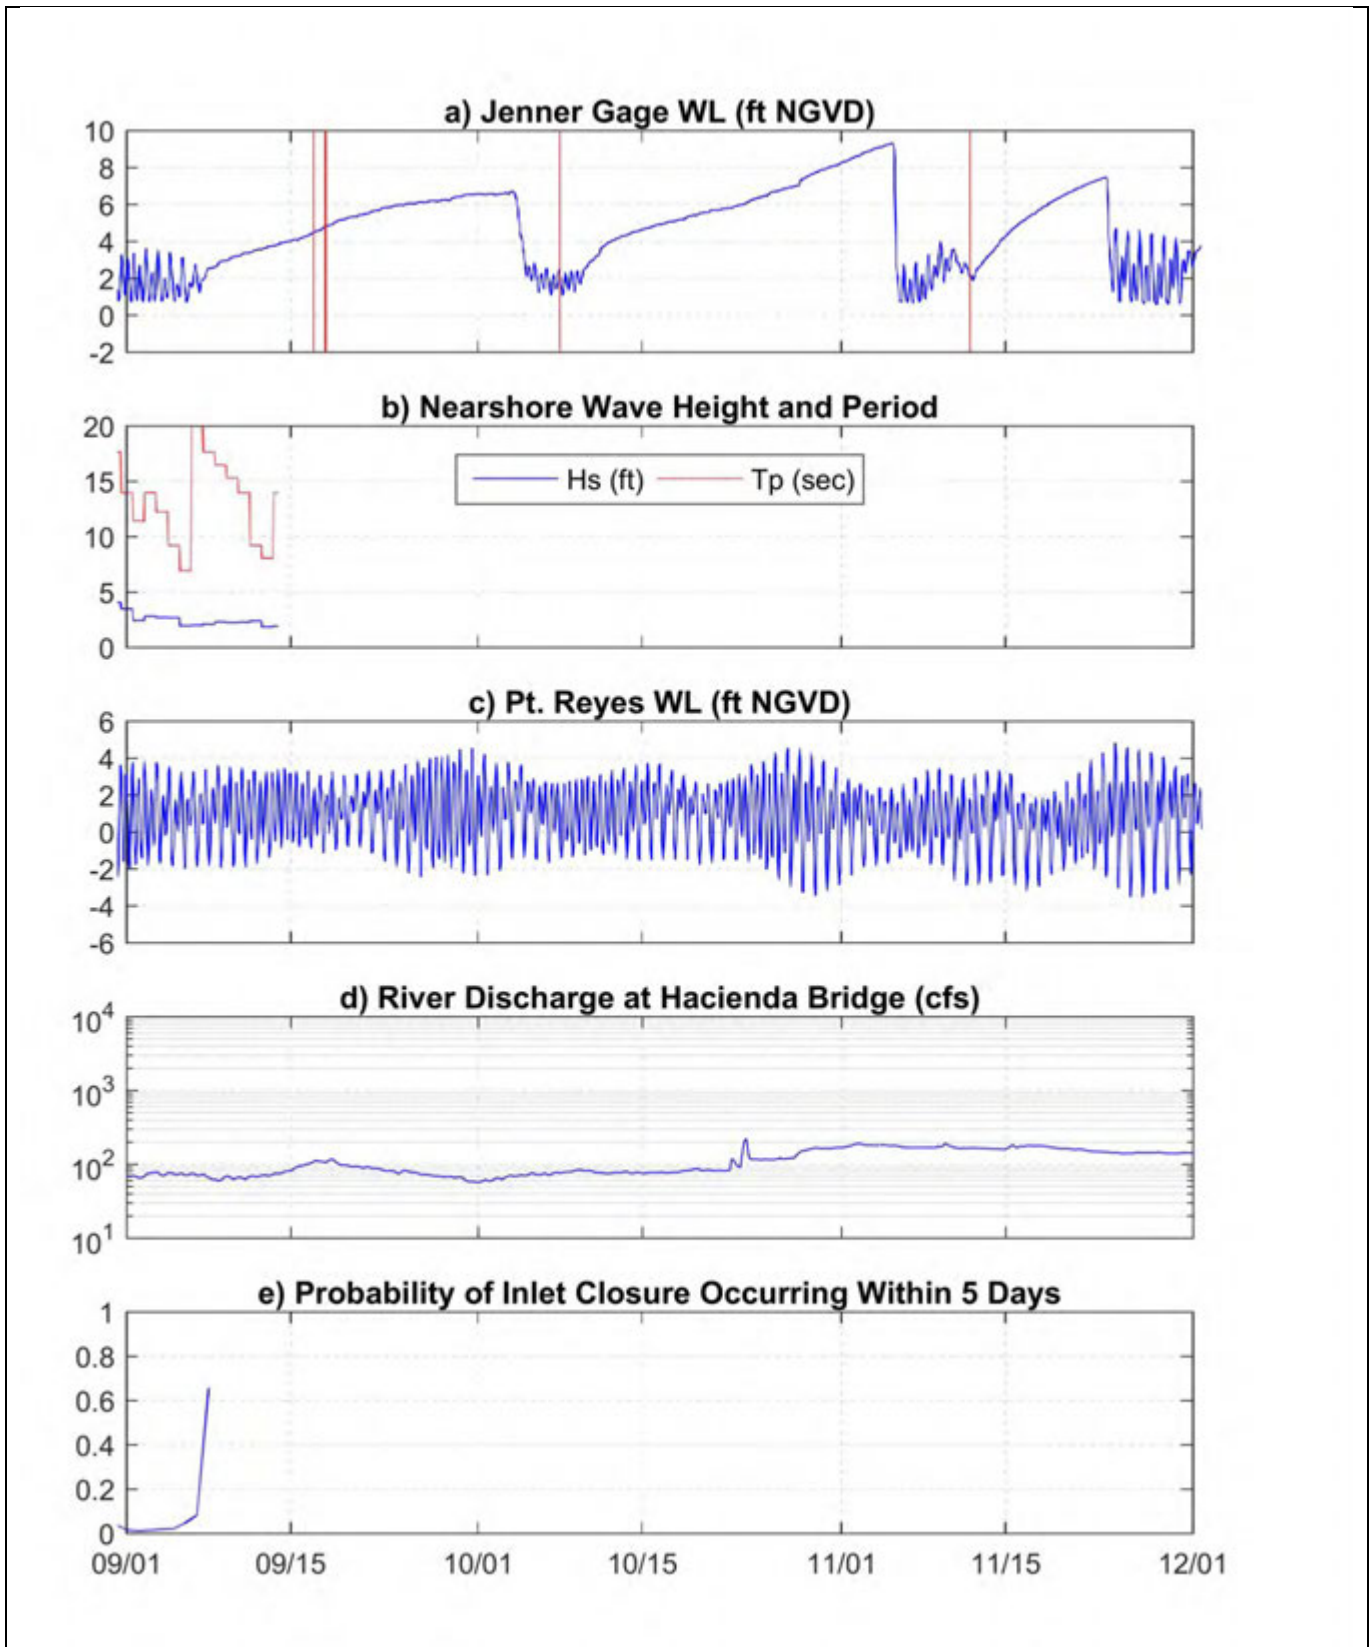
**Figure 1**  
 Estuary, Ocean, and River Conditions Compared  
 with Closure Probability:  
 April – November 2015

- a) Jenner gage water level provided by SCWA; red bar = beach survey
- b)  $H_s$  = sig. wave height;  $T_p$  = peak wave period (CDIP, Pt. Reyes, #029)
- c) Ocean water level provided by NOAA (Pt. Reyes #9415020)
- d) River discharge provided by USGS (Guerneville #11467000)
- e) Five-day closure probability provided after Behrens et al. (2013)

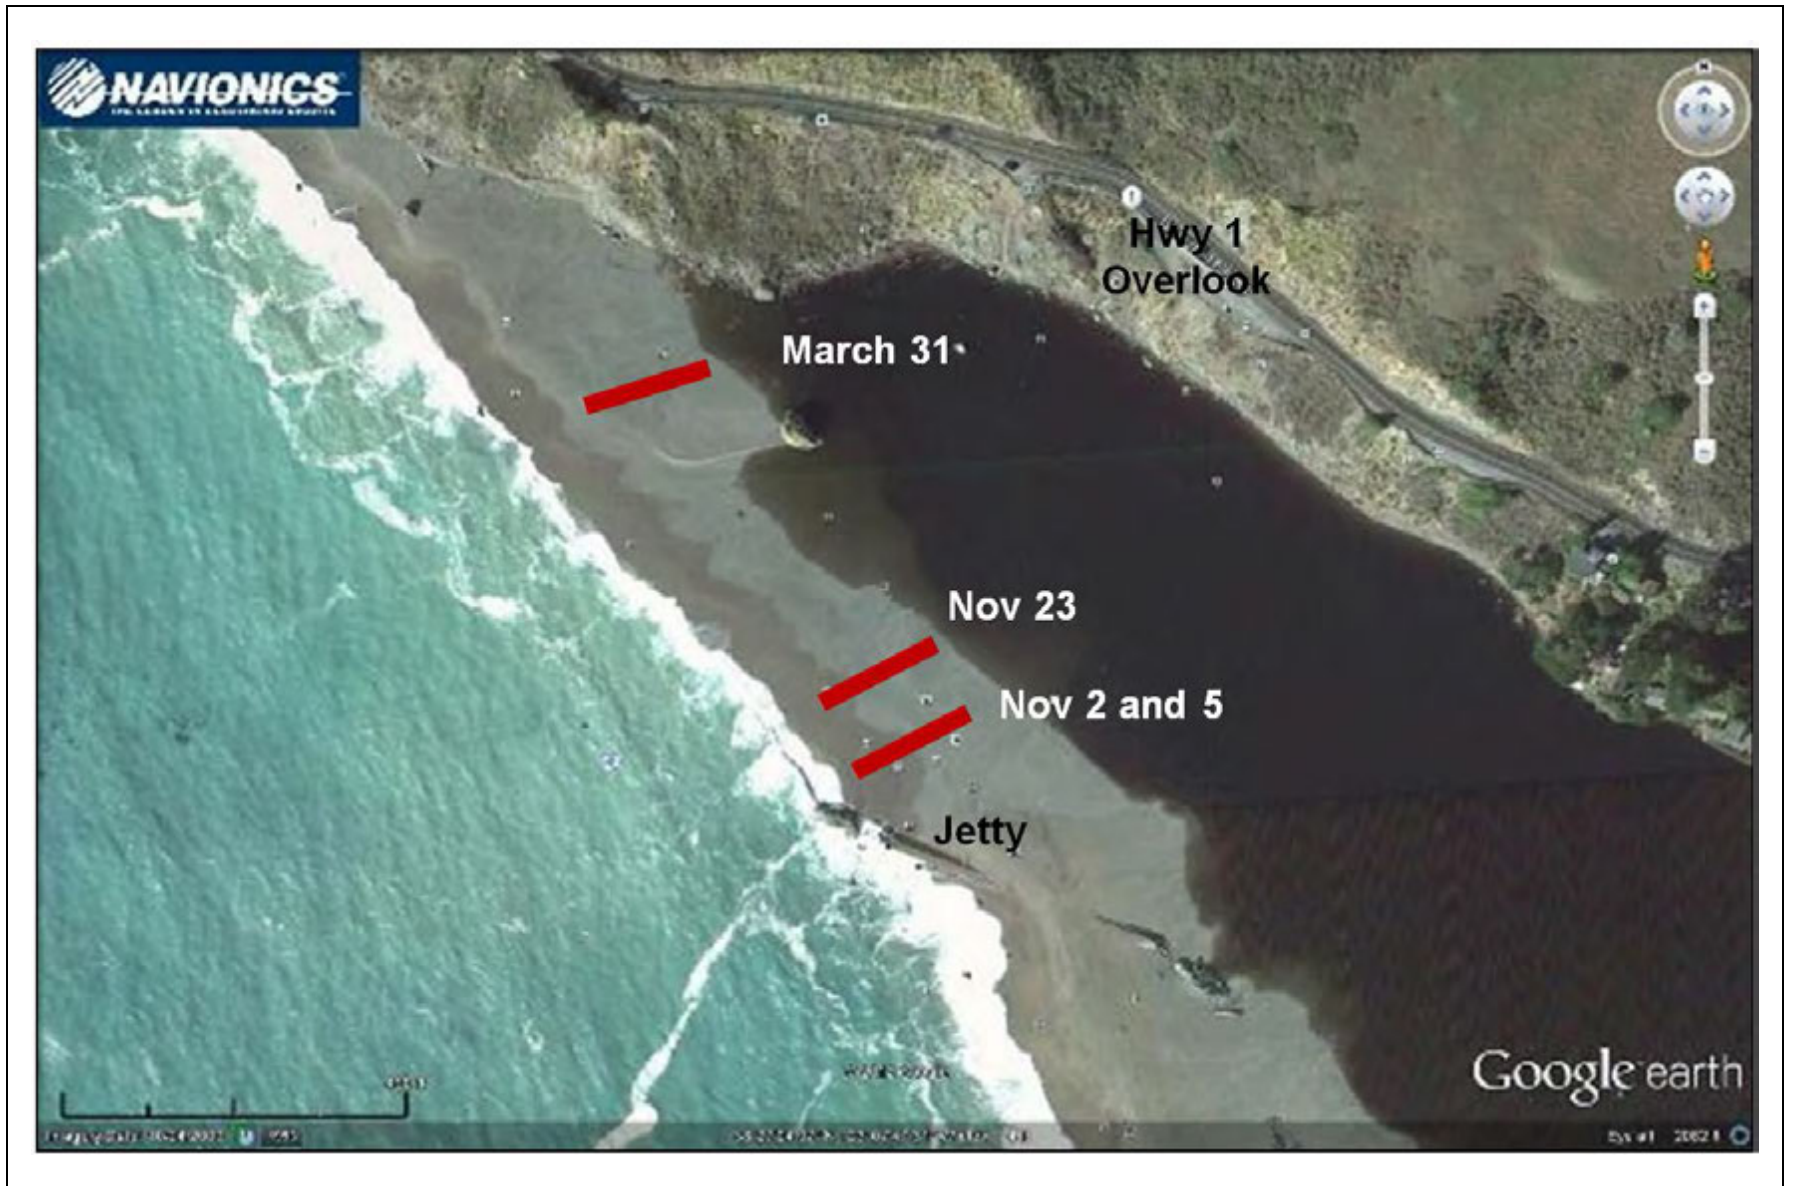
**Figure 3**  
General location of pilot channel excavations for artificial breaching

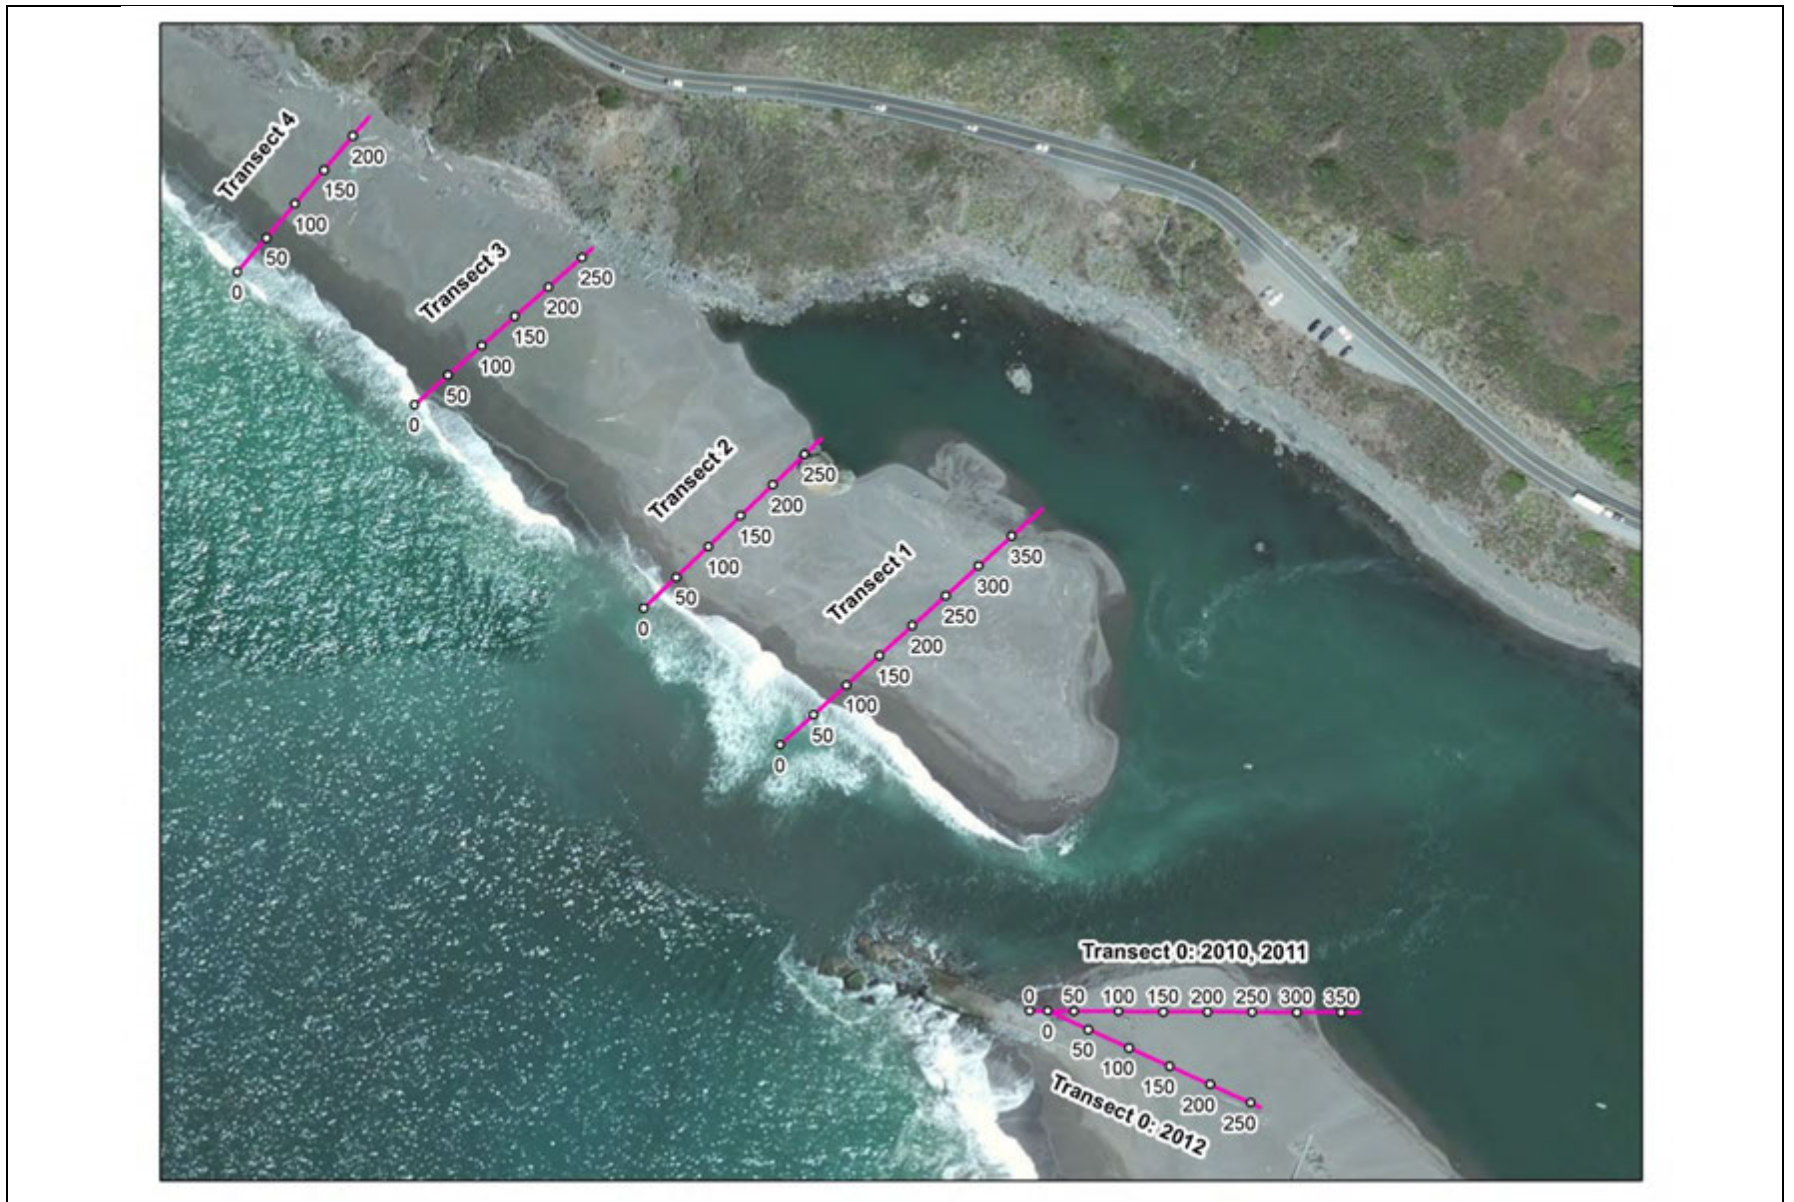
**Figure 5**

Russian River camera photographs showing some of the key morphologic influences during the September-October 2015 closure event.

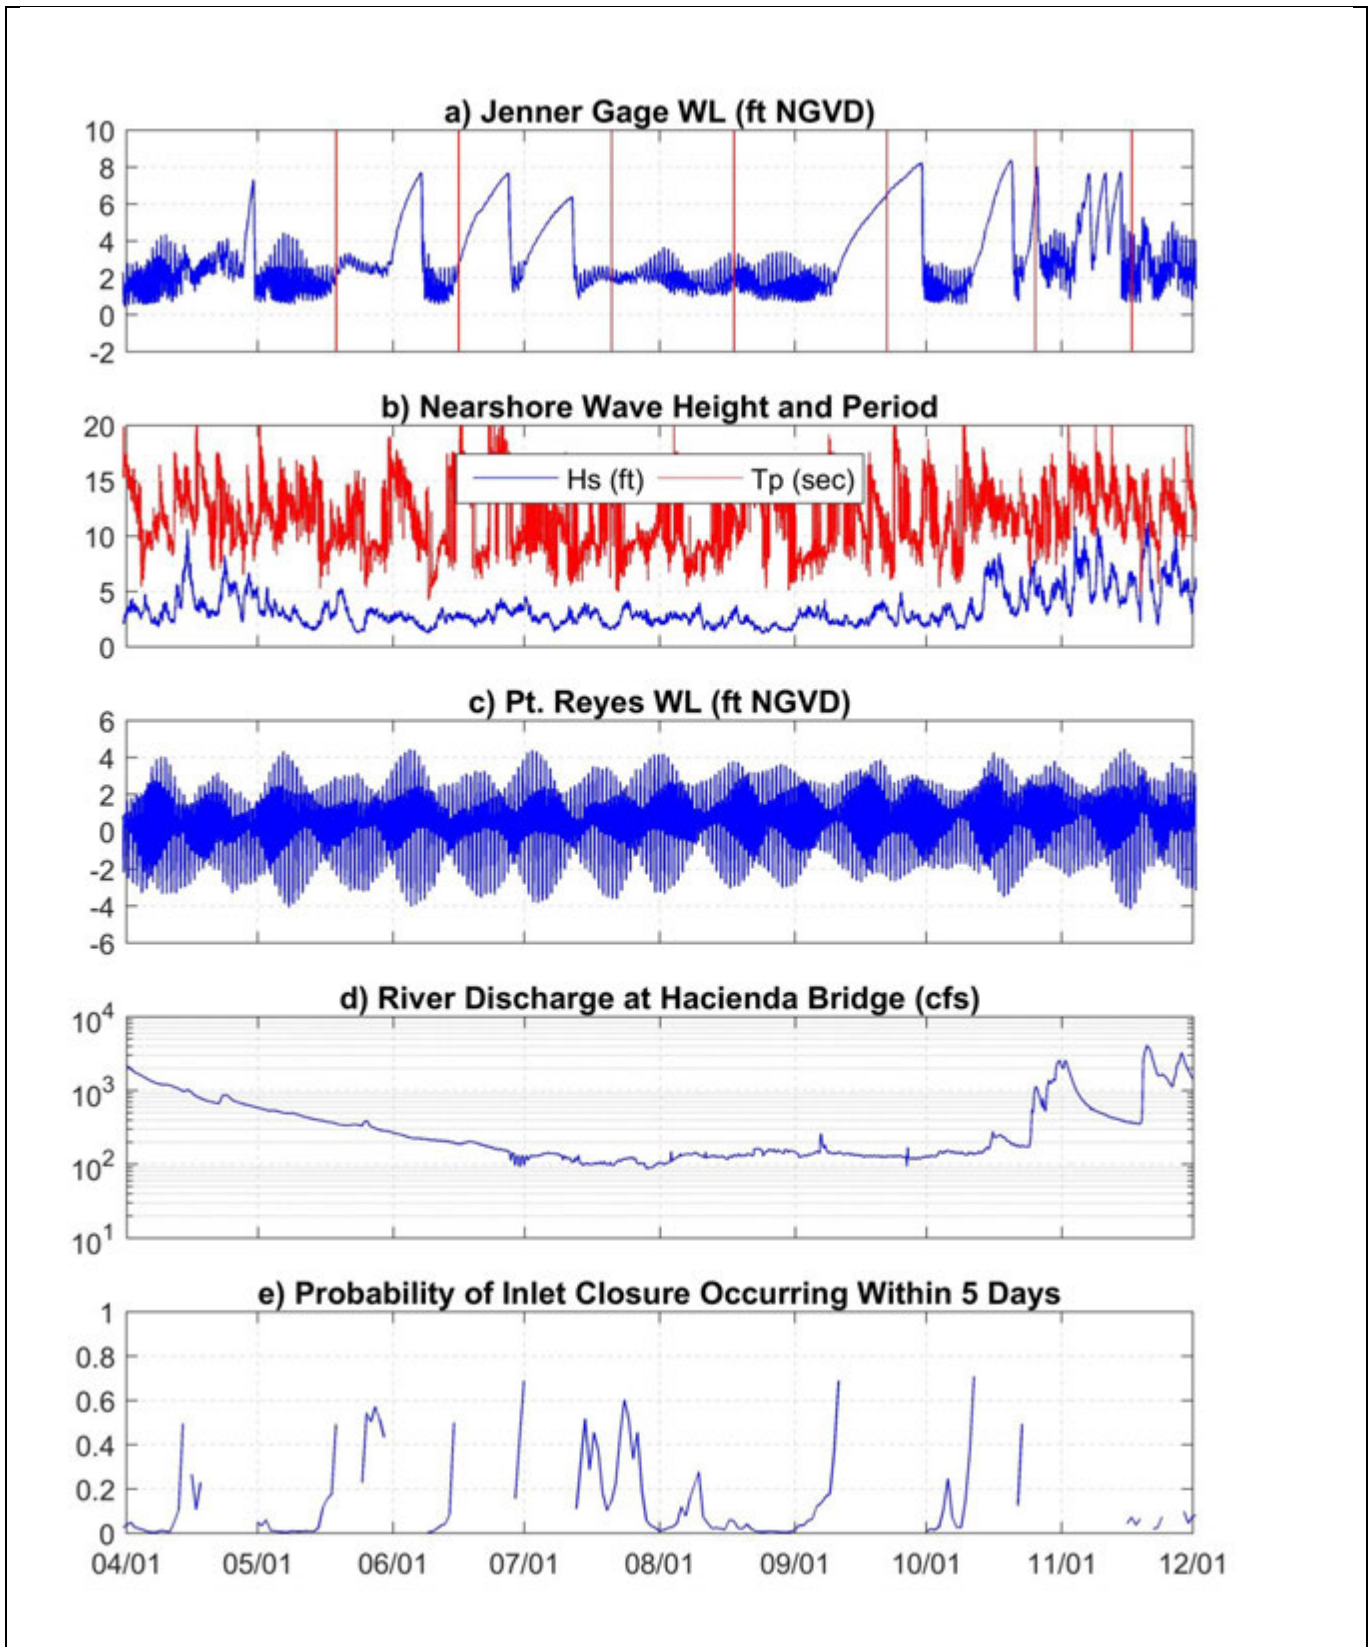
**Figure 1**  
 Estuary, Ocean, and River Conditions Compared  
 with Closure Probability:  
 April – November 2016

- a) Jenner gage water level provided by SCWA; red bar = beach survey
- b)  $H_s$  = sig. wave height;  $T_p$ =peak wave period (CDIP, Pt. Reyes, #029)
- c) Ocean water level provided by NOAA (Pt. Reyes #9415020)
- d) River discharge provided by USGS (Guerneville #11467000)
- e) Five-day closure probability provided after Behrens et al. (2013)

Time series of estuary water levels, as well as the key forcing factors (waves, tides, and riverine discharge), are shown in Figure 1 for the entire 2016 management period. The lagoon water level time series (Figure 1a) summarizes the closure events at the beginning of the management period, as well as the subsequent tidal conditions and later closure events in fall. During the management period, Russian River flows were higher in 2016 than the previous drought years, 2013-2015. As shown in Figure 1d, flows at Guerneville did not drop to 100 cfs until the end of July, which was more than a month later than in 2015, and two months later than in 2014. In August, flows increased to just above 100 cfs and remained above that for the rest of the management period.

The 5-day closure probability, a derivative of the inlet stability parameter described above, was hindcast for 2016 according to the method described in Behrens et al. (2013). This hindcast provides an indication of the utility of the stability parameter as a prediction tool for monitoring inlet conditions and planning management action. This parameter integrates wave and ocean forcing conditions, as well as estuary water levels, to provide greater predictive skill than just waves or ocean tides on their own. The predicted probability of closure exceeded 50% 2-5 days in advance of most of the closures in 2016 (Figure 1e).

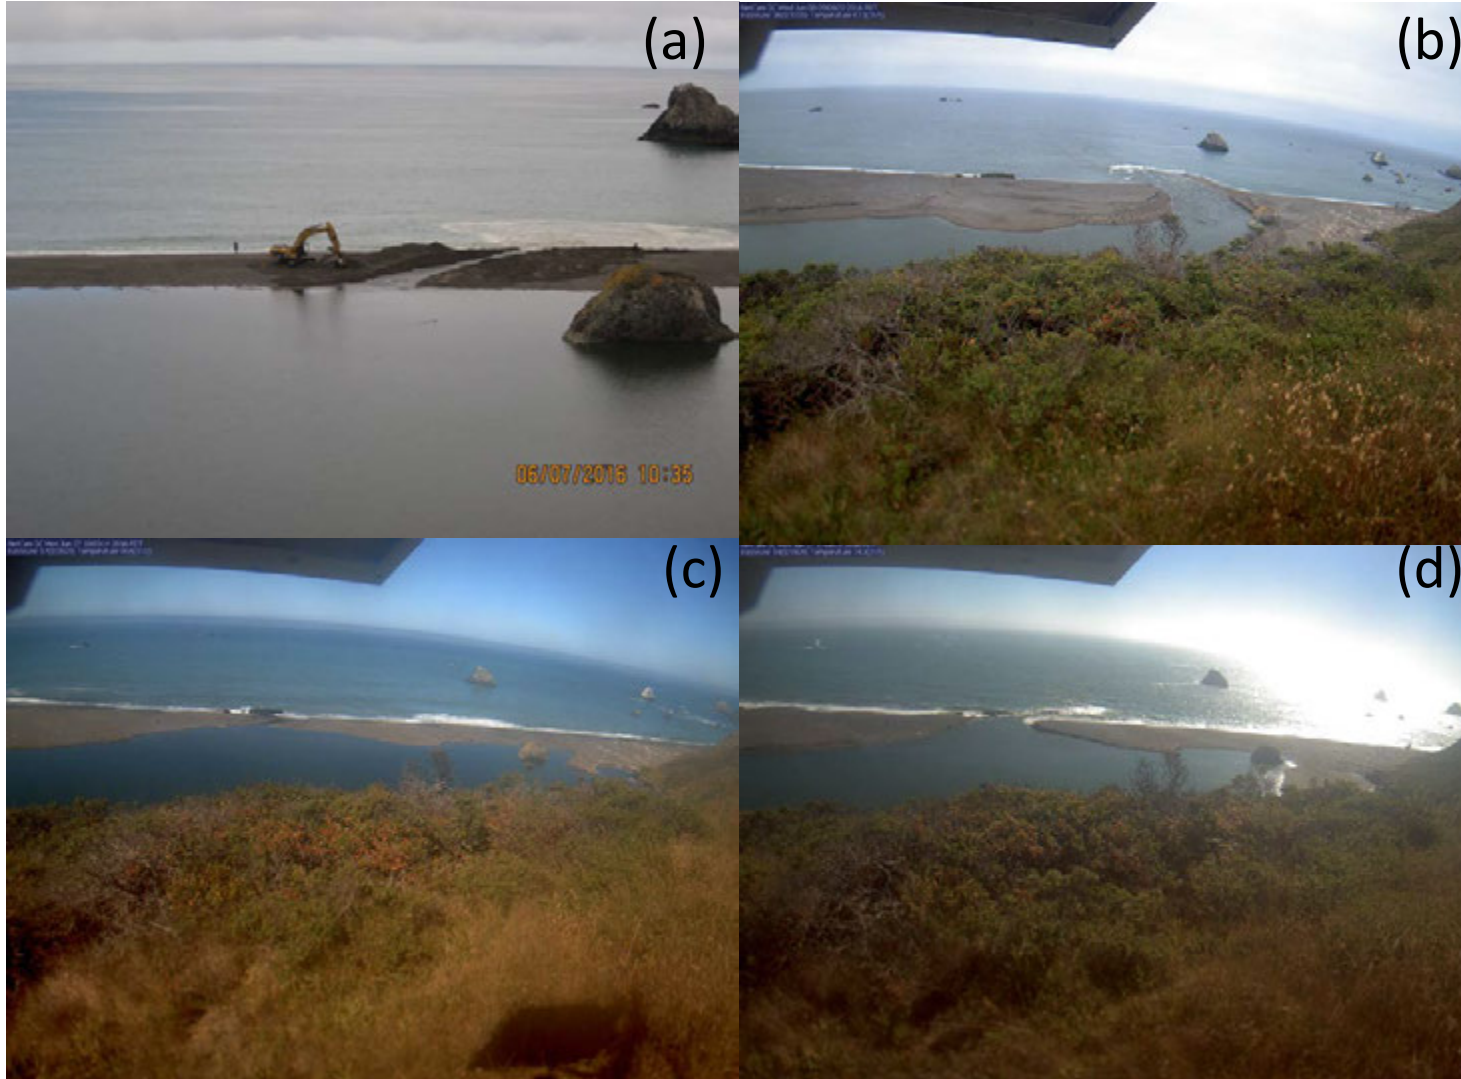
**Figure 5**

(a) Outlet channel after excavation on June 7<sup>th</sup> and (b) scoured inlet on June 8<sup>th</sup>, 2016. (c) Outlet channel after excavation on June 27<sup>th</sup> and (d) scoured inlet on June 27<sup>th</sup>.

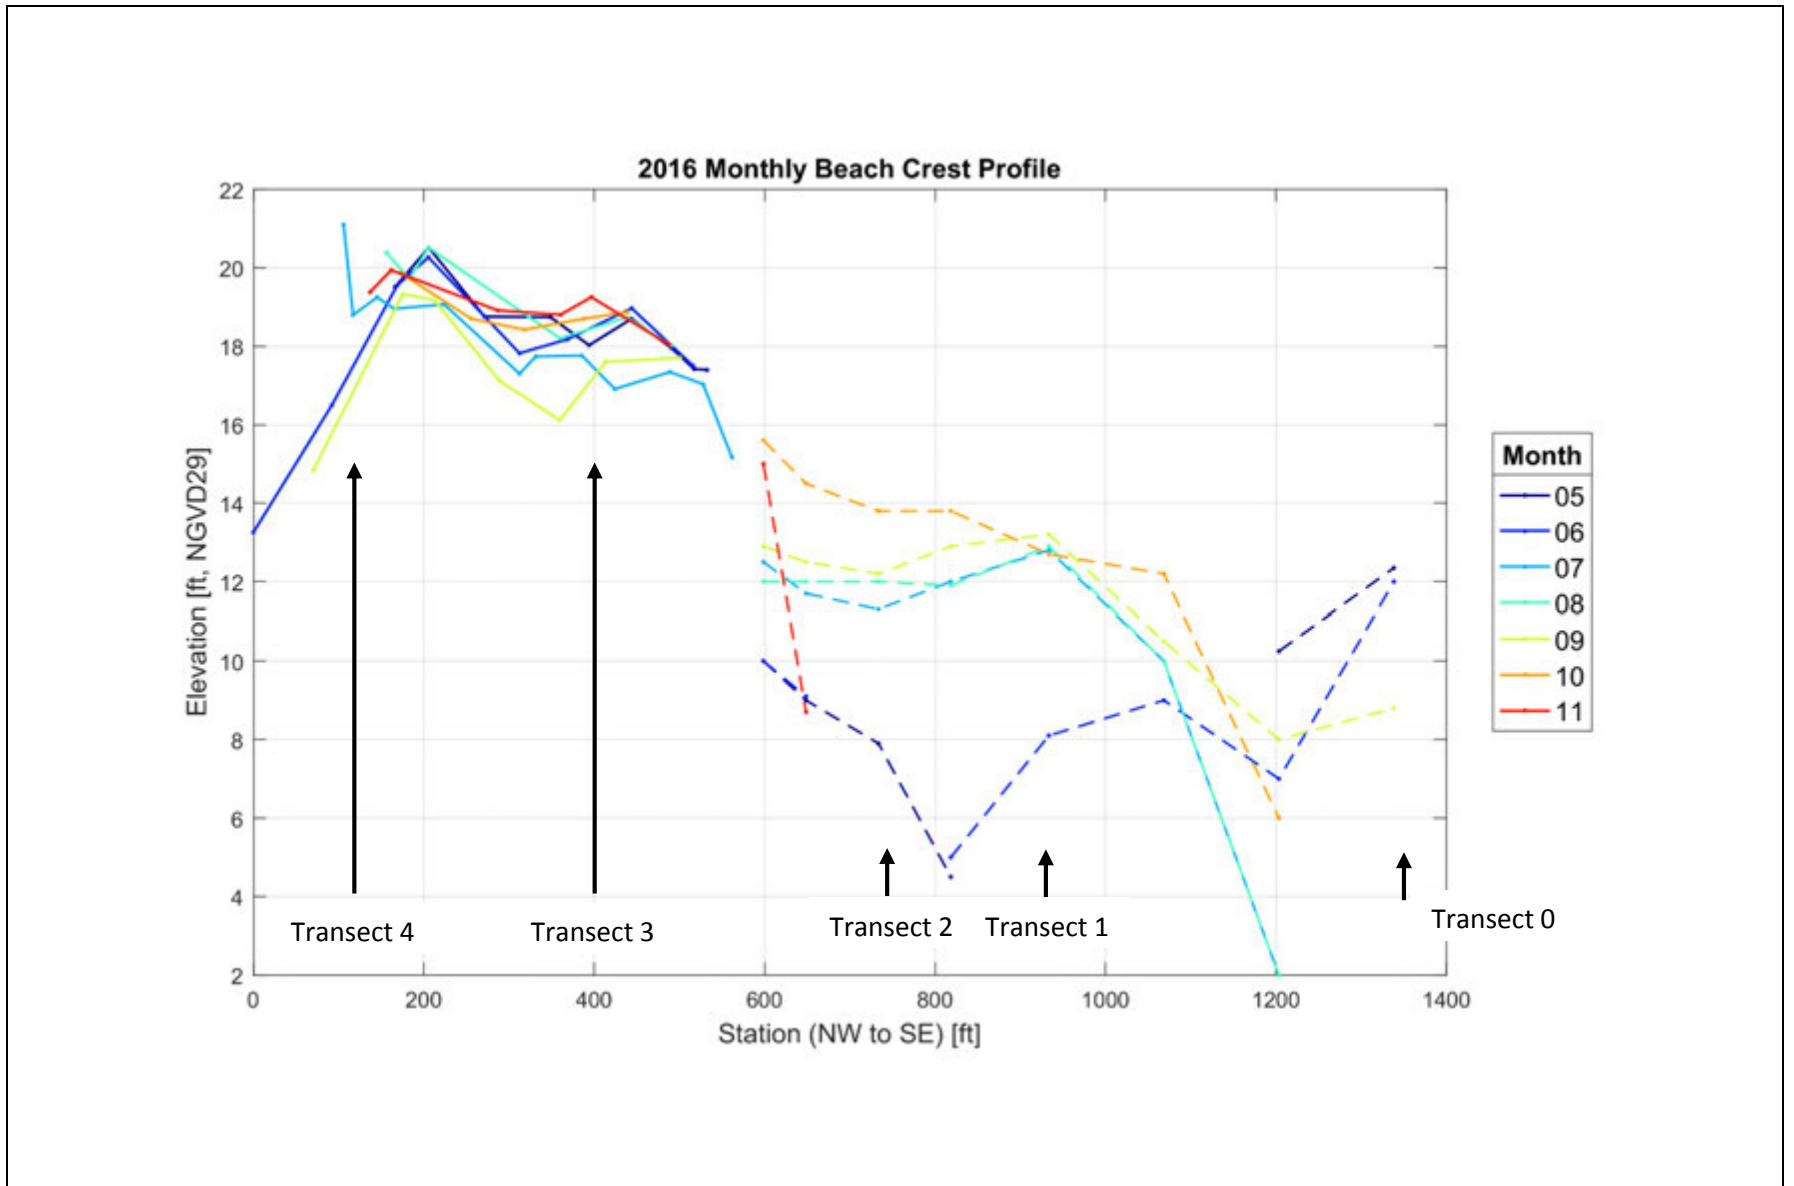
**Figure 13**  
Beach Crest Profiles During the 2016 Management Period.

Note: Solid lines are from points identified as the beach crest during the monthly survey. Dashed lines are interpolated from surveyed points on the beach.

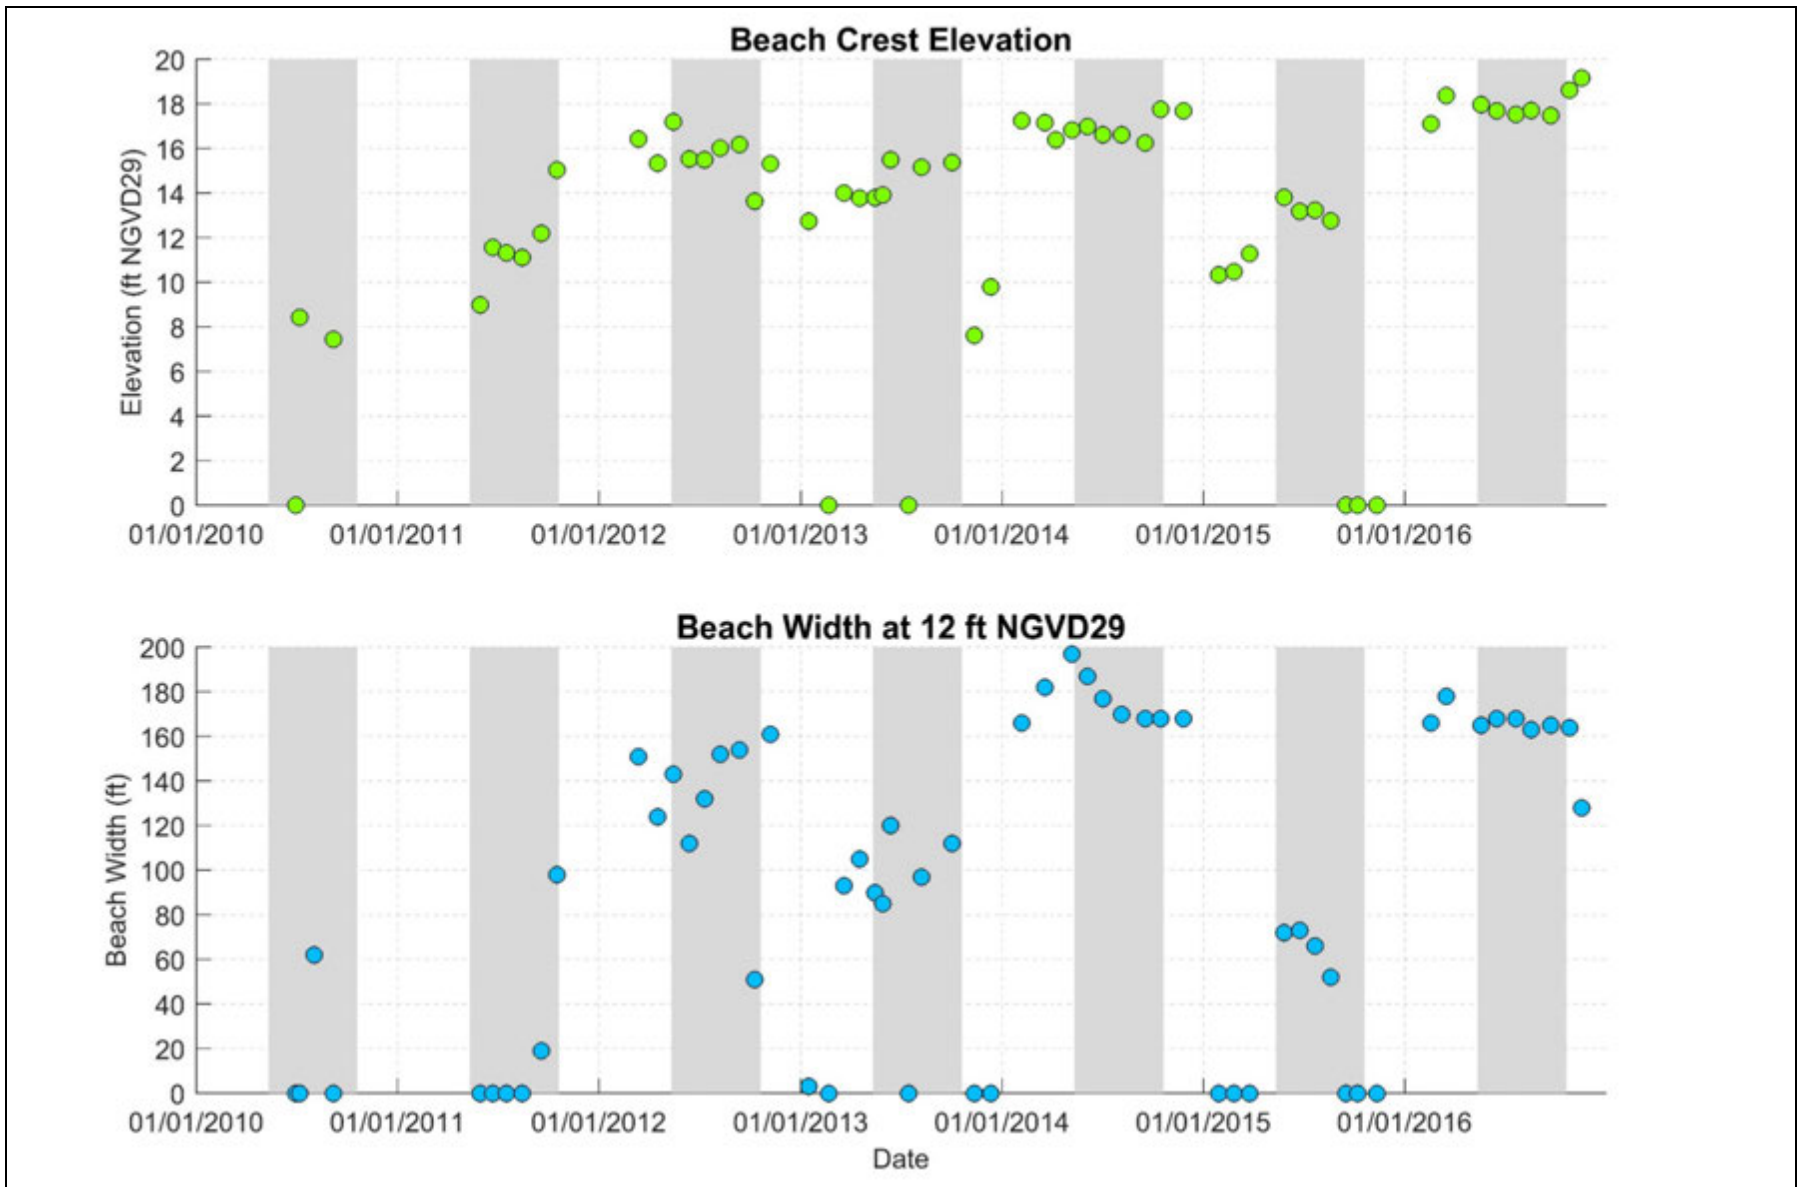
**Figure 14**

Transect 3 crest height and beach width (at 12ft NGVD elevation) from 2010 to 2016. Shaded areas represent management season.
