**RUSSIAN RIVER ESTUARY OUTLET CHANNEL  
ADAPTIVE MANAGEMENT PLAN  
2017**

Sonoma County Water Agency

ESA

May 30, 2017

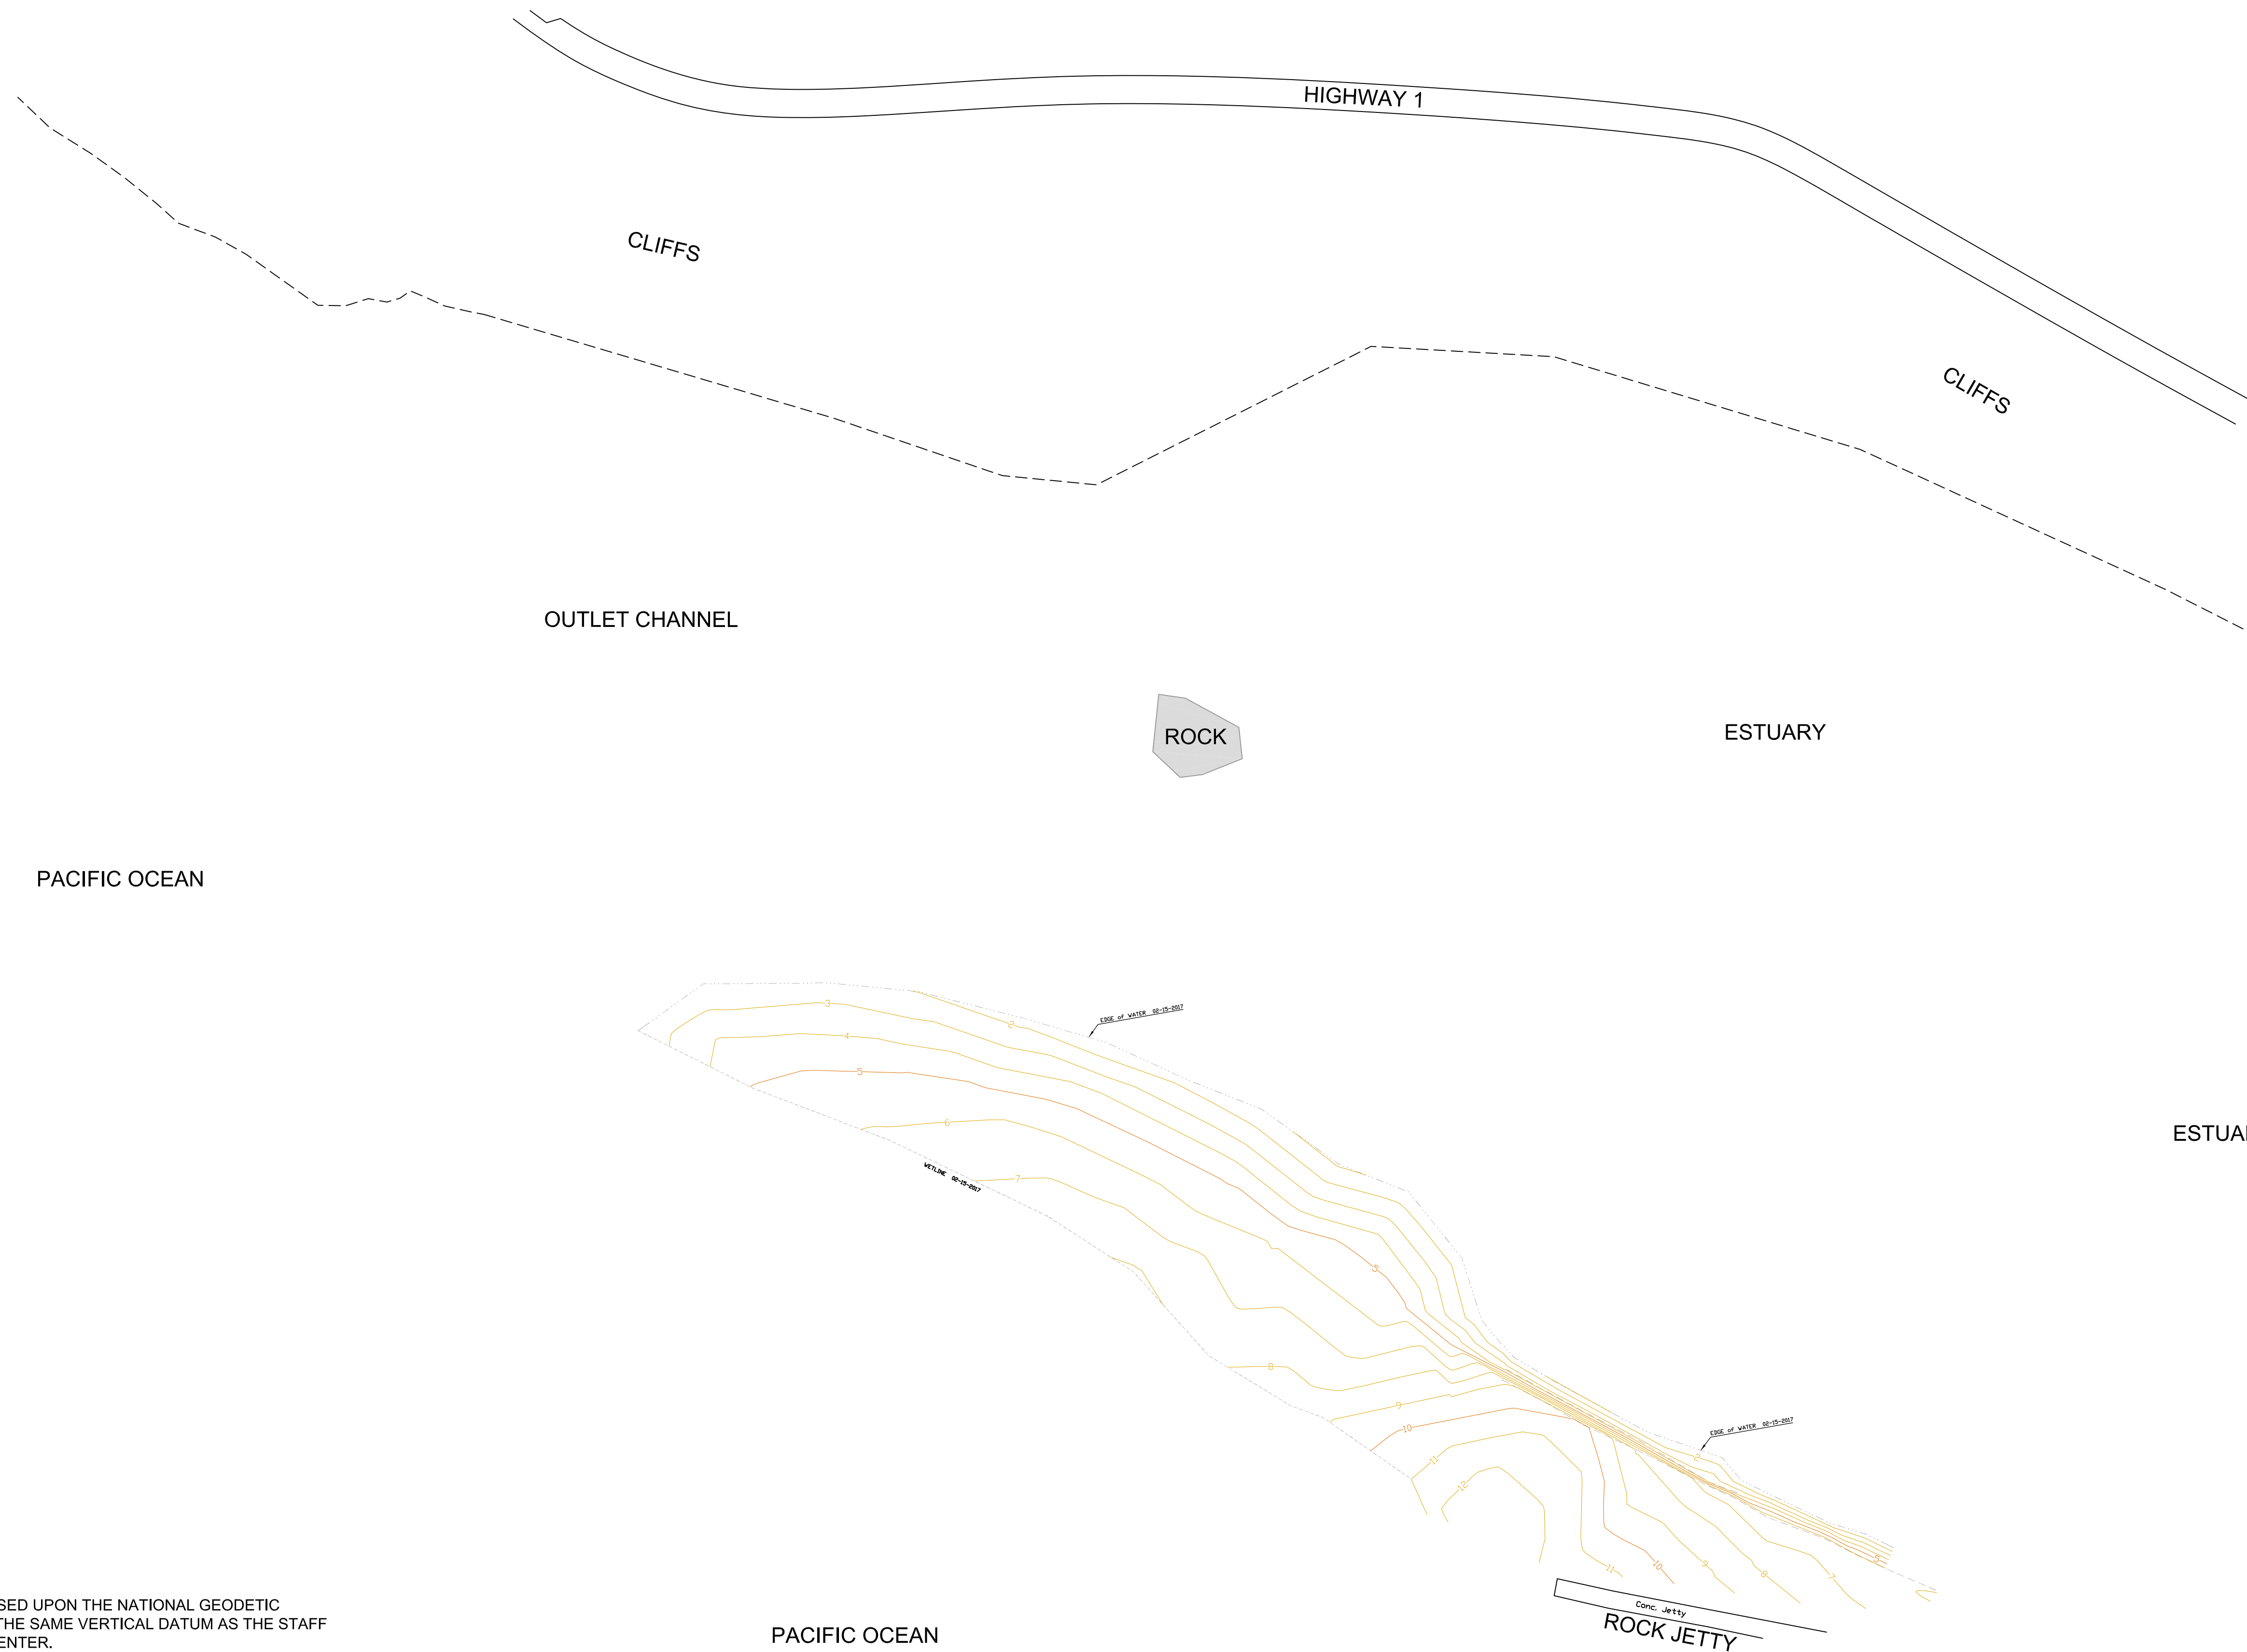
SCALE: AS NOTED	APPROVED DEPUTY CHIEF ENGR:	RUSSIAN RIVER INSTREAM FLOW RESTORATION (RRIFR) PROGRAM MONTHLY SURVEY OF BEACH TOPOGRAPHY AND OUTLET CHANNEL: Feb. 15, 2017	
				DATE: AS NOTED	SUBMITTED		
				DRAWN: EKM	DESIGNED	FILE NAME:	
				CHECKED: JRM			CONTRACT NO. XXX
NO.	DATE	BY		DRAWING NUMBER		SHEET NO. 1 OF 1

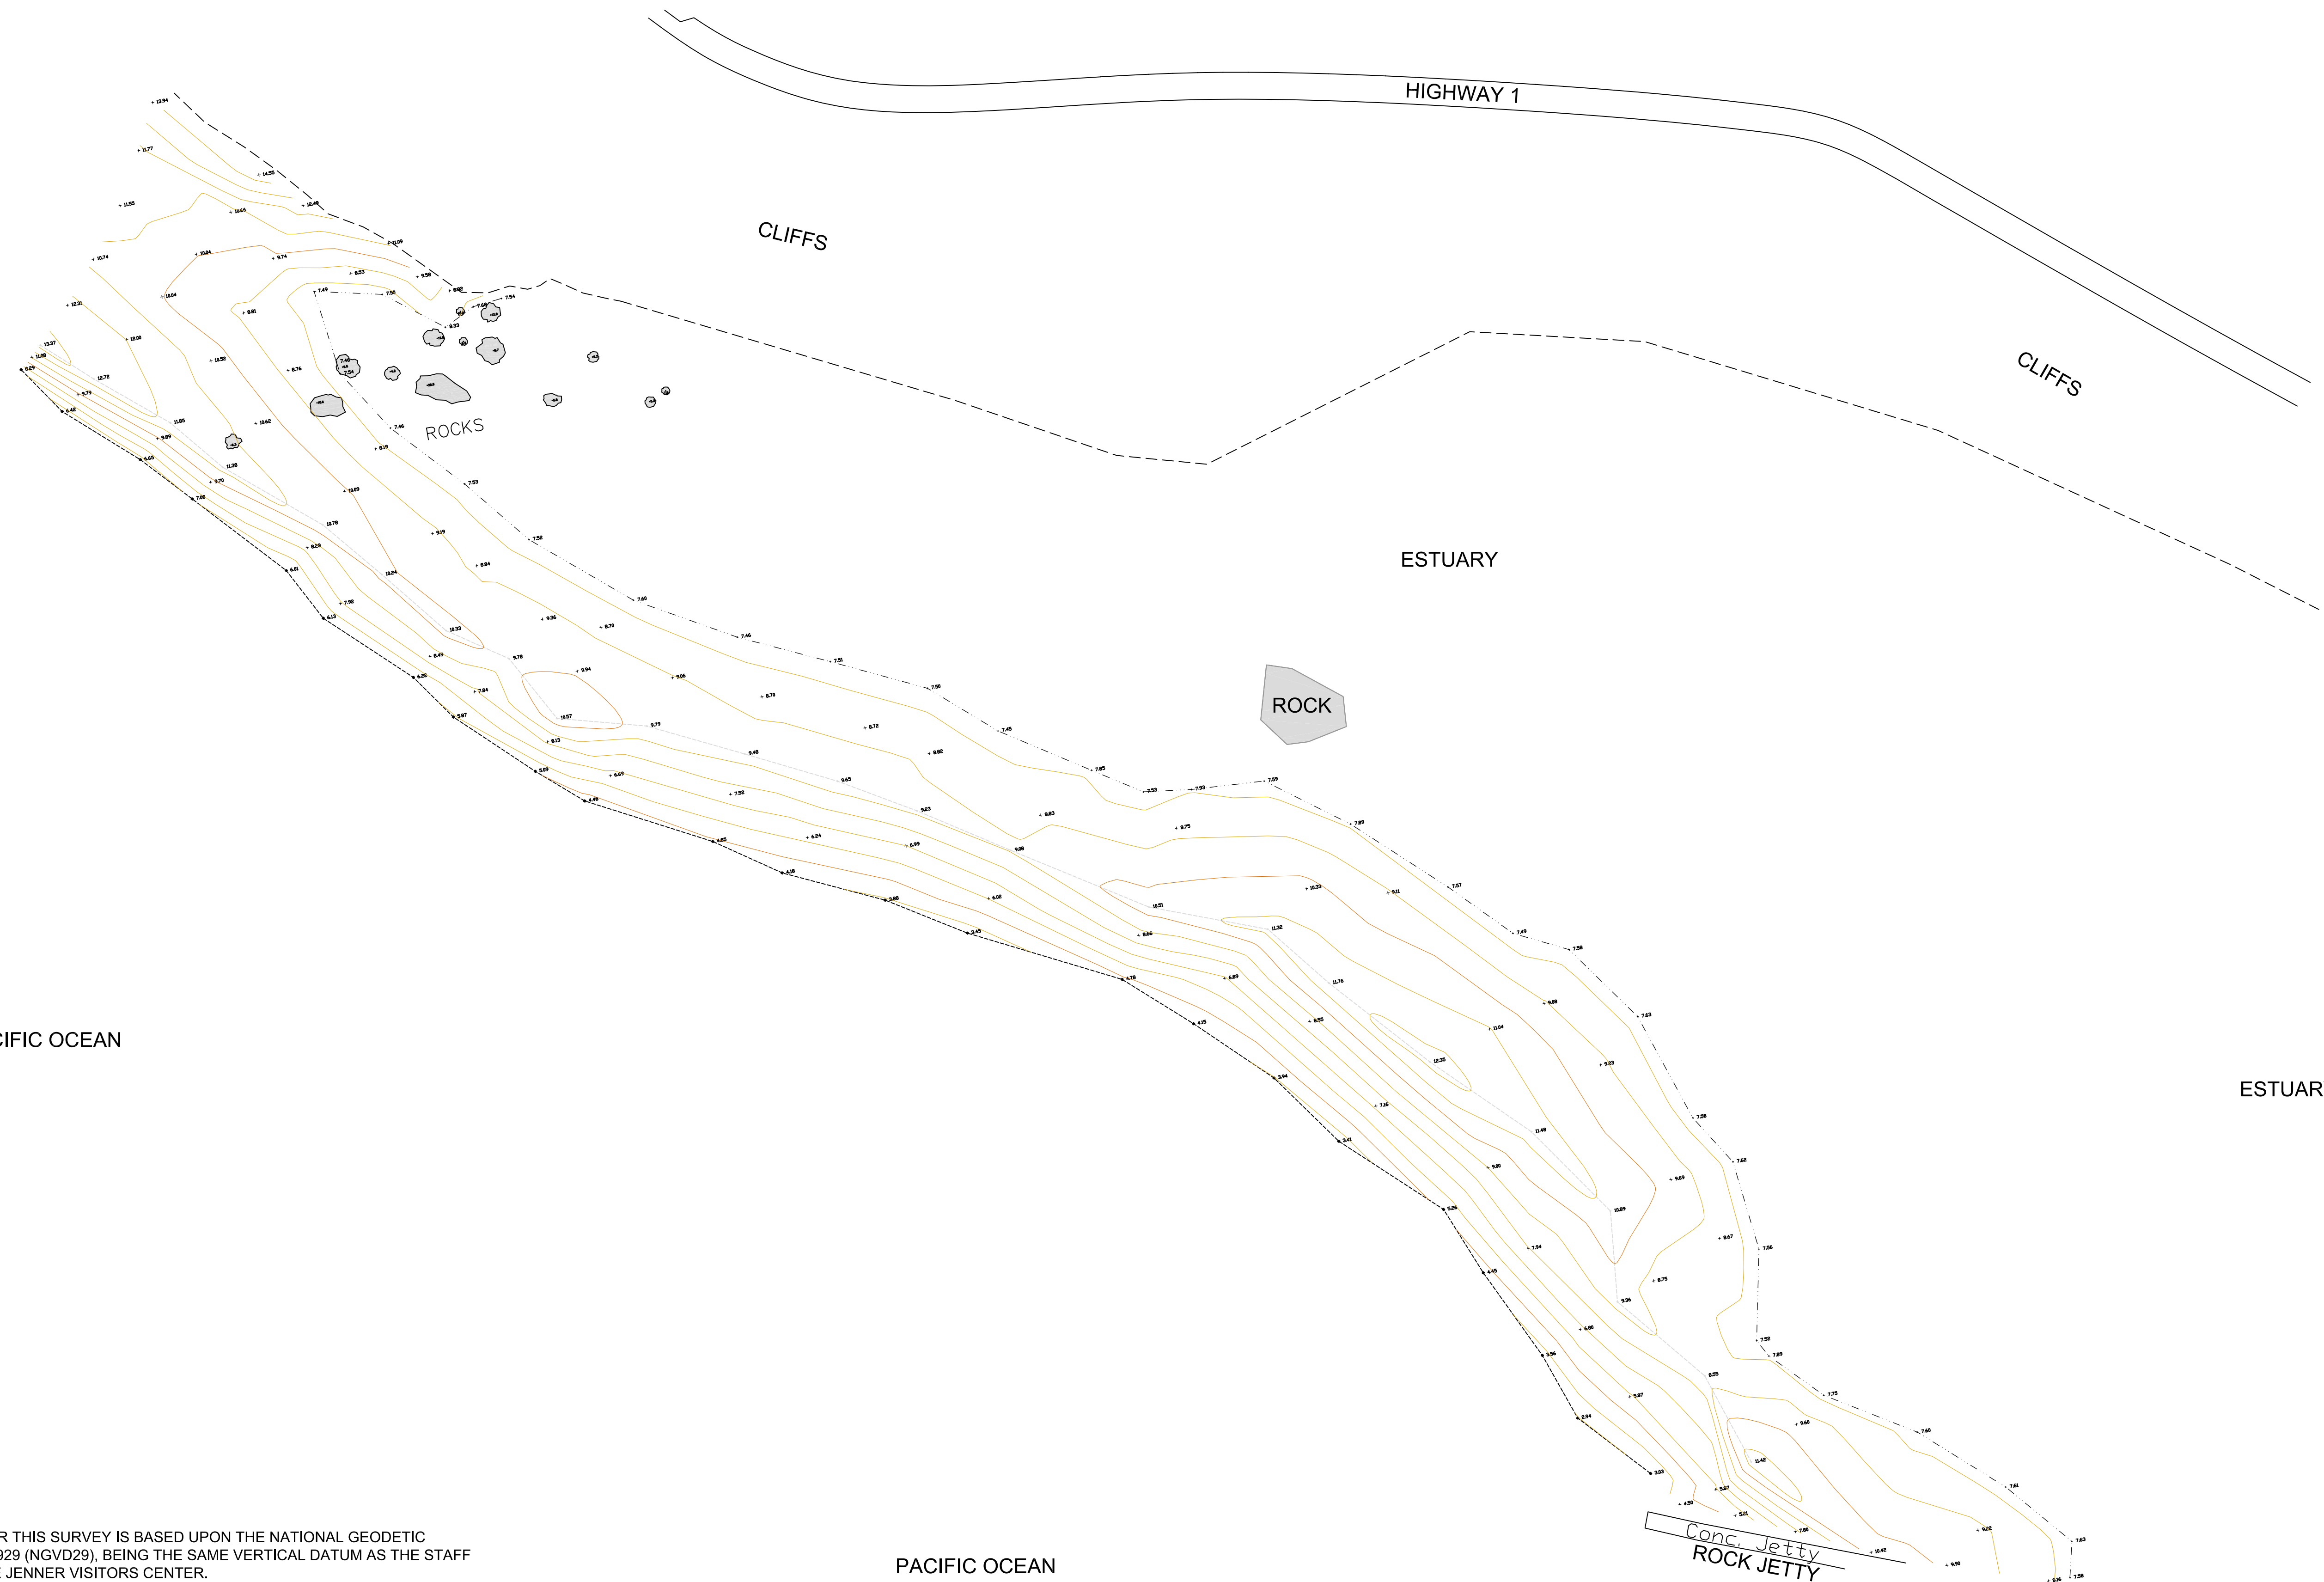
SCALE: AS NOTED	APPROVED DEPUTY CHIEF ENGR:	RUSSIAN RIVER INSTREAM FLOW RESTORATION (RRIFR) PROGRAM MONTHLY SURVEY OF BEACH TOPOGRAPHY AND OUTLET CHANNEL: Aug. 03, 2017	
				DATE: AS NOTED	SUBMITTED		
				DRAWN: EKM	DESIGNED		
				CHECKED: JRM			
NO.	DATE	BY		FILE NAME:		DRAWING NUMBER	SHEET NO. 1 OF 1

1. VERTICAL DATUM FOR THIS SURVEY IS BASED UPON THE NATIONAL GEODETIC VERTICAL DATUM OF 1929 (NGVD29), BEING THE SAME VERTICAL DATUM AS THE STAFF GAGE LOCATED AT THE JENNER VISITORS CENTER.

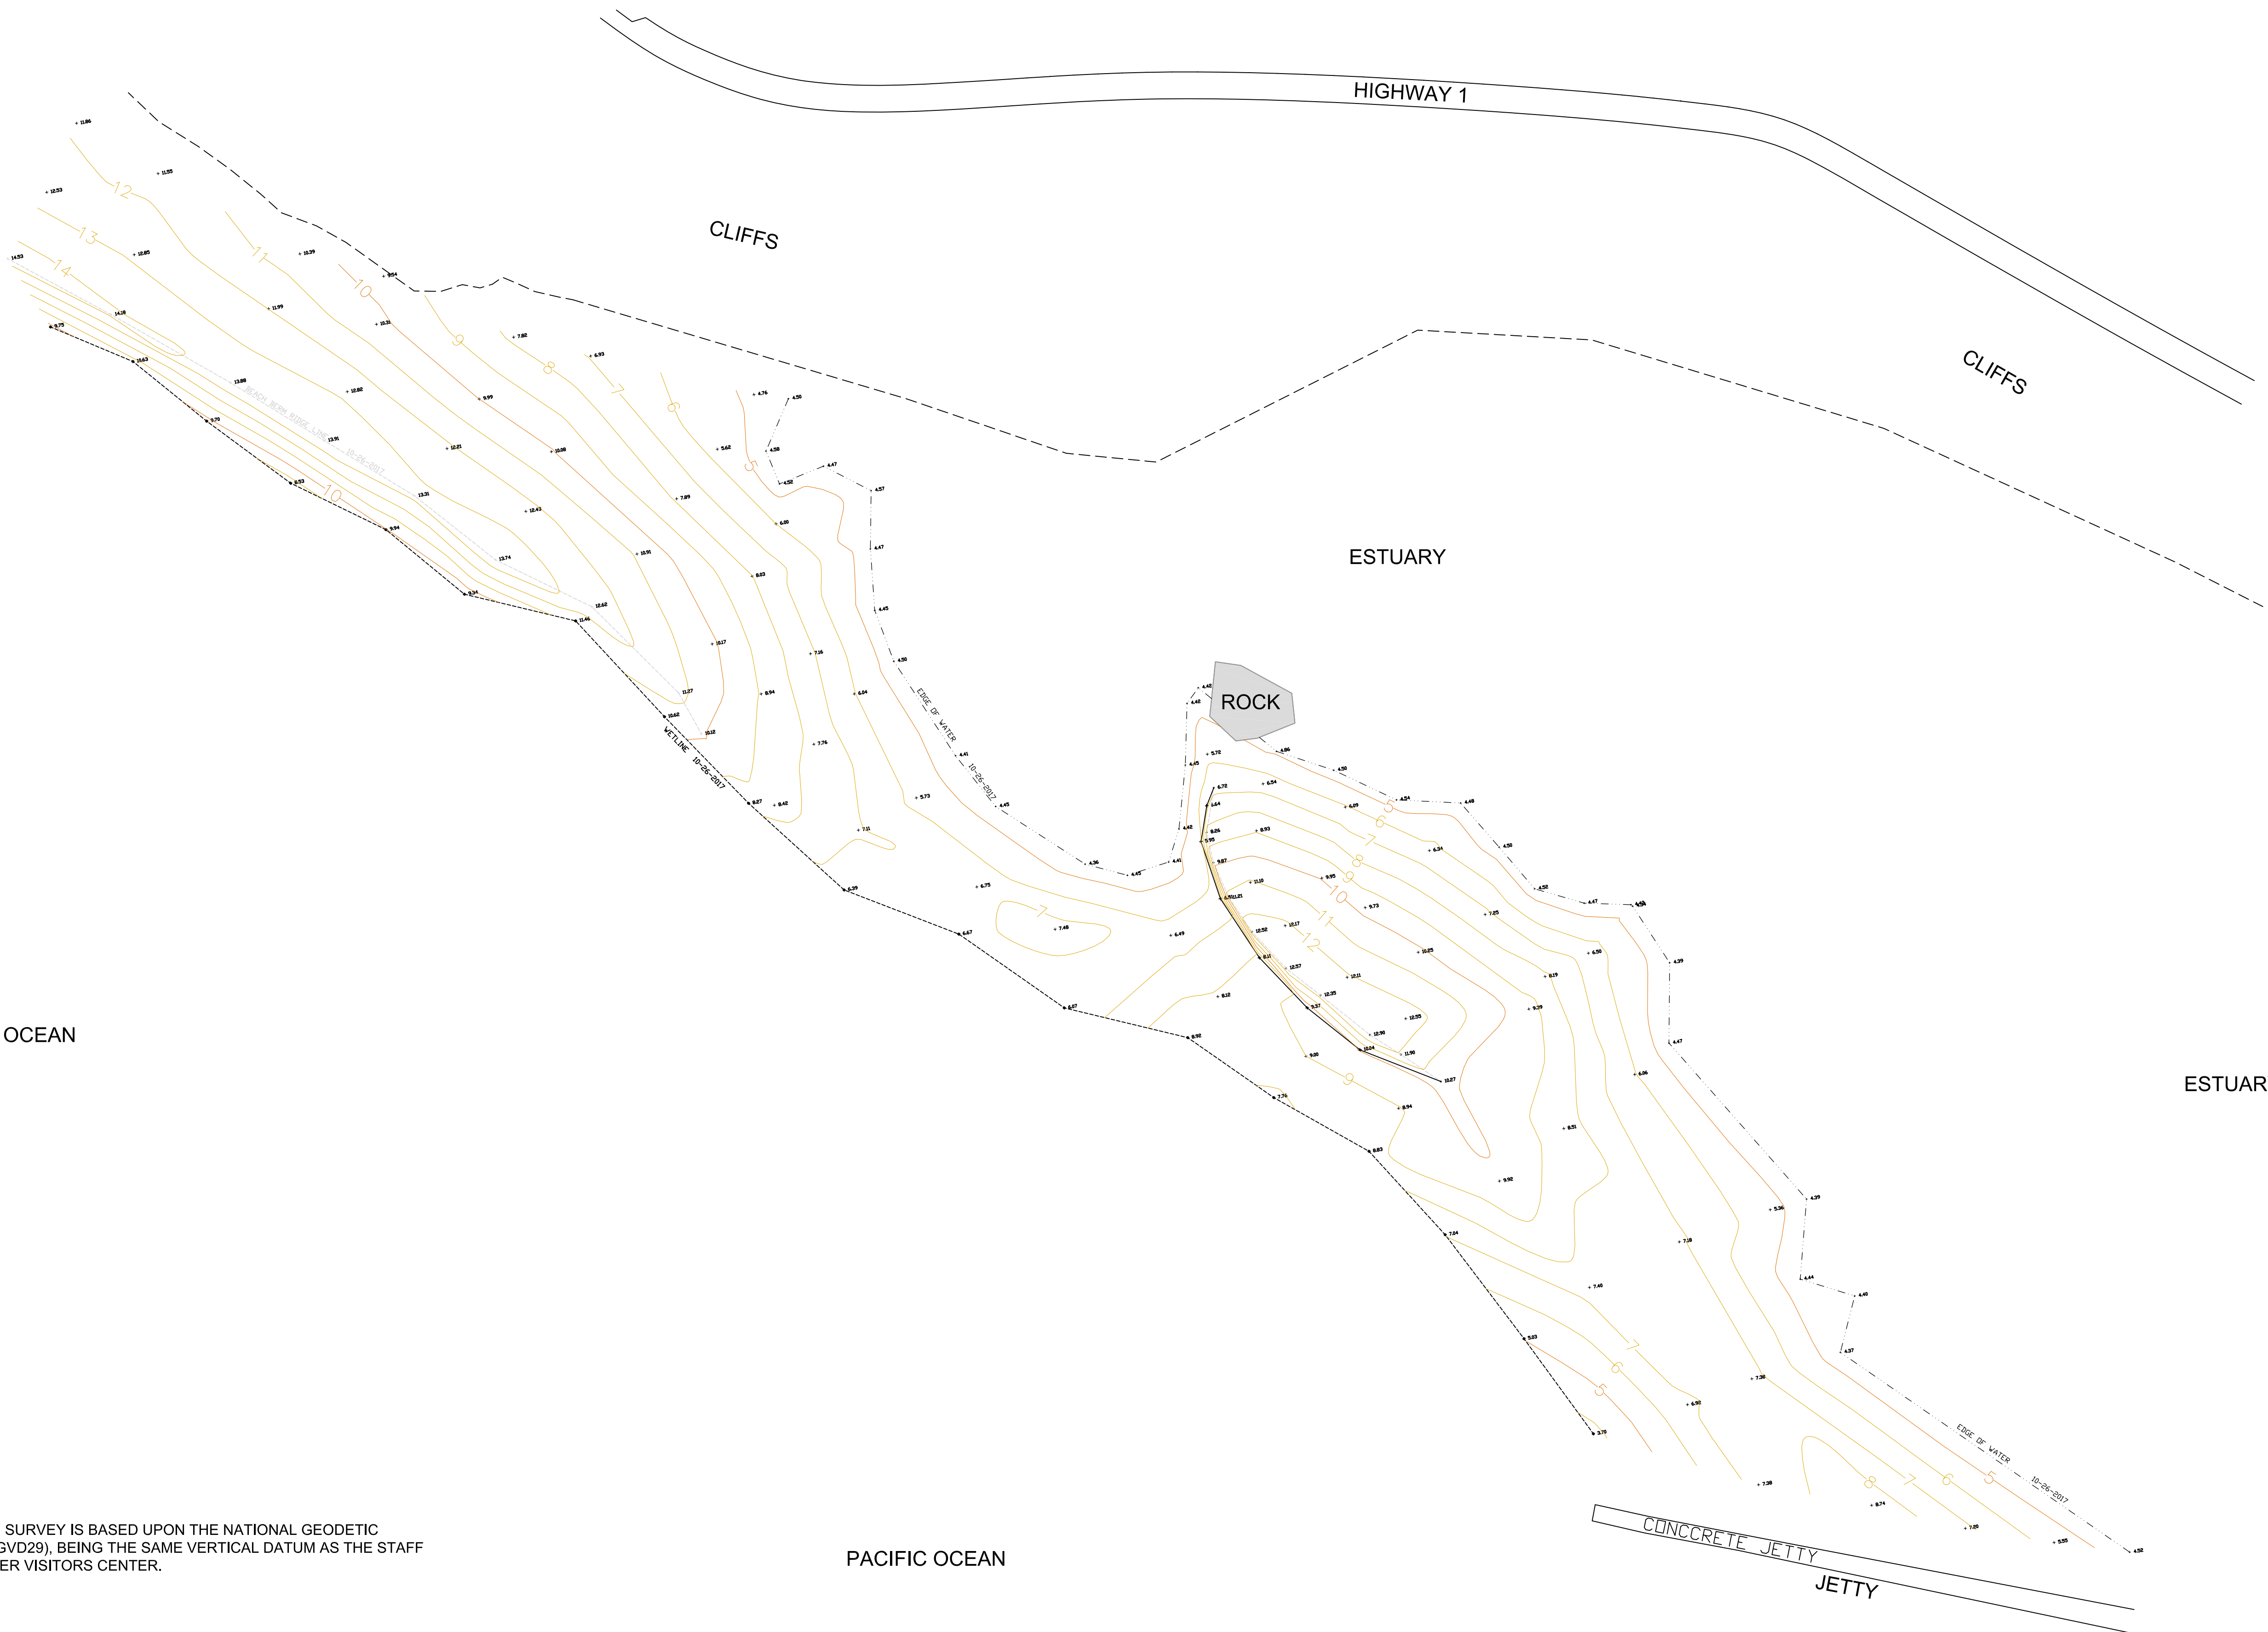
SCALE : AS NOTED	APPROVED DEPUTY CHIEF ENGR:	RUSSIAN RIVER INSTREAM FLOW RESTORATION (RRIFR) PROGRAM MONTHLY SURVEY OF BEACH TOPOGRAPHY AND OUTLET CHANNEL: Sept. 26, 2017	
				DATE : AS NOTED	SUBMITTED		
				DRAWN : EKM	DESIGNED		
				CHECKED : JRM			FILE NAME: CONTRACT NO. XXX
NO.	DATE	BY		DRAWING NUMBER		SHEET NO. 1 OF 1

NOTES:  
 1. VERTICAL DATUM FOR THIS SURVEY IS BASED UPON THE NATIONAL GEODETIC VERTICAL DATUM OF 1929 (NGVD29), BEING THE SAME VERTICAL DATUM AS THE STAFF GAGE LOCATED AT THE JENNER VISITORS CENTER.

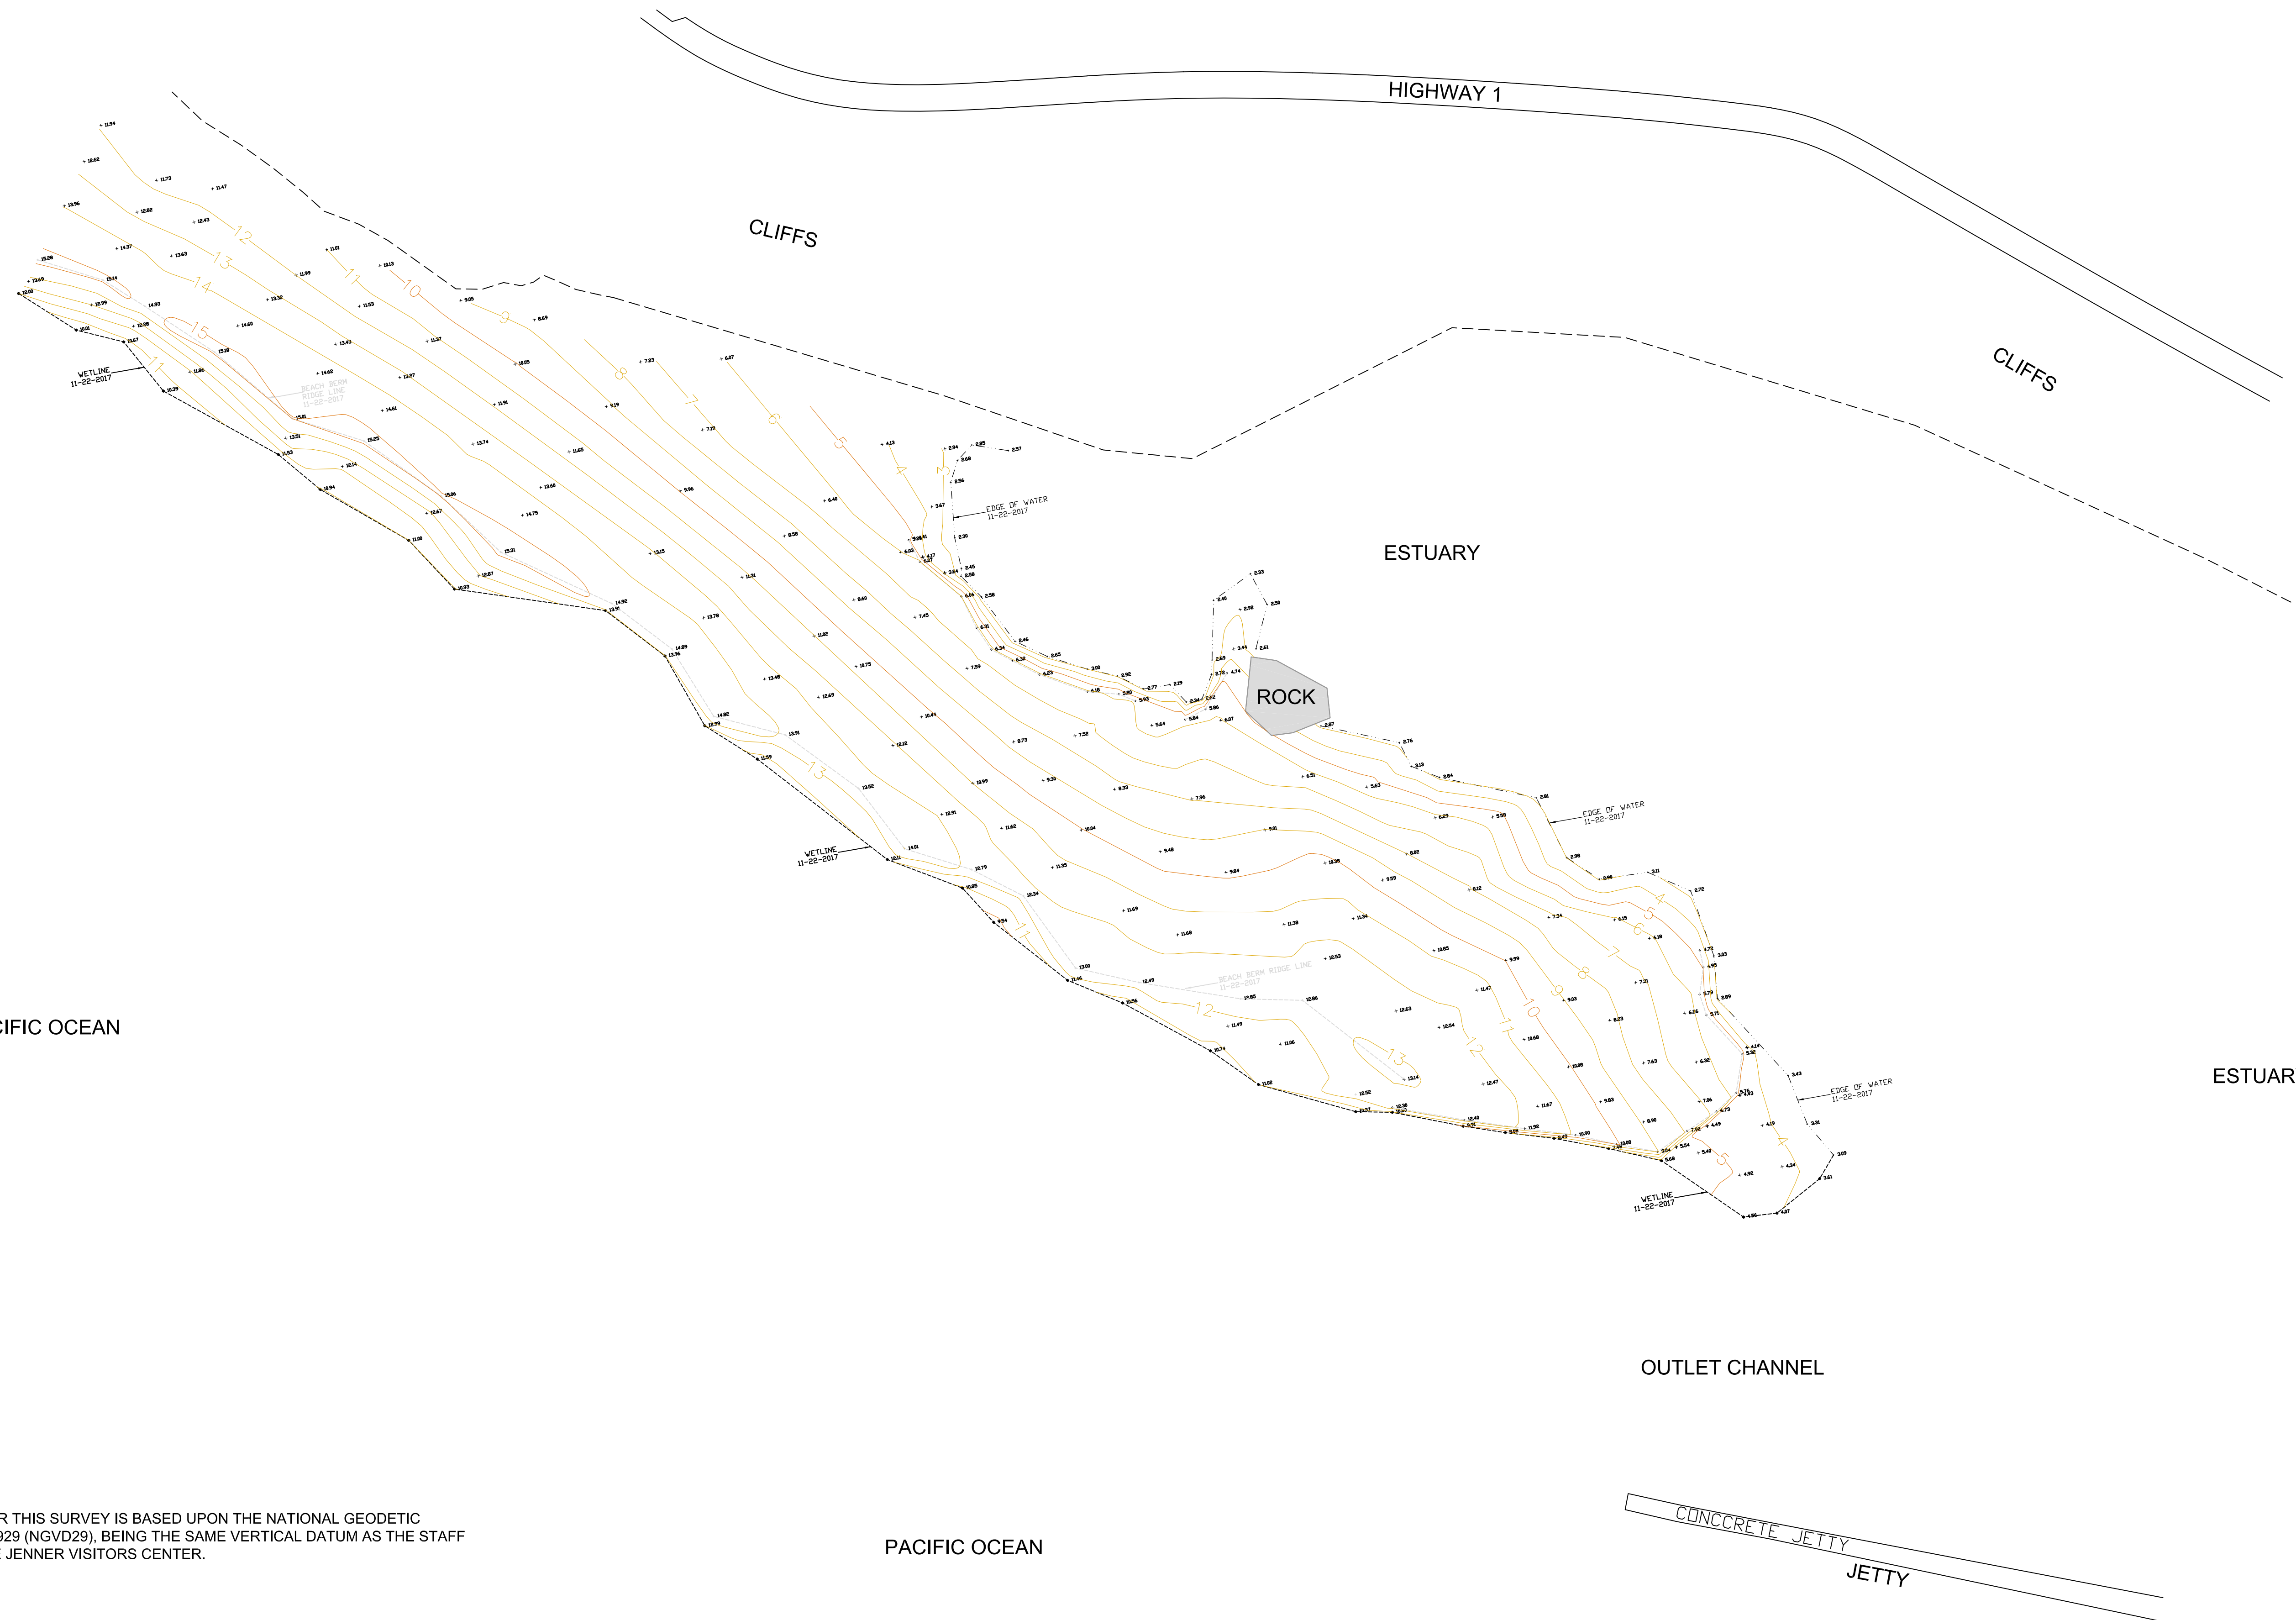
SCALE: AS NOTED	APPROVED DEPUTY CHIEF ENGR:	RUSSIAN RIVER INSTREAM FLOW RESTORATION (RRIFR) PROGRAM MONTHLY SURVEY OF BEACH TOPOGRAPHY AND OUTLET CHANNEL: Oct. 26, 2017	
				DATE: AS NOTED	SUBMITTED		
				DRAWN: EKM	DESIGNED	FILE NAME:	
				CHECKED: JRM	CONTRACT NO. XXX		DRAWING NUMBER
NO.	DATE	BY				SHEET NO. 1 OF 1

NOTES:  
 1. VERTICAL DATUM FOR THIS SURVEY IS BASED UPON THE NATIONAL GEODETIC VERTICAL DATUM OF 1929 (NGVD29), BEING THE SAME VERTICAL DATUM AS THE STAFF GAGE LOCATED AT THE JENNER VISITORS CENTER.

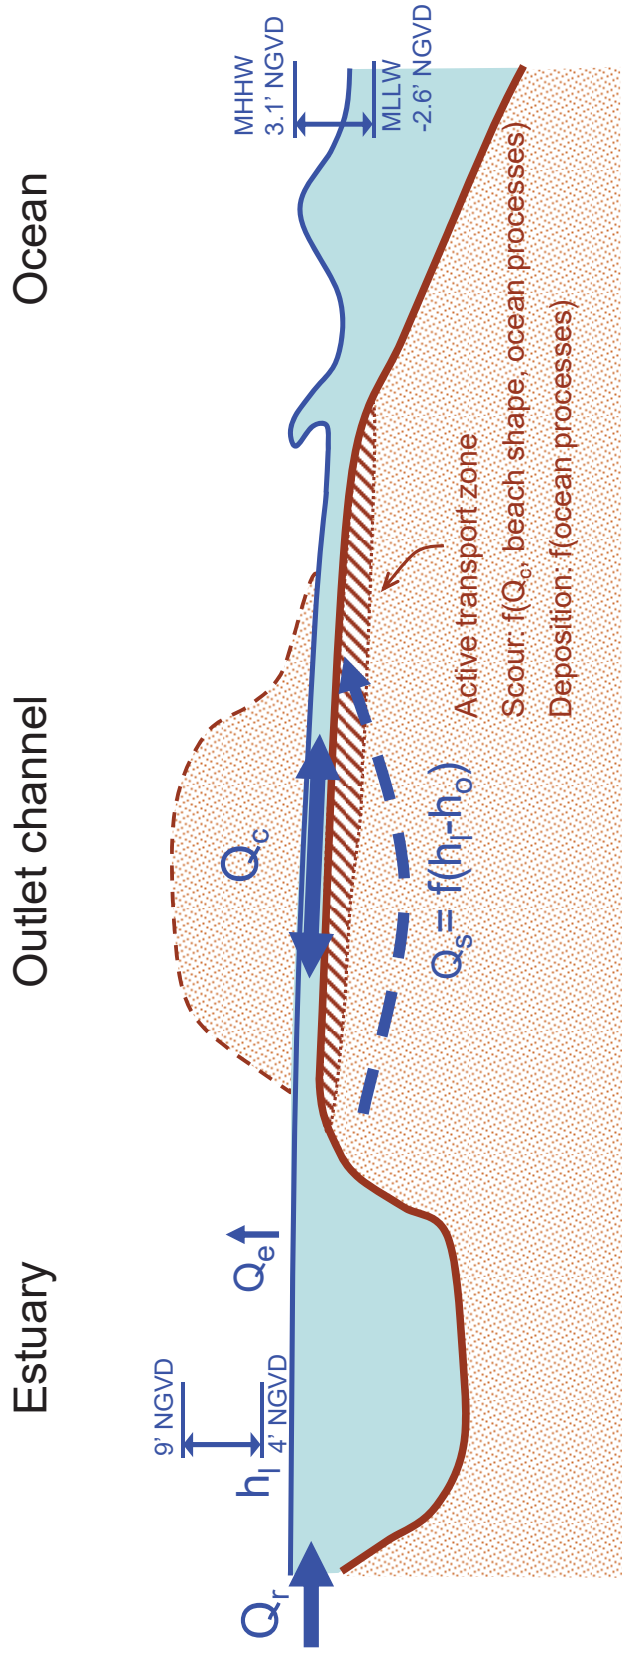
<p>figure 3 Russian River Estuary Outlet Channel Management Plan</p>	
<p>Conceptual model – Closure</p>	
<p>PWA Ref# 1958.01</p>

- $Z_{wave} \geq Z_{out}$
- wave-induced sediment transport closes outlet channel
- $Q_c \rightarrow 0$
- $h_l$  increasing

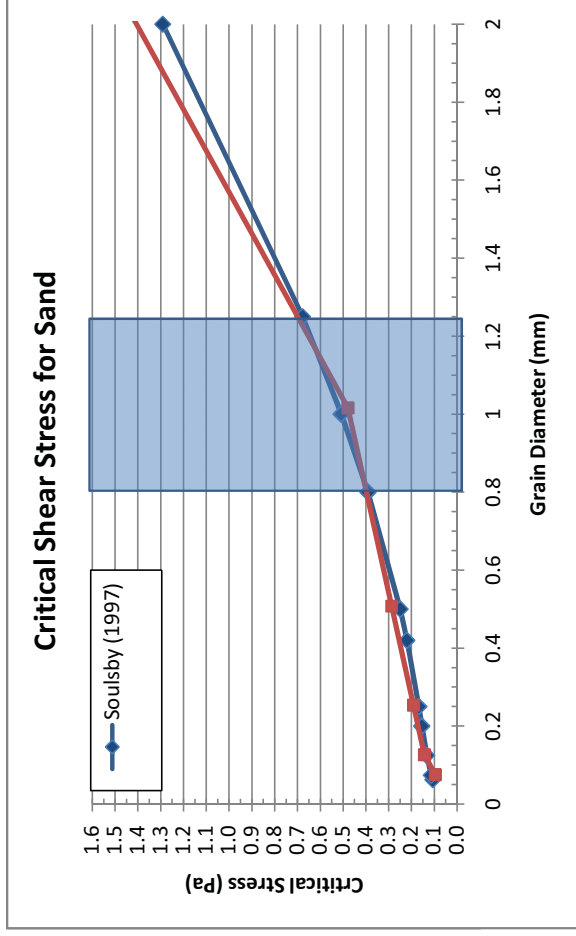
$$\theta_c = \frac{0.3}{1 + 1.2D_*} + 0.055[1 - \exp(-0.020D_*)]$$

$$\tau_c = \rho(s-1)gd\theta_c$$

Note: does not account for gravitational effects on sloping bed

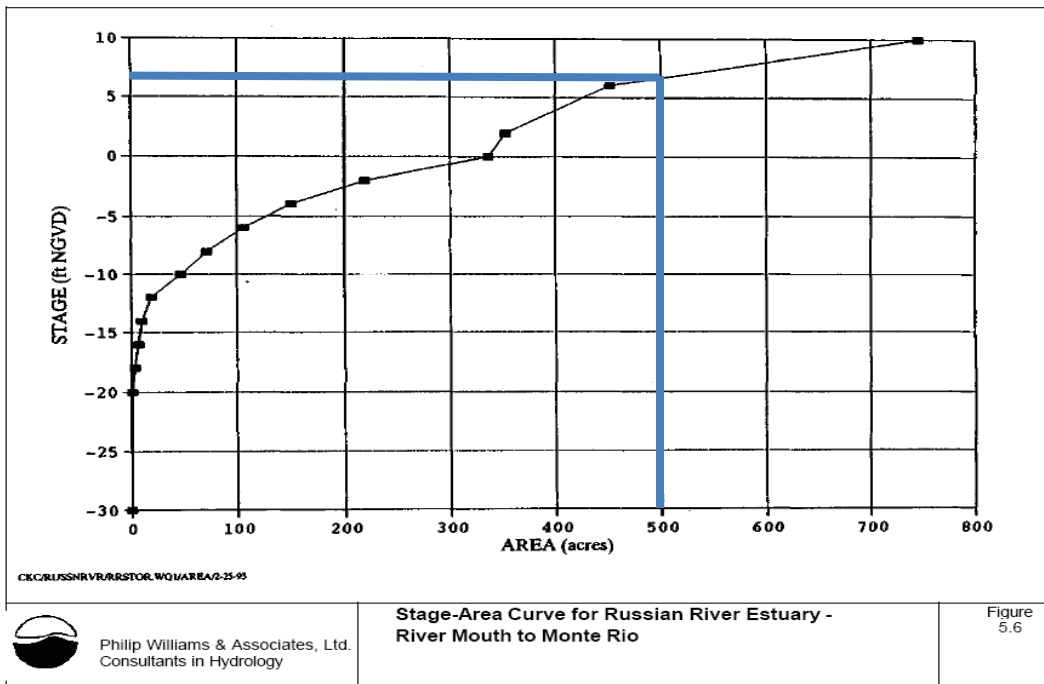
in/month	days	in/day	mm/day	cfs
Jan	0.93	31	0.03	0.76	0.6
Feb	1.40	28	0.05	1.27	1.1
Mar	2.48	31	0.08	2.03	1.7
Apr	3.30	30	0.11	2.79	2.3
May	4.03	31	0.13	3.30	2.7
Jun	4.50	30	0.15	3.81	3.2
Jul	4.65	31	0.15	3.81	3.2
Aug	4.03	31	0.13	3.30	2.7
Sep	3.30	30	0.11	2.79	2.3
Oct	2.48	31	0.08	2.03	1.7
Nov	1.20	30	0.04	1.02	0.8
Dec	0.62	31	0.02	0.51	0.4

RRE Surface Area                500     acres  
    21,780,000   sq ft

Notes: Daily evaporation rates for Russian River lagoon interpolated from CIMIS average monthly evapotranspiration statistics for Zone 1 (Coastal plains and heavy fog). Calculations assume lagoon surface area of 500 acres.

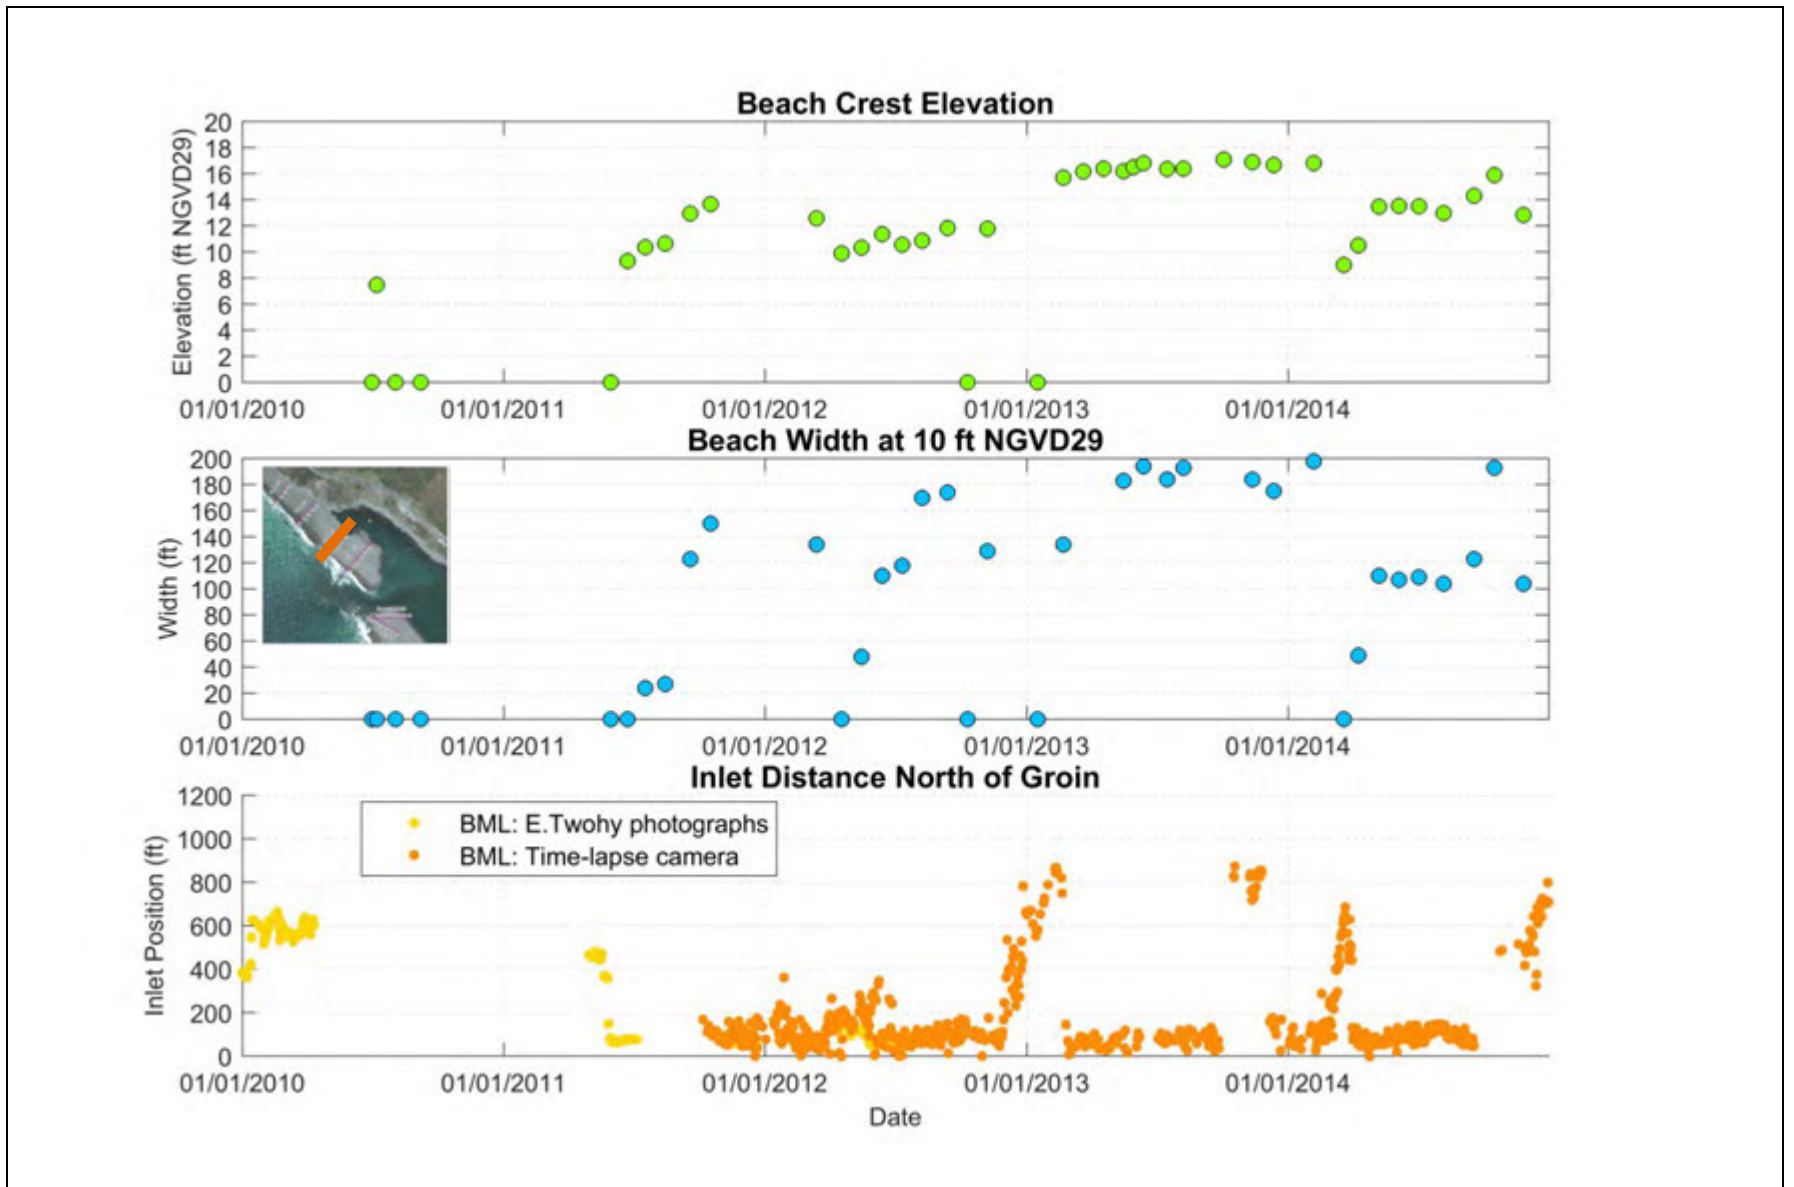
**Figure 6**  
Summary of **(top)** monthly beach crest and **(middle)** beach width at Transect 1, measured from Water Agency surveys, compared with **(bottom)** Mouth position.

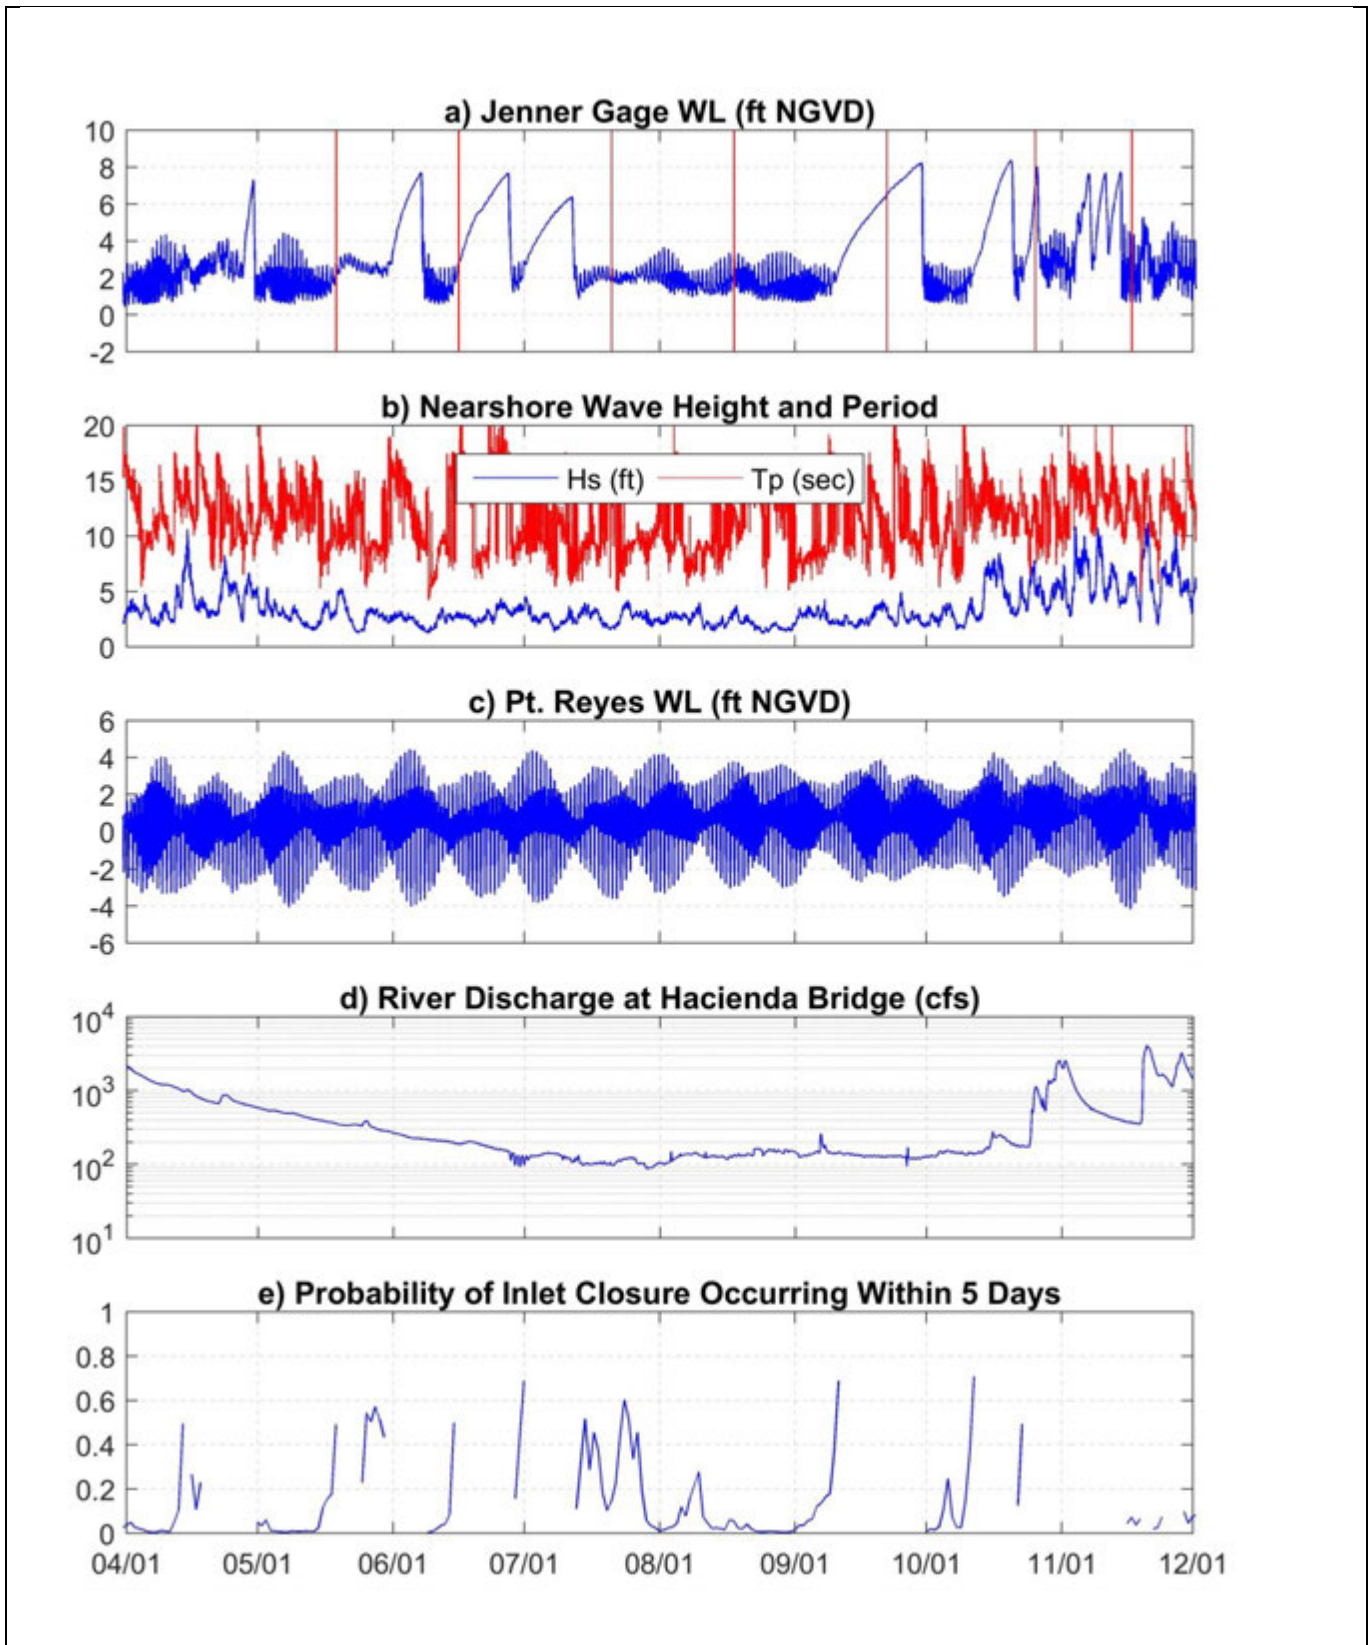
- a) Jenner gage water level provided by SCWA; red bar = beach survey
- b)  $H_s$  = sig. wave height;  $T_p$  = peak wave period (CDIP, Pt. Reyes, #029)
- c) Ocean water level provided by NOAA (Pt. Reyes #9415020)
- d) River discharge provided by USGS (Guerneville #11467000)
- e) Five-day closure probability provided after Behrens et al. (2013)
