**RUSSIAN RIVER ESTUARY OUTLET CHANNEL  
ADAPTIVE MANAGEMENT PLAN  
2017**

Sonoma County Water Agency

ESA

May 30, 2017

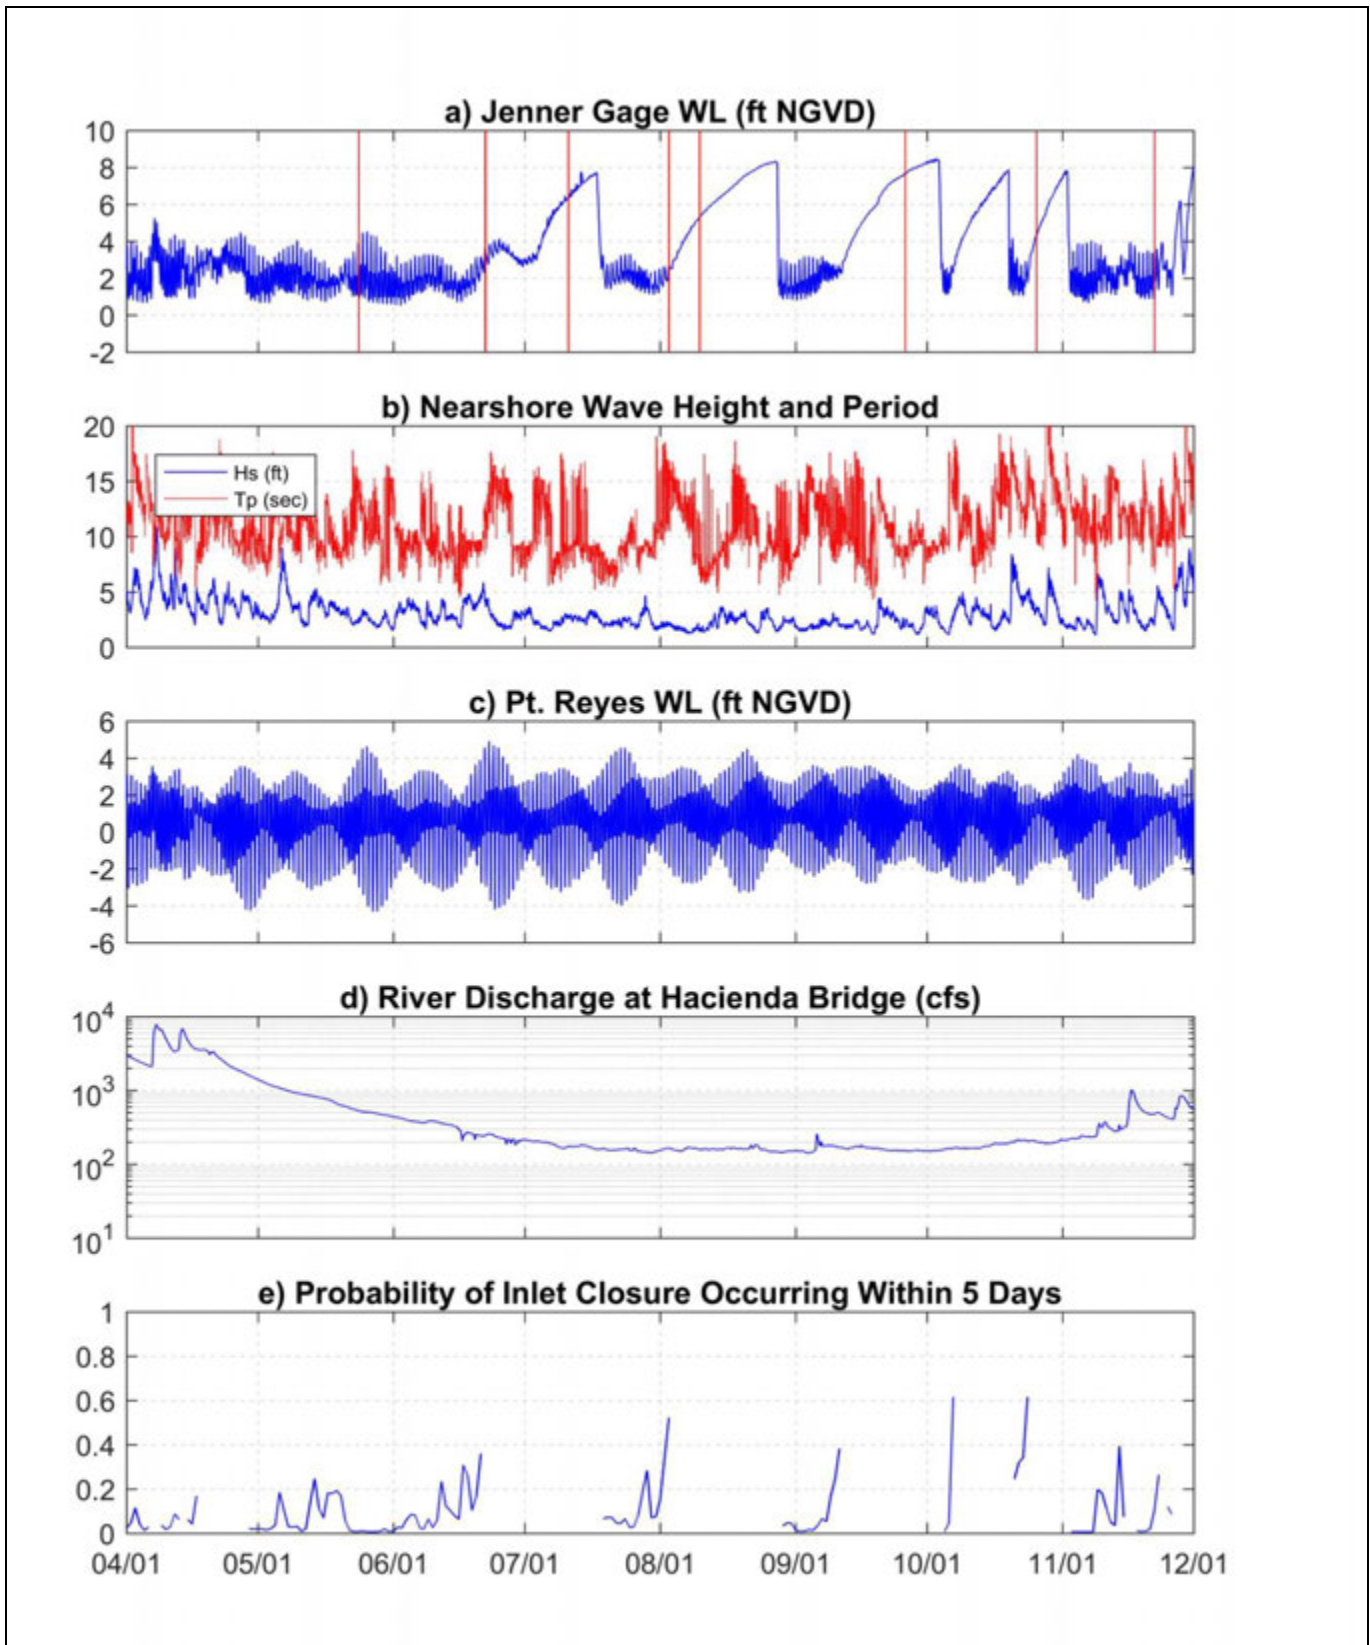
**Figure 1**  
 Estuary, Ocean, and River Conditions Compared  
 with Closure Probability:  
 April – November 2017

- a) Jenner gage water level provided by SCWA; red bar = beach survey
- b)  $H_s$  = sig. wave height;  $T_p$  = peak wave period (CDIP, Pt. Reyes, #029)
- c) Ocean water level provided by NOAA (Pt. Reyes #9415020)
- d) River discharge provided by USGS (Guerneville #11467000)
- e) Five-day closure probability provided after Behrens et al. (2013)

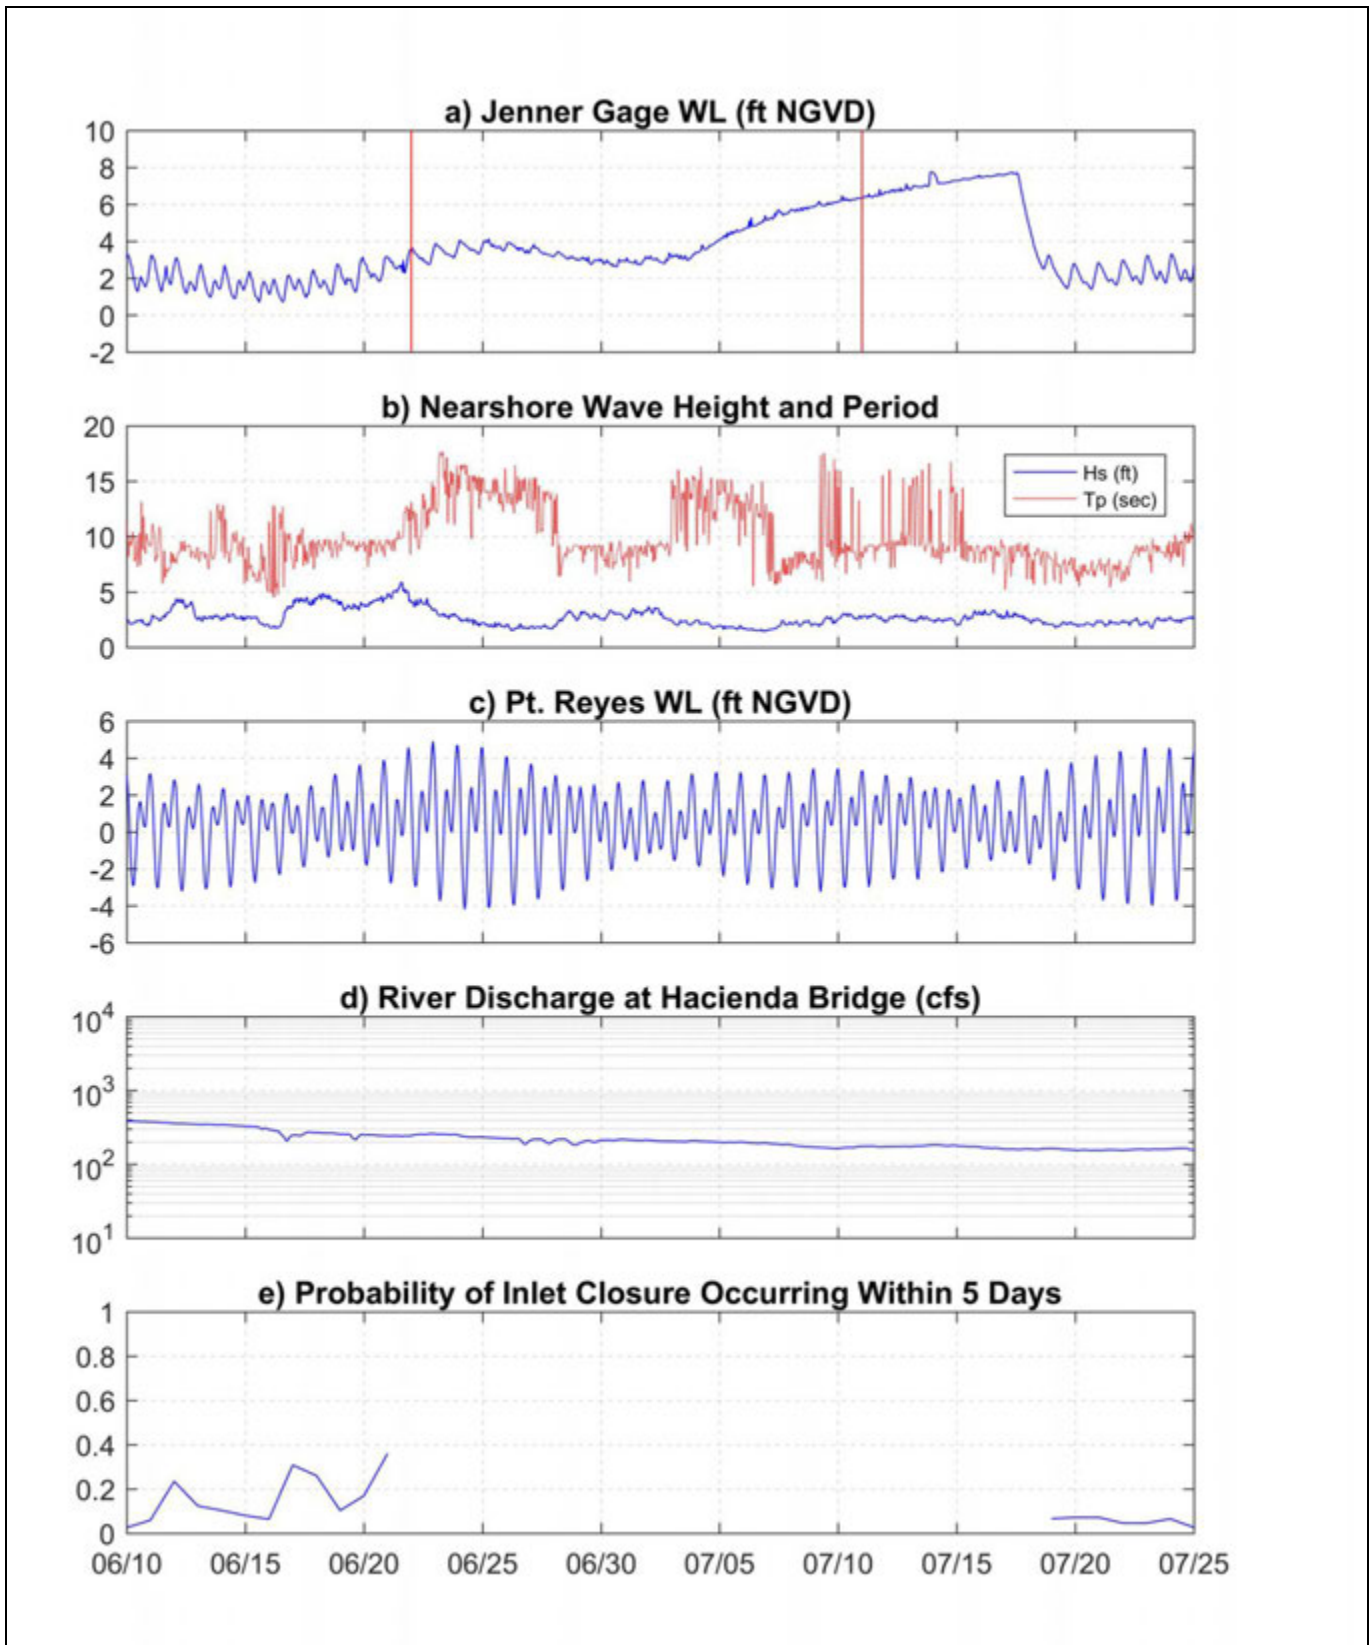
**Figure 2**  
 Estuary, Ocean, and River Conditions Compared  
 with Closure Probability:  
 June – July 2017

- a) Jenner gage water level provided by SCWA; red bar = beach survey
- b)  $H_s$  = sig. wave height;  $T_p$ =peak wave period (CDIP, Pt. Reyes, #029)
- c) Ocean water level provided by NOAA (Pt. Reyes #9415020)
- d) River discharge provided by USGS (Guerneville #11467000)
- e) Five-day closure probability provided after Behrens et al. (2013)

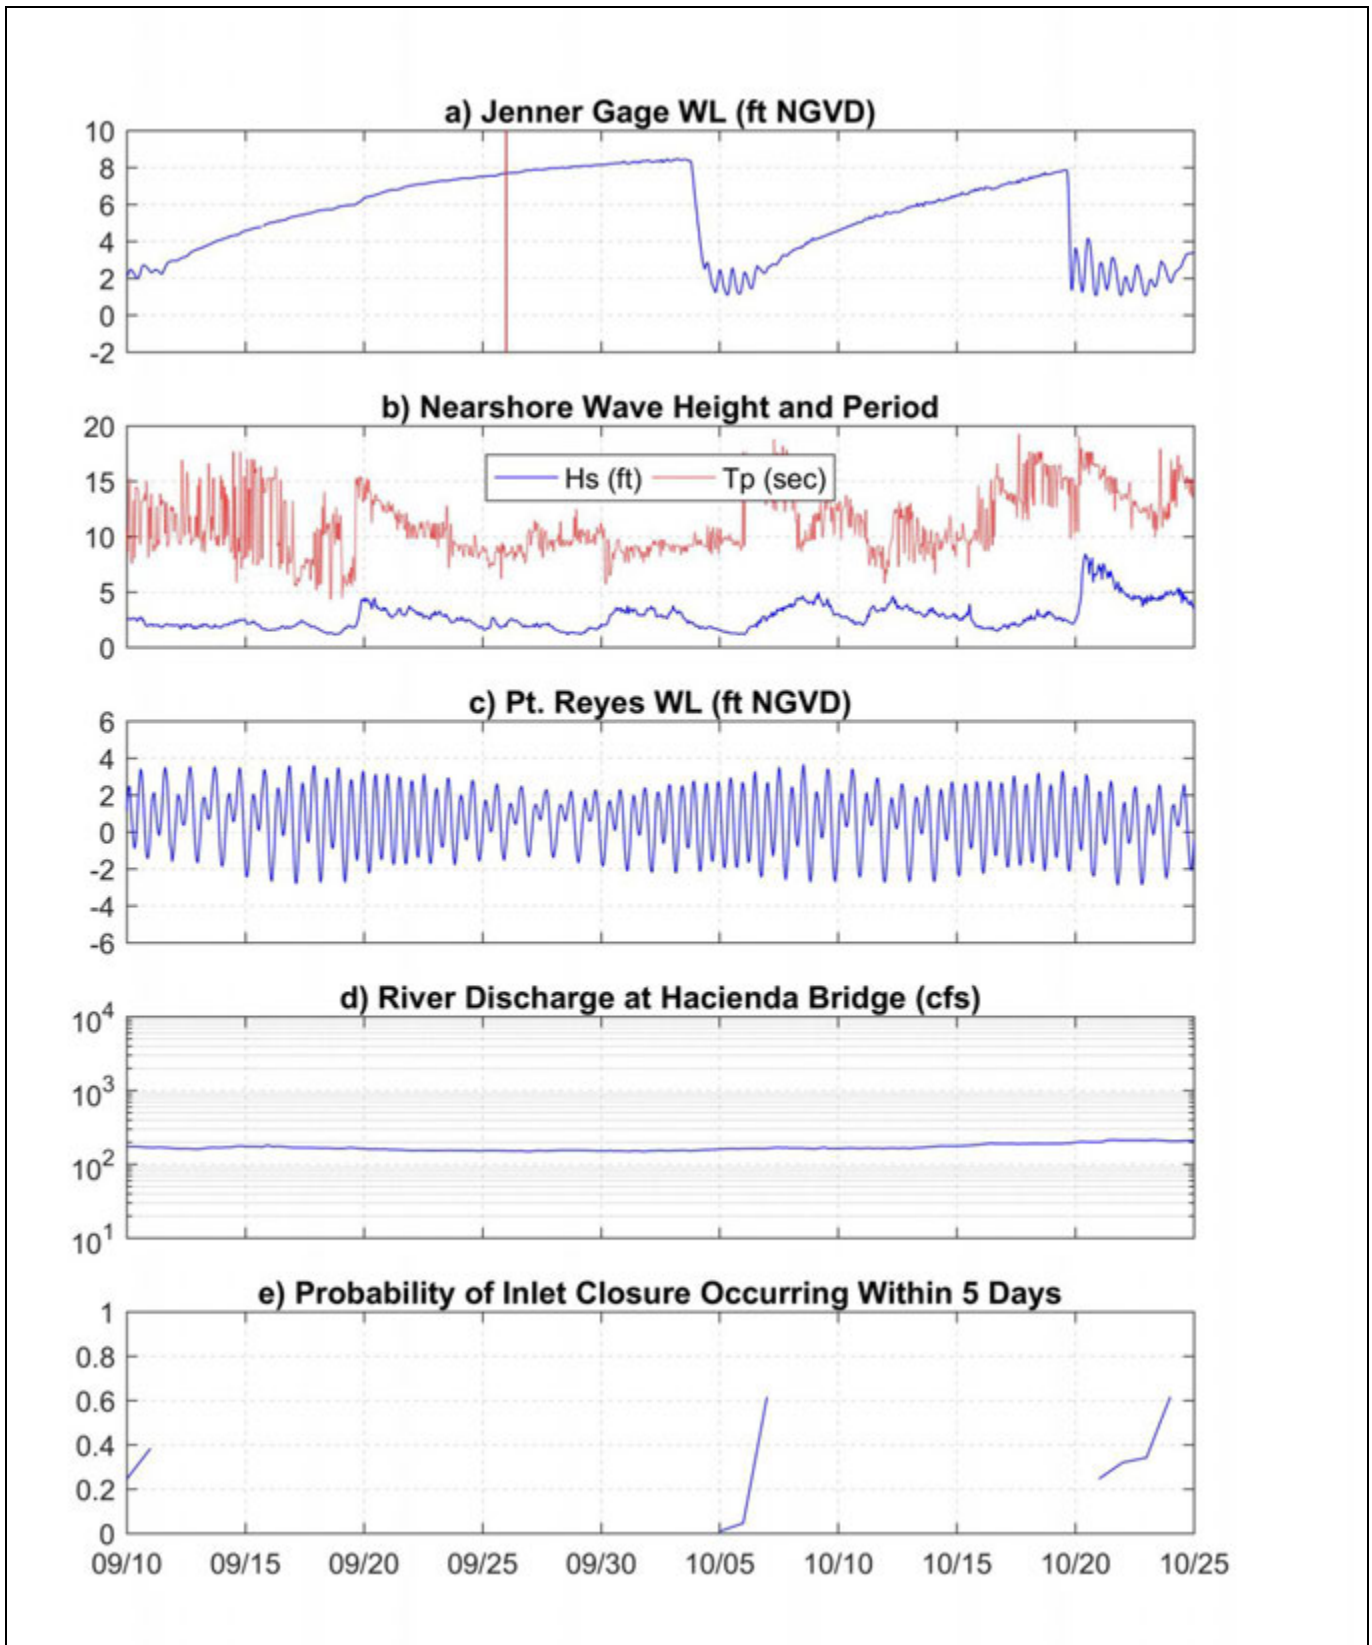
- a) Jenner gage water level provided by SCWA; red bar = beach survey
- b)  $H_s$  = sig. wave height;  $T_p$ =peak wave period (CDIP, Pt. Reyes, #029)
- c) Ocean water level provided by NOAA (Pt. Reyes #9415020)
- d) River discharge provided by USGS (Guerneville #11467000)
- e) Five-day closure probability provided after Behrens et al. (2013)

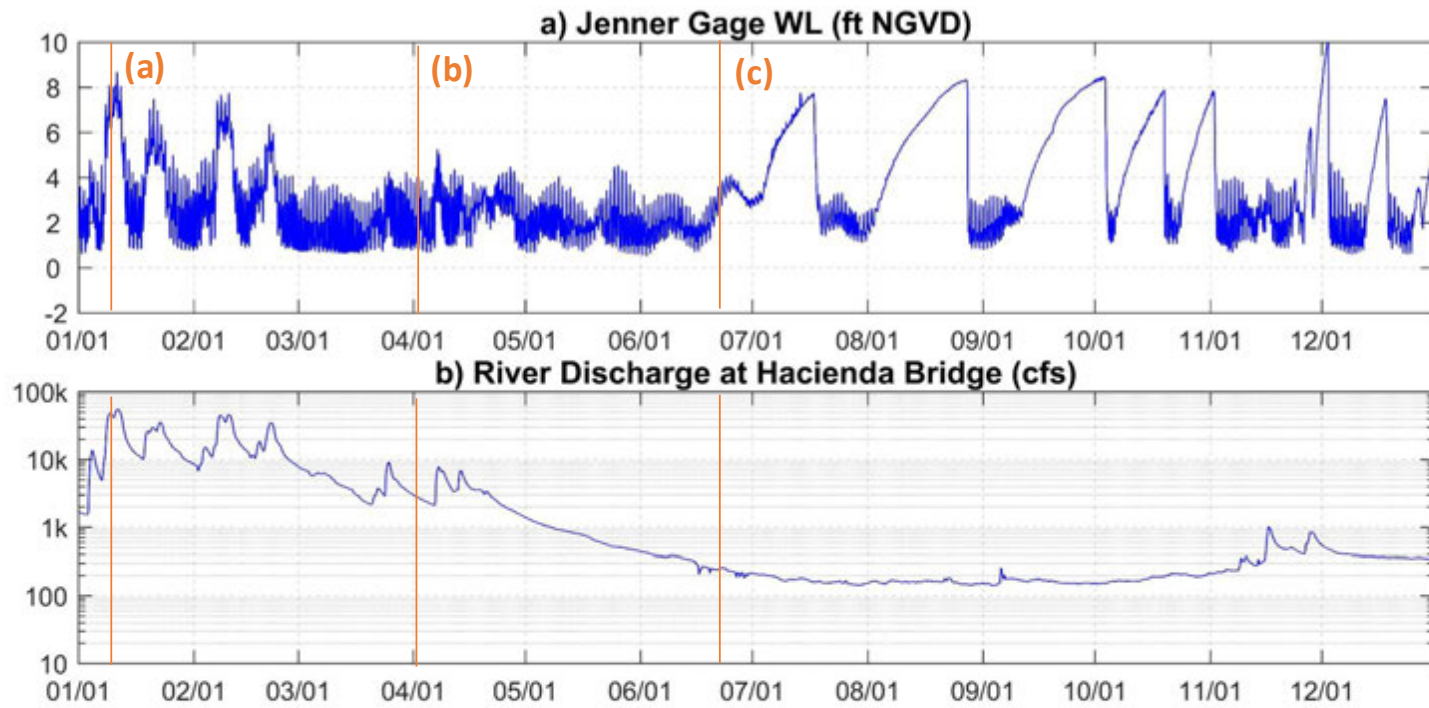
(a) Russian River during fluvial flooding on January 10<sup>th</sup>, 2017, (b) During moderate discharge conditions on April 2<sup>nd</sup>, 2017, and (c) during natural perched conditions on June 23<sup>rd</sup>, 2017.

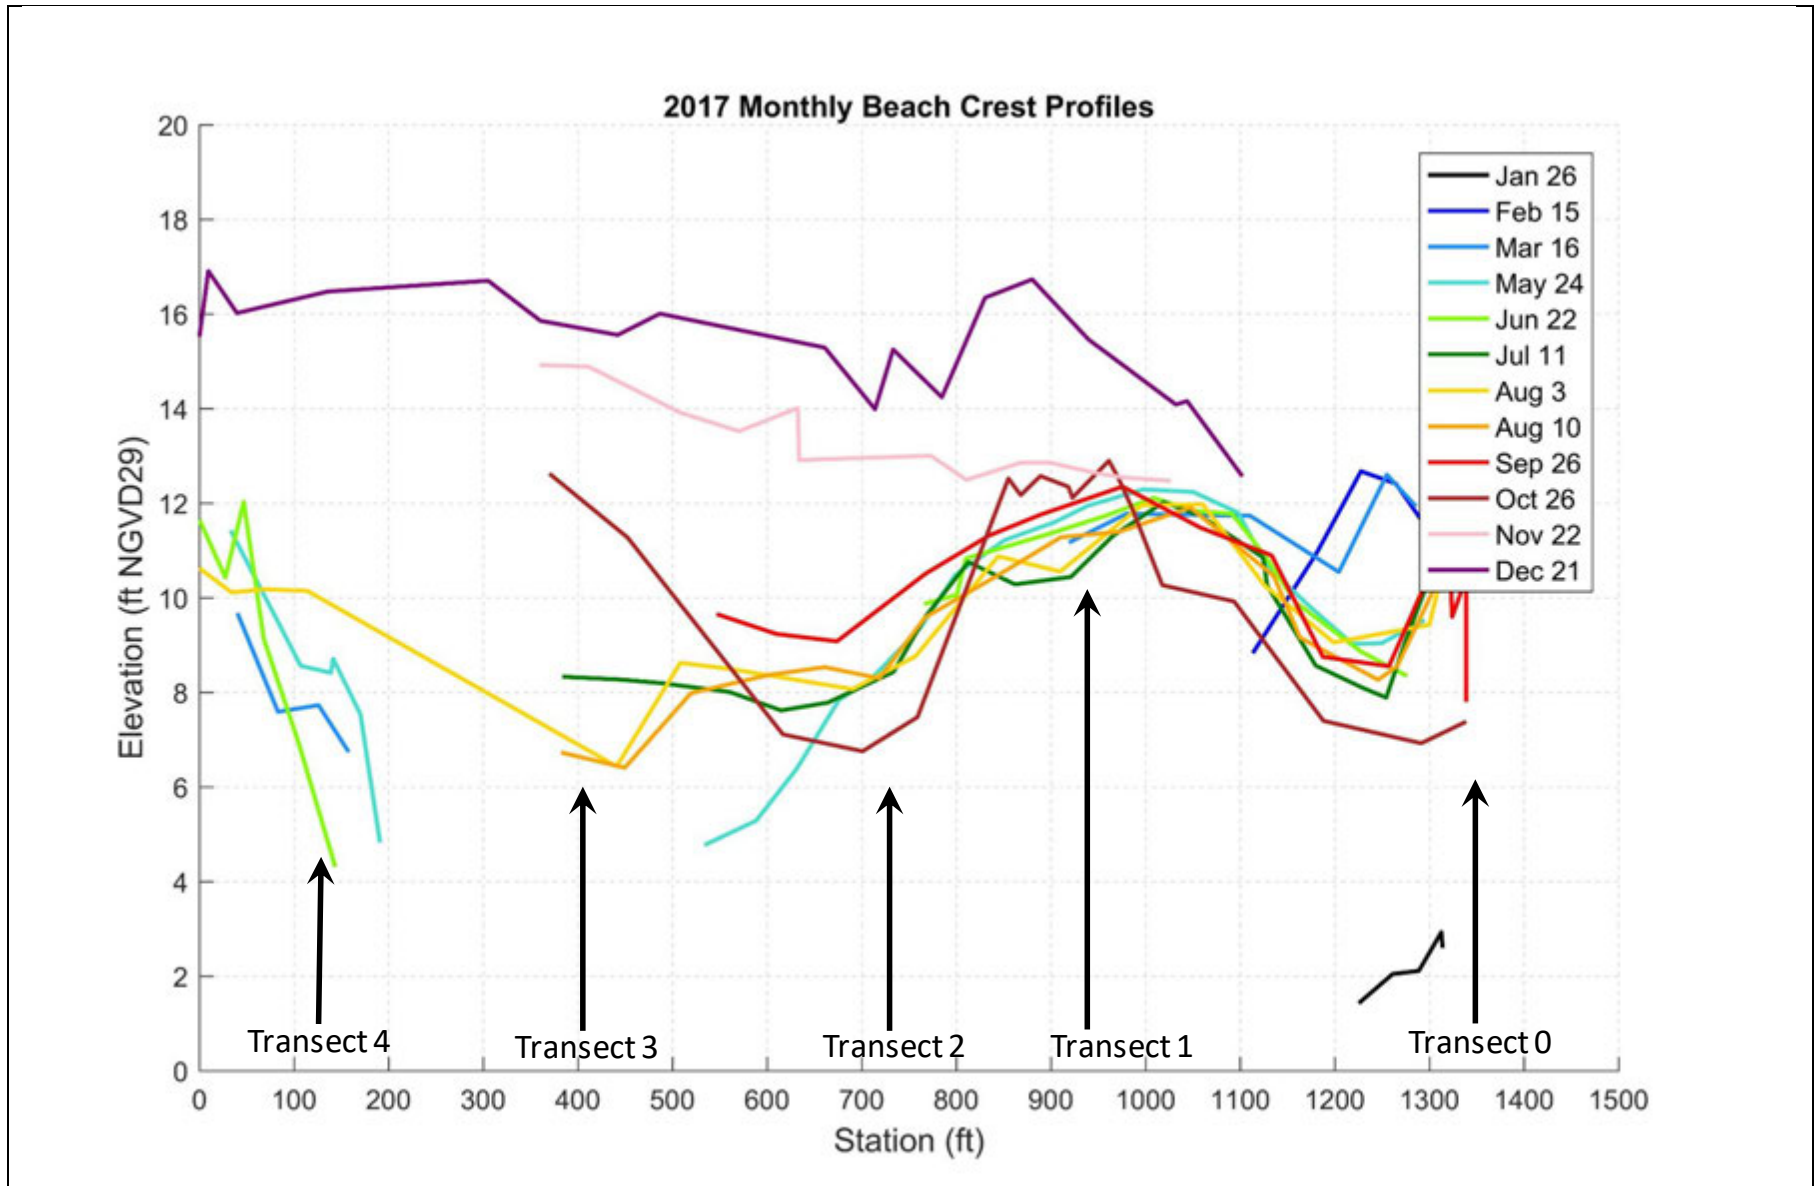
Note: Solid lines are from points identified as the beach crest during the monthly survey. Dashed lines are interpolated from surveyed points on the beach.

**Figure 13**  
Beach Crest Profiles During the 2017 Management Period.

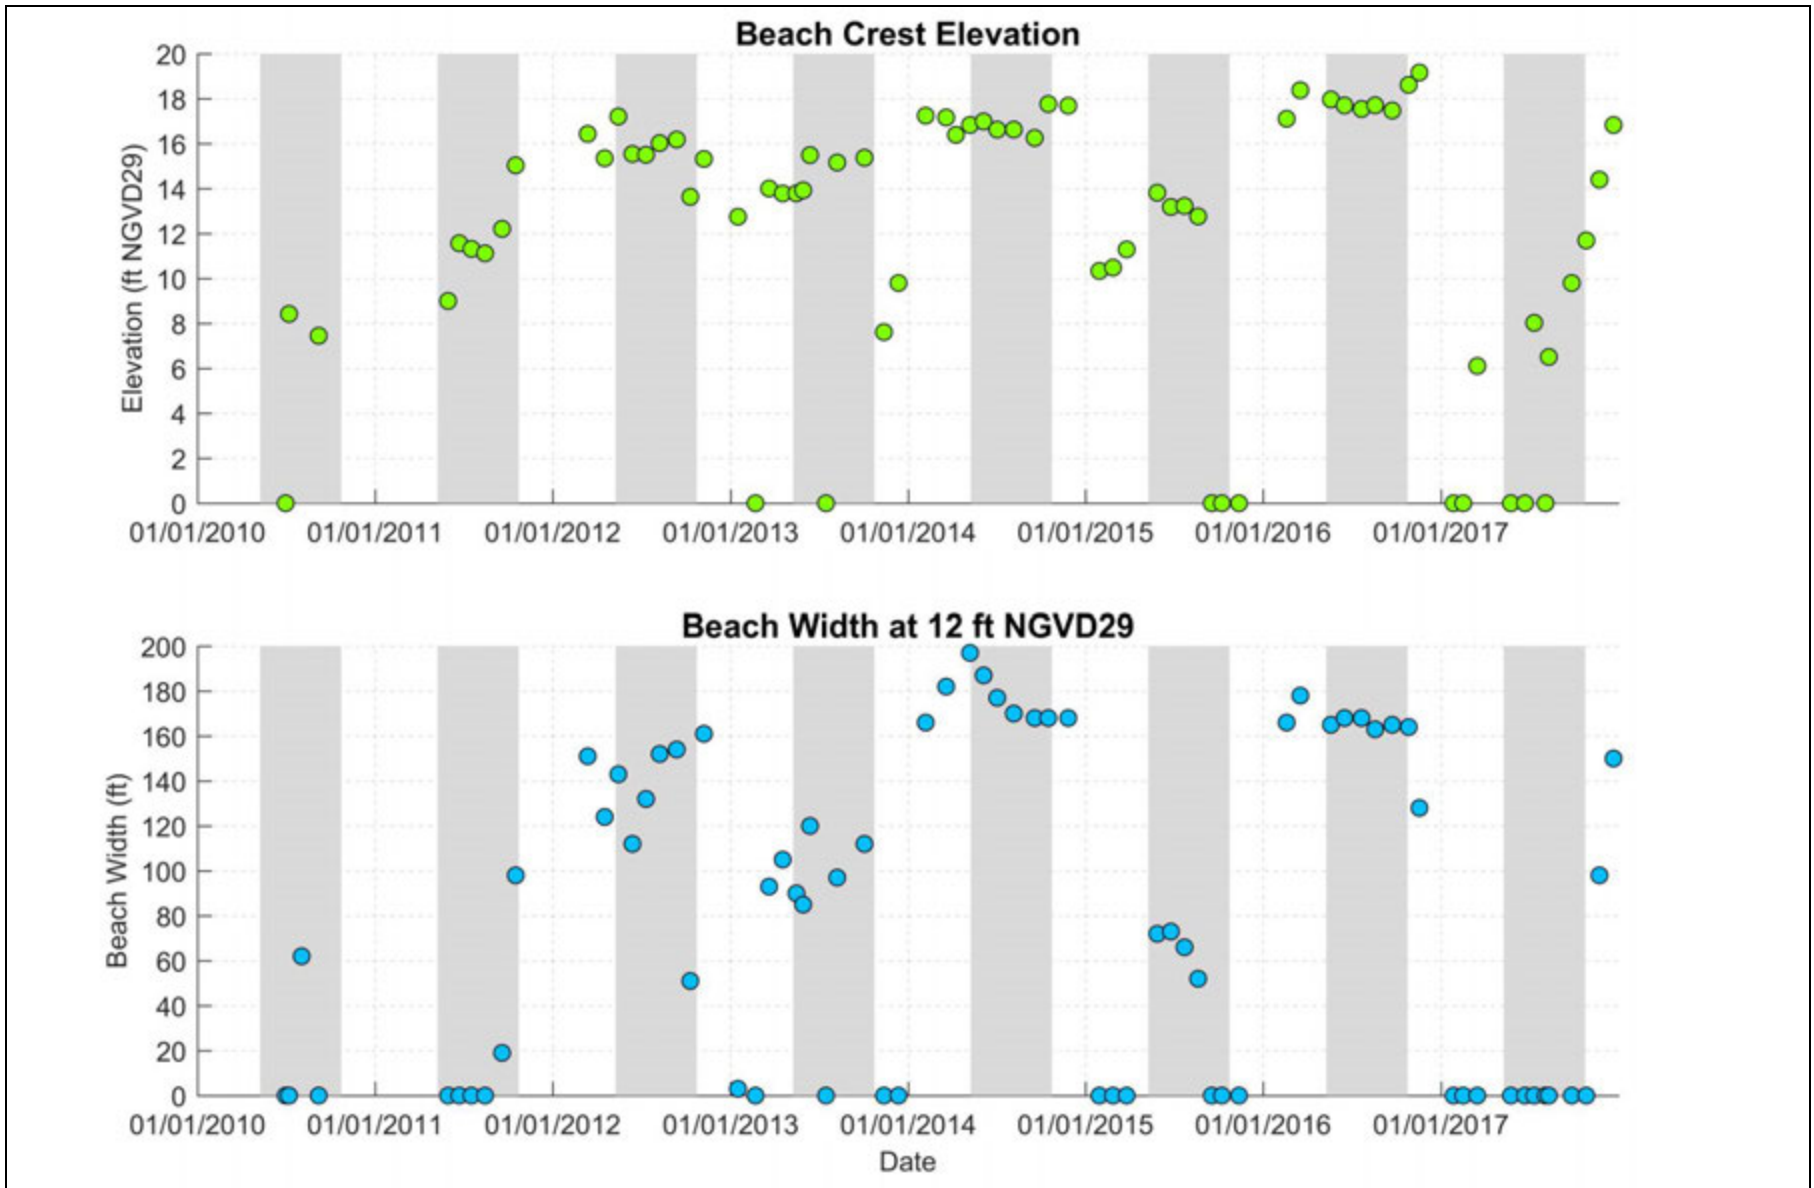
**Figure 14**

Note: width of zero indicates that the beach crest is below the elevation of 12 or 14 ft NGVD.

Transect 3 crest height and beach width (at 12ft NGVD elevation) from 2010 to 2017. Shaded areas represent management season.

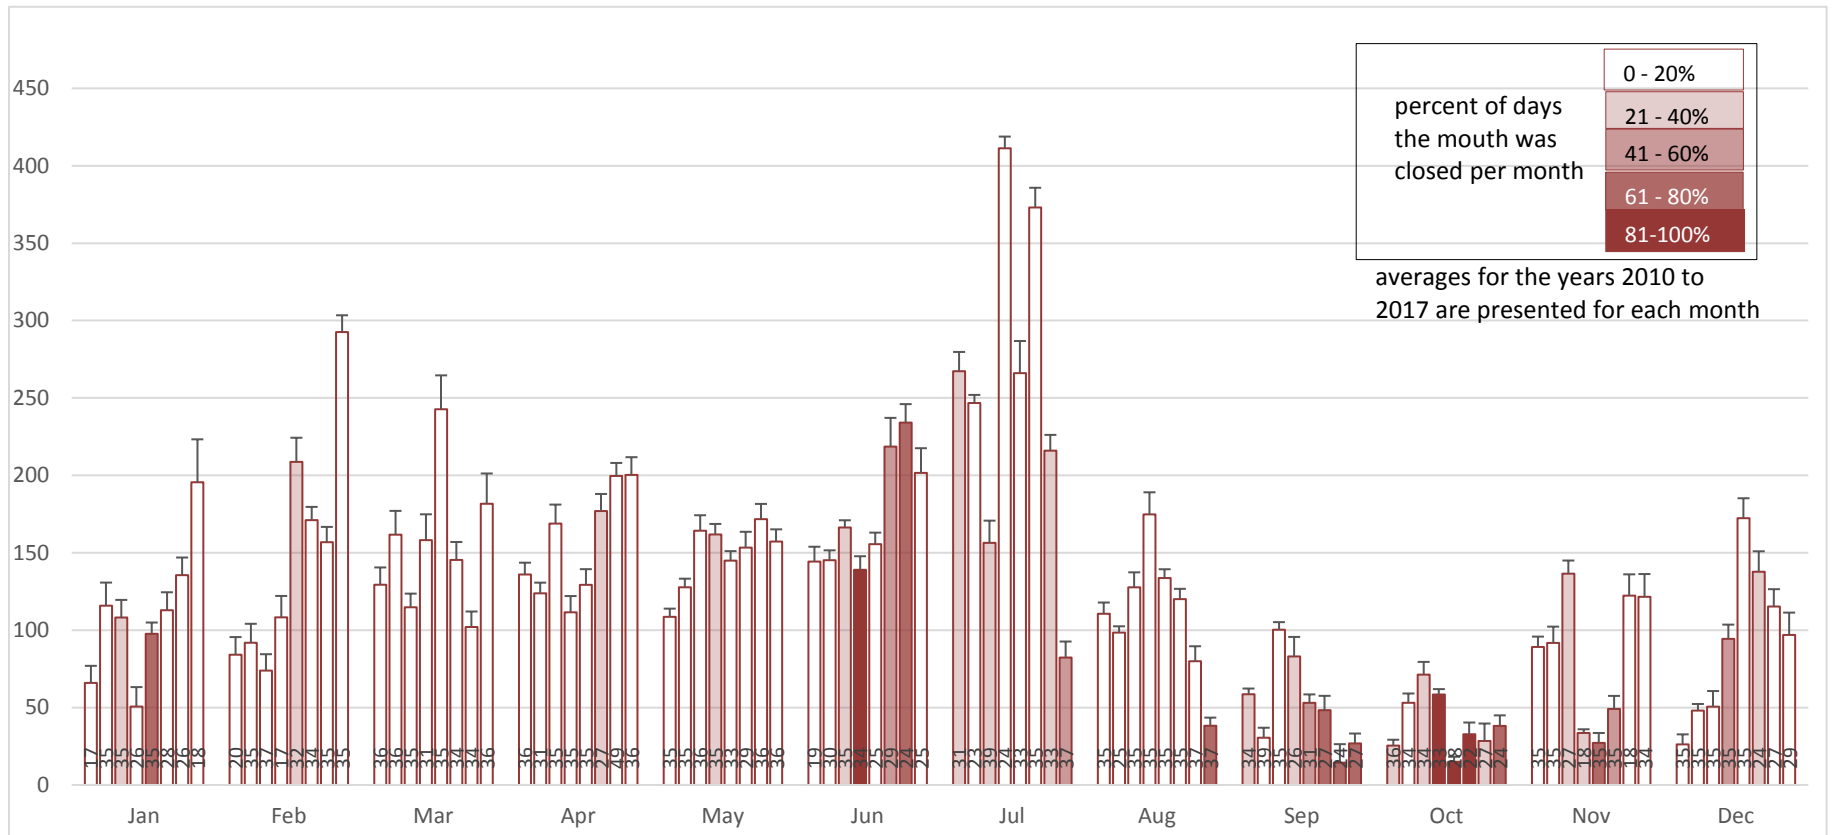
**Figure 2. The average number of harbor seals hauled out at the Jenner haul-out (Russian River mouth at Goat Rock State Beach) as counted during baseline surveys for each year (January 2010 – December 2017) categorized by month. Error bars represent standard error and sample size used to calculate means are presented inside the bars.**

Fewer seals were present during closed conditions (mean =  $22 \pm 3.5$  s.e., n = 68) compared to open conditions (mean =  $168 \pm 5.7$  s.e., n = 295; ANOVA  $p < 0.001$ ). However, the overall trend was an increase in seal abundance compared to earlier years (Figure 3).

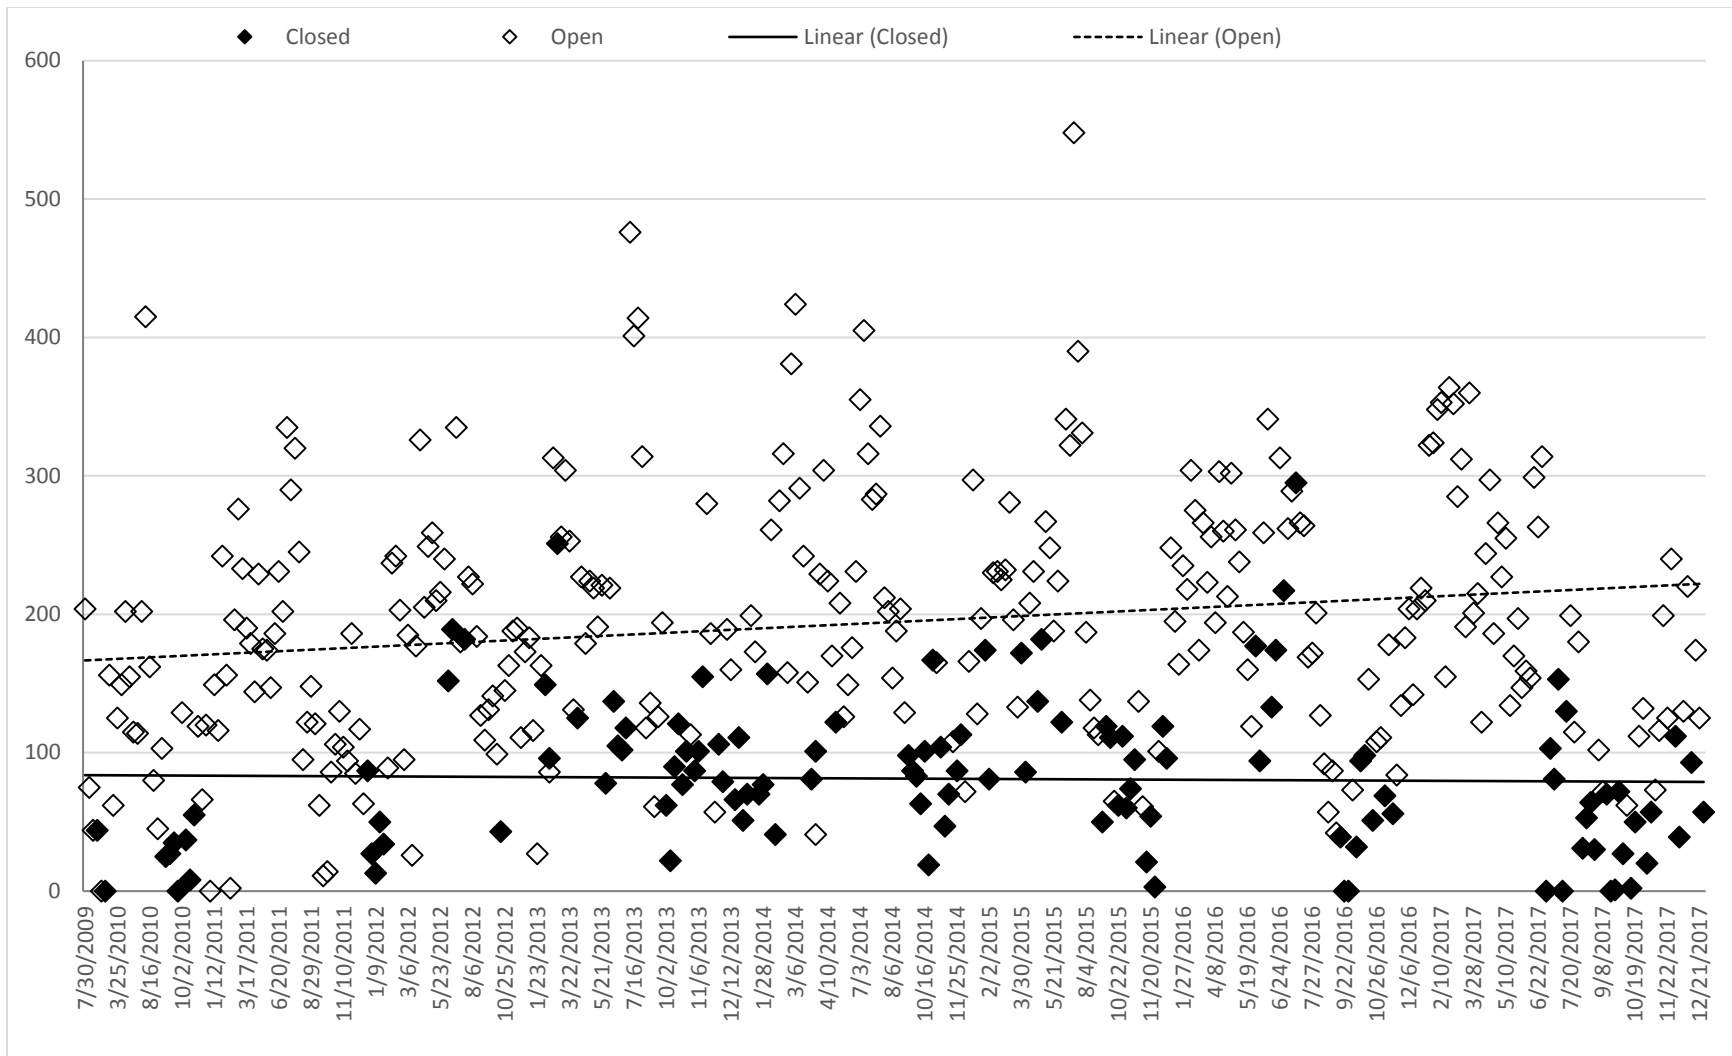
**Figure 3. Maximum number of harbor seals counted during all pinniped surveys at the Jenner haul-out (Russian River mouth at Goat Rock State Beach) since 2009. Open diamonds represent counts in mouth open conditions and black filled diamonds represent counts during mouth closed.**

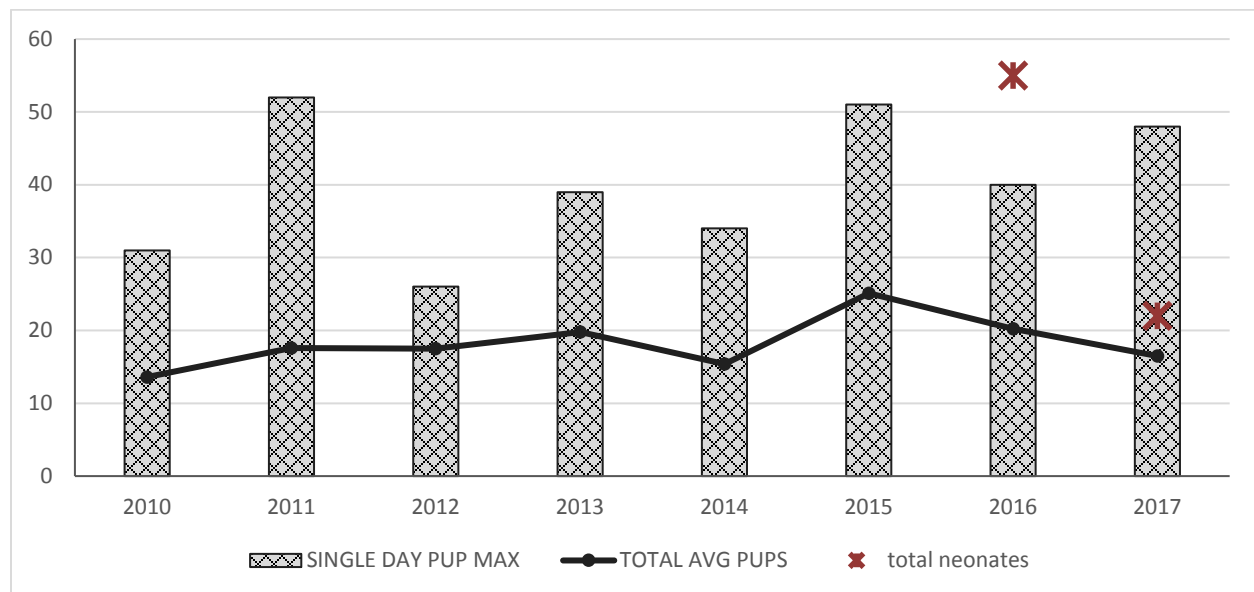
**Figure 4. Number of harbor seal pups observed at the Jenner haul-out (Russian River mouth at Goat Rock State Beach) by year. Bar height indicates the maximum single day pup count, line indicates the average of pups counted throughout the season and the red stars indicate the total number of neonates counted during weekly surveys throughout the season for each year.**

The number of pups observed at the Jenner haul-out was similar to previous years with an average of 16.5 pups observed (when pups were present) and a single highest maximum count of 48 pups for the season (Figure 4). Using the sum of the maximum number of pups observed on a single day during weekly counts in April and May, we estimate a minimum of 48 harbor seal pups born at Goat Rock State Beach in 2017. Counting neonates on the beach every 7 days and using the cumulative total of neonates to estimate the minimum number of pups born yielded a total of 22 pups, which would have underestimated the number of pups. The variability between the two methods was largely due to an observer not recoding pups of any age during one survey in May. It is unlikely there were no pups present on the beach that day, given that pups were observed the week prior and the week after.

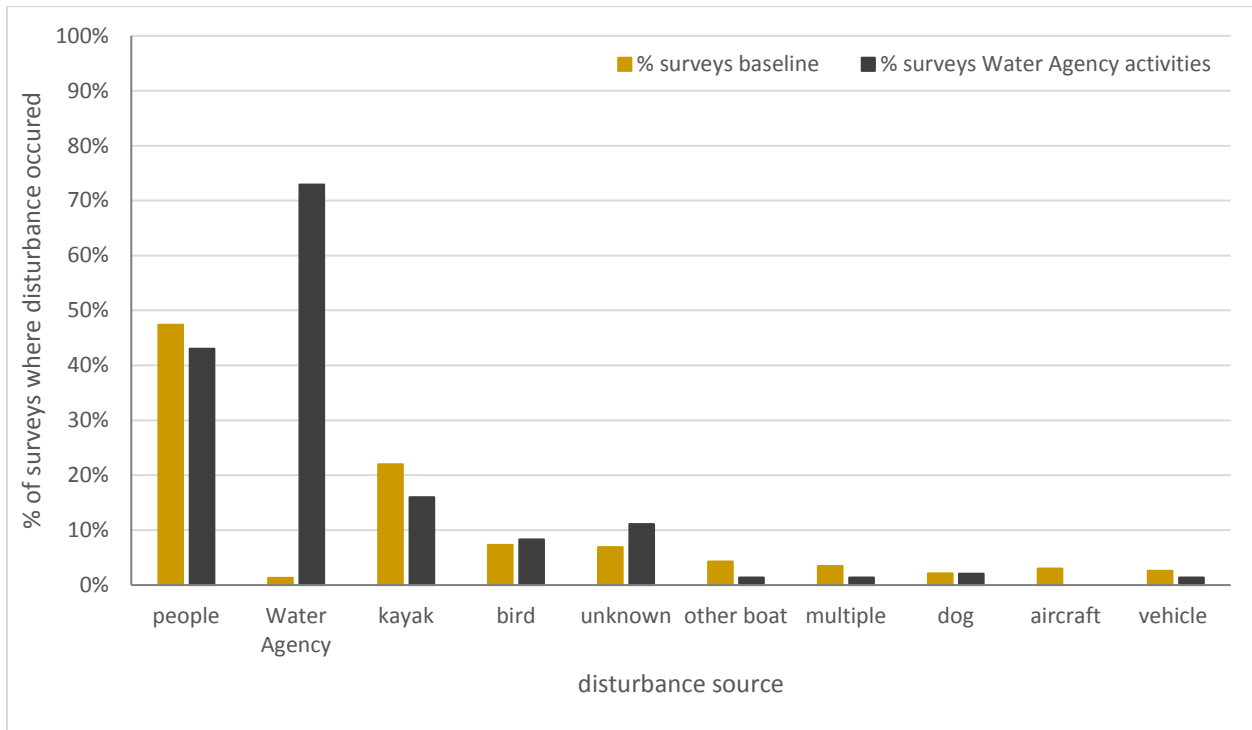
**Figure 5. The proportion of surveys where harbor seals were disturbed (moved or flushed) at the Jenner haul-out, described for each disturbance source. Data includes all baseline surveys since surveys began in 2009 (n=232) and Water Agency activity surveys (i.e., breaching, lagoon outlet implementation, topographic surveys, and jetty study) (n=144).**

Figure 5 illustrates the proportion of surveys when harbor seals were disturbed at the Jenner haul-out, categorized by disturbance source. Harbor seals were most frequently disturbed by people on foot (47% of surveys), with a similar frequency during Water Agency activities (43% of surveys). Water Agency personnel disturbed seals on 73% of days with Water Agency activity on the beach. People in kayaks were the next most frequent source of disturbance (22% of baseline surveys) (Figure 5). When people on foot were the source of a disturbance the distance between them and seals averaged 147 feet at the time the seals exhibited an alert response, 114 feet for a move response, and 102 feet for a flush response.

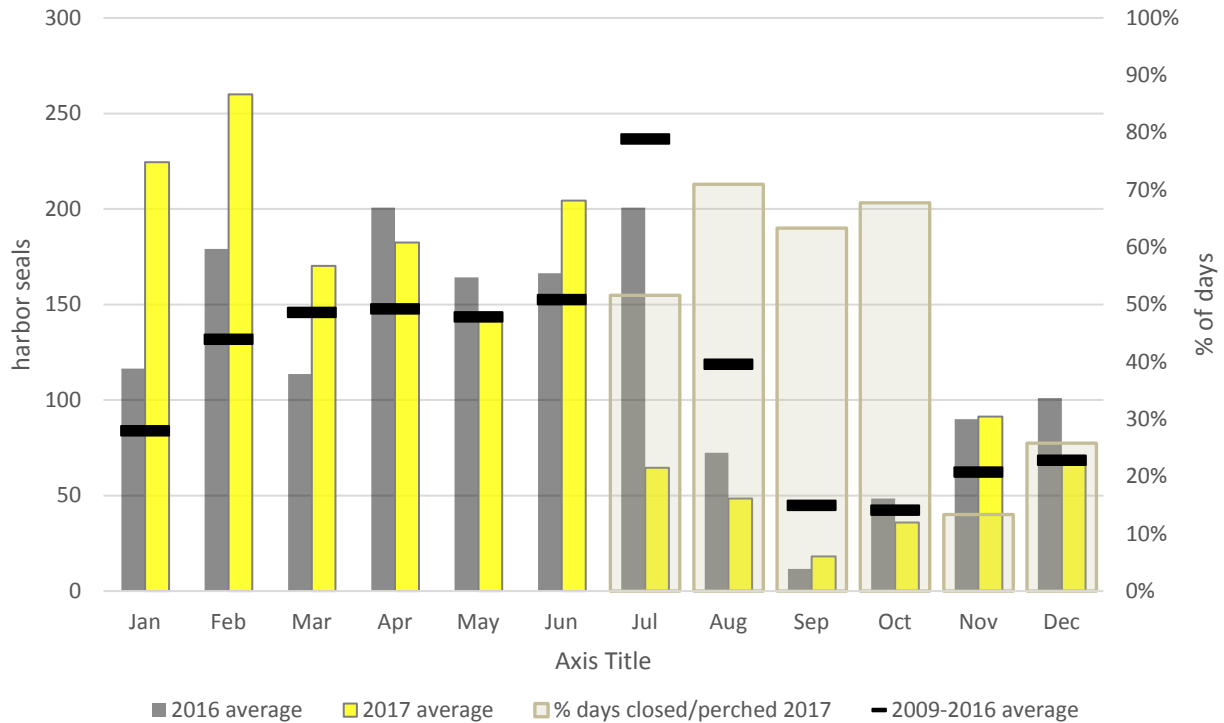
**Figure 6. Comparison of the average number of harbor seals hauled out at the Jenner haul-out by month for 2016, 2017 and the 2009-2016 average, including the percent of days the river mouth was closed or perched for each month in 2017.**
