Russian River Biological Opinion Status and Data Report

Year 2020 – 2021

**Sonoma
Water**

November 2023

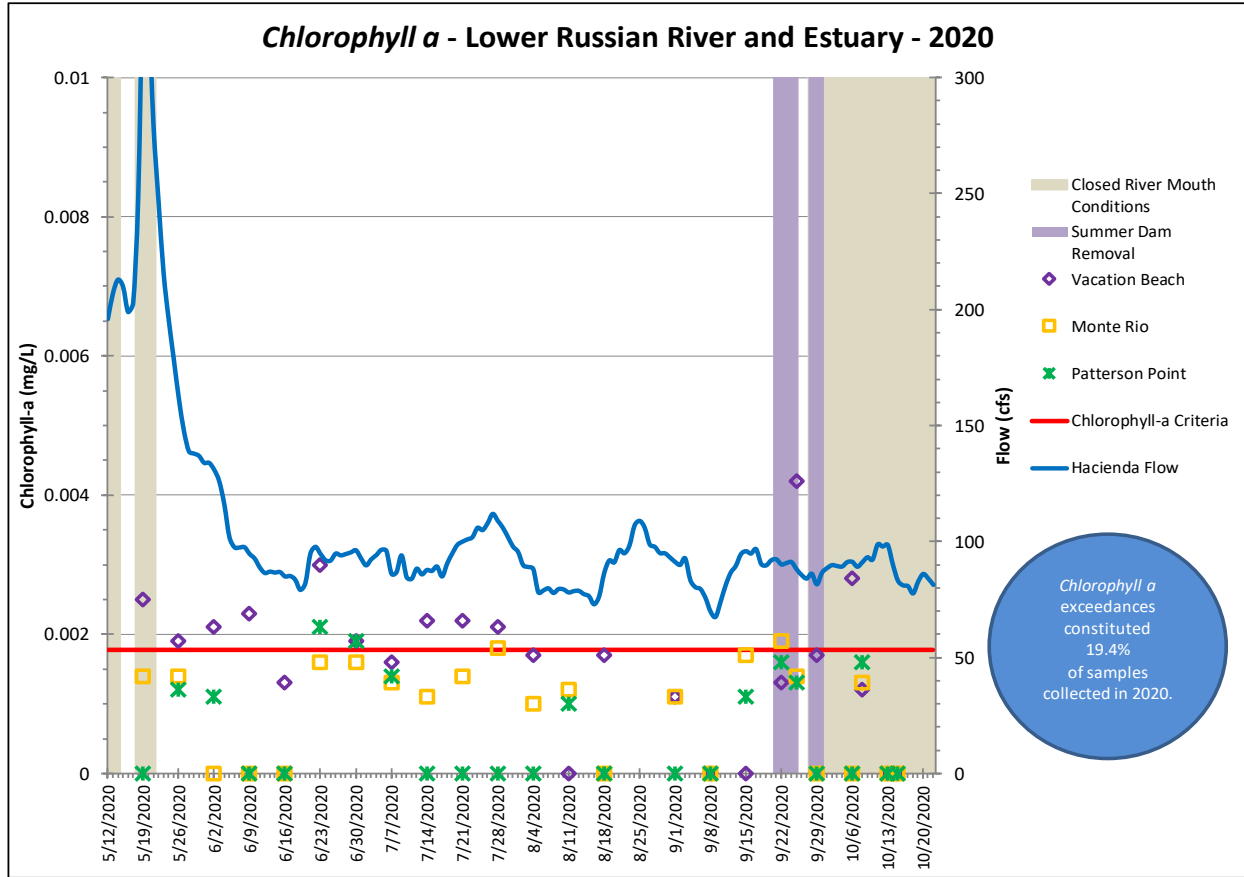
Figure 4.1.14. 2020 Russian River Grab Sampling Results for *Chlorophyll a*

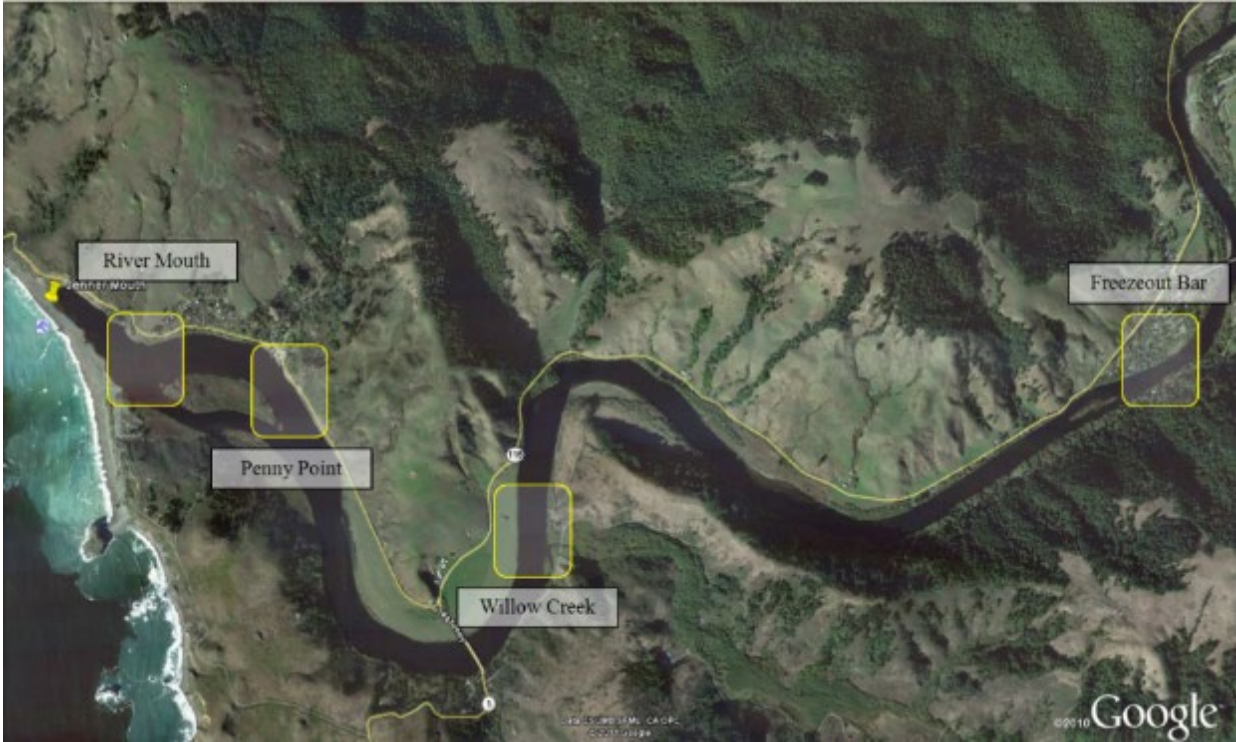
Figure 4.3.2 . Distribution of juvenile salmonid prey resource availability in three reaches of the Russian River Estuary.

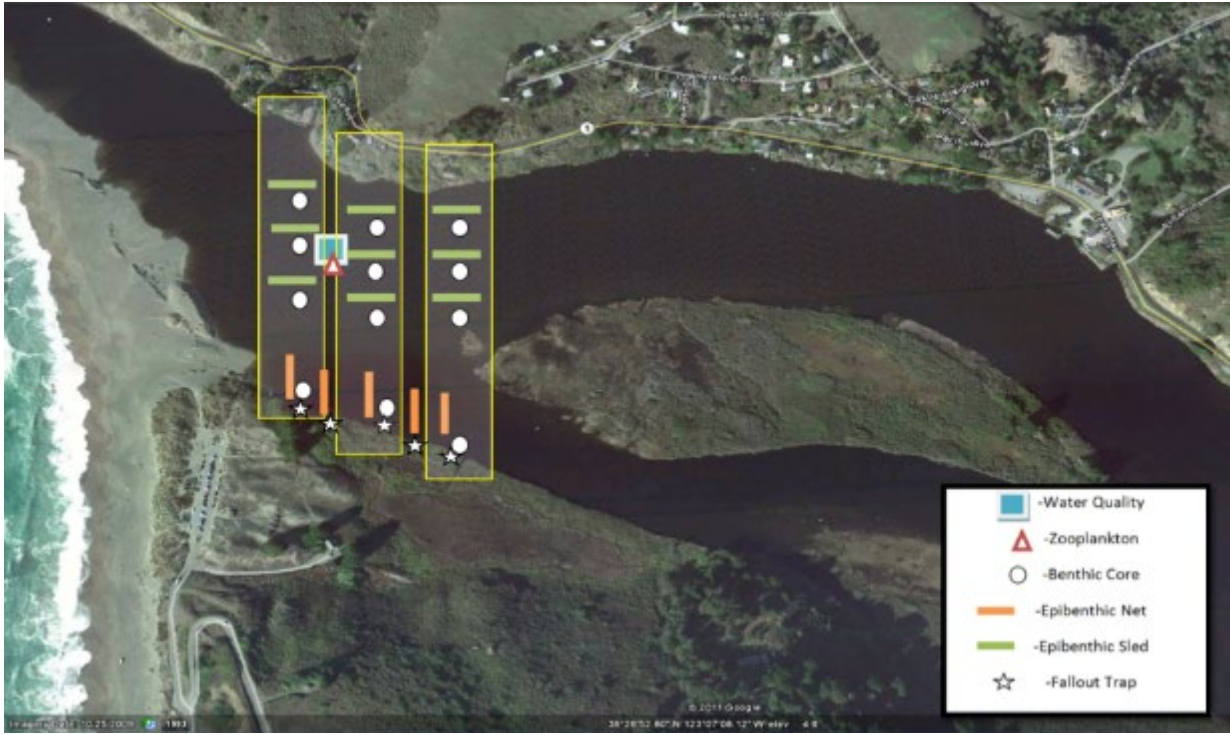
Figure 4.3.3. Distribution of juvenile salmonid prey availability sampling transects and techniques at the River Mouth site in the Russian River Estuary.

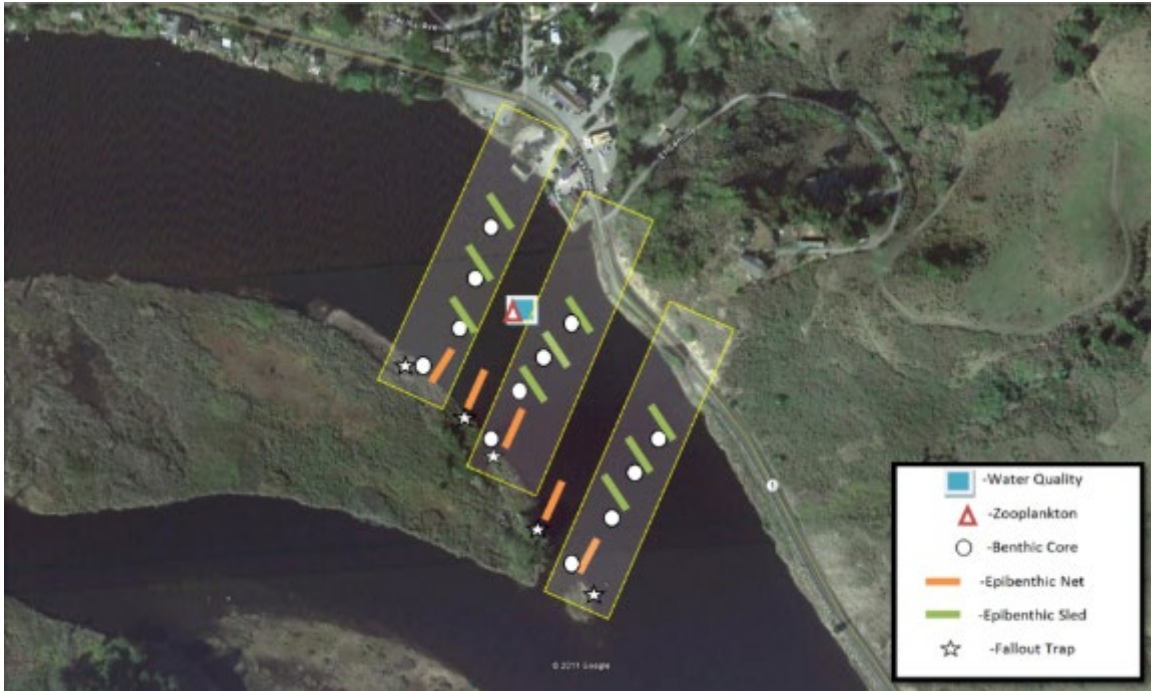
Figure 4.3.4. Distribution of juvenile salmonid prey availability sampling transects and techniques at the Penny Point site in the Russian River Estuary.

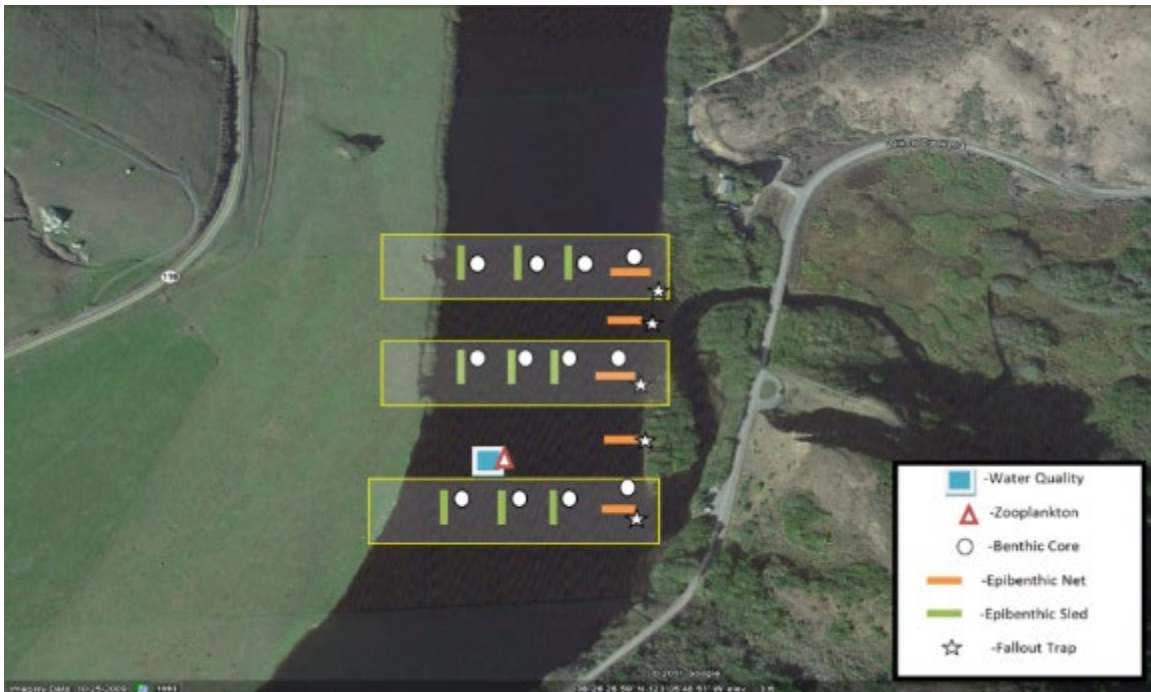
Figure 4.3.5. Distribution of juvenile salmonid prey availability sampling transects and techniques at the Willow Creek site in the Russian River Estuary.

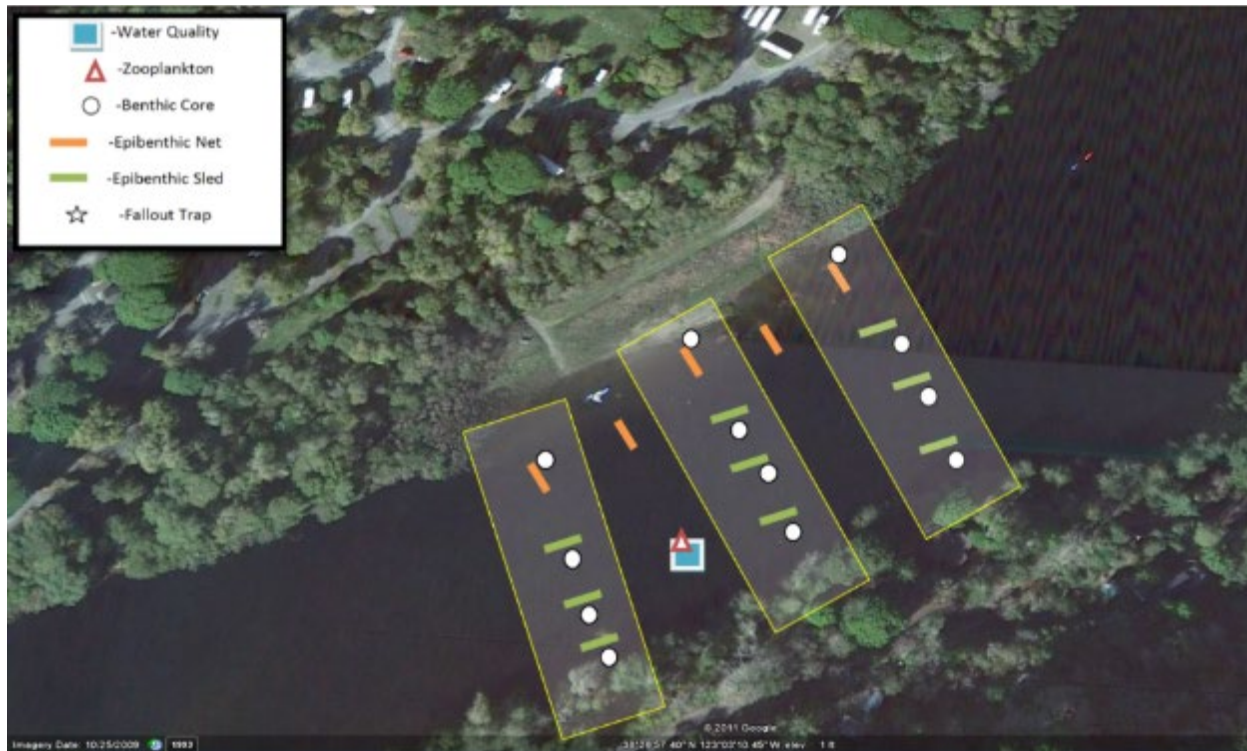
Figure 4.3.6. Distribution of juvenile salmonid prey availability sampling transects and techniques at the Freezeout Bar site in the Russian River Estuary.

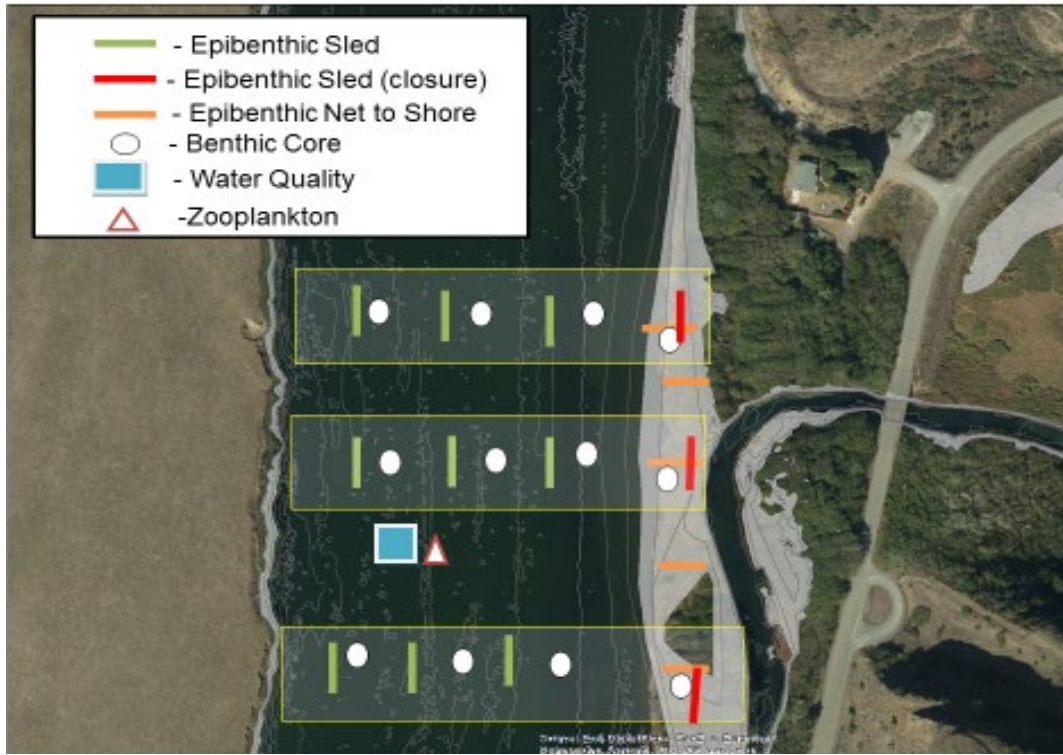
Figure 4.3.7. Modification of sampling techniques during closed conditions for distribution of juvenile salmonid prey availability sampling transects and techniques at Willow Creek site in the Russian River Estuary. The grey area is the inundation of area during closed conditions.

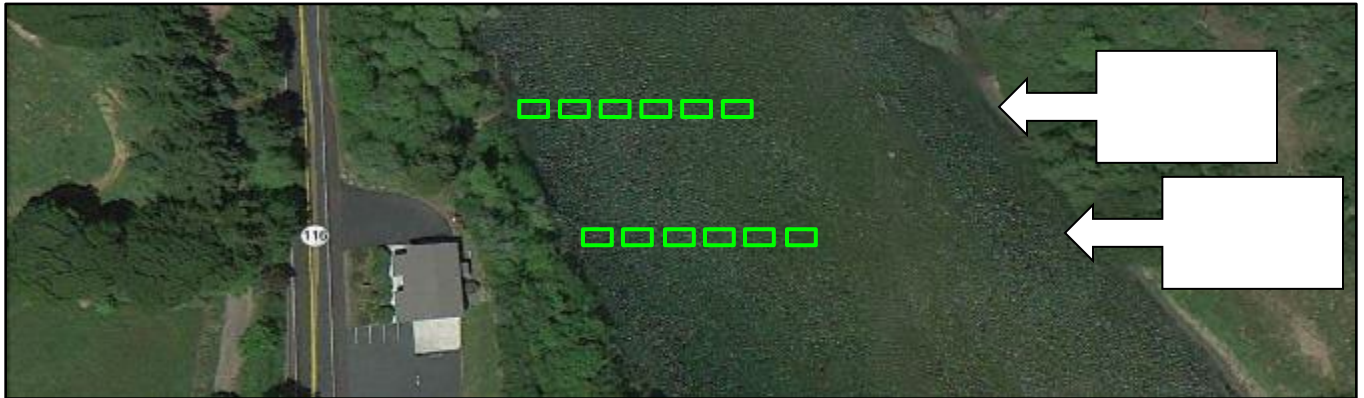
Typically two antenna arrays with multiple flat plate antennas (antennas designed to lay flat on the stream bottom) are installed in the upper Estuary near the town of Duncans Mills (rkm 10.44 and 10.46) to detect PIT-tagged fish entering the Estuary (Figure 4.5.2).

Figure 4.5.2. Flat plate antenna arrays at Duncans Mills (river km 10.44 and 10.46). Rectangles represent individual flat plate antennas.

Generally, 12 antennas were operated continuously throughout the year. The orientation of the antennas consisted of 2 rows of antennas with one row slightly upstream of the other. Each row contained 6 antennas placed side by side starting at the west river bank and extending out into the channel.

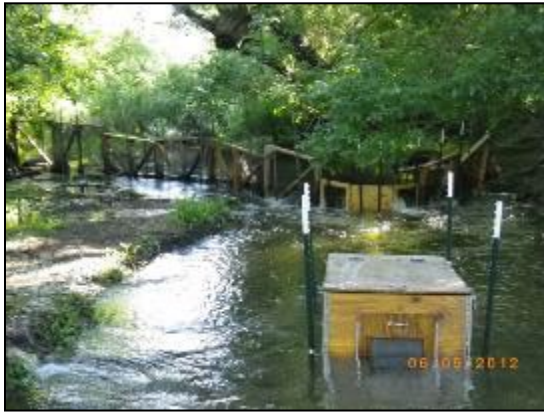
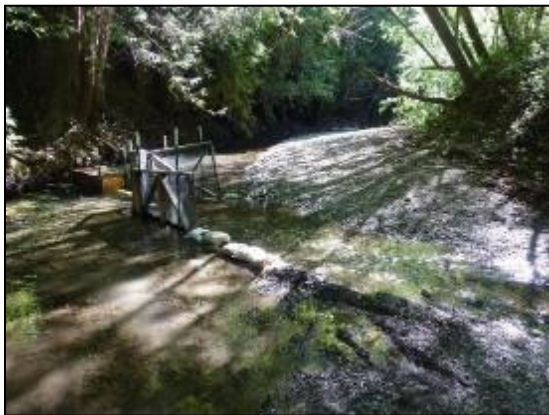
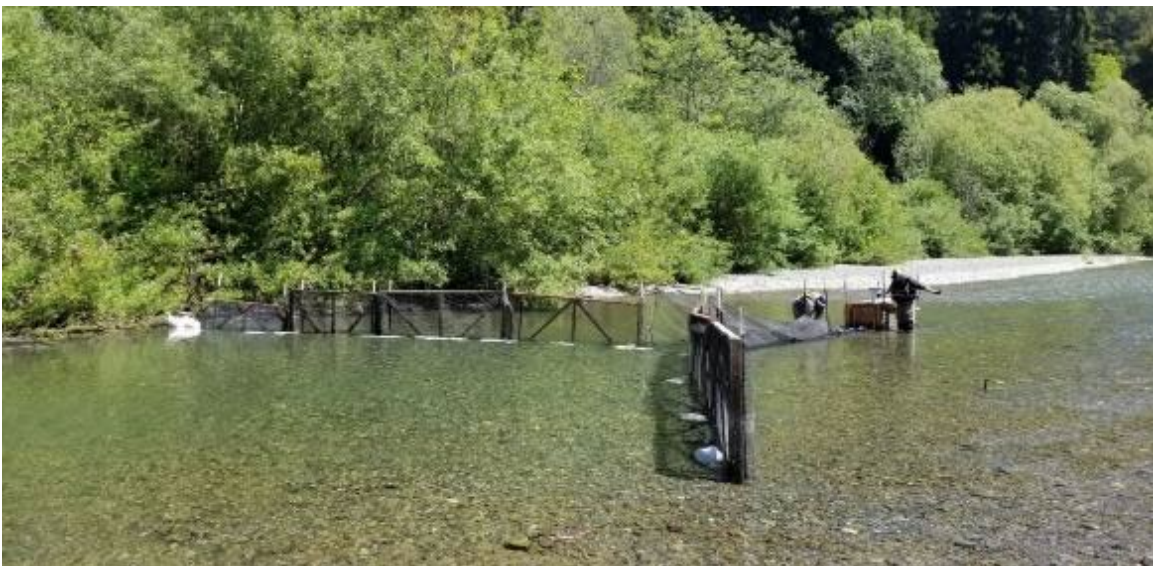
Mark West Creek: Pipe trap (fished 4/27-6/17).

Dutch Bill Creek: Funnel net (3/9-3/16).

Austin Creek: Funnel trap (fished 4/21-4/24, 5/20-6/4), pipe trap (fished 4/25-5/19, 6/5-6/12).

Figure 4.5.3. Photographs of downstream migrant traps operated by the Sonoma Water (Mark West, Dutch Bill and Austin creeks). See the Russian River Biological Opinion Status and Data Report year 2020-2021 for details regarding operation of the Mirabel and Dry Creek traps.

A pipe trap was installed on Mark West Creek approximately 4.8 km upstream of the mouth on April 28. The pipe trap was removed and all trapping operations were suspended on June 17 when fish captures declined rapidly (Table 4.5.1).

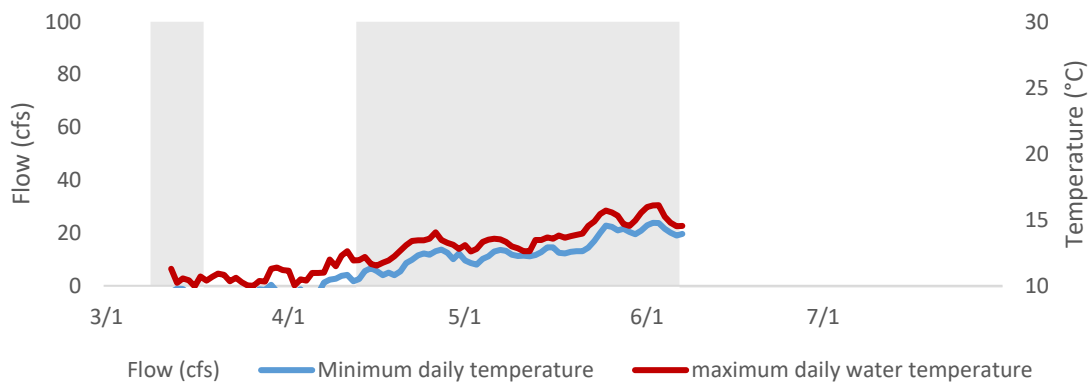
Figure 4.5.5. Environmental conditions at downstream migrant detection sites from March 1 to July 31, 2020. Gray shading indicates the proportion of each day that each facility was operated. Discharge data are from the USGS gage at Healdsburg (mainstem Russian, 11464000), the USGS gage at Trenton-Healdsburg Road (Mark West Creek, 11466800), a gage operated by CMAR on Dutch Bill Creek (data unavailable in 2020) and the USGS gauge at Cazadero (Austin Creek, 11467200). Stage (max daily) data for the Estuary are from the USGS gage near Highway 1 (11467270). Estuary and Mainstem water temperature data are from the USGS Hacienda gage (11467000) approximately 20 river Km upstream of the Estuary. At all other sites temperature data are from the data loggers operated by Sonoma Water at each monitoring site.

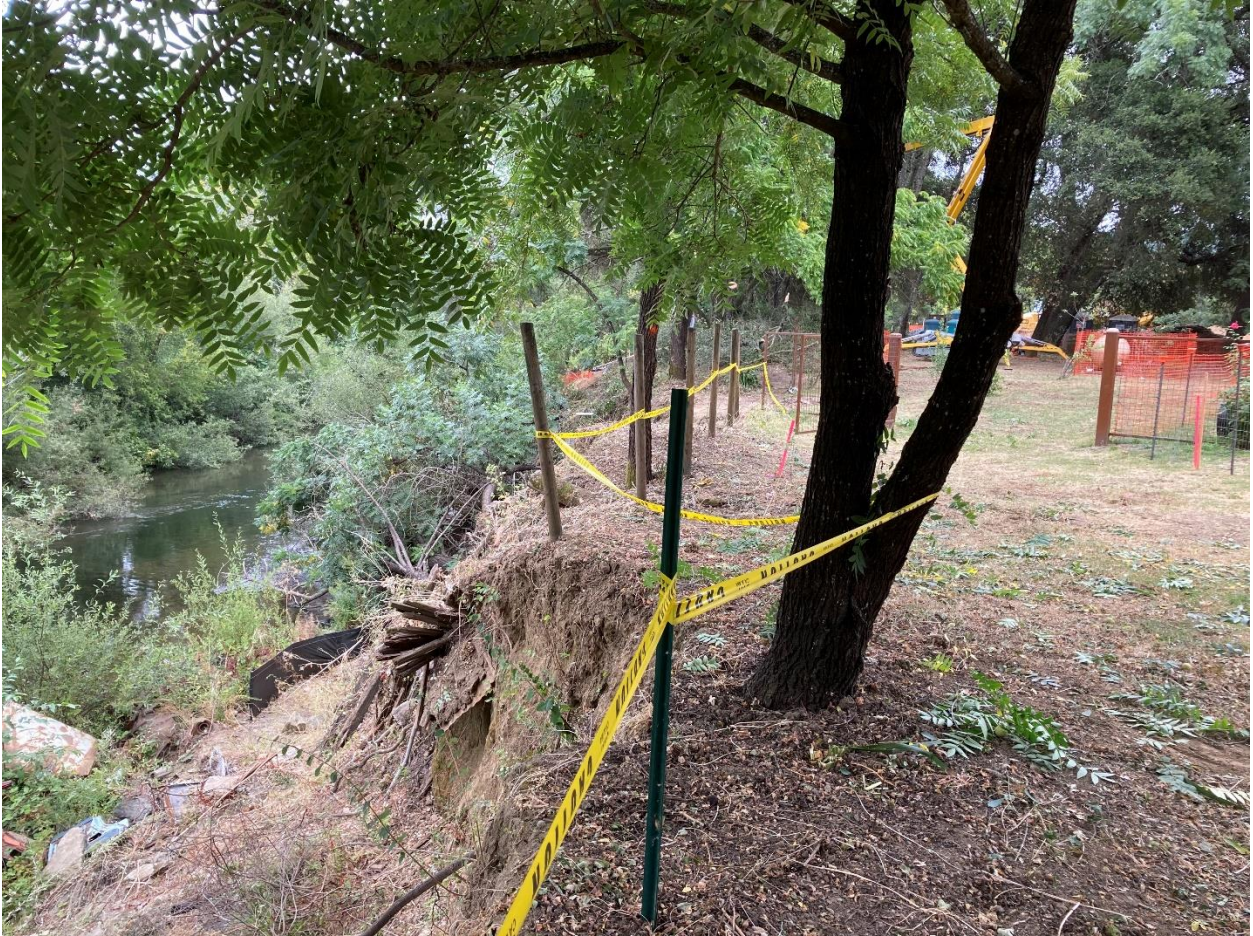
Photo 5.1.1. Phase 3, Part 3. Upper end of bank stabilization work area, looking downstream pre-project condition. July 30, 2020.

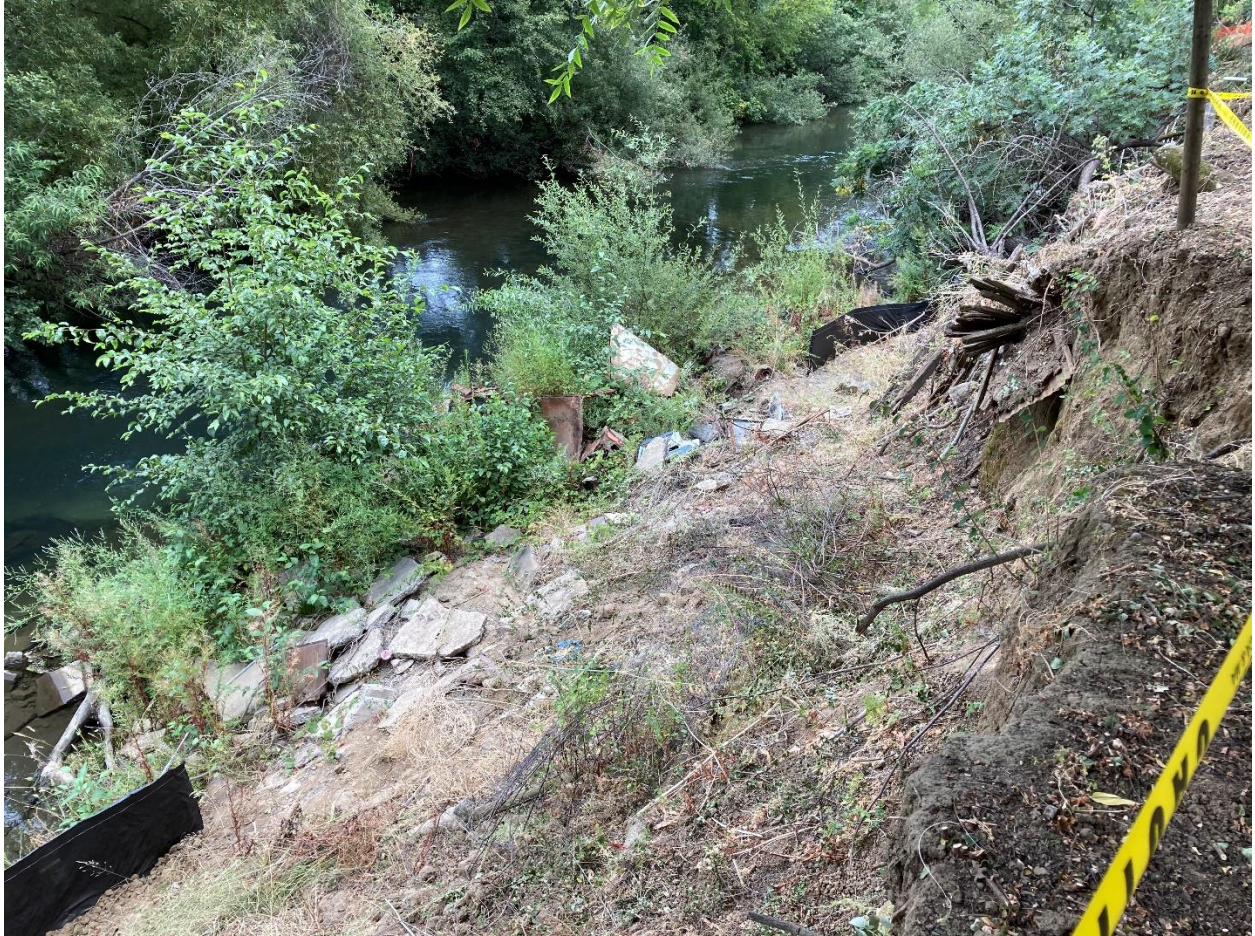
Photo 5.1 2. Phase 3, Part 3. Upper end of bank stabilization work area, looking downstream pre-project condition. July 30, 2020.

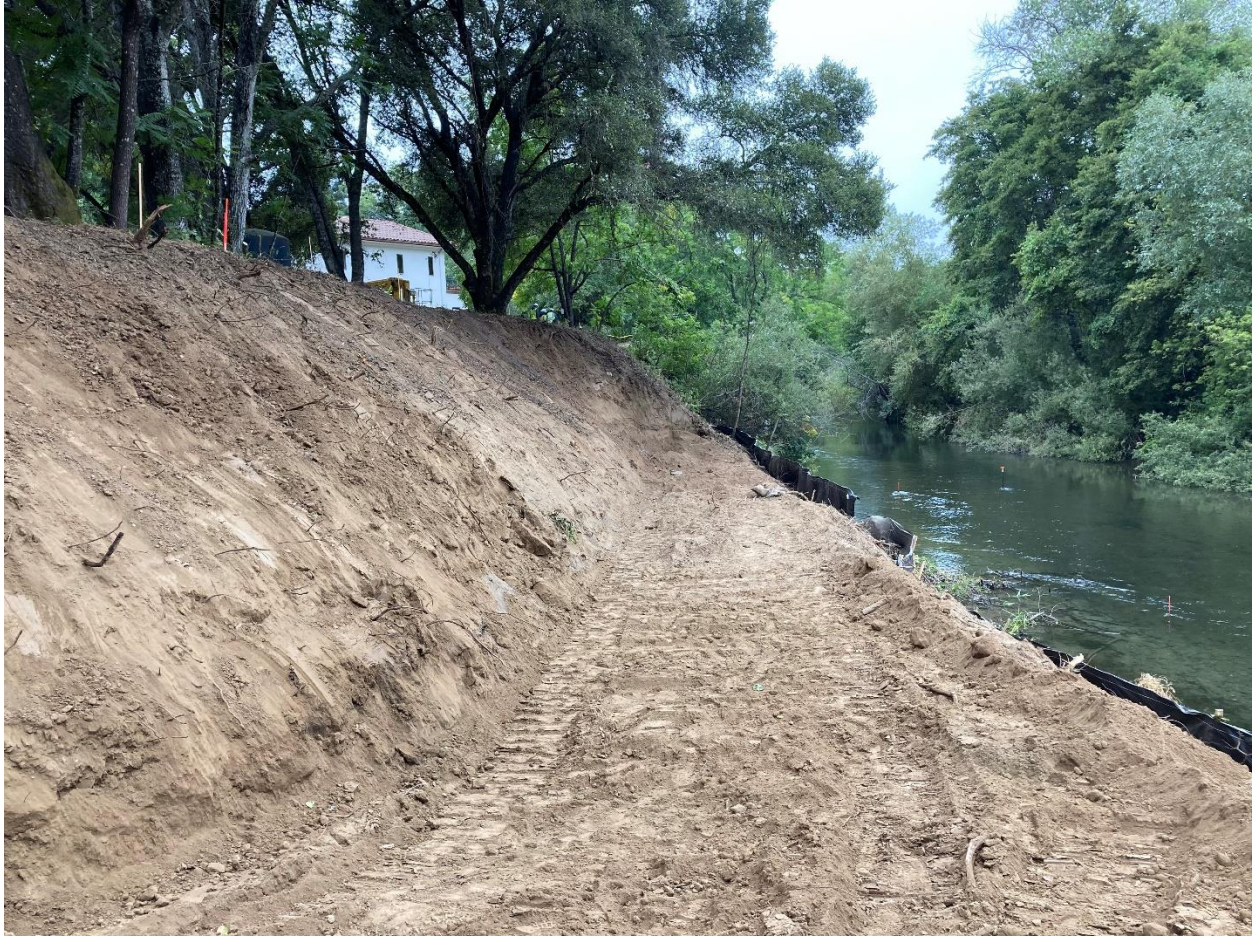
Photo 5.1.3. Phase 3, Part 3. Lower end of bank stabilization work area, looking upstream. Initial clearing and access road underway. July 30, 2020.

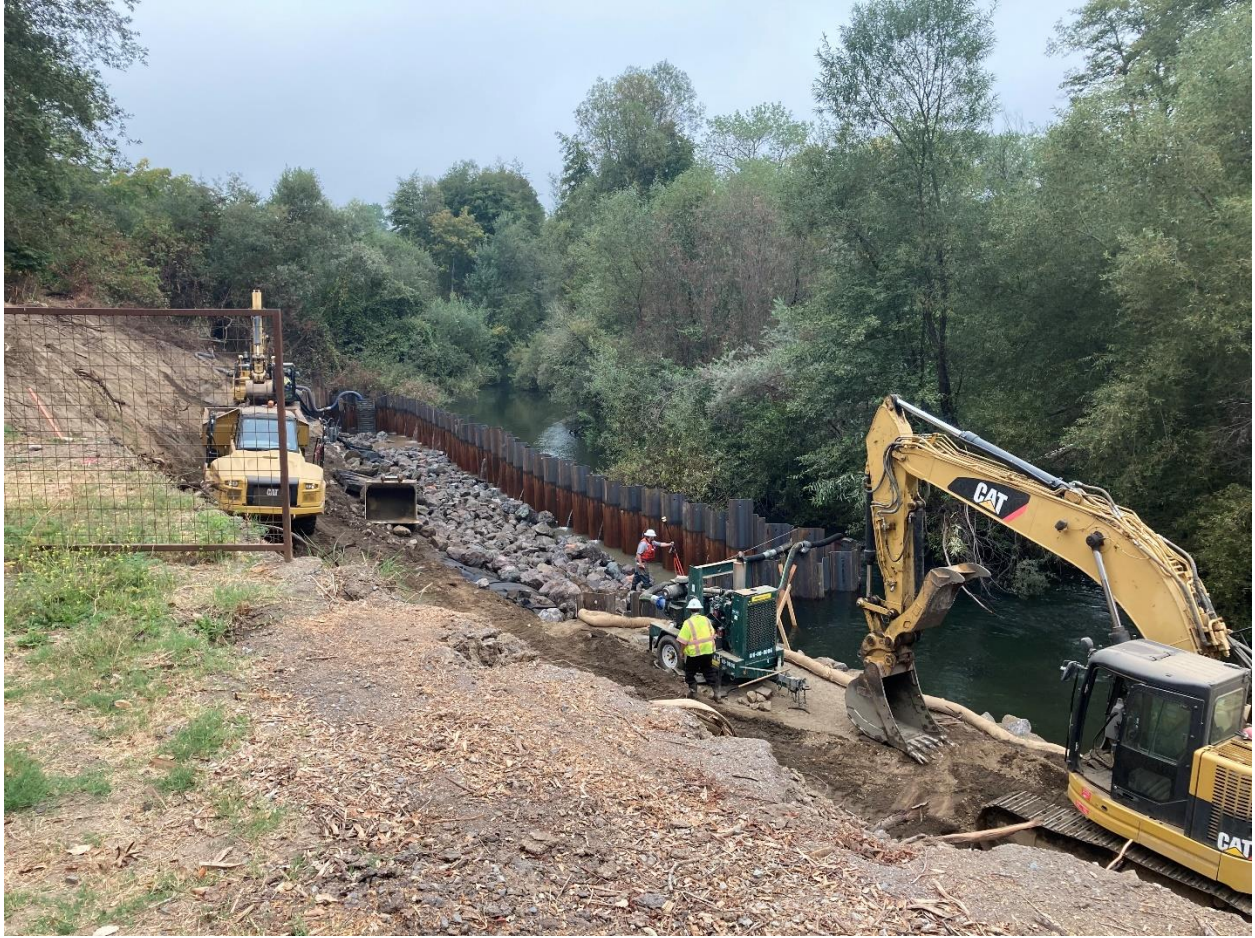
Photo 5.1.4. Phase 3, Part 3. Rock slope protection construction in progress. Note sheet-pile isolating work area from active flow of Dry Creek. September 10, 2020.

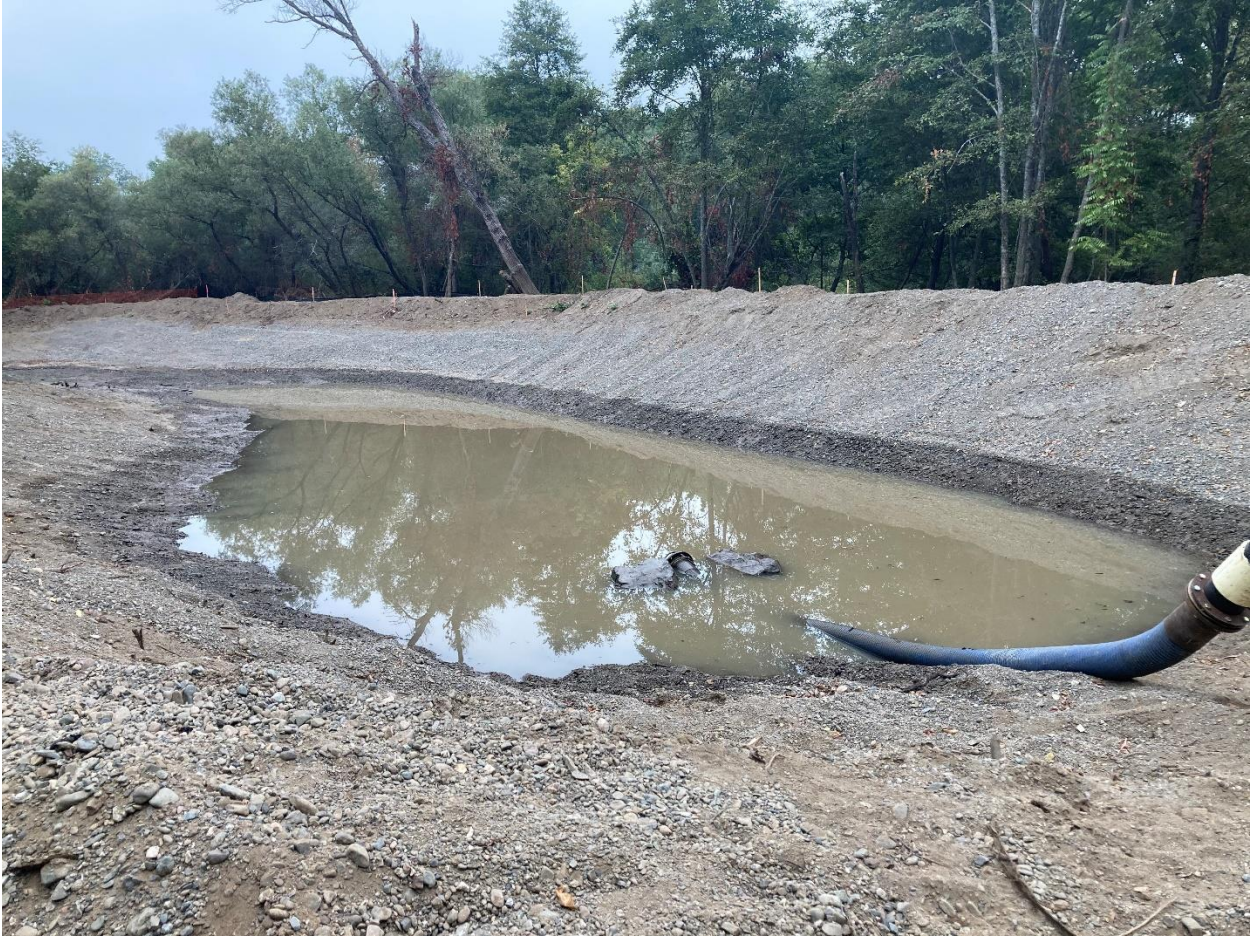
Photo 5.1.5. Phase 3, Part 3. Initial clearing of habitat site work area and being used as a dewatering basin for the bank stabilization work. September 10, 2020.

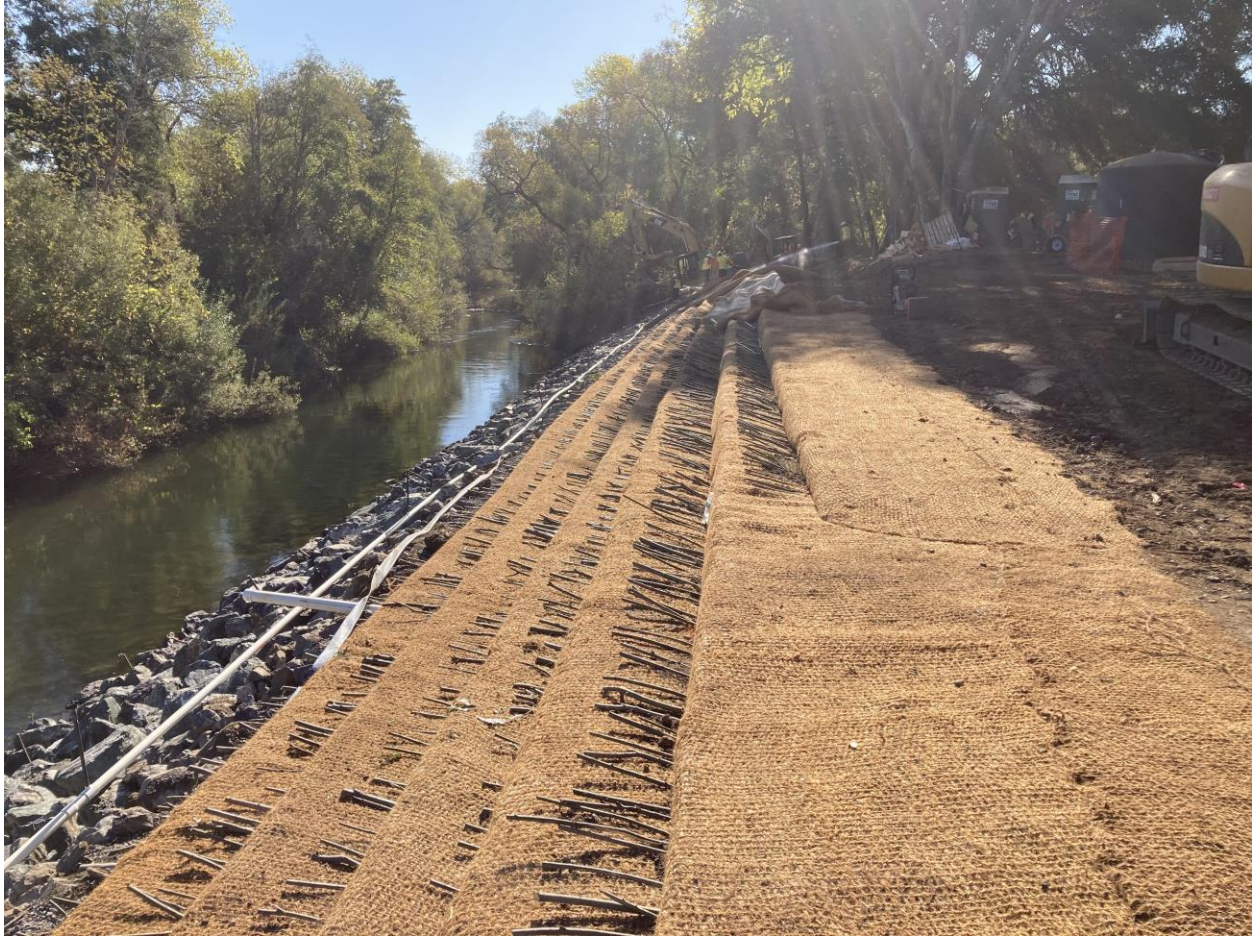
Photo 5.1.7. Phase 3, Part 3. Bank stabilization section work is complete. November 3, 2020.

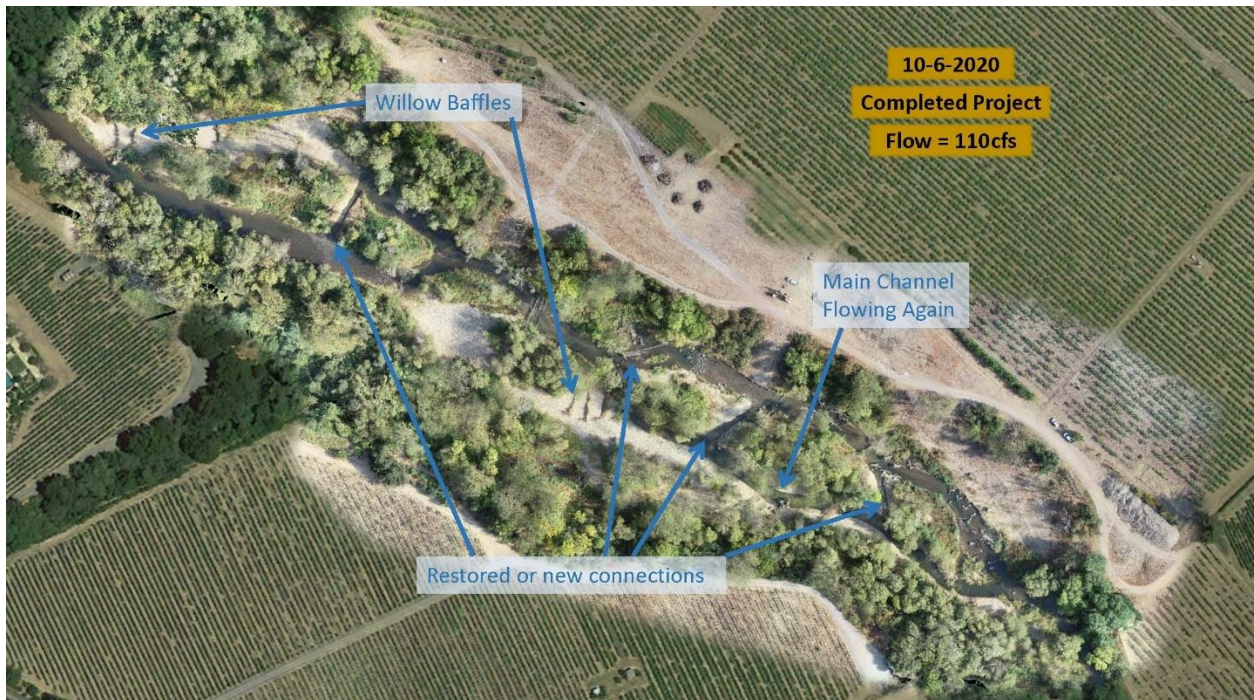
Photo 5.1.13. Reach 4A after 2020 maintenance work complete. October 6, 2020.

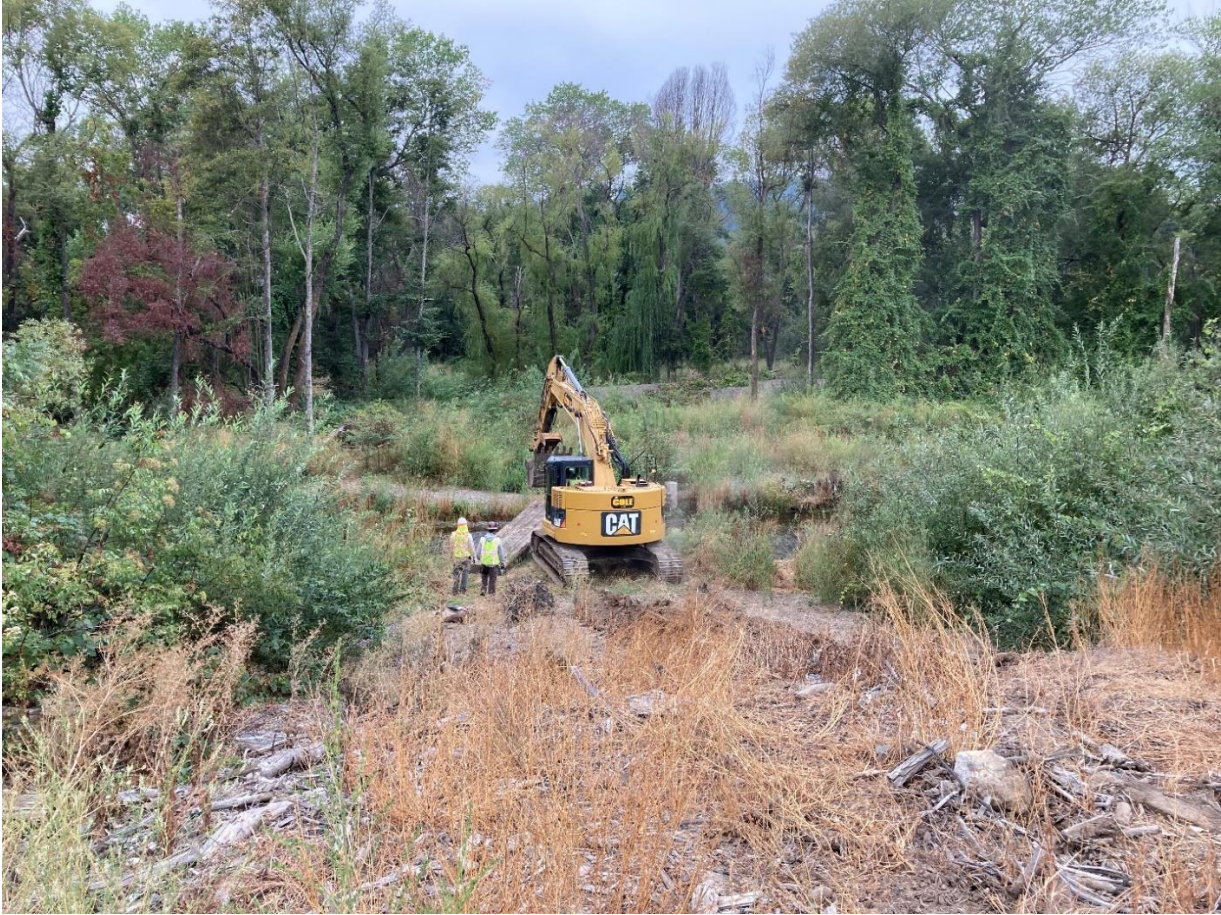
Photo 5.1.14. Reach 4A. Bridge crossing installation. September 2, 2020.

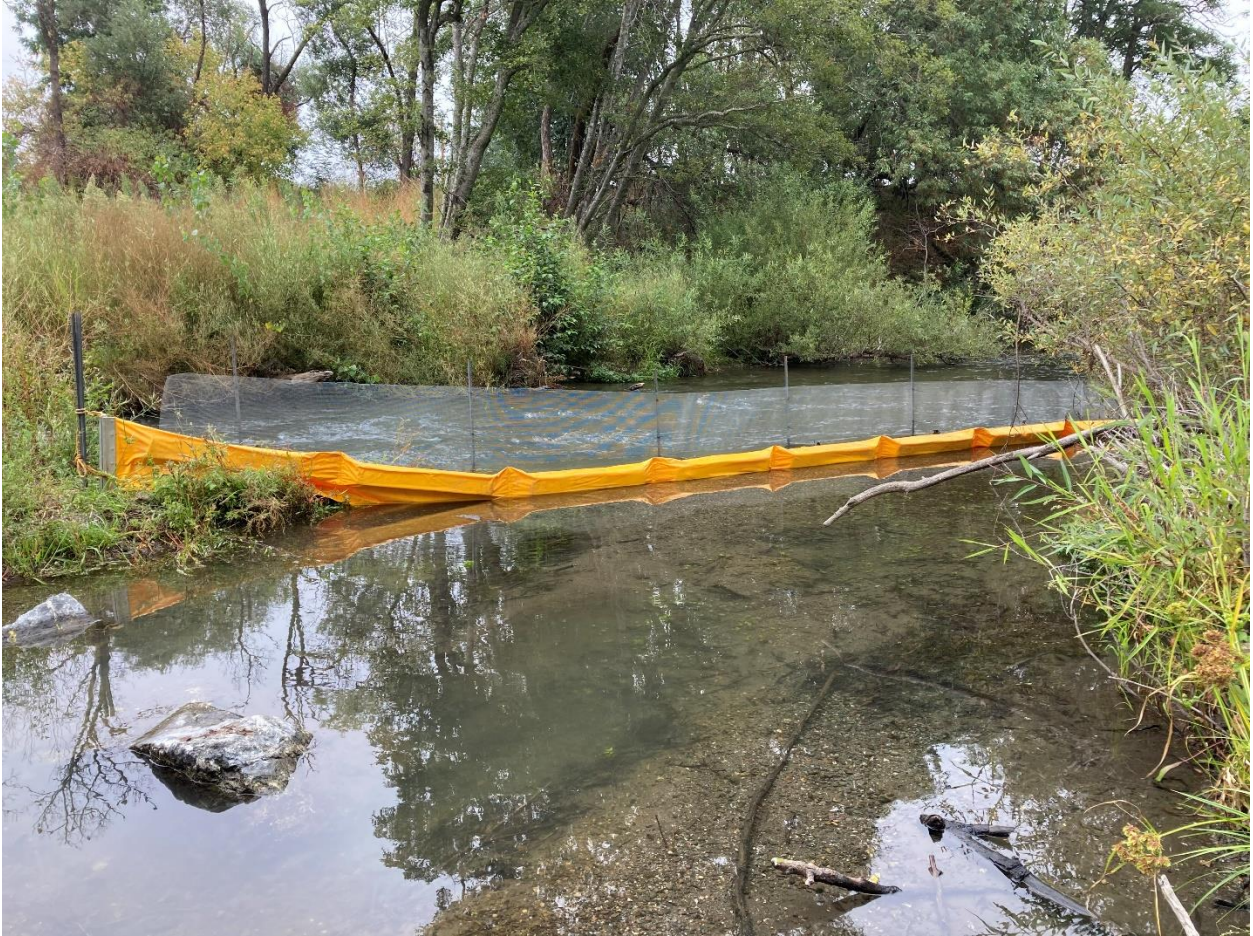
Photo 5.1.15. Reach 4A. Turbidity curtain and fish screening installed at downstream end of habitat work. September 3, 2020.

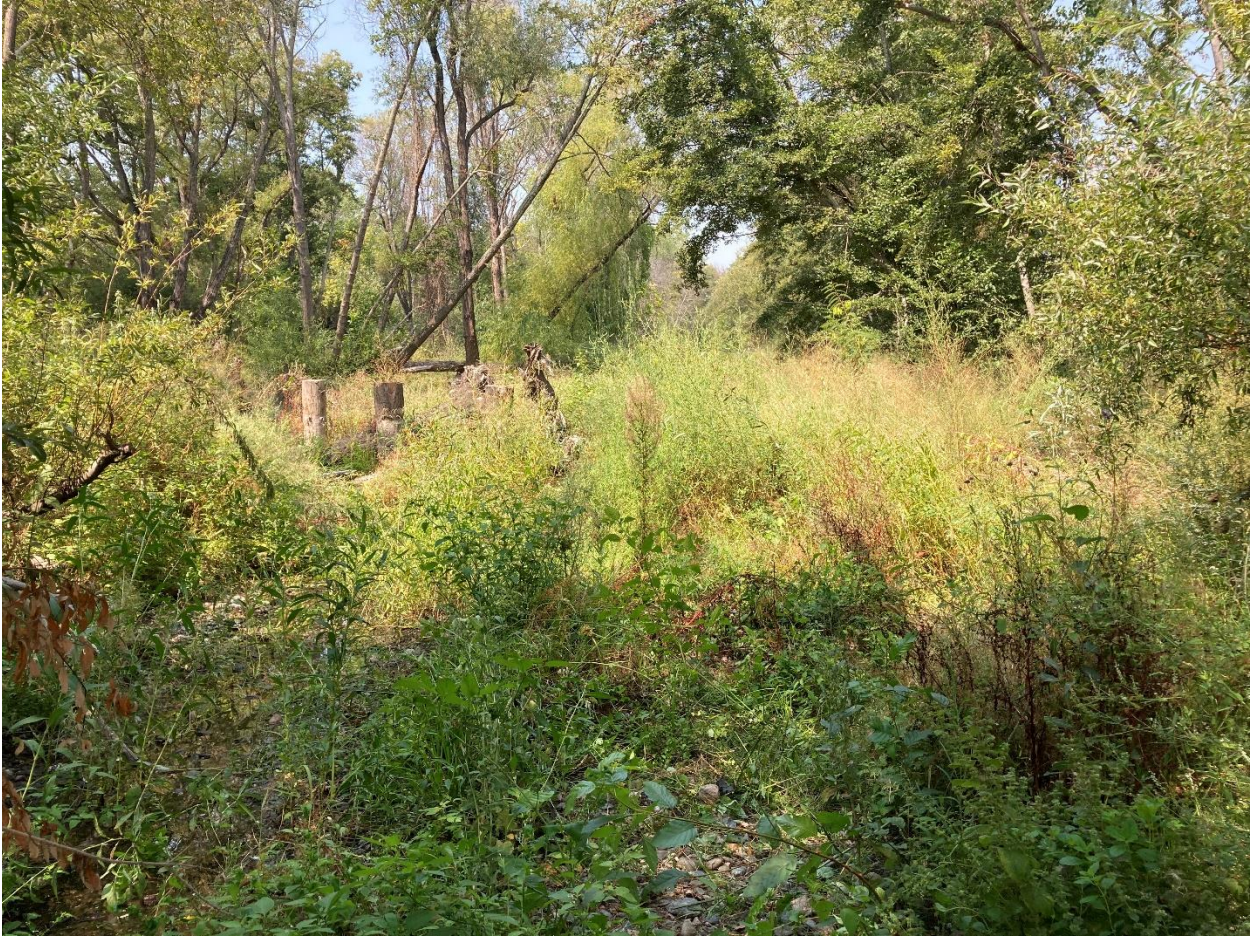
Photo 5.1.16. Reach 4A. Existing aggraded area in Reach 4. Existing habitat structure visible. Low flow no longer exists in this area due to aggradation that occurred in high flow events. September 3, 2020.

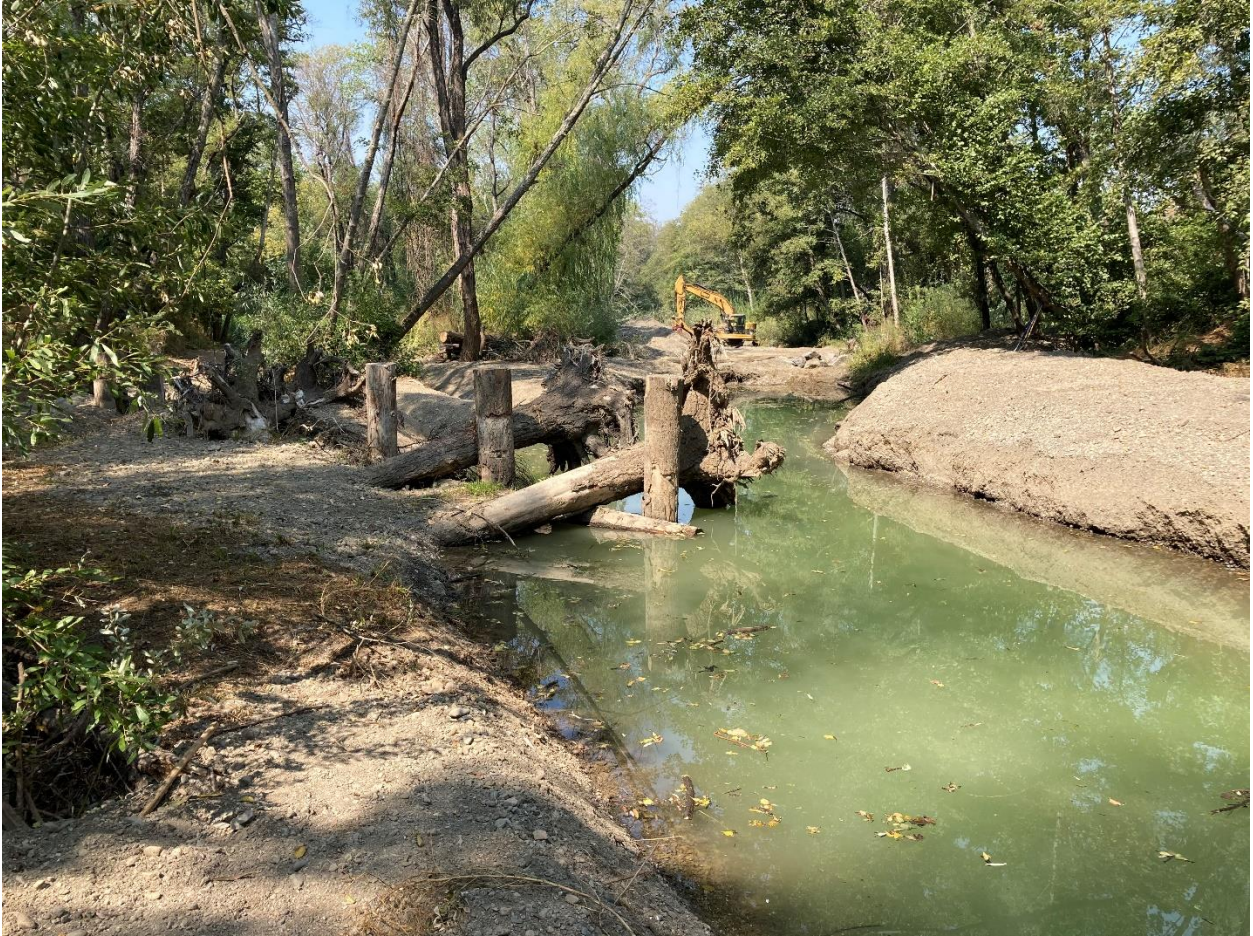
Photo 5.1.17. Reach 4A. Same view as in photo 5.1.10 above. Low flow channel re-established and existing habitat structure exposed again. September 21, 2020.
