Russian River Biological Opinion Status and Data Report

Year 2020 – 2021

**Sonoma
Water**

November 2023

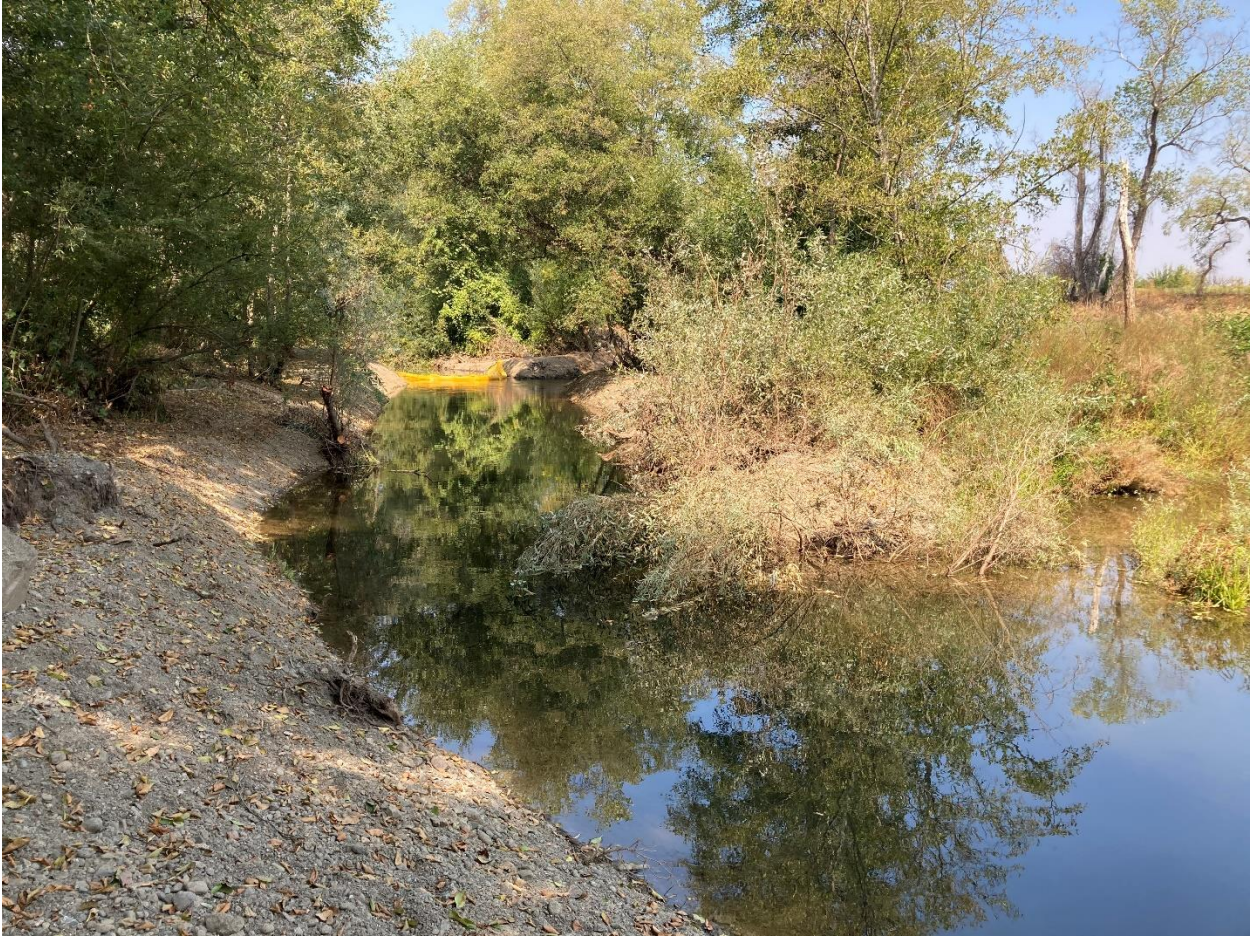
Photo 5.1.18. Reach 4A. Low flow channel re-established at lower end of Reach 4. September 21, 2020.

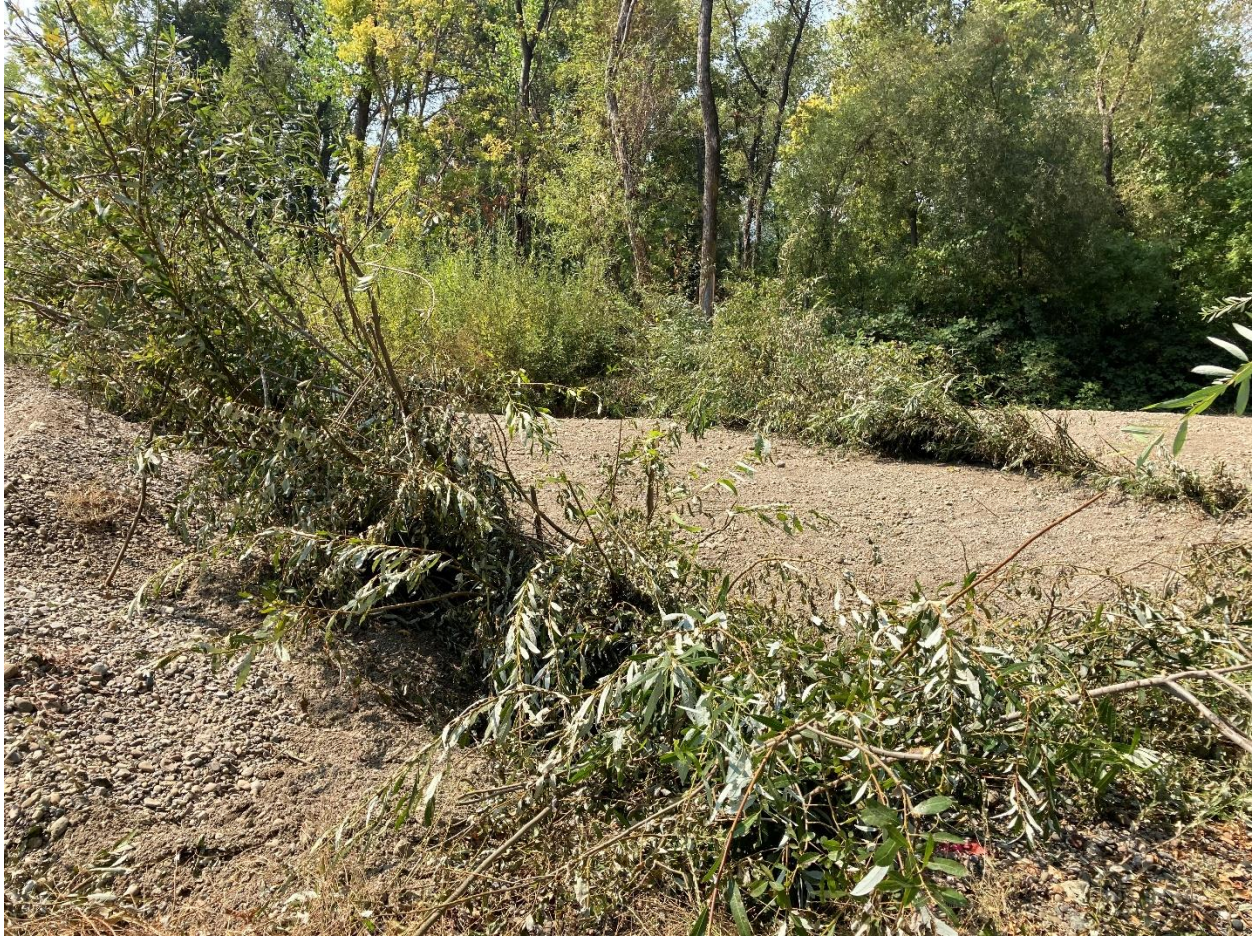
Photo 5.1.19. Reach 4A. New willow baffles installed to discourage paths for future aggradation within the habitat site. September 21, 2020.

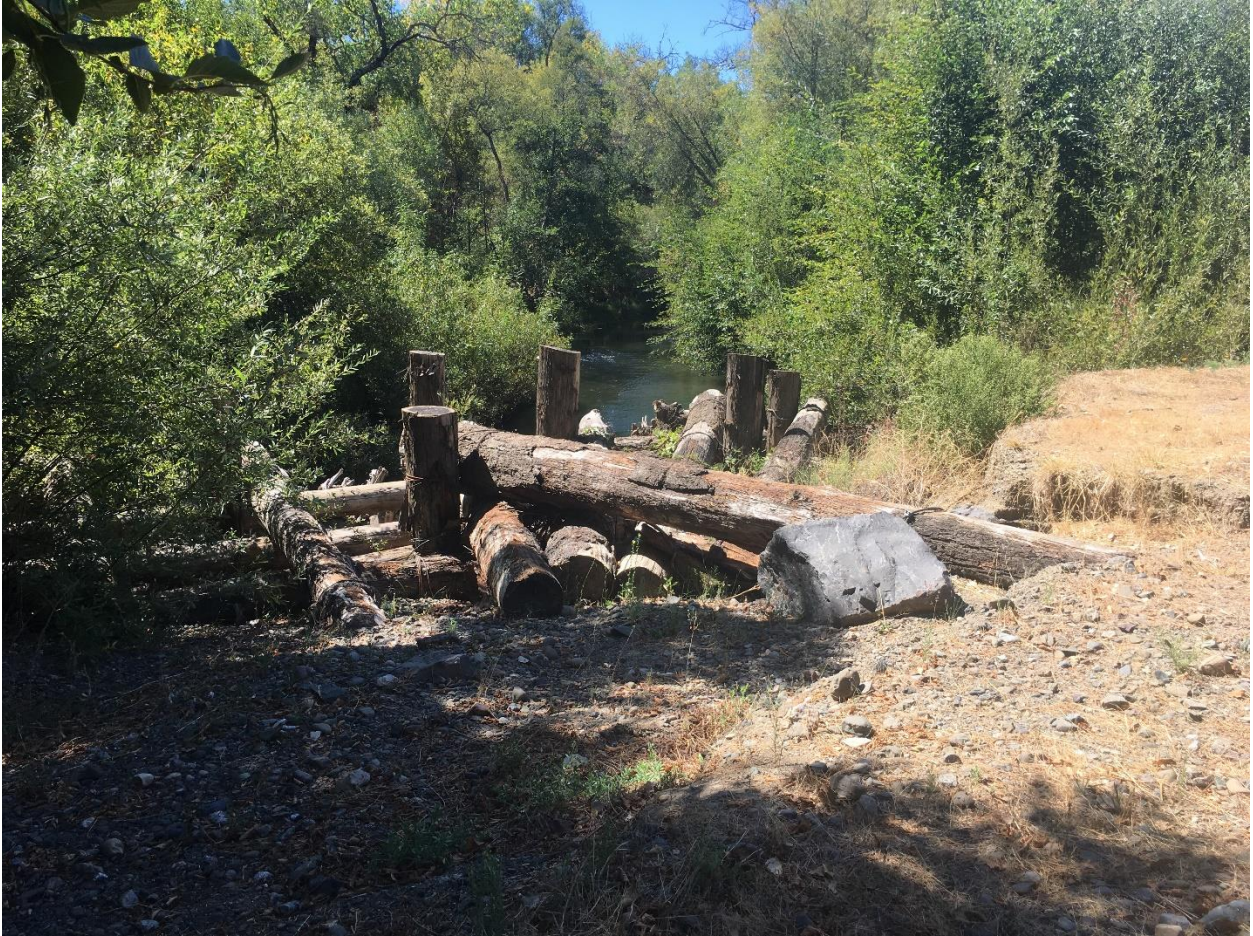
Photo 5.1.21. Reach 7 - Farrow site. Photo shows eroded area exposing back portion of engineered logjam at outlet of backwater pond. September 13, 2018.

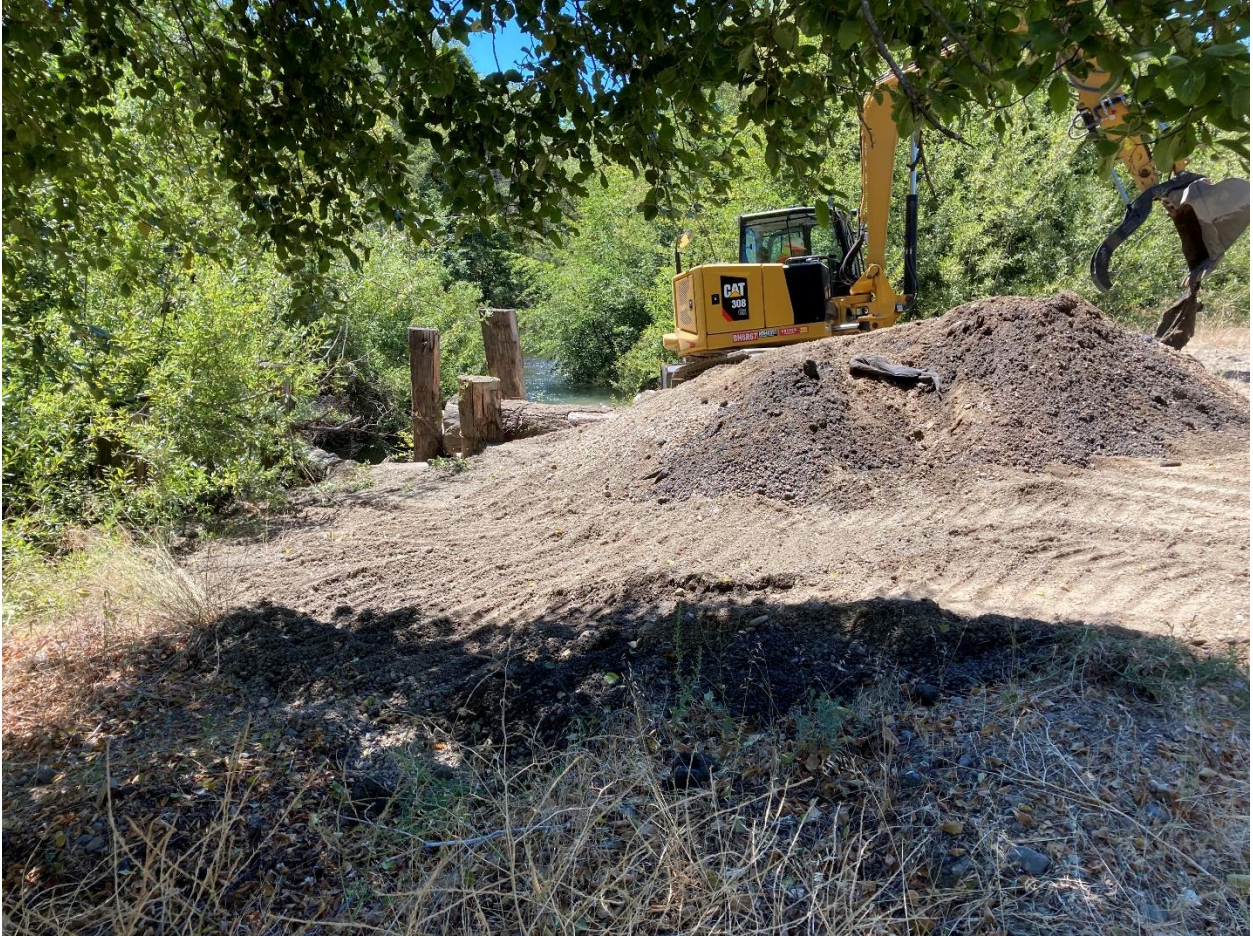
Photo 5.1.22. Reach 7 - Farrow site. Start of erosion repair work. July 30, 2020.

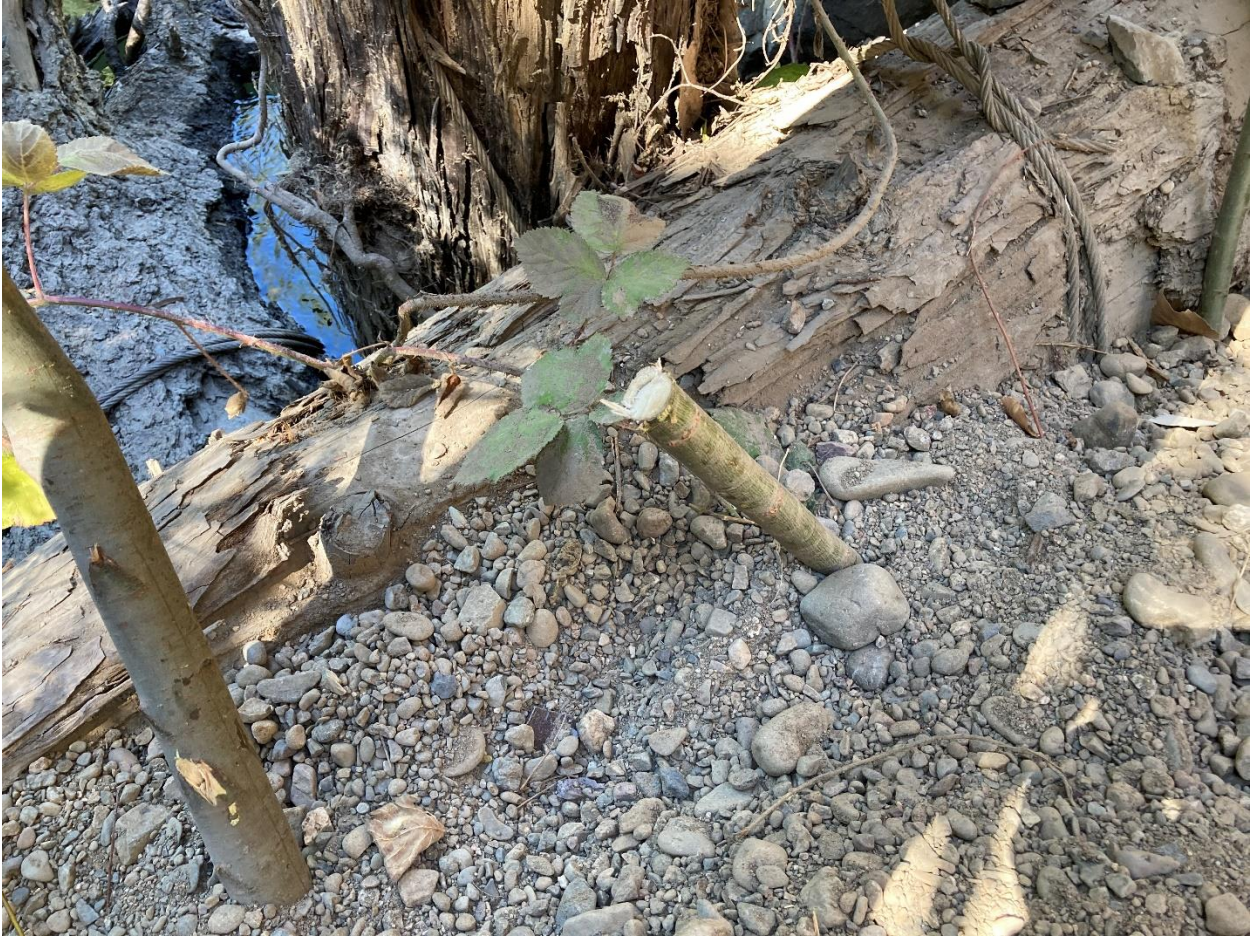
Photo 5.1.23. Reach 7 - Farrow site. New willow cuttings installed in engineered logjam. August 4, 2020.

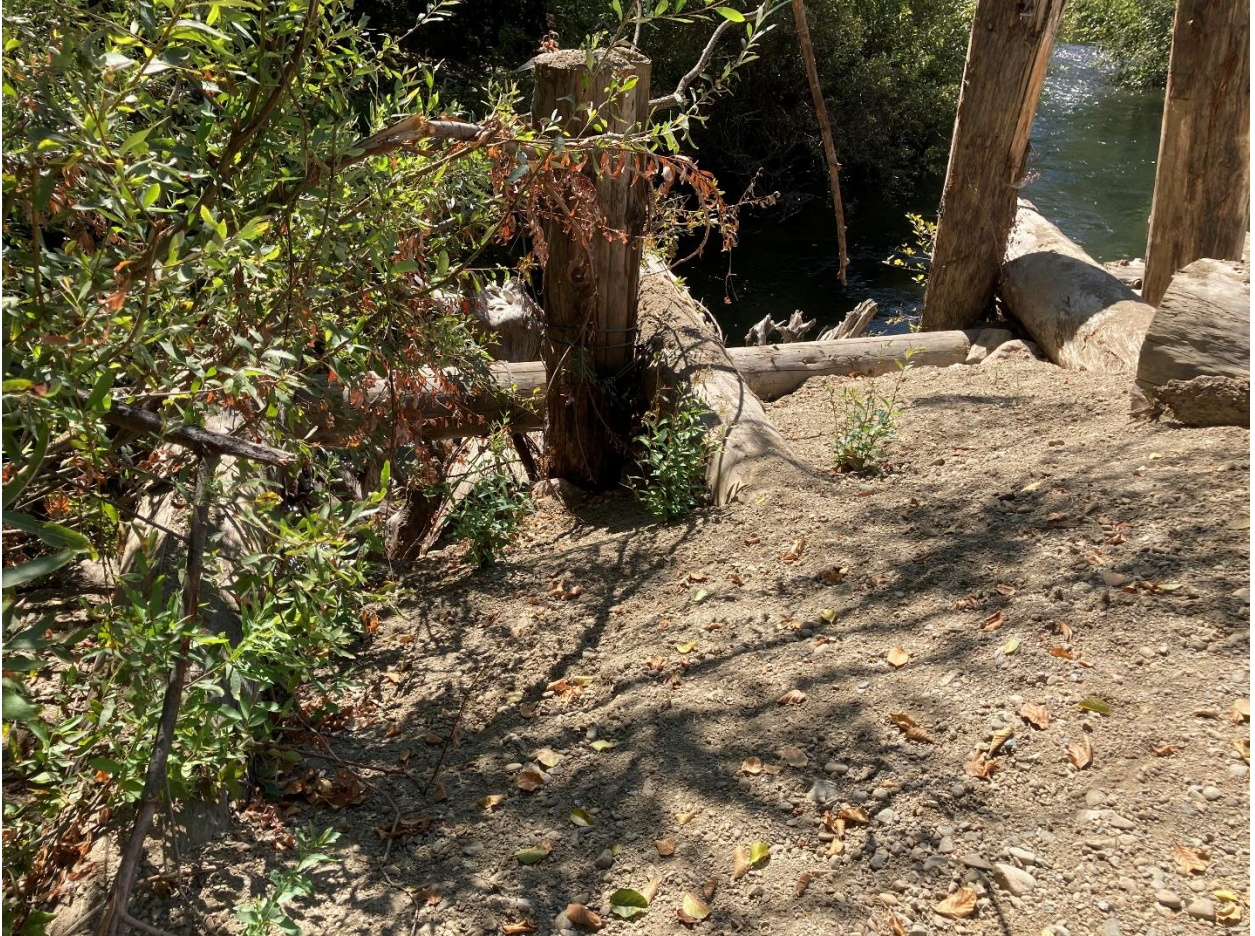
Photo 5.1.24. Reach 7 - Farrow site. New growth on willow cuttings at engineered logjam. September 17, 2020.

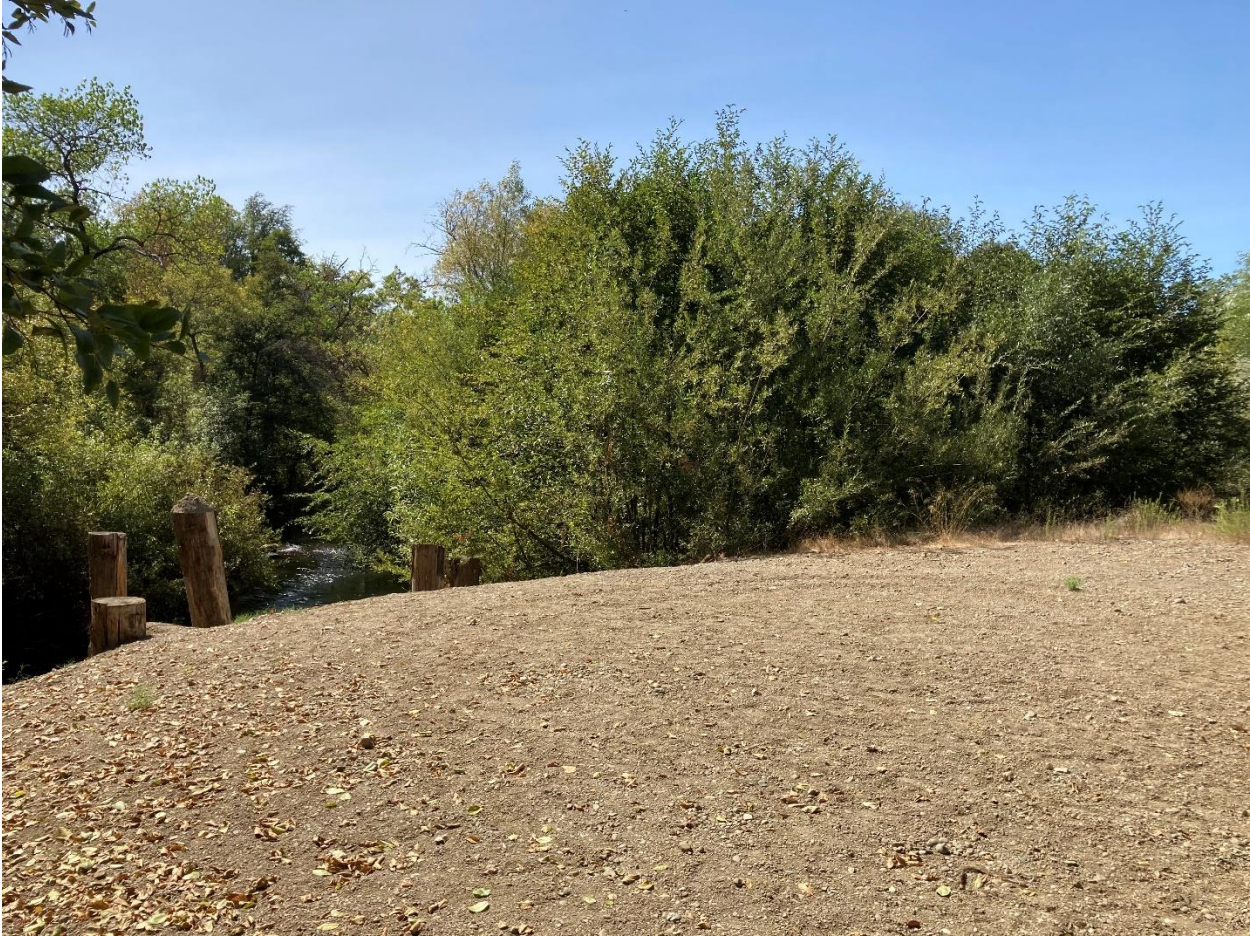
Photo 5.1.25. Reach 7 - Farrow site. Completed erosion repair at engineered logjam. September 17, 2020.

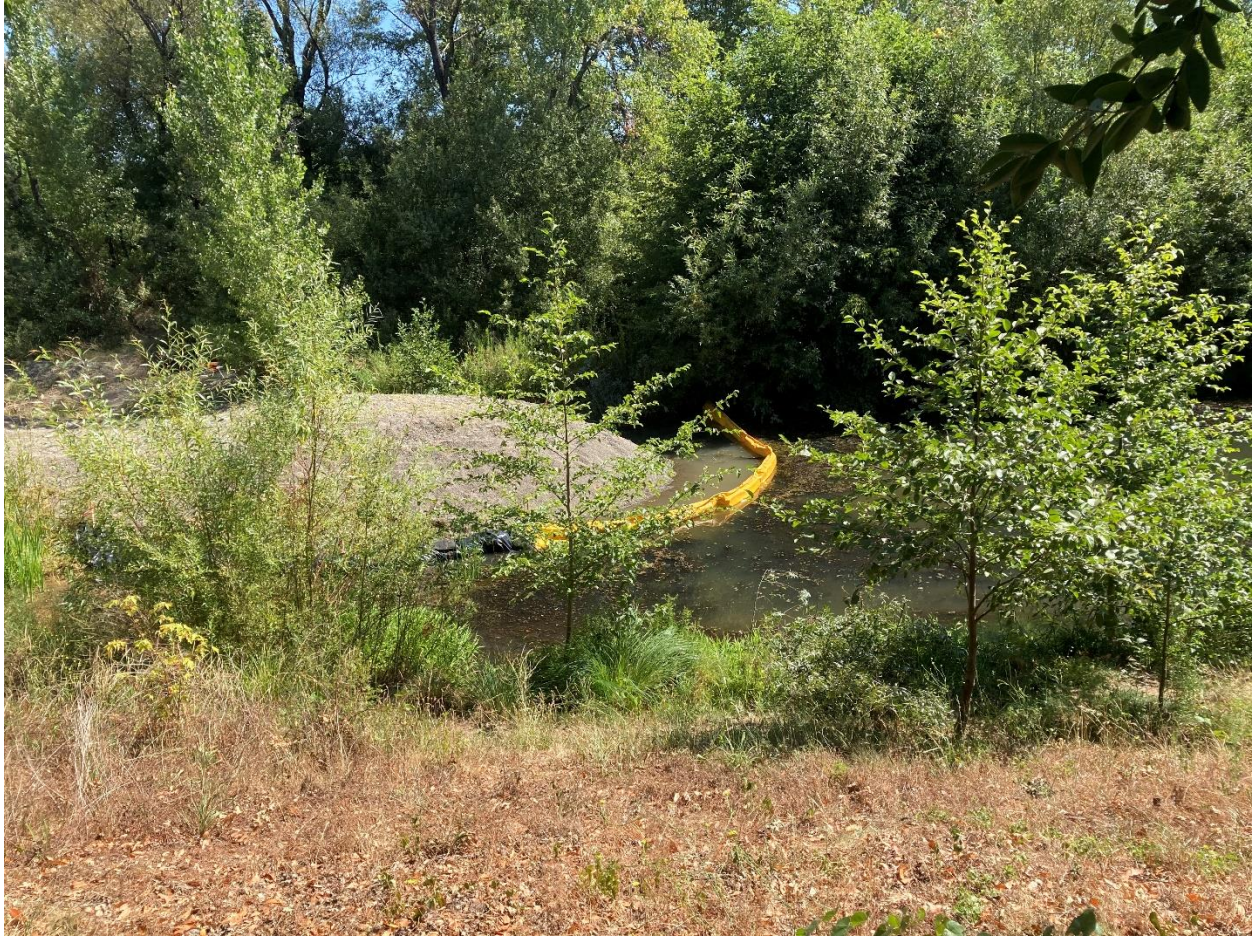
Photo 5.1.28. Reach 7 - Van Alyea Site. Gravel deposited in upper end of backwater pond, covering outlet of freshwater conduit from Dry Creek. Photo shows turbidity curtain installed around work site prior to removing gravel. July 29, 2020.

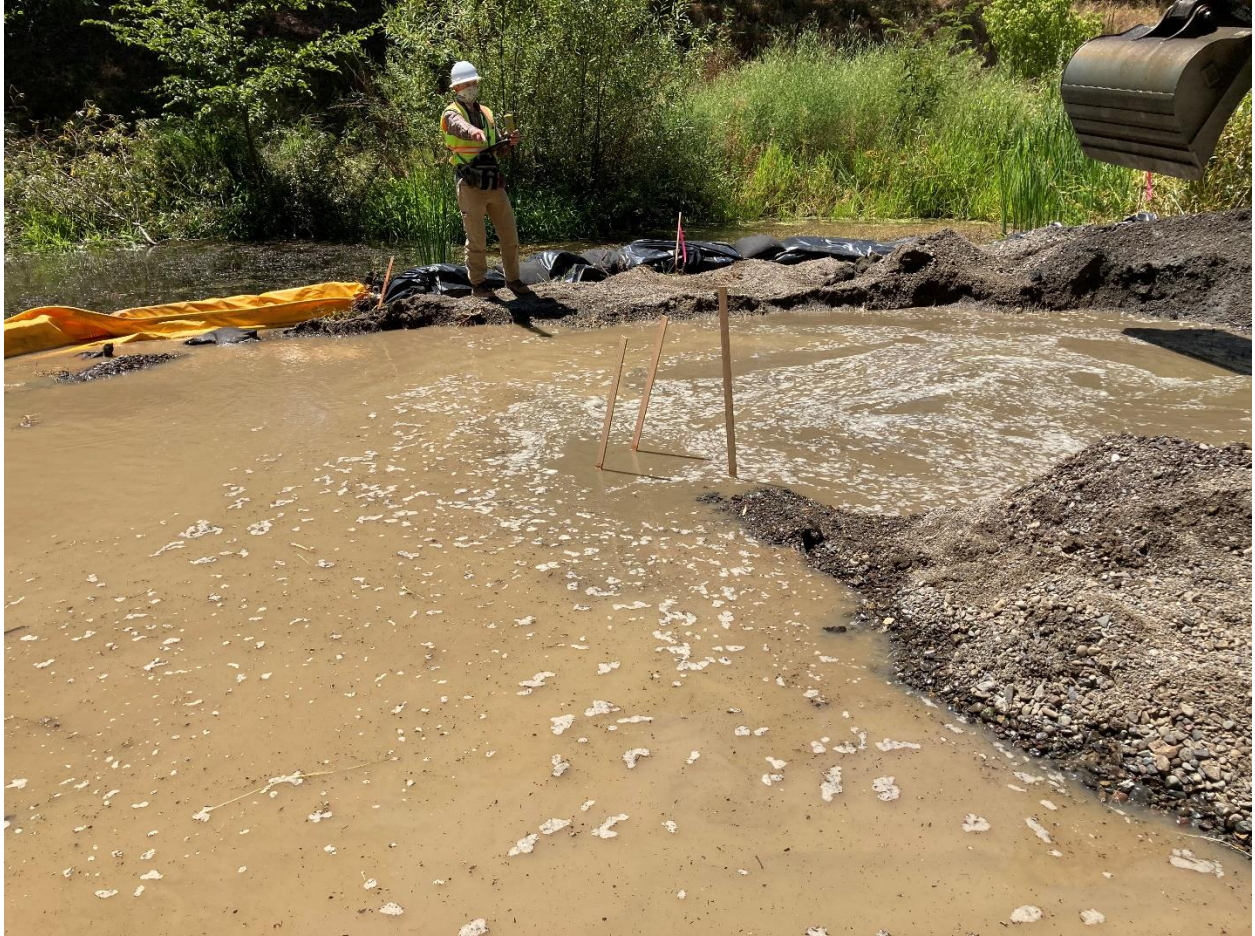
Photo 5.1.29. Reach 7 - Van Alyea Site. Removal of gravel material and locating freshwater conduit outlet in process. July 30, 2020.

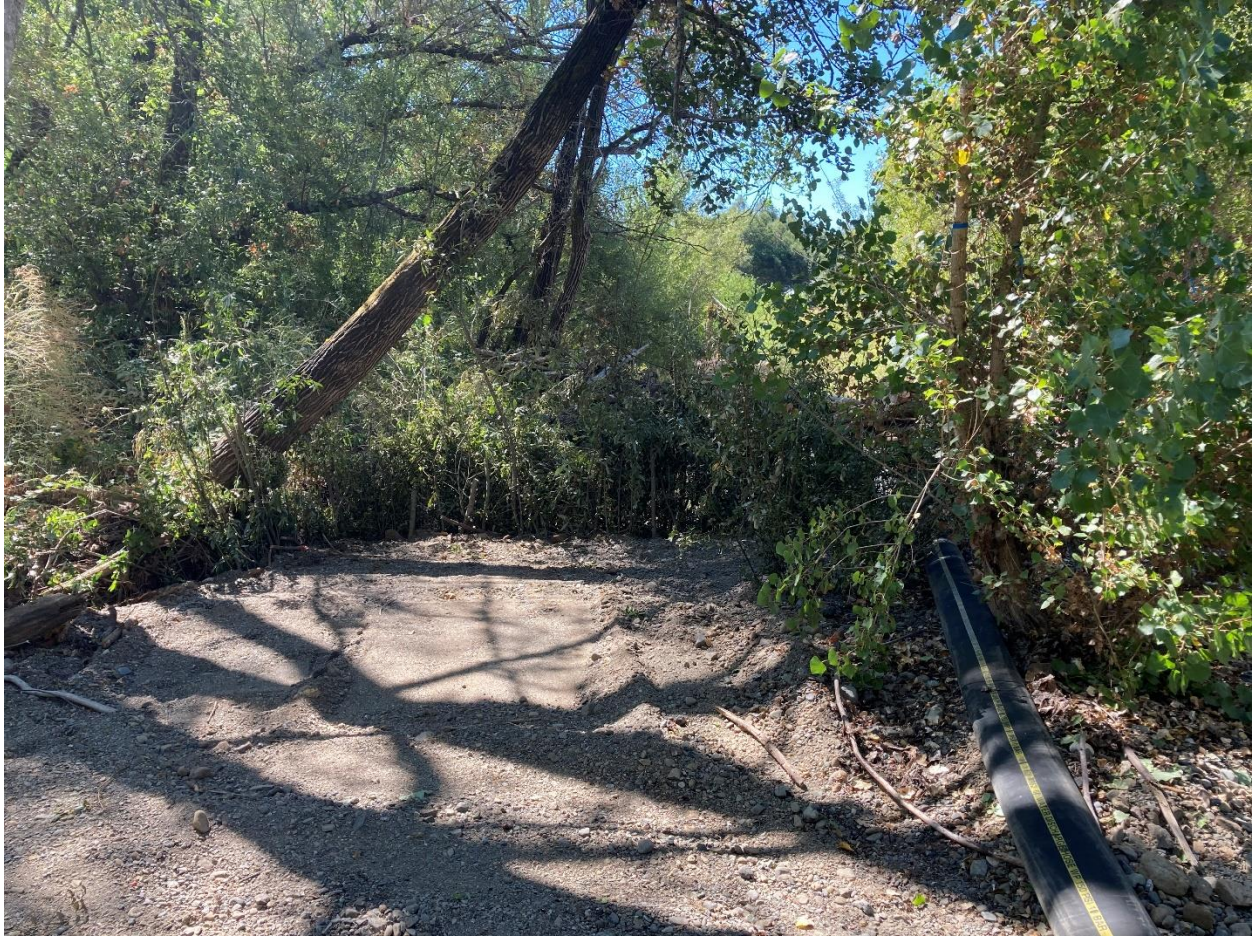
Photo 5.1.31. Reach 7 - Van Alyea Site. New willow baffle upstream of backwater pond to discourage future gravel deposition into the pond. August 4, 2020.

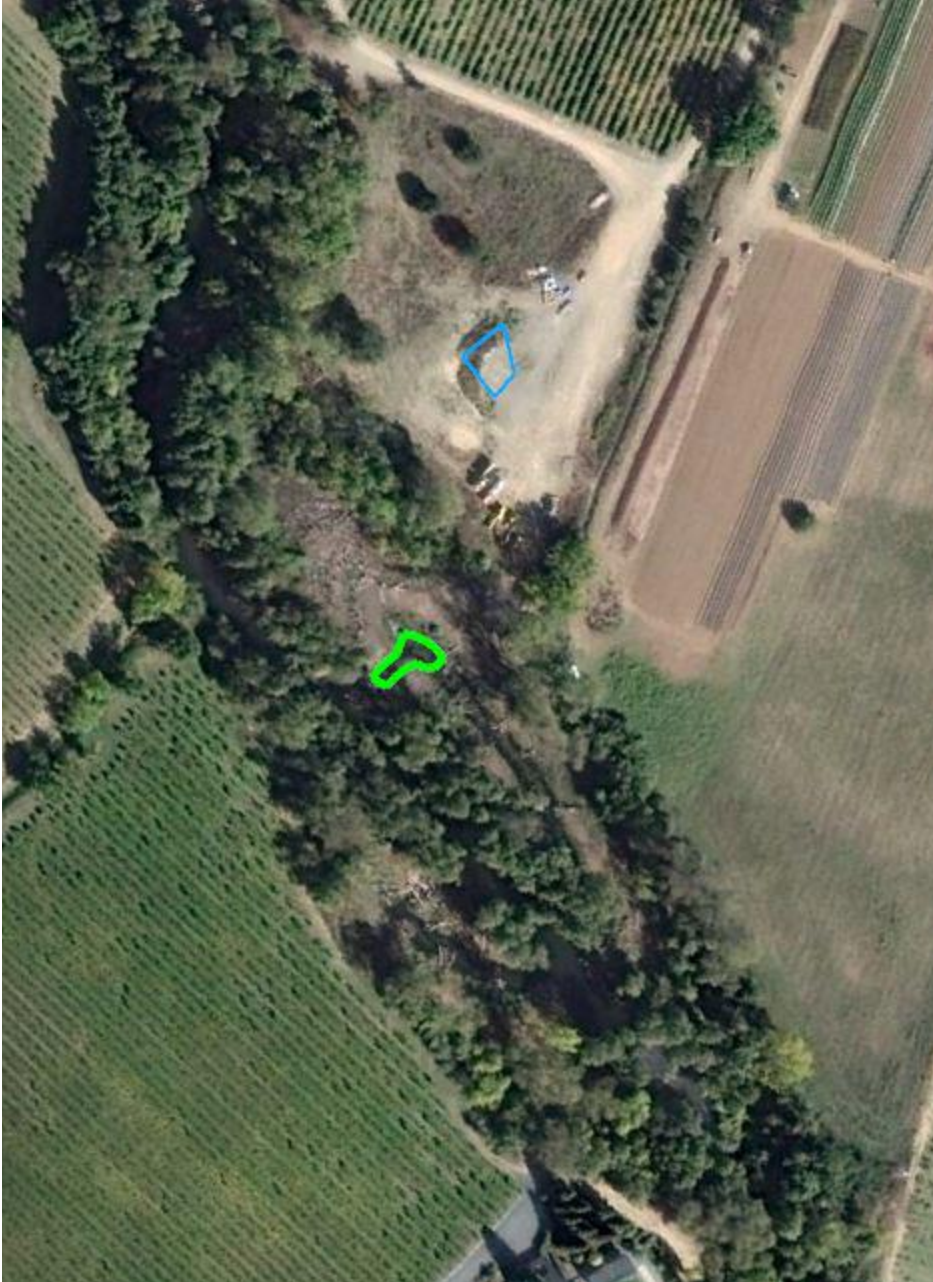
Photo 5.1.34. Showing the location of the 2020 Reach 8 (Carlson Site) habitat maintenance work. The work area to clear gravel from the side channel inlet is shown in green. The blue area indicates where gravel was left onsite per the request of the landowner.

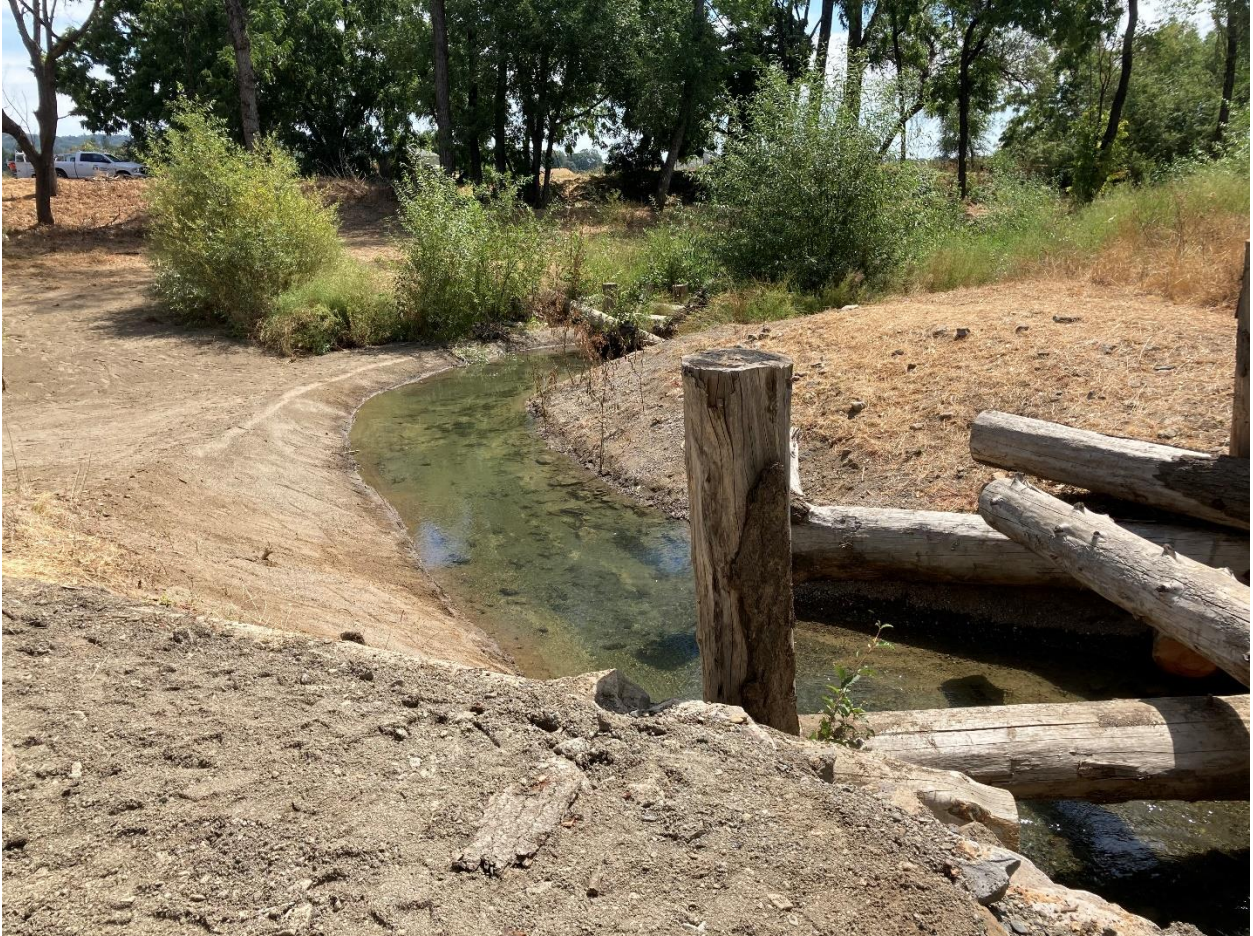
Photo 5.1.35. Reach 8 - Carlson Site. Photo showing inlet to the side-channel cleared of sediment blocking flow. August 18, 2020.

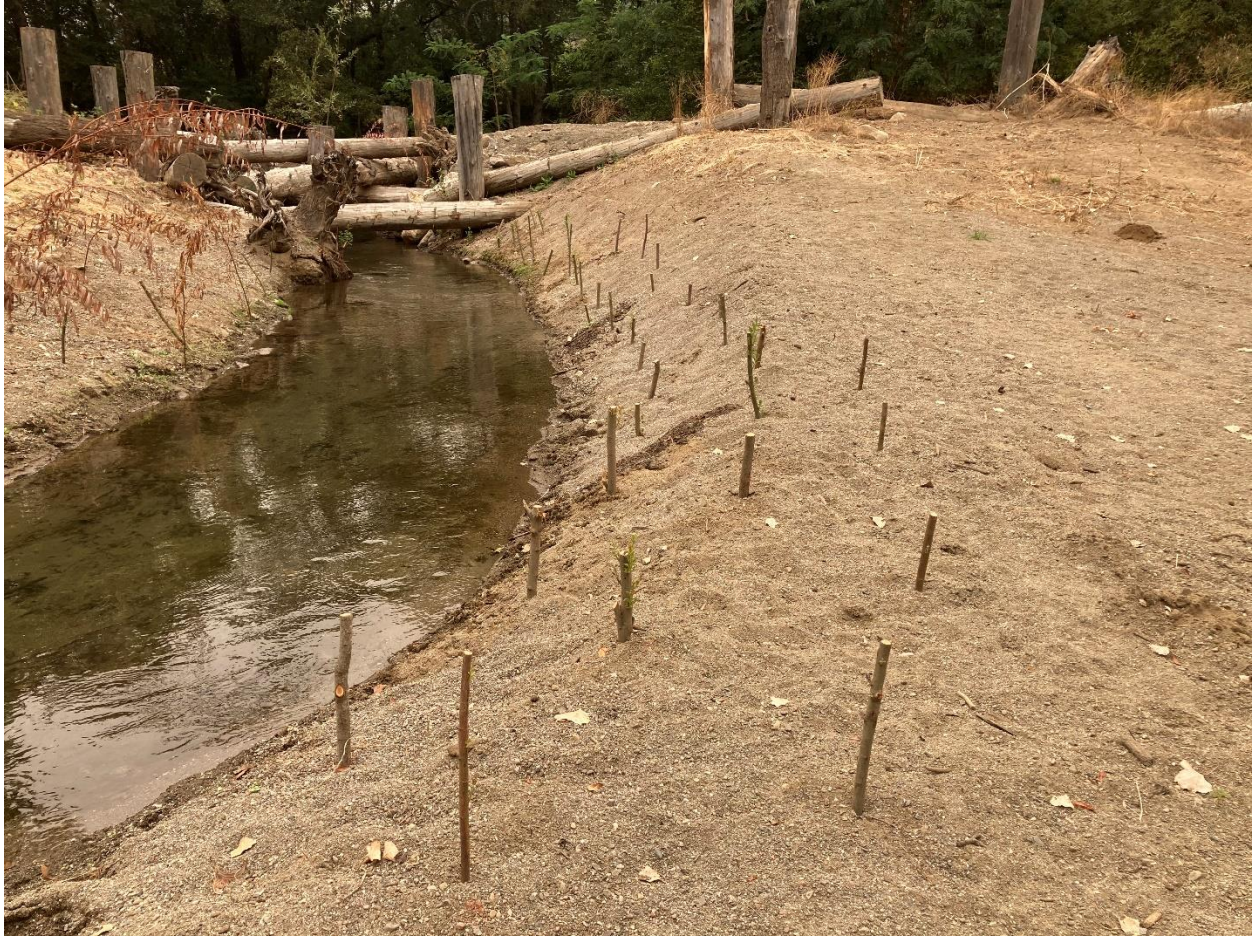
Photo 5.1.37. Reach 8 - Carlson Site. New willow cuttings sprouting along inlet area that was cleared. September 10, 2020.

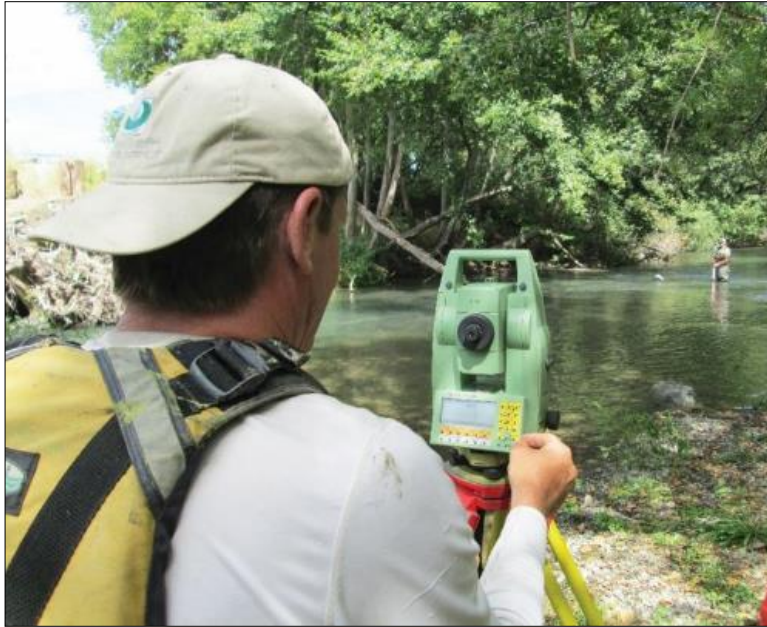
Figure 5.2.1. Dry Creek effectiveness monitoring. At each data point, we collected geographic location (latitude, longitude, elevation), and water depth and velocity by aiming the total station at a USGS topset rod fit with a survey prism and a flow meter.

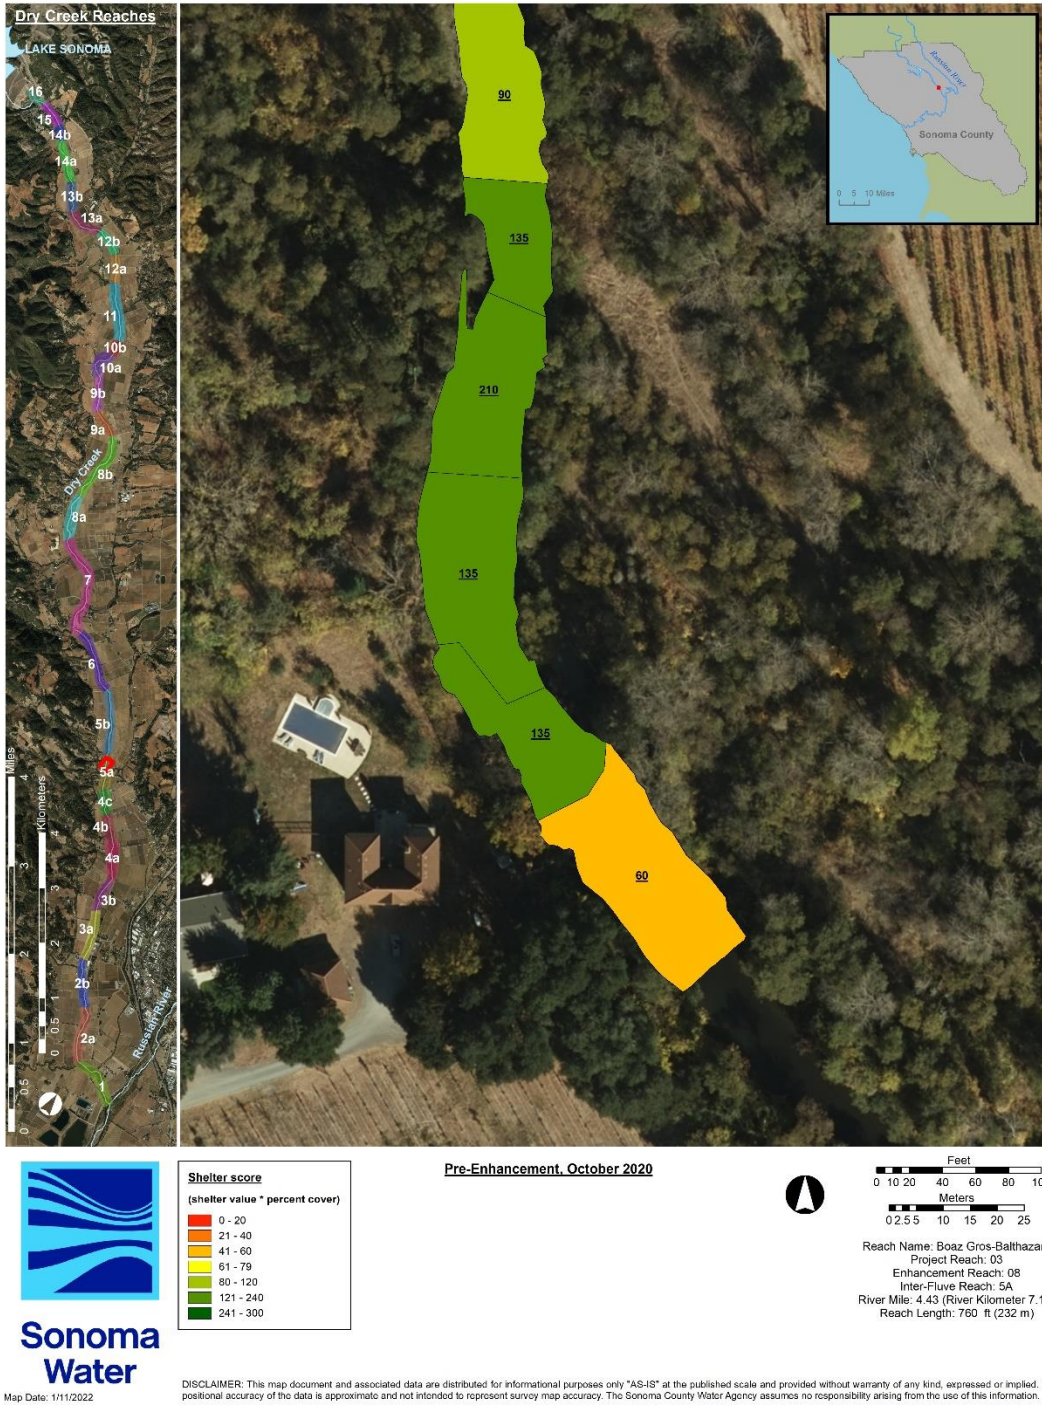
Figure 5.2.8. Habitat unit ratings for the Boaz Gros-Balthazard enhancement reach, May 2020.

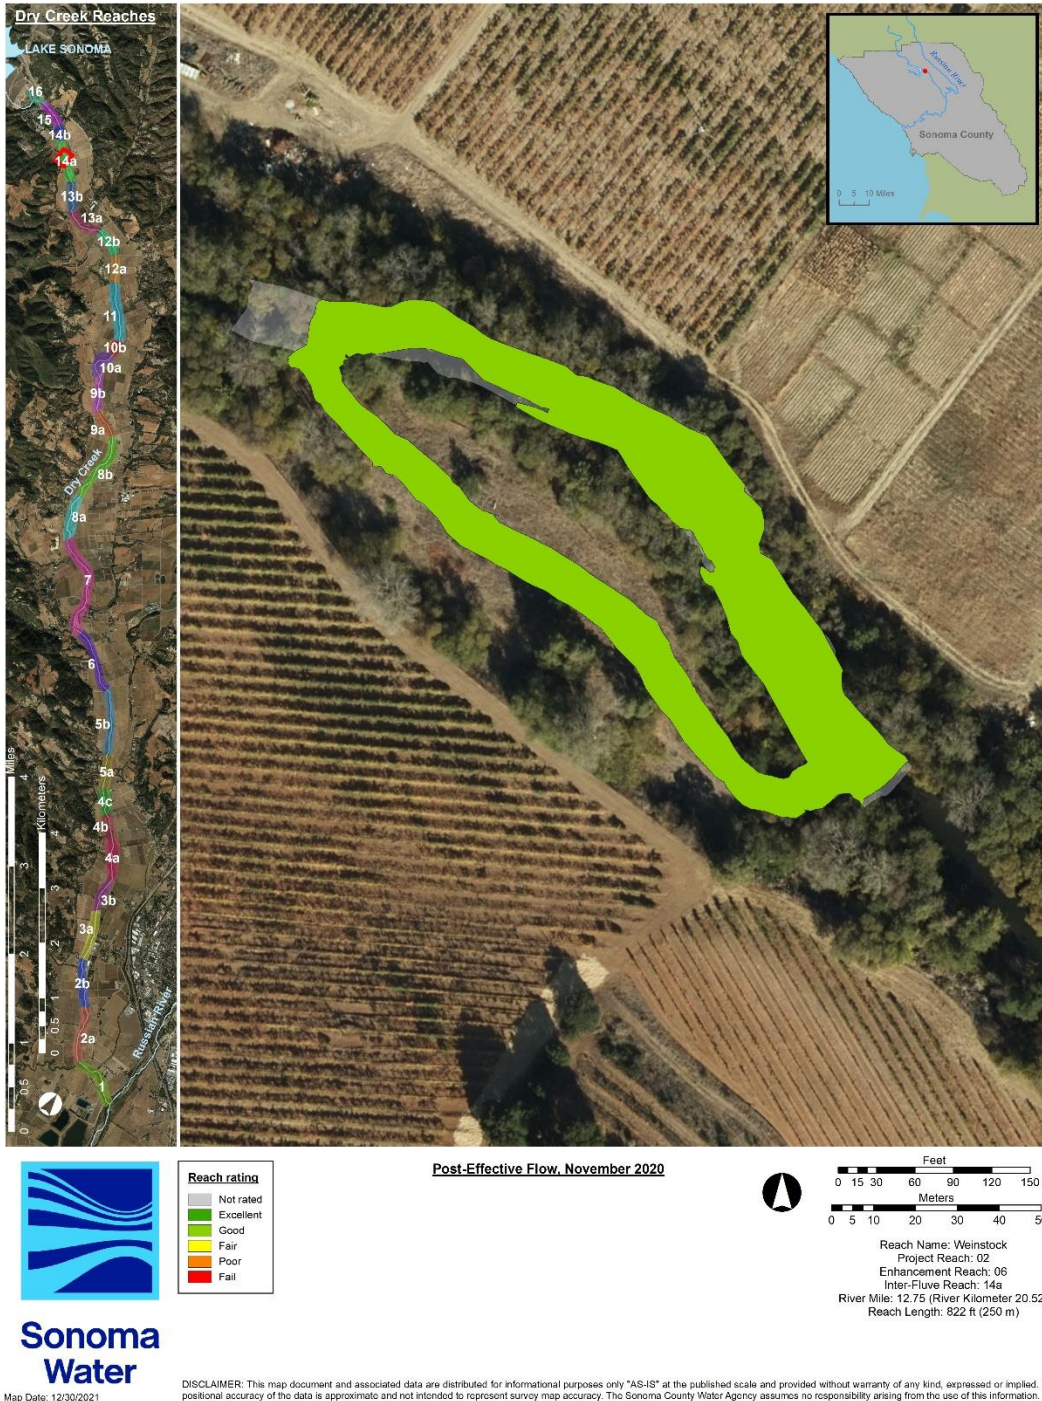
Figure 5.2.17. Post-effective flow reach rating for the Weinstock enhancement reach, November 2020.

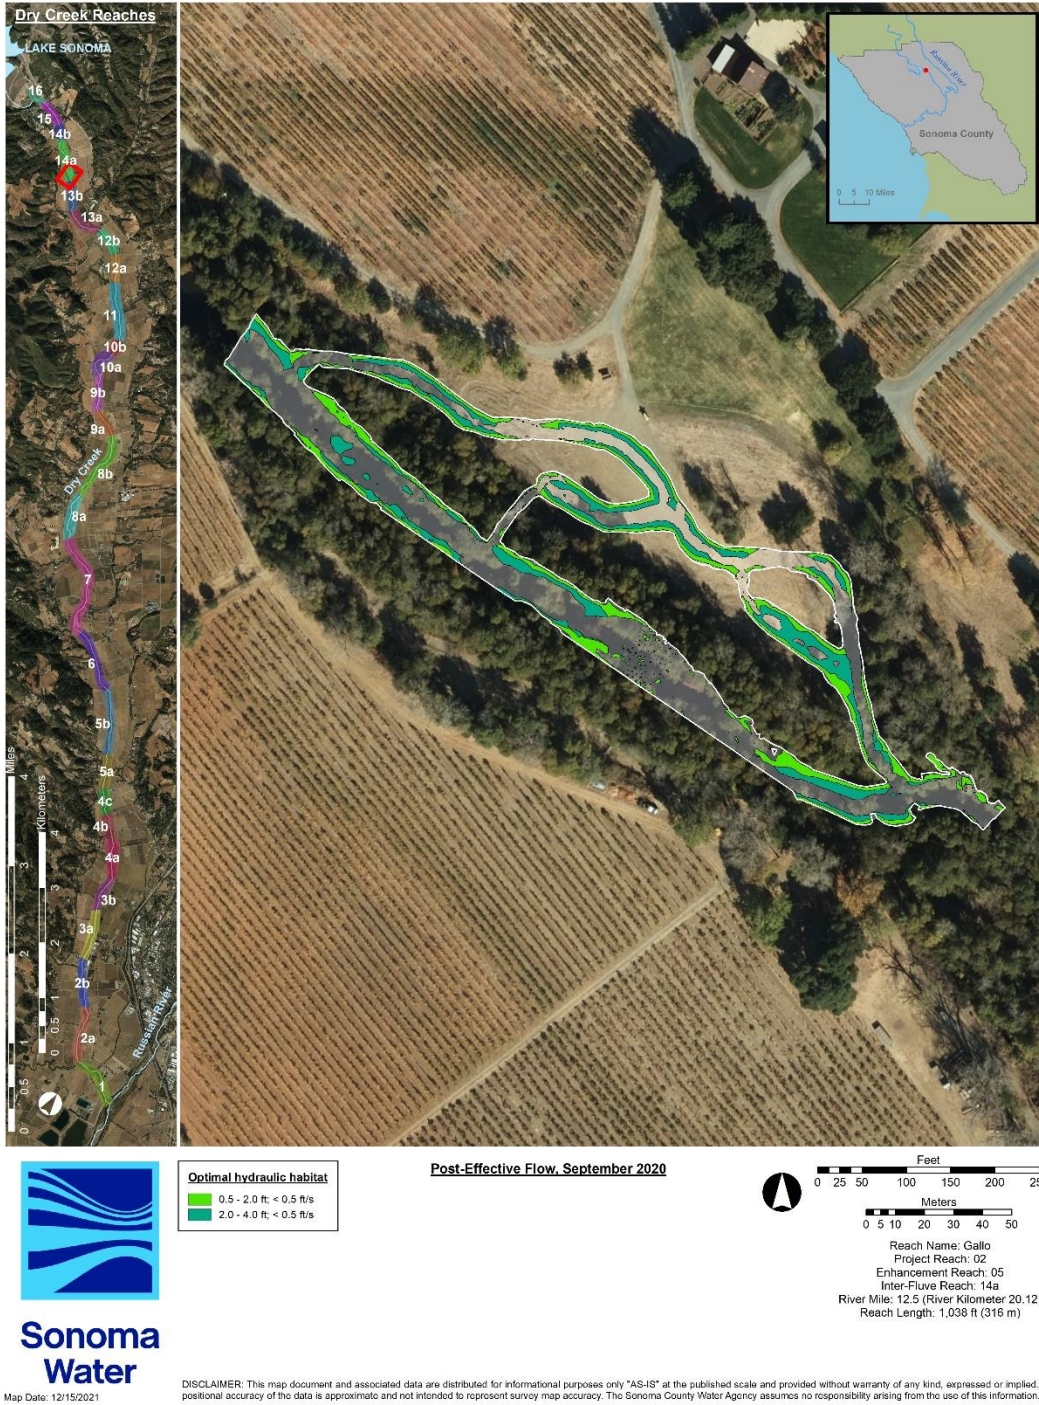
Figure 5.2.18. Optimal hydraulic habitat for fry (<0.5 ft/s, 0.5-2.0 ft) and parr (<0.5 ft/s, 2.0-4.0 ft) within the Gallo enhancement reach, September 2020.

Gallo Post-enhancement September 2020	Wetted area (ft²)	0.5 – 2.0 ft	2.0 – 4.0 ft	Total	< 0.5 ft/s	0.5 – 2.0 ft < 0.5 ft/s	2.0 – 4.0 ft < 0.5 ft/s	Total
Main channel area	49,177	18,907	17,256	36,163	20,406	6,818	6,216	13,034
Side channel area	34,399	12,613	11,707	24,319	23,838	7,282	8,304	15,587
Total area	83,576	31,520	28,963	60,483	44,244	14,100	14,521	28,621
Main channel % of wetted area	59%	38%	35%	74%	41%	14%	13%	27%
Side channel % of wetted area	41%	37%	34%	71%	69%	21%	24%	45%
Total % of wetted area	100%	38%	35%	72%	53%	17%	17%	34%

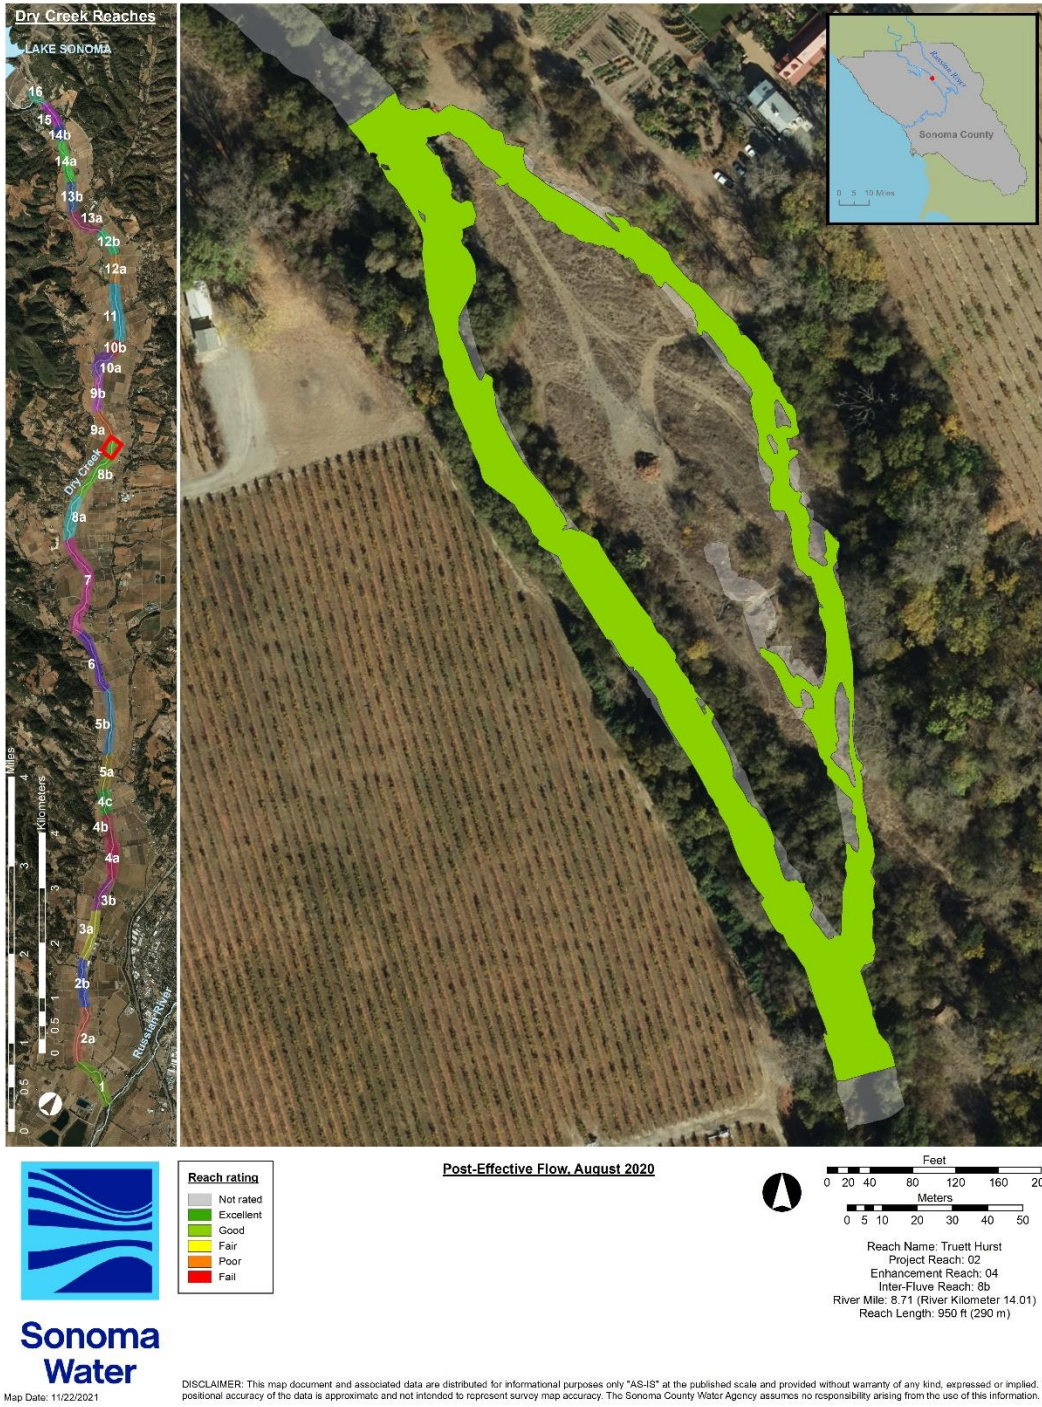
Figure 5.2.33. Post-effective flow reach rating for the Truett Hurst enhancement reach, August 2020.
