Russian River Biological Opinion Status and Data Report

Year 2020 – 2021

**Sonoma
Water**

November 2023

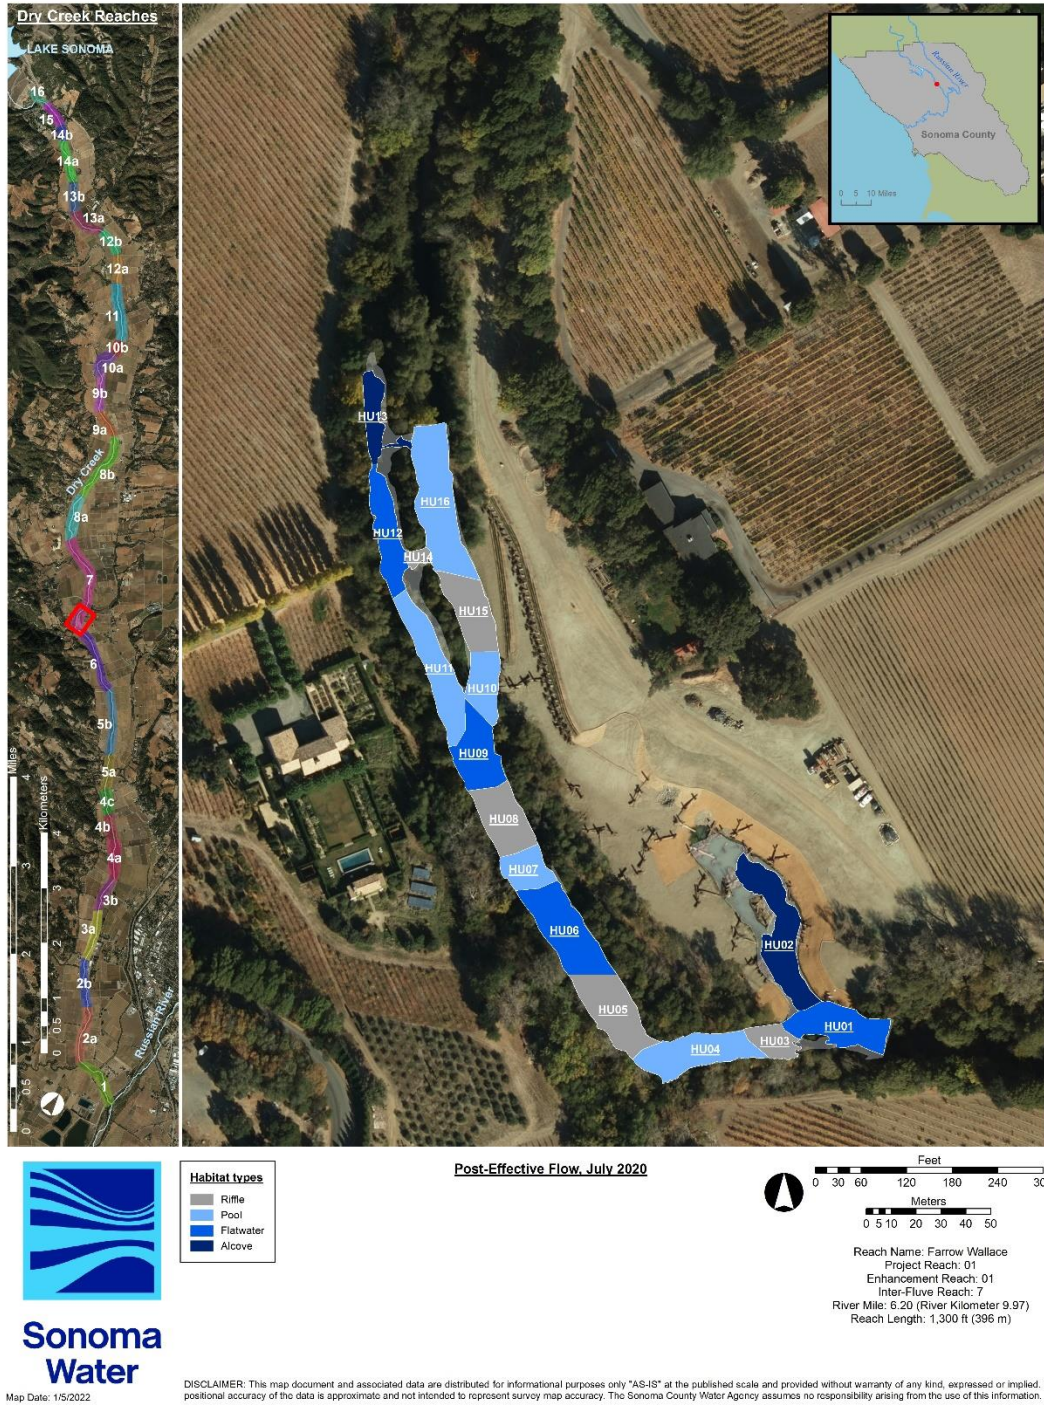
Figure 5.2.43. Habitat unit number and type within the Farrow, Wallace enhancement reach, July 2020.

Habitat Unit #	Habitat Type	Shelter Value	Percent Cover	Shelter Score
HU01	Flatwater	3	35	105
HU02	Alcove	3	80	240
HU03	Riffle	3	35	105
HU04	Pool	3	45	135
HU05	Riffle	2	15	30
HU06	Flatwater	1	10	10
HU07	Pool	3	40	120
HU08	Riffle	2	20	40
HU09	Flatwater	3	35	105
HU10	Pool	3	50	150
HU11	Pool	3	40	120
HU12	Flatwater	3	60	180
HU13	Alcove	3	80	240
HU14	Riffle	3	55	165
HU15	Riffle	2	15	30
HU16	Pool	1	15	15
Pool: riffle	5:5 (1.00)			Avg = 112

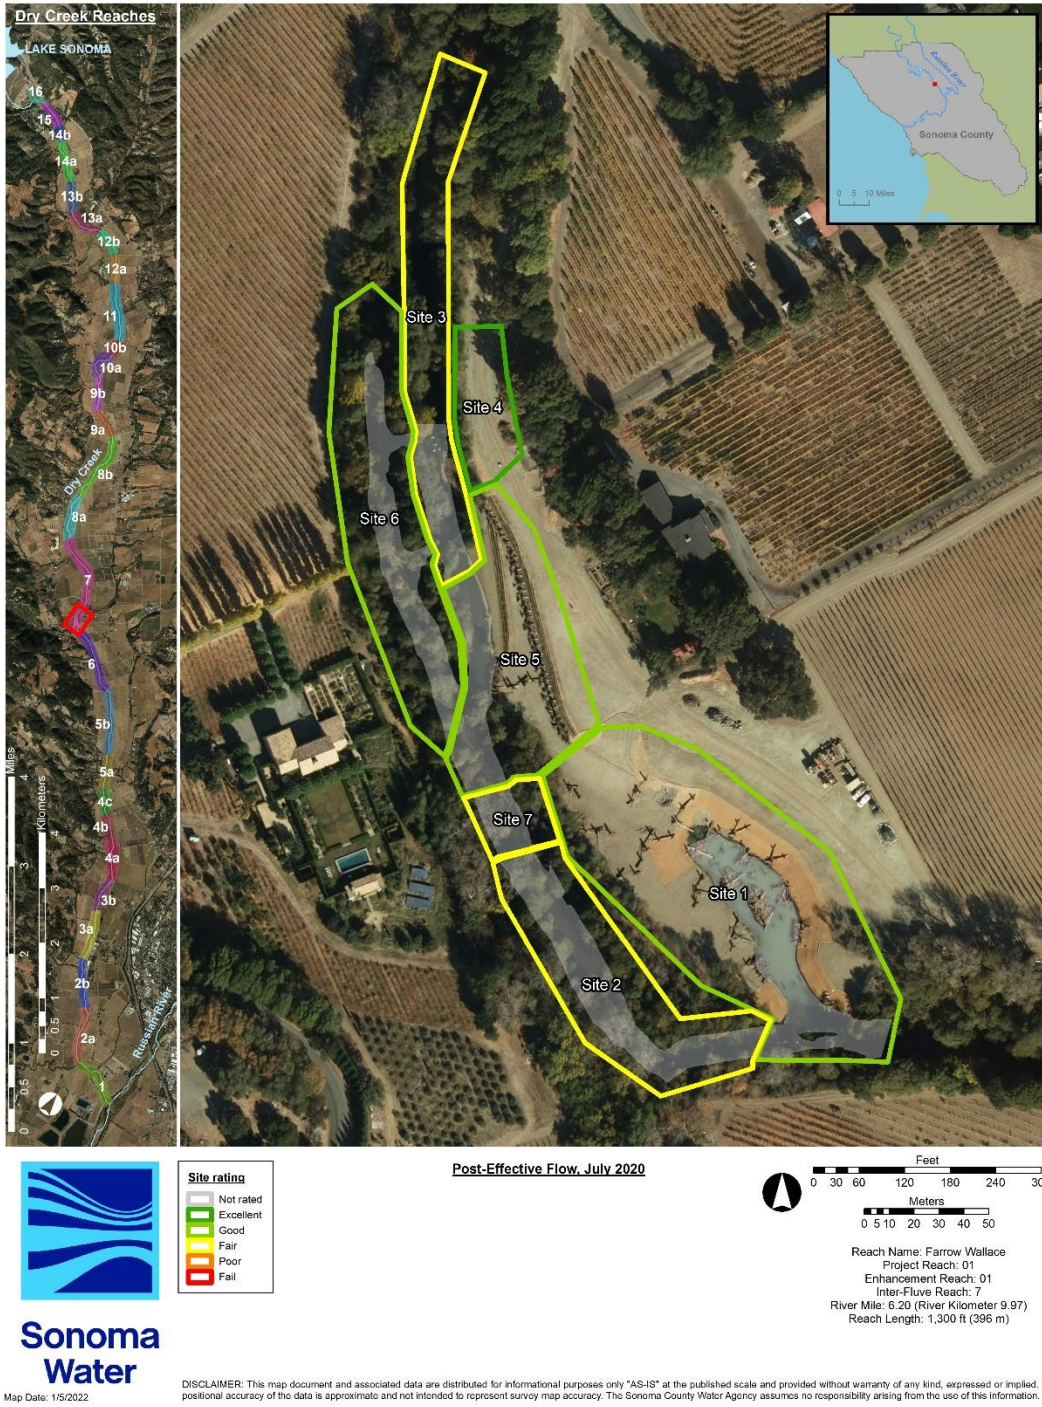
Figure 5.2.48. Post-effective flow site ratings for the Farrow, Wallace enhancement reach, July 2020.

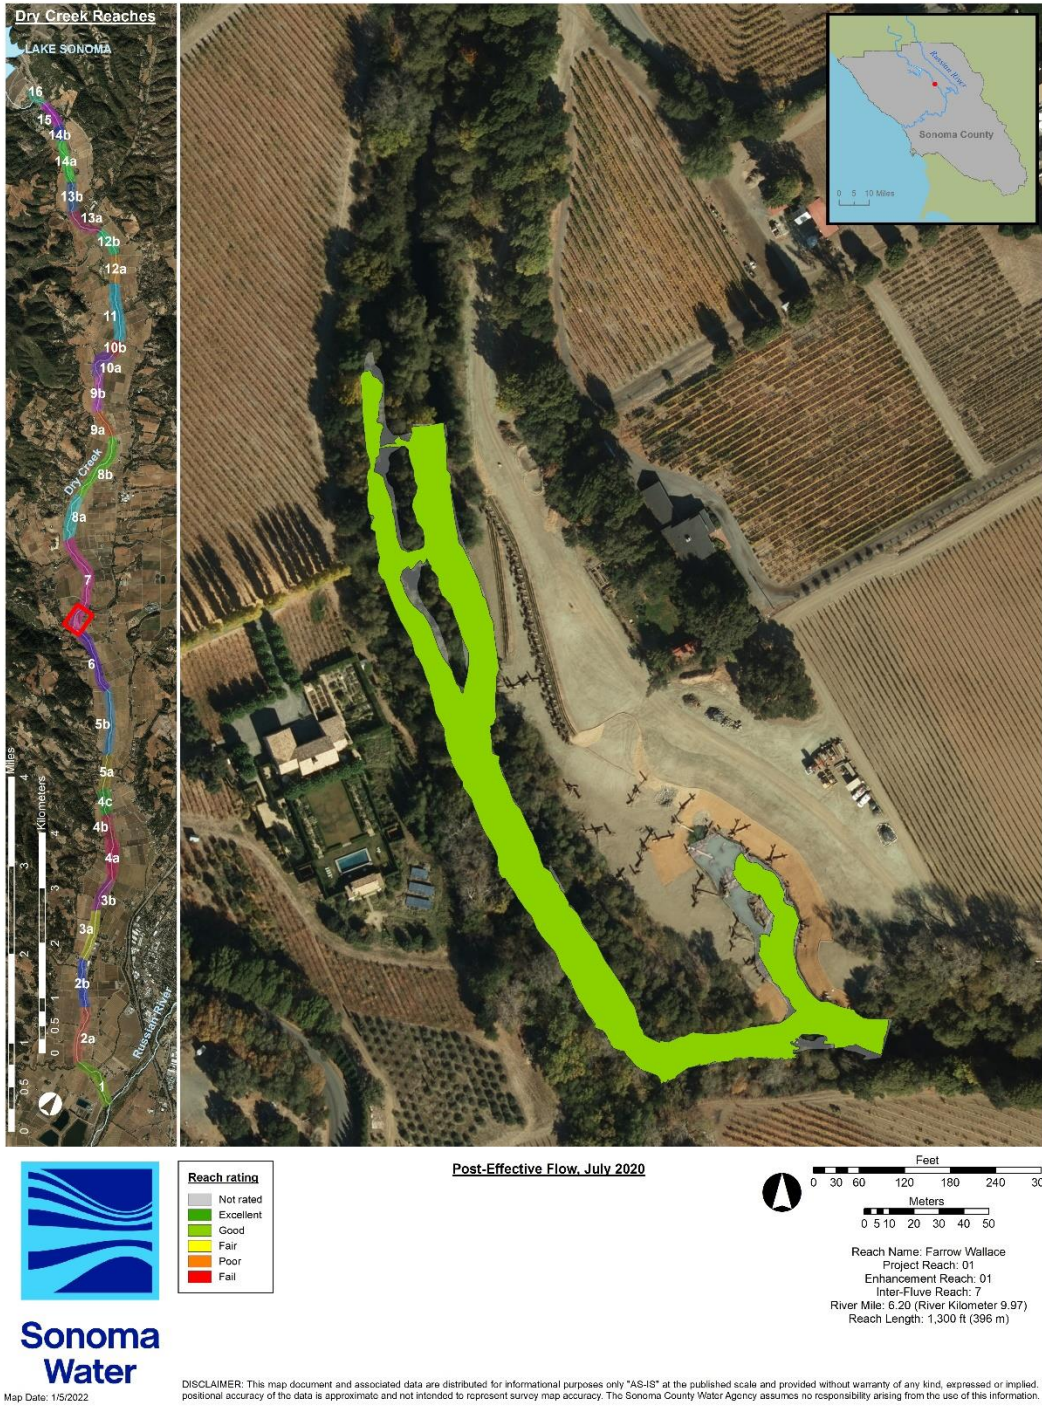
Figure 5.2.49. Post-effective flow reach rating for the Farrow, Wallace enhancement reach, July 2020.

Sonoma Water monitored the post-effective flow condition of the Farrow, Wallace enhancement reach in July 2020. Previous effectiveness monitoring surveys occurred in August 2015 (post-effective flow), August 2017 (post-effective low), and November 2019 receiving good, fair, and good ratings, respectively. The 2020 monitored area encompassed 80,913 ft² within main- and off-channel areas of Dry Creek with 32% of the total area meeting optimal depth and velocity criteria (Table 5.2.27, Figure 5.2.42). The monitoring characterized 15,817 ft² of main channel alcove area and 19,351 ft² of side channel area, of which 52% and 53% met optimal depth and velocity criteria, compared with 45,745 ft² and 16% for the main channel area. Sixteen habitat units composed the enhancement reach, with a pool to riffle ratio of 5:5 (1.00) and average shelter score of 112 (Table 5.2.28, Figure 5.2.43, Figure 5.2.44). Eleven habitat units met or exceeded the optimum shelter score of 80. The enhancement reach comprised seven enhancement sites (four main-channel sites, one alcove, one side channel, one bank site; Table 5.2.29, Figure 5.2.45), with excellent site average feature ratings (we did not rate enhancement site 1 as it contained no features), and poor to good site average habitat unit ratings (we did not rate site 4 as it contained no aquatic habitat; Table 5.2.29, Figure 5.2.46, Figure 5.2.47). Enhancement sites received fair to excellent ratings (Table 5.2.29, Figure 5.2.48). Overall, the Farrow, Wallace enhancement reach received a good effectiveness monitoring rating (Table 5.2.29, Figure 5.2.49; see Appendix 5.2 for all measured values, scores, and ratings).

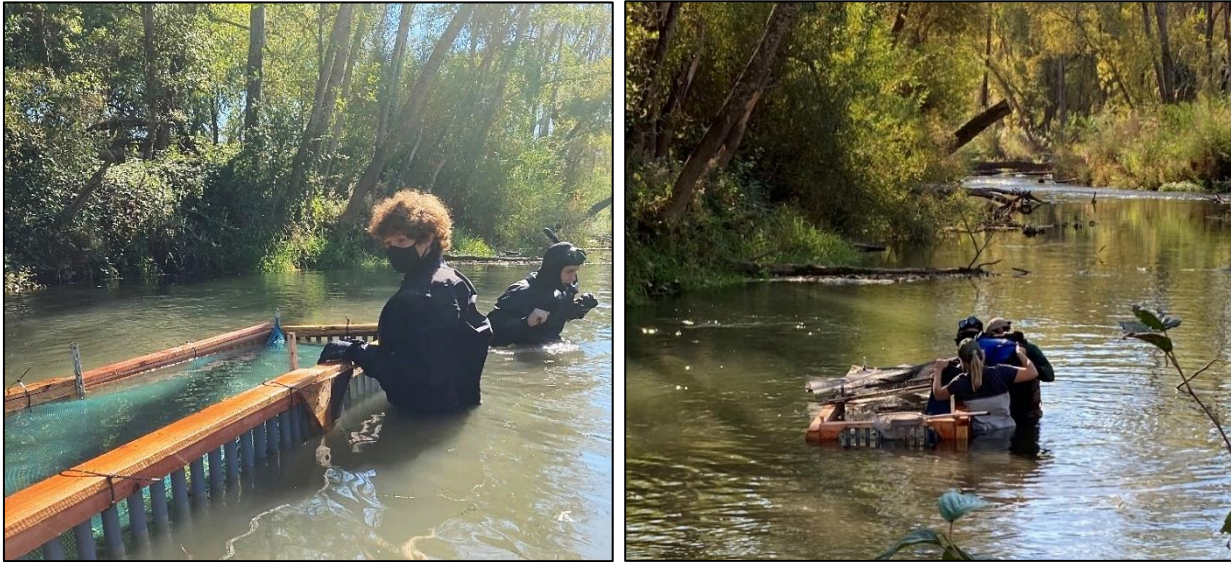
Photo 5.3.1. Installation of net pen and rigid frame (left photo) and hatchery-reared juvenile Coho Salmon being placed inside completed net pen enclosure (right photo) at Ferrari-Carano Olson backwater (rkm 5.36).

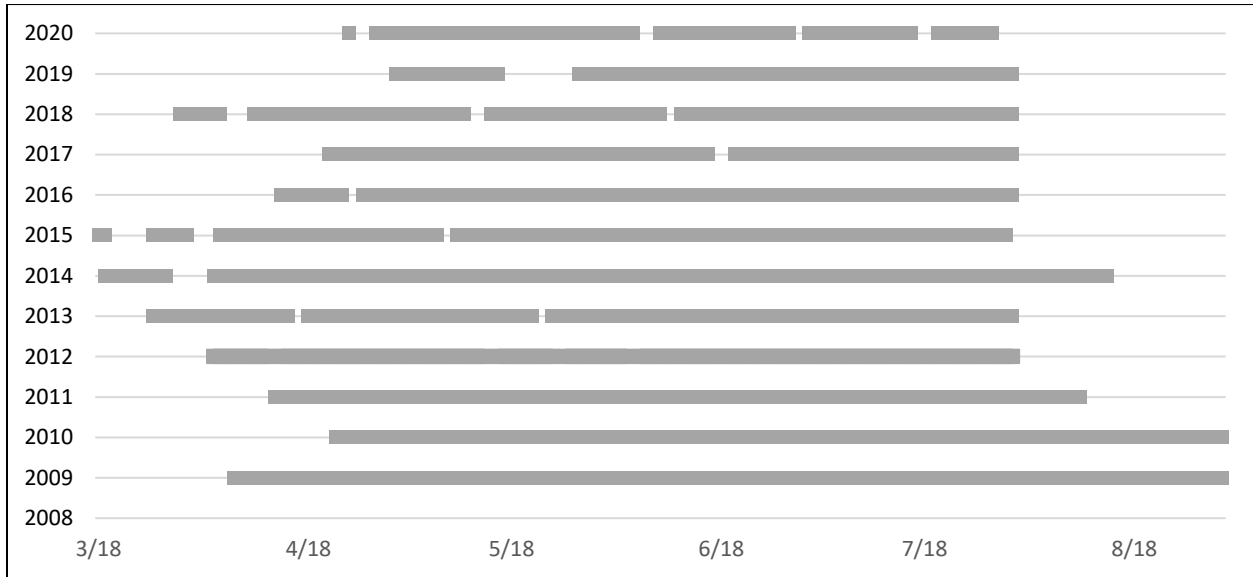
Figure 5.3.13. Begin and end dates and data gaps (spaces in lines) for operation of the Dry Creek downstream migrant trap, 2009-2020.

We installed the rotary screw trap on April 24 (Figure 5.3.13). Except for brief periods when trapping was suspended because of high debris loading in the trap from high winds, the trap was checked daily during operation until it was removed on July 28.
