Russian River Biological Opinion Status and Data Report

Year 2021 – 2022

February 2024

**Sonoma
Water**

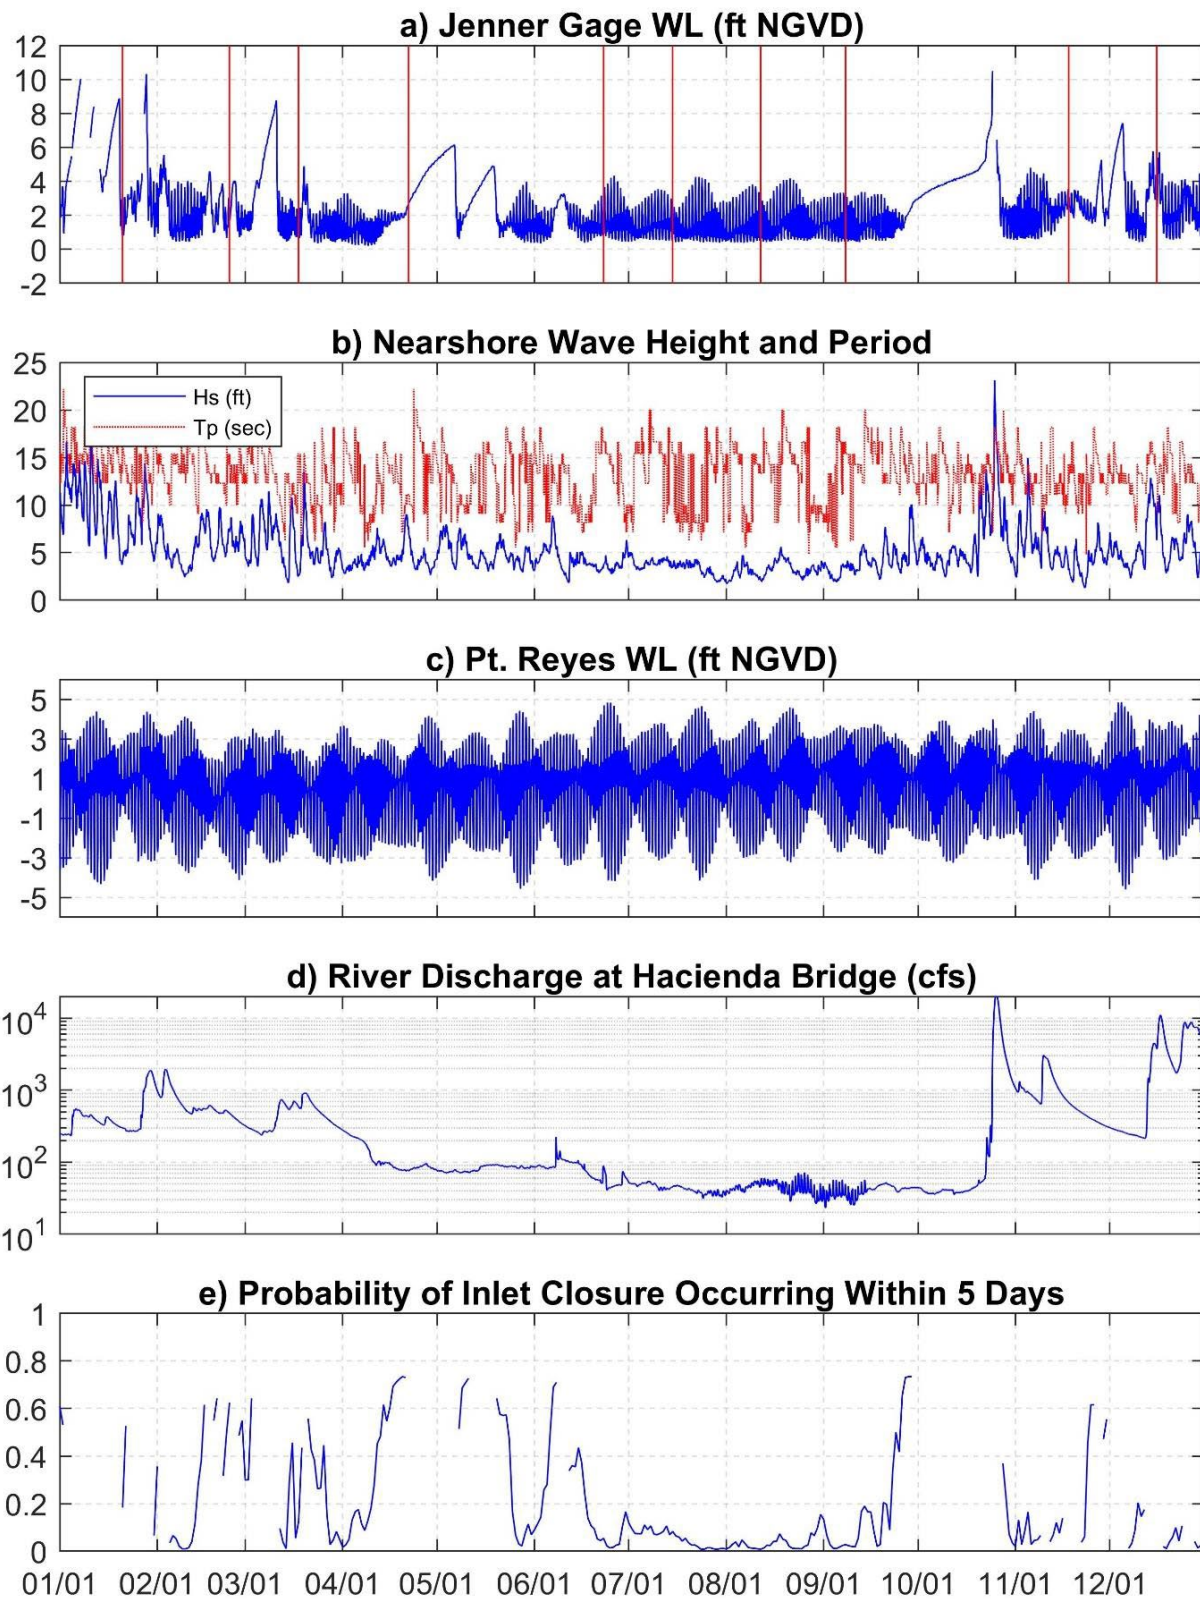
Figure 4.0.1. Estuary, Ocean, and River Conditions Compared with Closure Probability, 2021.

Time series of Estuary water levels, as well as the key forcing factors (waves, tides, and riverine discharge), are shown in Figure 4.0.1 for the entire 2021 lagoon management season (ESA, 2022). The lagoon water level time series (Figure 4.0.1a) summarizes the fully-tidal conditions in the Estuary throughout summer, and also shows the closure events that occurred later in the fall. During the management period, Russian River flows were similar to 2020 conditions with flow rates below 100 cfs during summer (ESA, 2022).

As in prior years, wave heights declined from April to September and were lowest through July and August (Figure 4.0.1b). Although swell events during the summer tended to have wave heights of less than 5 feet throughout the summer, there were nearly a dozen times that waves had periods above 15 seconds, and the first several days of July experienced swells with

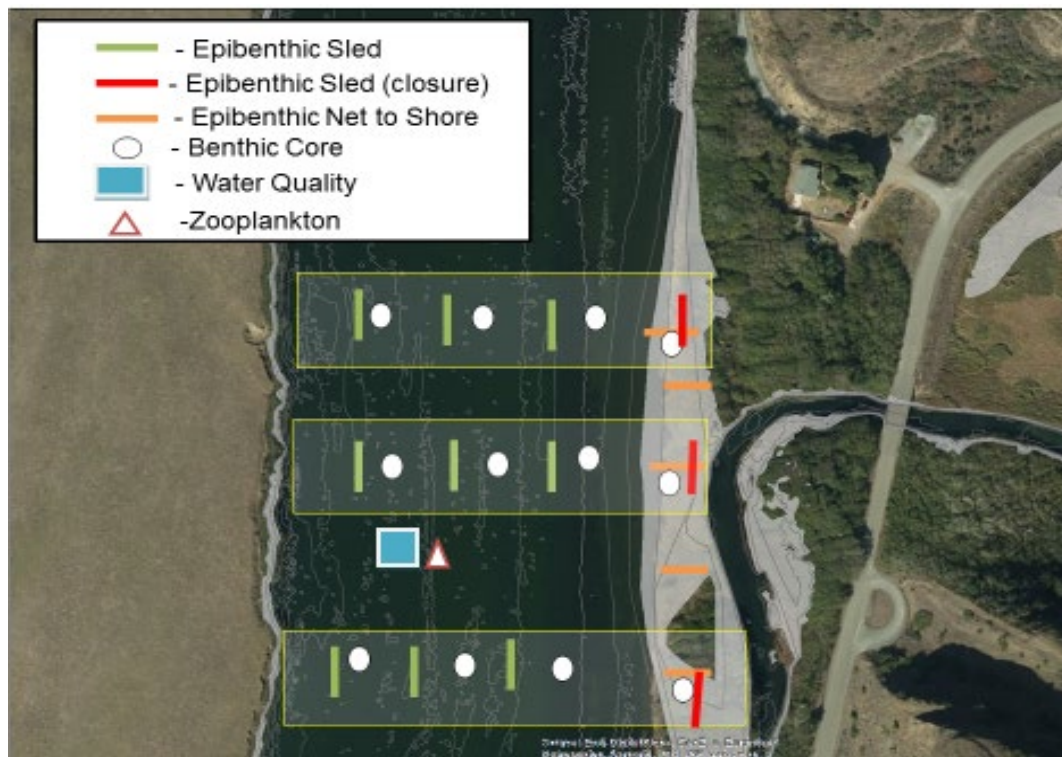
Figure 4.3.7. Modification of sampling techniques during closed conditions for distribution of juvenile salmonid prey availability sampling transects and techniques at Willow Creek site in the Russian River Estuary. The grey area is the inundation of area during closed conditions.

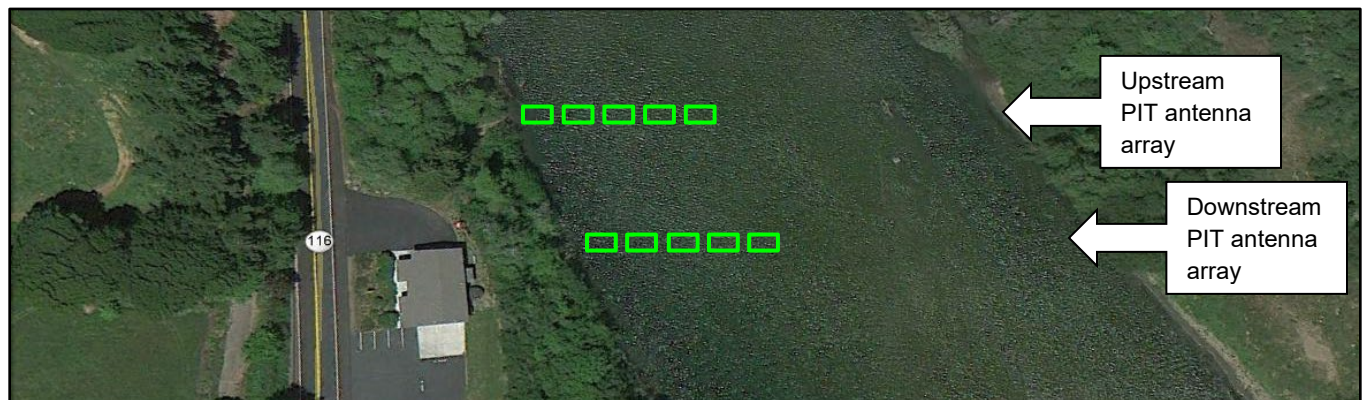
Figure 4.5.2. Flat plate antenna arrays at Duncans Mills (river km 10.46). Rectangles represent individual flat plate antennas.

Typically, two antenna arrays with multiple flat plate antennas (antennas designed to lay flat on the stream bottom) are installed in the upper Russian River estuary near the town of Duncans Mills (riverkm 10.46) to detect PIT-tagged fish entering the estuary (Figure 4.5.2). Generally, 10 antennas were operated continuously throughout the year. The orientation of the antennas consisted of 2 rows of antennas with one row slightly upstream of the other. Each row contained 5 antennas placed side by side starting at the west river bank and extending out into the channel.

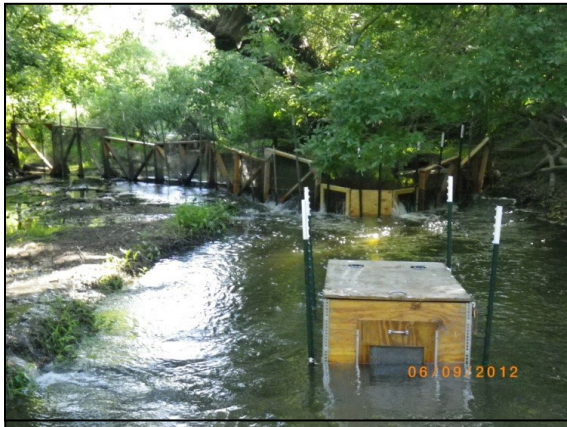
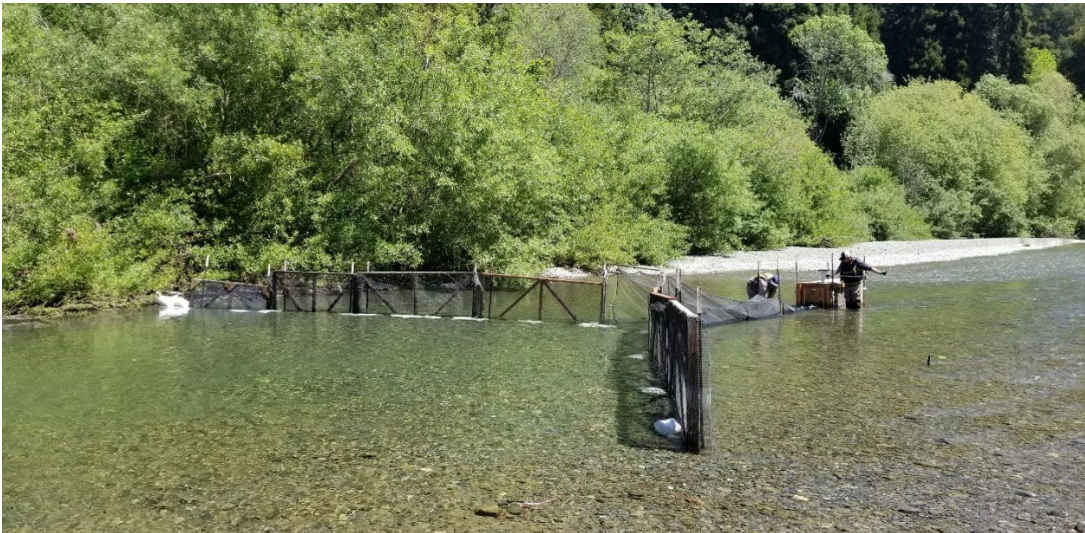
Mark West Creek: Pipe trap (fished 3/31-5/27).

Austin Creek: Funnel trap (fished 3/25-4/19), pipe trap (fished 4/20-5/22).

Figure 4.5.3. Photographs of downstream migrant traps operated by the Sonoma Water (Mark West, Dutch Bill and Austin creeks). See the Russian River Biological Opinion Status and Data Report Year 2021-2022 for details regarding operation of the Dry Creek trap.

Following consultation with NMFS and CDFW, Sonoma Water identified three lower Russian River tributaries (Mark West Creek, Dutch Bill Creek and Austin Creek, Figure 4.5.1) in which to operate fish traps as a way to supplement data collected from the Duncans Mills PIT antenna array and during sampling by beach seining throughout the estuary (Figure 4.5.1). Downstream migrant traps are also operated at the Mirabel inflatable dam. Sonoma Water operated three types of downstream migrant traps in 2021: rotary screw trap, funnel trap and pipe trap depending on the stream, water depth, and velocity (Figure 4.5.3). Fish traps were checked

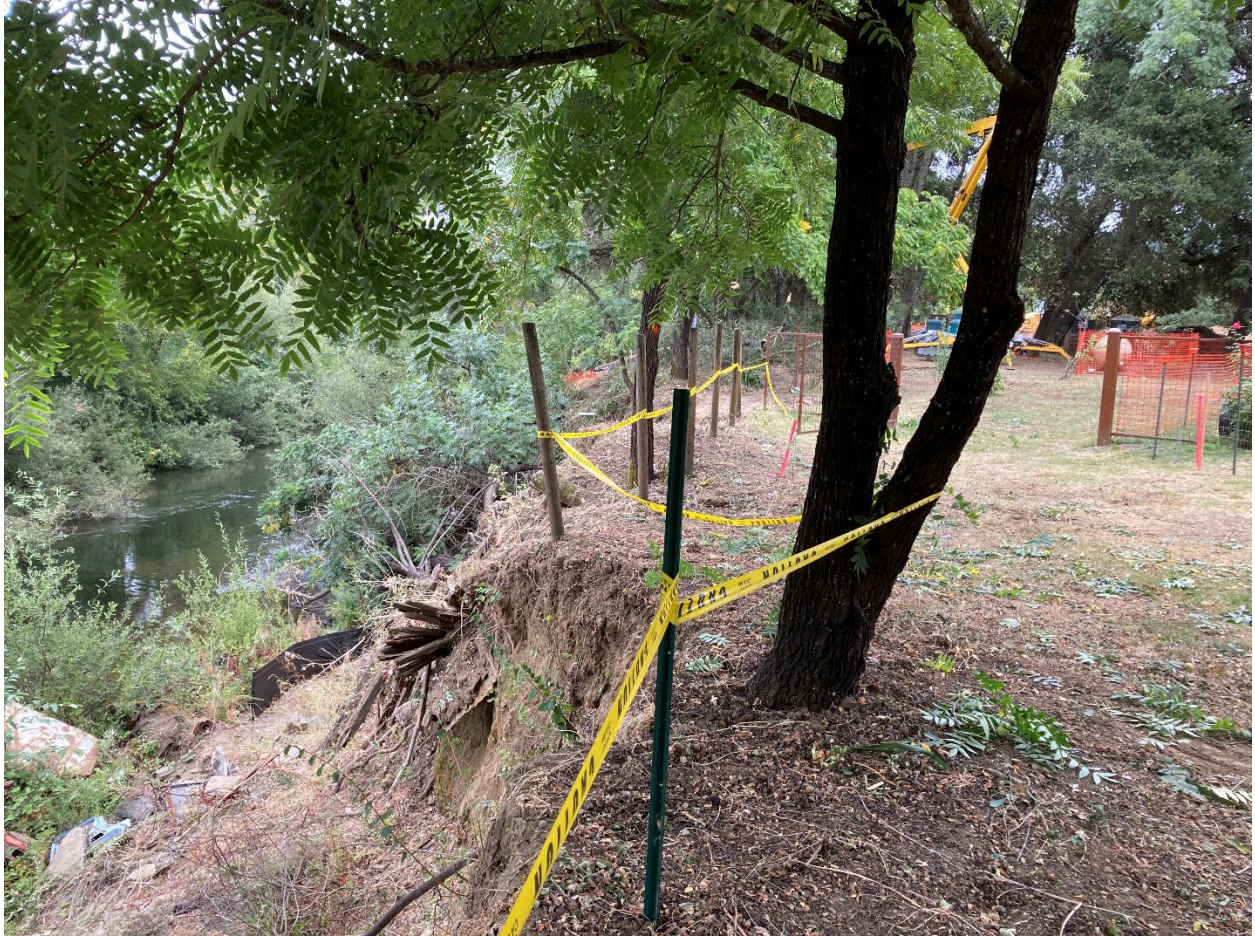
Photo 5.1.2. Phase 3, Part 3. Upper end of bank stabilization work area, looking downstream pre-project condition. July 30, 2020.

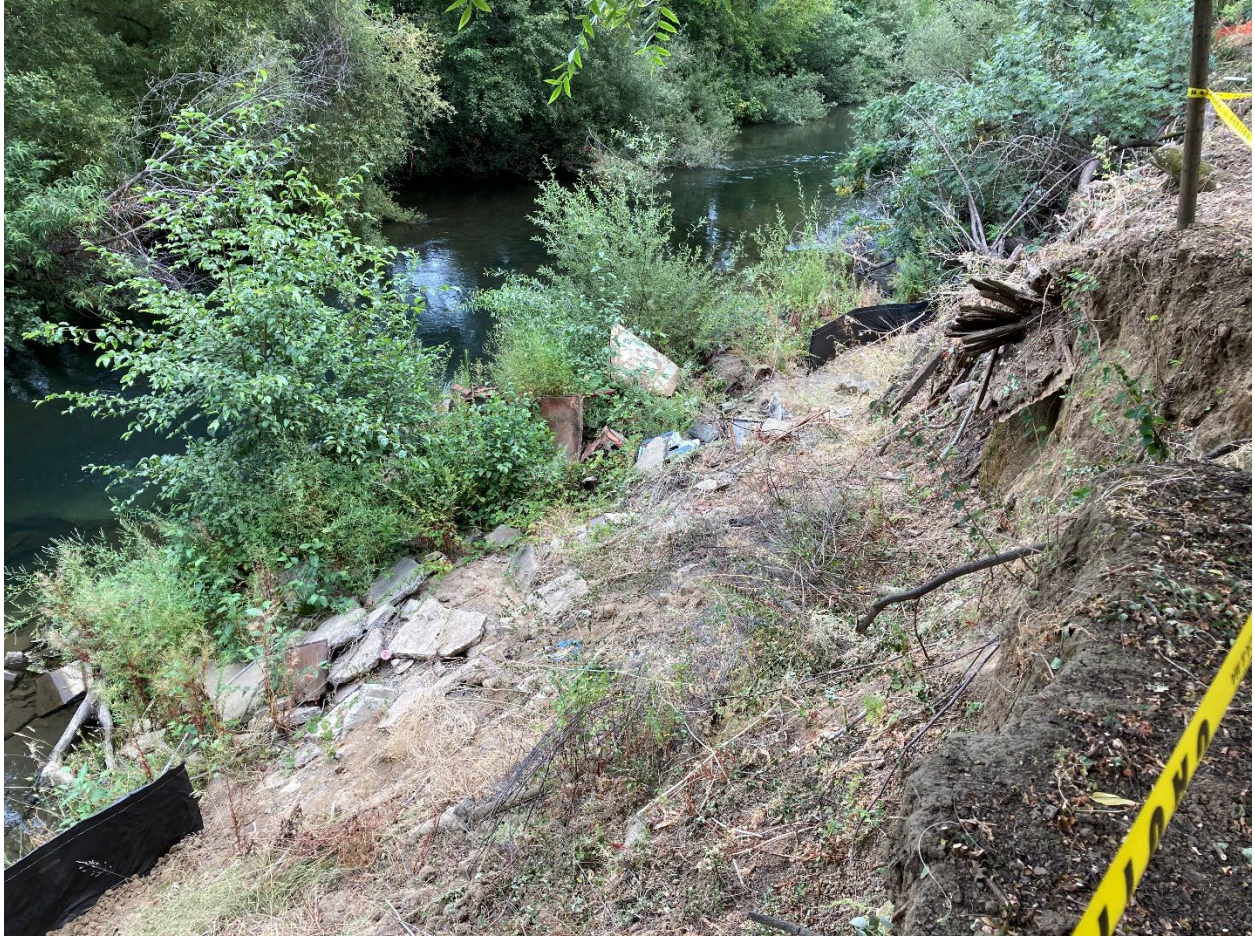
Photo 5.1 3. Phase 3, Part 3. Upper end of bank stabilization work area, looking downstream pre-project condition. July 30, 2020.

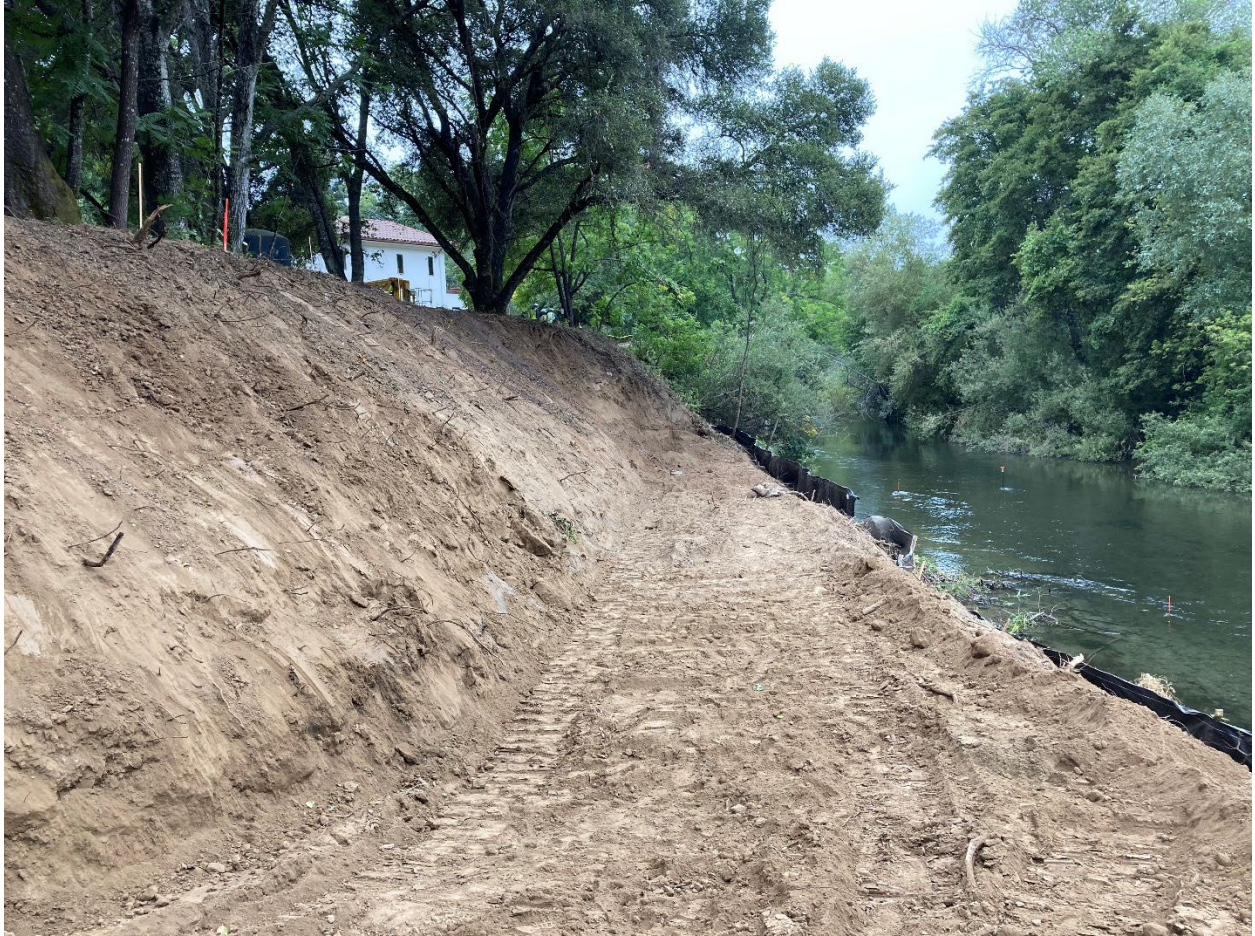
Photo 5.1.4. Phase 3, Part 3. Lower end of bank stabilization work area, looking upstream. Initial clearing and access road underway. July 30, 2020.

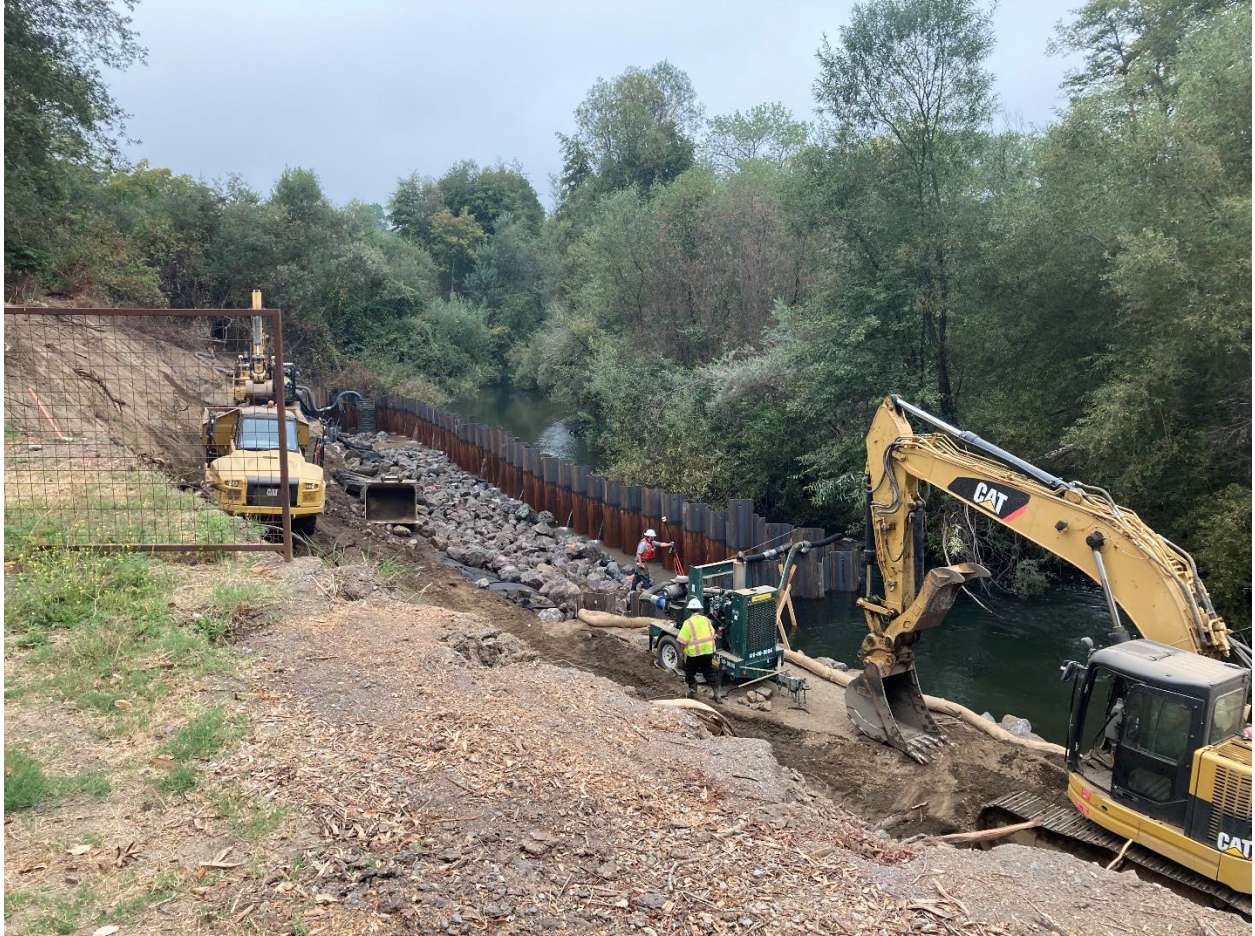
Photo 5.1.5. Phase 3, Part 3. Rock slope protection construction in progress. Note sheet-pile isolating work area from active flow of Dry Creek. September 10, 2020.

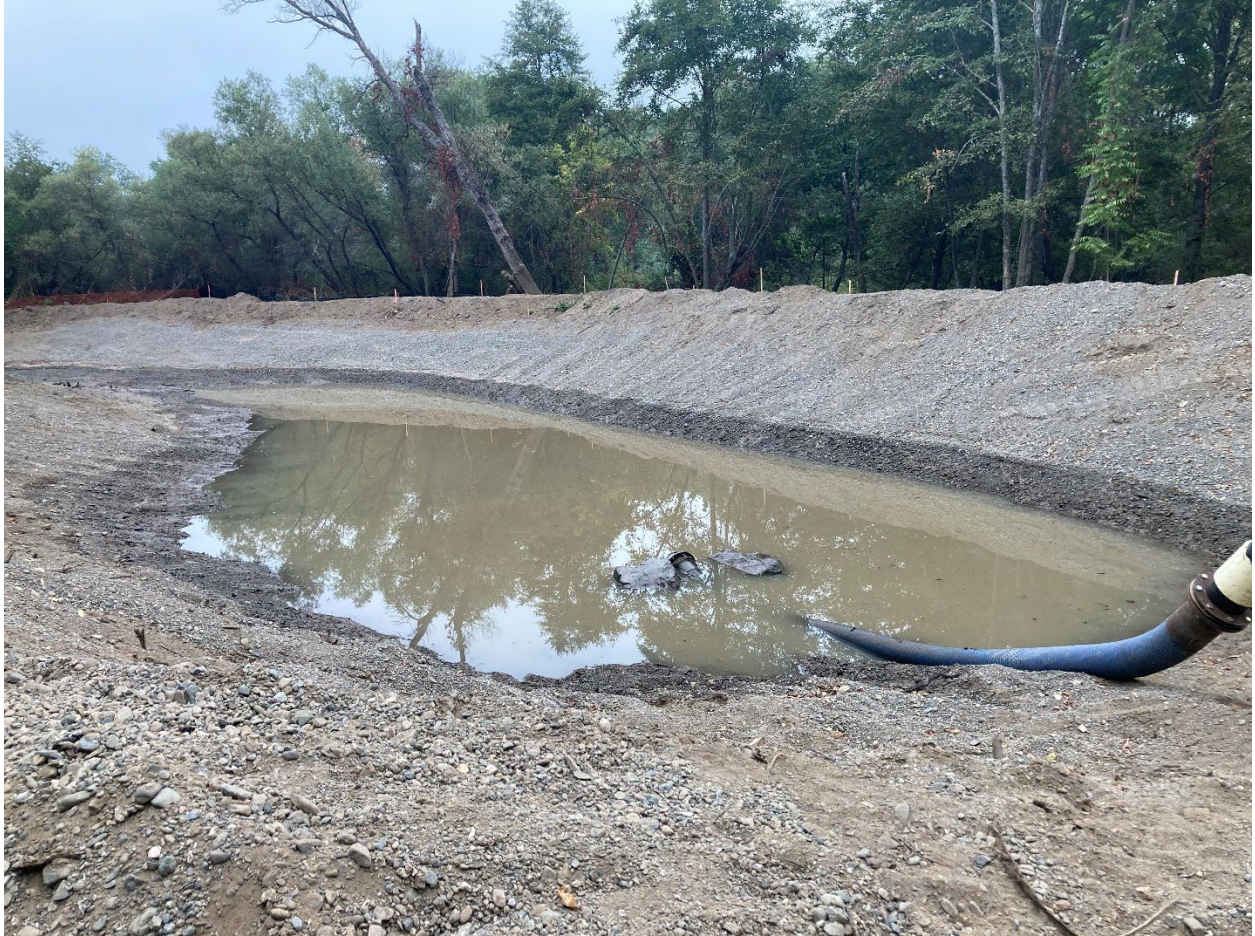
Photo 5.1.6. Phase 3, Part 3. Initial clearing of habitat site work area and being used as a dewatering basin for the bank stabilization work. September 10, 2020.

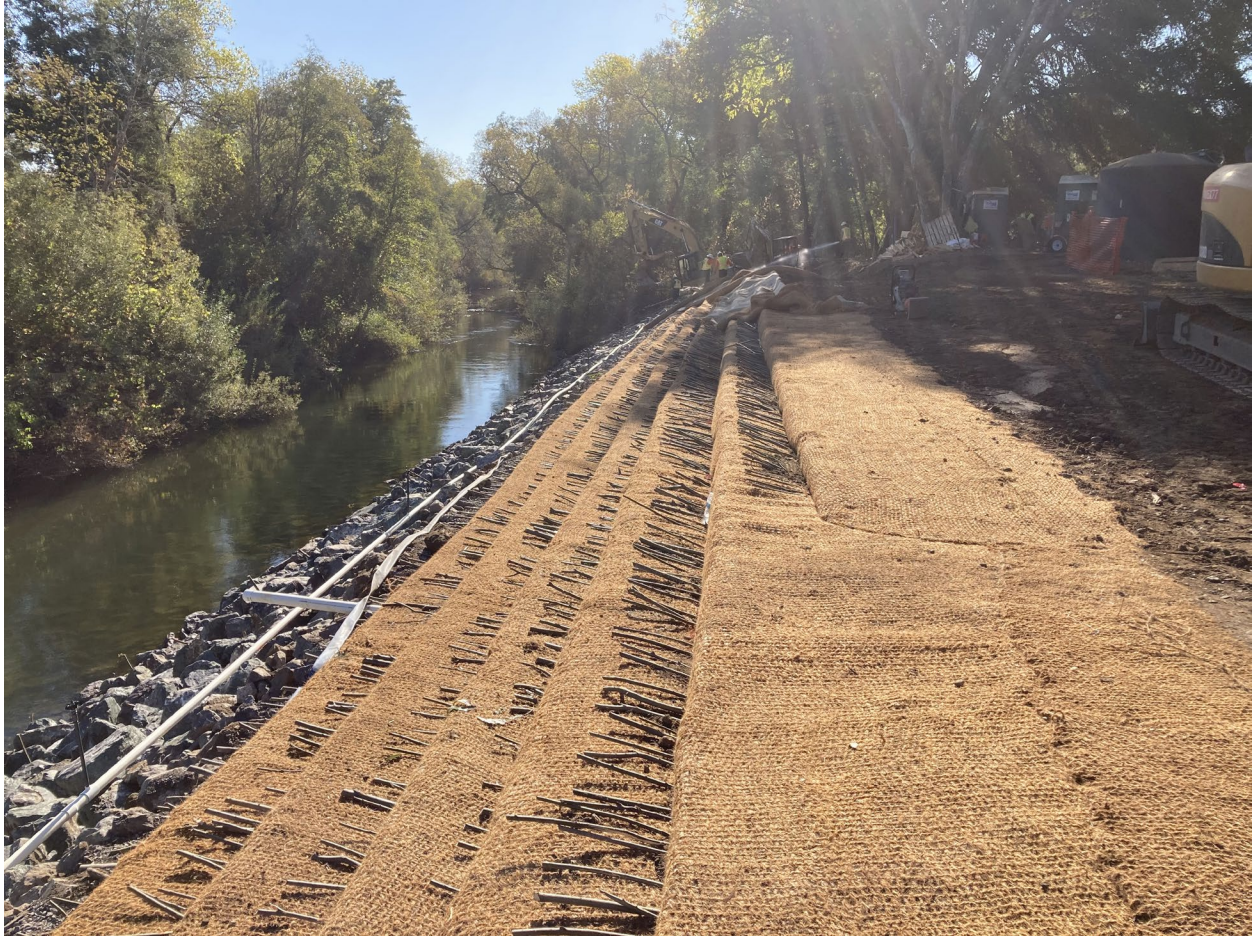
Photo 5.1.8. Phase 3, Part 3. Bank stabilization section work is complete. November 3, 2020.

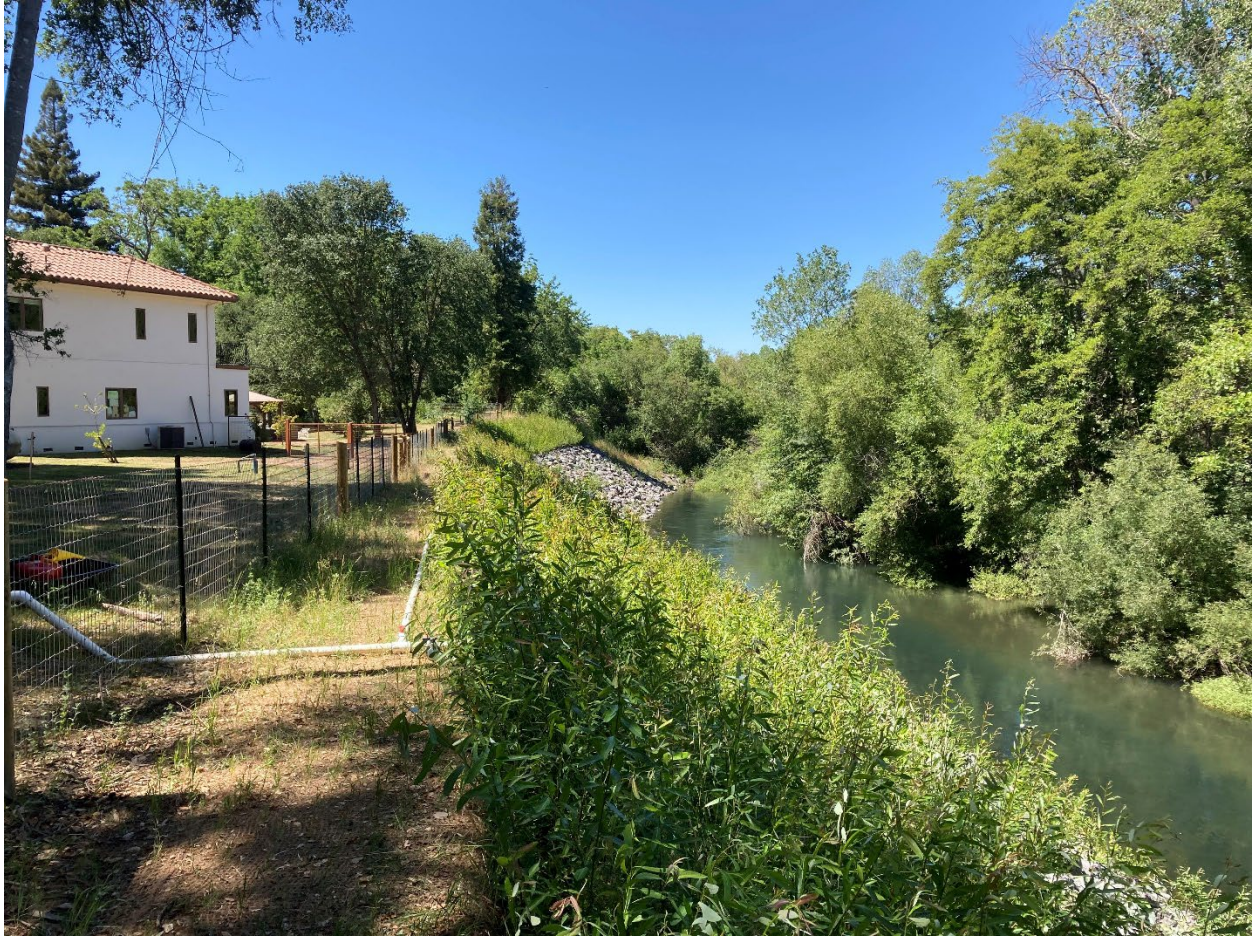
Photo 5.1.9. Phase 3, Part 3. Bank stabilization section work completed in 2020 and showing willow cuttings established and leafing out. May 19, 2021.

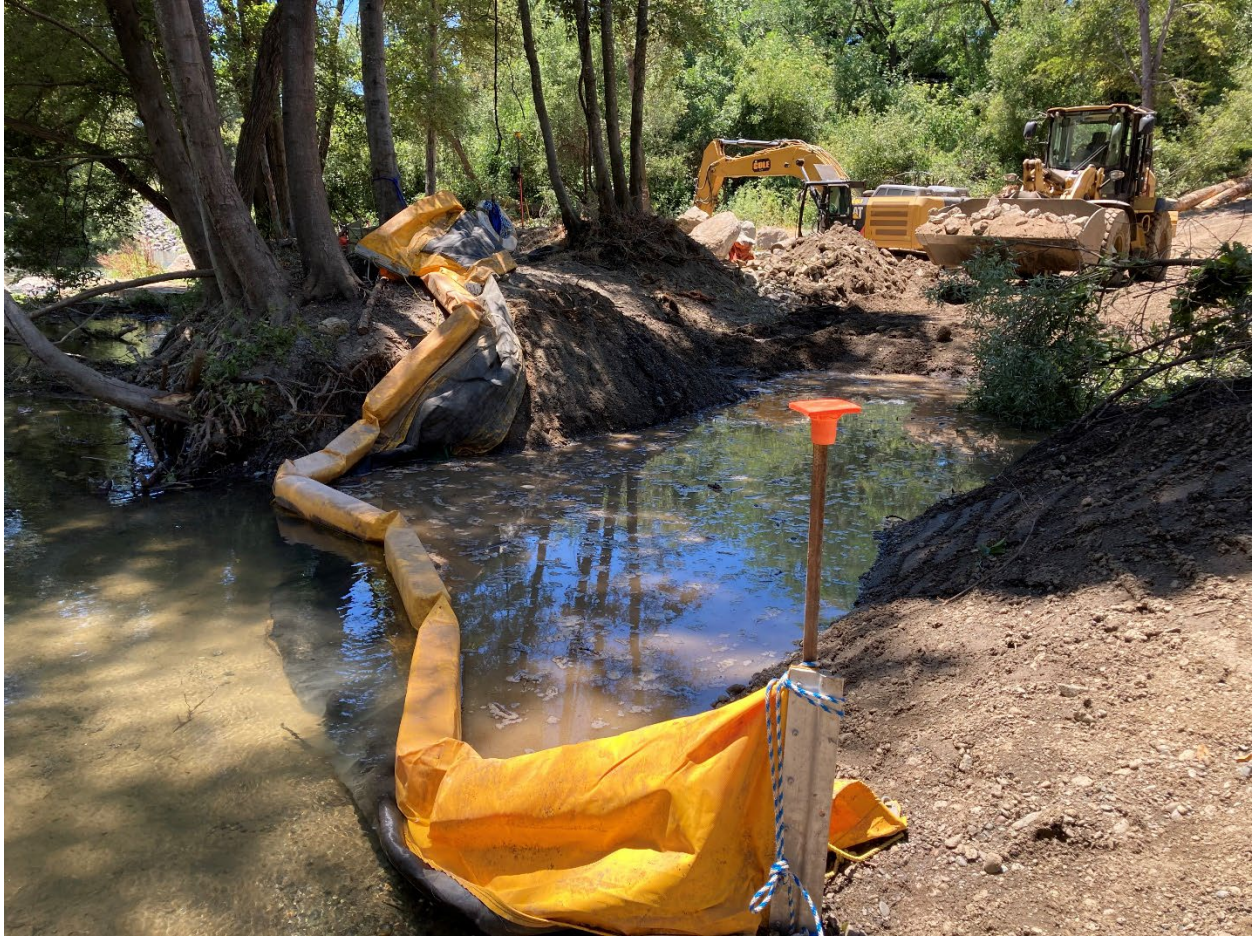
Photo 5.1.10. Phase 3, Part 3. New habitat side-channel feature under construction (Stromberg site). Photo is showing the side-channel inlet area with a turbidity curtain isolating the inlet area from the active flow of Dry Creek. June 24, 2021.

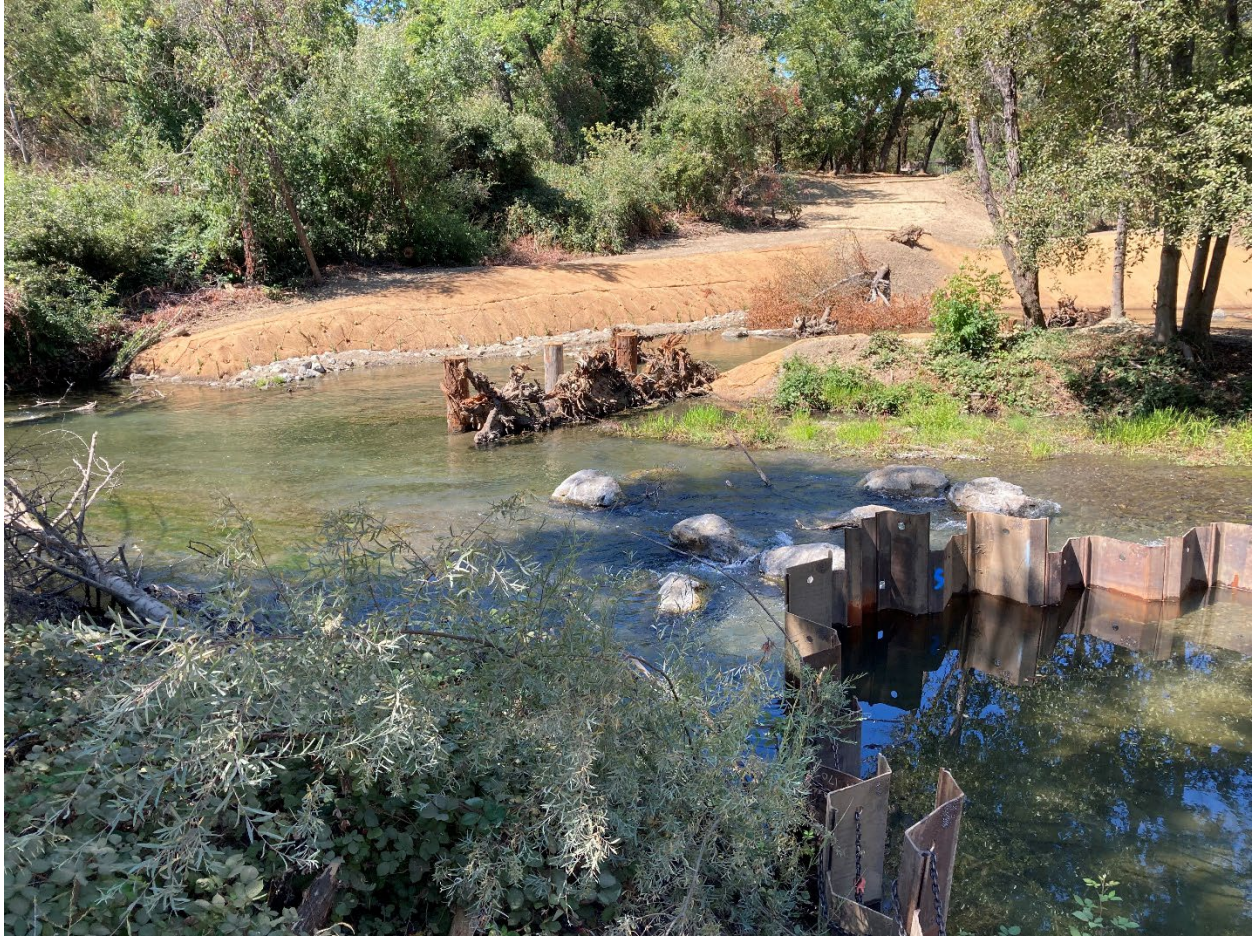
Photo 5.1.11. Phase 3, Part 3. New habitat side-channel feature (Stromberg site) recently completed, showing the side-channel outlet back into the mainstem of Dry Creek. Also visible in this photo is a newly installed boulder field in the mainstem of Dry Creek, and a portion of sheet piling being used to isolate the active flow of Dry Creek from the Gros-Balthazard site work area). August 25, 2021.

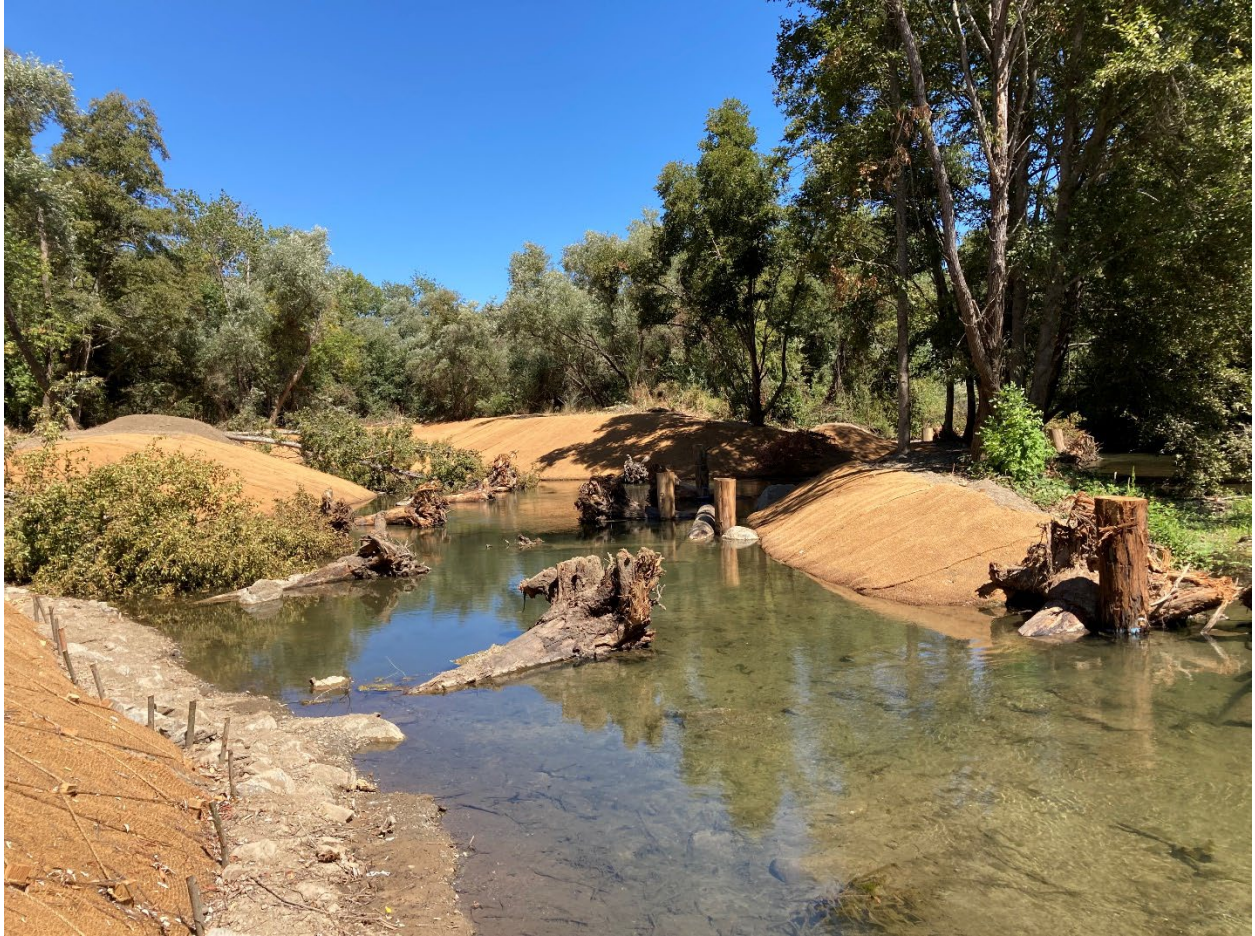
Photo 5.1.12. Phase 3, Part 3. New habitat side-channel feature (Stromberg site) recently completed. August 4, 2021.

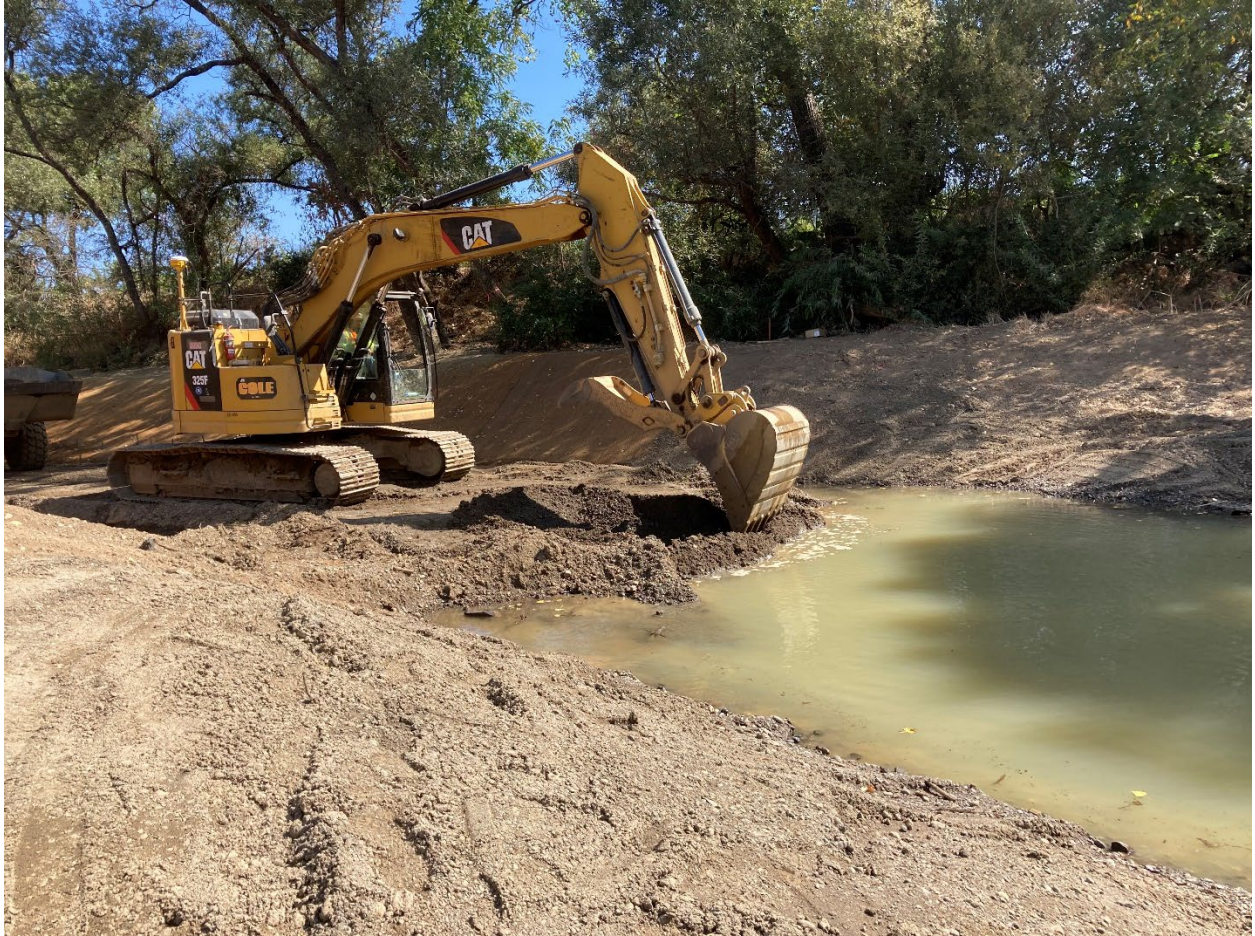
Photo 5.1.13. Phase 3, Part 3. New habitat side-channel feature (Gros-Balthazard site). New side-channel excavation in process. August 25, 2021.

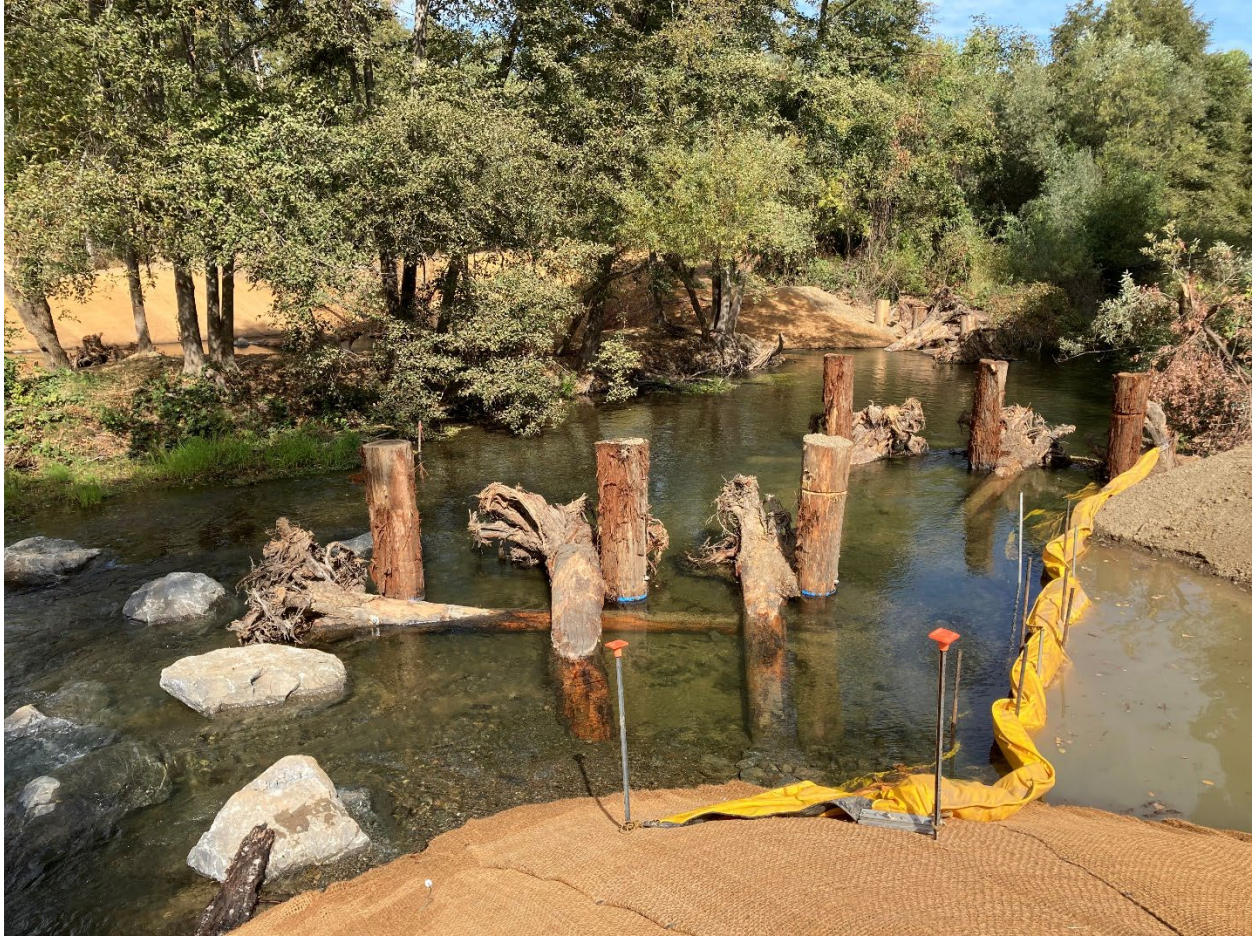
Photo 5.1.14. Phase 3, Part 3. Newly installed wood structures at the inlet to the habitat side-channel feature (Gros-Balthazard site). The side-channel is under construction and a turbidity curtain is visible isolating the work area from the active flow of Dry Creek. September 8, 2021.

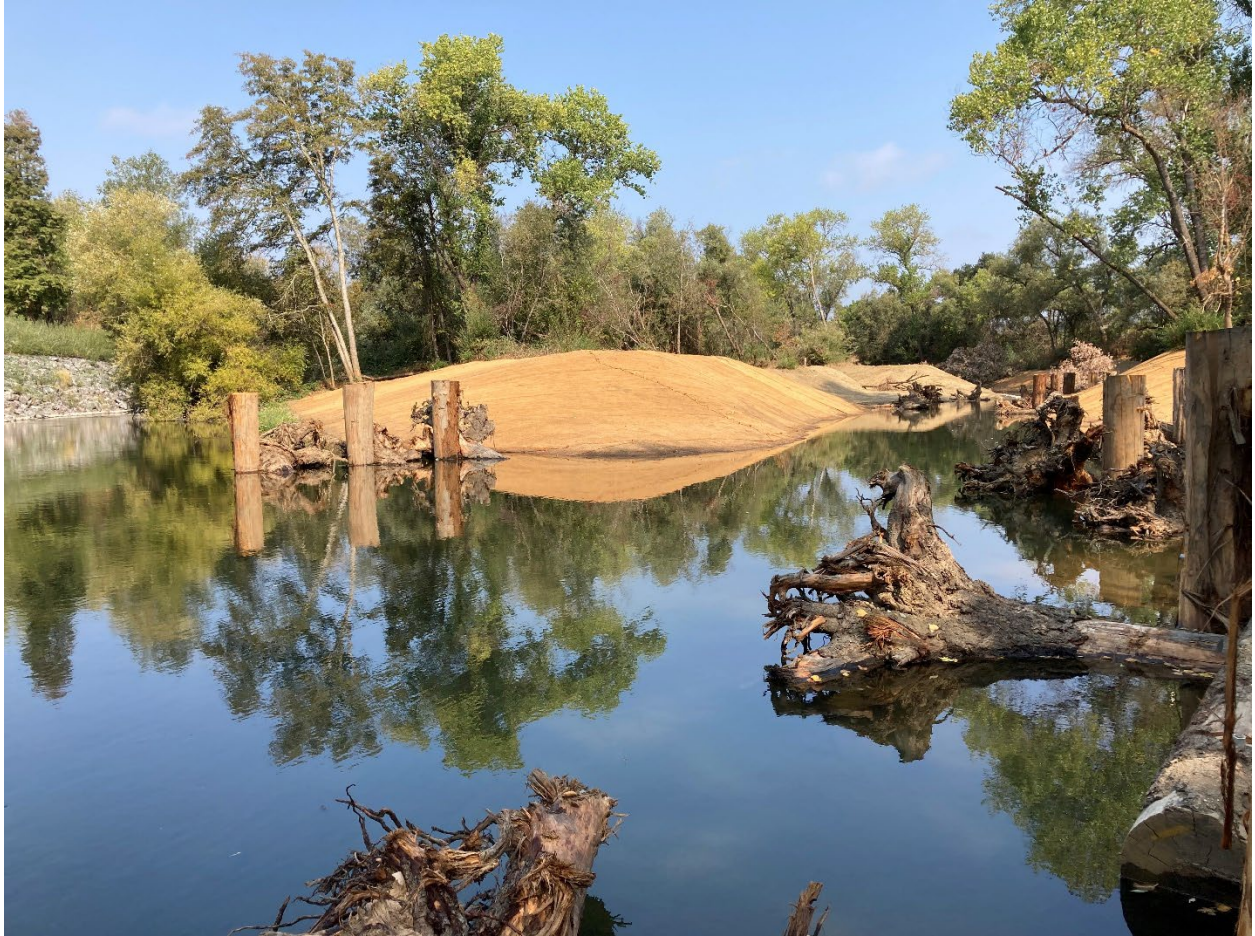
Photo 5.1.15. Phase 3, Part 3. Newly completed habitat side-channel feature (Gros-Balthazard site). Photo is looking back upstream at the outlet of the side-channel on the right and the mainstem of Dry Creek is on the left. A portion of the bank stabilization work (Boaz property) that was completed in 2020 is visible on the far left of this photo. September 15, 2021.

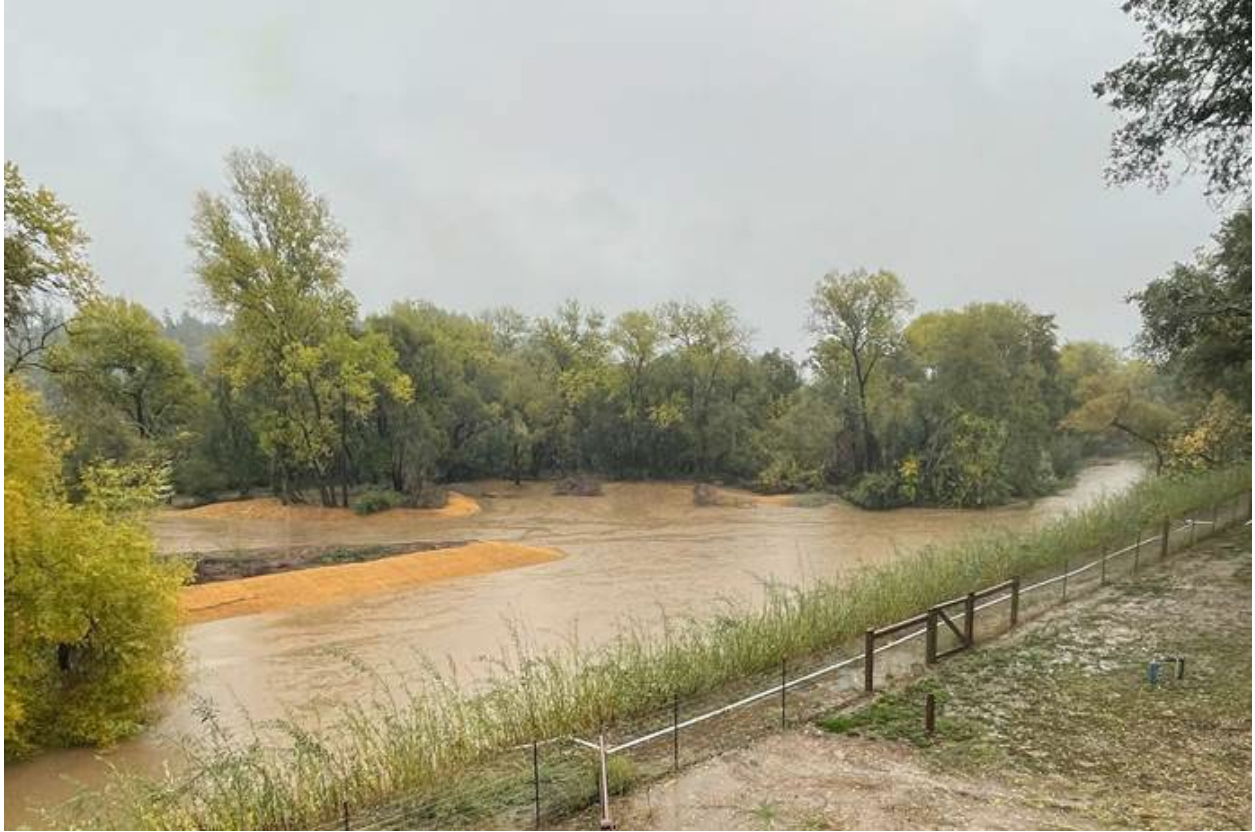
Photo 5.1.16. Phase 3, Part 3. High flow event that occurred soon after completion of construction. View is from the river-right side of Dry Creek from the bank repair area (Boaz site) looking downstream with the mainstem of Dry Creek in the foreground and the outlet of the Gros-Balthazard site side-channel towards the middle of the photo. Photo courtesy of Jason Boaz. October 24, 2021.
