Russian River Biological Opinion Status and Data Report

Year 2021 – 2022

February 2024

**Sonoma
Water**

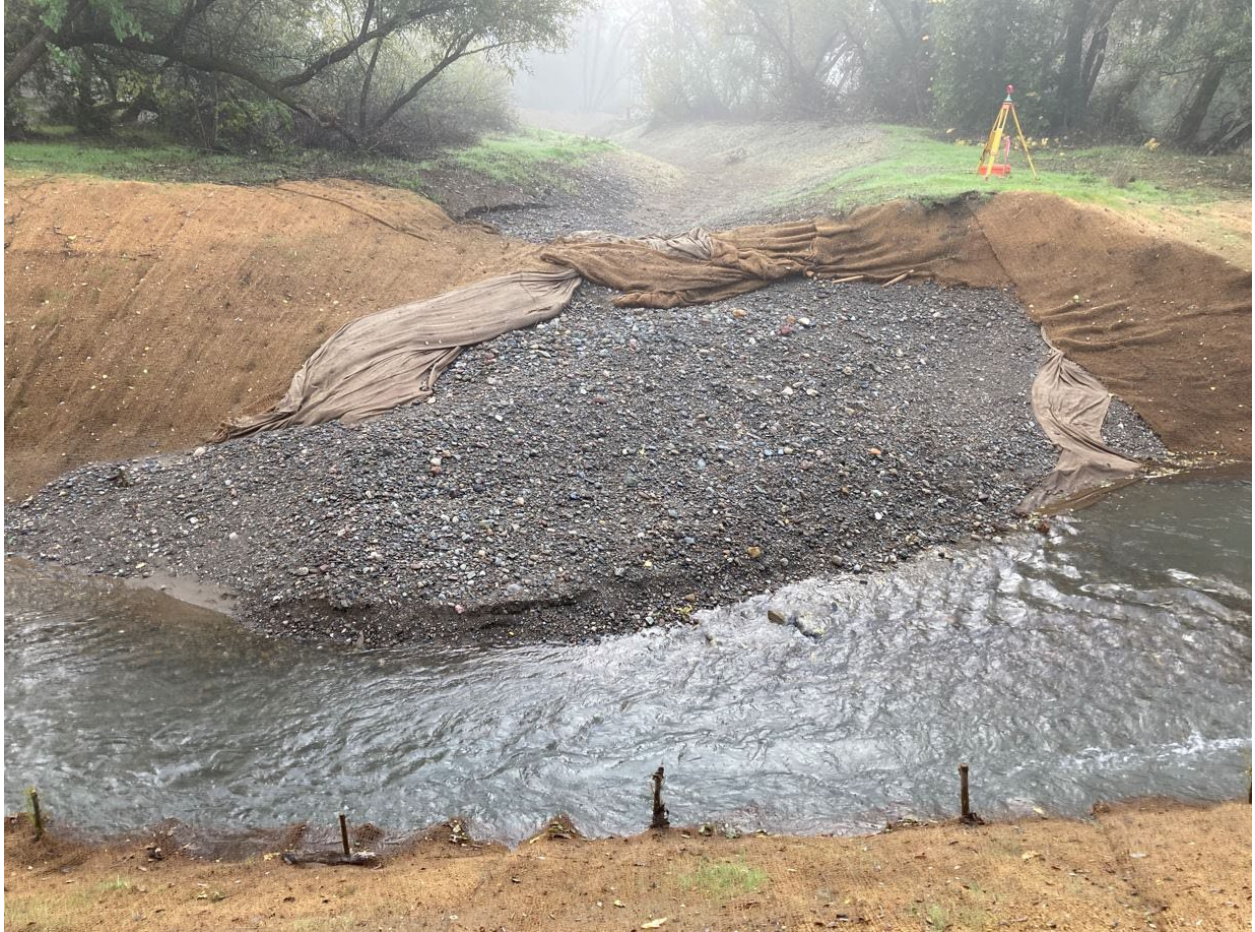
Photo 5.1.17. Phase 3, Part 3. Minor damage to erosion control fabric in the inlet area to the Gros-Balthazard site side channel as a result of the October 24, 2021 high flow event. November 3, 2021.

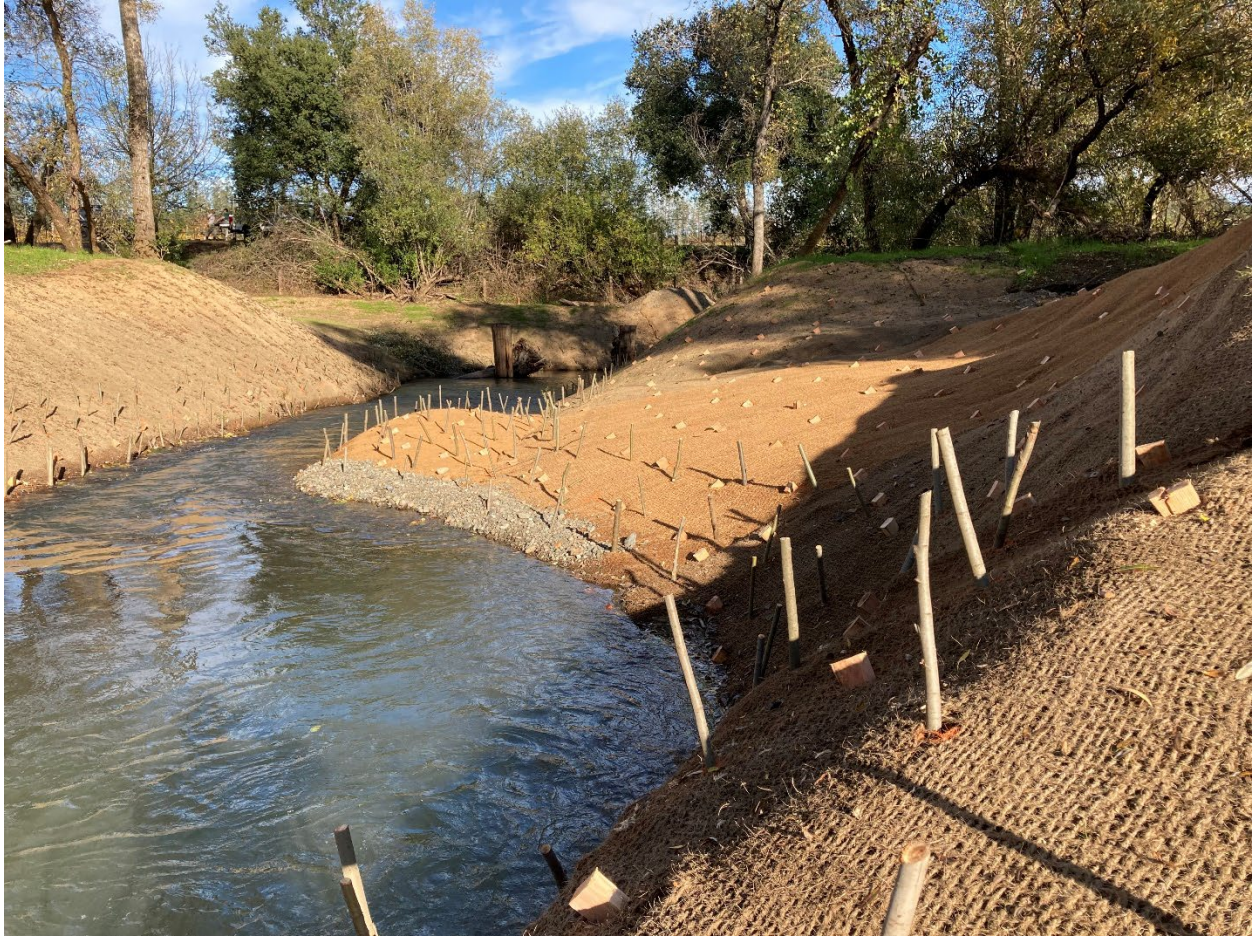
Photo 5.1.18. Phase 3, Part 3. Inlet area to the Gros-Balthazard, erosion control fabric repaired and area re-staked with willow cuttings after the October 24, 2021 high flow event. November 23, 2021.

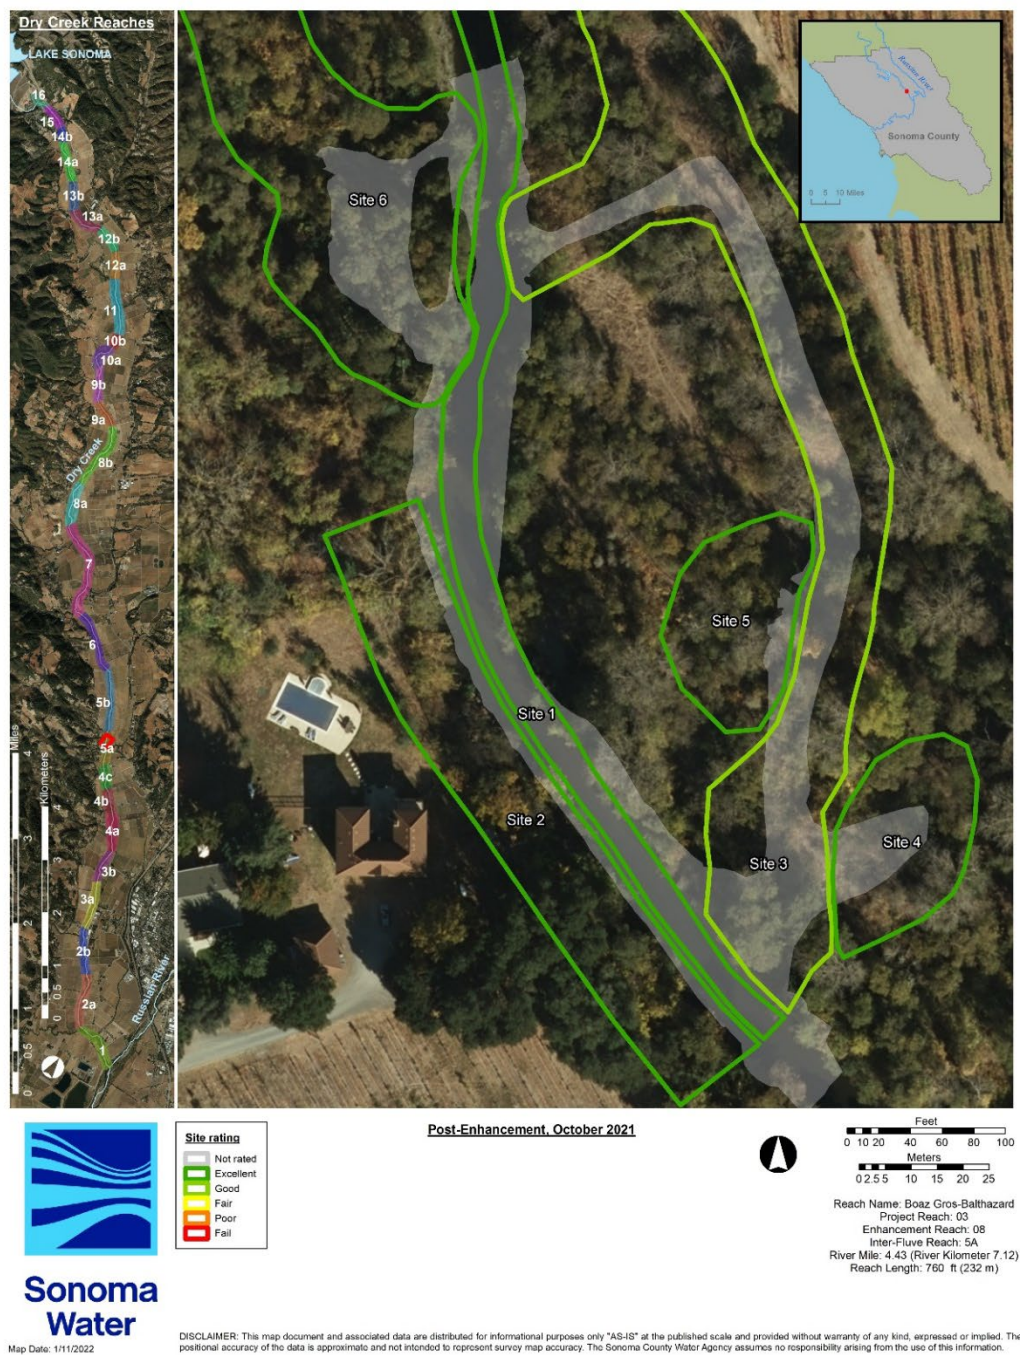
Figure 5.2.11. Post-enhancement site ratings for the Boaz Gros-Balthazard enhancement reach, October 2021.

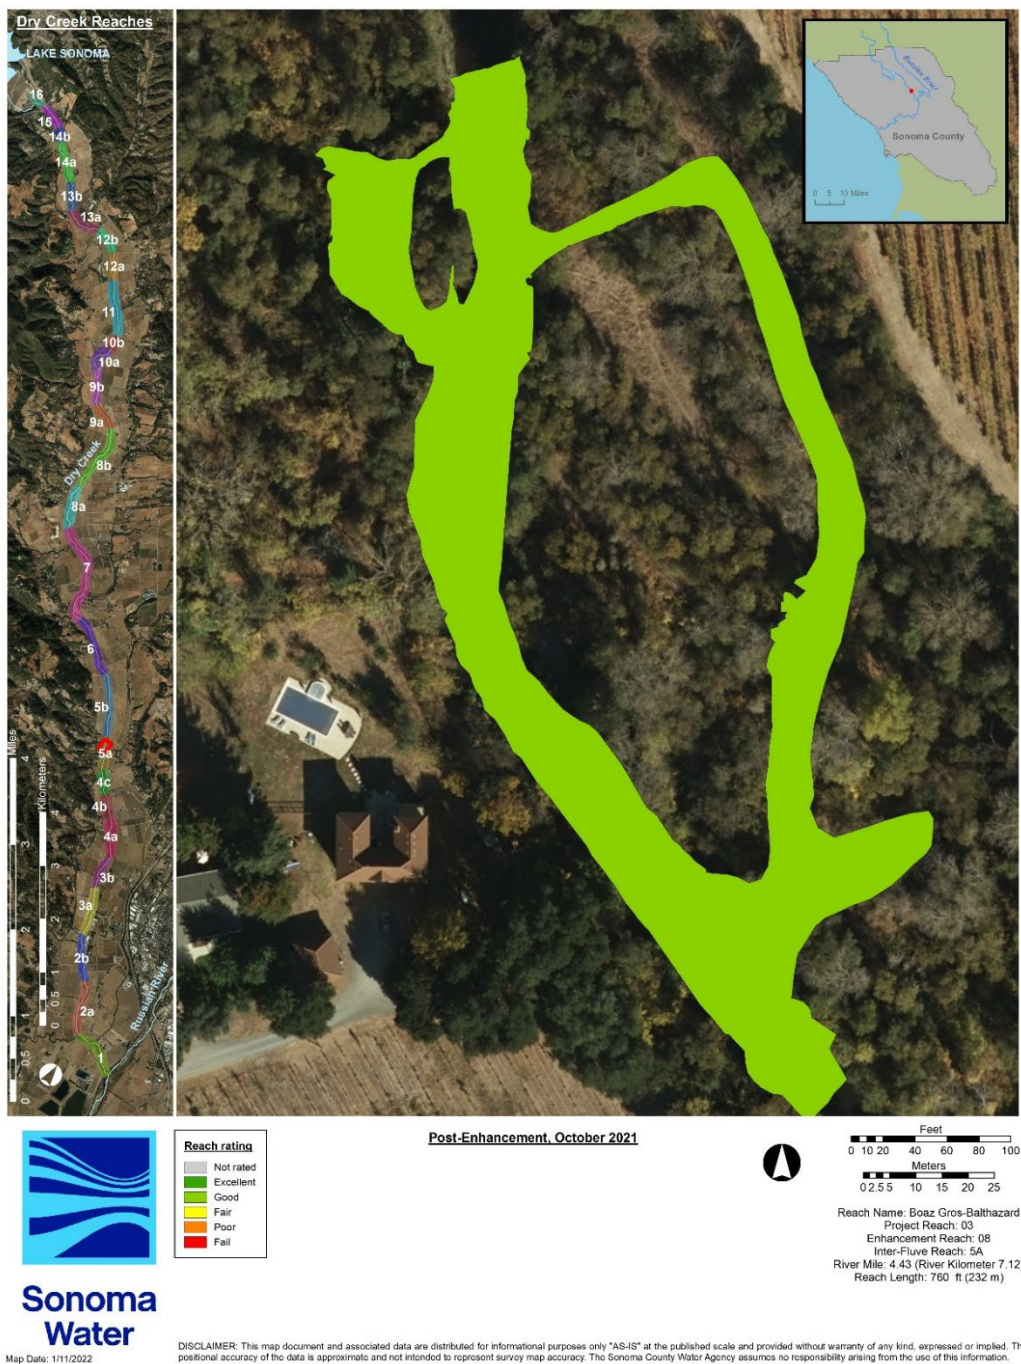
Figure 5.2.12. Post-enhancement reach rating for the Boaz Gros-Balthazard enhancement reach, October 2021.

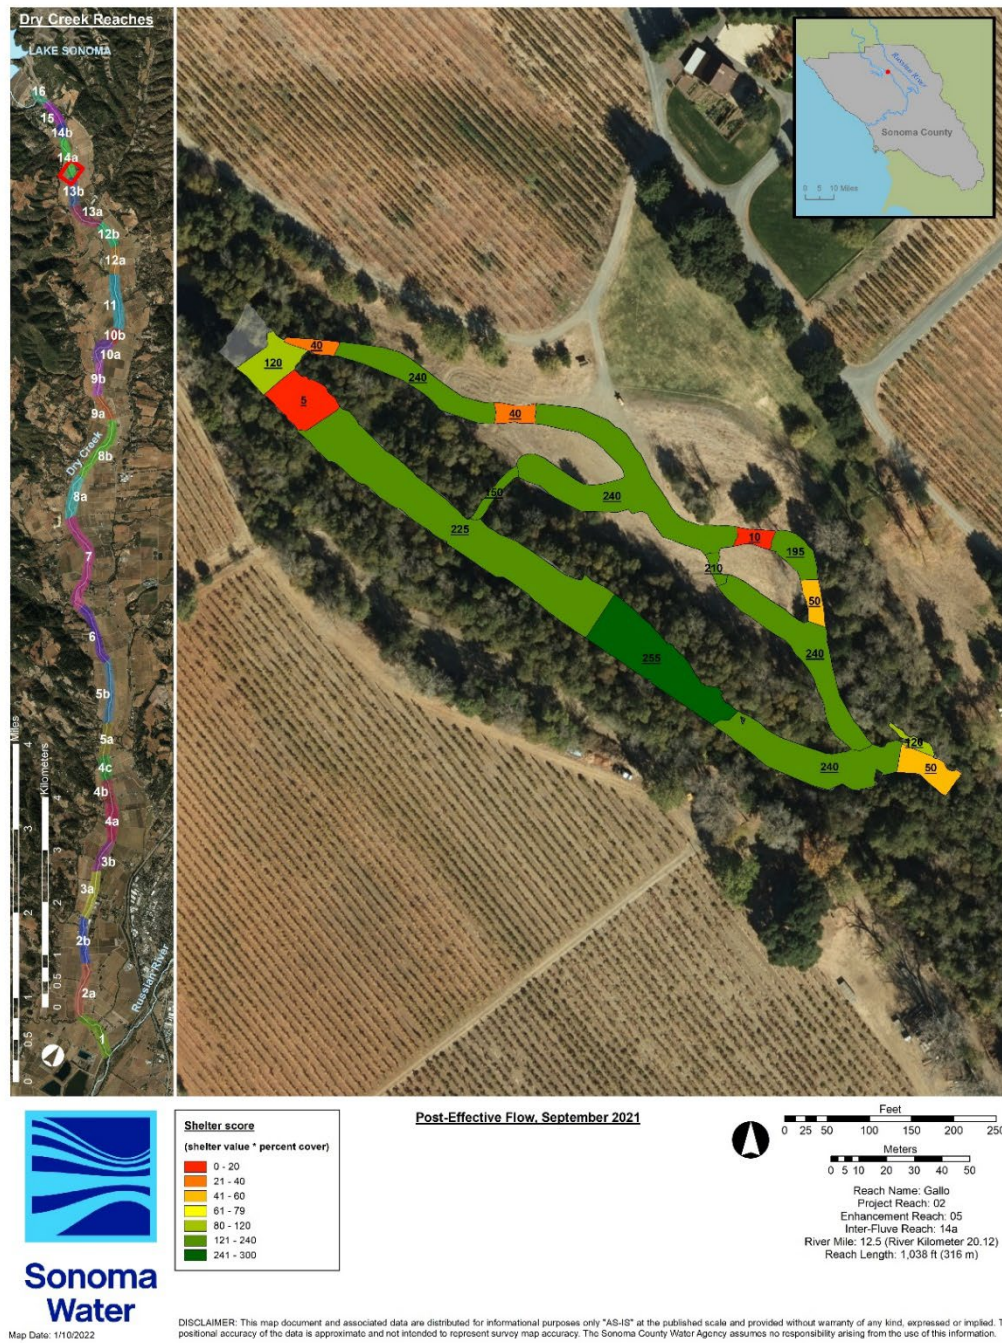
Figure 5.2.15. Habitat unit shelter scores within the Gallo enhancement reach, September 2021.

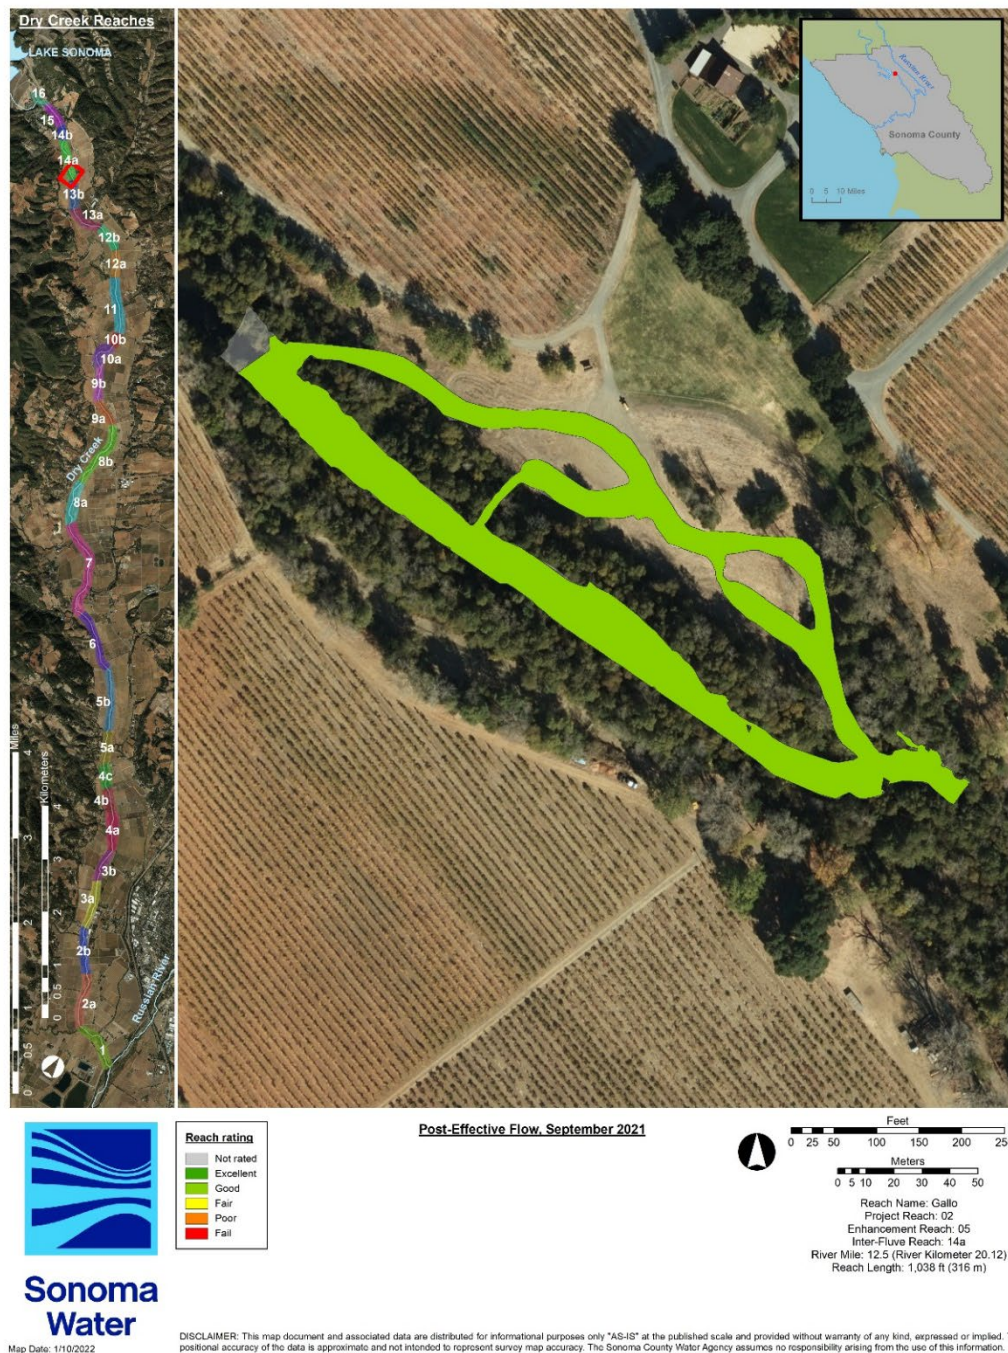
Figure 5.2.20. Post-enhancement reach rating for the Gallo enhancement reach, September 2021.

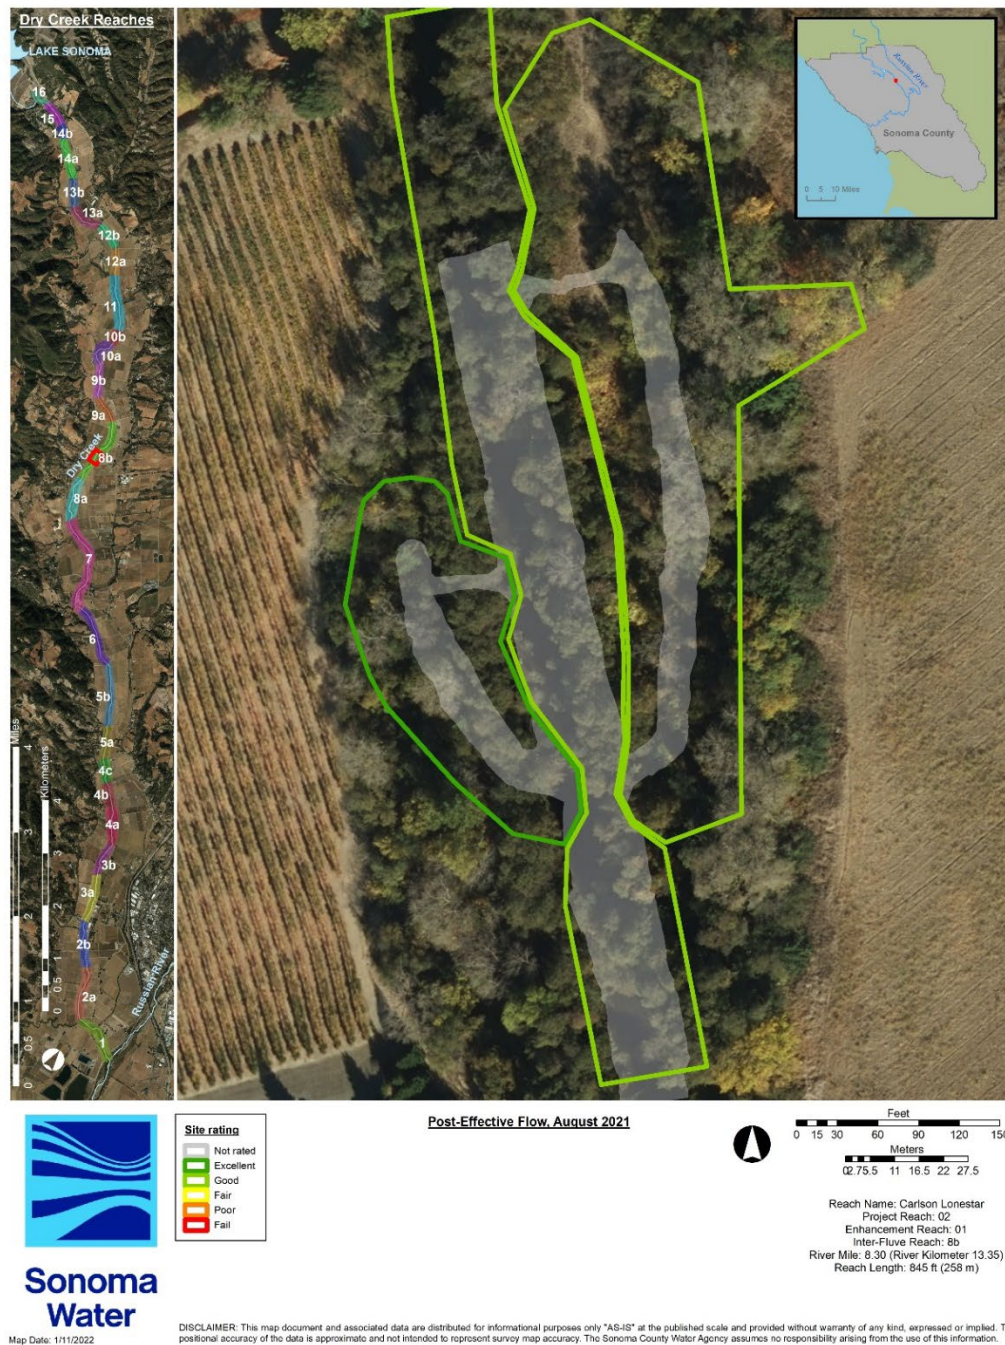
Figure 5.2.43. Post-effective flow site ratings for the Carlson Lonestar enhancement reach, August 2021.

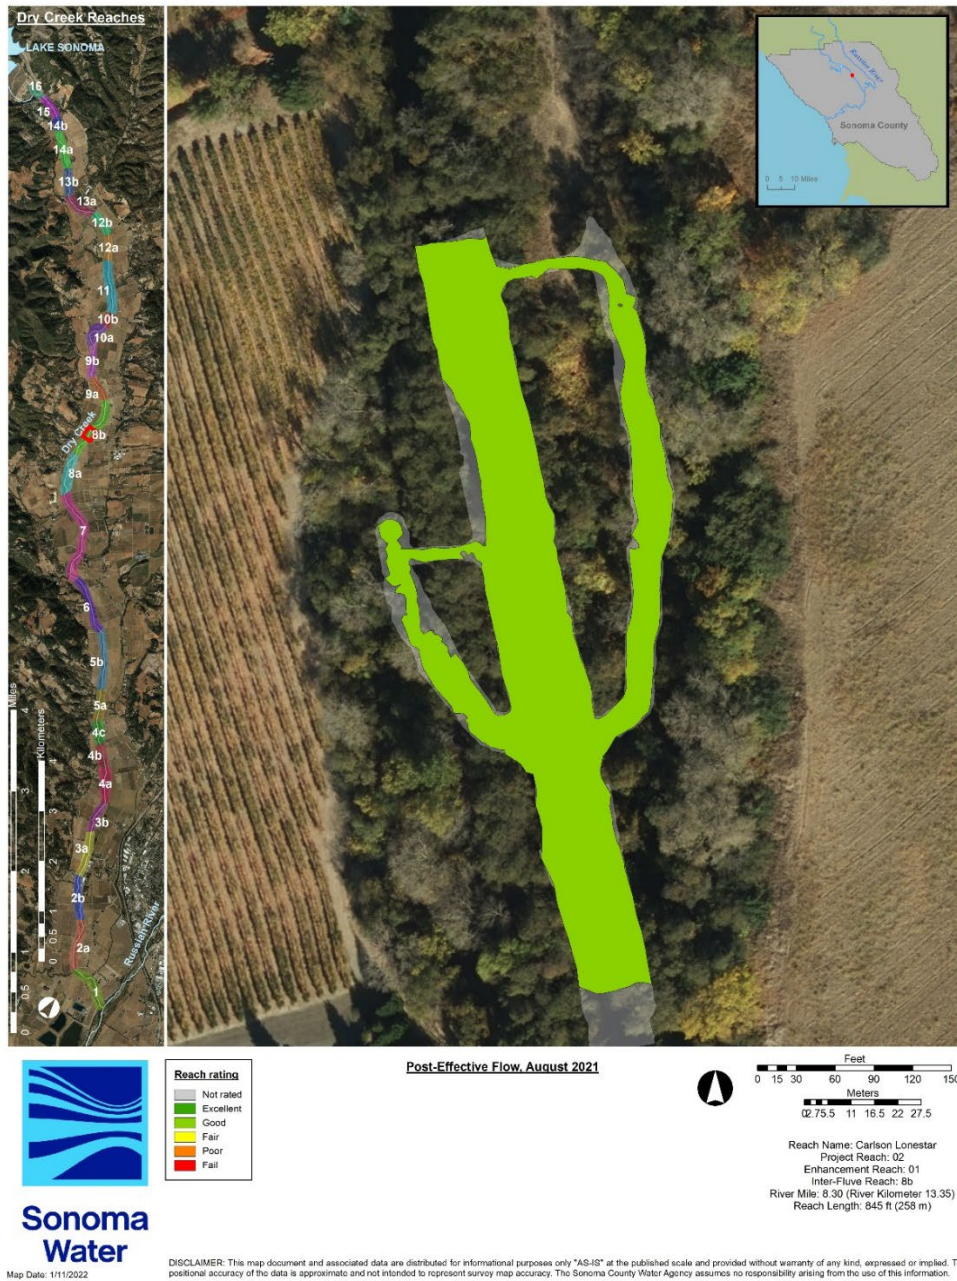
Figure 5.2.44. Post-effective flow reach rating for the Carlson Lonestar enhancement reach, August 2021.

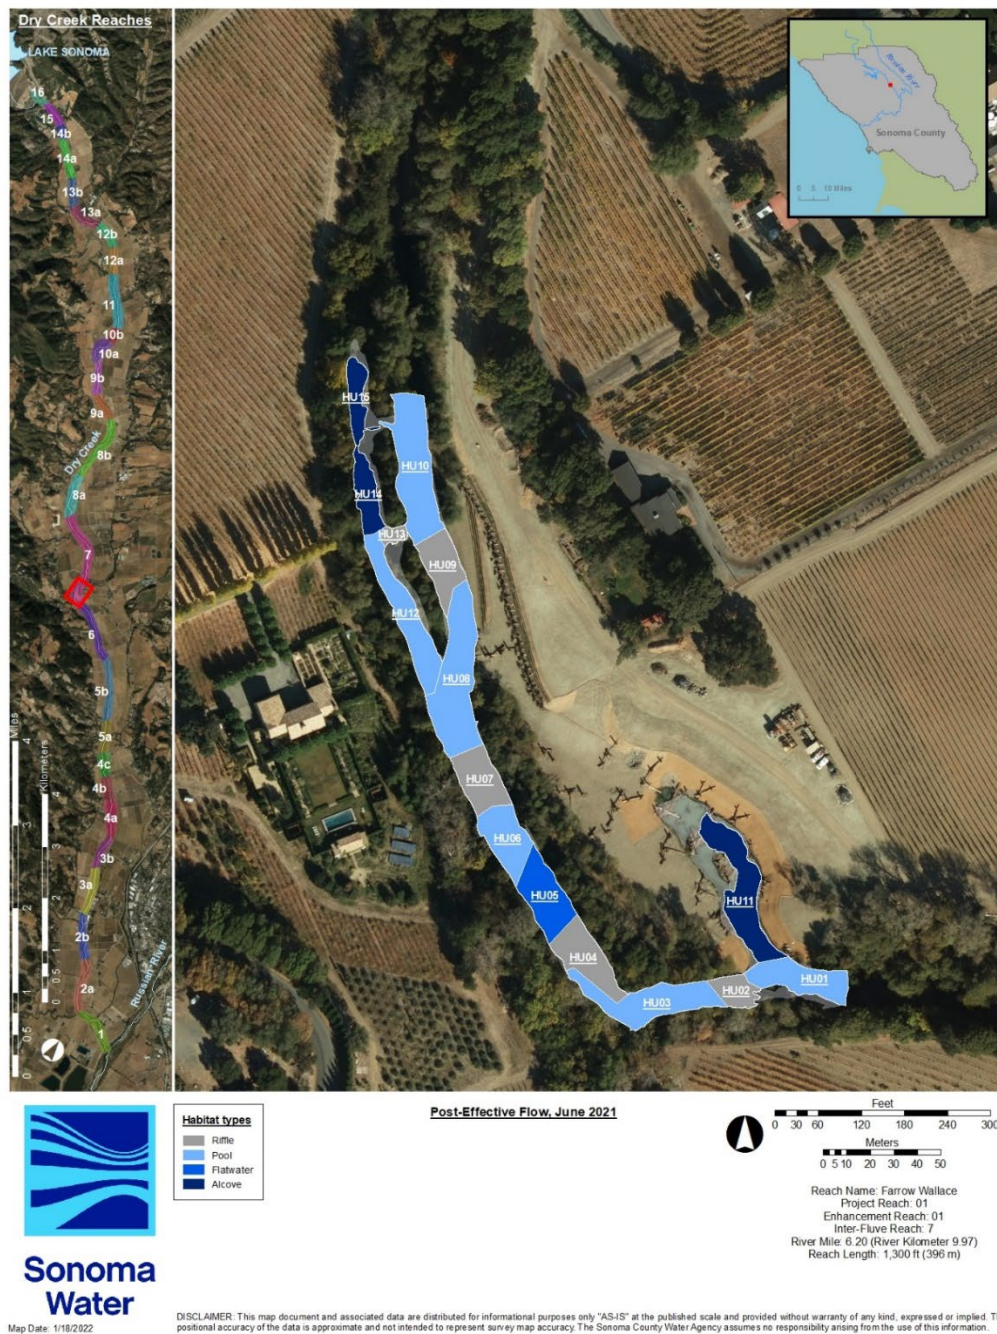
Figure 5.2.46. Habitat unit number and type within the Farrow Wallace enhancement reach, June 2021.

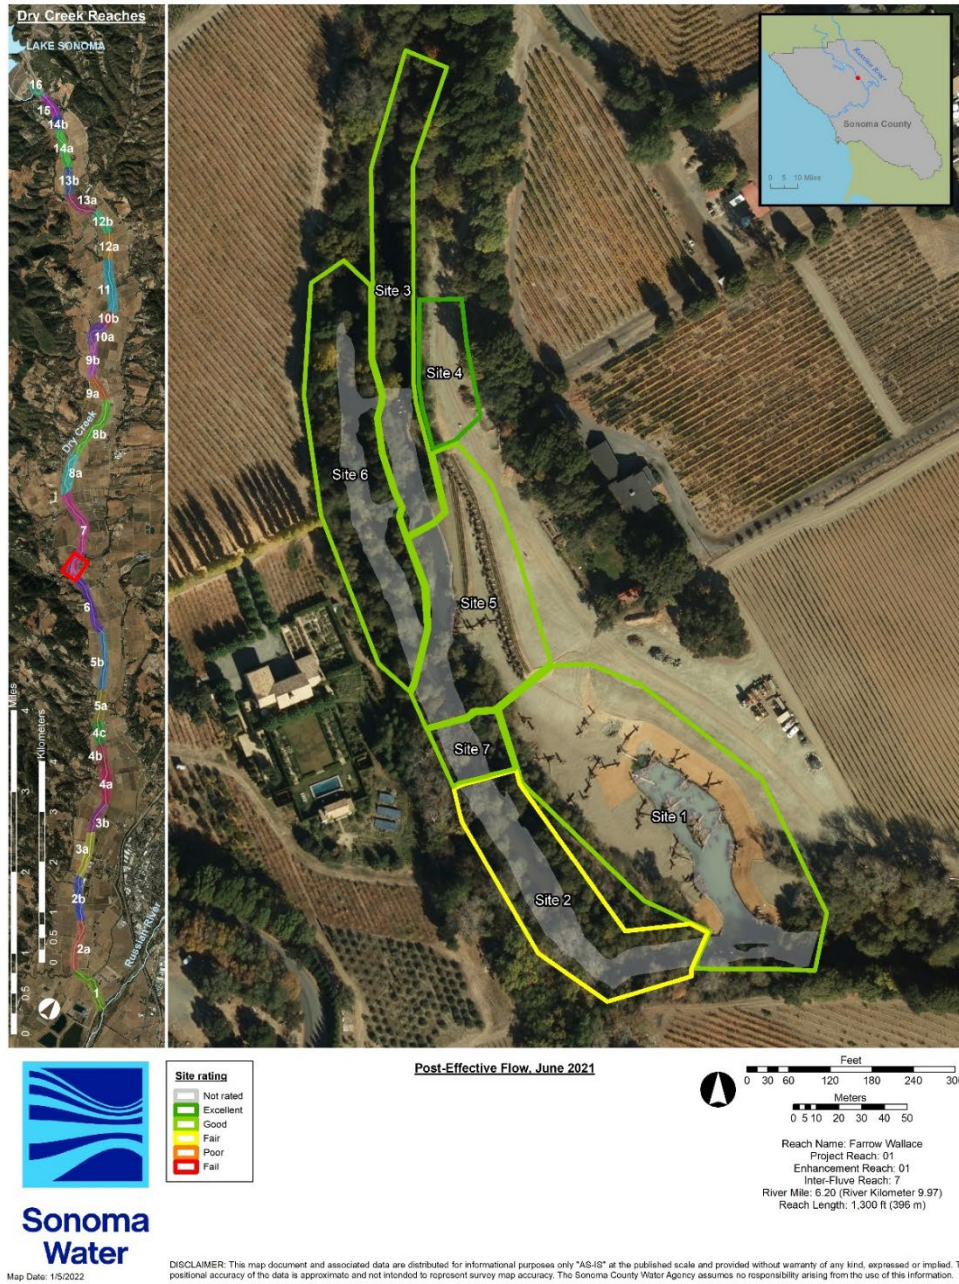
Figure 5.2.51. Post-effective flow site ratings for the Farrow Wallace enhancement reach, June 2021.

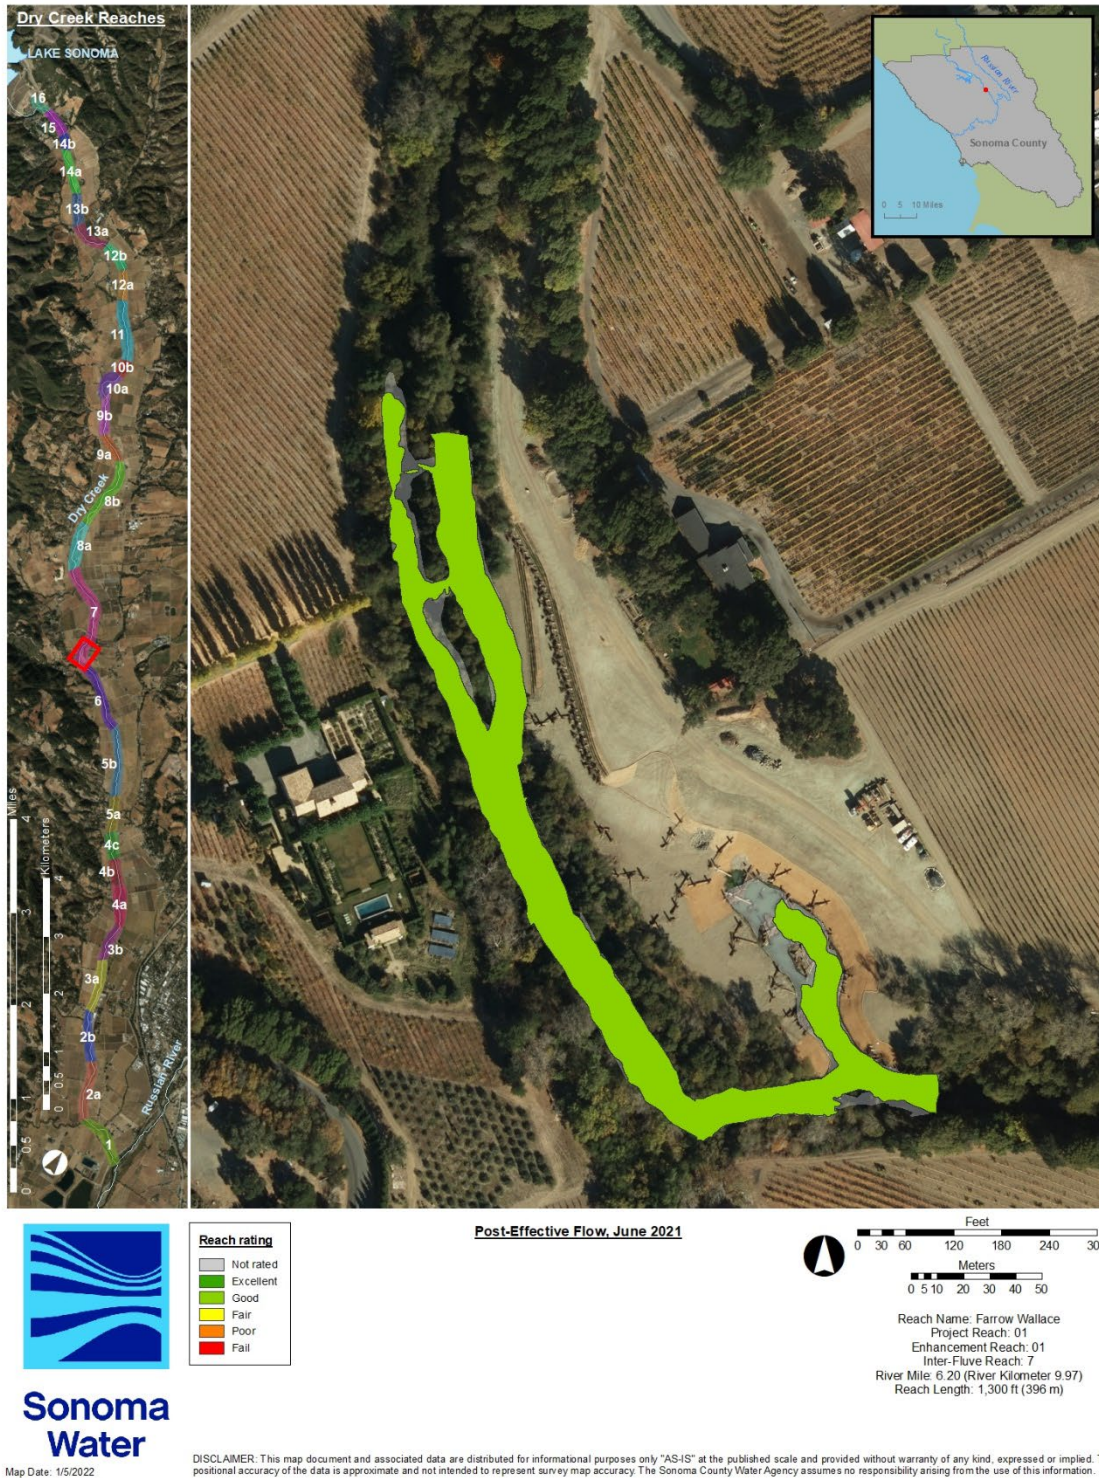
Figure 5.2.52. Post-effective flow reach rating for the Farrow Wallace enhancement reach, June 2021.

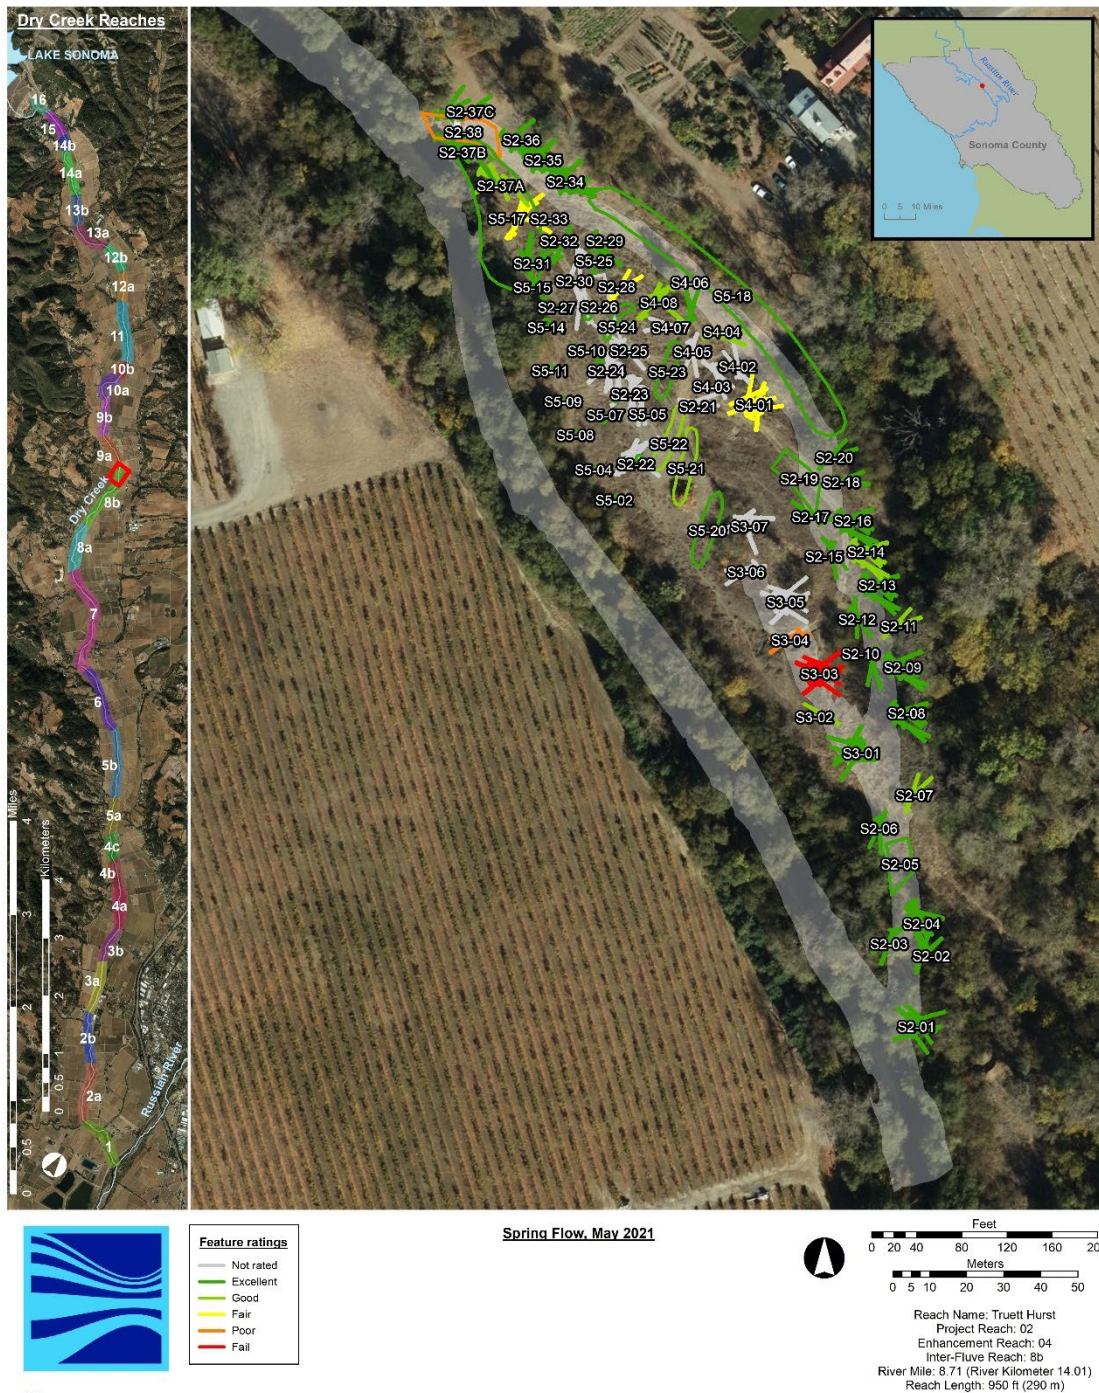
Figure 5.2.65. Feature ratings for the Truett Hurst enhancement reach, May 2021.

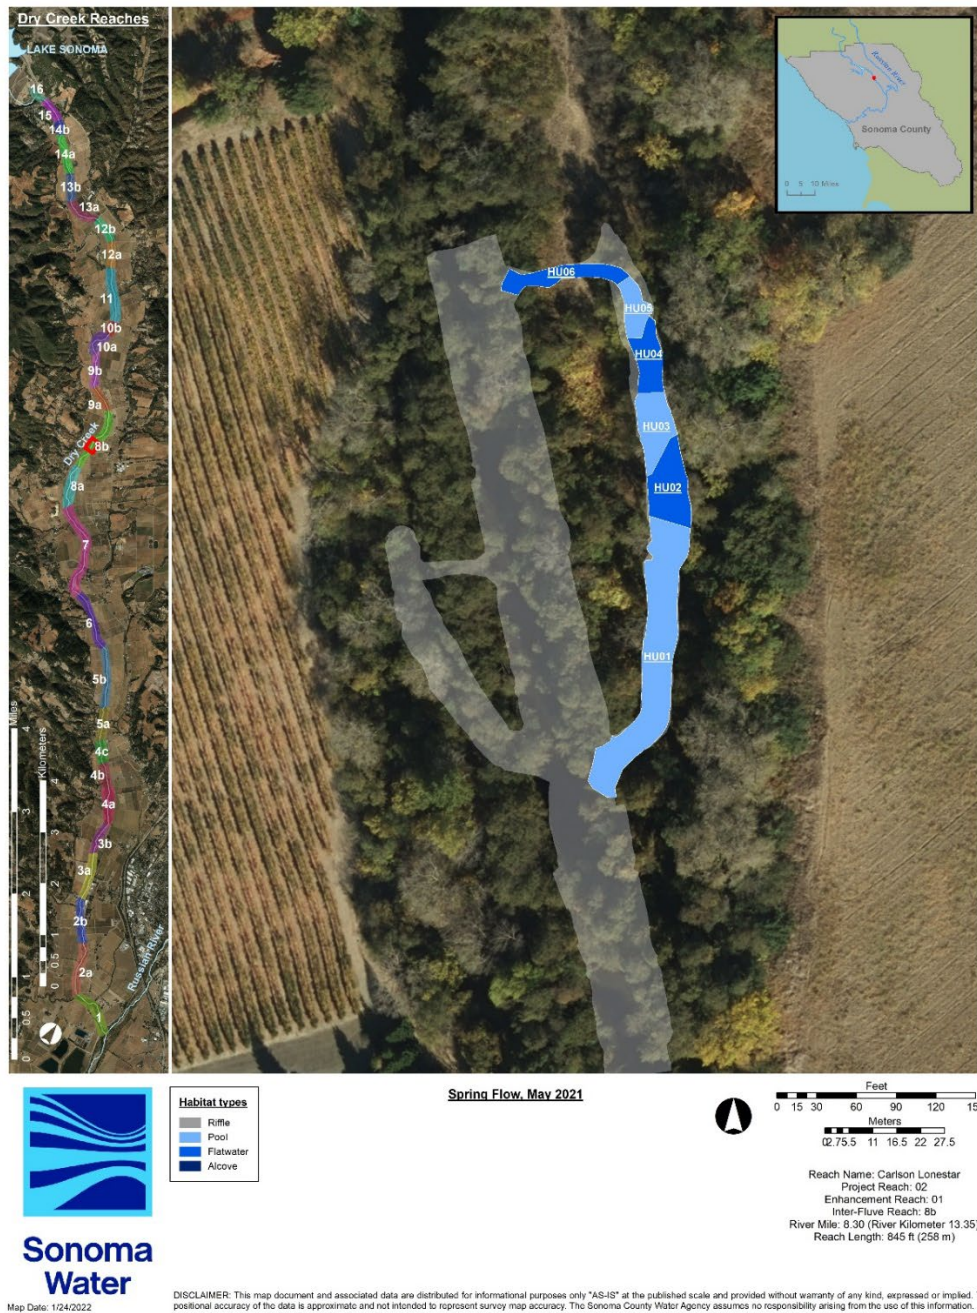
Figure 5.2.78. Habitat unit number and type within the Carlson Lonestar enhancement reach, May 2021.
