Russian River Biological Opinion Status and Data Report

Year 2018 – 2019

**Sonoma
Water**

October 2022

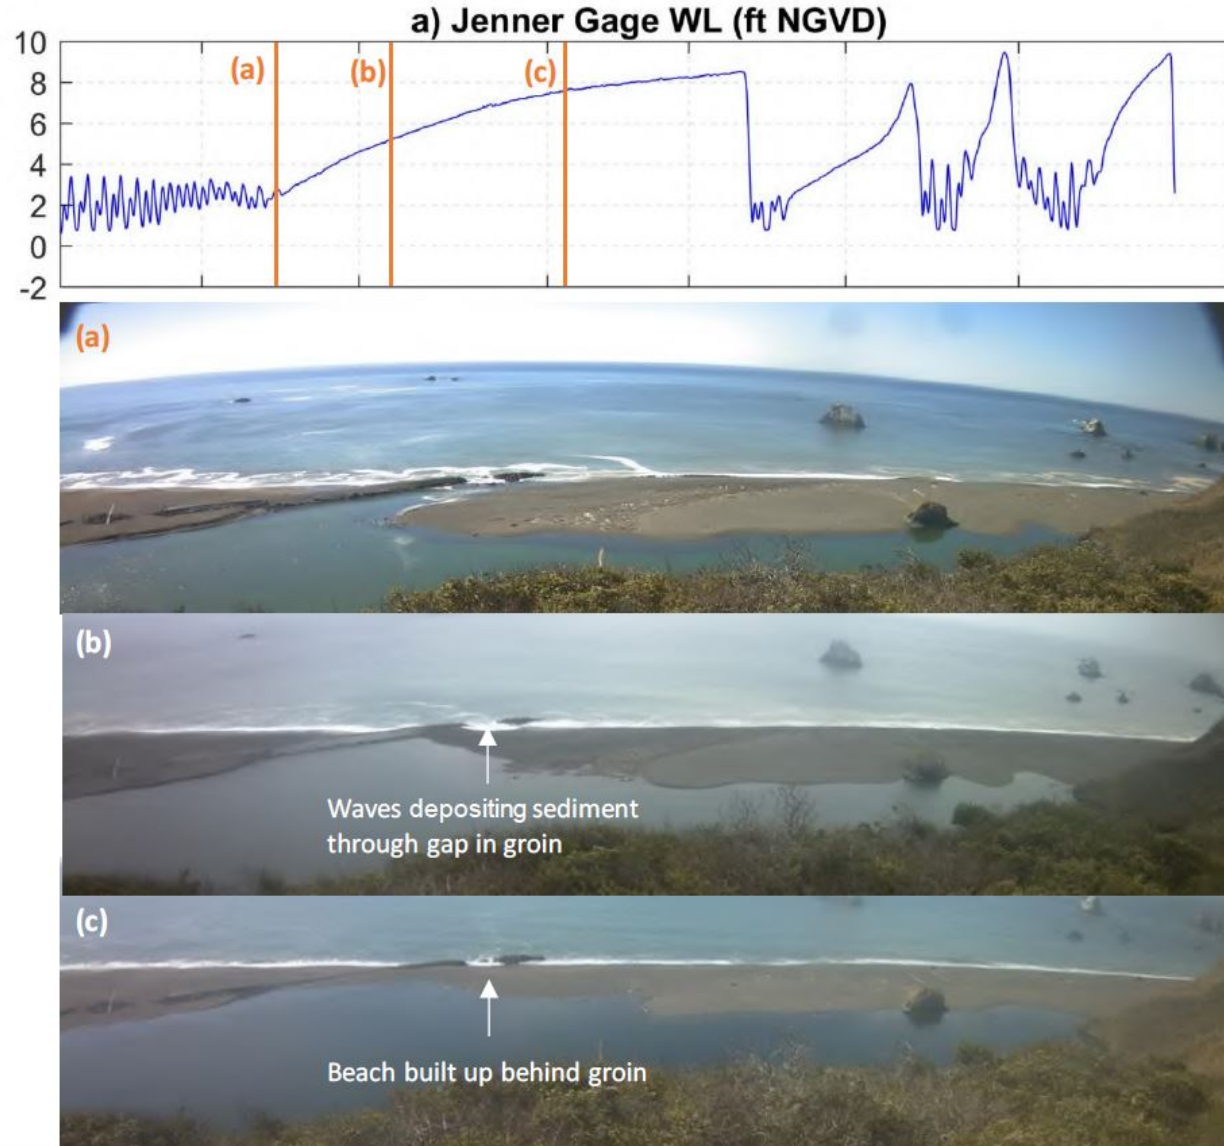
Figure 4.3. Russian River mouth a) prior to closure on October 15, 2018; b) immediately after closure, showing wave transmission through a gap in the jetty groin; and c) after several weeks of closure.

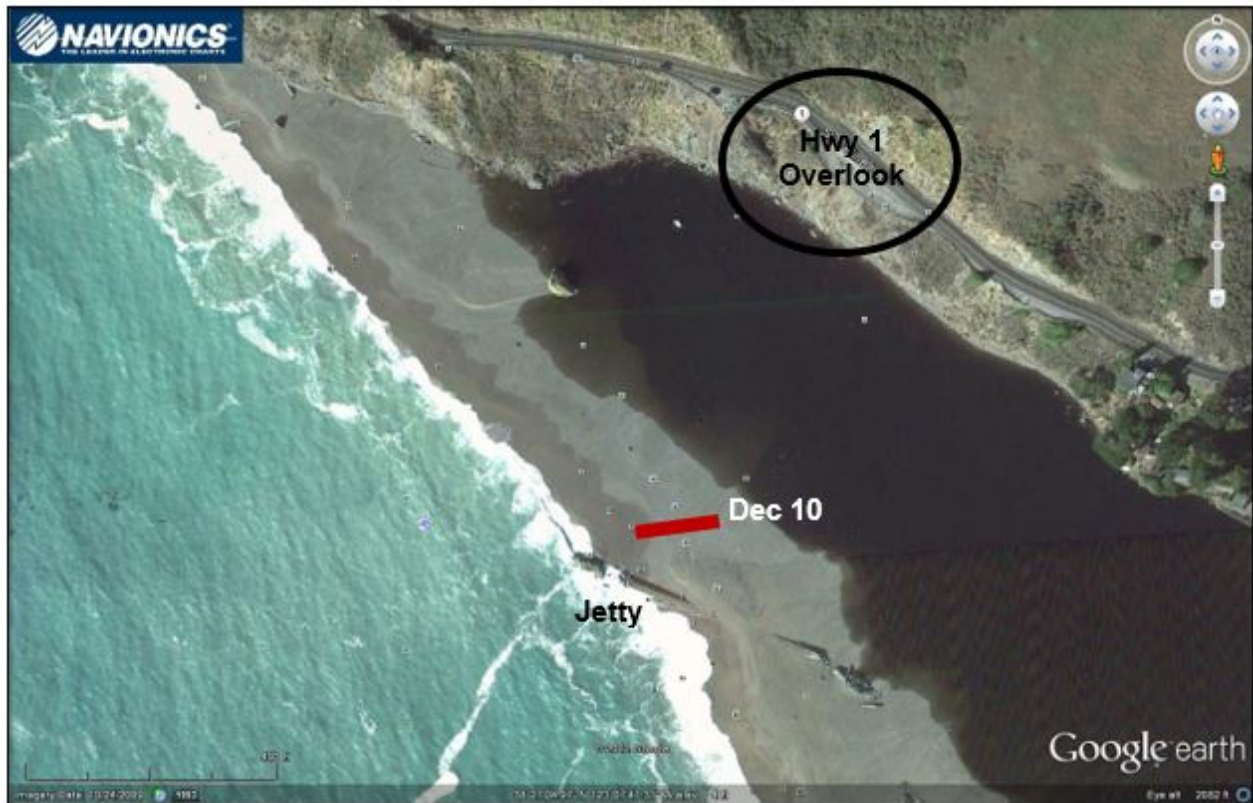
Figure 4.4. Location of beach management activity in 2018 at the Russian River mouth, Goat Rock State Beach. Line crossing the barrier beach is the location of a pilot channel for artificial breaching (red). Self-breach events are not shown.

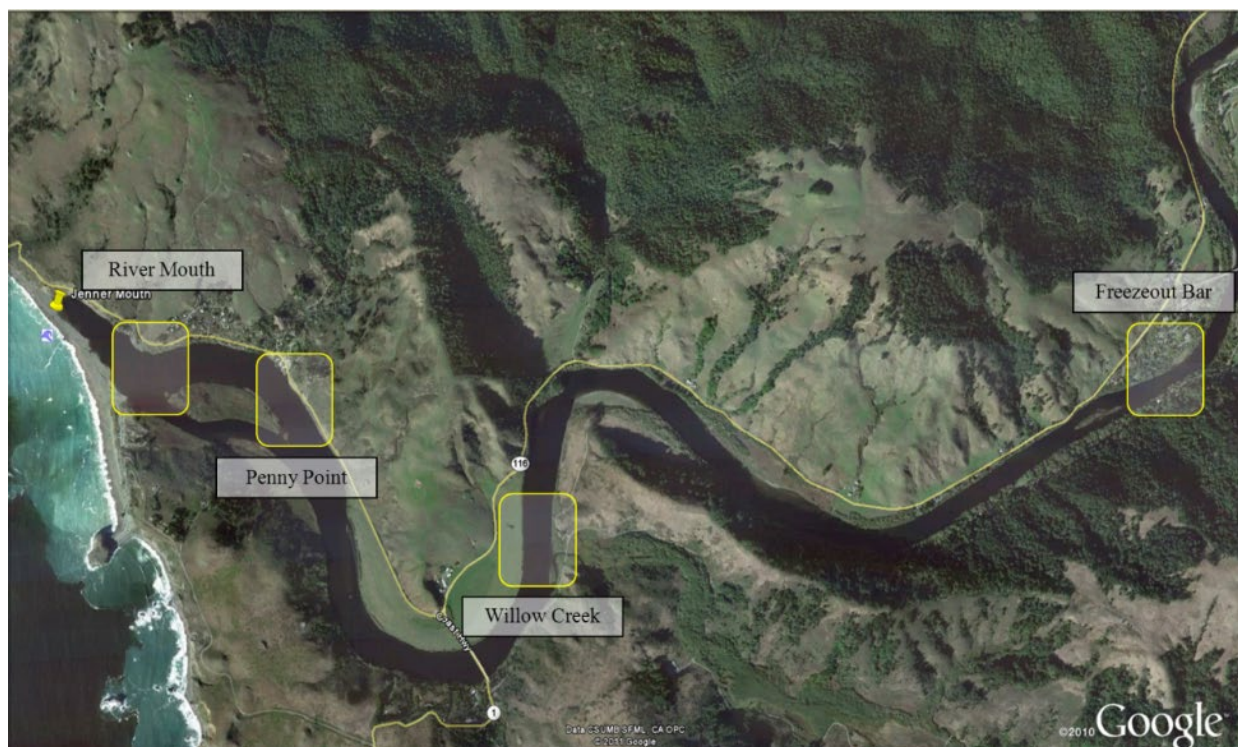
Figure 4.2.2 . Distribution of juvenile salmonid prey resource availability in three reaches of the Russian River Estuary.

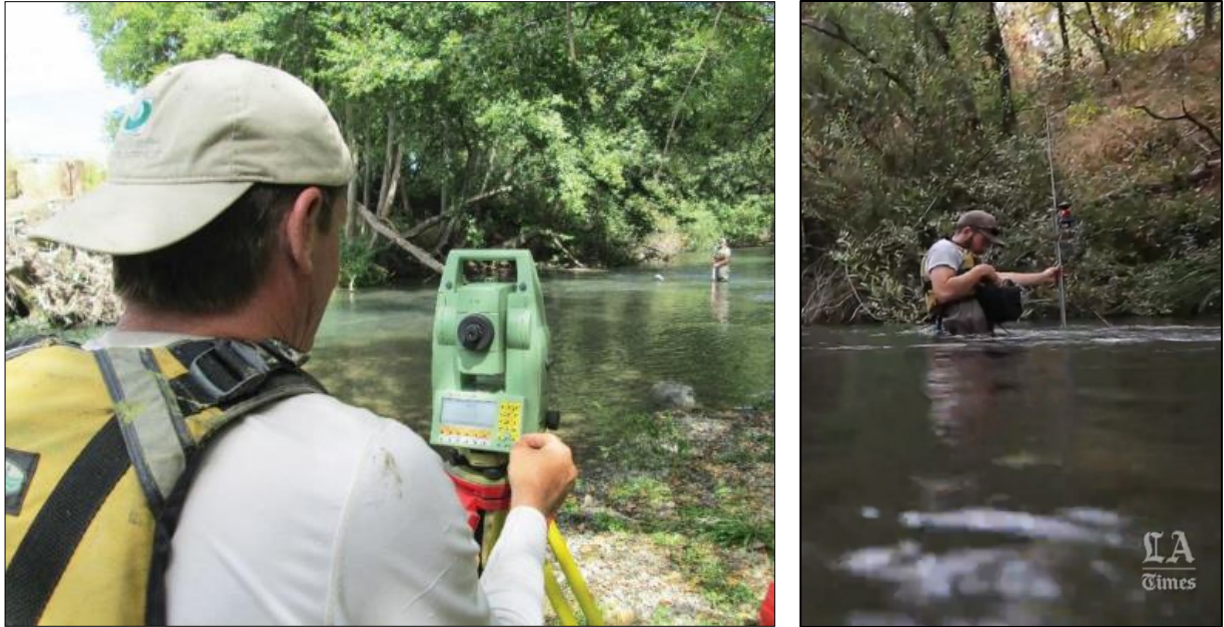
Figure 5.2. 1. Dry Creek effectiveness monitoring. At each data point, we collected geographic location (latitude, longitude, elevation), and water depth and velocity by aiming the total station at a USGS topset rod fit with a survey prism and a flow meter

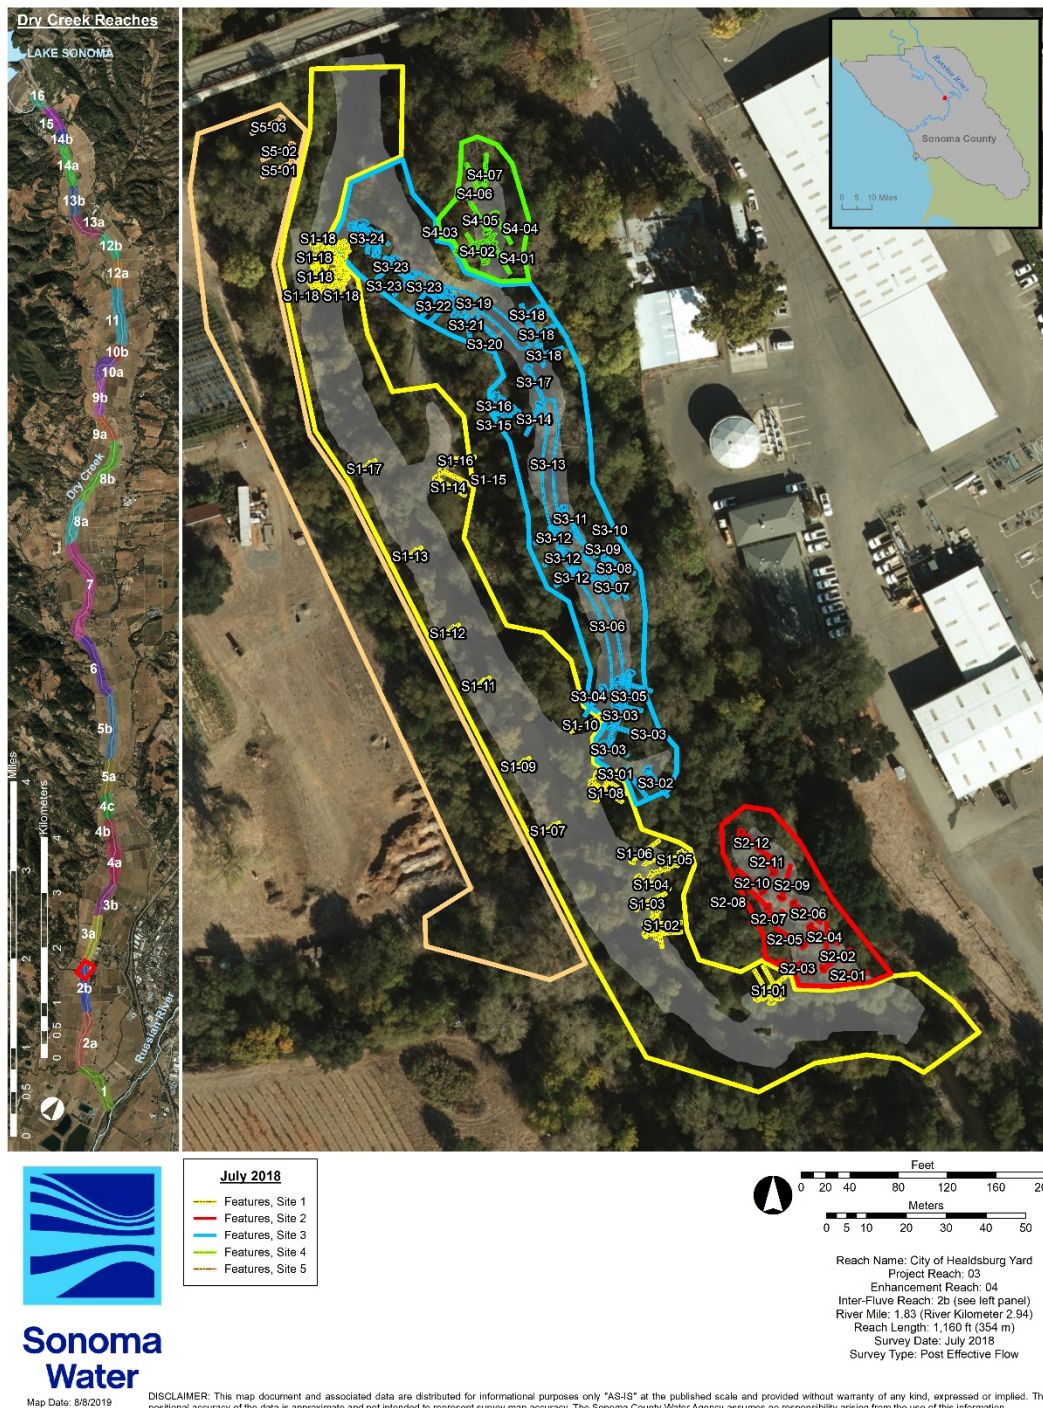
Figure 5.2.73. Enhancement sites and features within the City of Healdsburg Yard enhancement reach, July 2018.

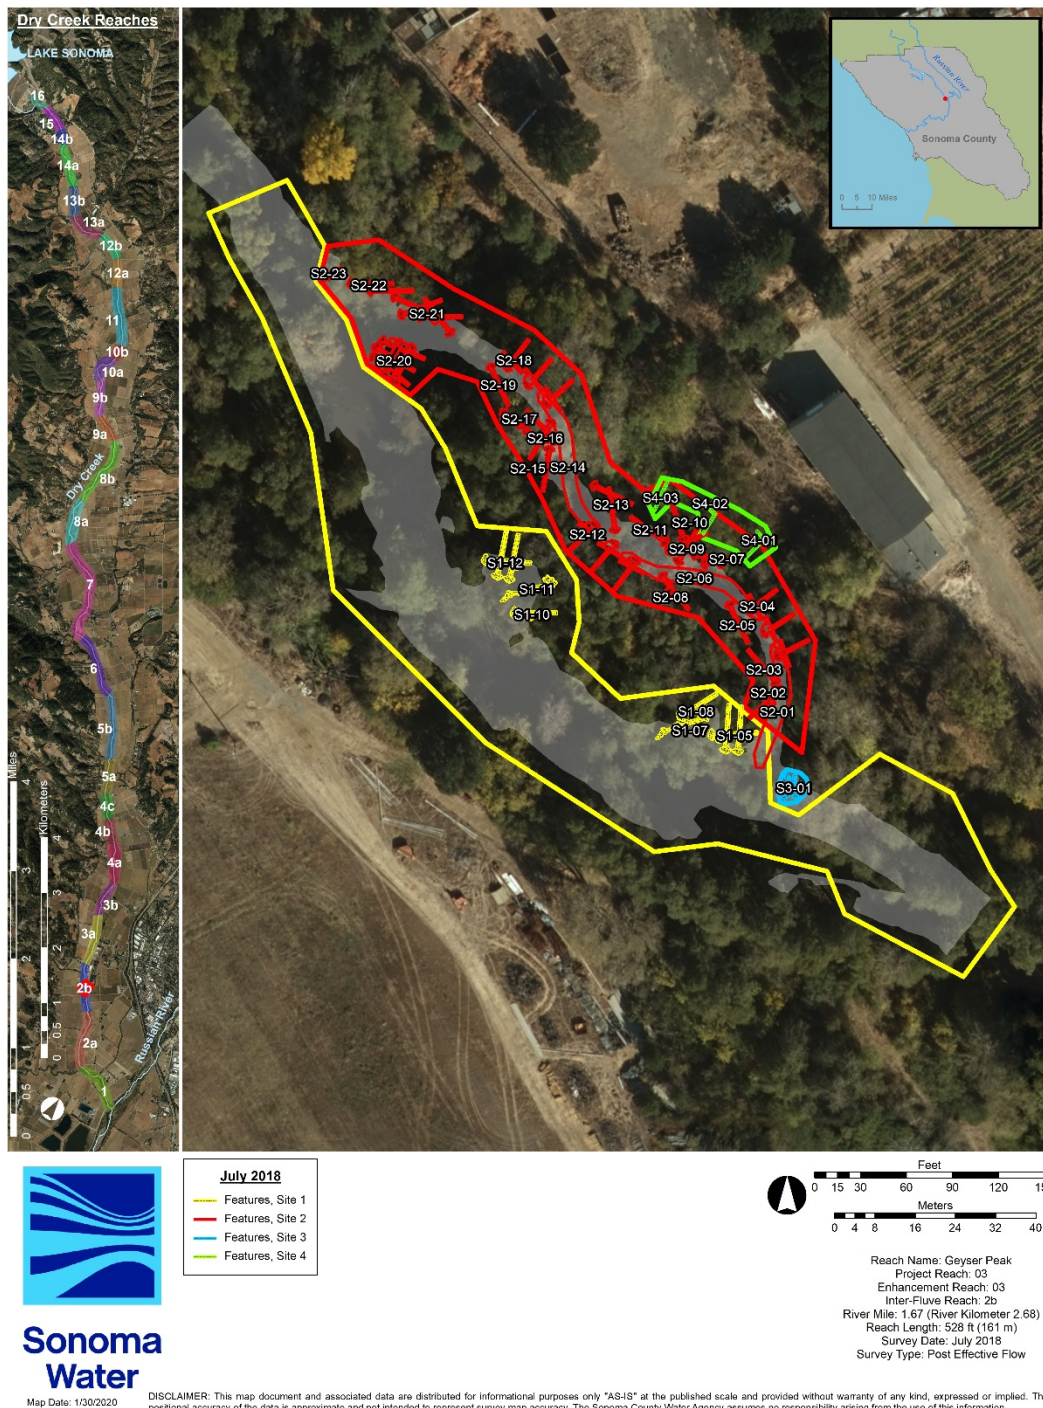
Figure 5.2.81. Enhancement sites and features within the Geyser Peak enhancement reach, July 2018.
