Russian River Biological Opinion Status and Data Report

Year 2019 – 2020

**Sonoma
Water**

January 2023

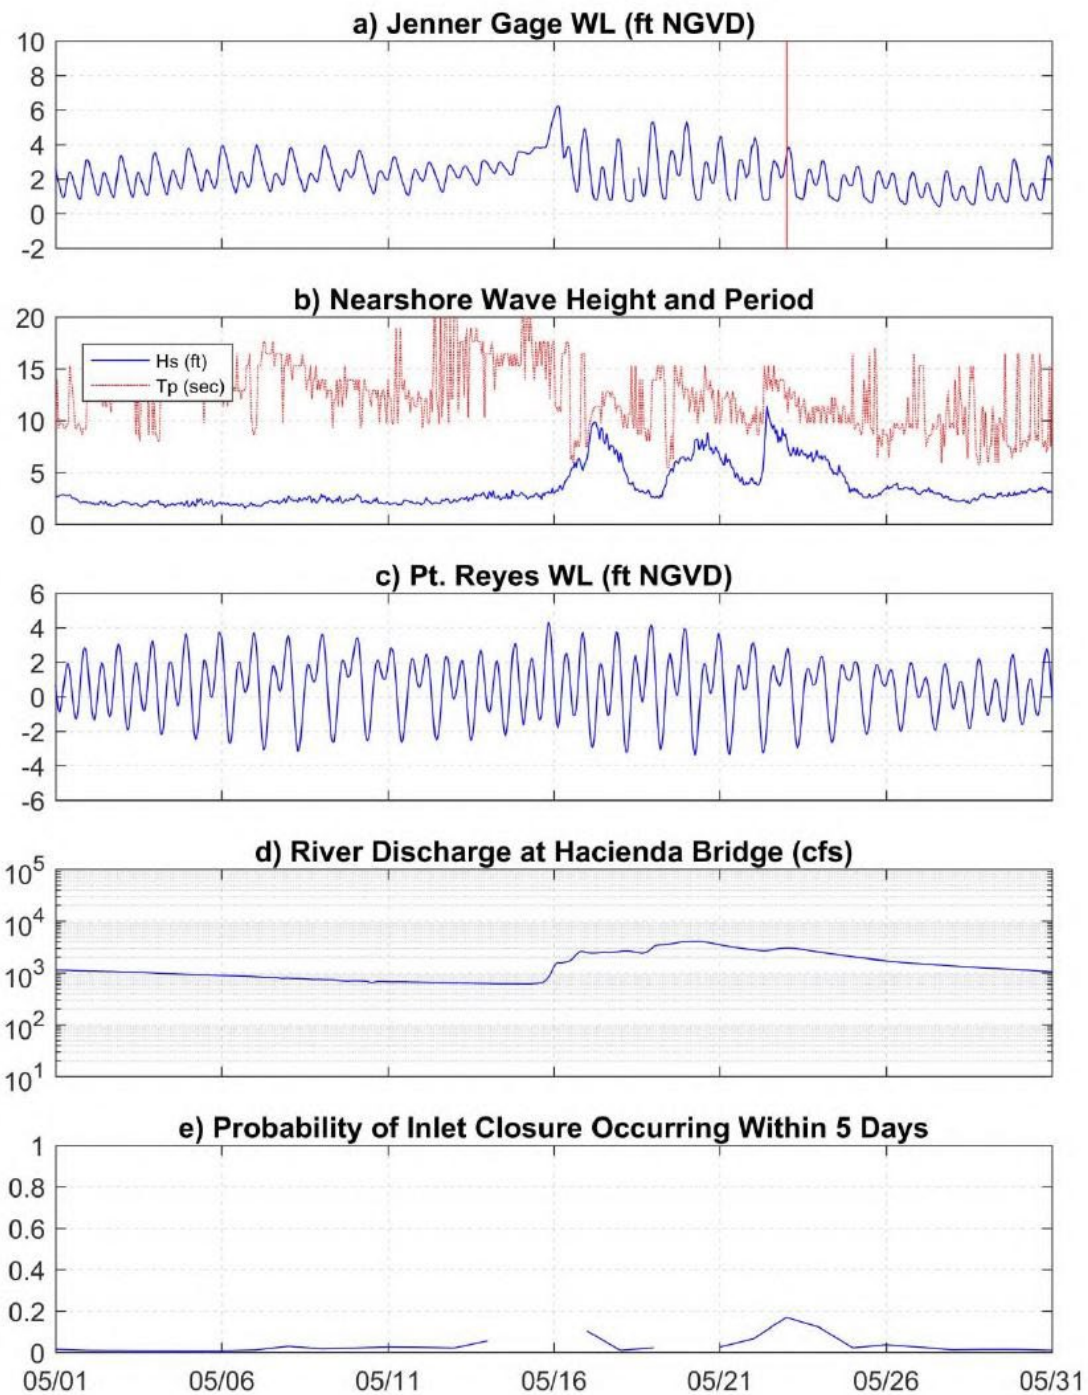
Figure 4.0.2. Estuary, Ocean, and River Conditions Compared with Closure Probability: May 2019

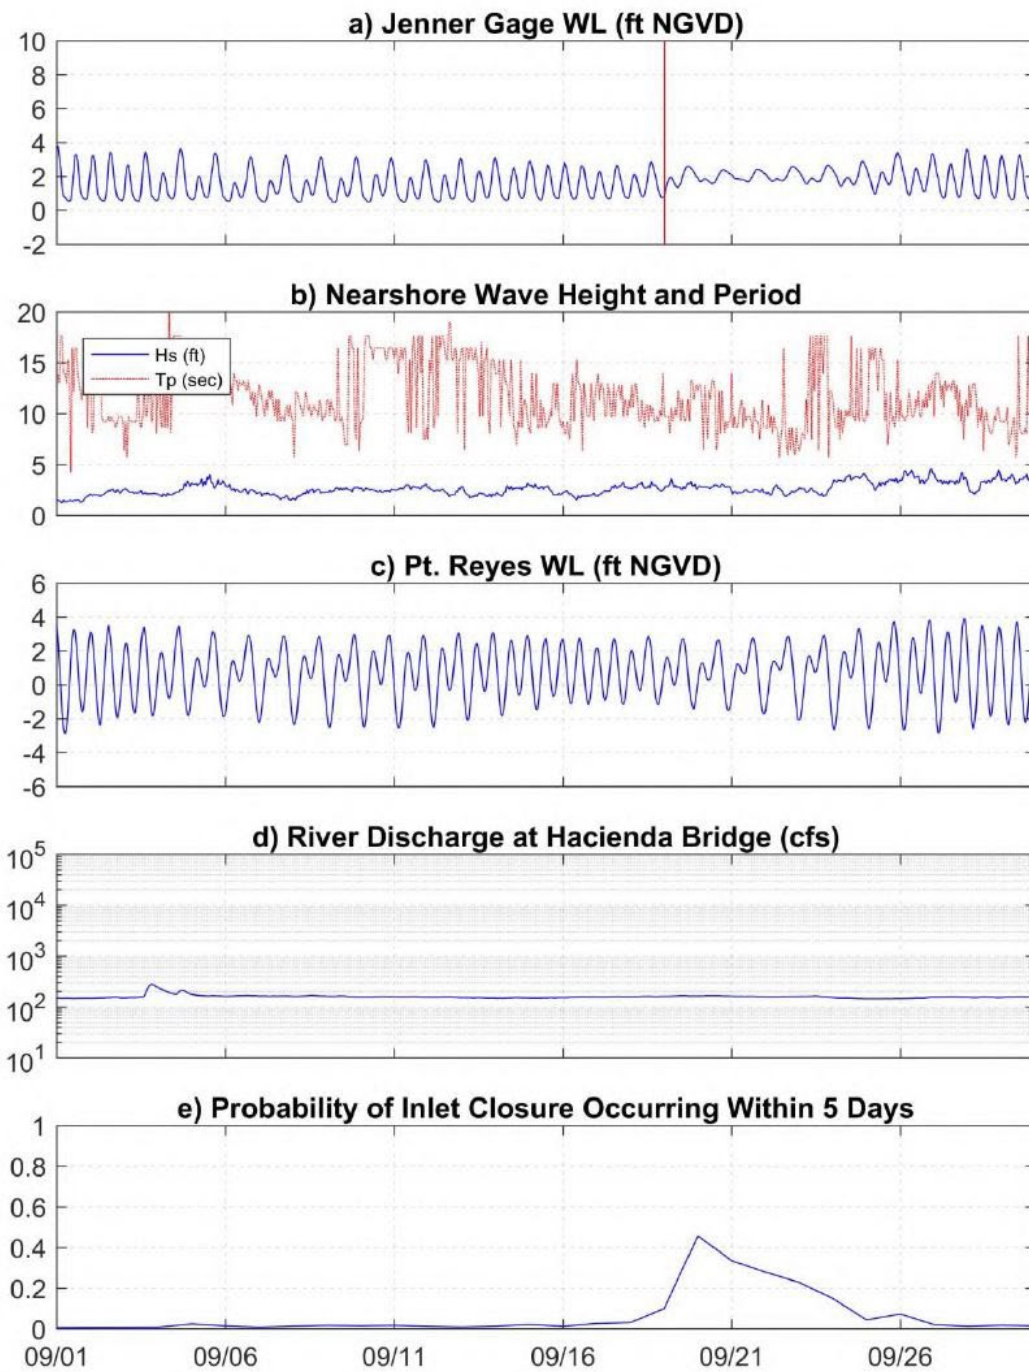
Figure 4.0.3. Estuary, Ocean, and River Conditions Compared with Closure Probability: September 2019.

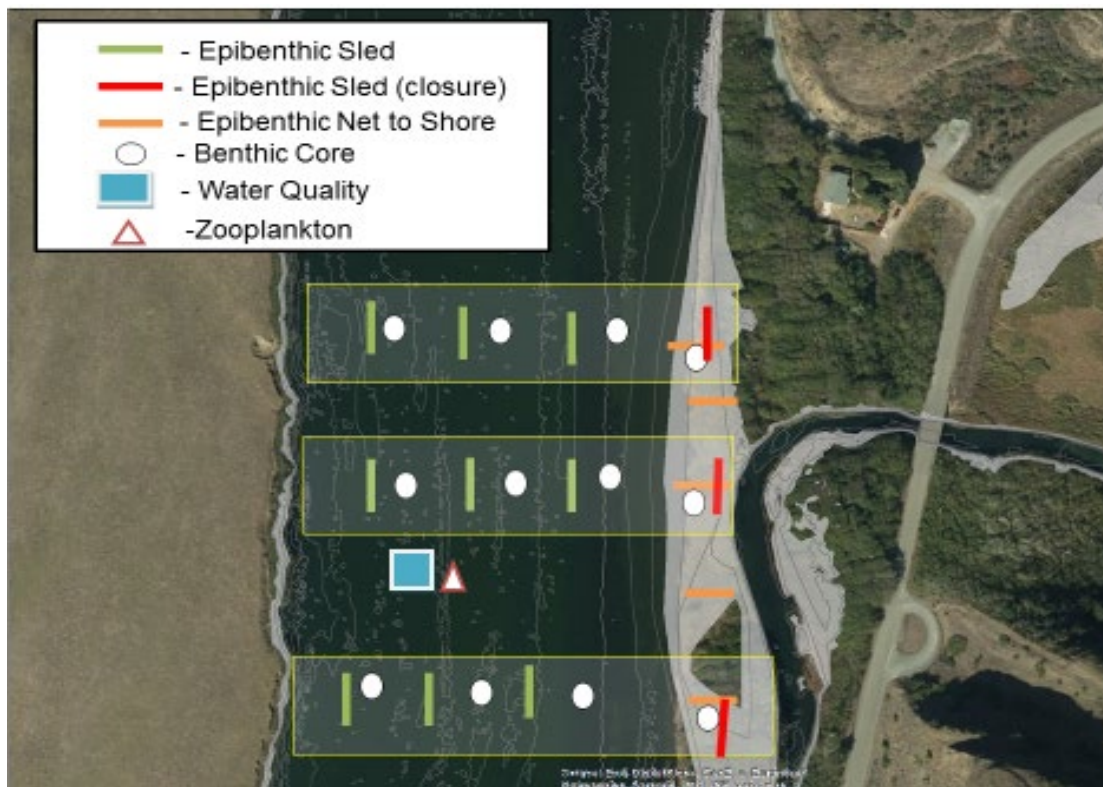
Figure 4.3.7. Modification of sampling techniques during closed conditions for distribution of juvenile salmonid prey availability sampling transects and techniques at Willow Creek site in the Russian River Estuary. The grey area is the inundation of area during closed conditions.

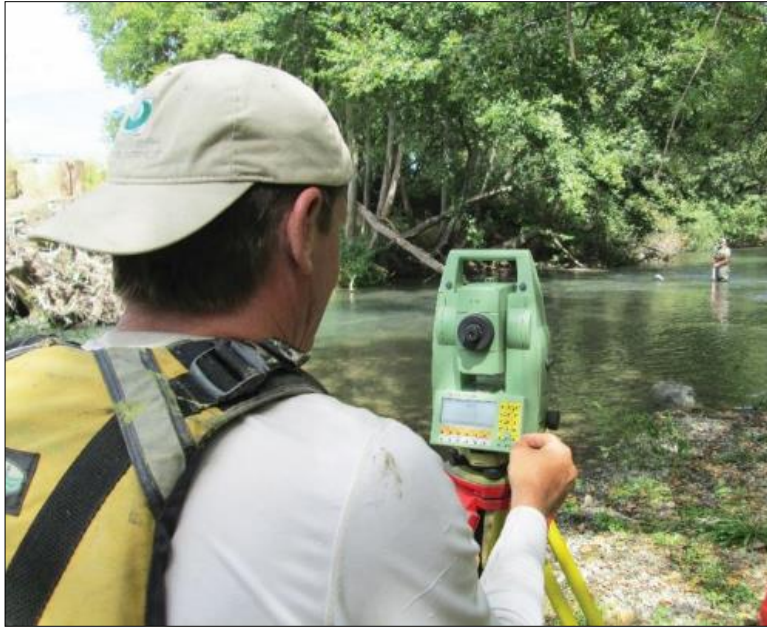
Figure 5.2.1. Dry Creek effectiveness monitoring. At each data point, we collected geographic location (latitude, longitude, elevation), and water depth and velocity by aiming the total station at a USGS topset rod fit with a survey prism and a flow meter

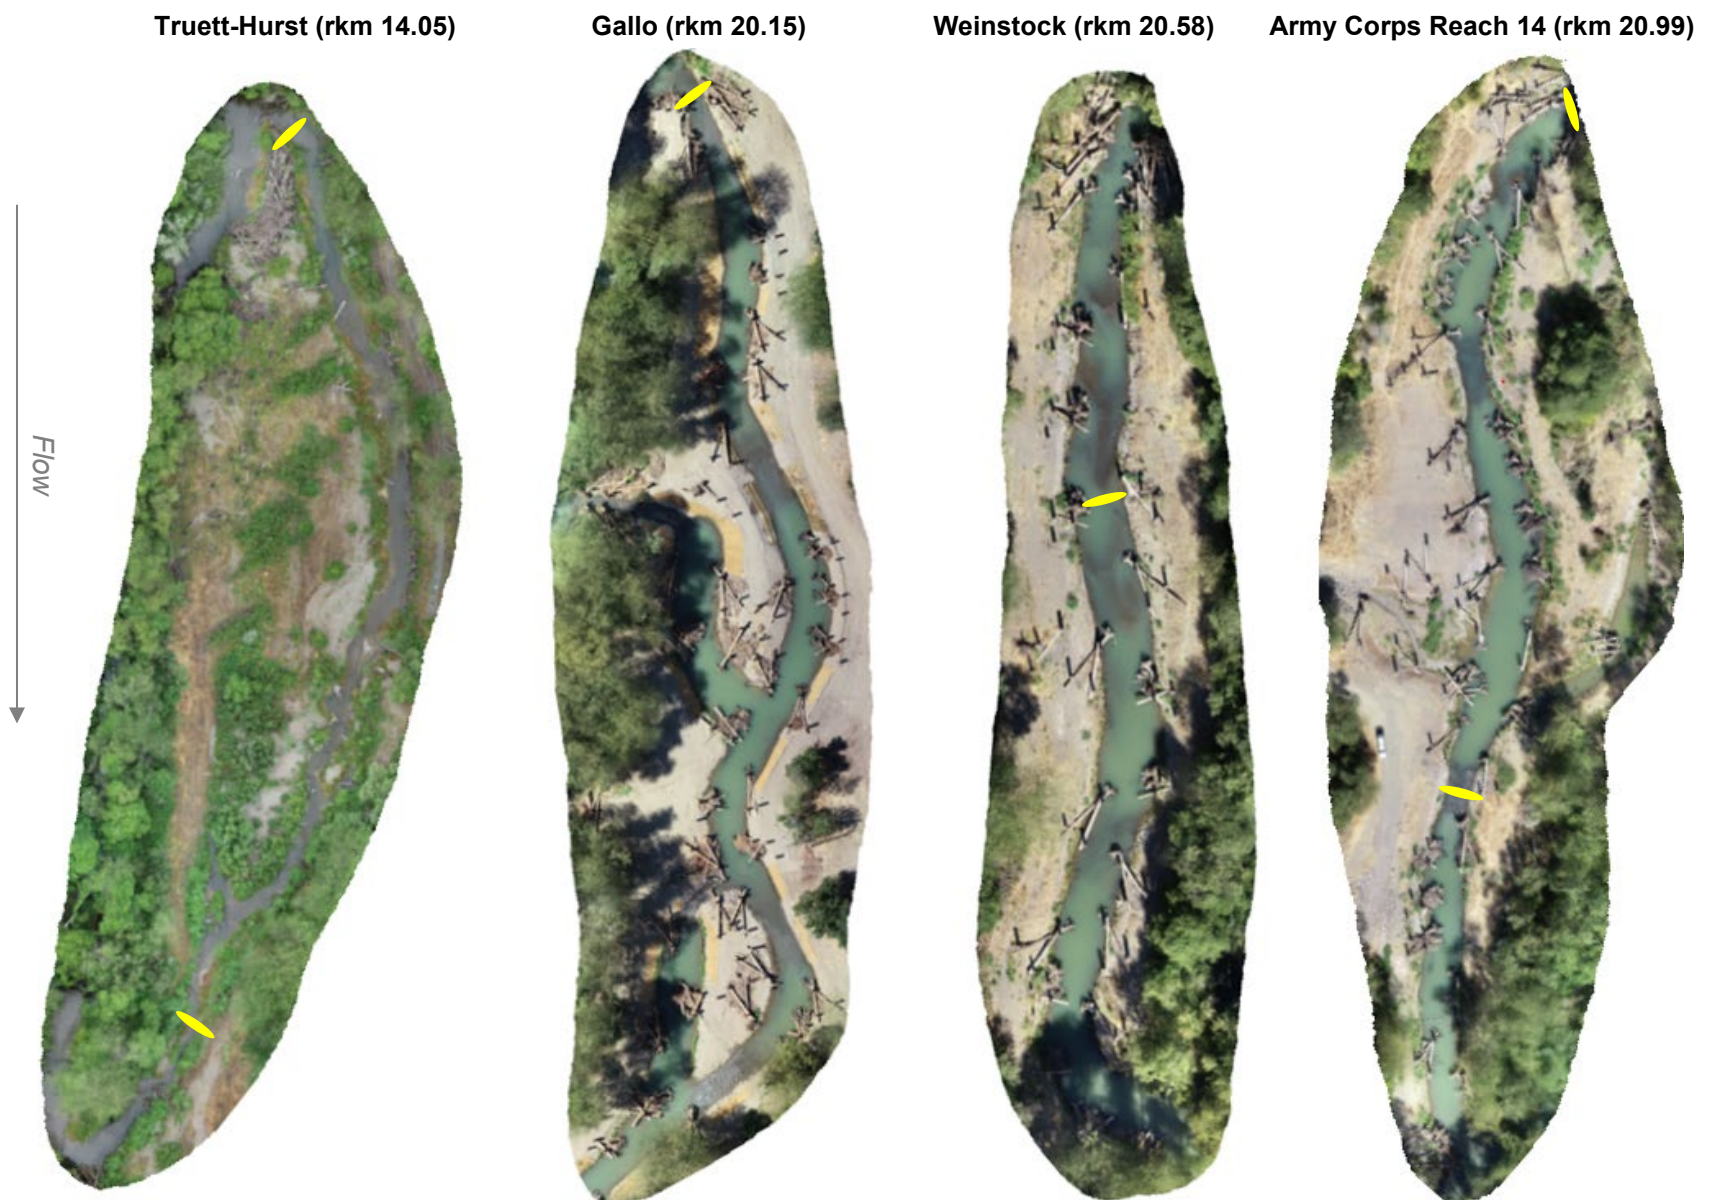
Figure 5.3.3. Approximate location of PIT antennas (yellow ovals) in Dry Creek habitat enhancements.

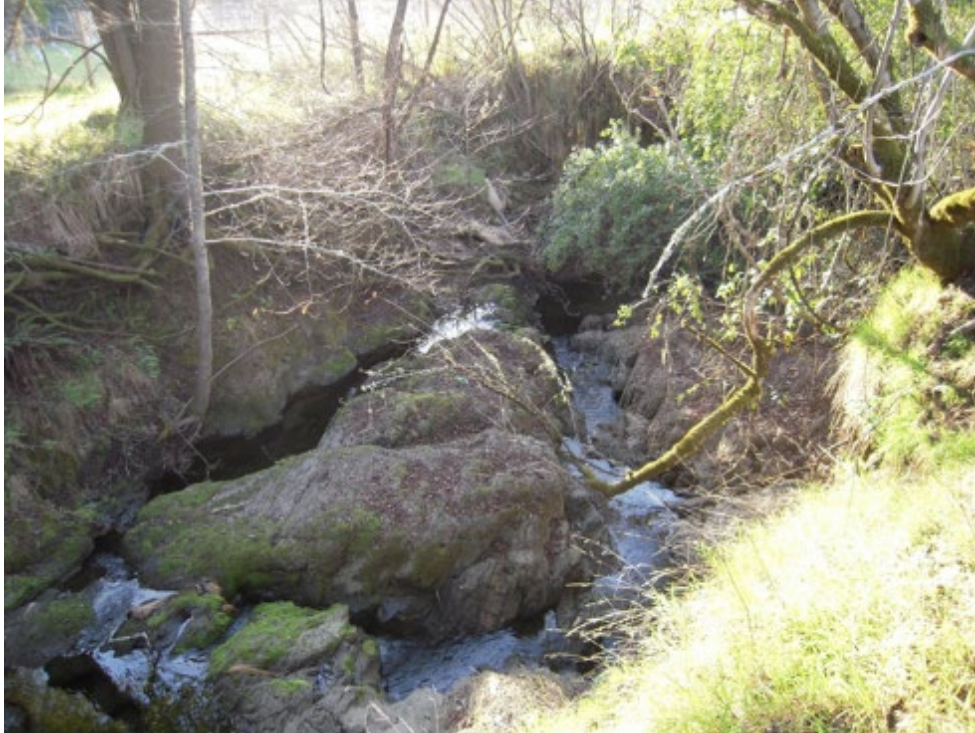
Figure 6. 10. Crane Creek Fish Passage Access Project. Bedrock outcropping.

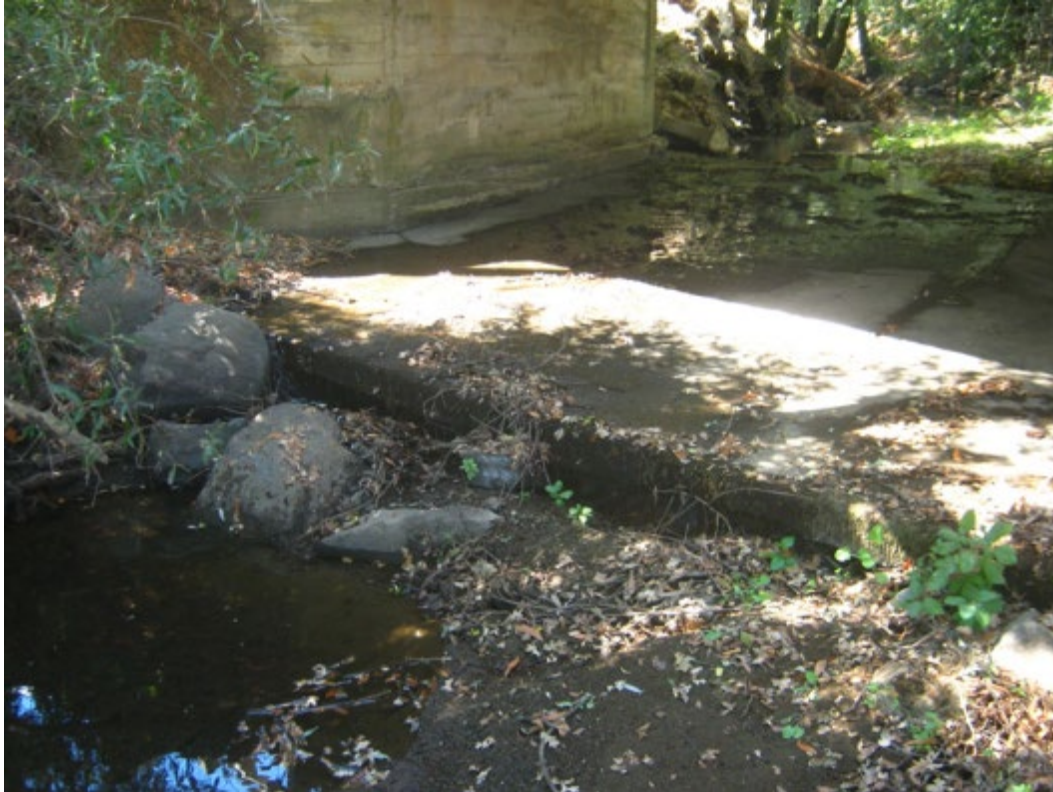
Figure 6. 13. Grape Creek Fish Passage Project – Flat culvert invert proposed for modification.
