**FINAL REPORT**  
**Mill Creek Dam Fish Passage Project**  
**Trout Unlimited Final Report to CDFW**  
**February 2020**

**Project Title:** Mill Creek Dam Fish Passage Project  
**FRGP Grant Number:** P1530400  
**Grantee Name:** Trout Unlimited, Inc.  
**Contact Information:** Mary Ann King, California Water Project Director  
5950 Doyle Street, Suite 2  
Emeryville, CA 94608  
(510) 649-9987  
Fax: N/A  
[maryann.king@tu.org](mailto:maryann.king@tu.org)

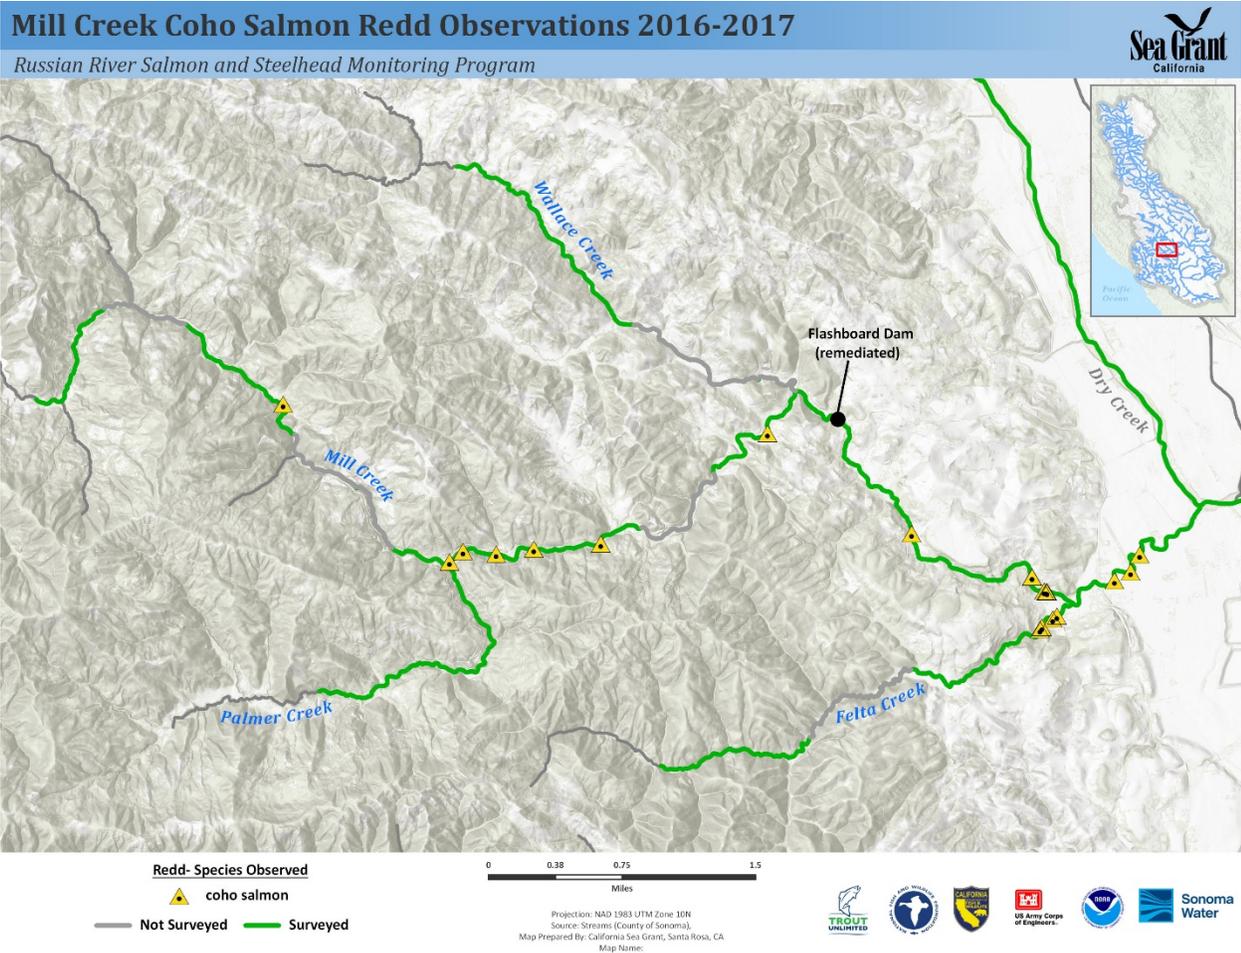
Figure 3. Coho salmon redds observed in Mill Creek during winter 2016/17.

In the two winters following completion of the dam remediation, coho salmon redds have been much more evenly distributed throughout the stream. In the winter of 2016/17, a total of seven redds were observed upstream of the former barrier site (Figure 3), nearly twice as many as were observed in all five years prior to the barrier remediation work. CSG estimates that 19 adult coho salmon passed through the project site in the winter of 2016/17 based on PIT tag detections.

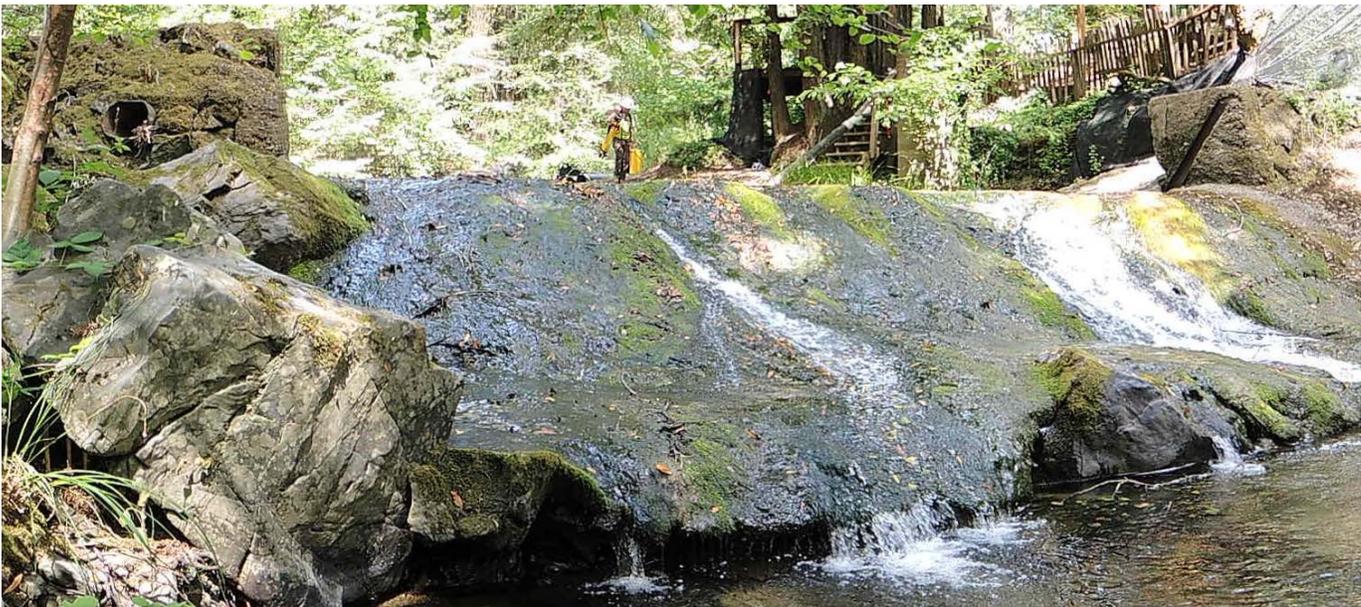
File Name	Date	Subject/Site Name	Description	Standing	Facing
Photo 1	6/14/2016	Mill Creek Dam face	Pre-project	On right bank downstream of dam	Upstream - West
Photo 2	9/30/2016	Weir at crest of Mill Creek Dam with roughened ramp	During construction	Mid-channel downstream of original dam	Upstream - West
Photo 3	10/14/2016	Project site	First rain and flow immediately following construction	On right bank upstream of original dam location	North
Photo 4	3/1/2017	Project site during mid-range flow (63 cfs)	PCI post-project monitoring (Credit: PCI)	Downstream of confluence of main and side channels	Upstream - West
Photo 5	12/3/2016	Coho salmon female and jack spawning upstream of project site	Post-project (Credit: CSG)	Upstream of project site	N/A
Photo 6	3/8/2017	Salmonid species upstream of pre-existing dam and new roughened channel	Post-project (Credit: Bob Mattei)	On left bank above new roughened channel	South

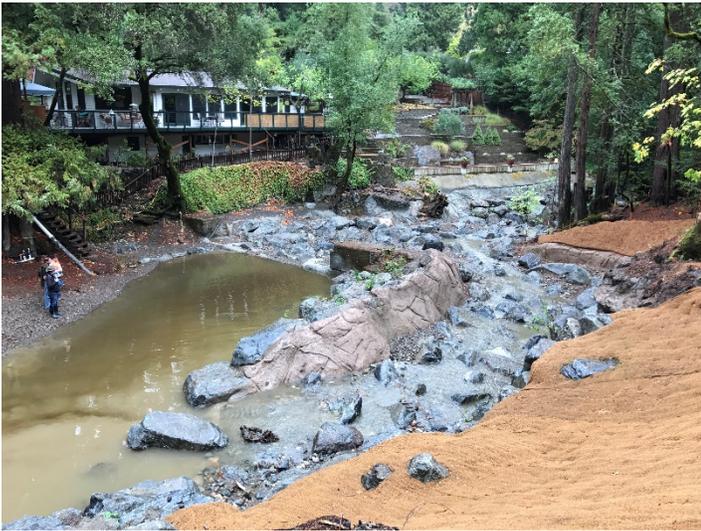
Photo 7	10/16/2017	Main channel and side channel	Immediately following construction (Credit: PCI)	On right bank	Downstream - East
Photo 8	12/11/2017	Main channel and side channel	One year after construction	On right bank	Downstream - East
Photo 9	5/24/2018	Main channel and side channel	Second spring after construction	On right bank	Downstream - East
Photo 10	10/3/2018	Main channel and side channel	Two years after construction (Credit: PCI)	On right bank	Downstream - East

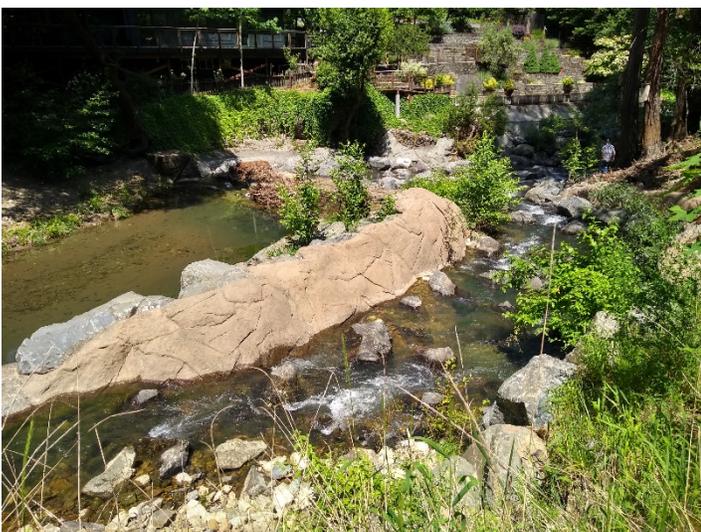
Photo 11	5/29/2019	Main channel and side channel	Third spring after construction	On right bank	Downstream - East
Photo 12	11/15/2019	Main channel and side channel	Third fall after construction	On right bank	Downstream - East
Photo 13	10/16/2016	Side channel	Immediately following construction (Credit: PCI)	On right bank	Upstream - West
Photo 14	8/11/2017	Side channel in foreground	One year after construction	On right bank	Upstream - West
Photo 15	5/24/2018	Side channel in foreground	Second spring after construction (Credit: PCI)	On right bank	Upstream - West
Photo 16	10/3/2018	Side channel in foreground	Two years after construction (Credit: PCI)	On right bank	Upstream - West
Photo 17	5/29/2019	Side channel	Third spring after construction	On right bank	Upstream - West
