# Russian River Biological Opinion Status and Data Report

**Year 2022 – 2023**

**February 2024**

**Sonoma  
Water**

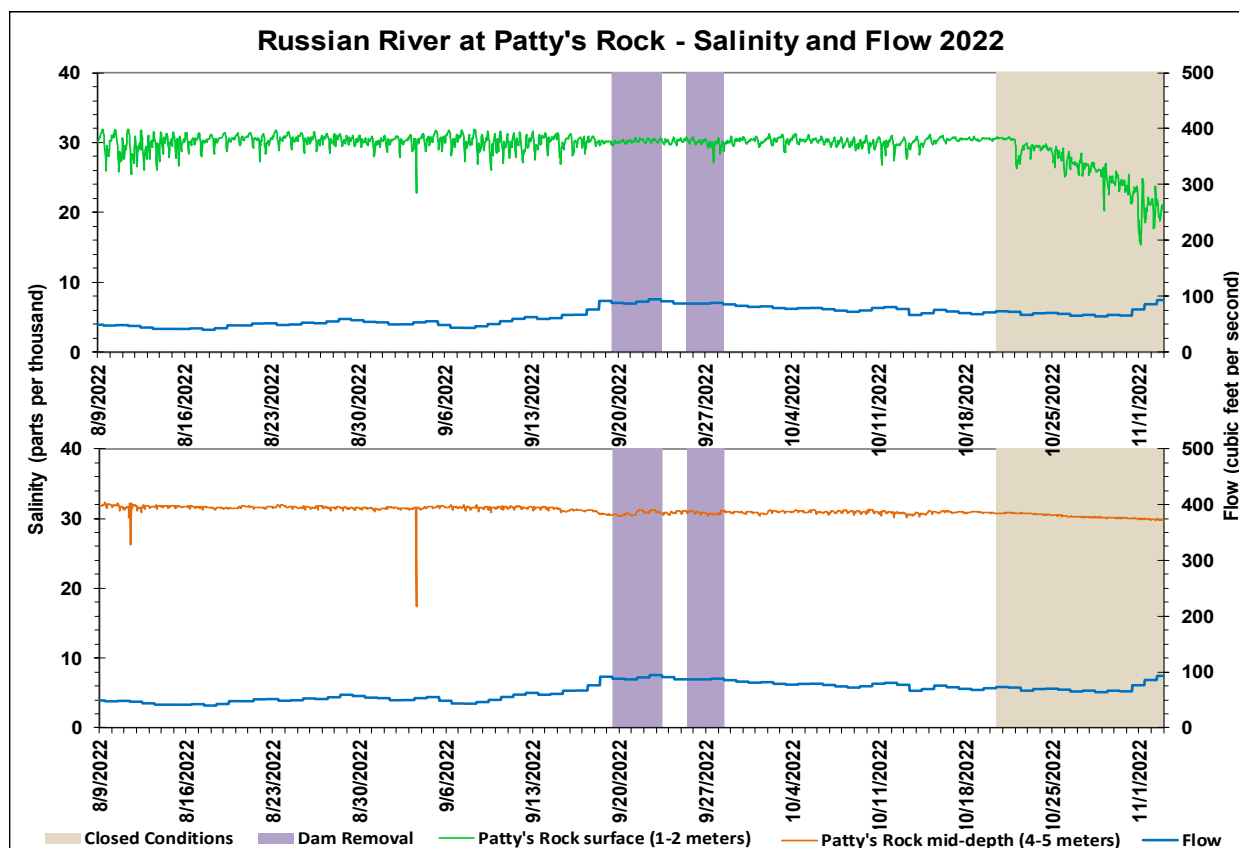
**Figure 4.1.3. 2022 Russian River at Patty's Rock Salinity and Flow Graph**

The mid-depth sonde at the Patty's Rock station was suspended at a depth of approximately 4 to 5 meters, and also experienced fluctuations in salinity concentrations, though to a lesser degree and frequency than the surface sonde. Concentrations ranged from 17.4 to 32.3 ppt at the Patty's Rock mid-depth sonde with a mean salinity value of 31.1 ppt (Table 4.1.1).

The Patty's Rock surface sonde had a minimum DO concentration of 6.0 mg/L (Table 4.1.1). Minimum concentrations were observed to occur in brackish to saline water during open and closed conditions (Figures 4.1.11 and 4.1.3).

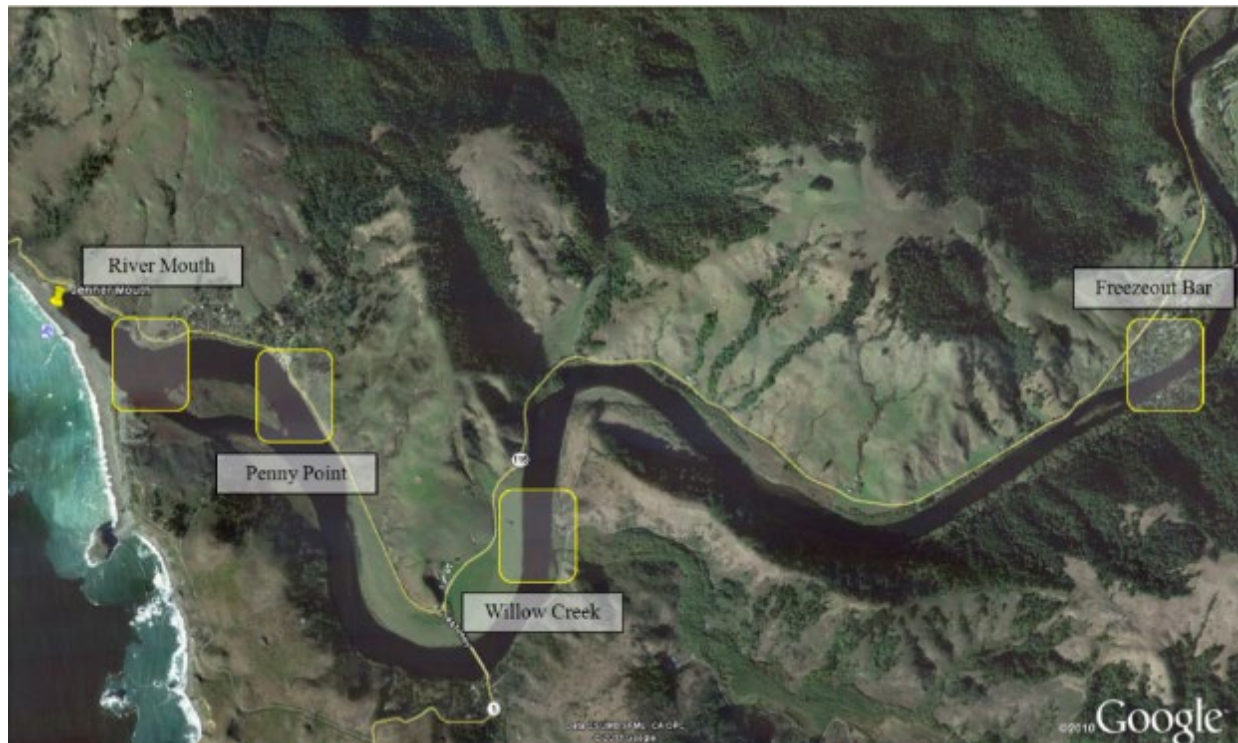
**Figure 4.3.2 . Distribution of juvenile salmonid prey resource availability in three reaches of the Russian River Estuary.**

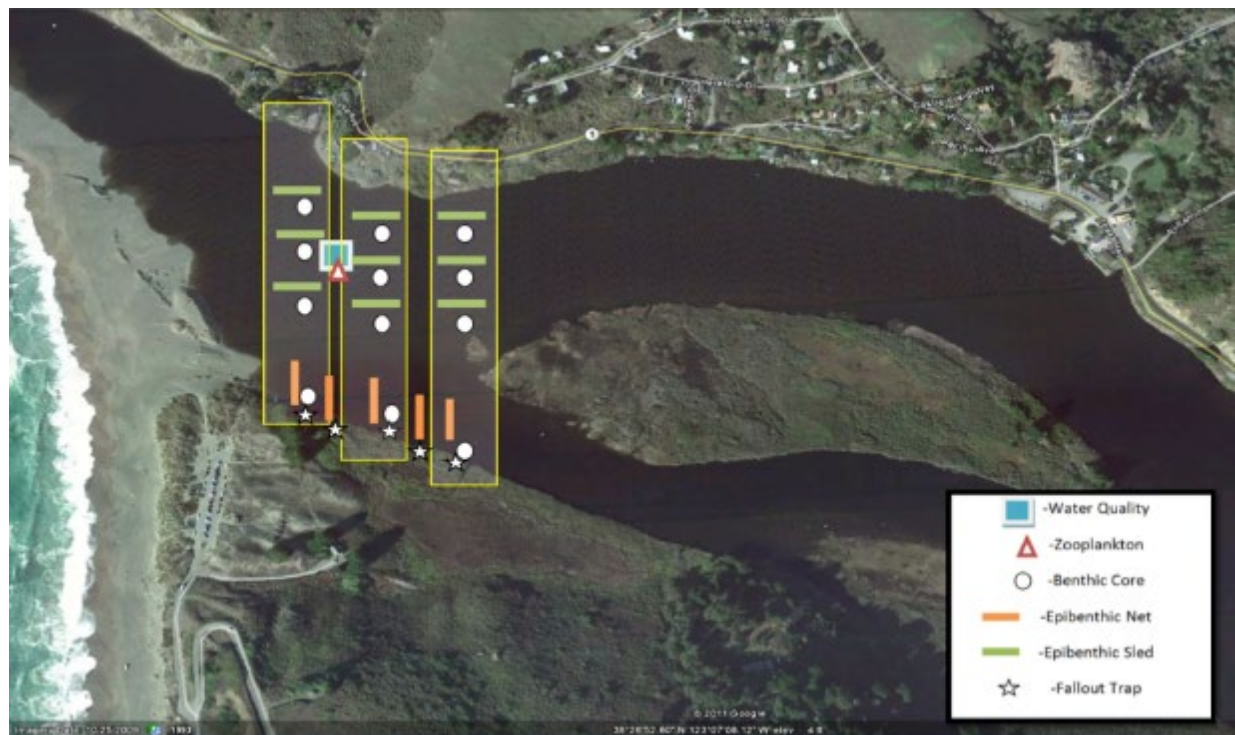
**Figure 4.3.3. Distribution of juvenile salmonid prey availability sampling transects and techniques at the River Mouth site in the Russian River Estuary.**

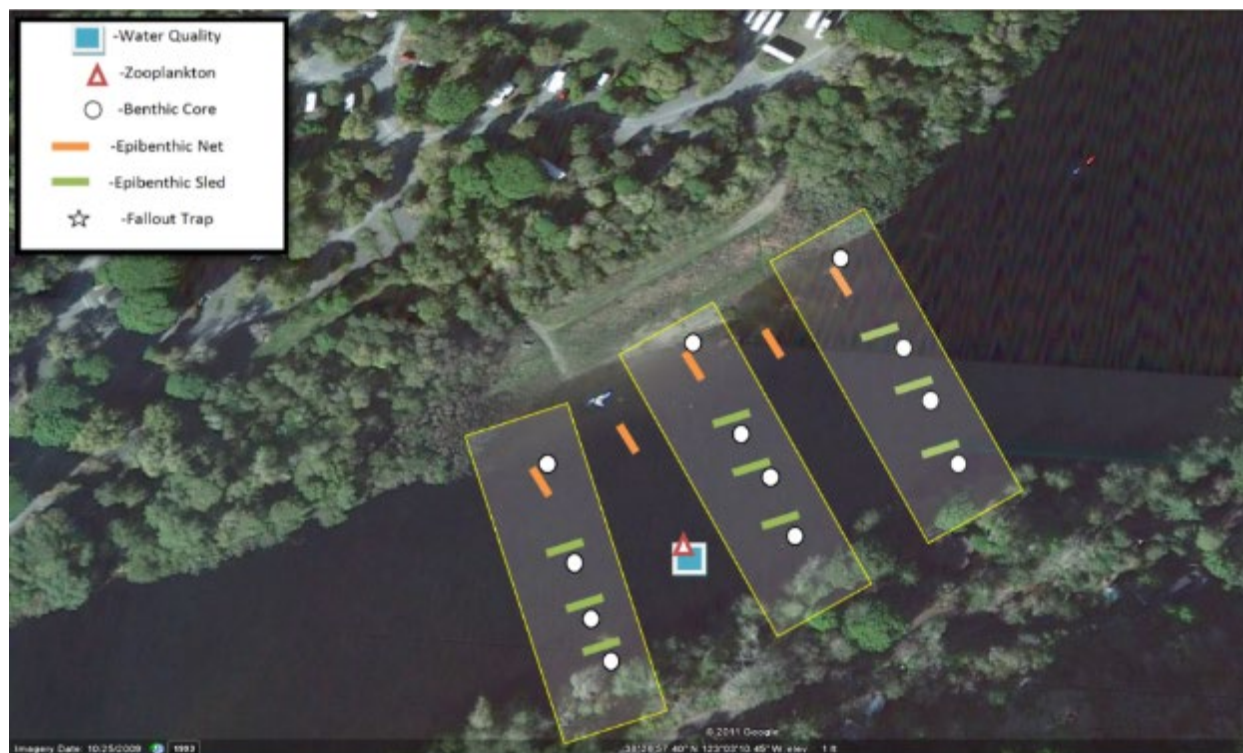
**Figure 4.3.6. Distribution of juvenile salmonid prey availability sampling transects and techniques at the Freezeout Bar site in the Russian River Estuary.**

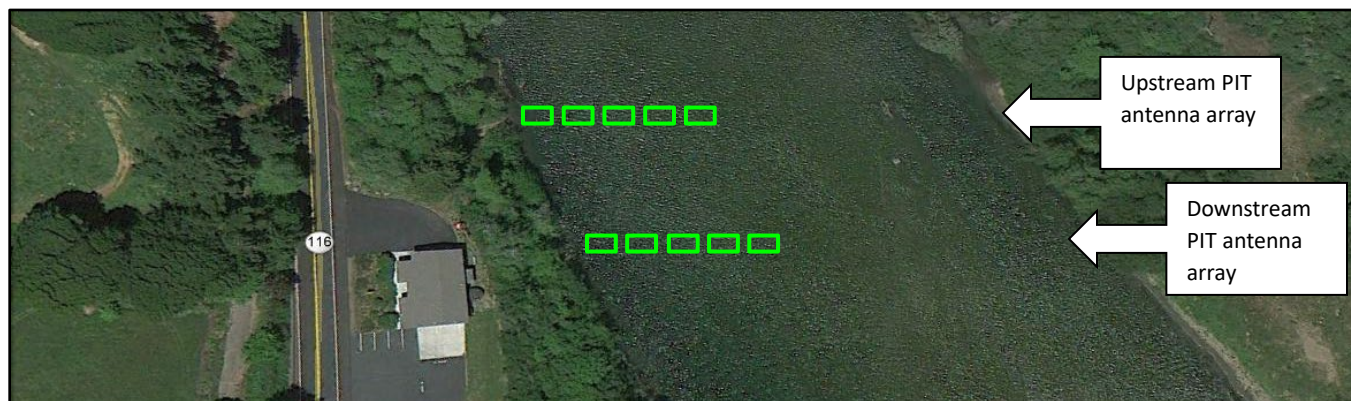
**Figure 4.5.2. Flat plate antenna arrays at Duncans Mills (river km 10.46). Rectangles represent individual flat plate antennas.**

Typically, two antenna arrays with multiple flat plate antennas (antennas designed to lay flat on the stream bottom) are installed in the upper Russian River estuary near the town of Duncans Mills (riverKm 10.46) to detect PIT-tagged fish entering the estuary (Figure 4.5.2). Generally, 10

antennas were operated continuously throughout the year. The orientation of the antennas consisted of 2 rows of antennas with one row slightly upstream of the other. Each row contained 5 antennas placed side by side starting at the west river bank and extending out into the channel.

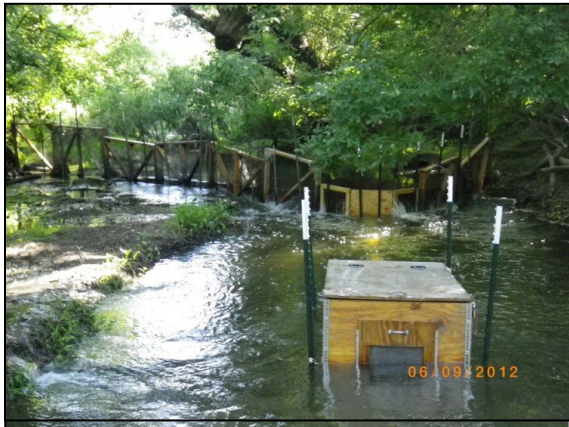
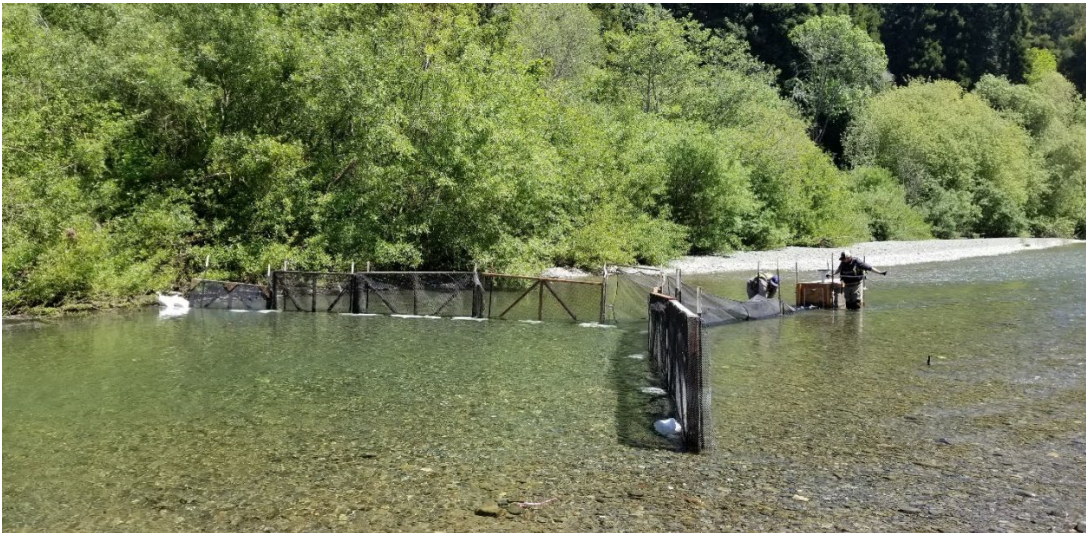
**Figure 4.5.3. Photographs of downstream migrant traps operated by the Sonoma Water (Mark West, Dutch Bill and Austin Creeks). See the Russian River Biological Opinion Status and Data Report year 2022-2023 for details regarding operation of the Dry Creek trap.**

Mark West Creek: Pipe trap (fished 3/4-6/20).

Austin Creek: Funnel trap (fished 3/17-5/31), pipe trap (fished 6/1-6/20).

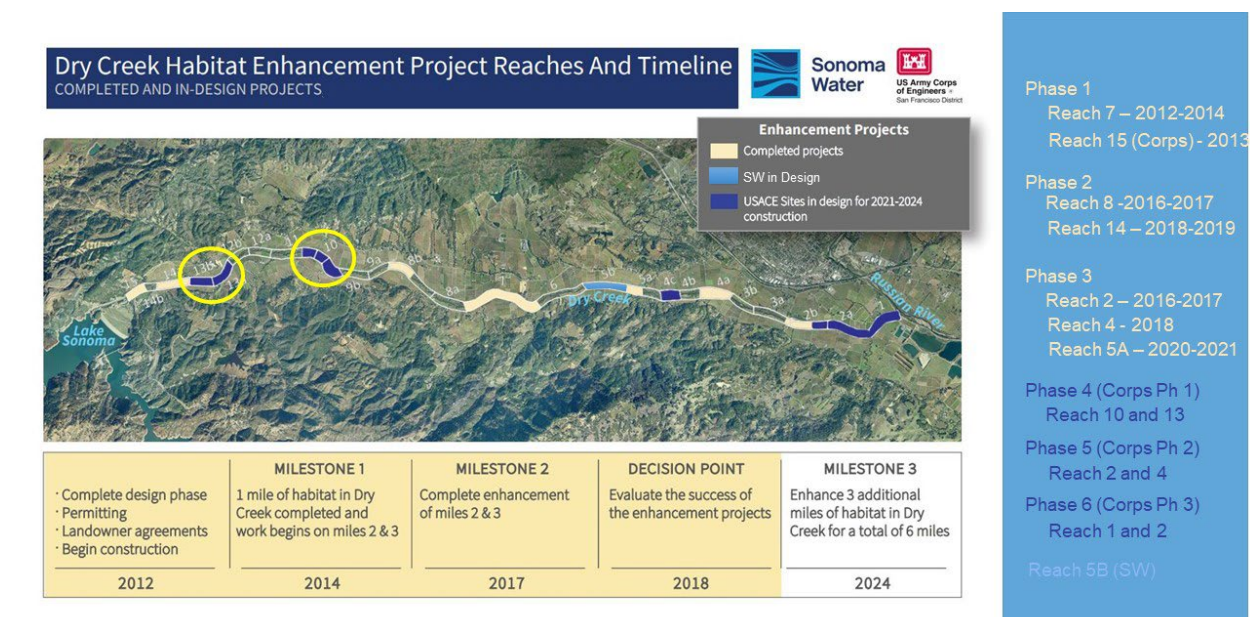
**Figure 5.2. Dry Creek habitat projects constructed in 2022 and tentatively planned for future construction. The two areas circled, Reach 13 and Reach 10, make up the two project areas included in the Dry Creek Ecosystem Restoration Project - Phase 1 construction contract. The Reach 13 work area construction was in 2022 and the Reach 10 work area will be in 2023.**

The 2022 construction season saw the start of construction for the Dry Creek Ecosystem Restoration Project – Phase 1 (Reaches 13 and 10) habitat work, with the Reach 13 work in 2022 and the Reach 10 work scheduled for 2023. The construction management for Phase 1 work is being overseen by the U.S. Army Corps of Engineers. This project was cost-shared through the Corps of Engineers' Ecosystem Restoration Project, which is being used to fund work towards Miles 4, 5, and 6 (Corps of Engineers Phases 1, 2, and 3) of the habitat work in Dry Creek. Sonoma Water managed the design contract with InterFluve and the U.S. Army Corps of Engineers is managing the construction process. Construction of this work began in 2022 in Reach 13 and continued in 2023 in Reach 10. The Reach 10 work is expected to be completed during the 2024 construction season. See Figure 5.2 above for the general project location and Figure 5.6 below for the project work area layout at the site.

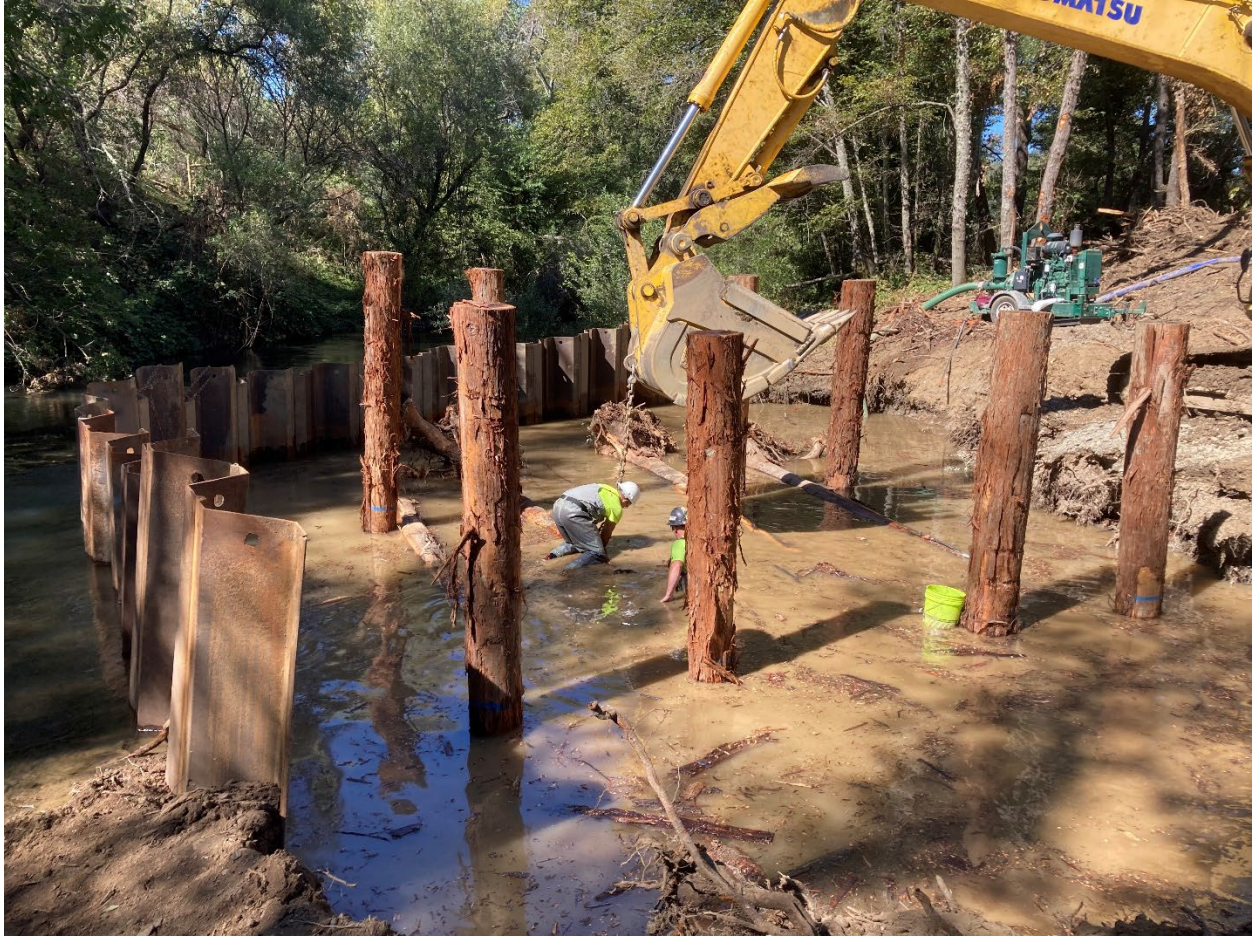
**Photo 5.1. Dry Creek Ecosystem Restoration Project - Phase 1. Installation of an apex log feature at the inlet to a constructed side-channel in Reach 13. October 4, 2022.**

The Phase 1 project area is along approximately 2,100 feet of Dry Creek in the Reach 13 area of Dry Creek, approximately 2 miles downstream of Warm Springs Dam and approximately 4,200 feet of Dry Creek in the Reach 10 area, immediately downstream of Yoakim Bridge. The Reach 13 sites consist of two side-channels. The Reach 10 area is a complex of side-channels, alcoves, and bank repair sites. The Reach 13 sites were constructed in 2022 and the Reach 10 area is scheduled for construction in 2023. Please refer to Photo 5.1, Photo 5.2, and Photo 5.3.

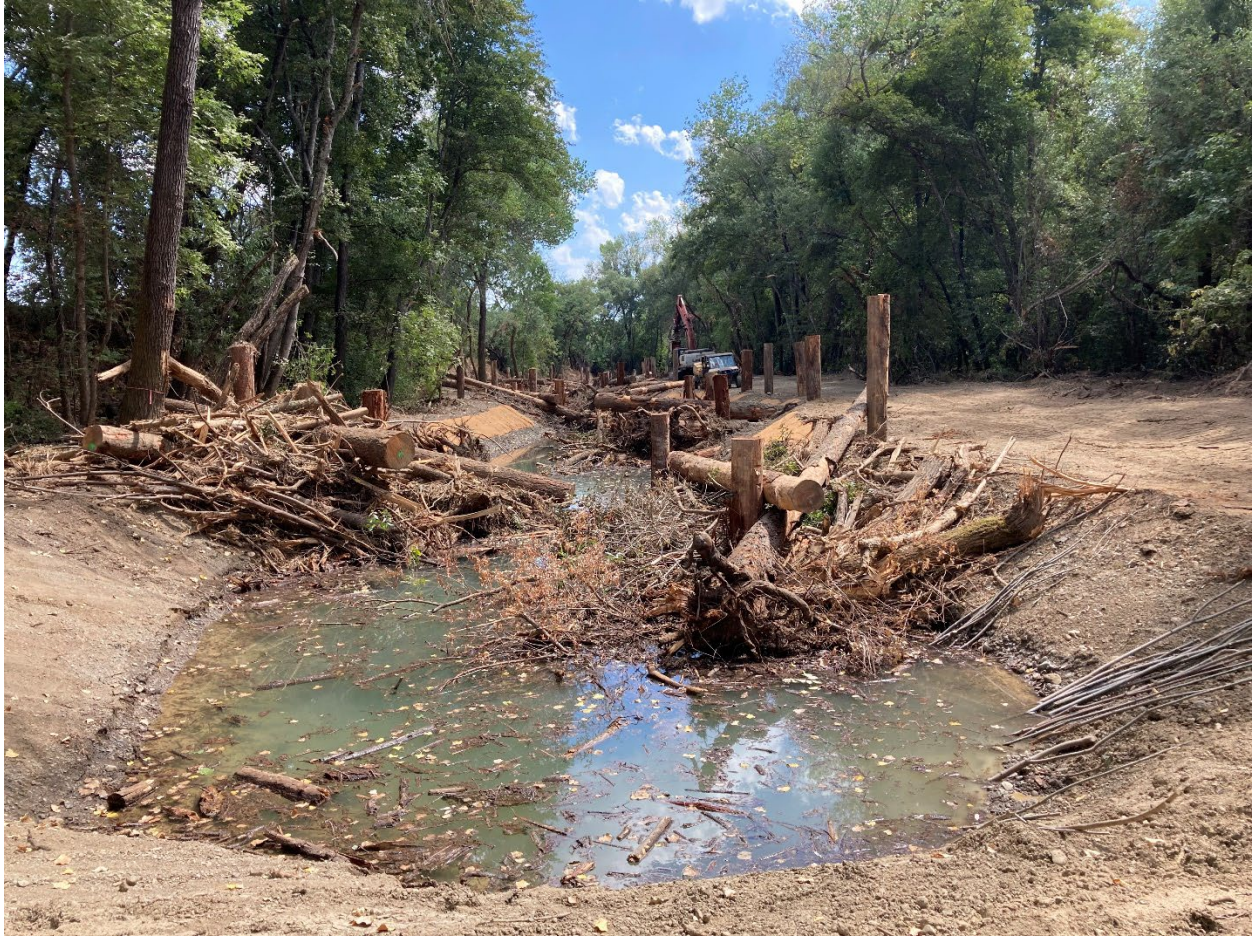
**Photo 5.2. Dry Creek Ecosystem Restoration Project - Phase 1. Construction of habitat side-channel partially complete in Reach 13. August 29, 2022.**

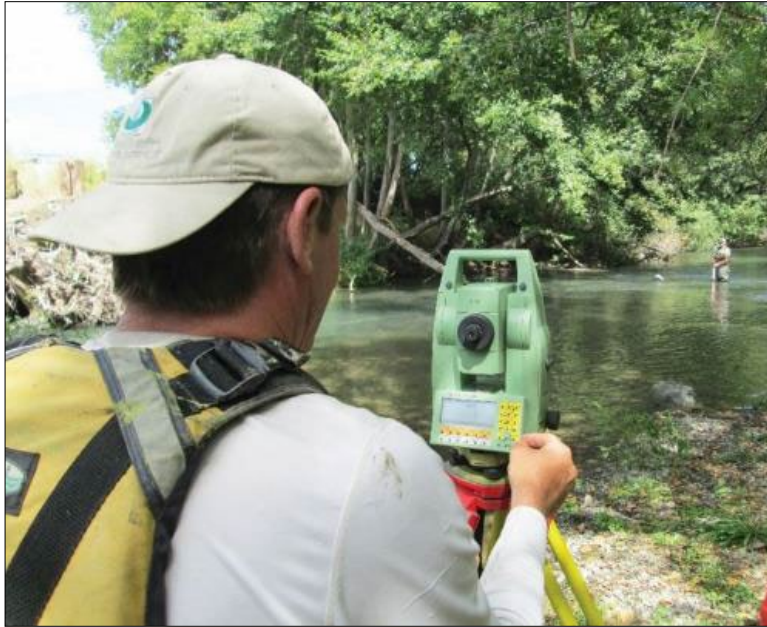
**Figure 5.2.1. Dry Creek effectiveness monitoring.** At each data point, we collected geographic location (latitude, longitude, elevation), and water depth and velocity by aiming the total station at a USGS topset rod fit with a survey prism and a flow meter.

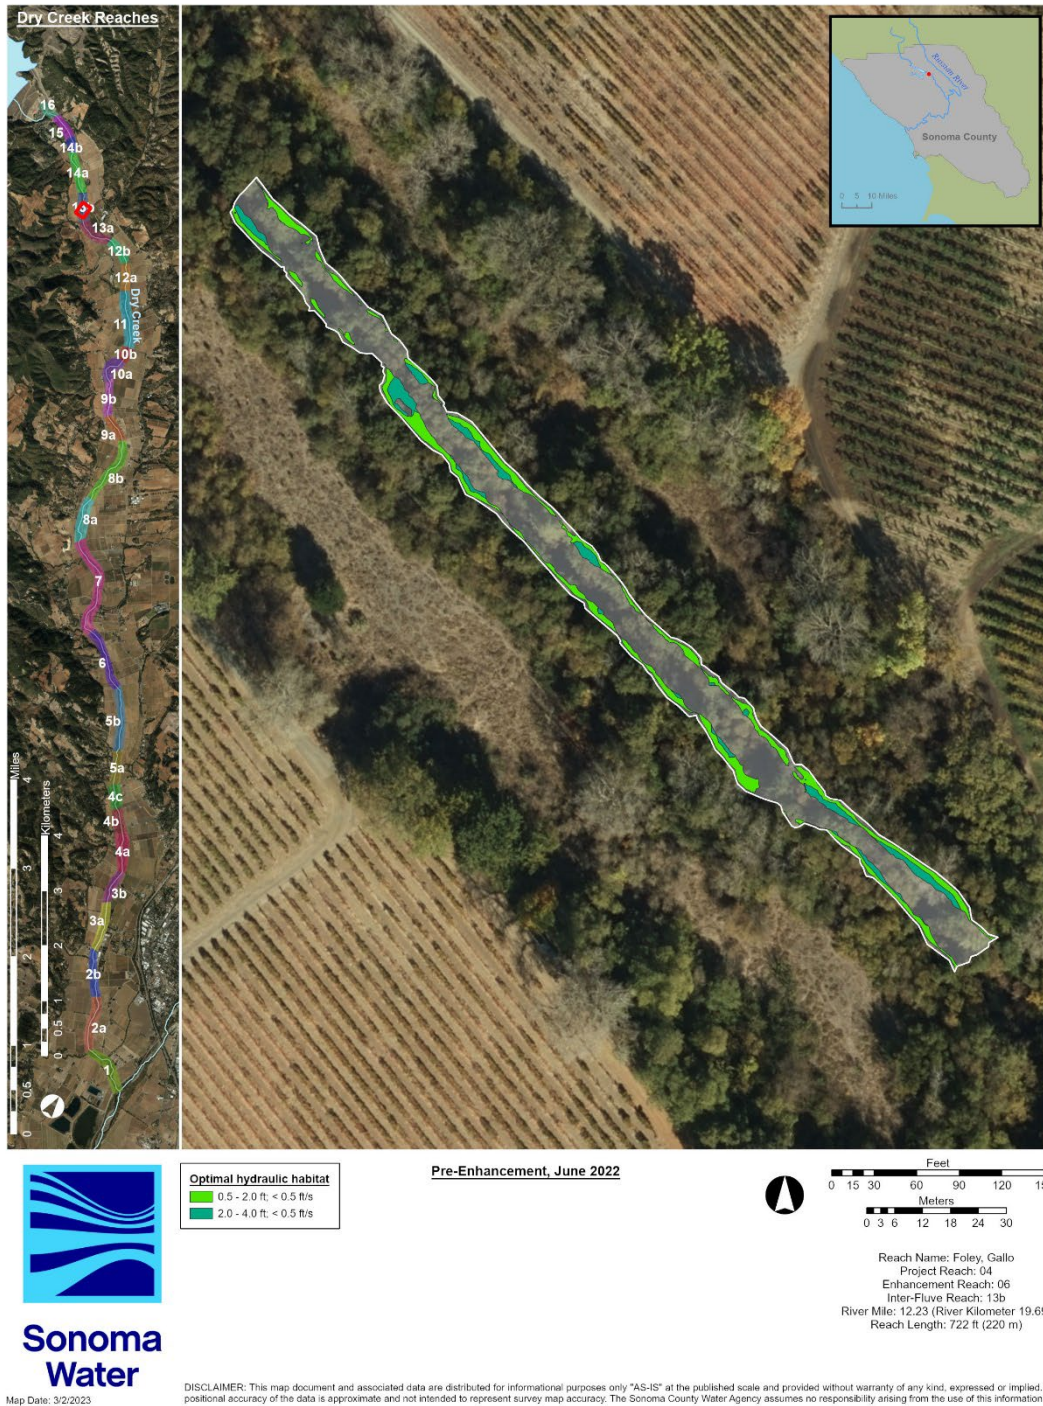
**Figure 5.2.5. Optimal hydraulic habitat for fry (<0.5 ft/s, 0.5-2.0 ft) and parr (<0.5 ft/s, 2.0-4.0 ft) within the Foley Gallo enhancement reach, June 2022.**

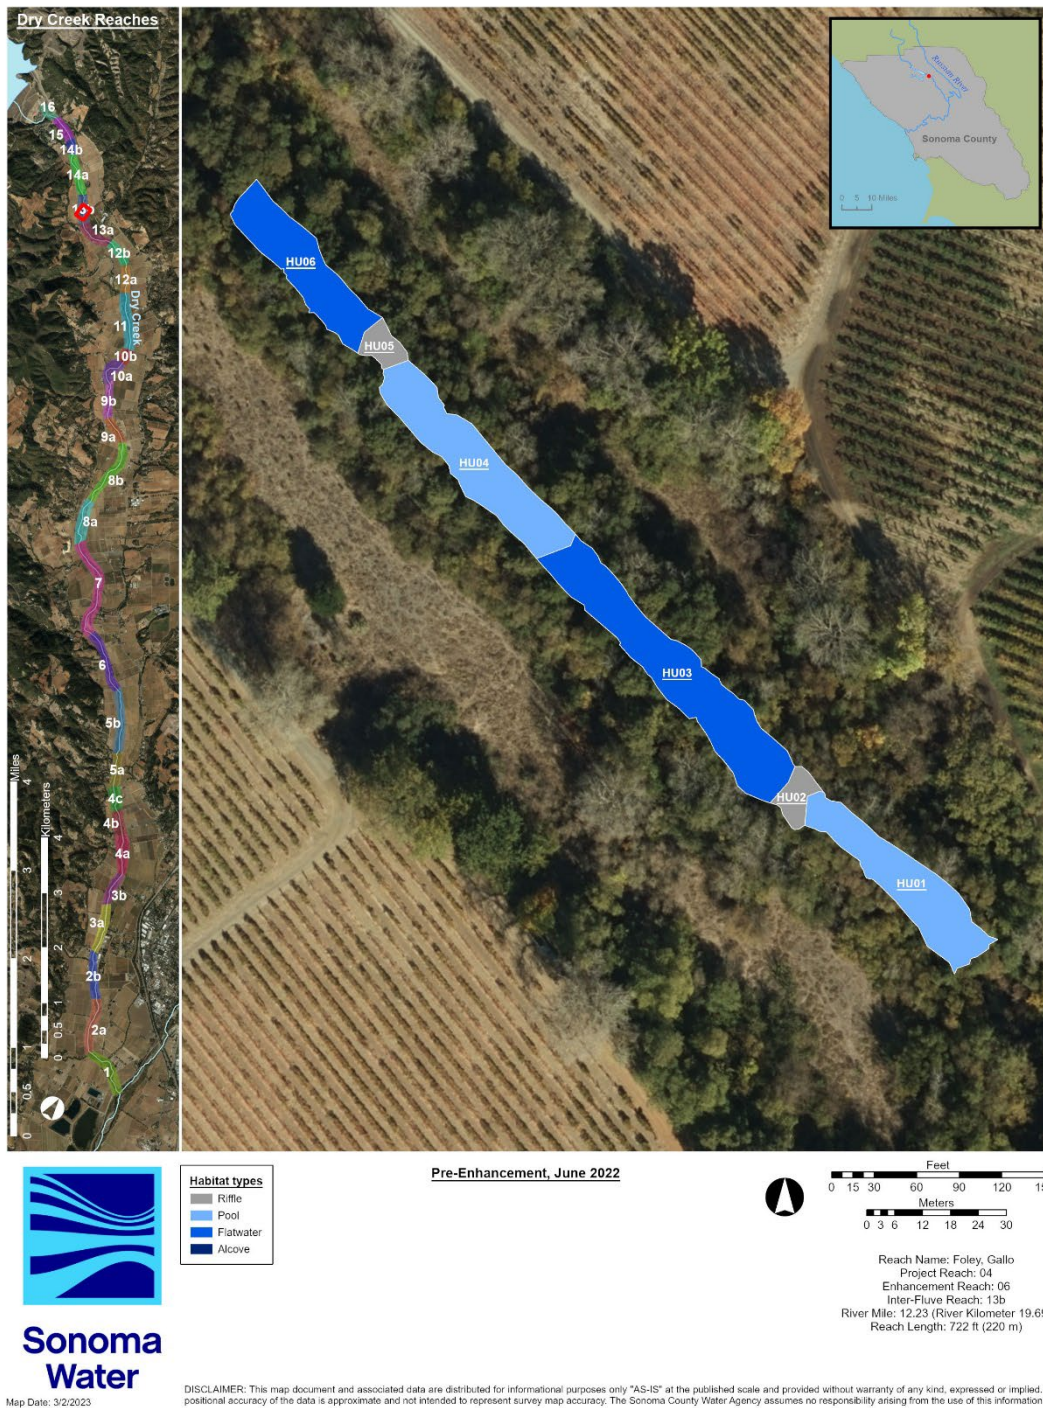
Figure 5.2.6. Habitat unit number and type within the Foley Gallo enhancement reach, June 2022.

Habitat Unit #	Habitat Type	Shelter Value	Percent Cover	Shelter Score
HU01	Pool	3	35	105
HU02	Riffle	3	50	150
HU03	Flatwater	3	35	105
HU04	Pool	3	35	105
HU05	Riffle	2	20	40
HU06	Flatwater	2	15	30
<b>Pool: riffle</b>	<b>2: 2 (1.00)</b>			<b>Avg = 89</b>

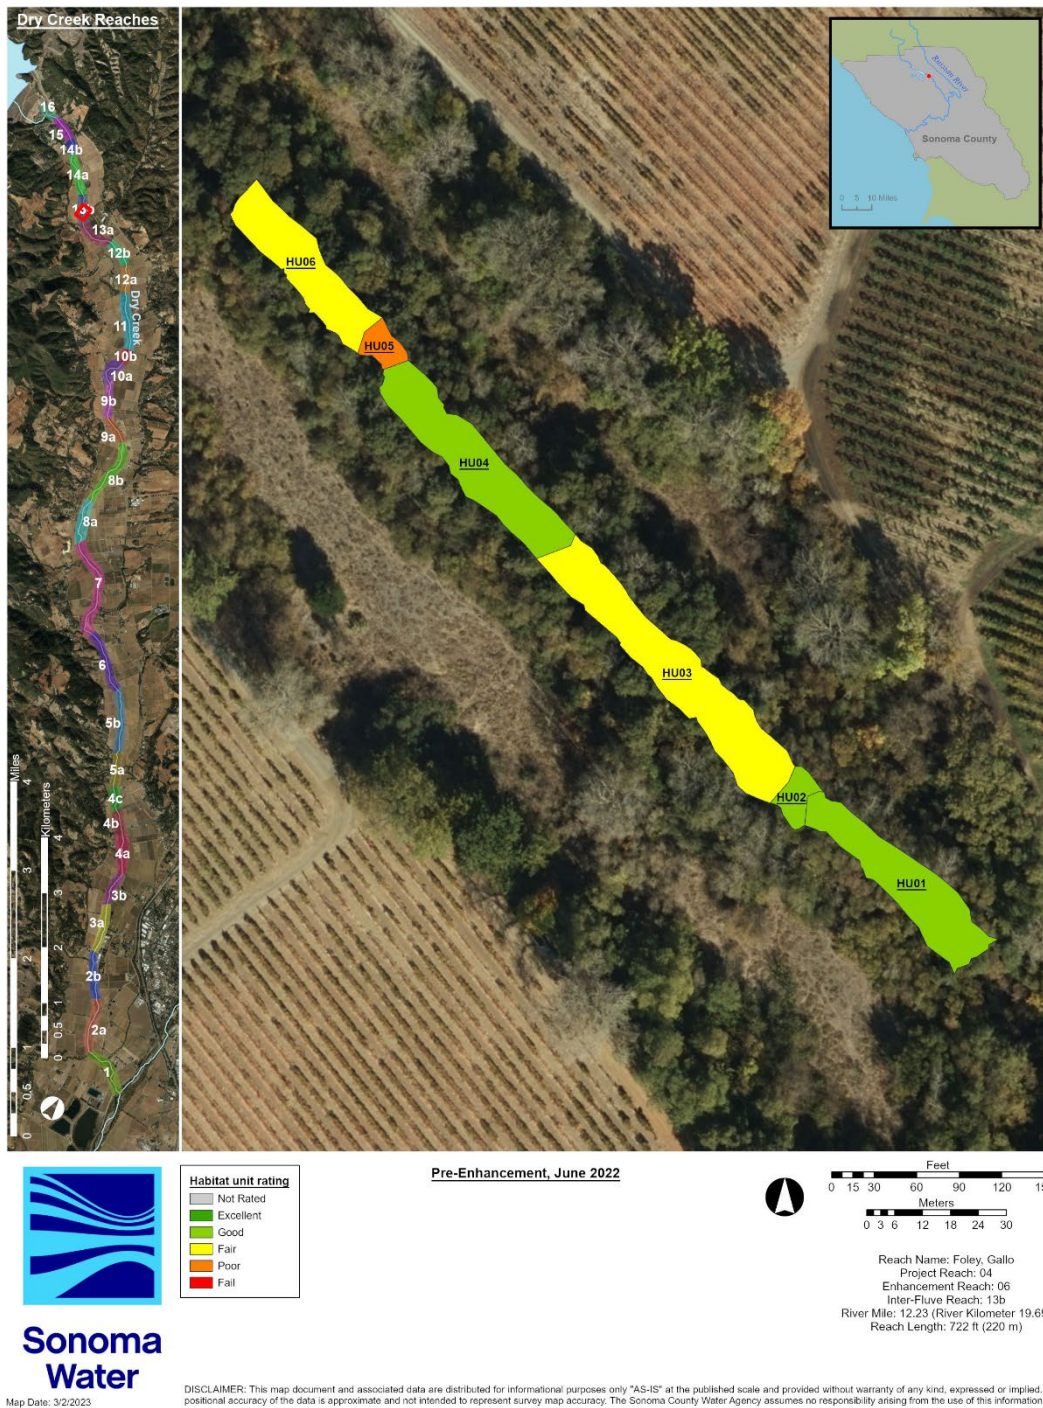
Figure 5.2.8. Habitat unit ratings for the Foley Gallo enhancement reach, June 2022.

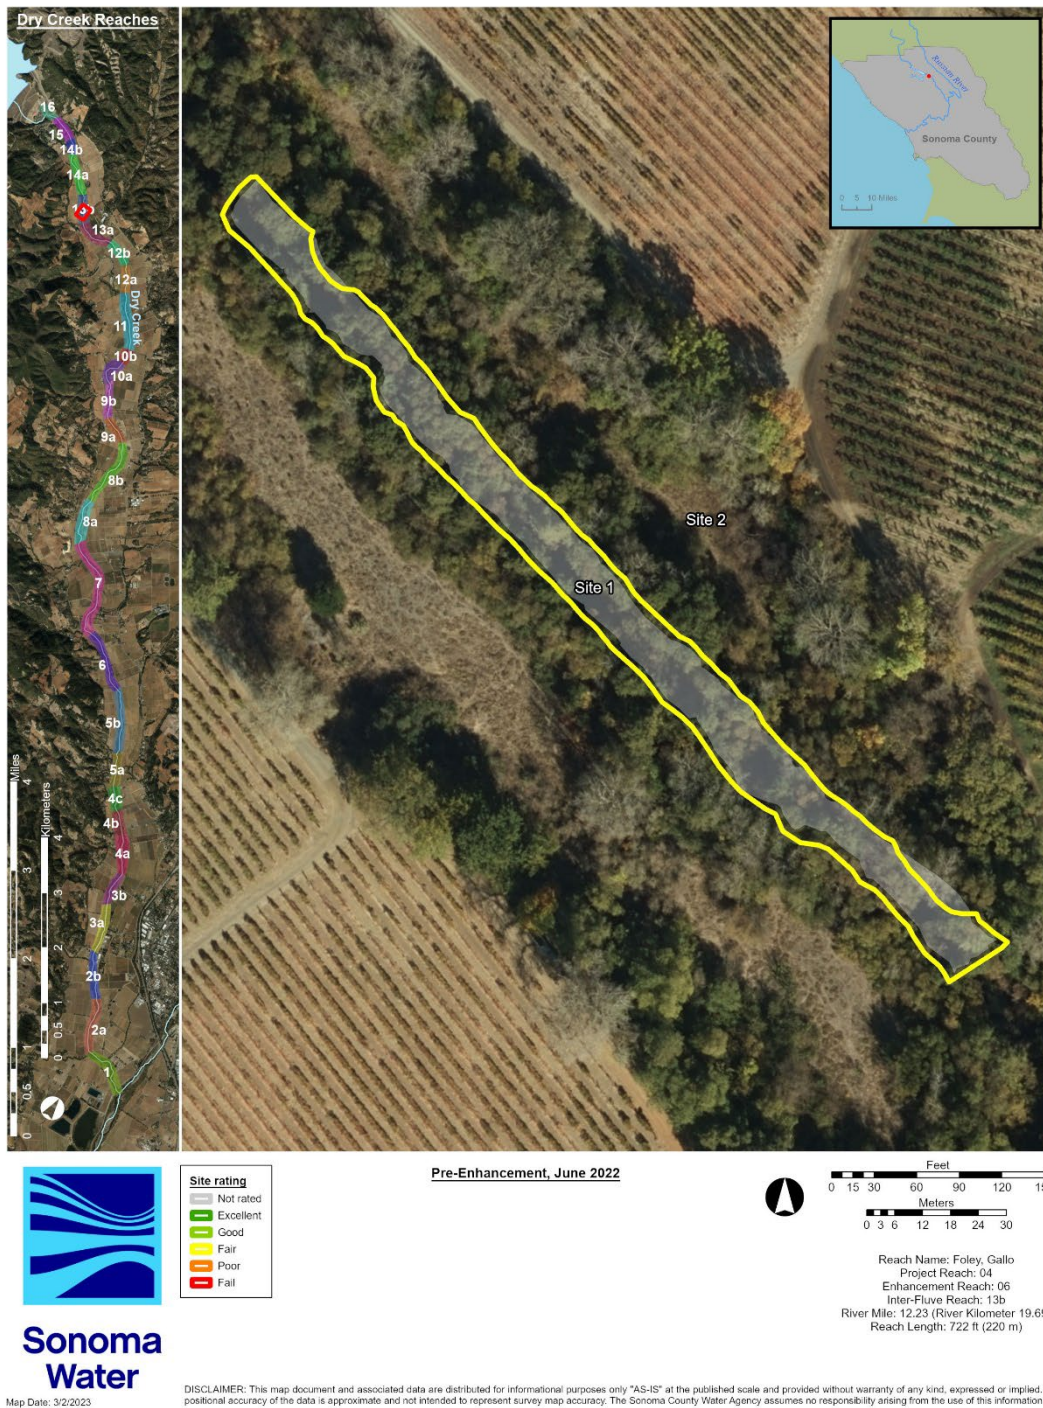
Figure 5.2.9. Pre-enhancement site rating for the Foley Gallo enhancement reach, June 2022.

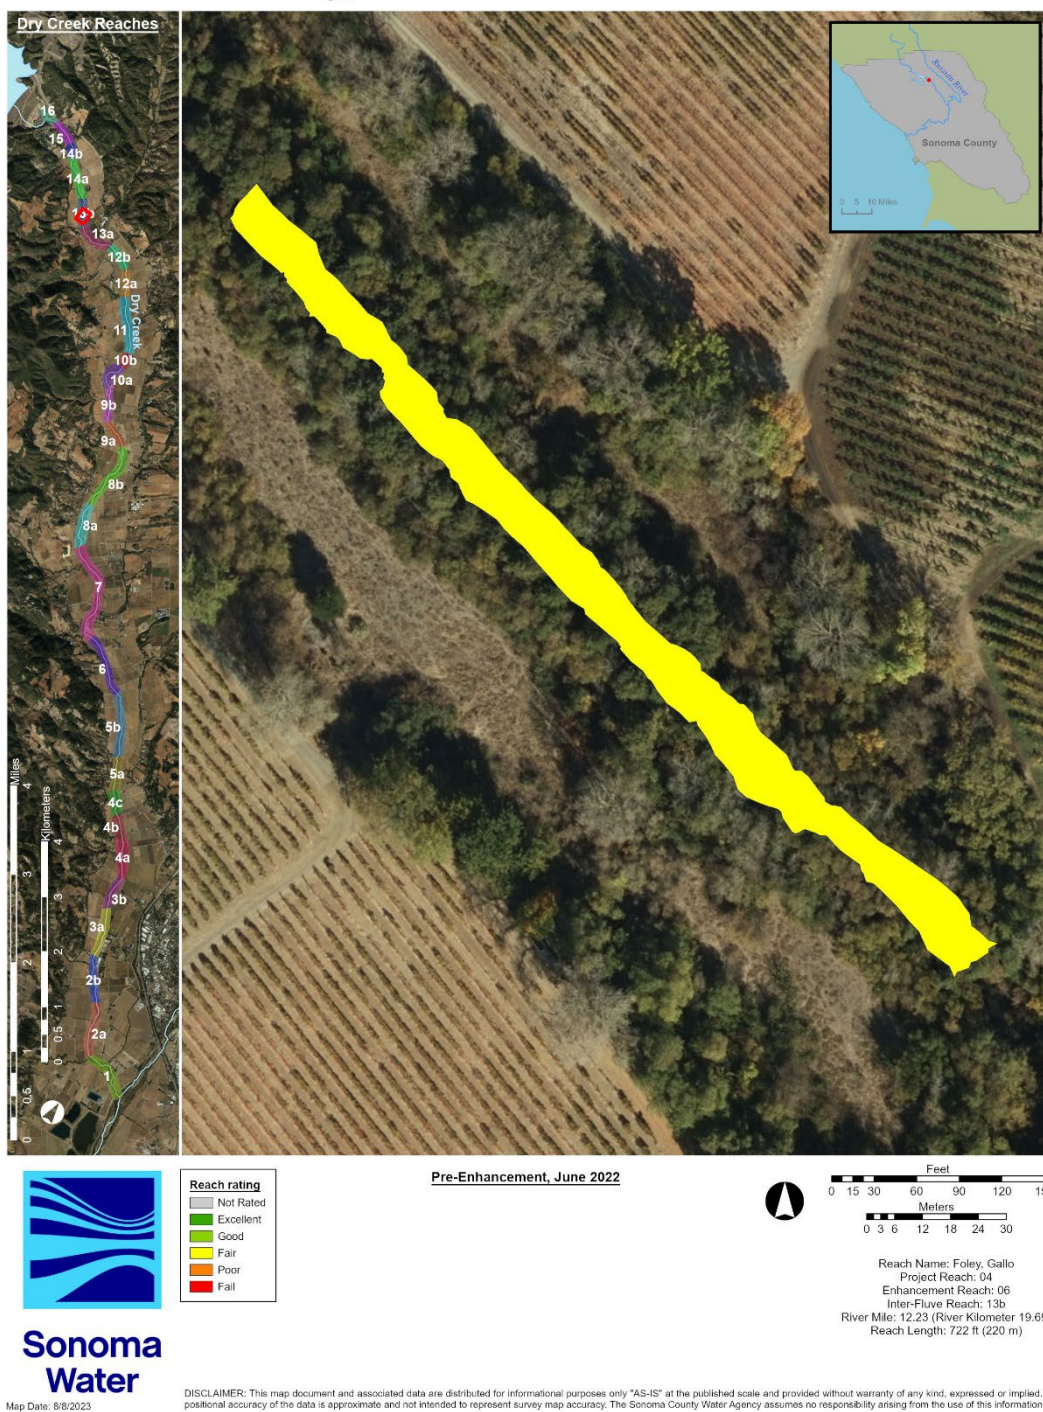
Figure 5.2.10. Pre-enhancement reach rating for the Foley Gallo enhancement reach, June 2022

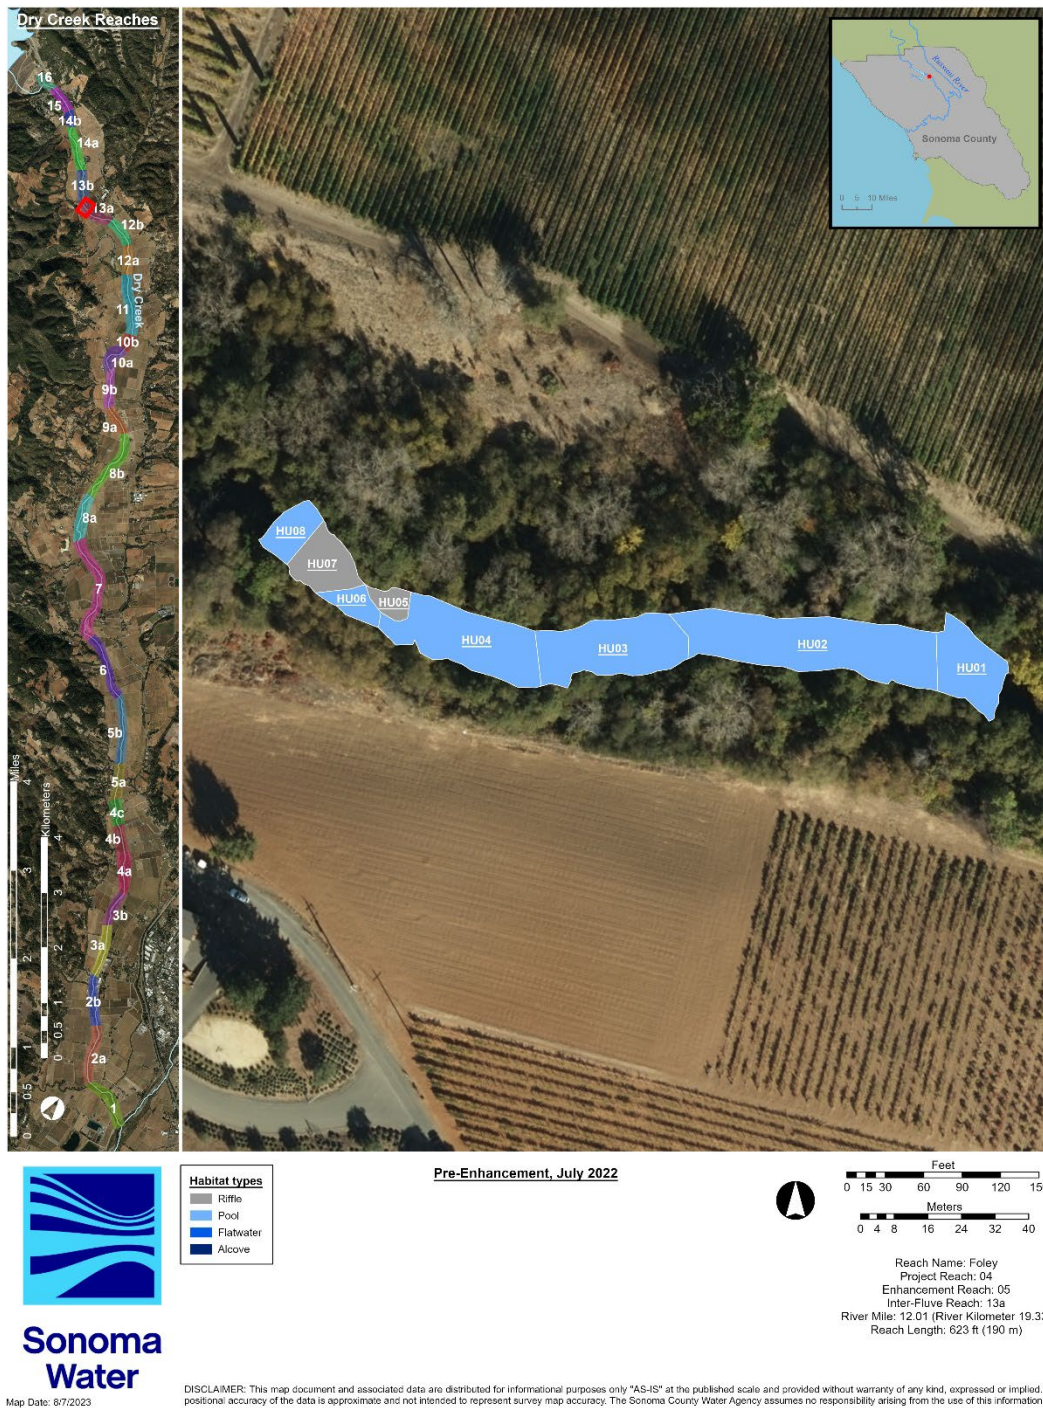
Figure 5.2.12. Habitat unit number and type within the Foley enhancement reach, July 2022.

Habitat Unit #	Habitat Type	Shelter Value	Percent Cover	Shelter Score
HU01	Pool	3	35	105
HU02	Pool	3	45	135
HU03	Pool	3	40	120
HU04	Pool	3	15	45
HU05	Riffle	3	25	75
HU06	Pool	1	5	5
HU07	Riffle	3	30	90
HU08	Pool	3	40	120
<b>Pool: riffle</b>	<b>6: 2 (3.00)</b>			<b>Avg = 73</b>

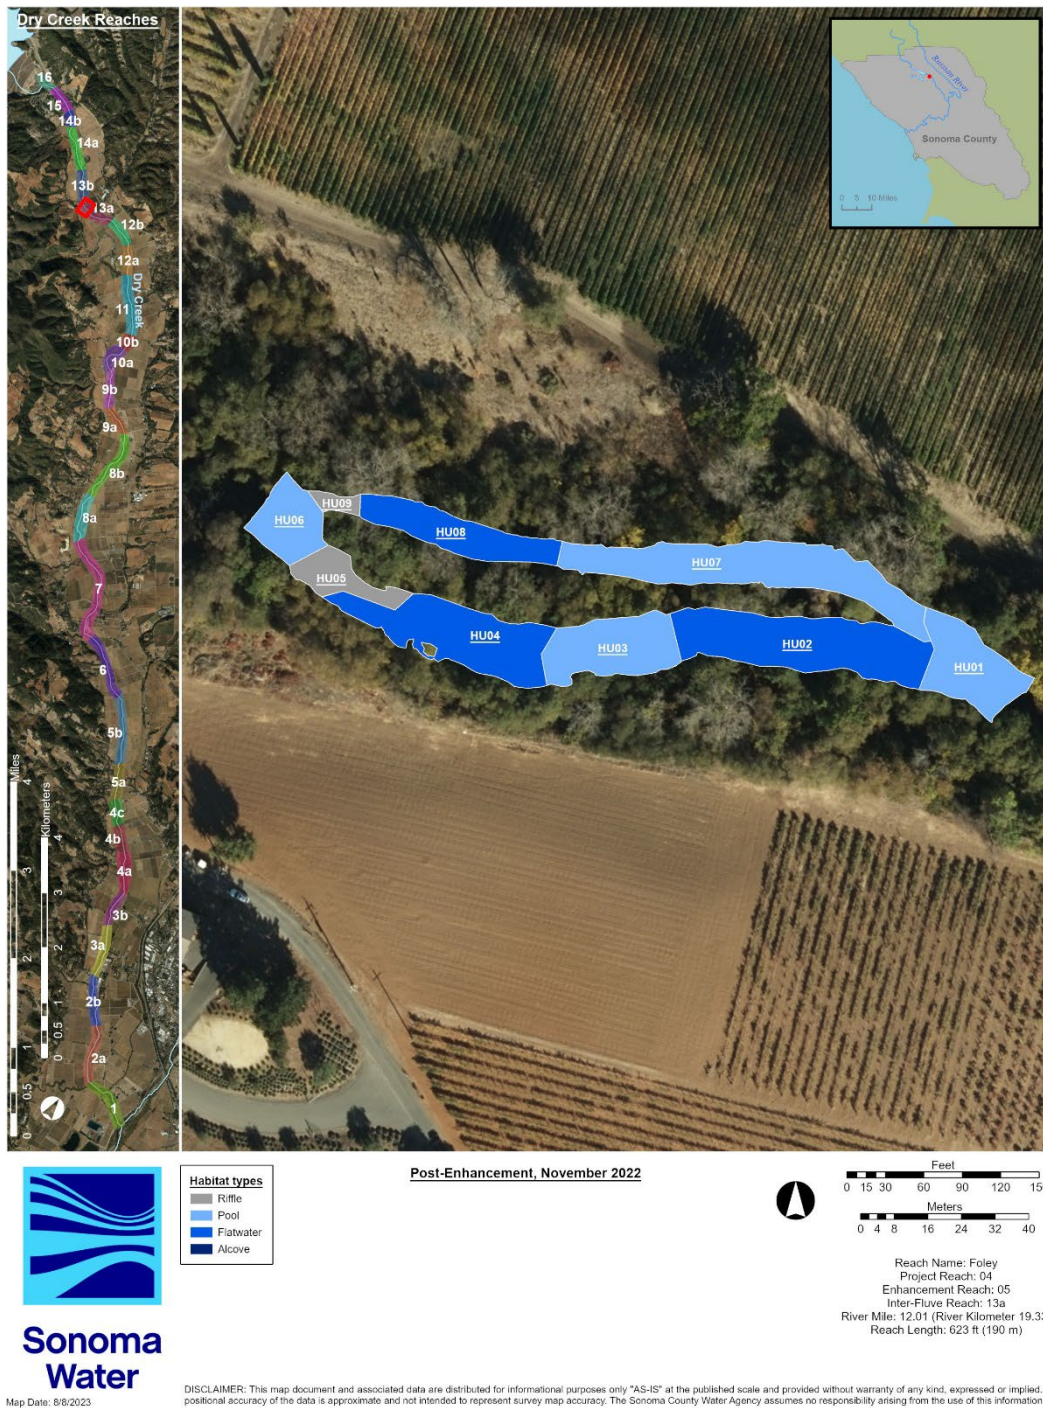
Figure 5.2.18. Habitat unit number and type within the Foley enhancement reach, November 2022.

Habitat Unit #	Habitat Type	Shelter Value	Percent Cover	Shelter Score
HU01	Pool	3	15	45
HU02	Flatwater	2	15	30
HU03	Pool	2	20	40
HU04	Flatwater	3	45	135
HU05	Riffle	2	5	10
HU06	Pool	3	35	105
HU07	Pool	3	50	150
HU08	Flatwater	3	45	135
HU09	Riffle	3	30	90
<b>Pool: riffle</b>	<b>4: 2 (2.00)</b>			<b>Avg = 82</b>

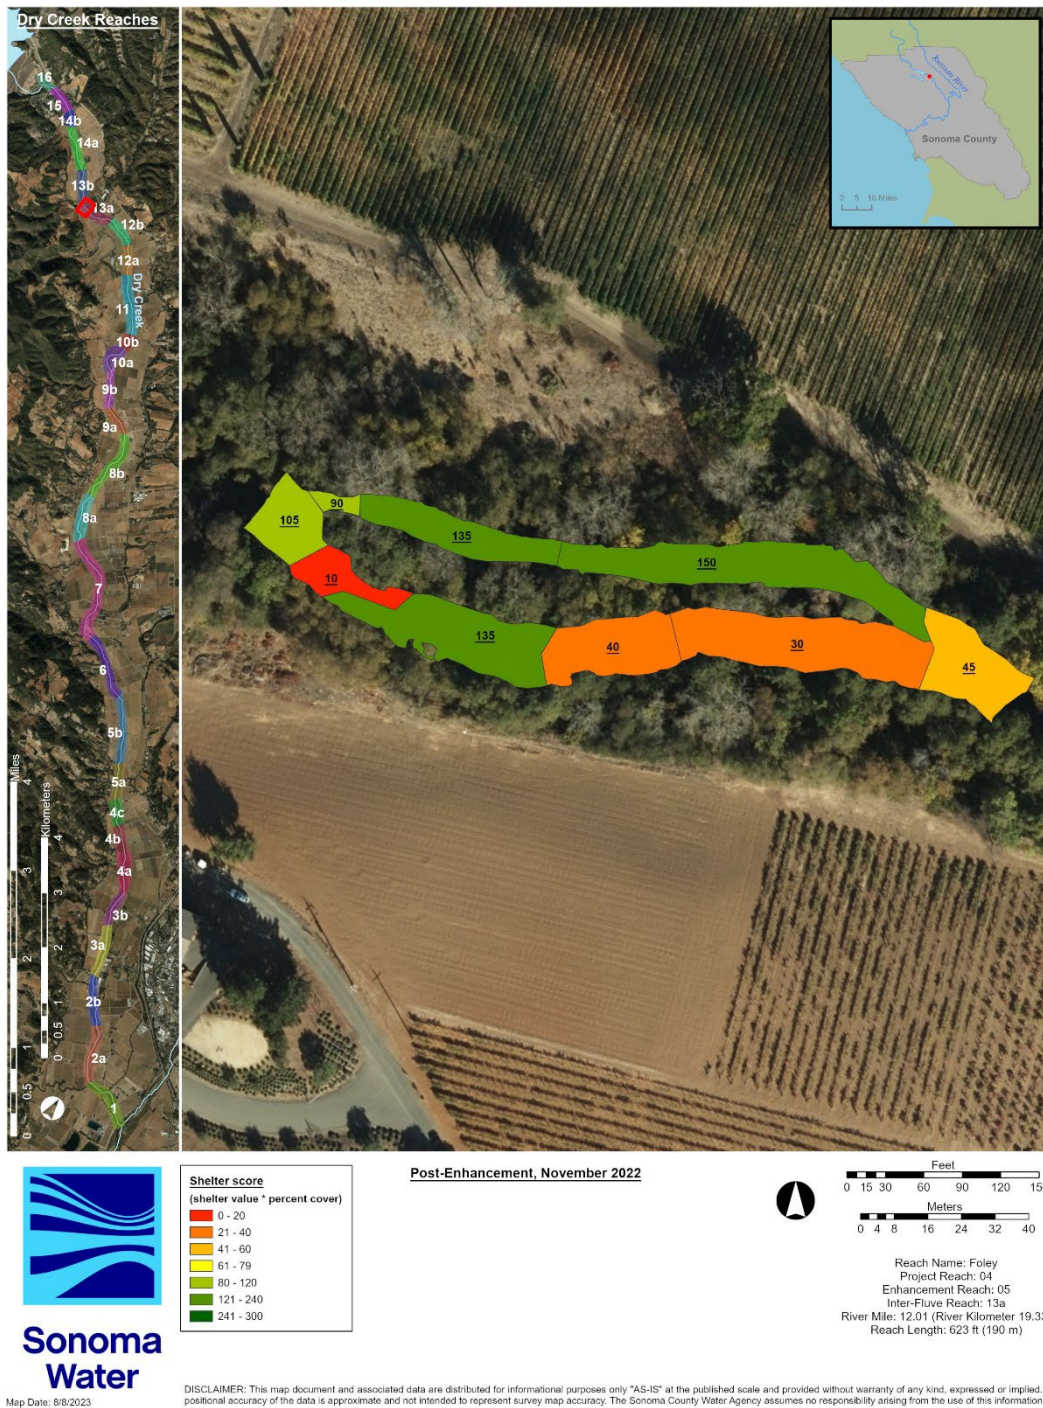
Figure 5.2.19. Habitat unit shelter values within the Foley enhancement reach, November 2022.
