# Russian River Biological Opinion Status and Data Report

**Year 2022 – 2023**

**February 2024**

**Sonoma  
Water**

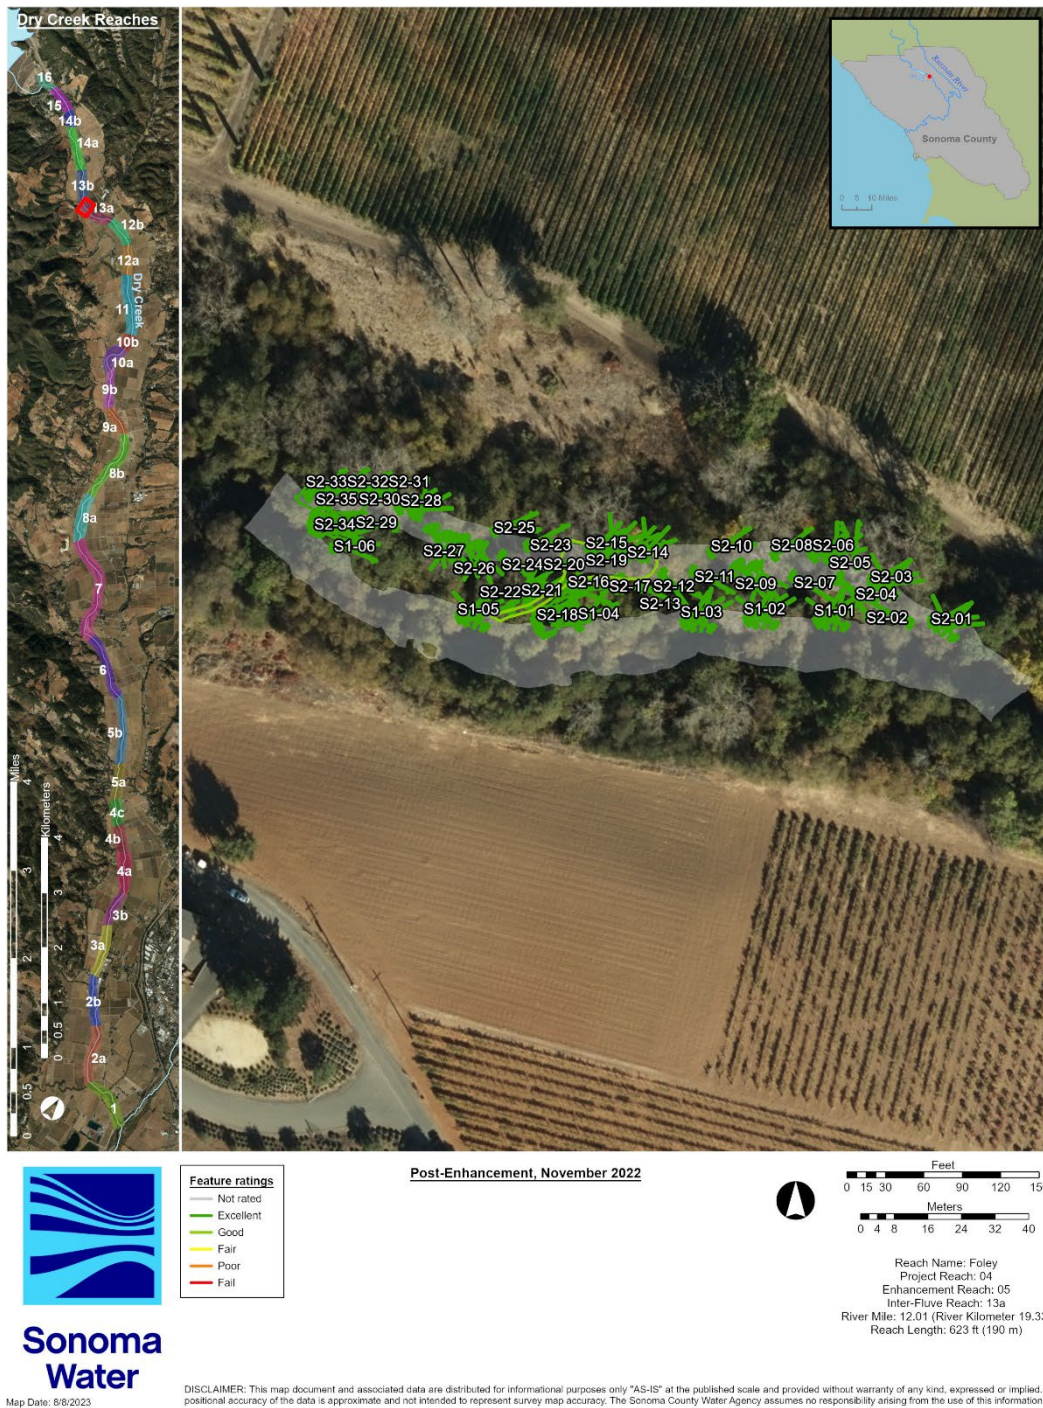
Figure 5.2.21. Feature ratings for the Foley enhancement reach, November 2022.

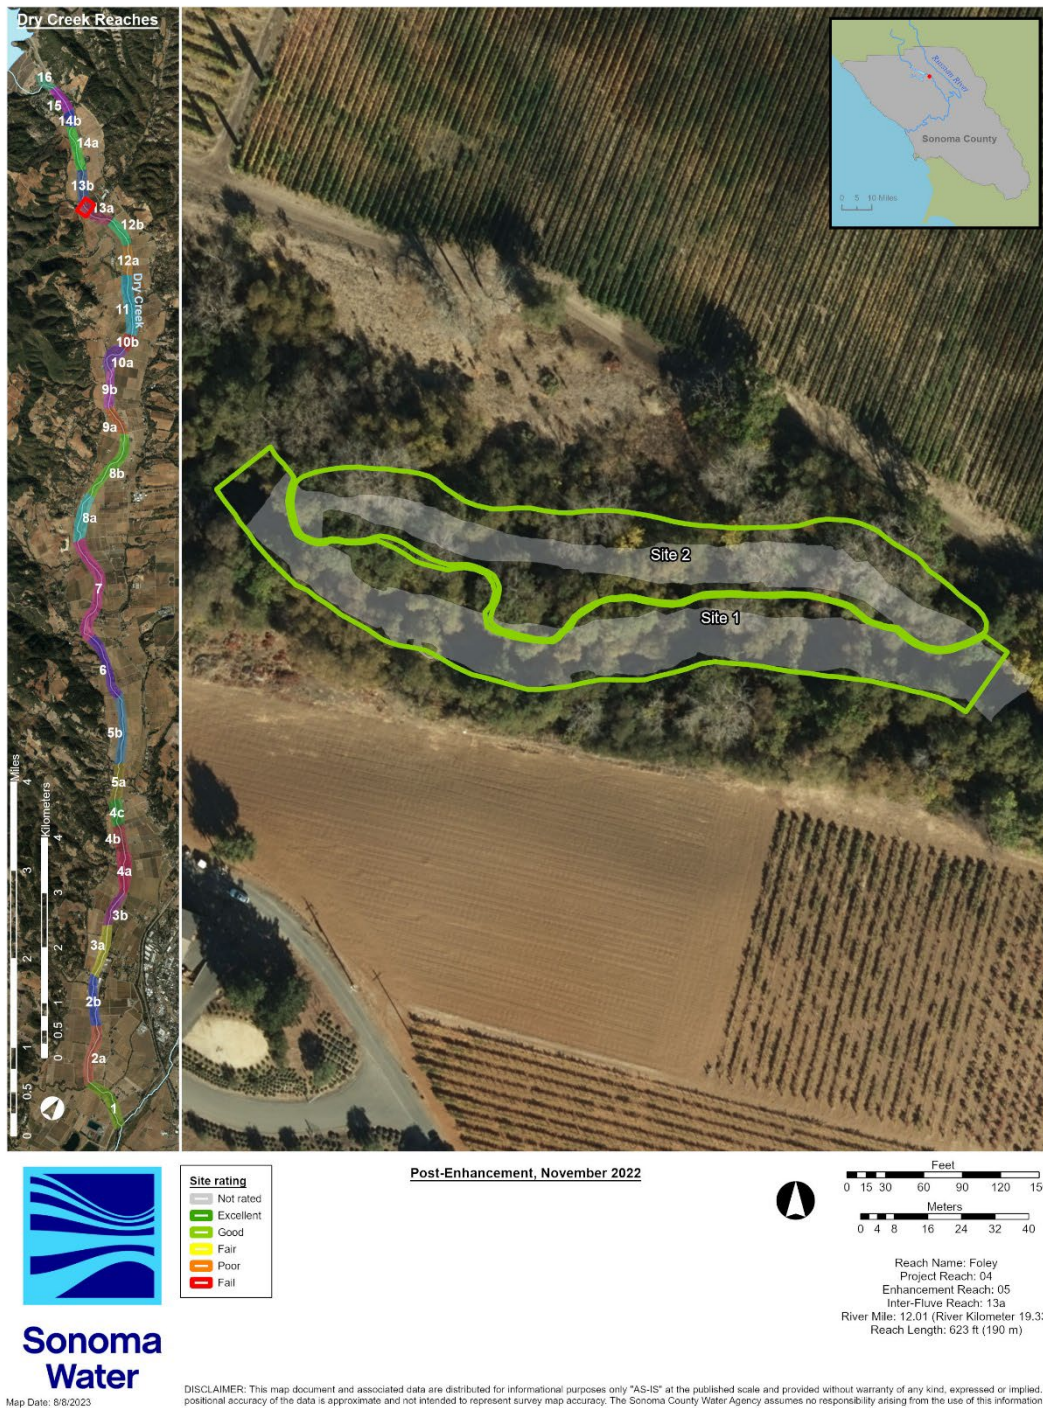
Figure 5.2.23. Post-enhancement site ratings for the Foley enhancement reach, November 2022.

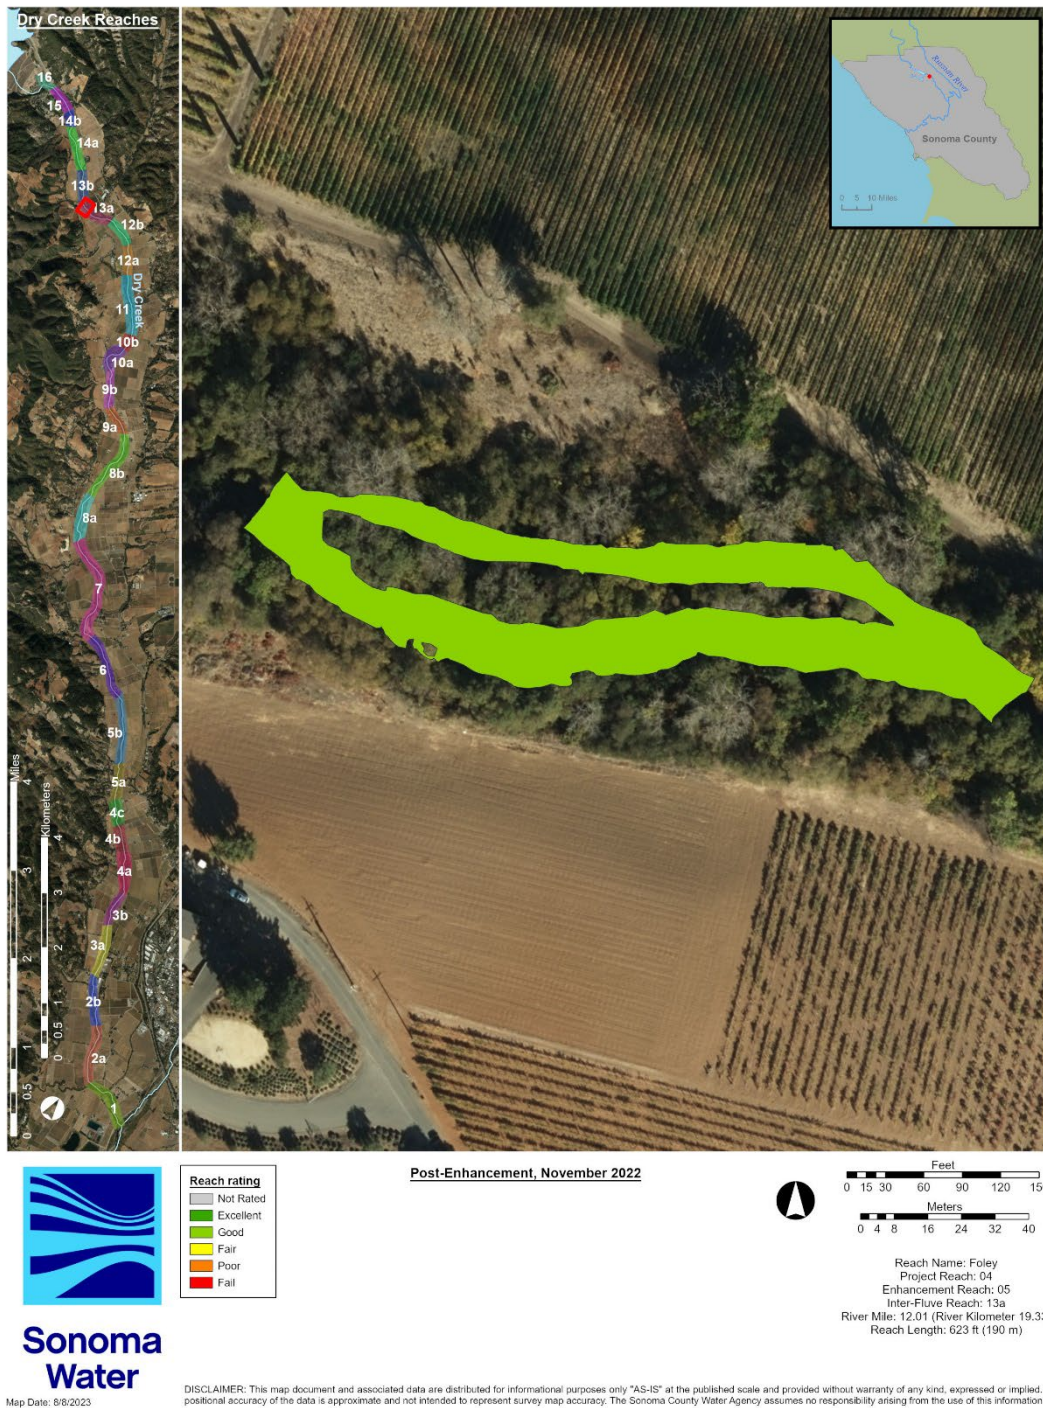
Figure 5.2.24. Post-enhancement reach rating for the Foley enhancement reach, November 2022.

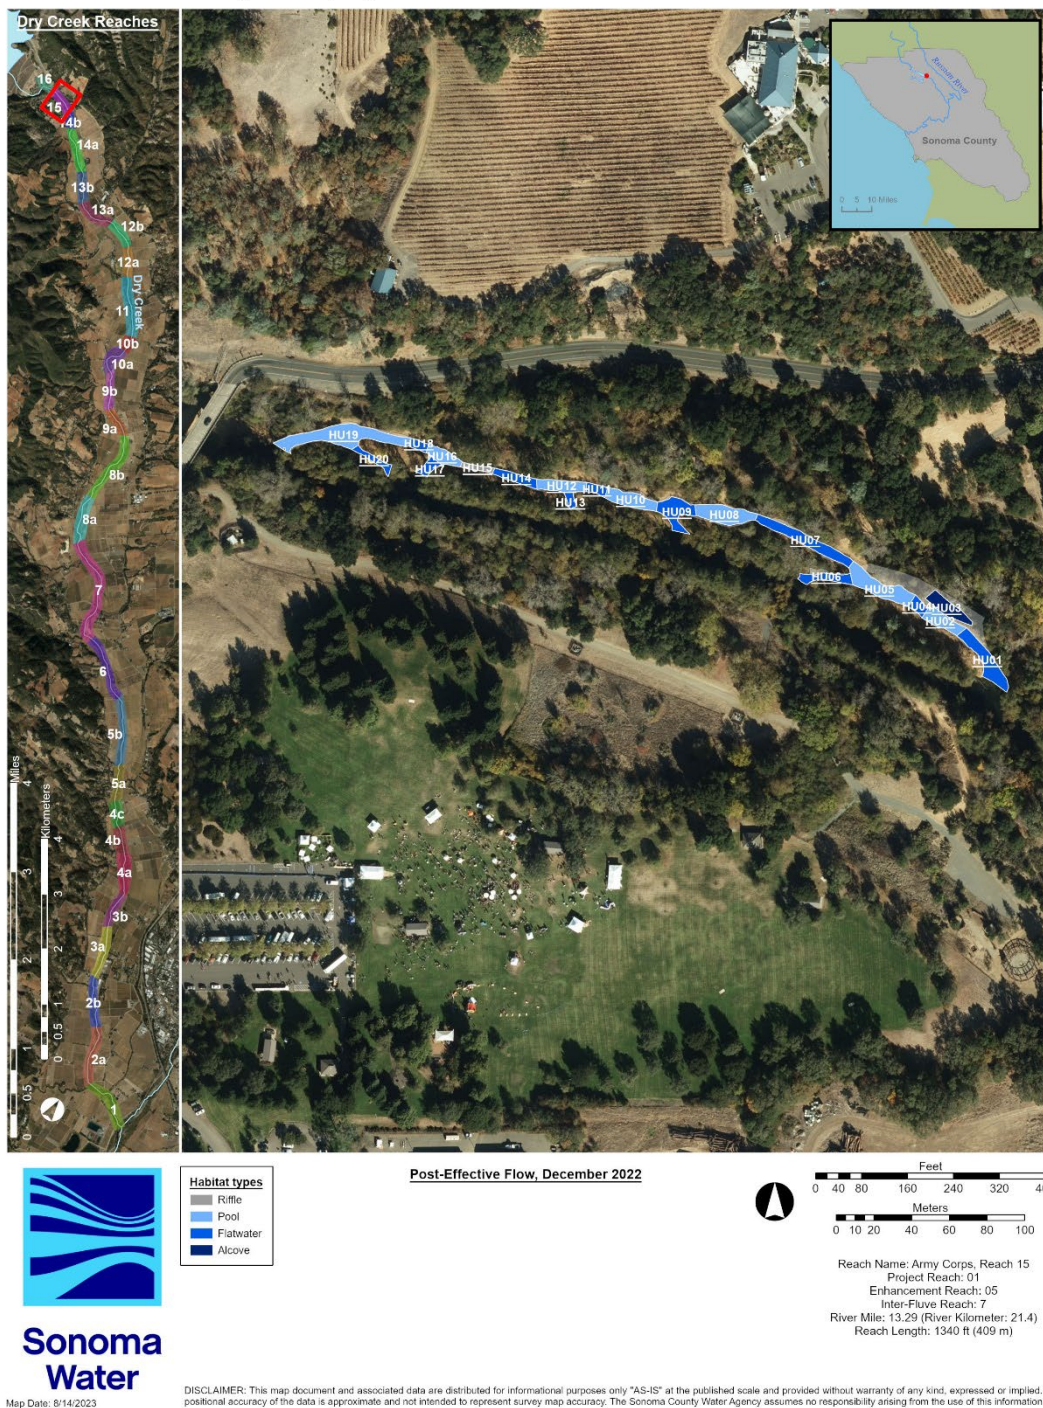
**Figure 5.2.26. Habitat unit number and type within the Army Corps enhancement reach, December 2022.**

Habitat Unit #	Habitat Type	Shelter Value	Percent Cover	Shelter Score
HU01	Flatwater	3	45	135
HU02	Pool	3	85	255
HU03	Alcove	3	80	240
HU04	Flatwater	3	20	60
HU05	Pool	3	60	180
HU06	Flatwater	2	70	140
HU07	Flatwater	3	15	45
HU08	Pool	3	45	135
HU09	Flatwater	3	35	105
HU10	Pool	3	20	60
HU11	Flatwater	2	15	30
HU12	Pool	3	45	135
HU13	Flatwater	2	35	70
HU14	Flatwater	3	15	45
HU15	Riffle	2	15	30
HU16	Pool	3	65	195
HU17	Flatwater	3	70	210
HU18	Flatwater	2	60	120
HU19	Pool	3	40	120
HU20	Flatwater	2	20	40
<b>Pool: riffle</b>	<b>7:1 (7.0)</b>			<b>Avg = 118</b>

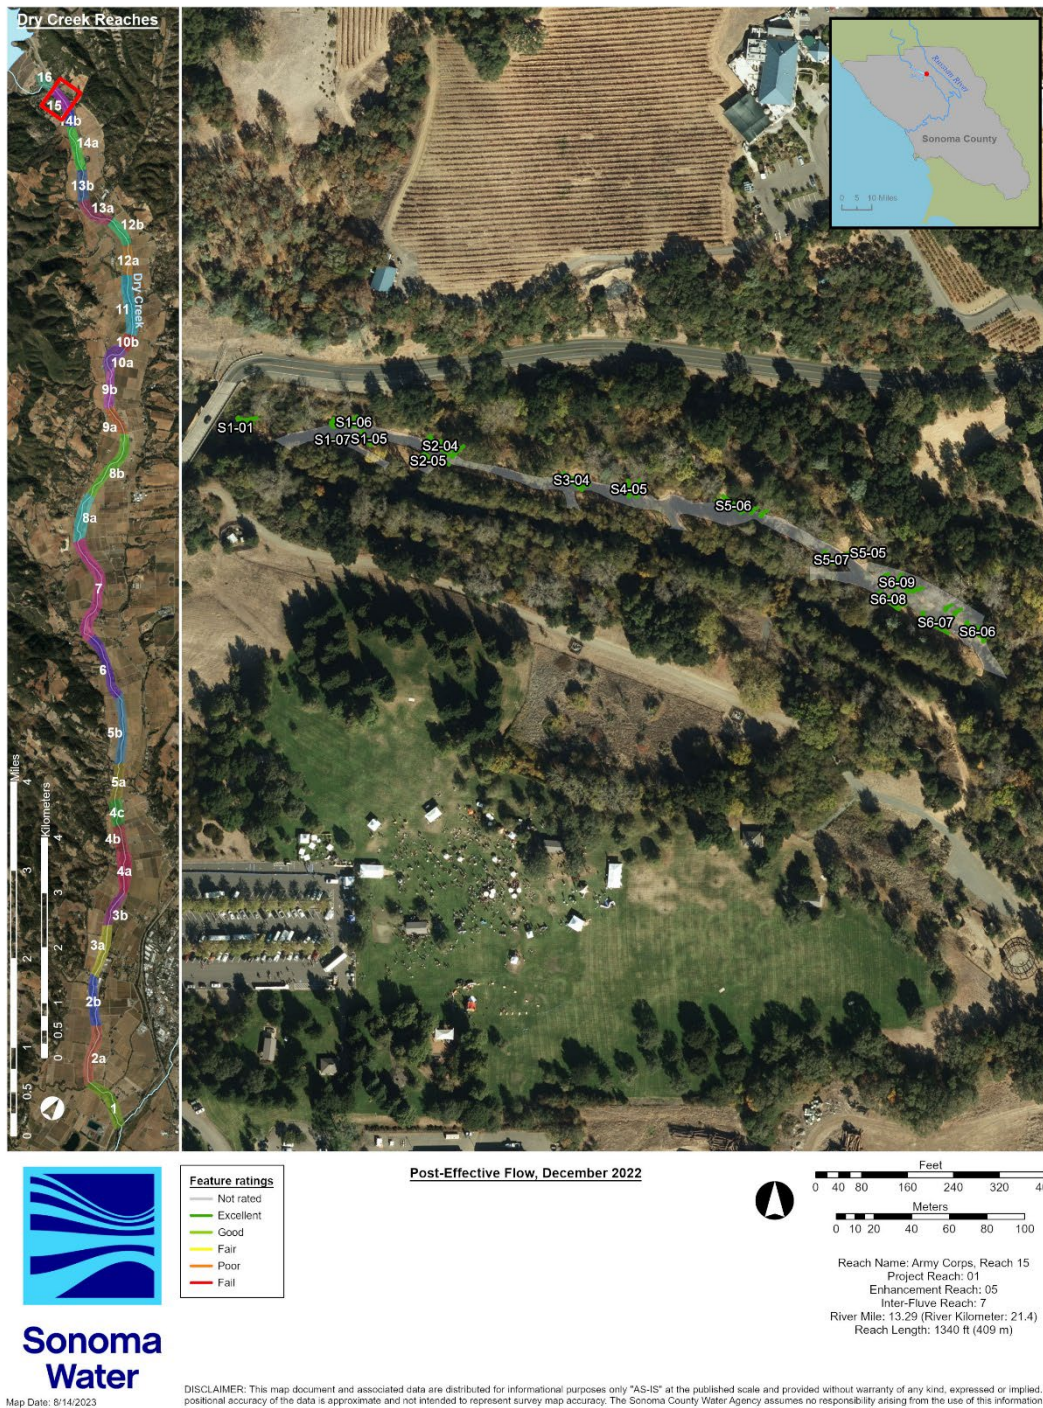
Figure 5.2.29. Feature ratings for the Army Corps enhancement reach, December 2022.

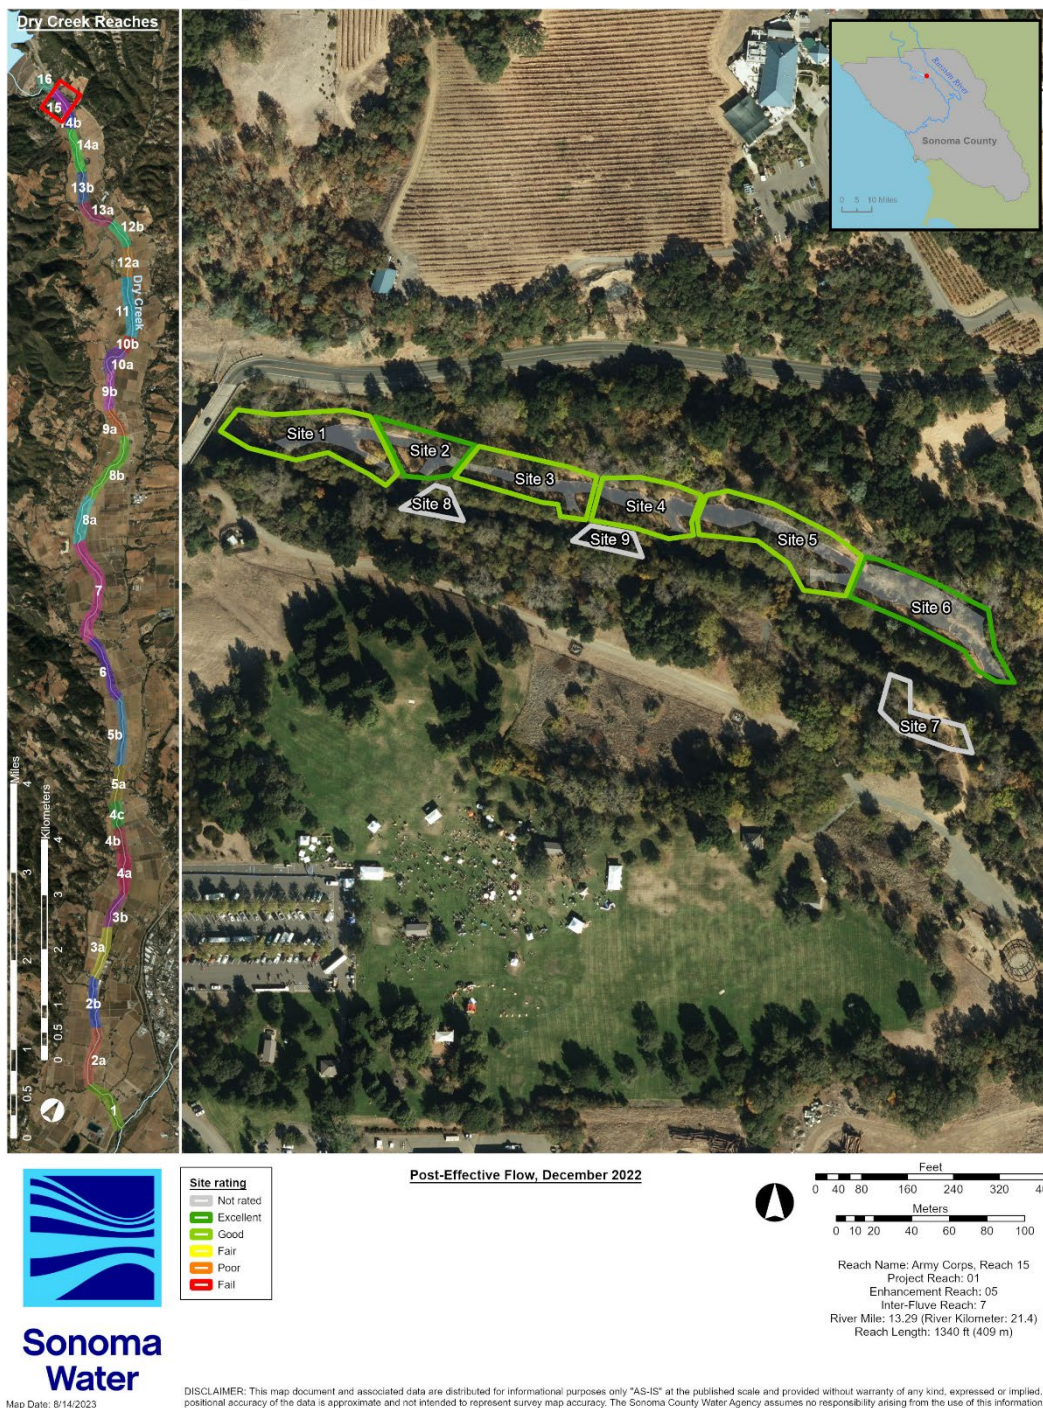
**Figure 5.2.31. Post-enhancement site ratings for the Army Corps enhancement reach, December 2022.**

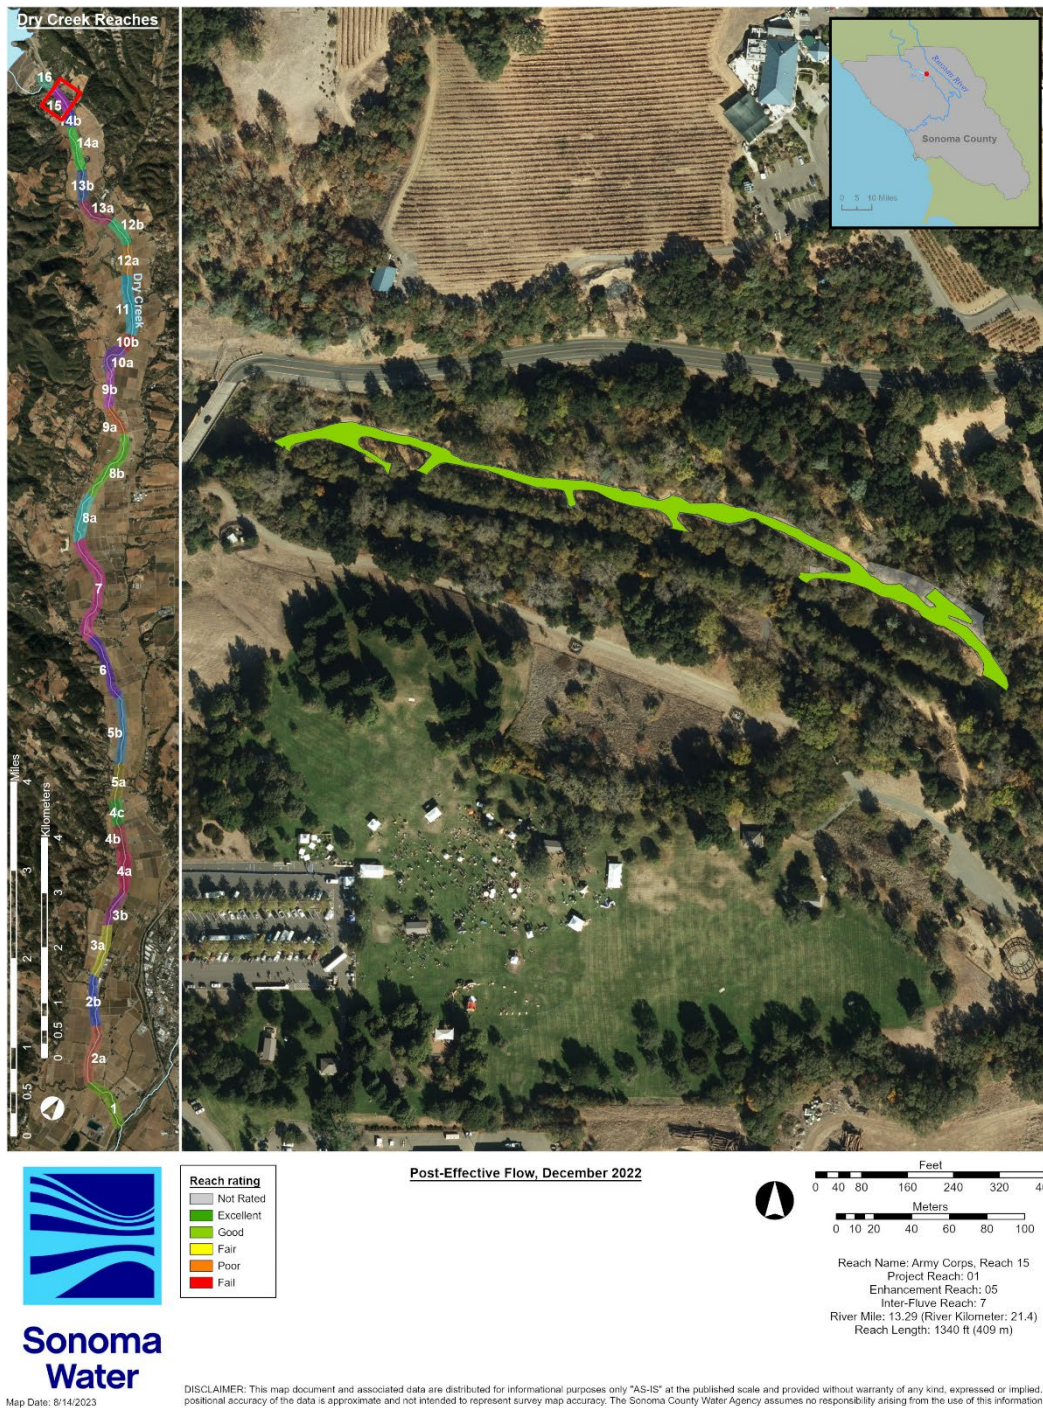
**Figure 5.2.32. Post-enhancement reach rating for the Army Corps enhancement reach, December 2022.**

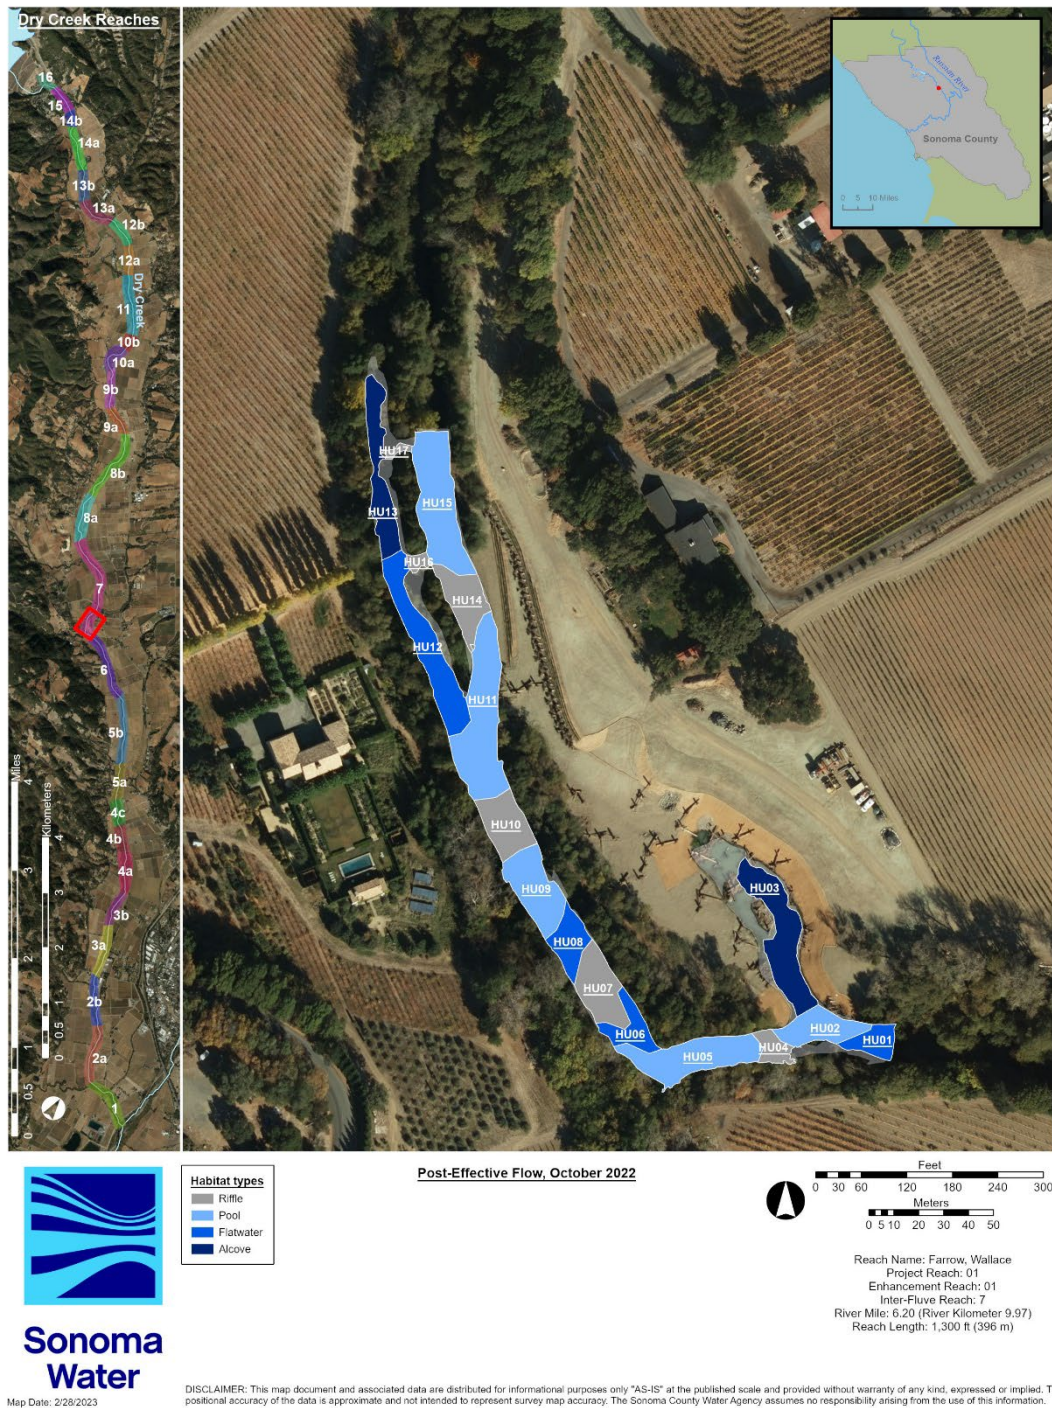
**Figure 5.2.50. Habitat unit number and type within the Farrow Wallace enhancement reach, October 2022.**

Habitat Unit #	Habitat Type	Shelter Value	Percent Cover	Shelter Score
HU01	Flatwater	2	30	60
HU02	Pool	3	50	150
HU03	Alcove	3	90	270
HU04	Riffle	3	40	120
HU05	Pool	3	45	135
HU06	Flatwater	2	30	60
HU07	Riffle	1	5	5
HU08	Flatwater	2	10	20
HU09	Pool	2	15	30
HU10	Riffle	2	45	90
HU11	Pool	3	50	150
HU12	Flatwater	3	60	180
HU13	Alcove	2	90	180
HU14	Riffle	2	15	30
HU15	Pool	2	10	20
HU16	Riffle	3	70	210
HU17	Riffle	2	10	20
<b>Pool: riffle</b>	<b>5:6 (0.83)</b>			<b>Avg = 102</b>

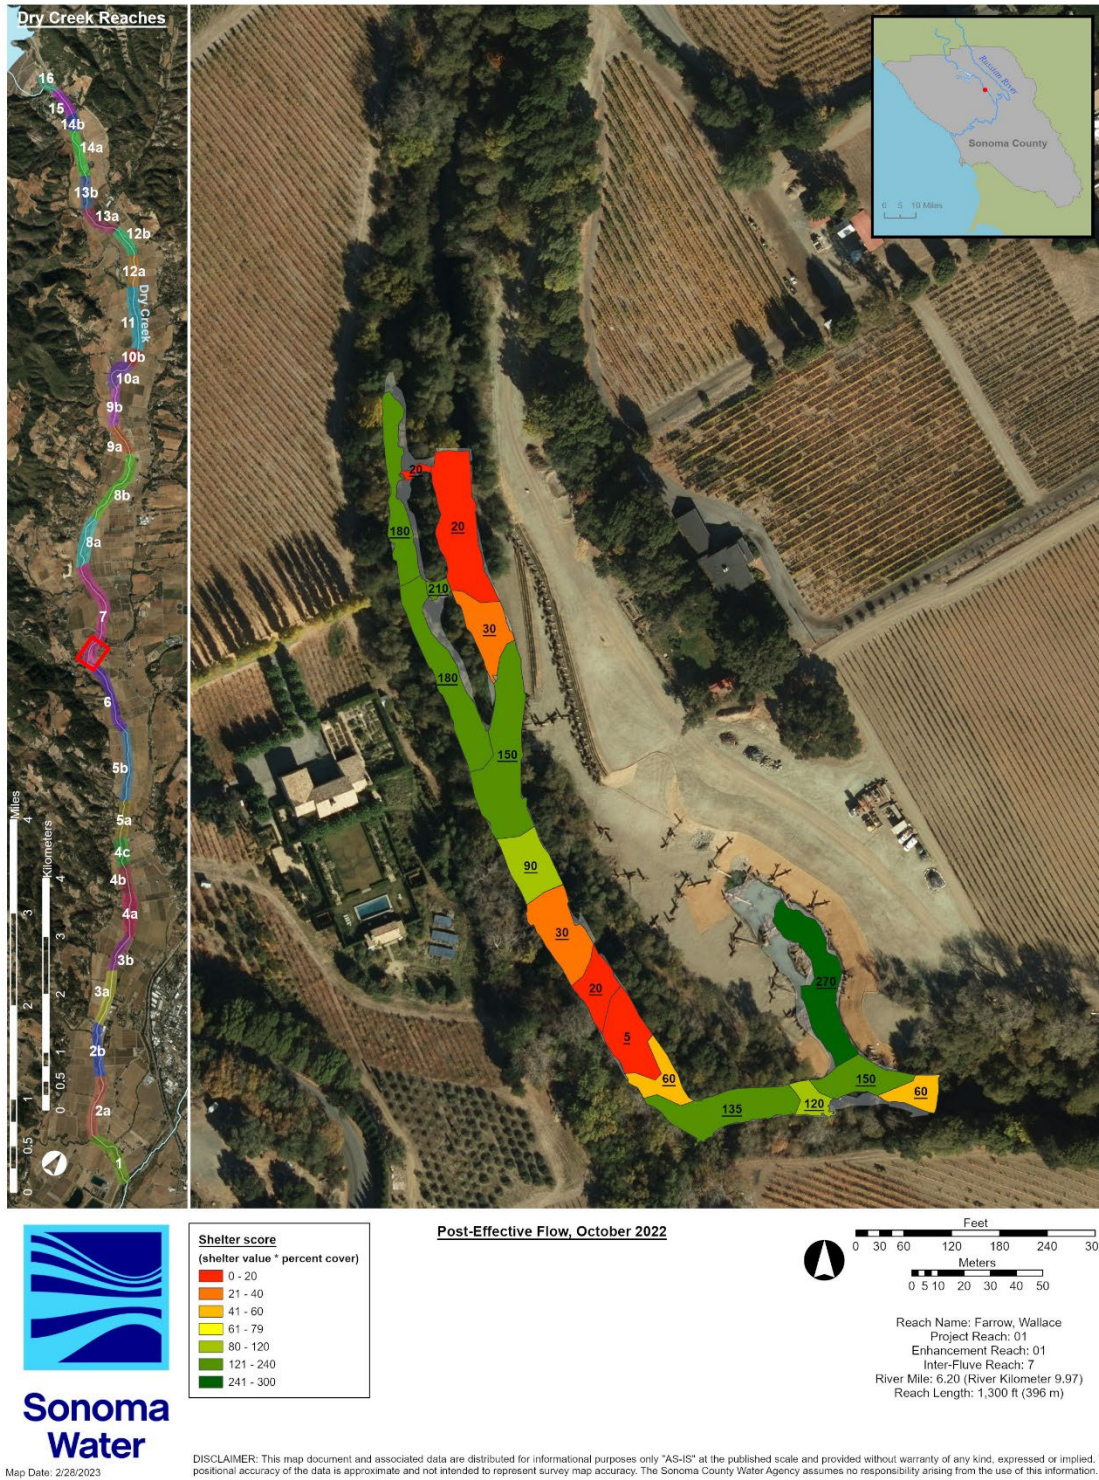
**Figure 5.2.51. Habitat unit shelter scores within the Farrow Wallace enhancement reach, October 2022.**

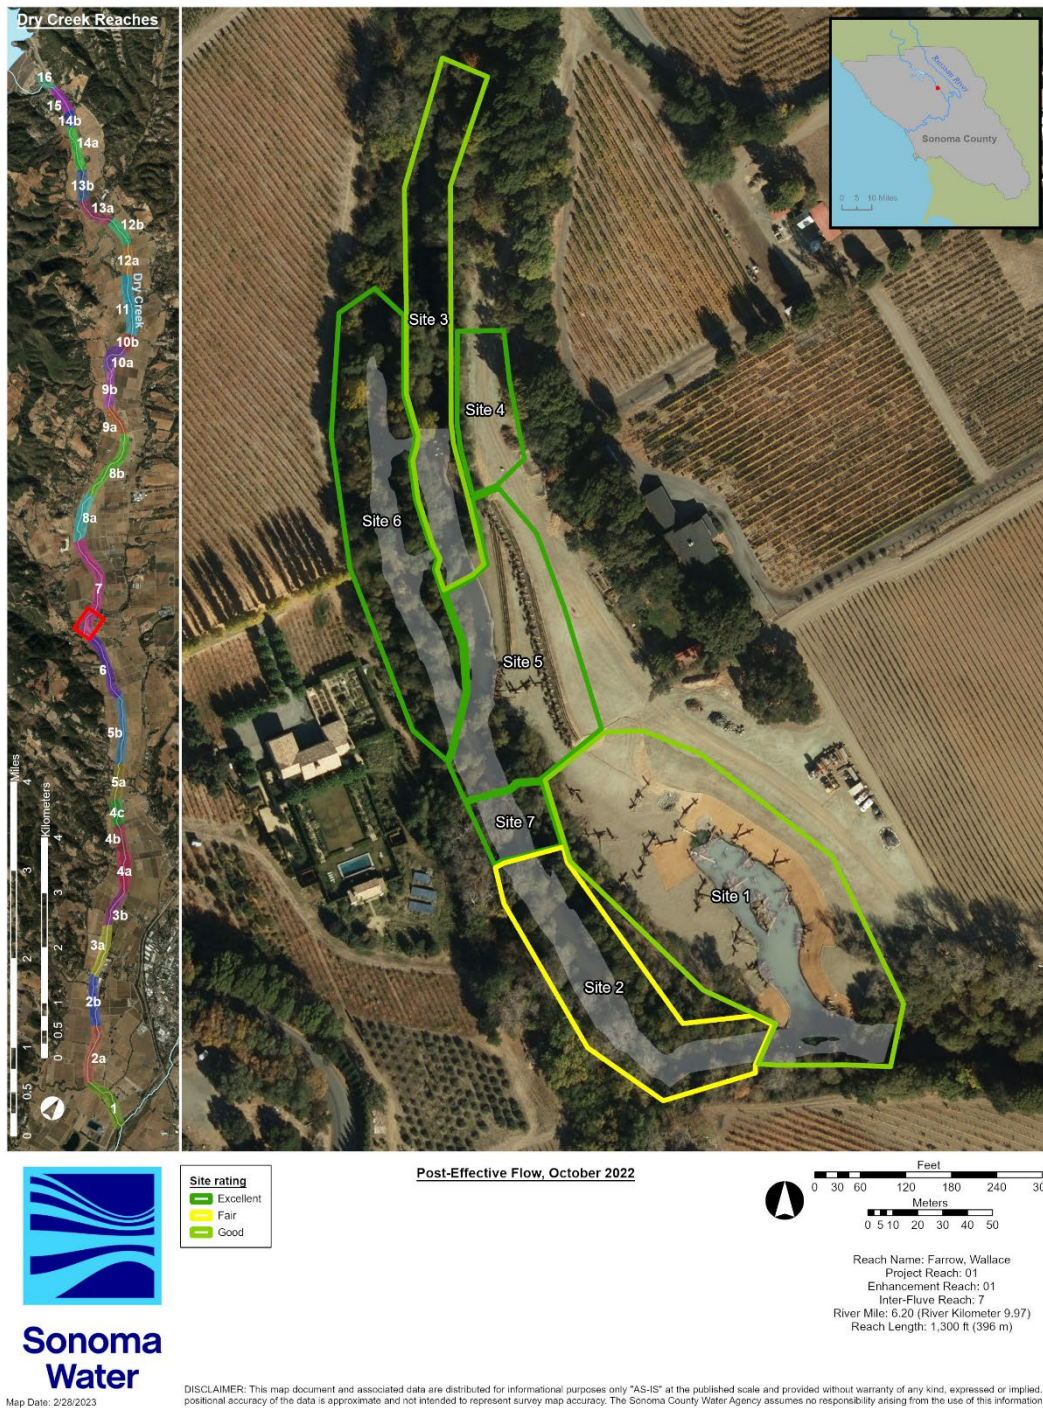
**Figure 5.2.55. Post-effective flow site ratings for the Farrow Wallace enhancement reach, October 2022.**

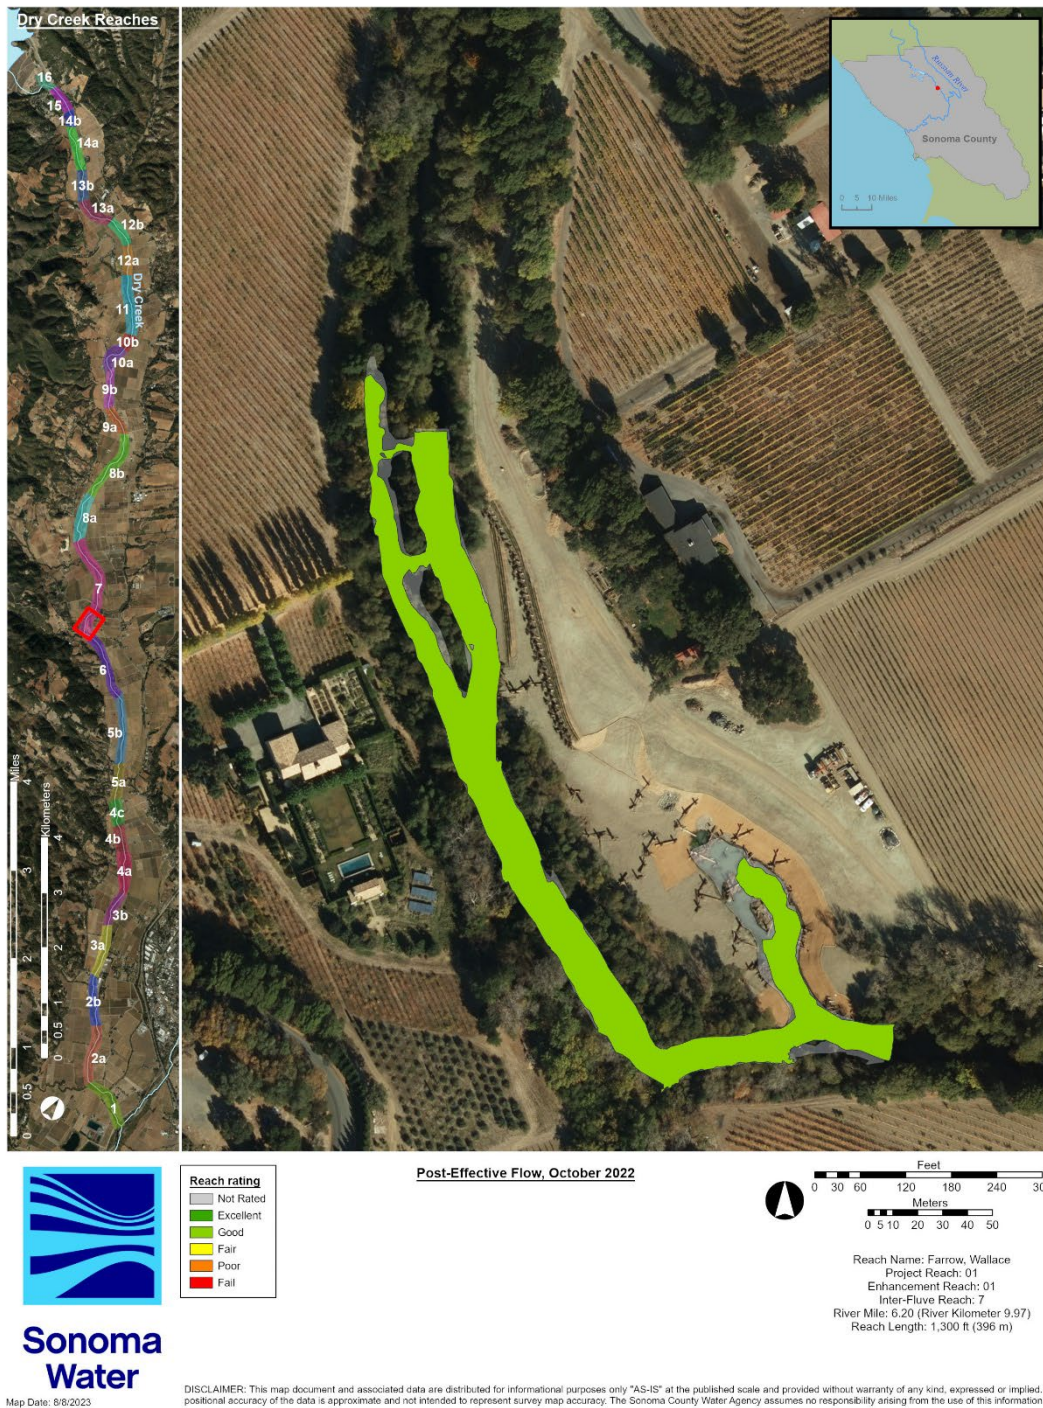
**Figure 5.2.56. Post-effective flow reach rating for the Farrow Wallace enhancement reach, October 2022.**

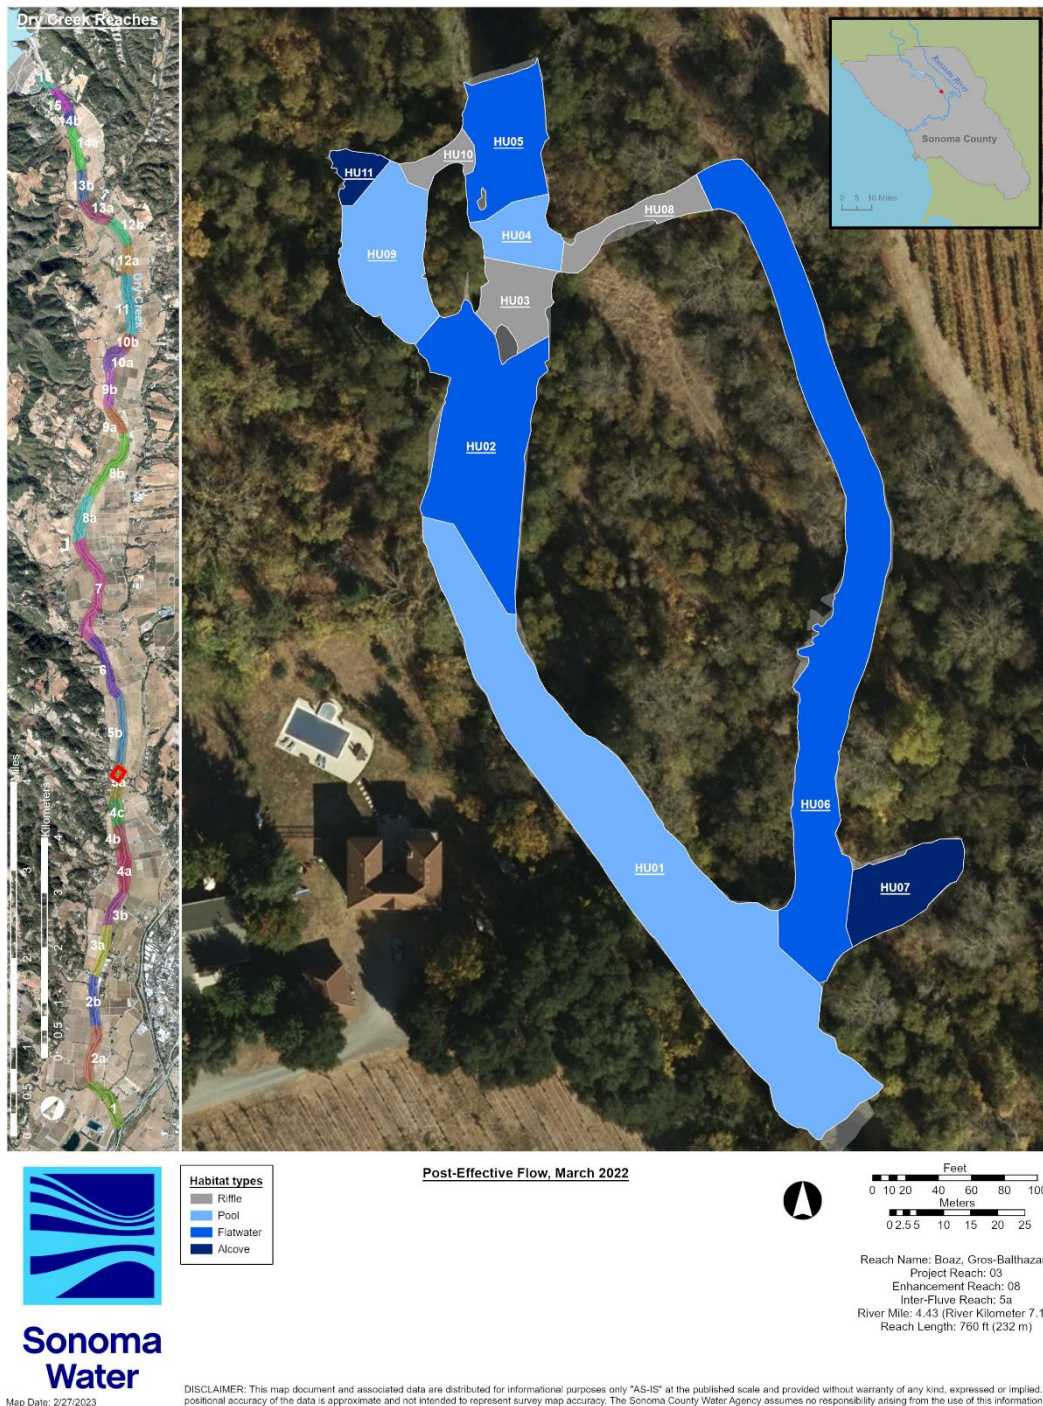
**Figure 5.2.58. Habitat unit number and type within the Boaz Gros-Balthazard enhancement reach, March 2022.**

Habitat Unit #	Habitat Type	Shelter Value	Percent Cover	Shelter Score
HU01	Pool	3	60	180
HU02	Flatwater	3	45	135
HU03	Riffle	3	50	150
HU04	Pool	3	30	90
HU05	Flatwater	3	40	120
HU06	Flatwater	3	45	135
HU07	Alcove	3	50	150
HU08	Riffle	2	20	40
HU09	Pool	3	45	135
HU10	Riffle	1	5	5
HU11	Alcove	3	80	240
<b>Pool: riffle</b>	<b>3:3 (1.00)</b>			<b>Avg = 125</b>

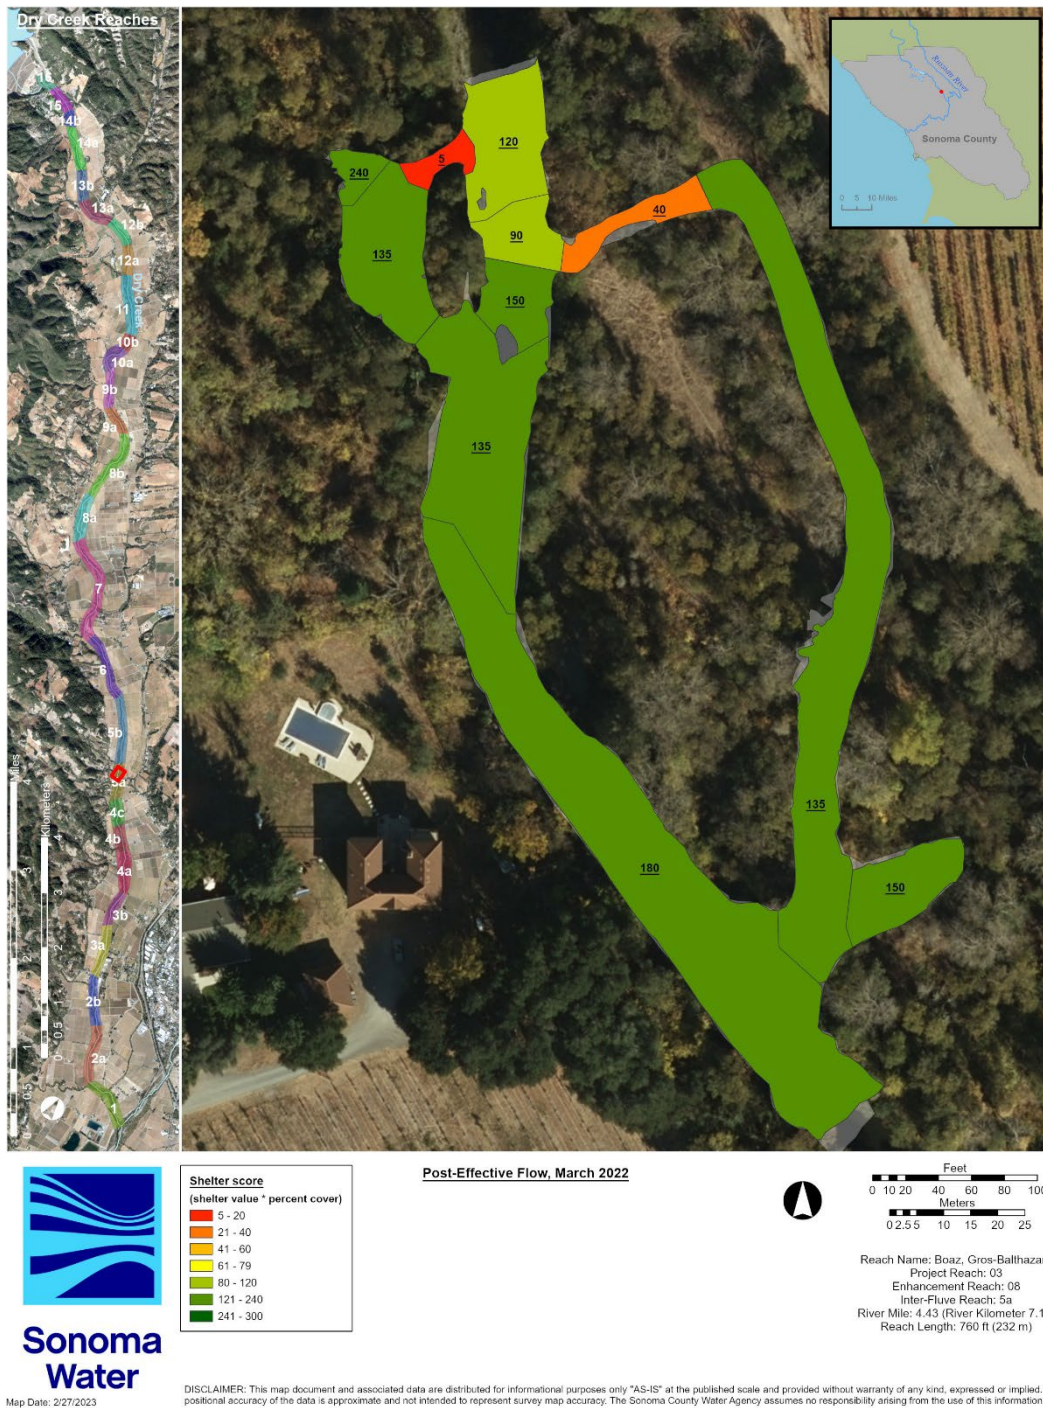
**Figure 5.2.59. Habitat unit shelter values within the Boaz Gros-Balthazard enhancement reach, March 2022.**

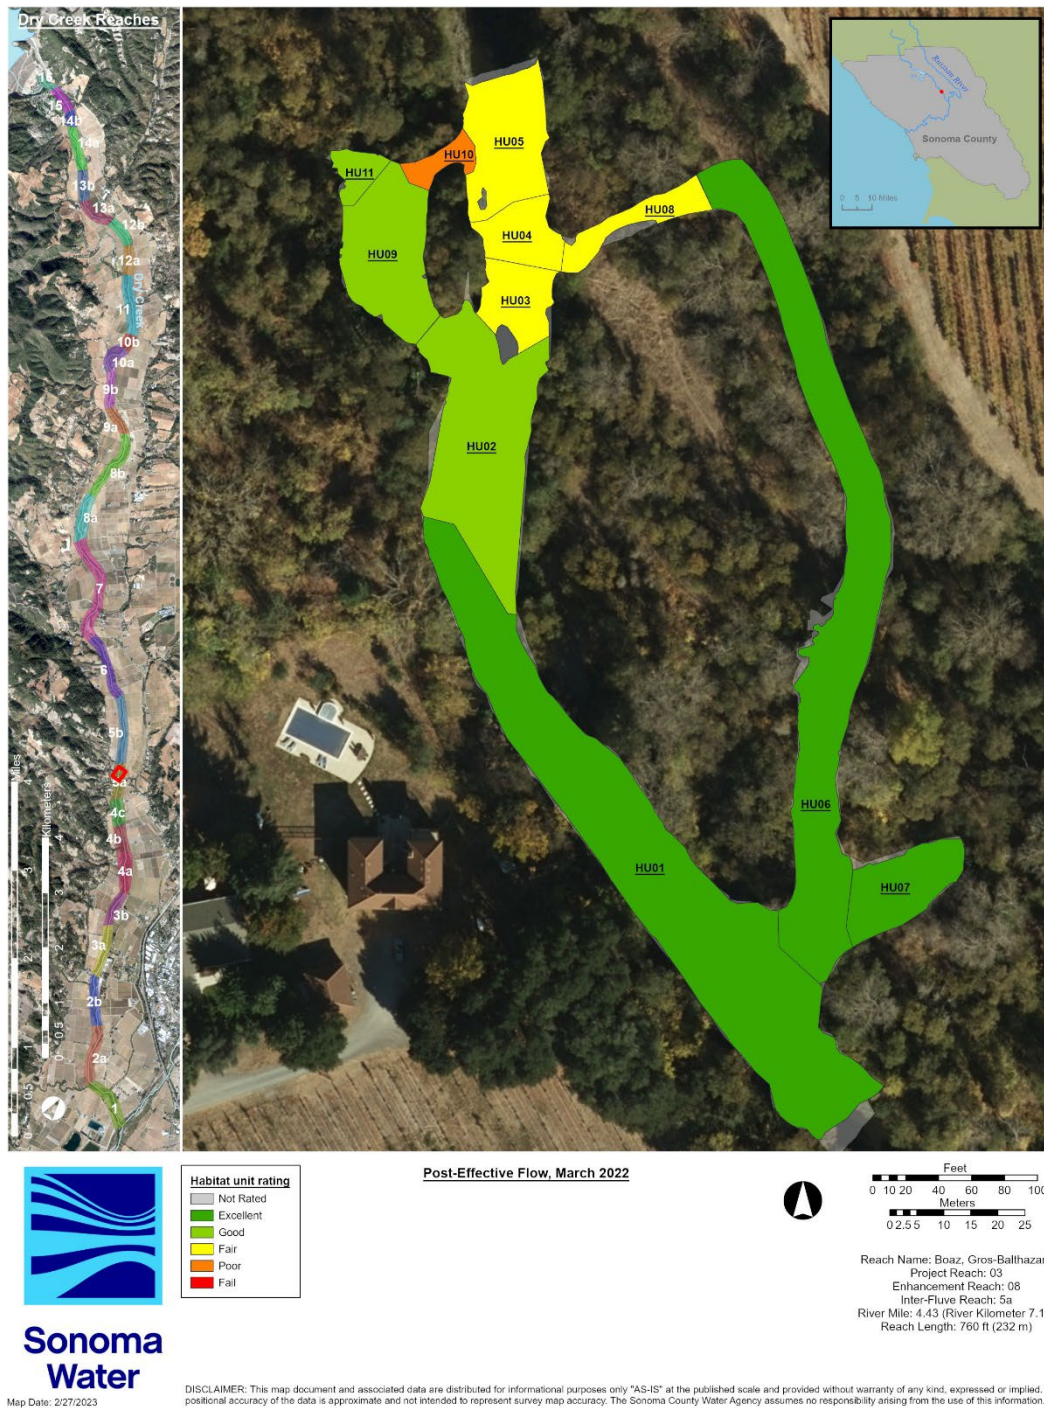
Figure 5.2.62. Habitat unit ratings for the Boaz Gros-Balthazard enhancement reach, March 2022.

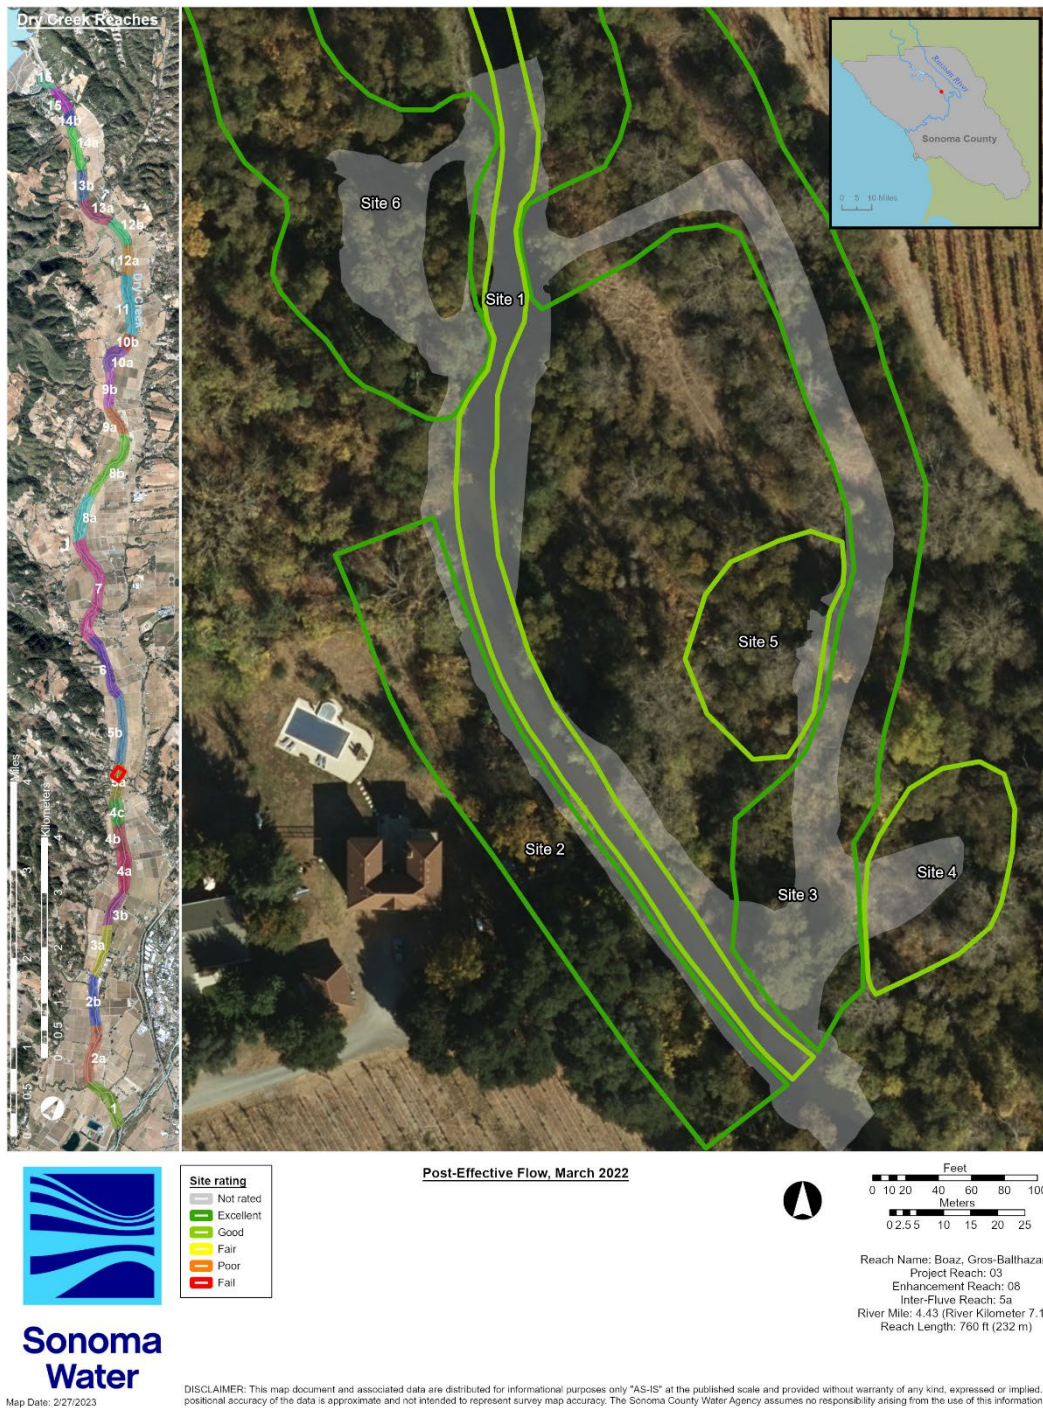
**Figure 5.2.63. Post-enhancement site ratings for the Boaz Gros-Balthazard enhancement reach, March 2022.**
