# Russian River Biological Opinion Status and Data Report

**Year 2022 – 2023**

**February 2024**

**Sonoma  
Water**

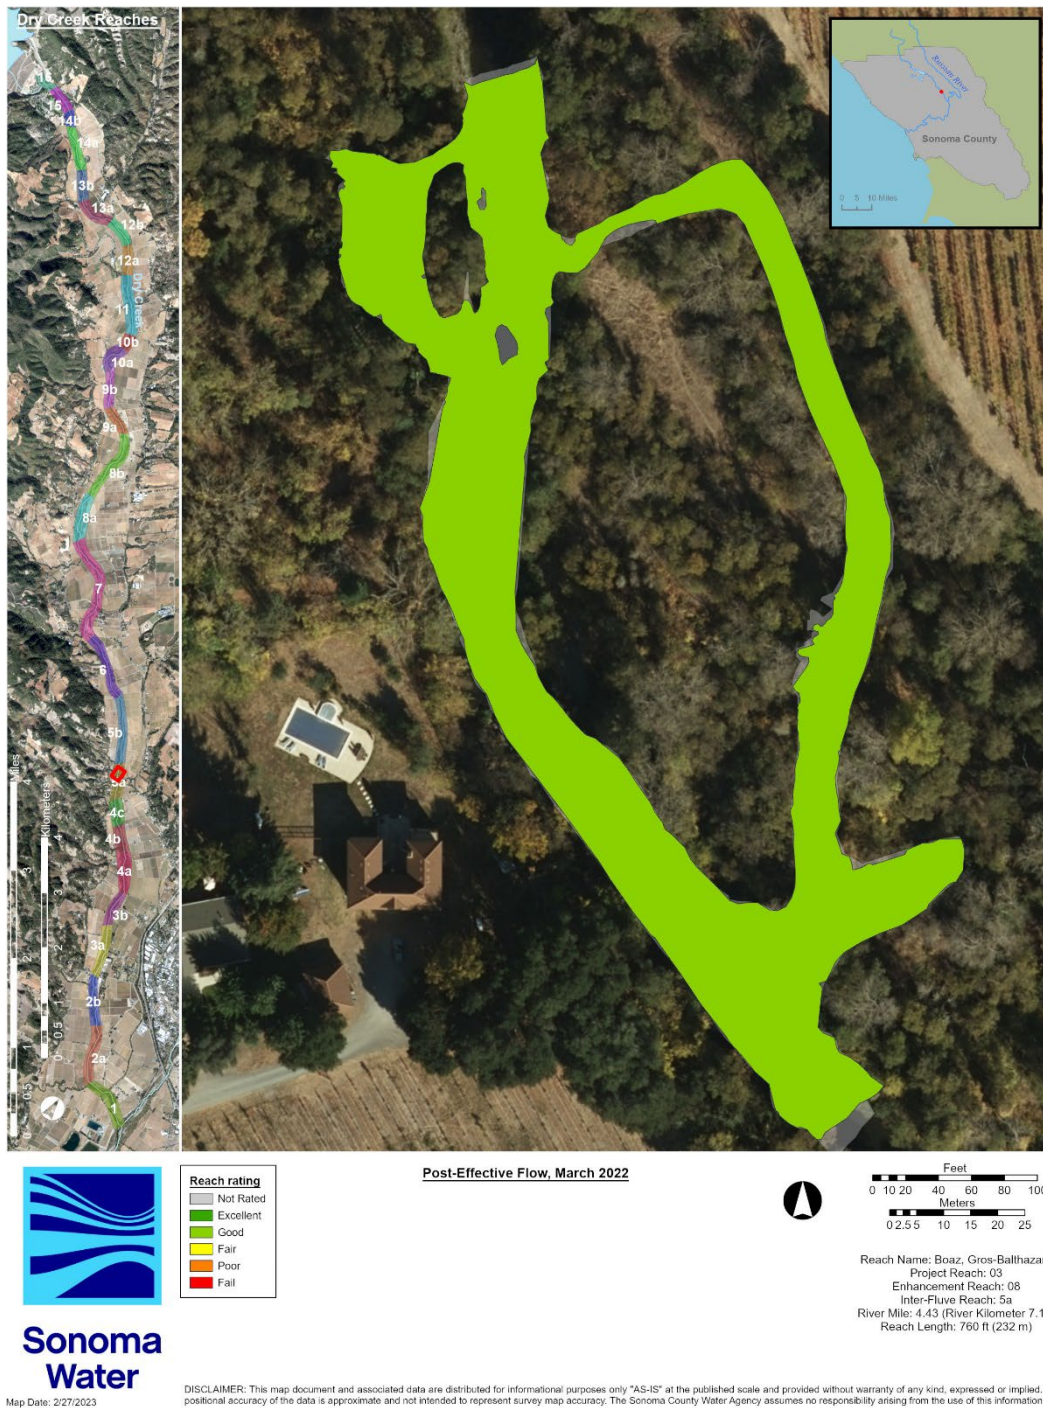
**Figure 5.2.64. Post-enhancement reach rating for the Boaz Gros-Balthazard enhancement reach, March 2022.**

Sonoma Water monitored the post-effective flow condition of the Boaz Gros-Balthazard enhancement reach in March 2022. Previous effectiveness monitoring surveys occurred in May 2020 (pre-enhancement) and October 2021 (post-enhancement) (Table 5.2.41).
