**RUSSIAN RIVER ESTUARY  
ADAPTIVE BEACH MANAGEMENT PLAN  
2023**

May 15, 2023

**ESA REF. # DW01958**

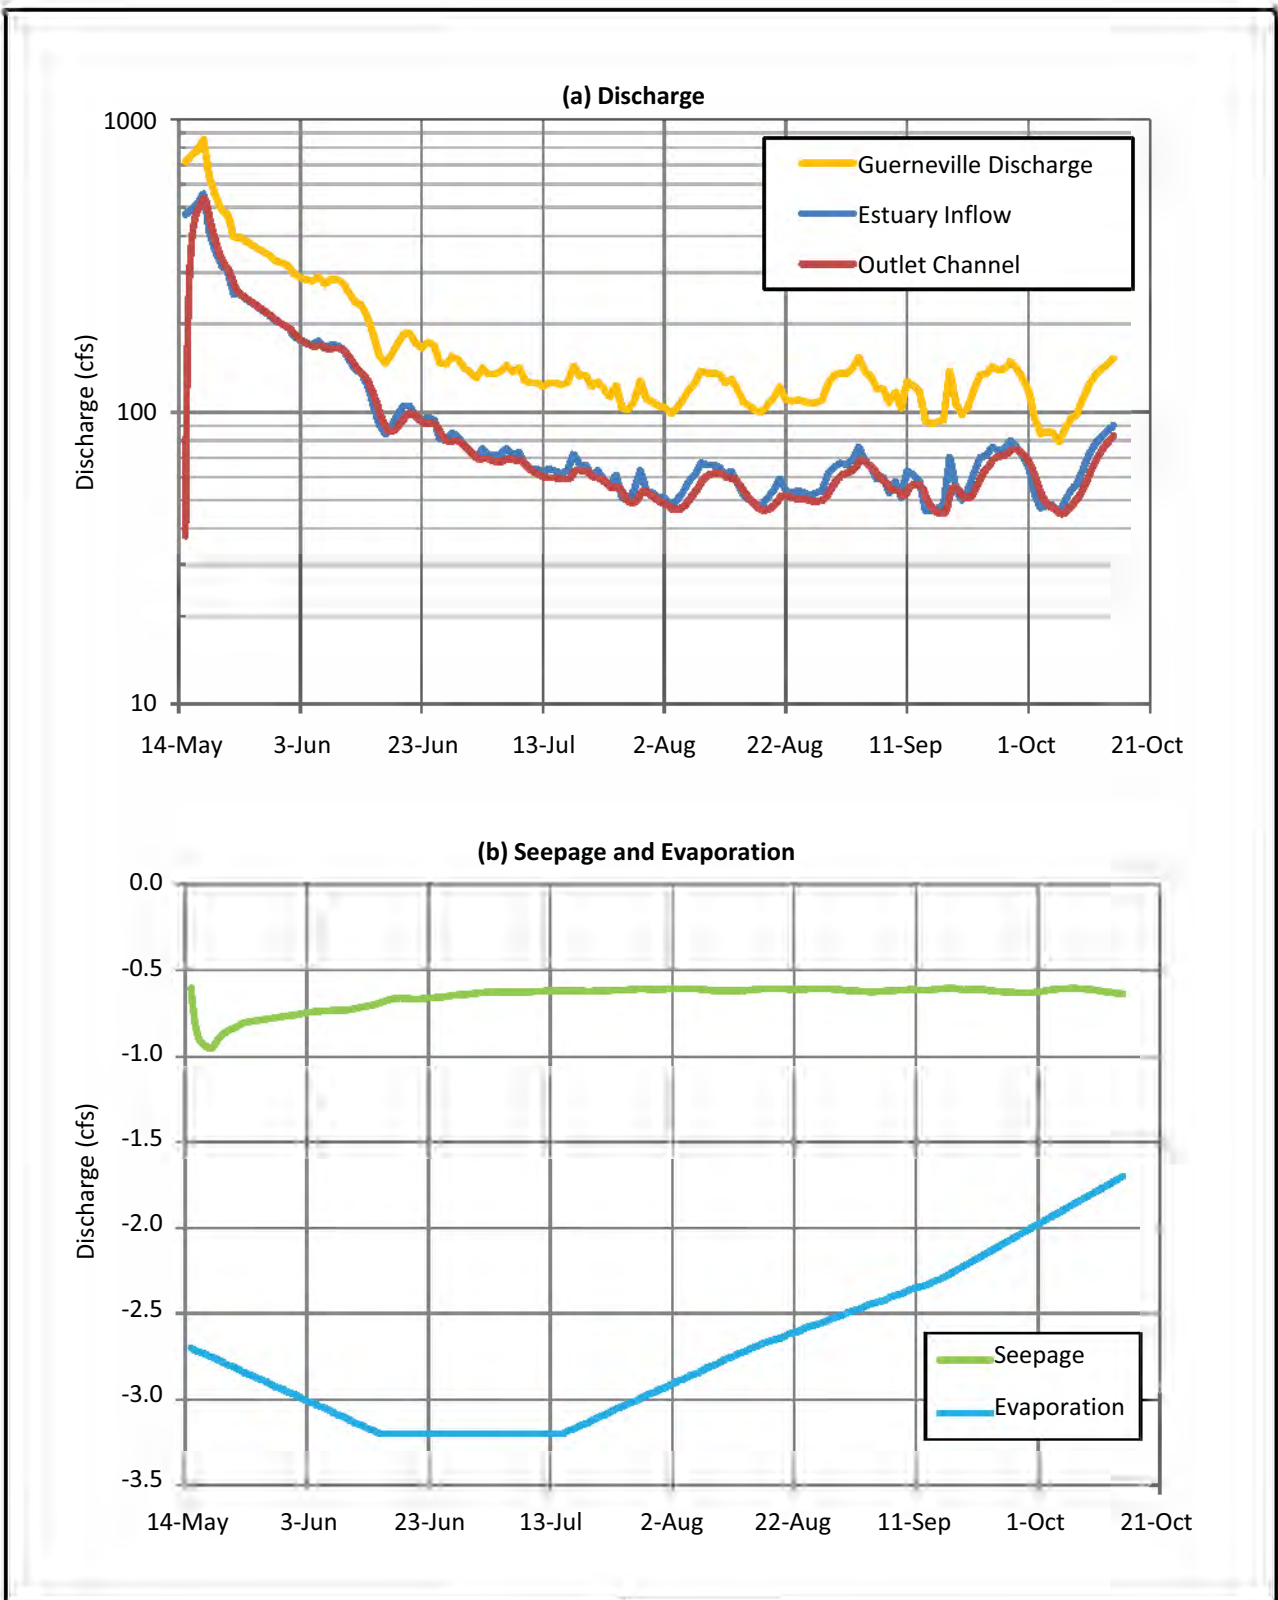
*figure A-3*

Source: 2010 anticipated discharge at Guerneville and into lagoon calculated by scaling observed 2000 discharge at USGS gage #11467000 (Russian River near Guerneville, CA). Evaporation rates calculated from monthly climatological rates for CIMIS evapotranspiration zone 1 (California coast).

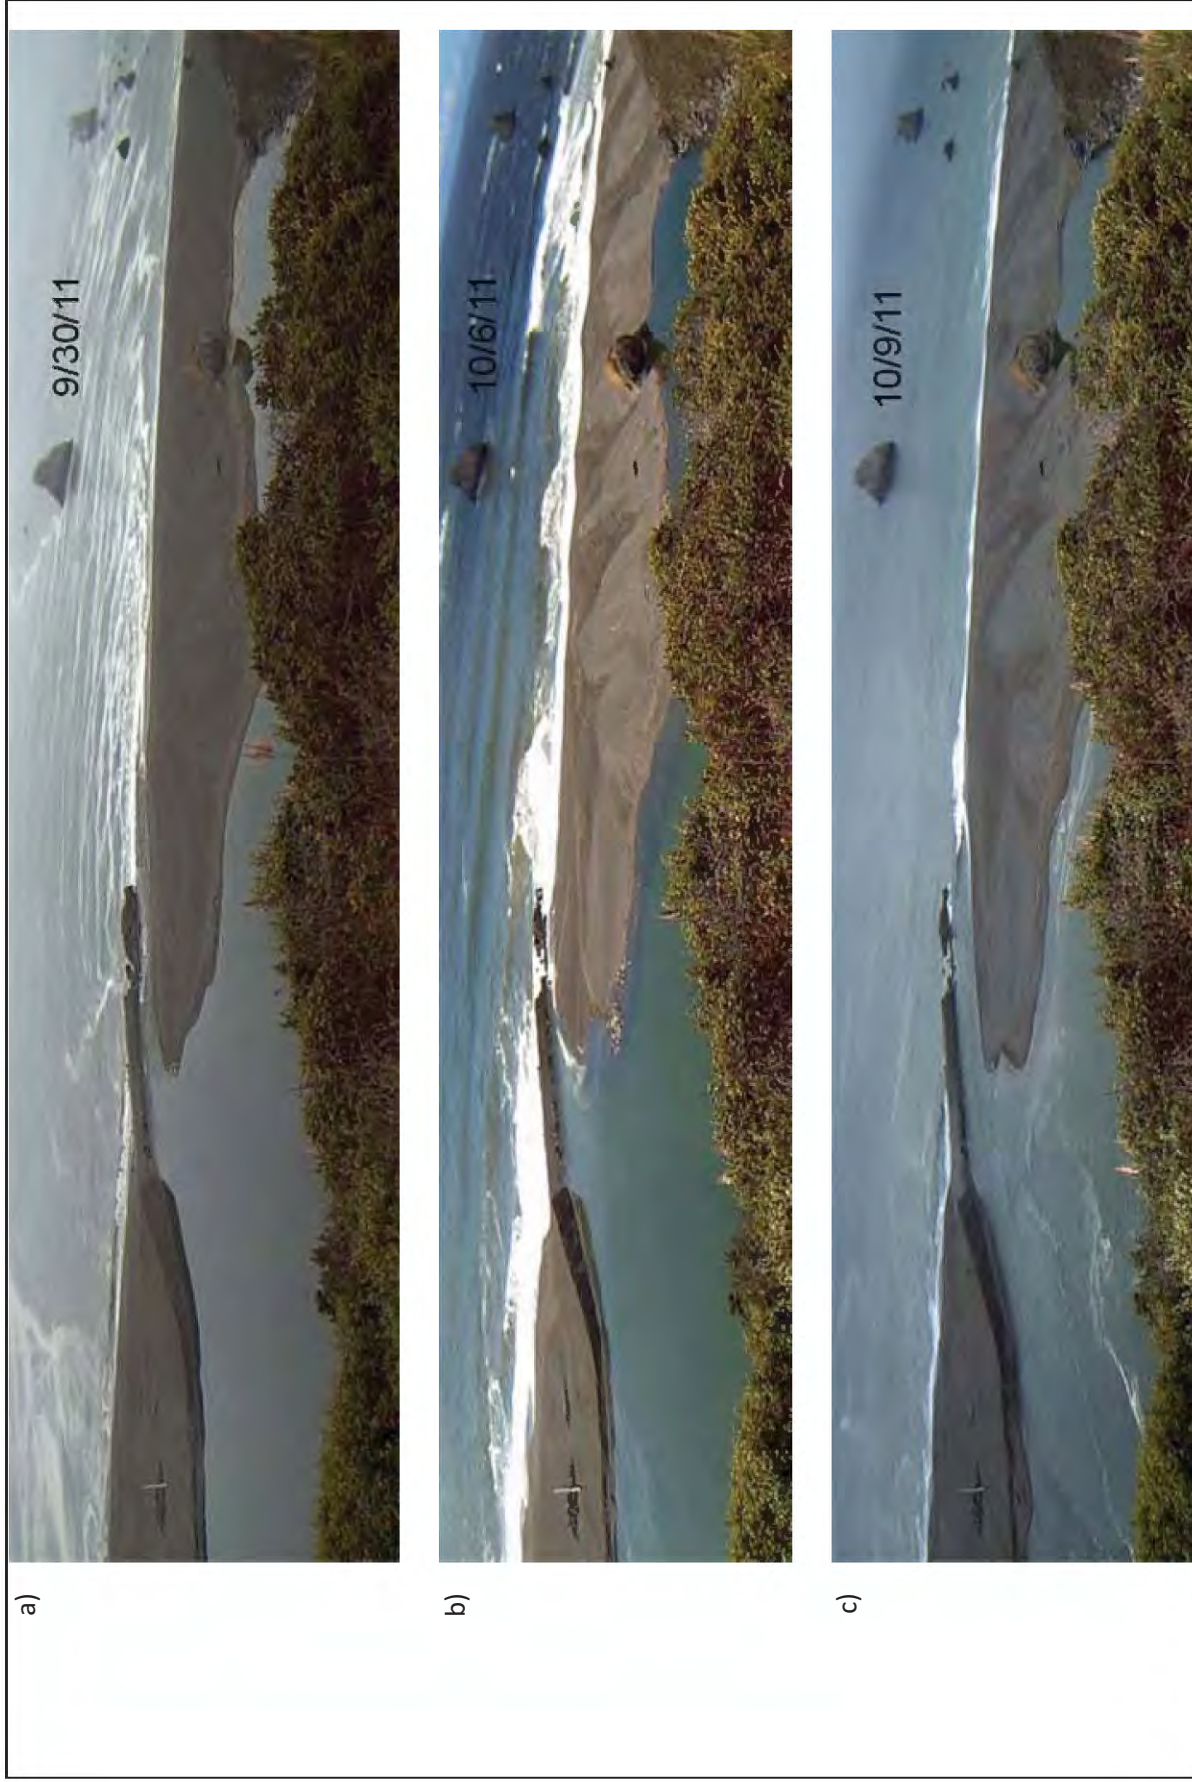
Russian River Estuary Outlet Channel Management Plan · DW01958  
Inlet State, September 30, October 6, and October 9, 2011  
**Figure 3**

SOURCE: Bodega Marine Lab

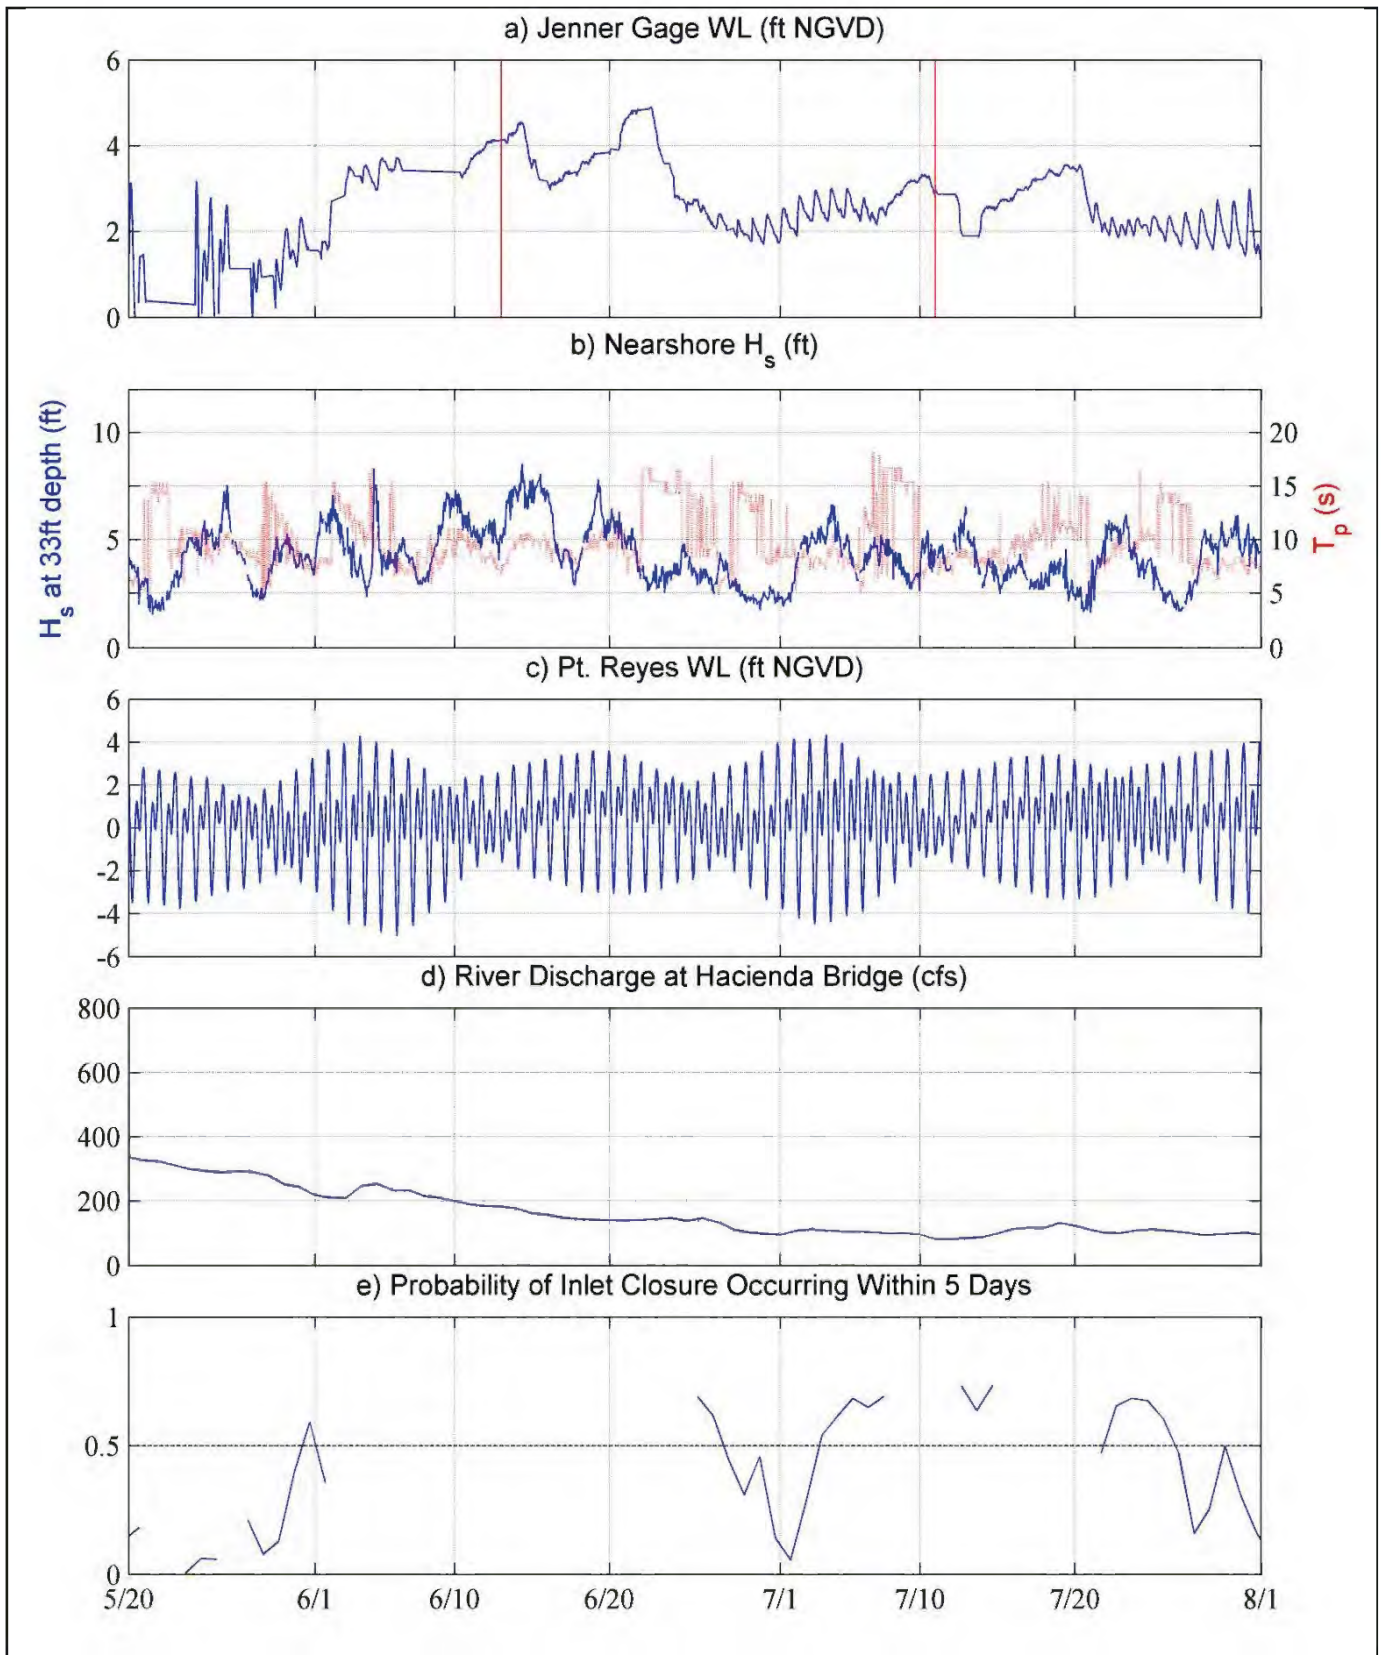
**Figure 2**  
 Estuary Ocean, and River Conditions Compared  
 with Closure Probability  
 May 20 – August 1, 2012

a) Jenner gage data provided by C...; red bar = beach survey  
 Hs = significant wave height; Tp = peak wave period  
 NOAA Pt. Reyes 67...  
 River discharge provided by USGS (Guernville 679...  
 5-day closure probability provided after B... et al. 4... ?

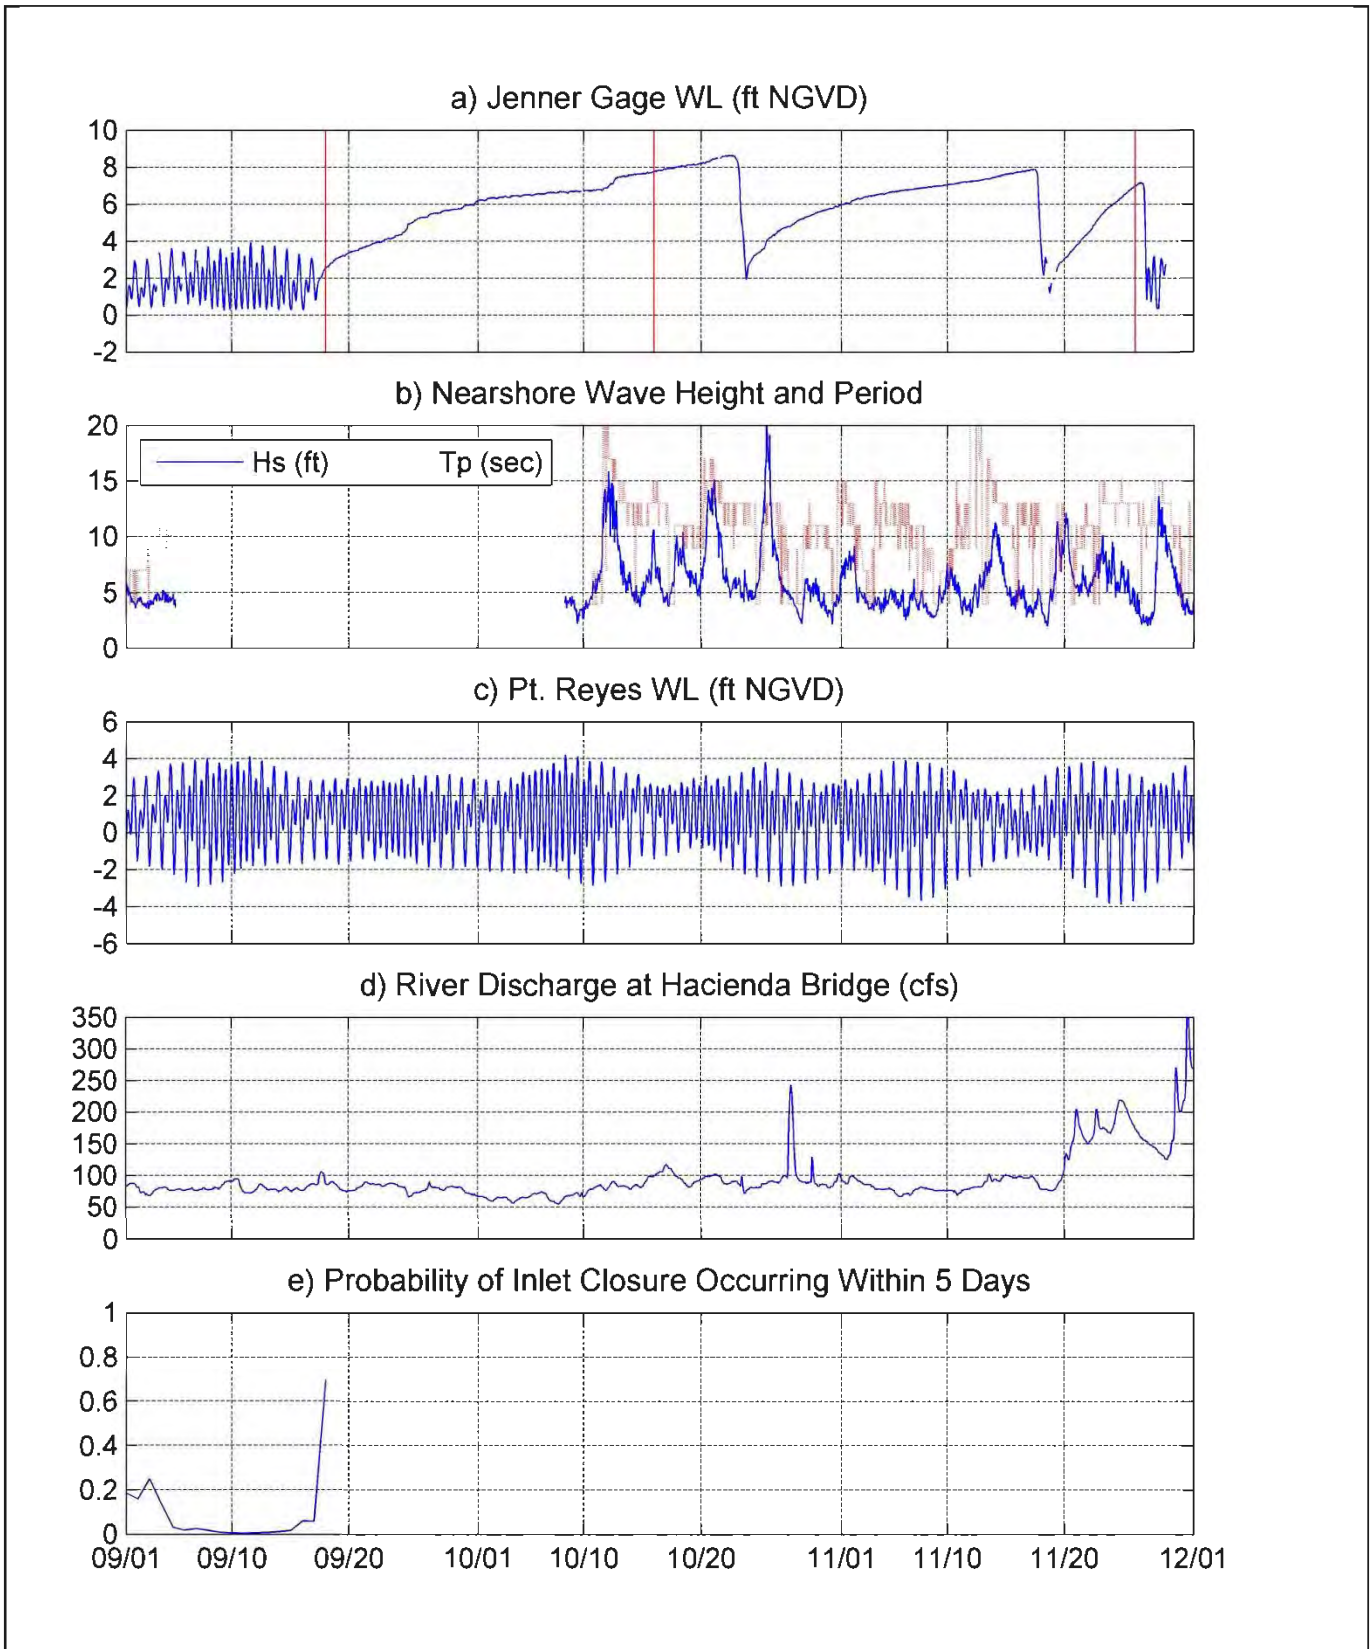
Estuary, Ocean, and River Conditions Compared  
with Closure Probability:  
September – November 2014

- a) Jenner gage water level provided by SCWA; red bar = beach survey
- b)  $H_s$  = sig. wave height;  $T_p$  = peak wave period (CDIP, Pt. Reyes, #029)
- c) Ocean water level provided by NOAA (Pt. Reyes #9415020)
- d) River discharge provided by USGS (Guerneville #11467000)
- e) Five-day closure probability provided after Behrens et al. (2013)

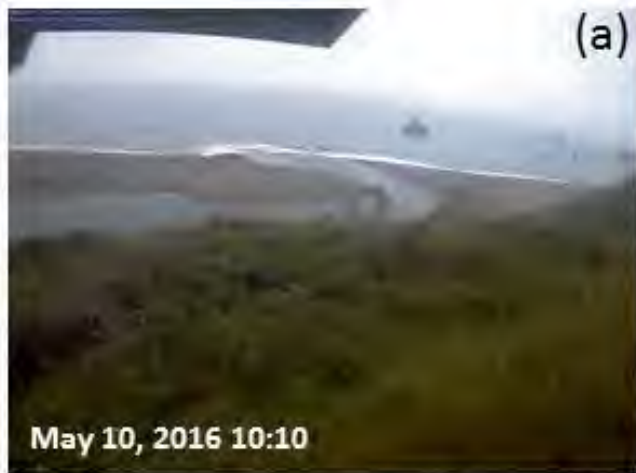
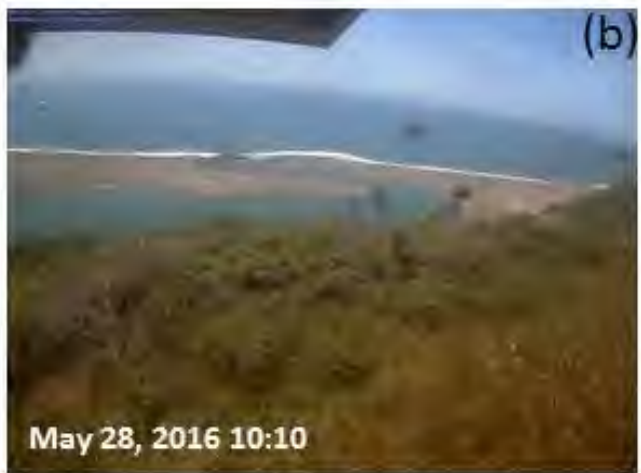
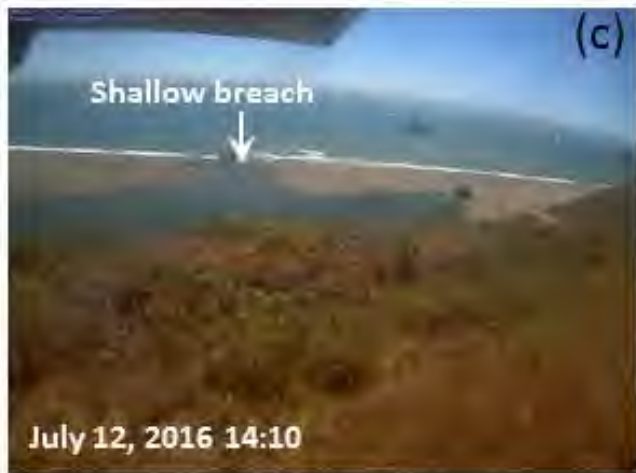
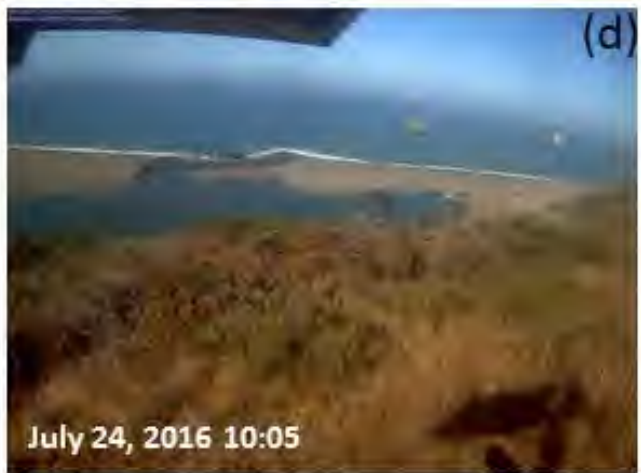
**Figure 3**  
Russian River camera photographs showing some of the muted tidal conditions observed in 2016.

SOURCE: SCWA camera

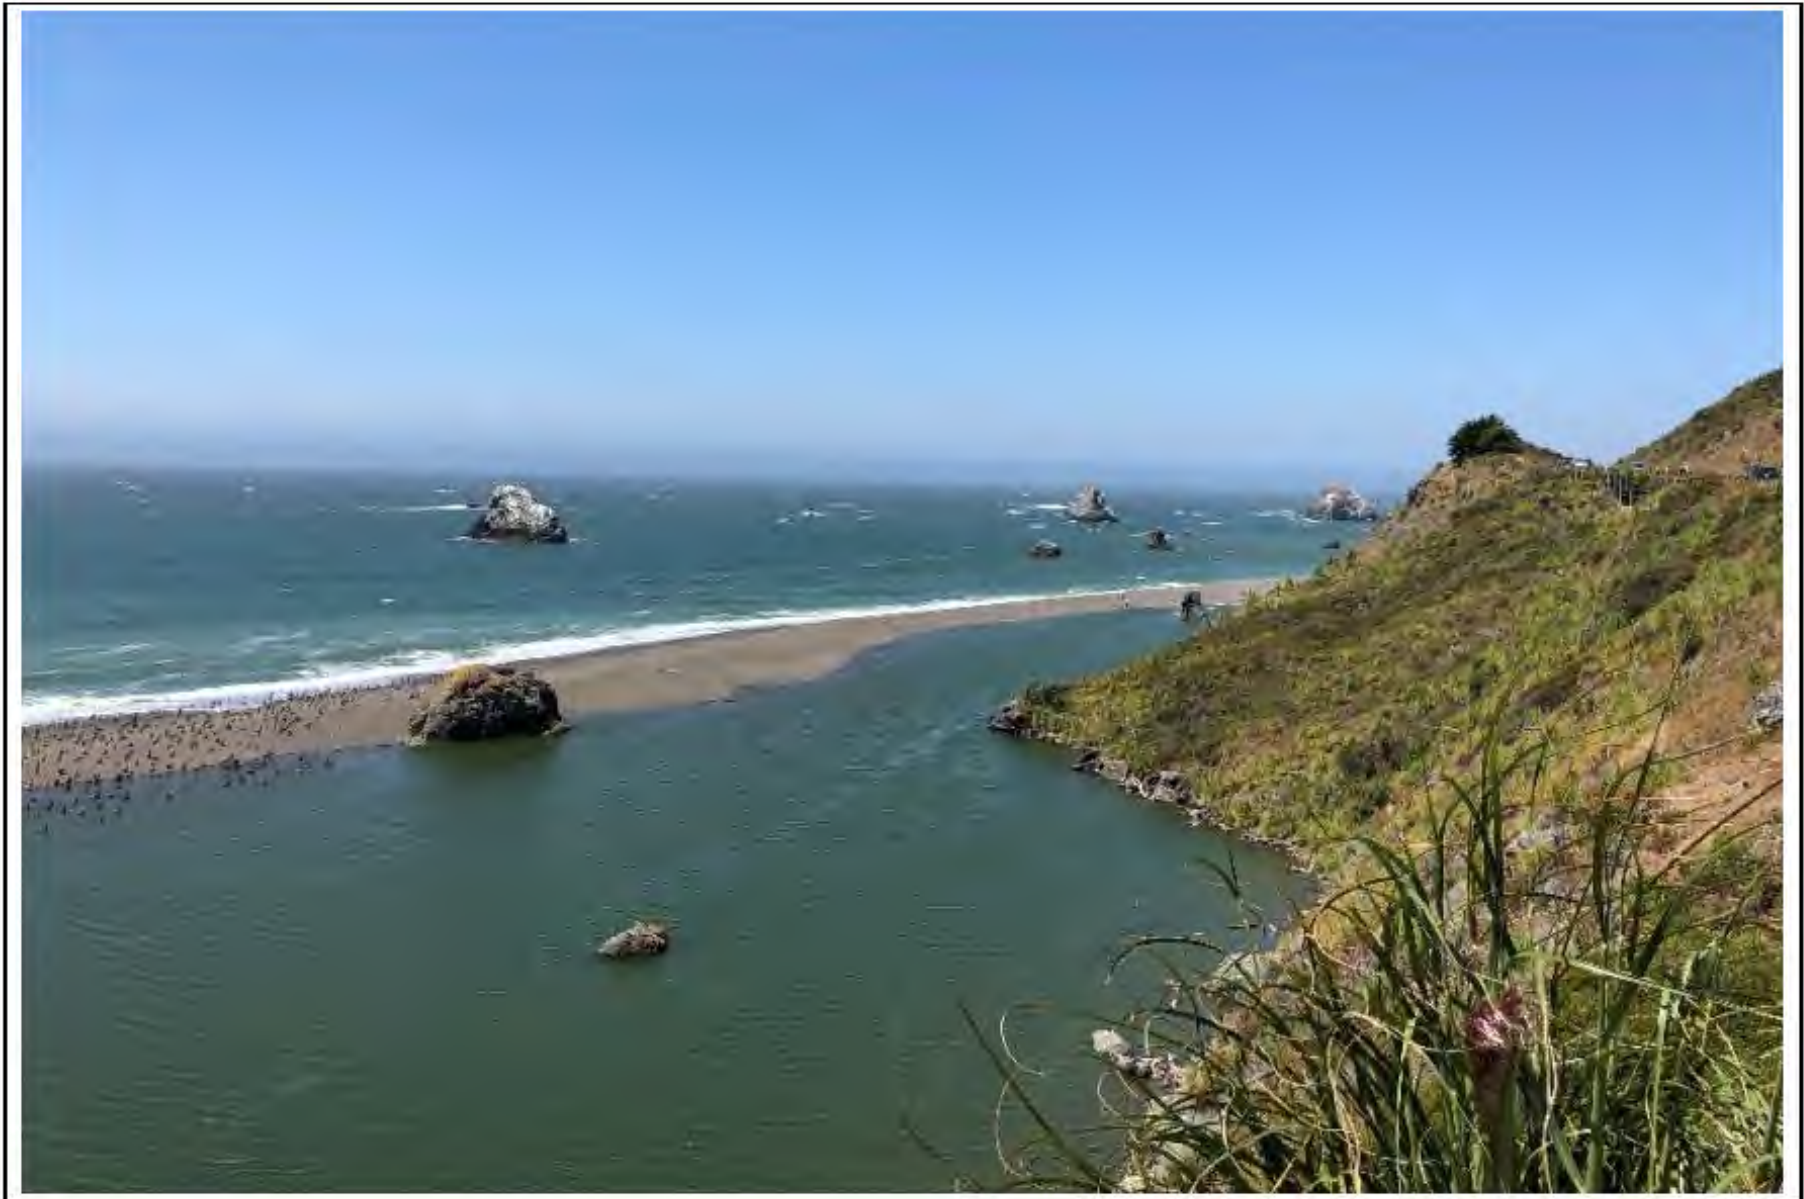
Condition of the beach on July 29<sup>th</sup>, 2019.
