Beavers at Fryer Creek STREAM MAINTENANCE PROGRAM

Stream Maintenance Program

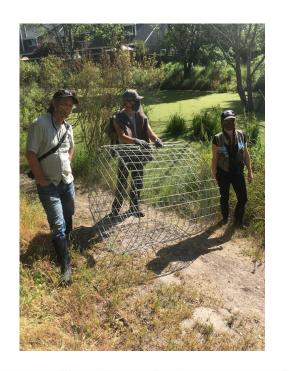
Pond Management

- Pond Leveler
 - Maintain dam height and water level
 - Ensure dry access road

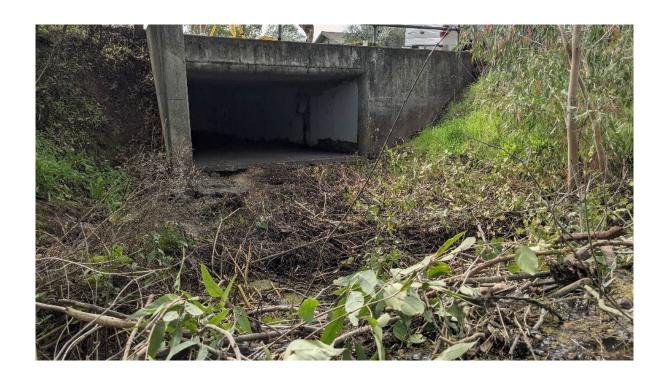
Flood Factor

Culvert at MacArthur St. has greatest affect from backwatering, which diminishes the influence of beaver dams
