Vortex Tube Repair Santa Rosa Creek

- 8-foot reinforced concrete pipe culvert under Montgomery Drive
- Part of the Santa Rosa Creek Diversion that sends high flows to Spring Lake to prevent severe flooding in Santa Rosa
- Allows and low moderate flows and sediment to remain in Santa Rosa Creek
- Constructed by the Soil Conservation Service (now National Resource Conservation Service) in 1960s as part of the Central Sonoma Watershed Project
- Sonoma Water (then the Sonoma County Flood Control and Water Conservation District) was the local sponsor of the project and responsible for maintenance

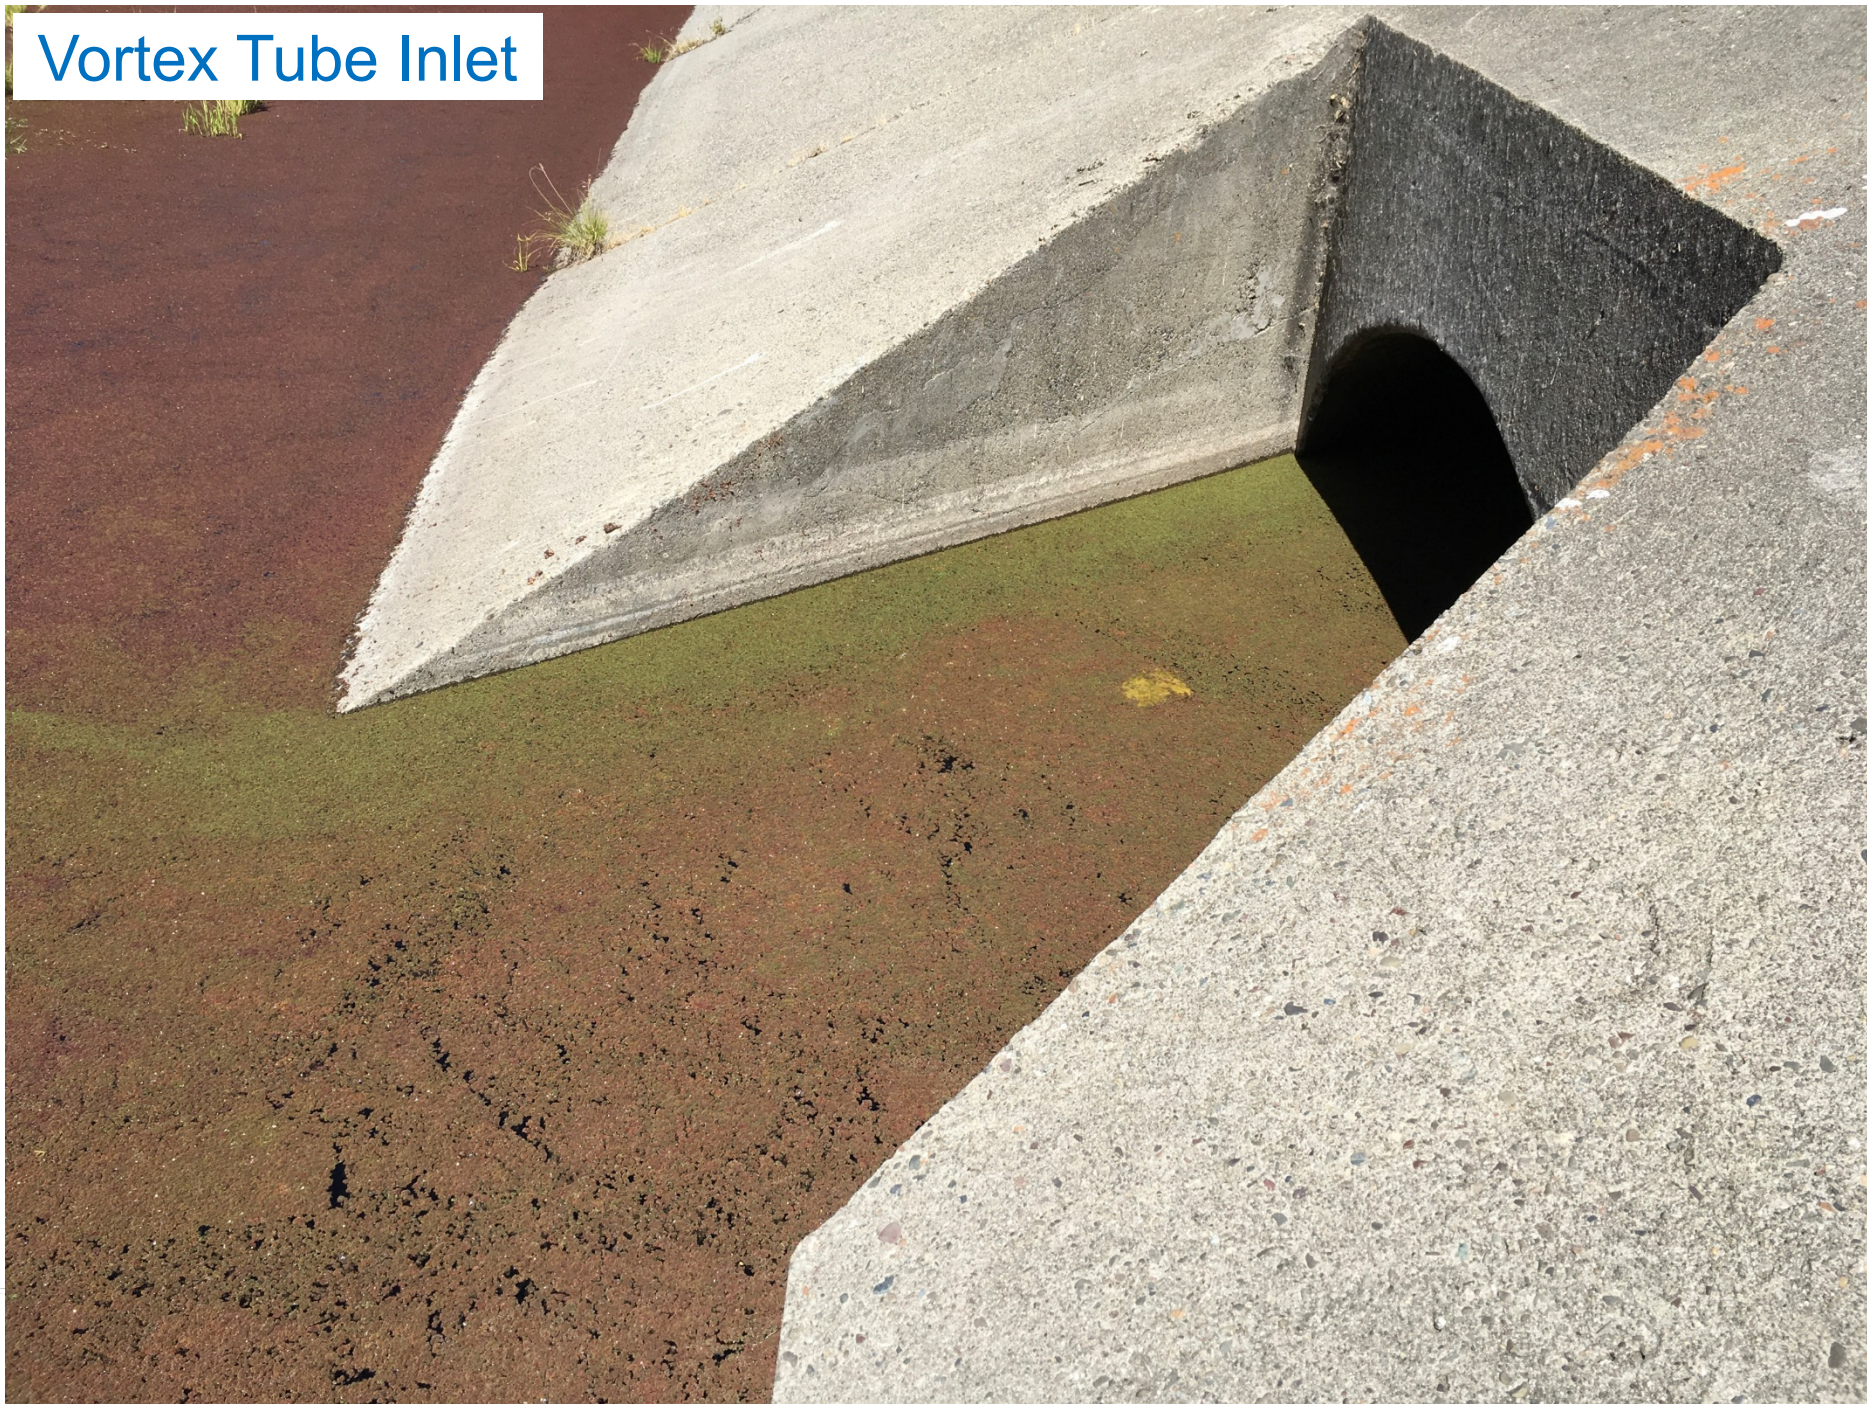
Vortex Tube Inlet

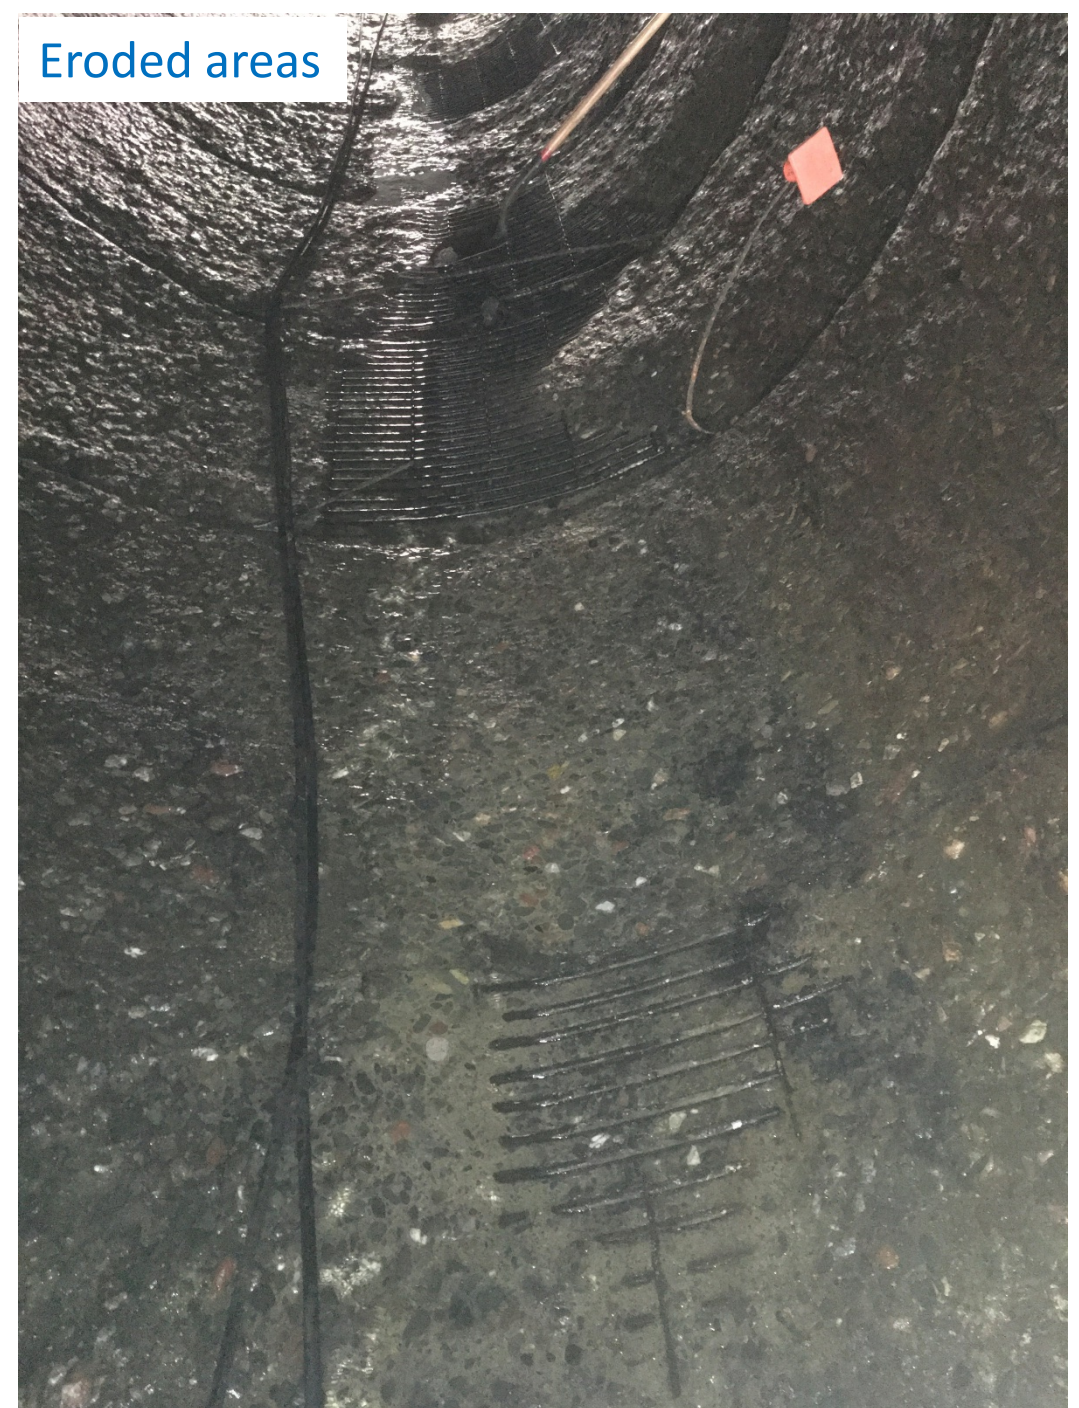
- Examined with underwater camera (diver)
- Material eroded from culvert floor exposing rebar reinforcement
- SW hired BKF Engineering to design repair
- Repair included coating with Fiber Reinforced Mortar and installing a 36" bypass pipe to divert water during construction
- Bypass pipe will also facilitate fish ladder maintenance and sediment removal
- Culvert repaired in Summer 2021 by Granite Construction

Eroded areas

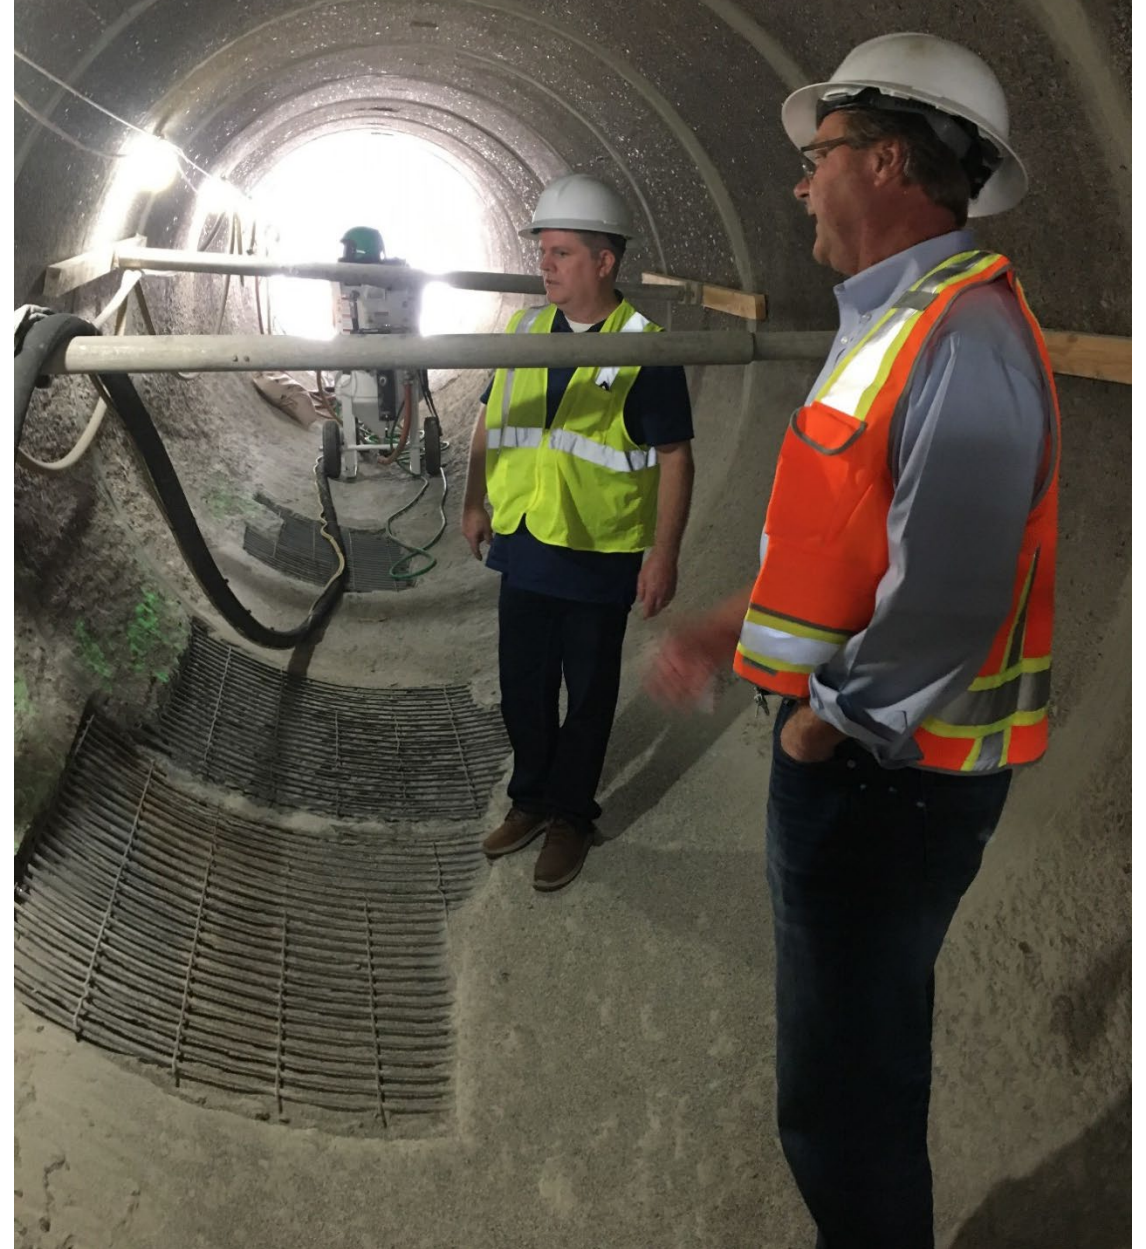
Kent Gylfe and Grant Davis looking at eroded areas after cleaning prior to repair

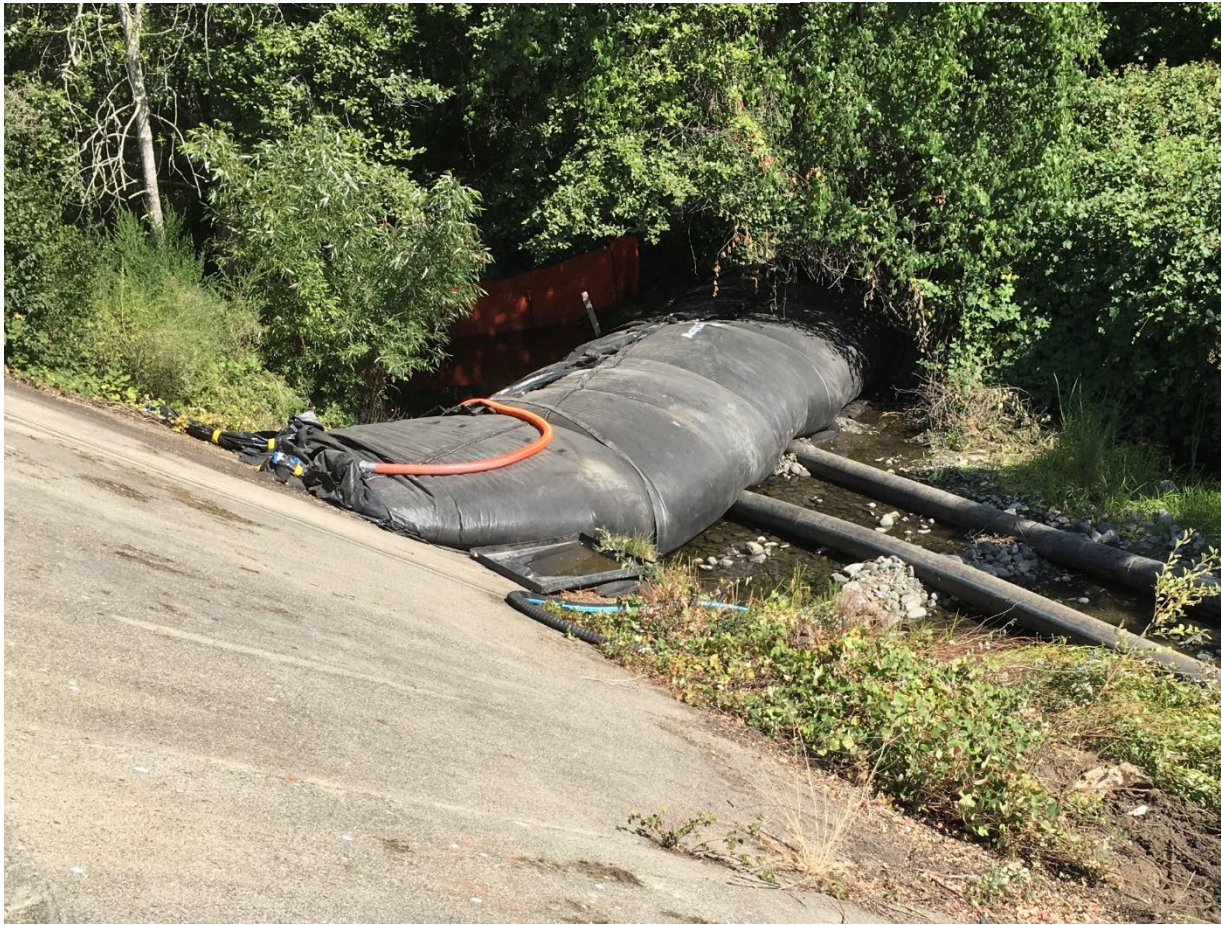
Upstream Coffer Dam in Creek

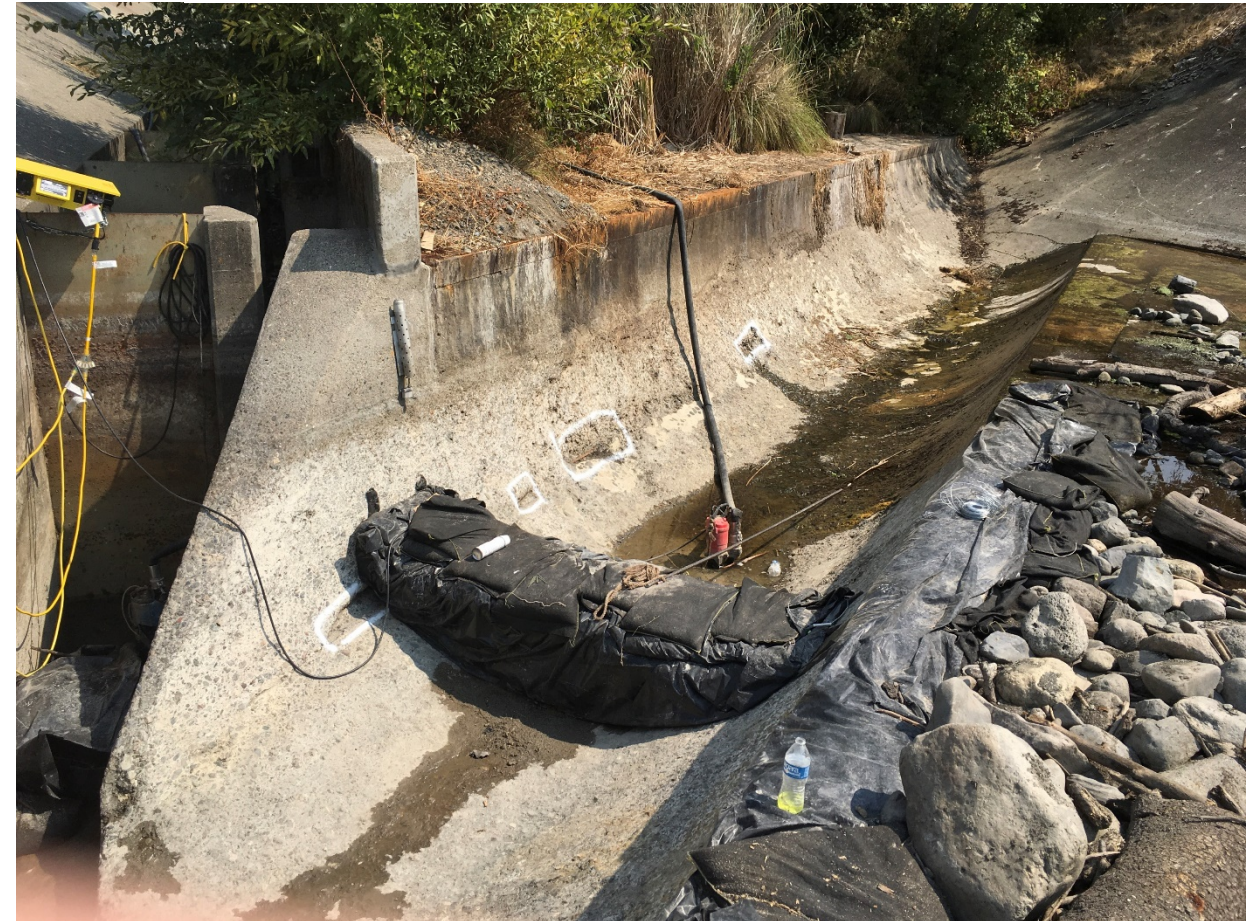
Upstream Coffer Dam in Sediment Trench

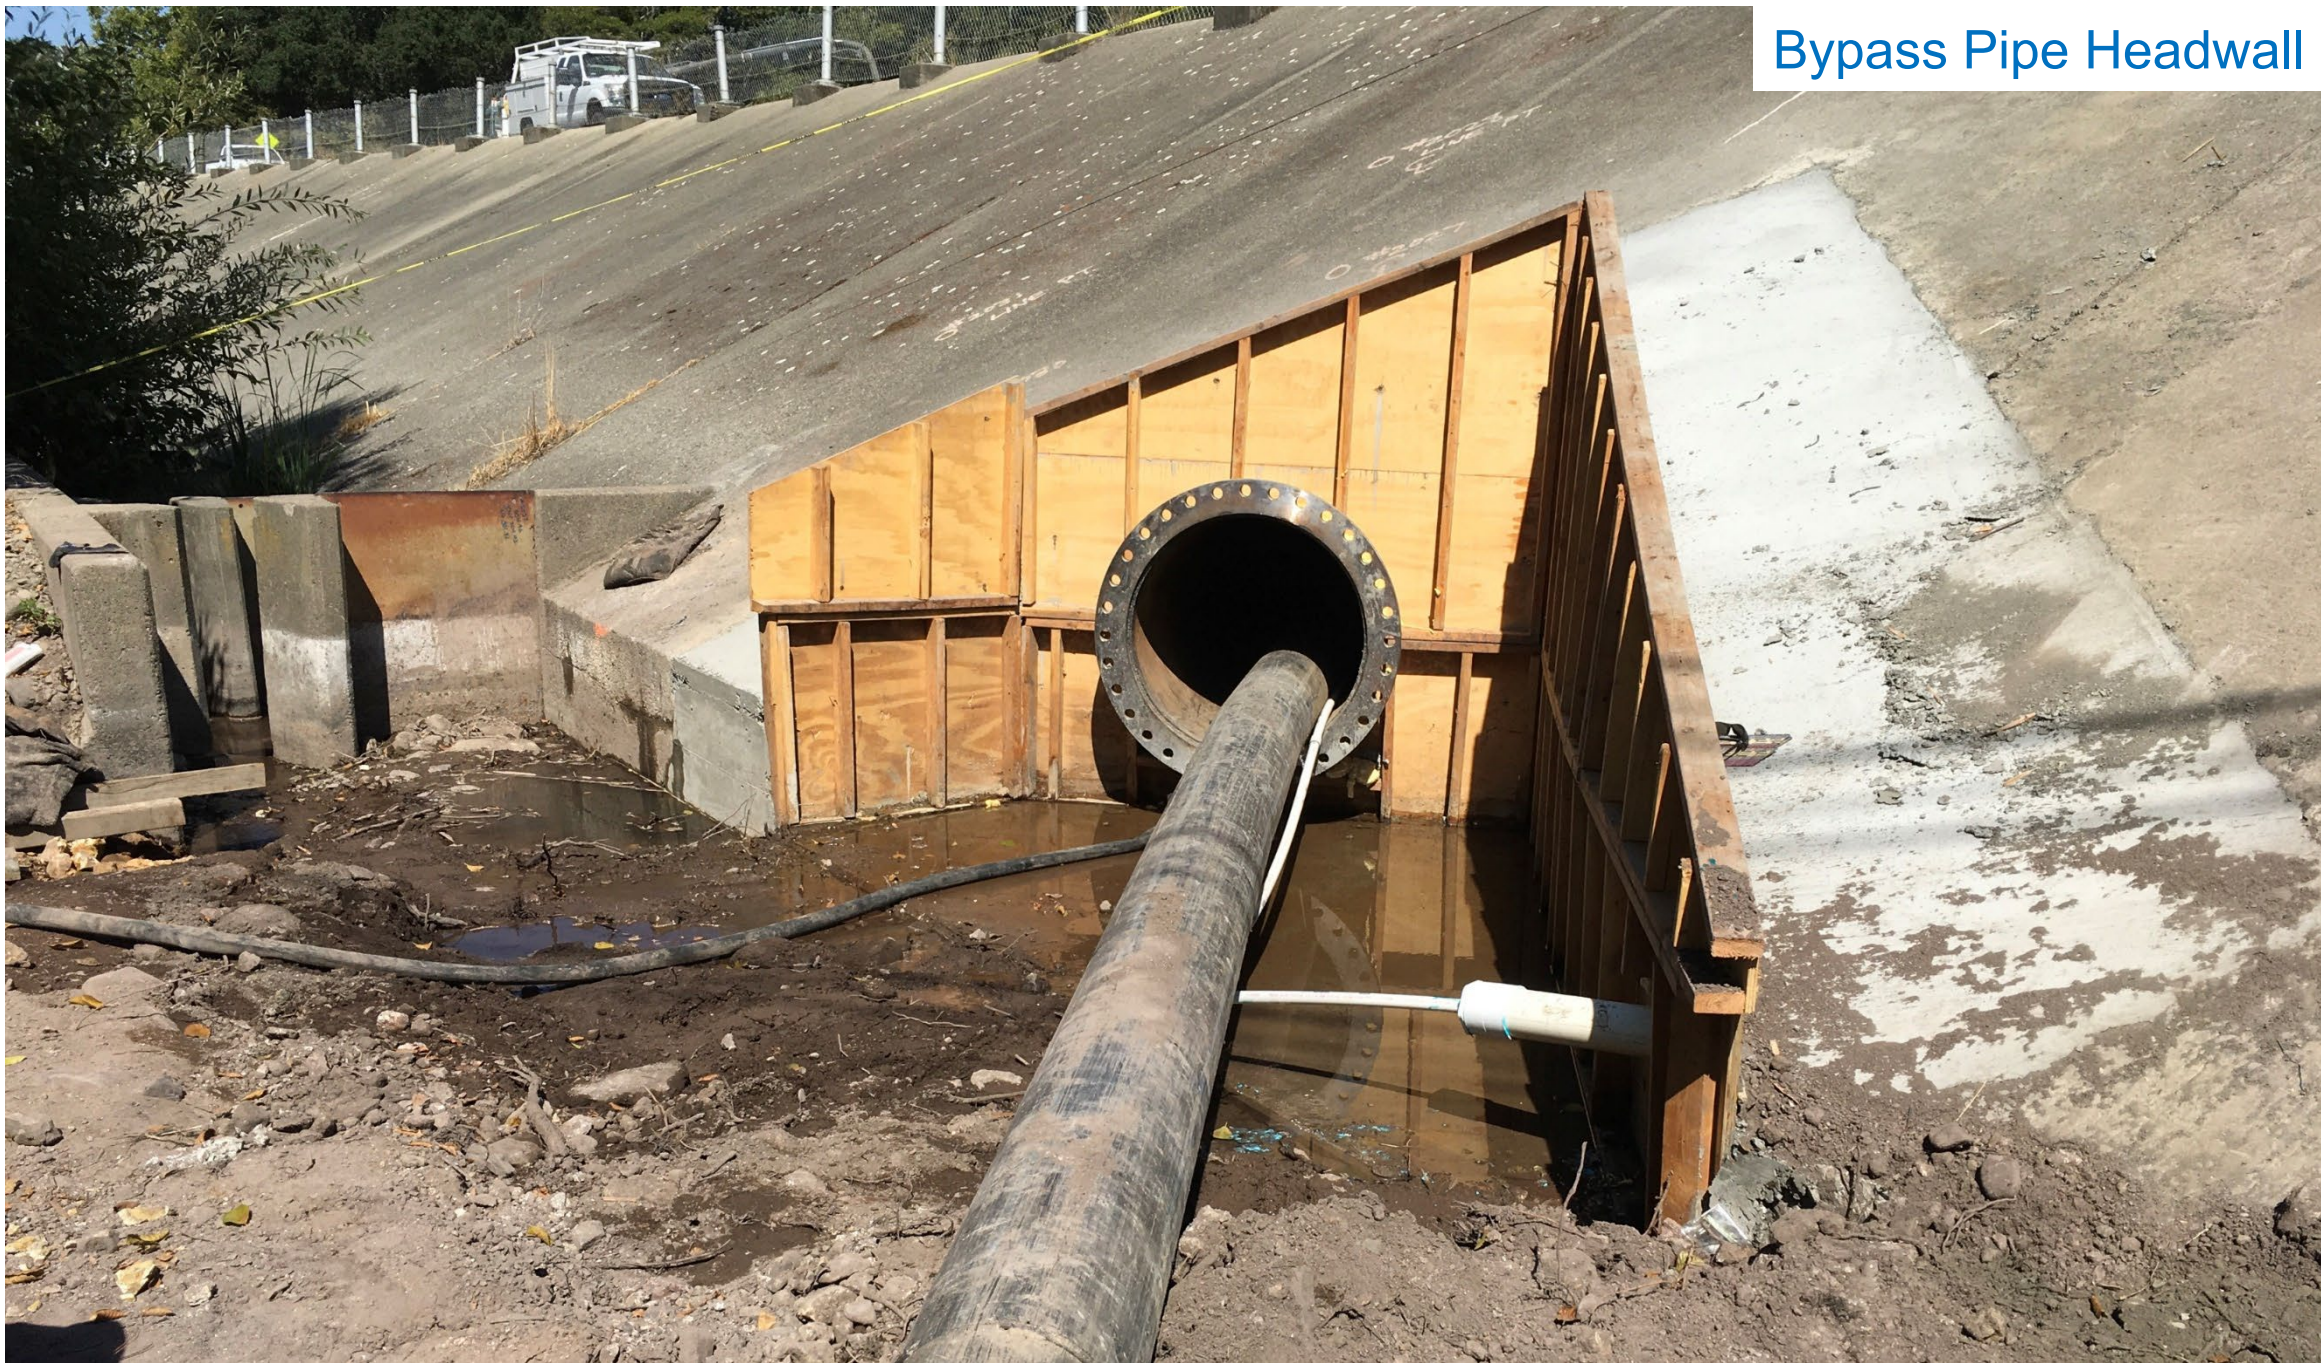
Bypass Pipe Headwall

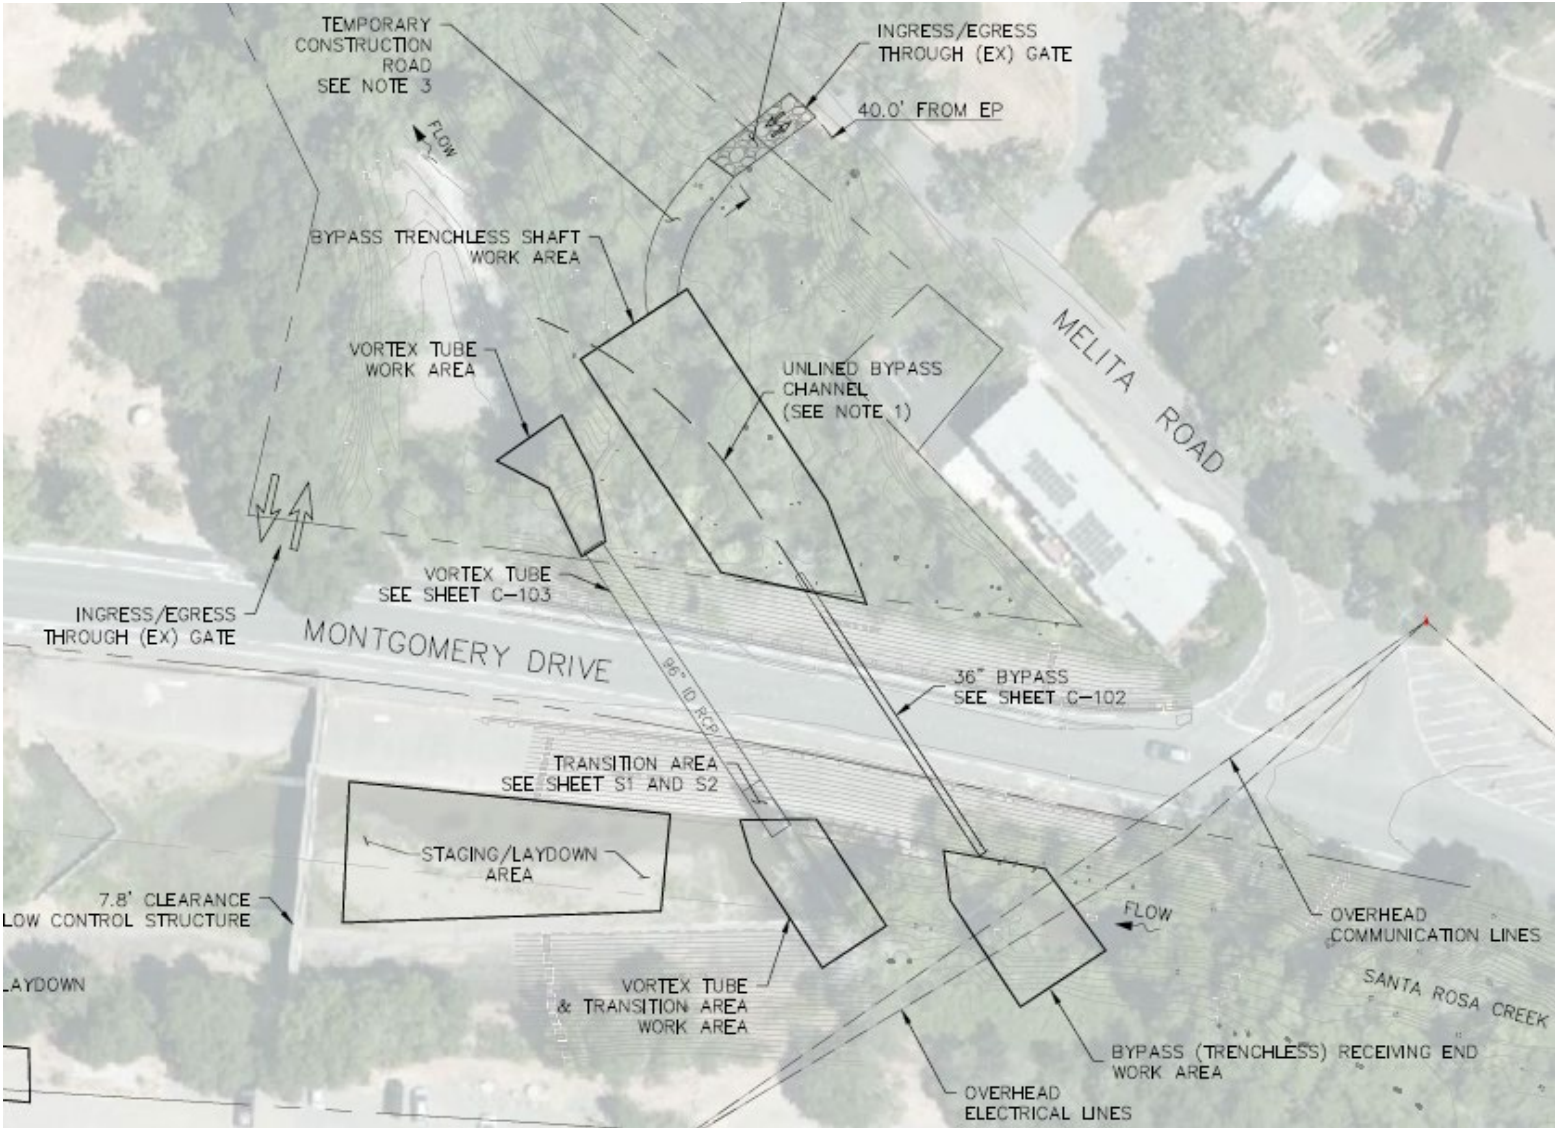
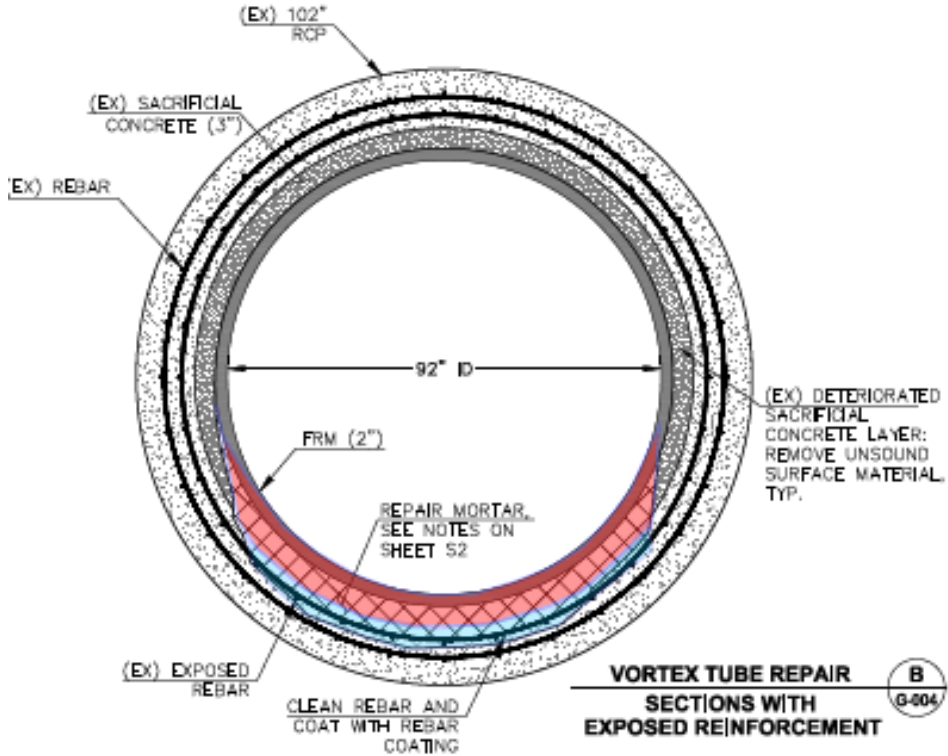
Access Sheet and Overview

Pipe Repair Plan

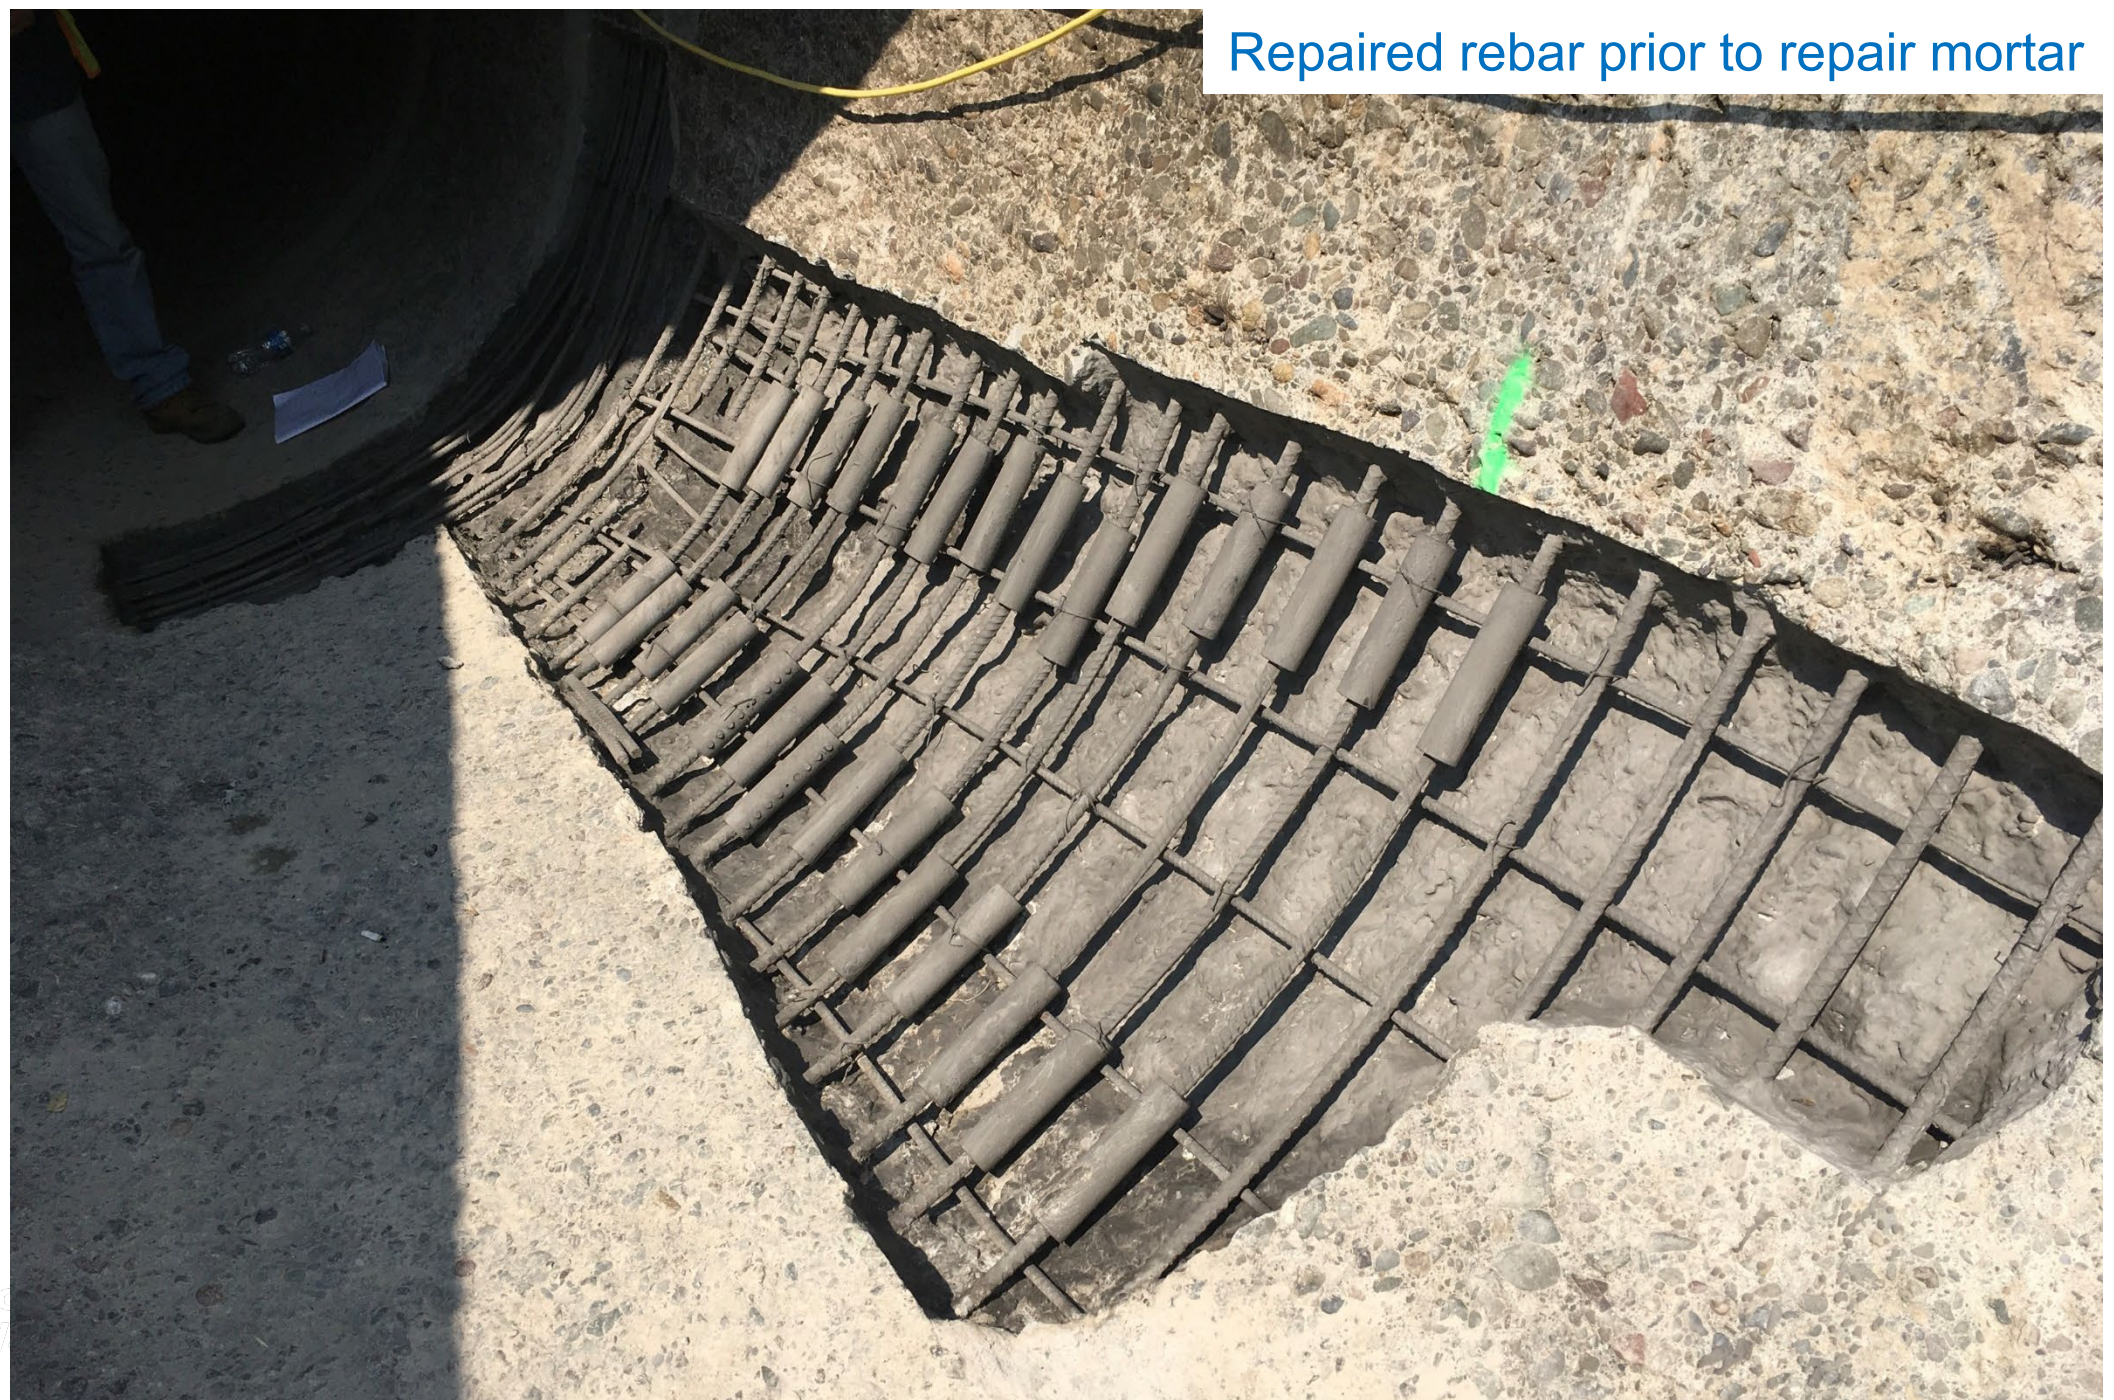
Repaired rebar prior to repair mortar

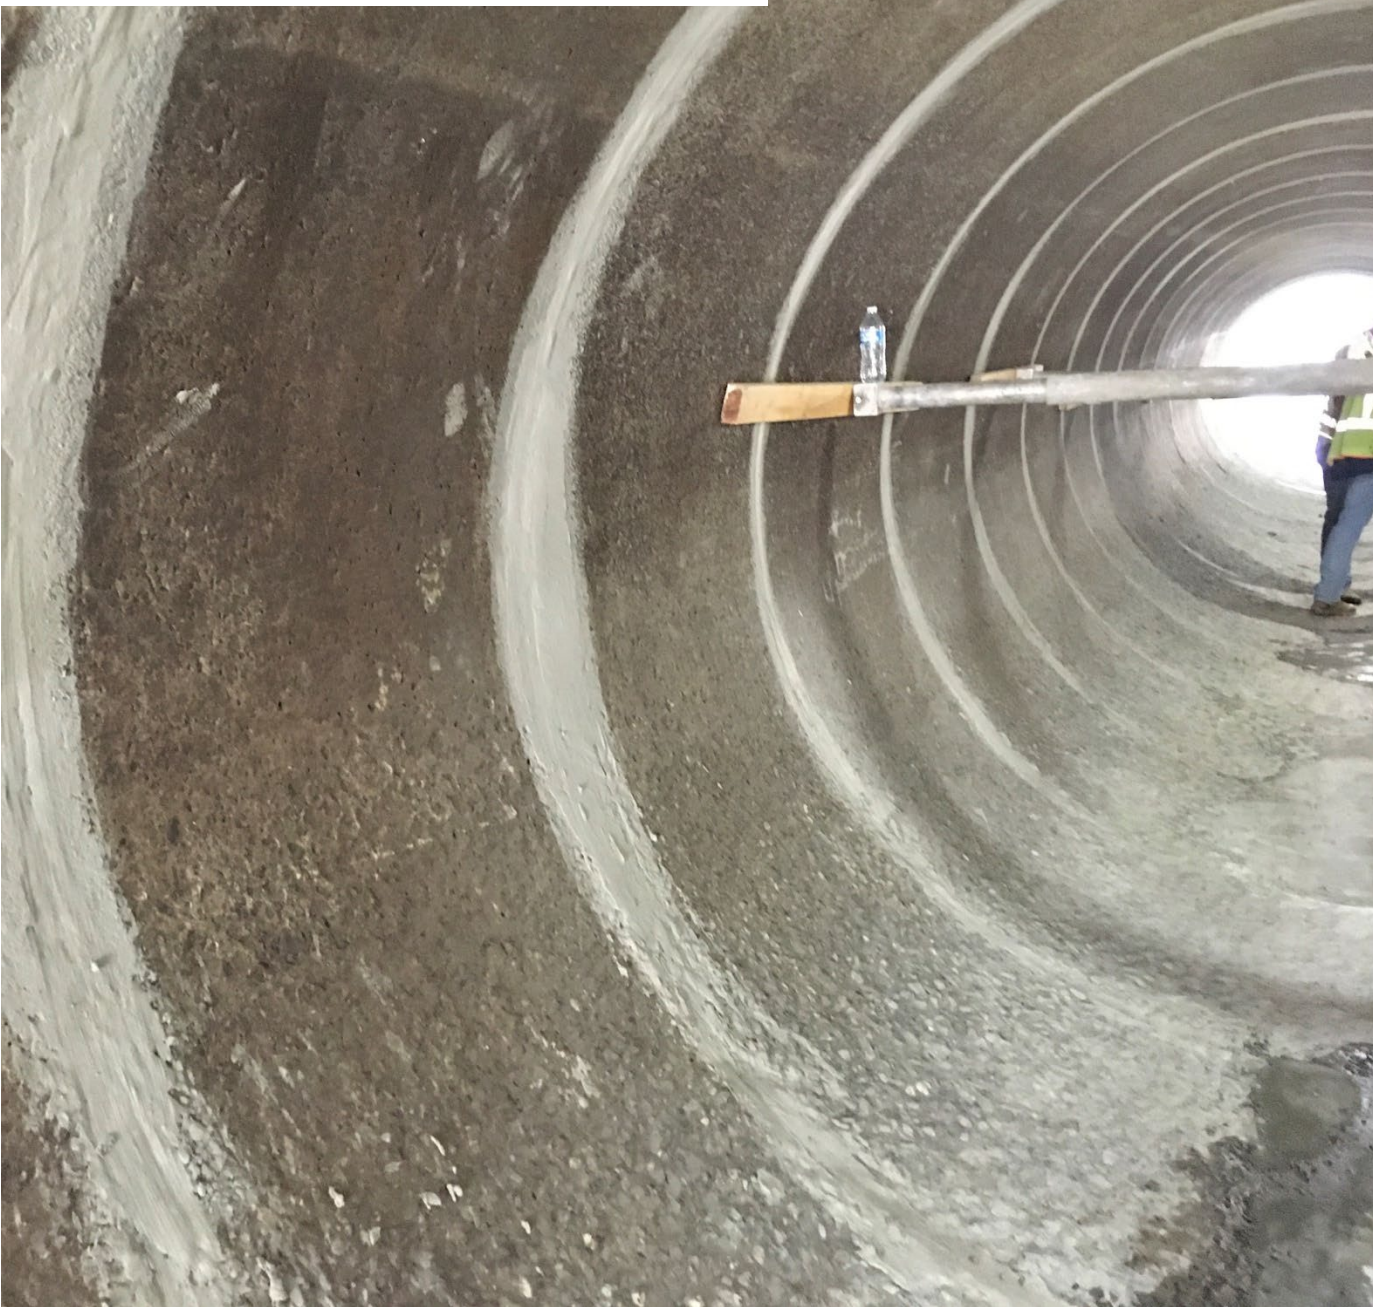
Repaired seams prior to FRM

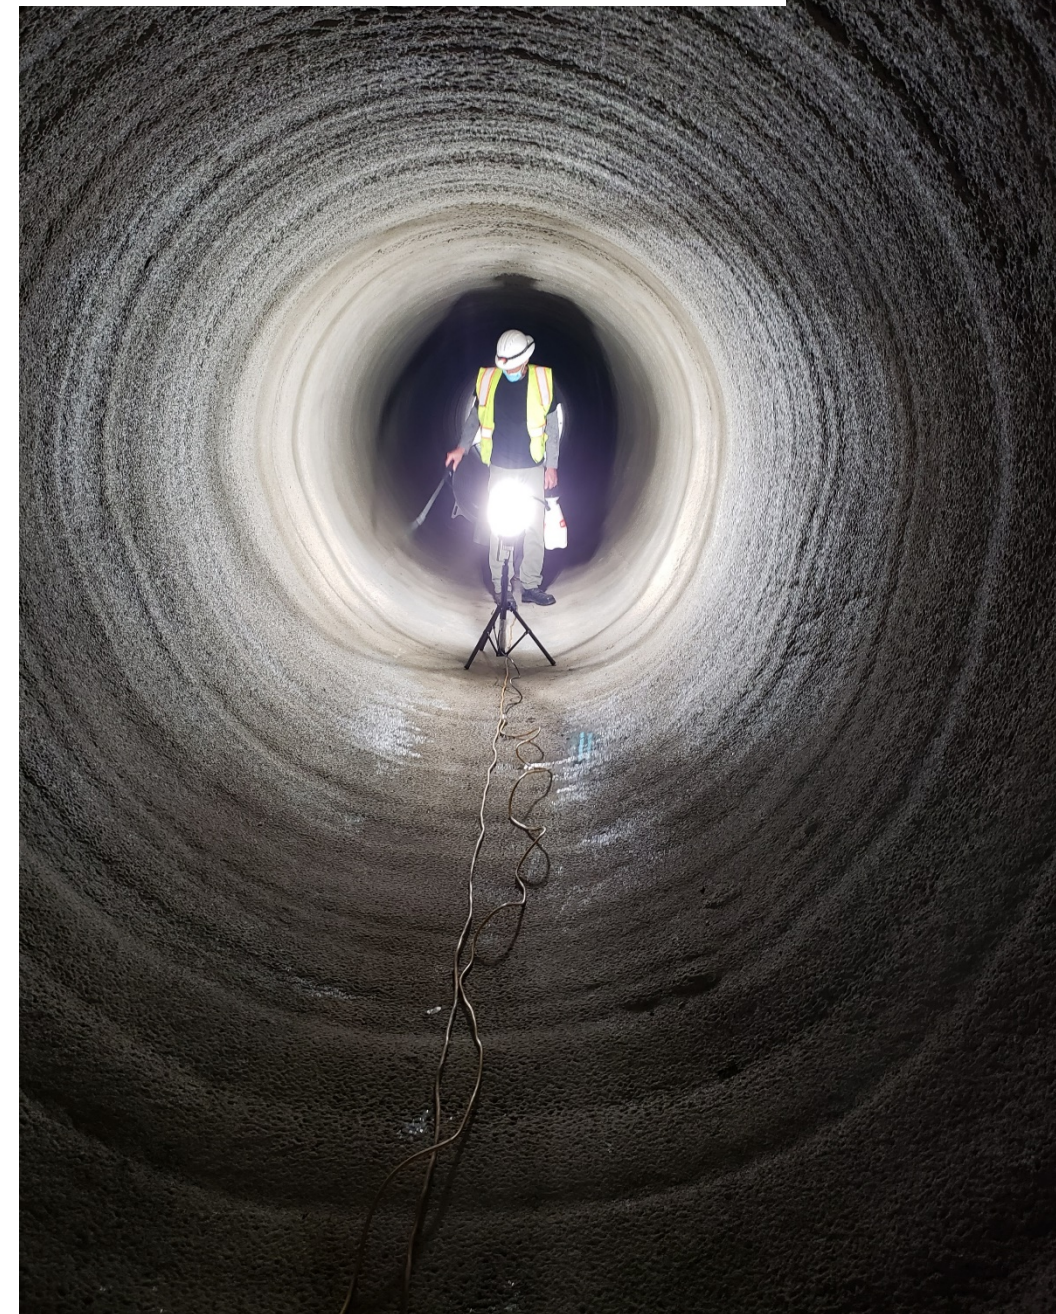
Applying FRM

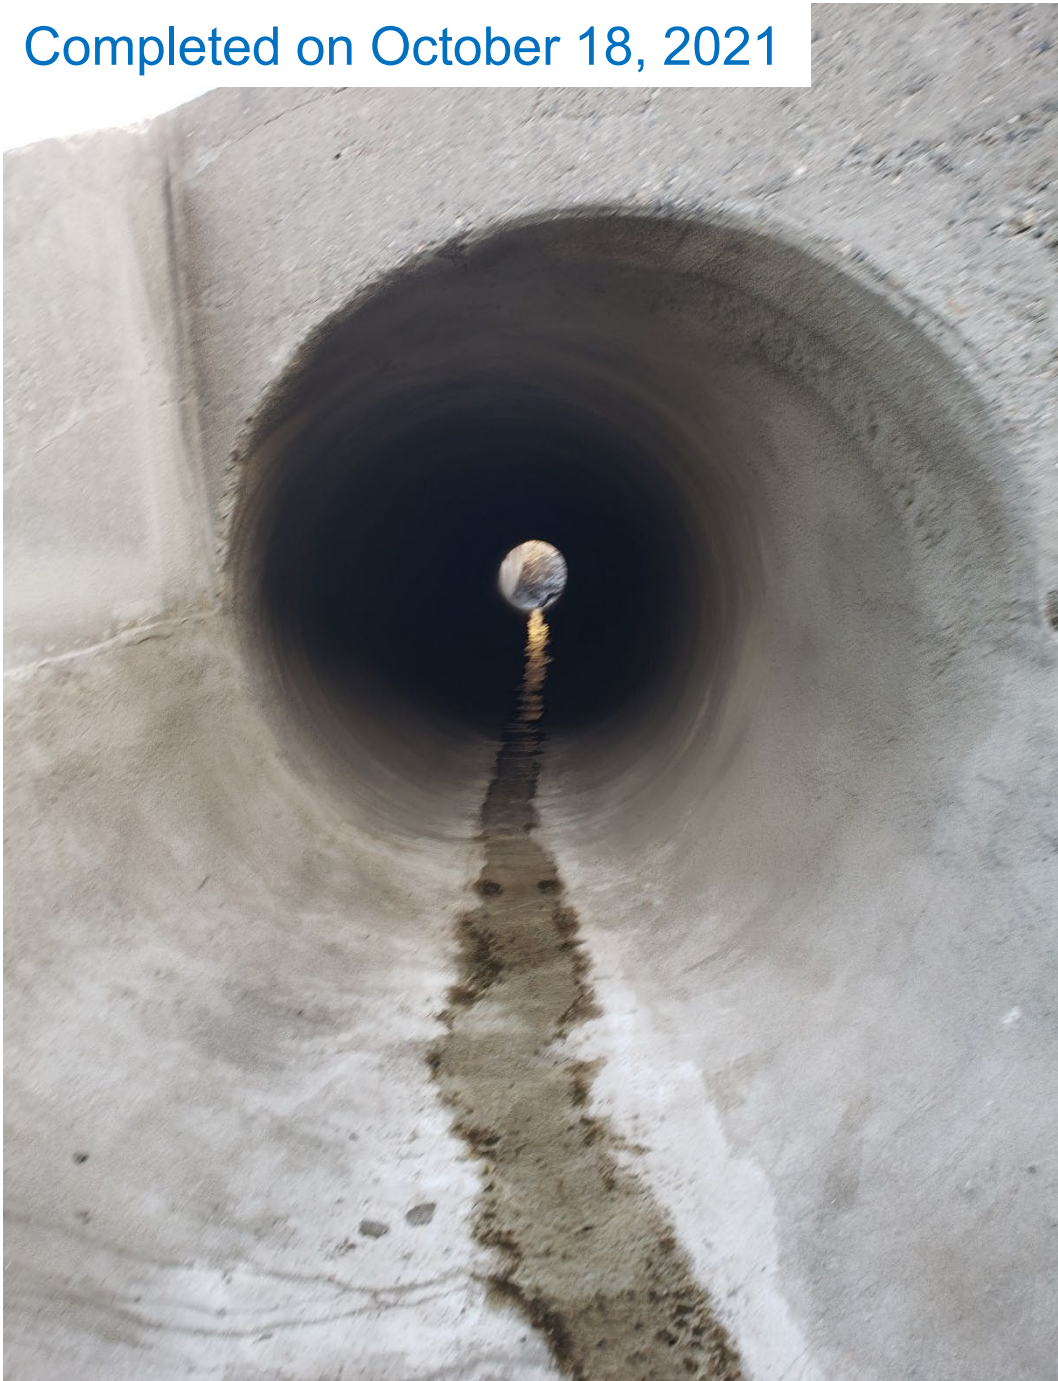
Completed on October 18, 2021

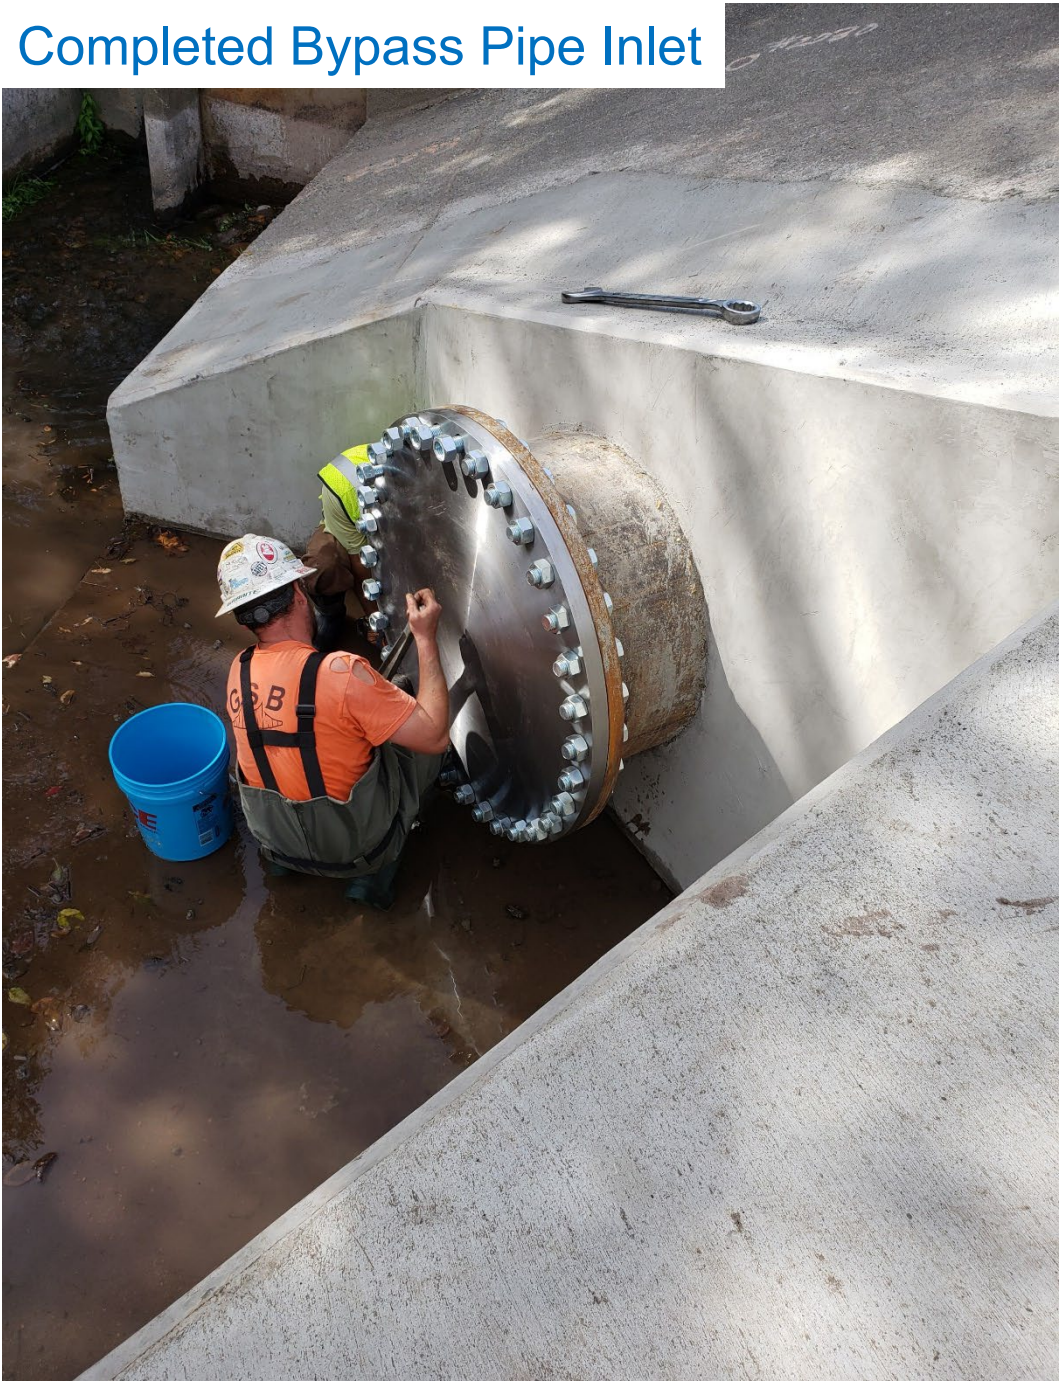
Completed Bypass Pipe Inlet
