Vortex Tube Repair Santa Rosa Creek

- 8-foot reinforced concrete pipe culvert under Montgomery Drive
- Part of the Santa Rosa Creek Diversion that sends high flows to Spring Lake to prevent severe flooding in Santa Rosa
- Allows and low moderate flows and sediment to remain in Santa Rosa Creek
- Constructed by the Soil Conservation Service (now National Resource Conservation Service) in 1960s as part of the Central Sonoma Watershed Project
- Sonoma Water (then the Sonoma County Flood Control and Water Conservation District) was the local sponsor of the project and responsible for maintenance

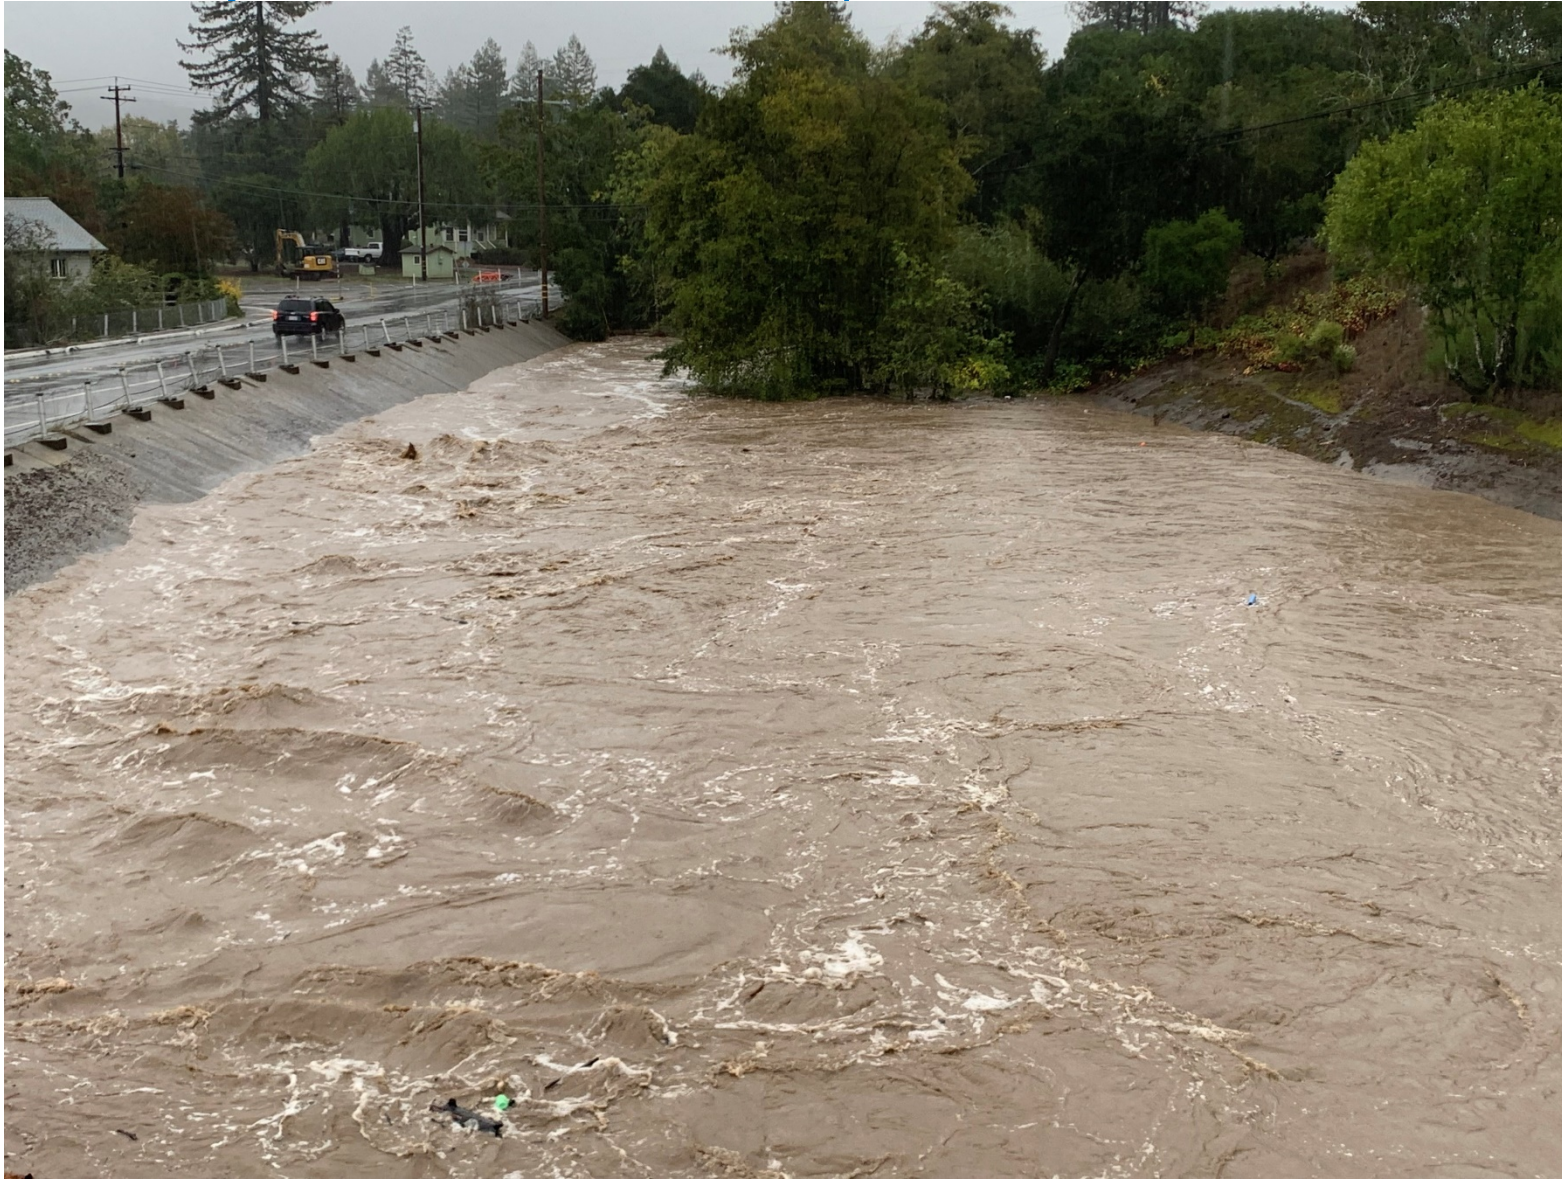
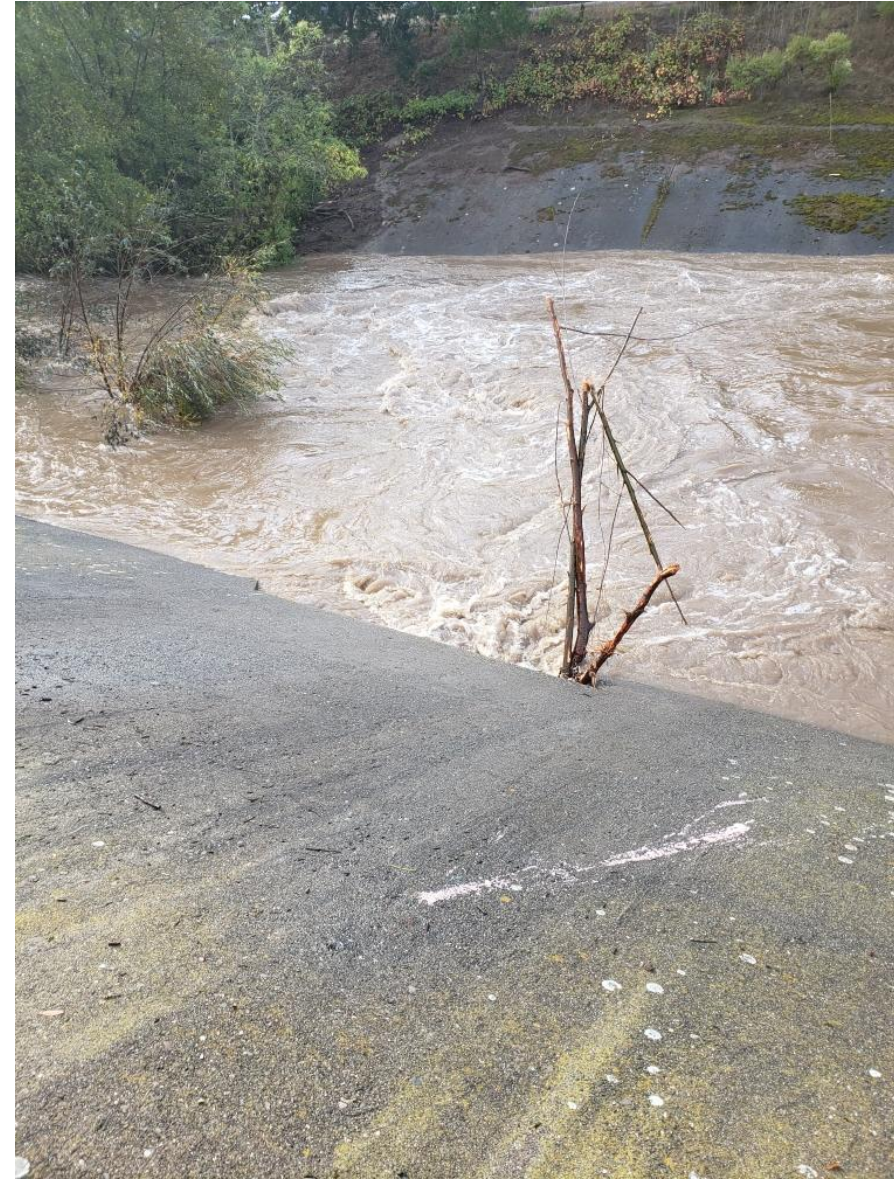
Tested by October 24, 2021 Atmospheric River

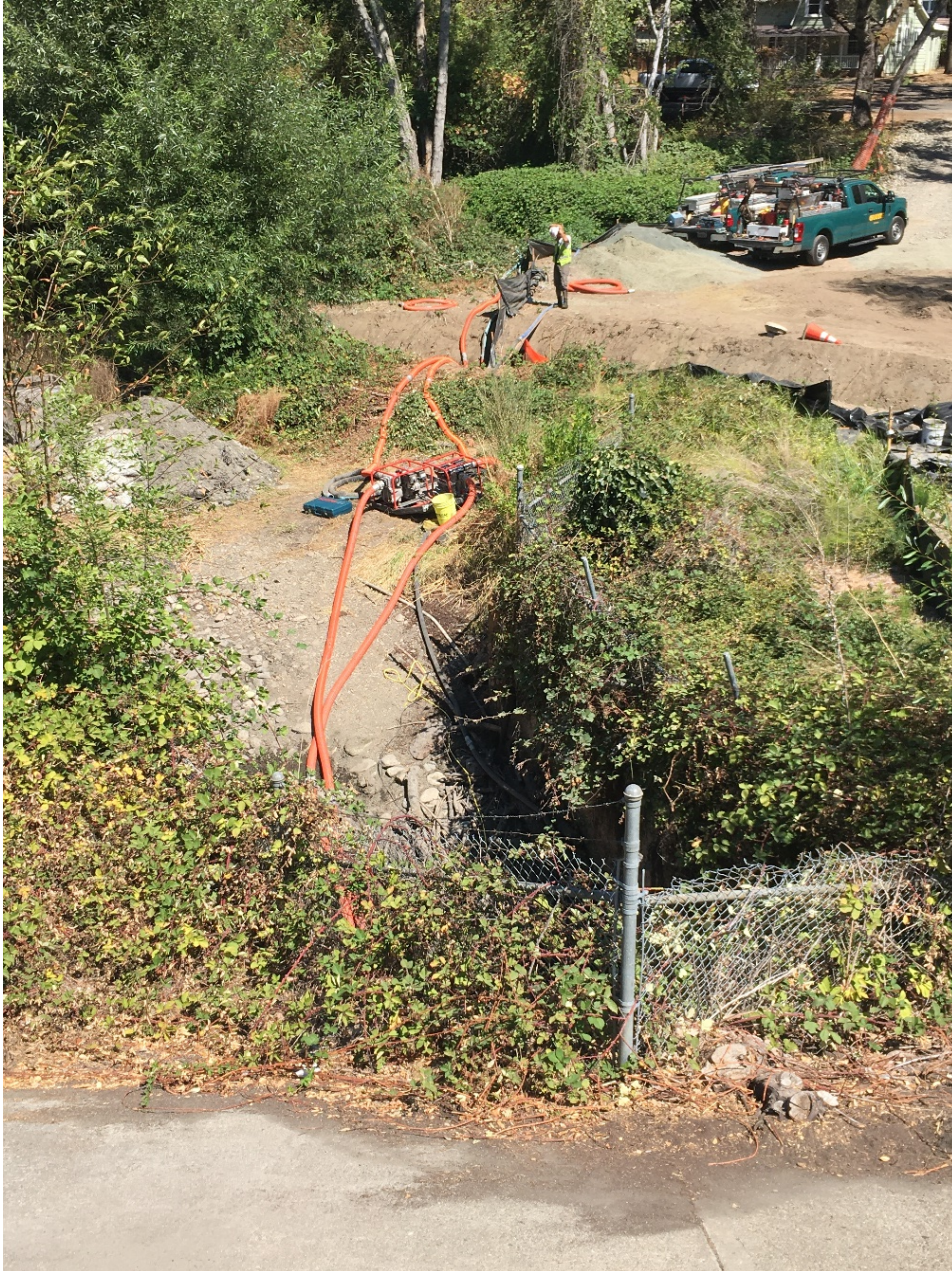
Outlet During Construction

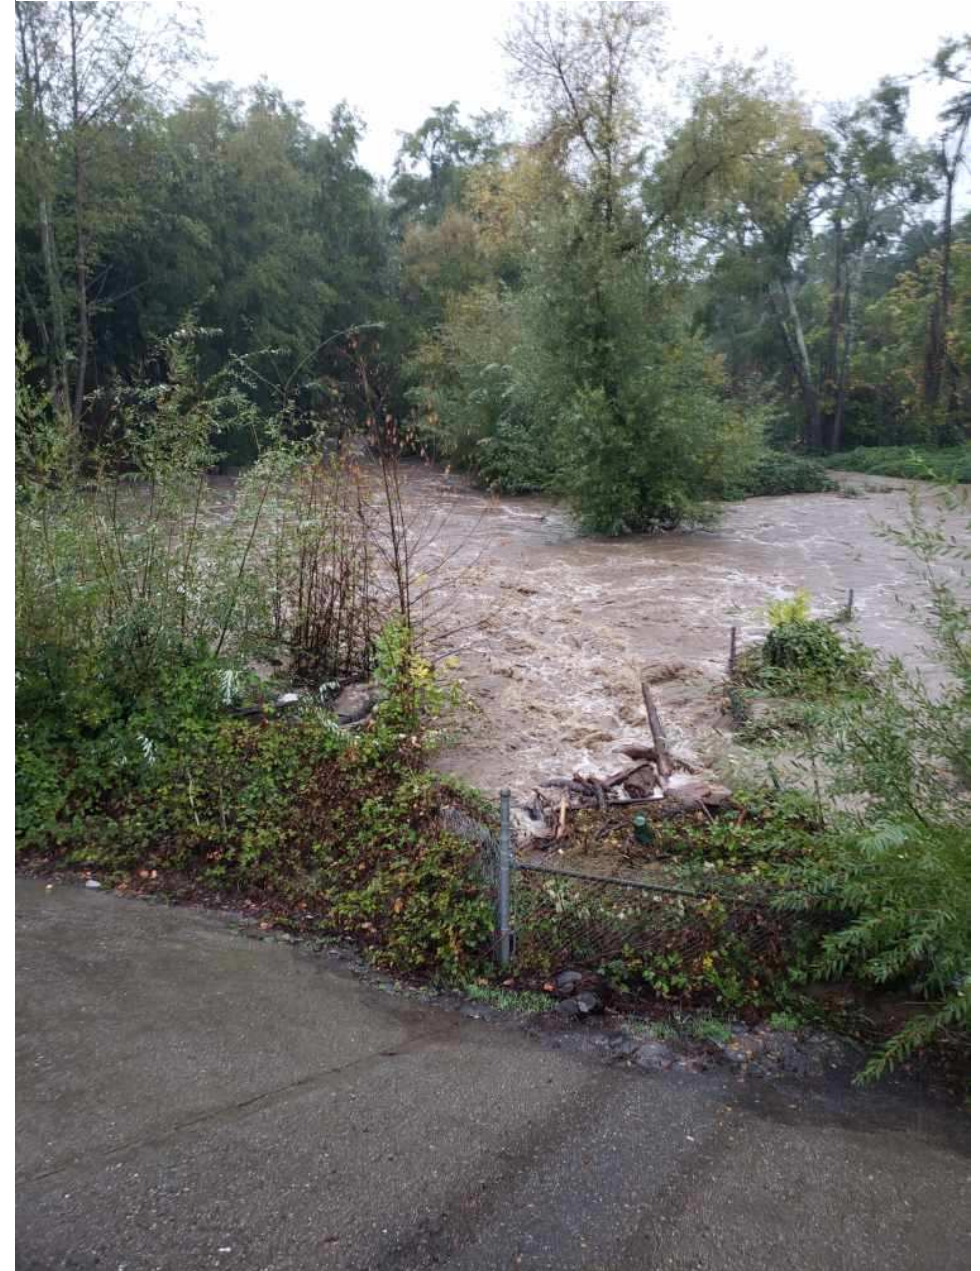
Outlet During October 24th Storm
