SONOMA ECOLOGY CENTER RESTORATION PROGRAM PROJECTS 2021

Funded by SCWA Zone 3A

Presented at Annual Meeting

December 9, 2021

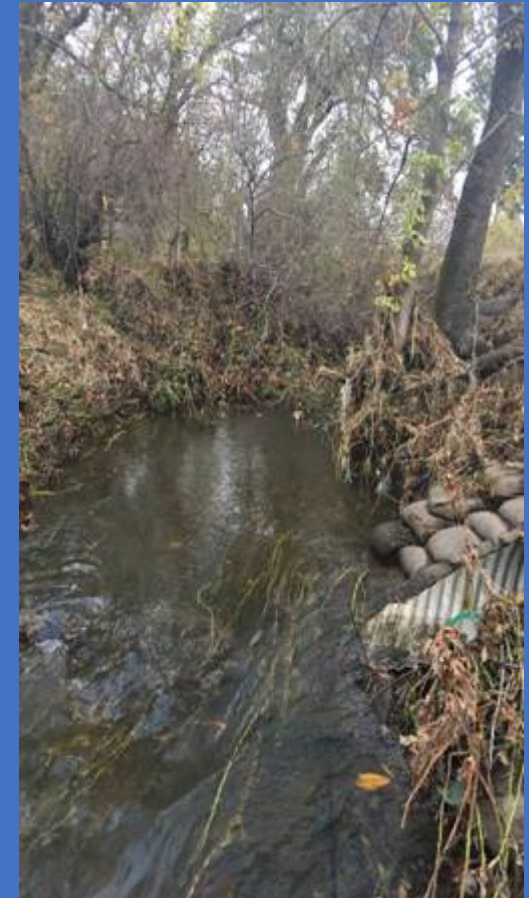
- **Nathanson Creek
WPP Phases 1 to 6**

- Minimal damage to erosion control measures
- Very little woody debris in channel
- Banks overtopped at some locations
- Overflow channel worked well
- Minor damage to irrigation systems
- Bank erosion not extensive
- Sedges in channel protected bed from incision

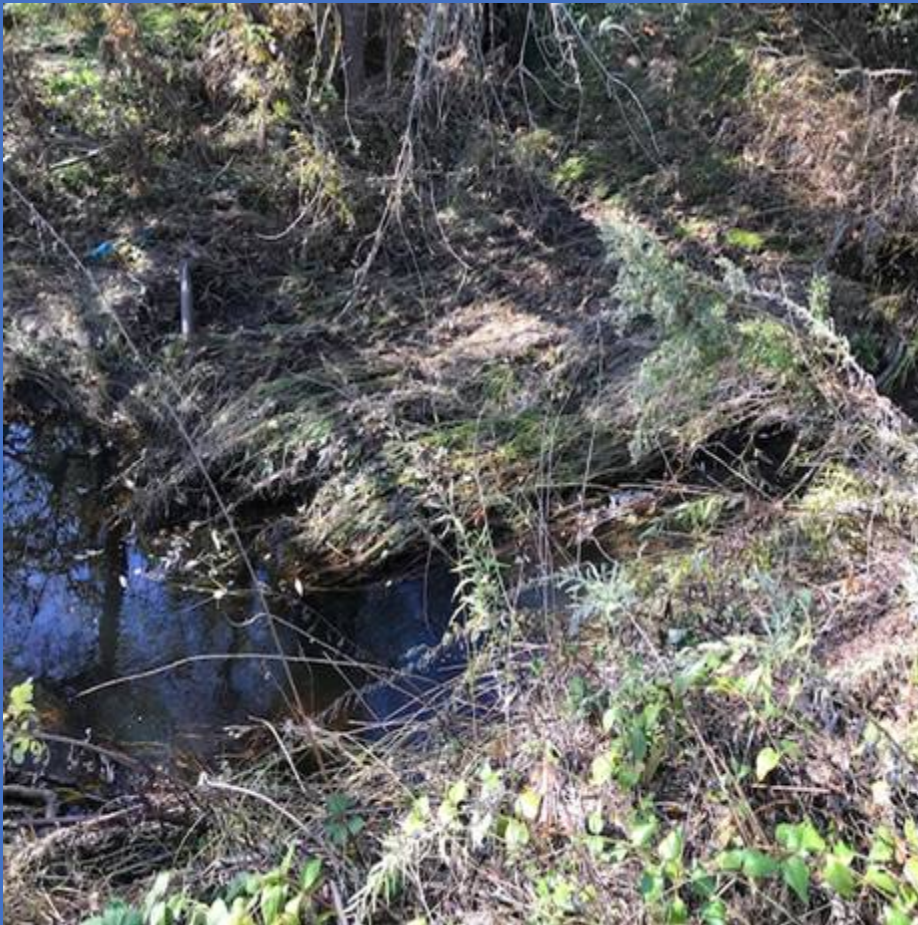
Sedges and willows protecting the channel bed

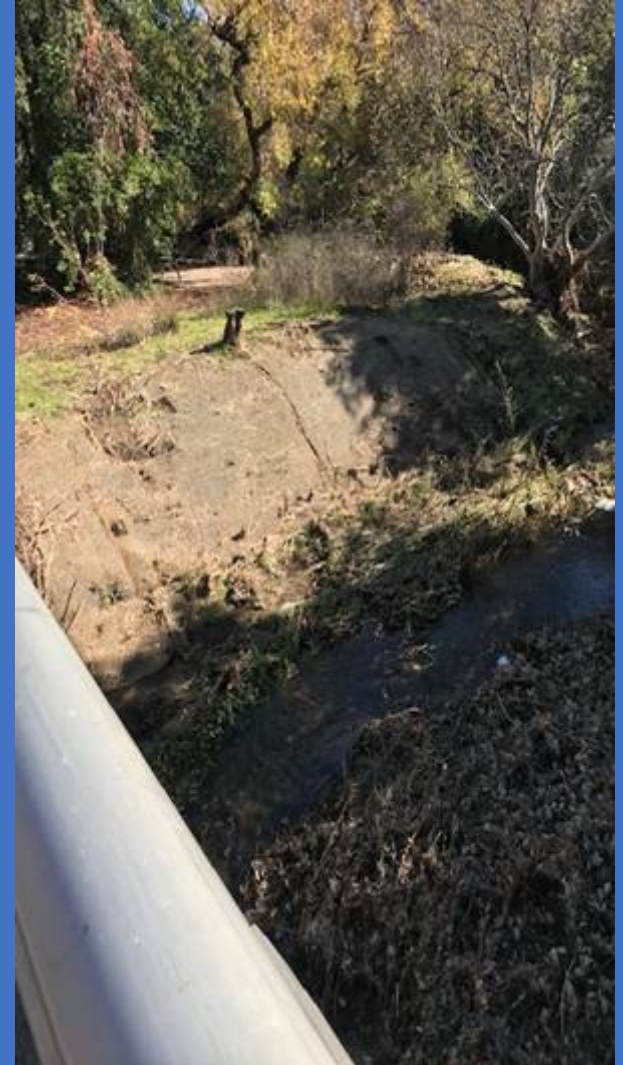
Jute netting downstream of bridge

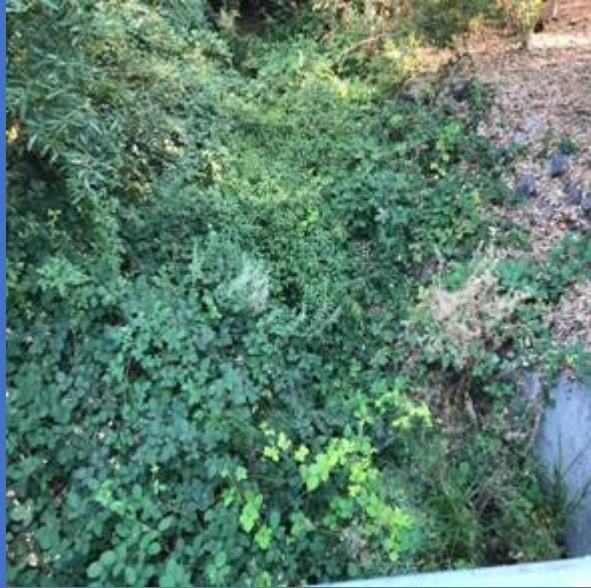
Invasive plants in Rogers Creek

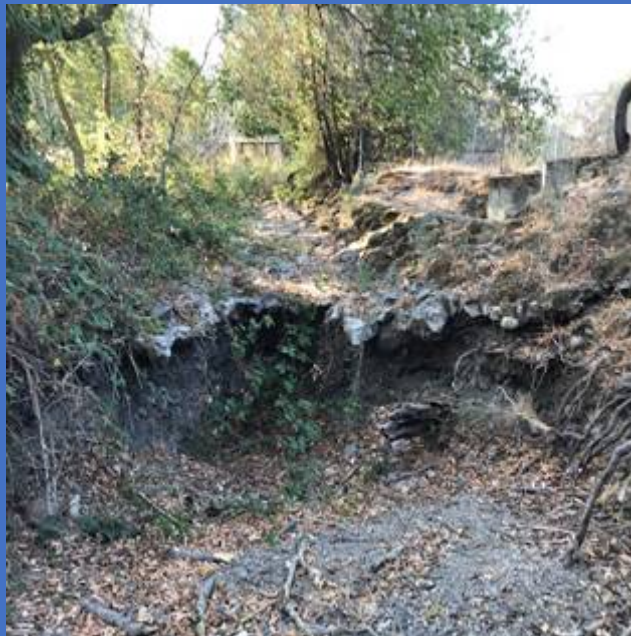
Headcut and channel incision, Rogers Creek

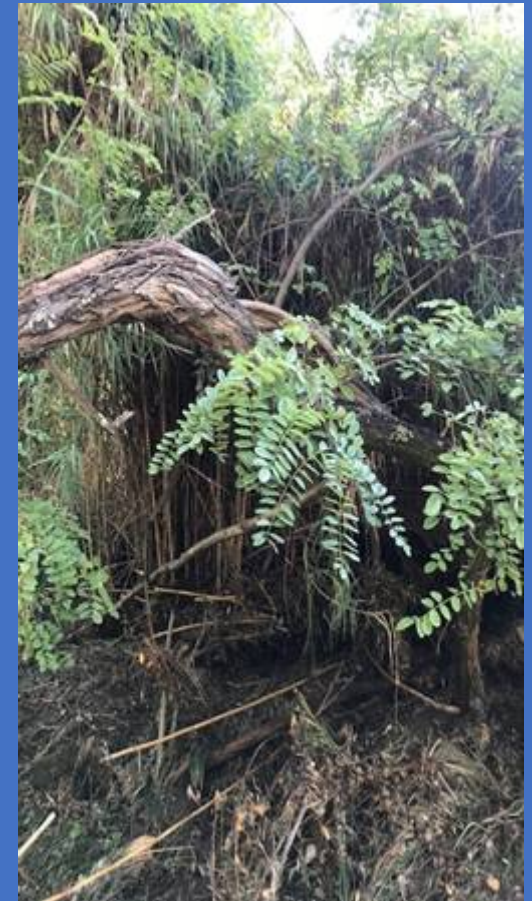
Arundo
infestation,
Sonoma
Creek

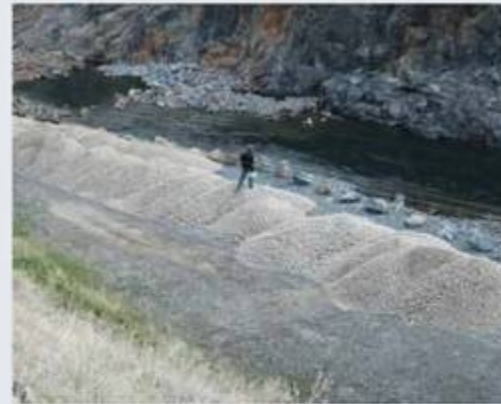
FIGURE 30

CONCEPTUAL SEDIMENT PLACEMENT

SITES 17 & 19 PLAN
