Southern Laguna de Santa Rosa Watershed

Sediment Source Assessment

Southern Laguna de Santa Rosa Watershed Sediment Source Assessment

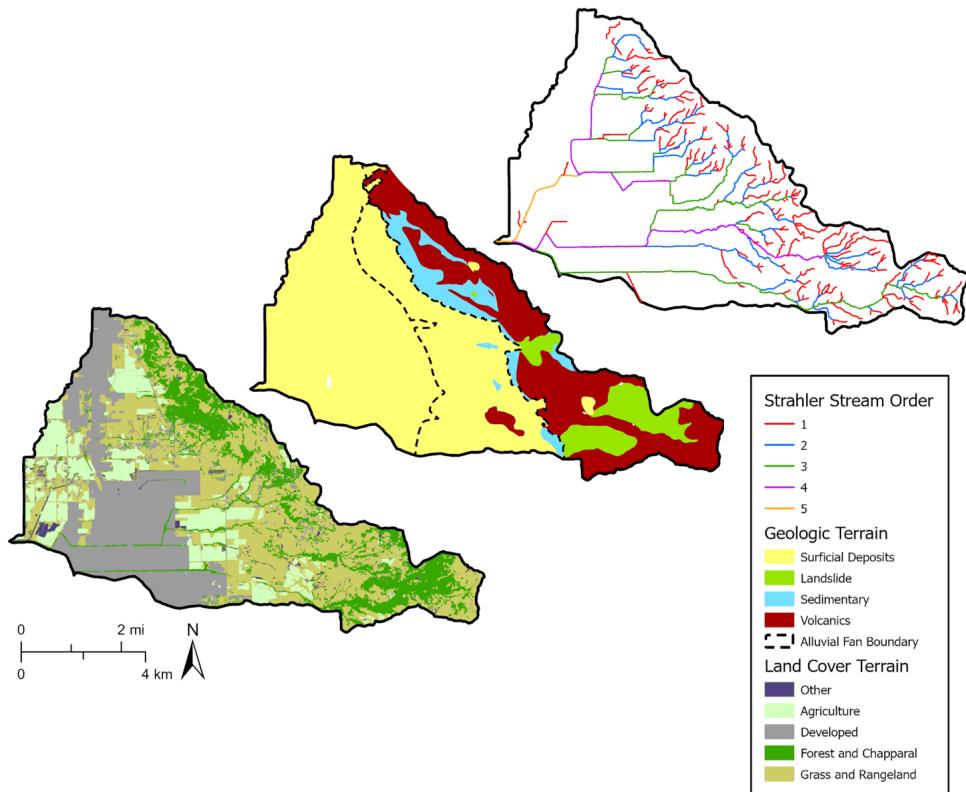
Channel GLU approach

- Label all channel reaches by combination of Stream Order, Geology, and Land Cover to determine channel Geomorphic Landscape Units (or GLUs)
- Conduct intensive field surveys to determine GLU-specific erosion rates in representative channel reaches
- Apply erosion rates to unsurveyed channel reaches
- Combined erosion rates to get sediment supply by subwatershed

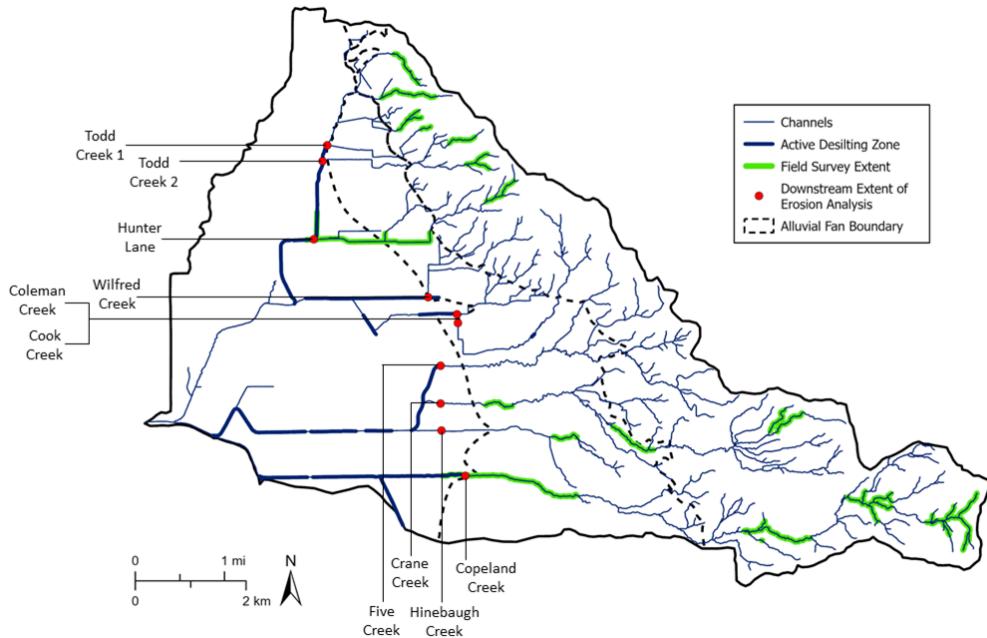
- Assessed bank and bed erosion on 22 km of channels (or 12% of total channel length) between June 2021 and March 2022
 - Bank retreat
 - Bank failure/shallow landslide
 - Gully erosion
 - Channel incision
- Focused on area upstream of SMP activities

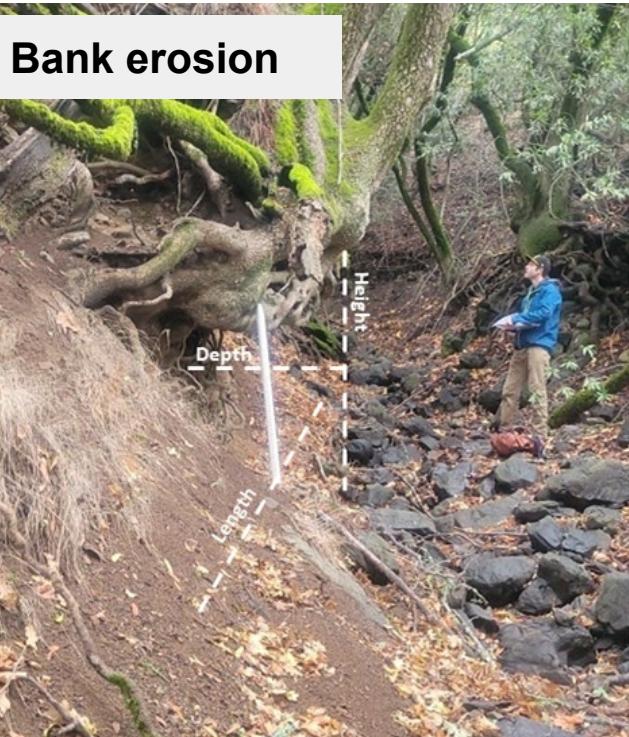
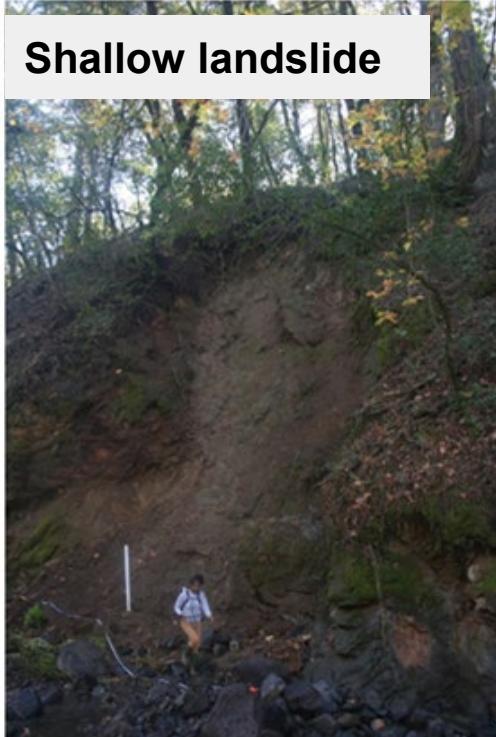
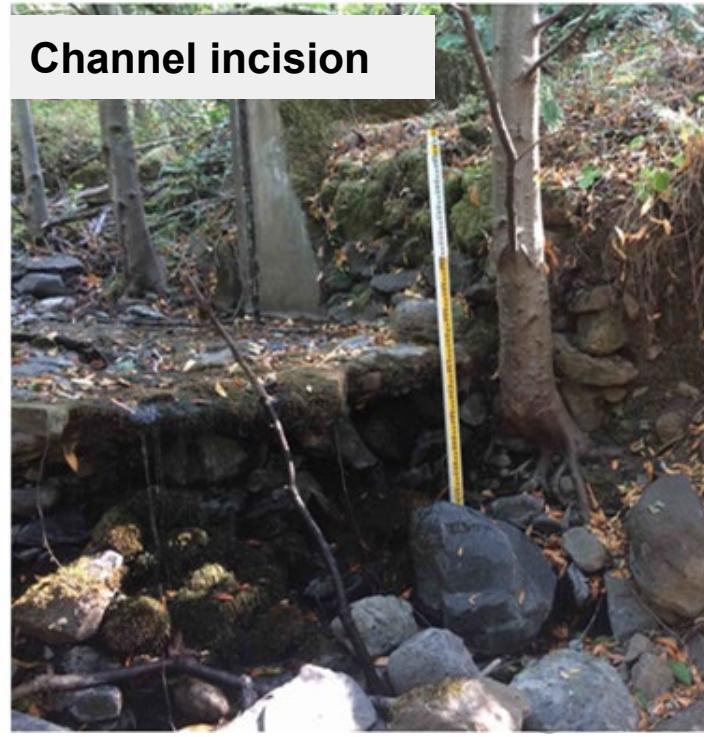
Field Survey

- 614 erosion observations
 - 378 bank retreat
 - 135 local bank failures/shallow landslides
 - 13 gullies
 - 88 incision observations

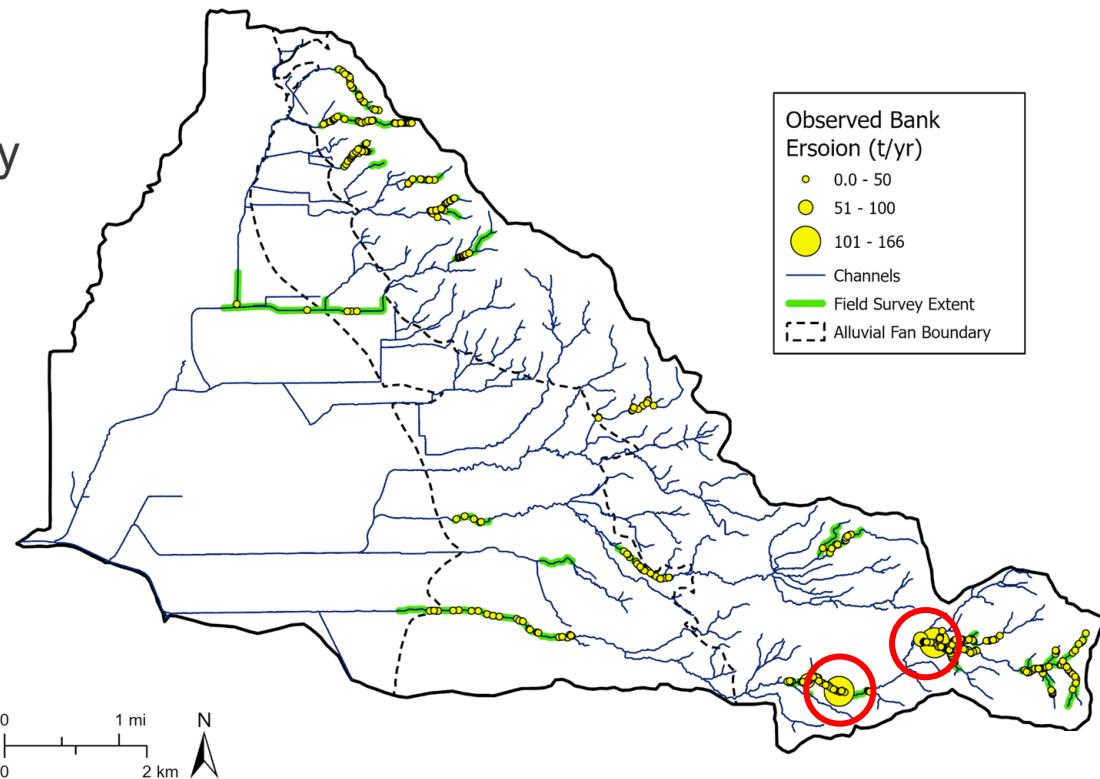
Largest bank erosion features by far were in the Copeland Creek Drainage

- Valentine's Day Slide
- Unnamed landslide

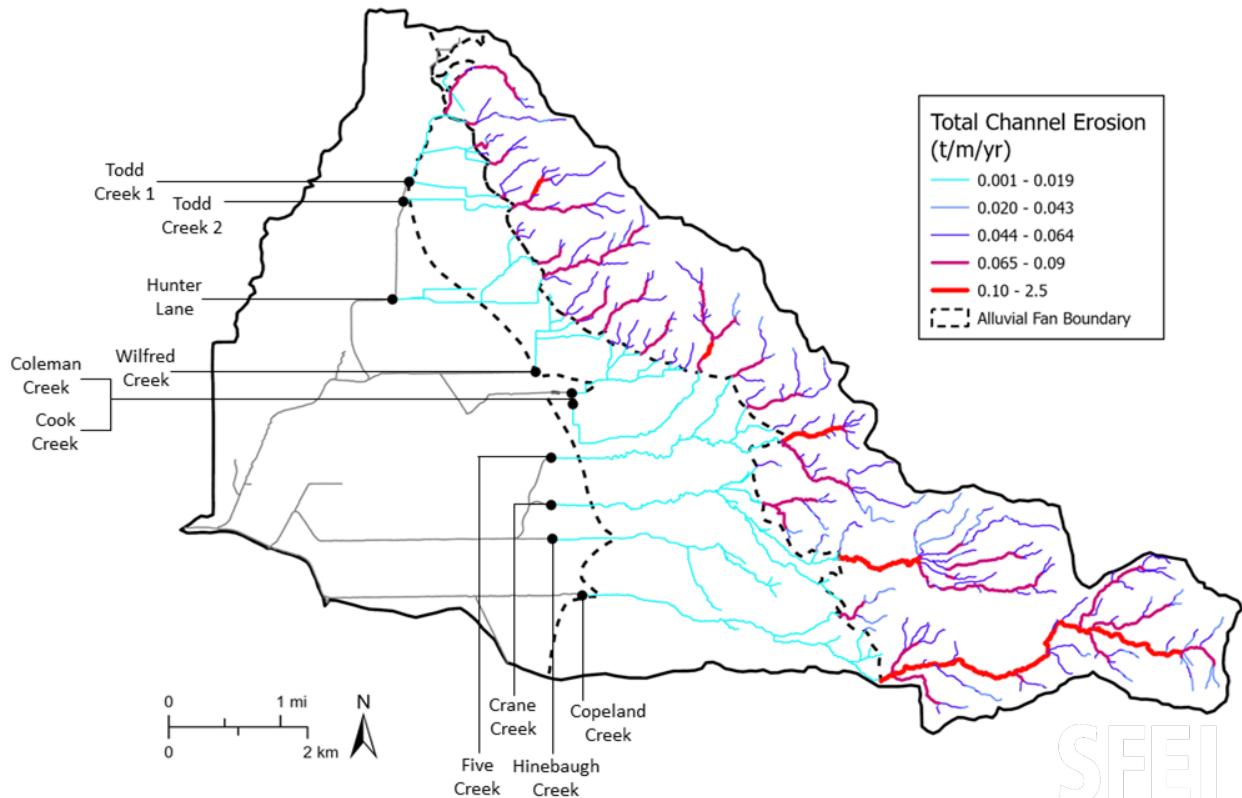
- Over 90% of channel erosion occurred in Headwaters Zone
- Bank erosion and bed erosion each supply about $\frac{1}{2}$ of the total annual sediment supply
- Highest erosion rates in SE corner due to high ann precip and erosive geology

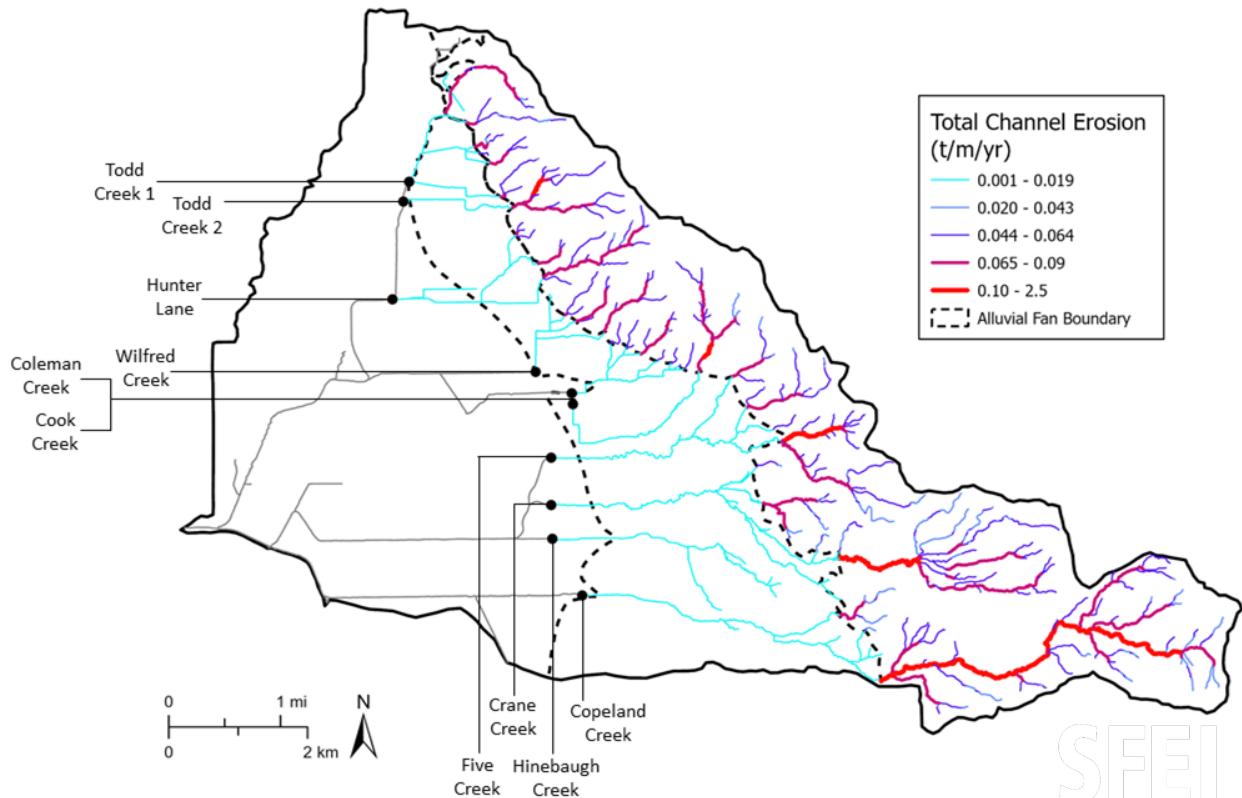
Total avg ann sed supply from channel erosion

Copeland: 4,000 t/yr

Hinebaugh: 3,800 t/yr

B-W Chan: 2,500 t/yr

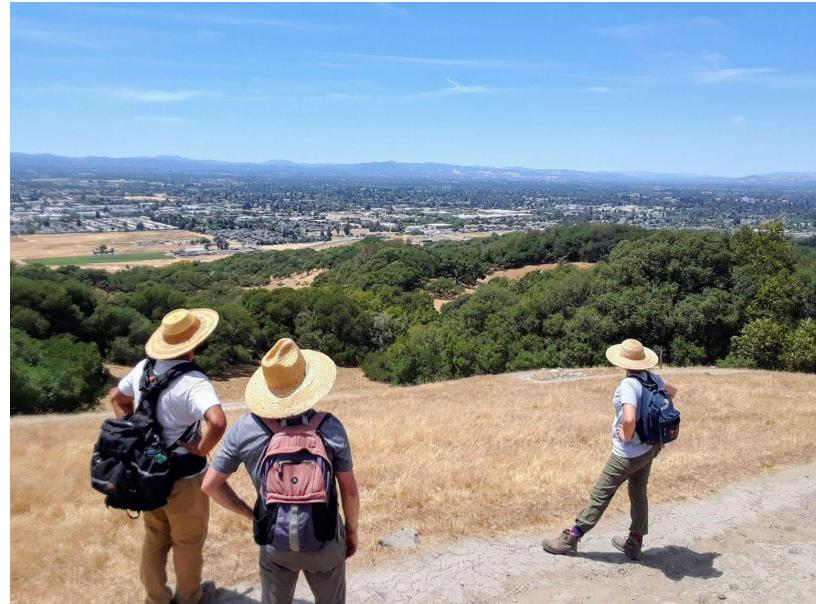
- **Copeland Creek**
 - Massive landslides limit sediment control actions
 - Capture flow and sediment on alluvial fan (alluvial fan restoration)
- **Hinebaugh Creek**
 - Alluvial fan restoration
 - Upper reaches - channel stabilization
- **Bellevue-Wilfred Channel**
 - Upper reaches - channel stabilization

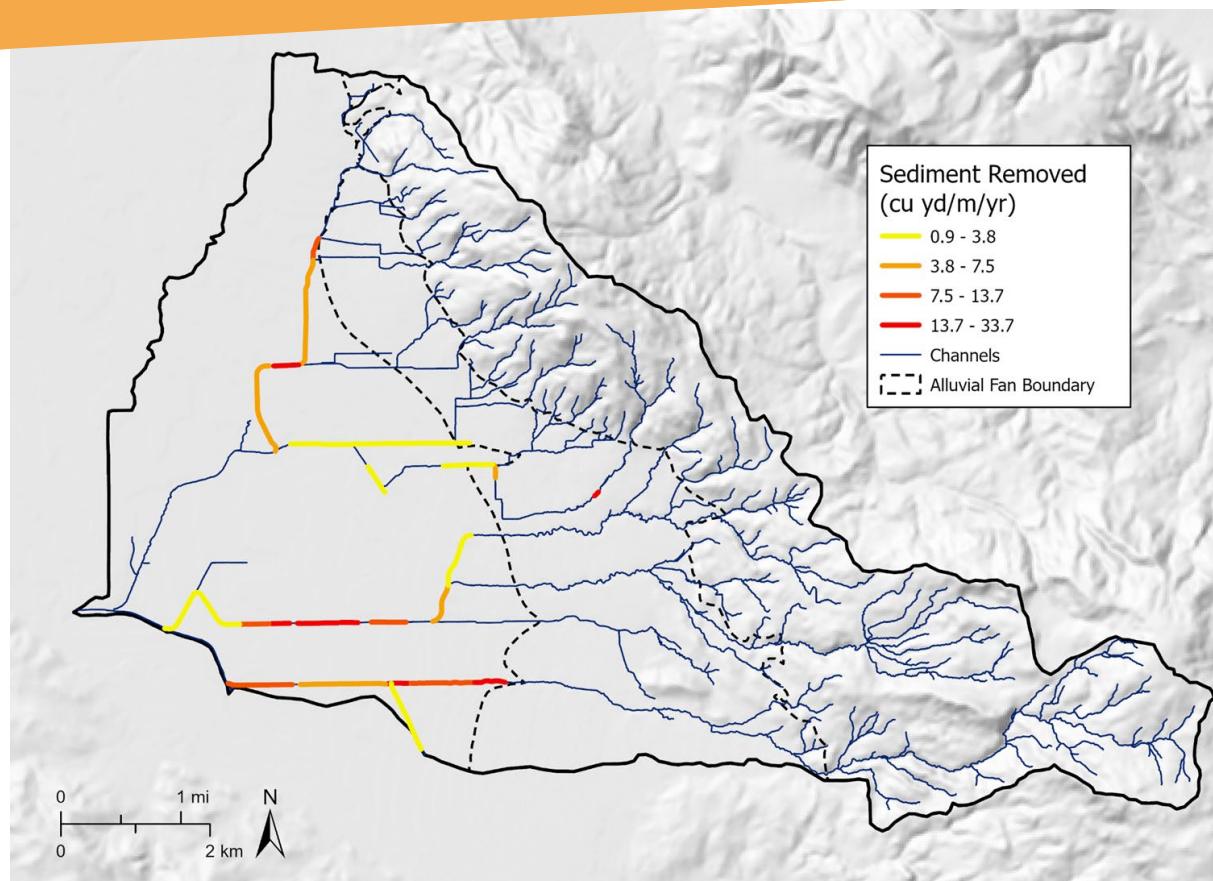
Sediment Removal rates
in active desilting zones
from 2012-2022
