## **Appendix A**

### **Program Summary Data**

# Sonoma County Water Agency

Stream Maintenance Program (SMP)

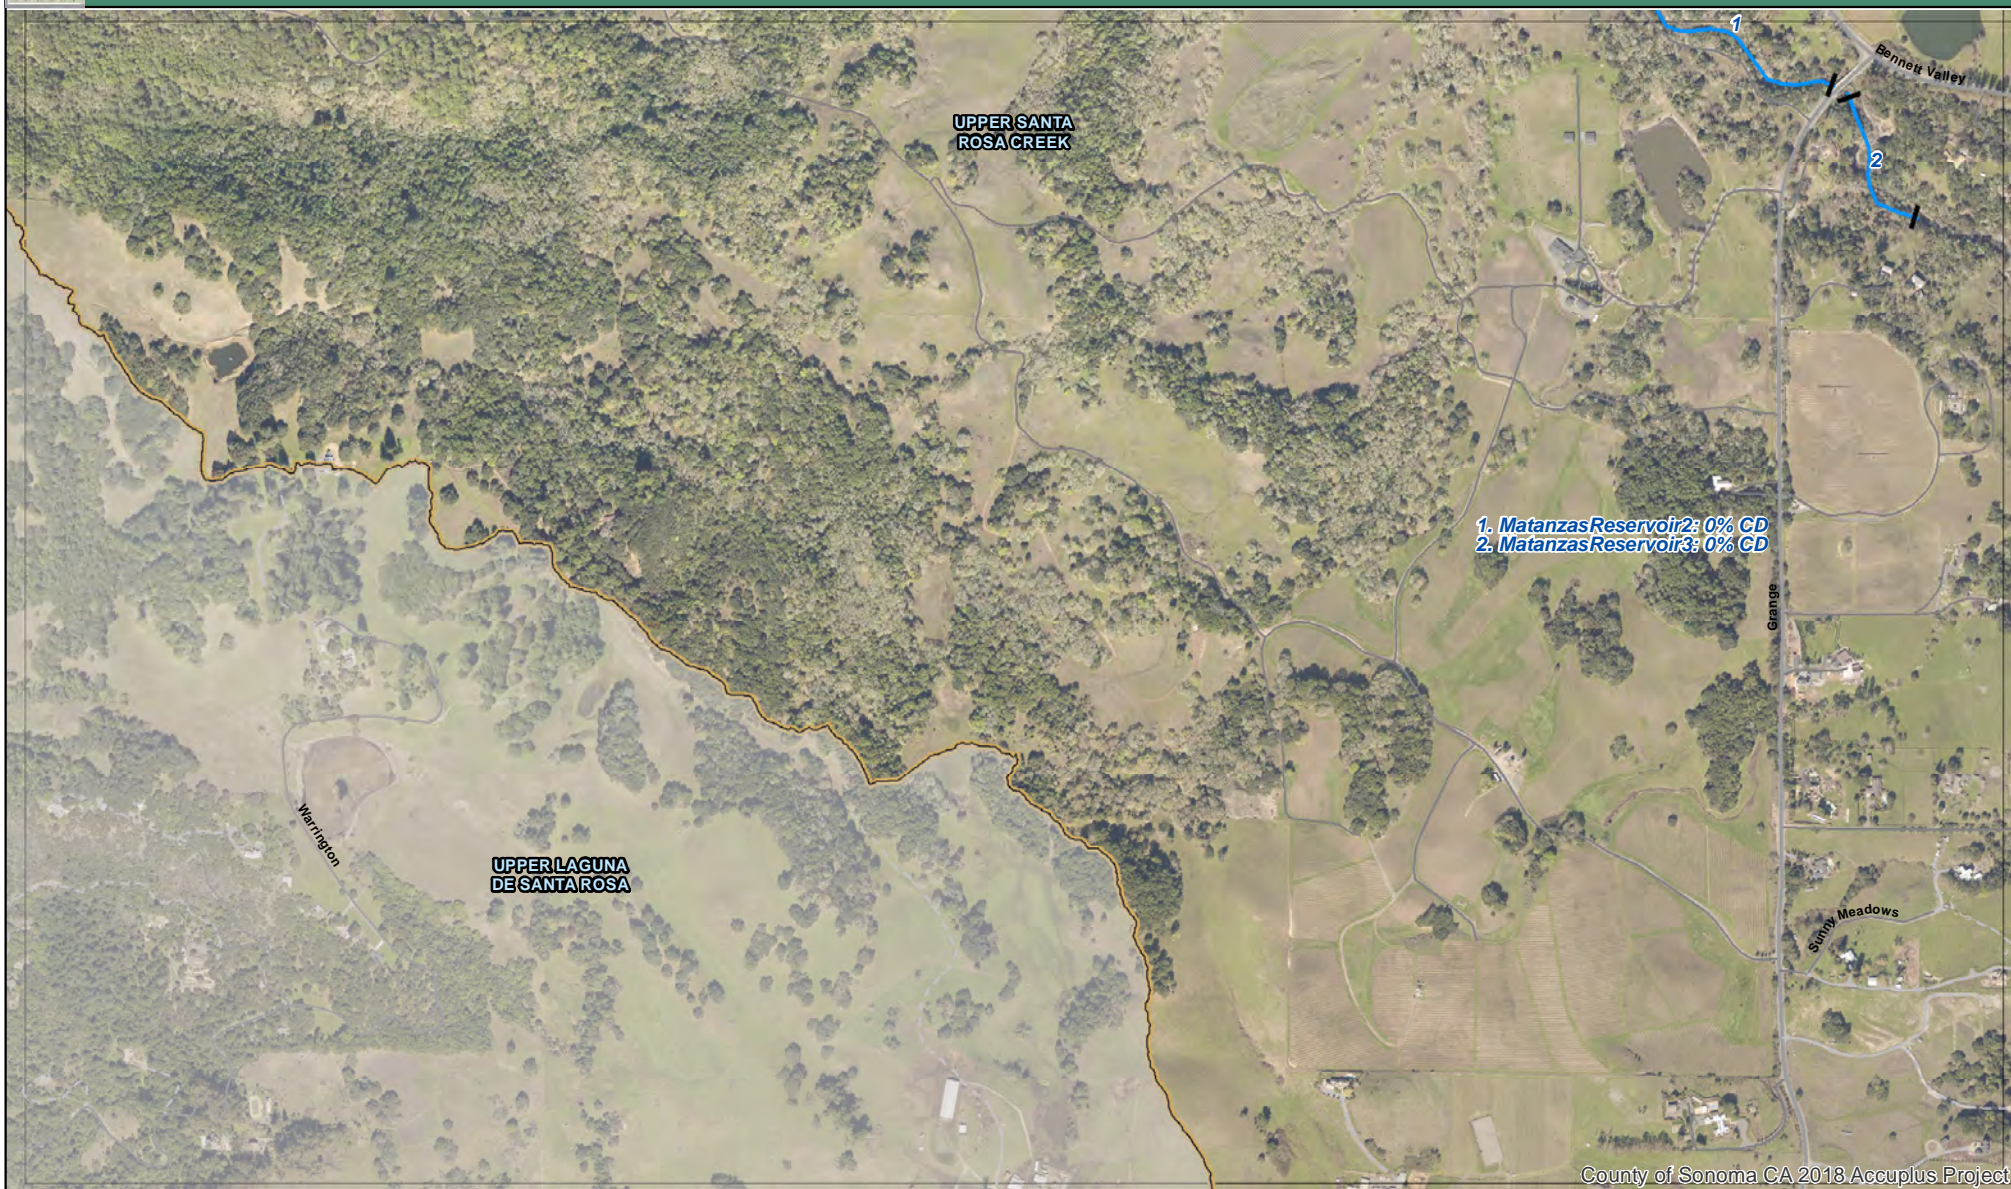
Figure C-49  
Reaches and Vegetation  
Upper Santa Rosa Creek

Sources: Sonoma County Water Agency; Sonoma County GIS  
Note: % CD = Percent Canopy Density (as of August 2019); 0% CD indicates that data is unavailable for the particular reach.

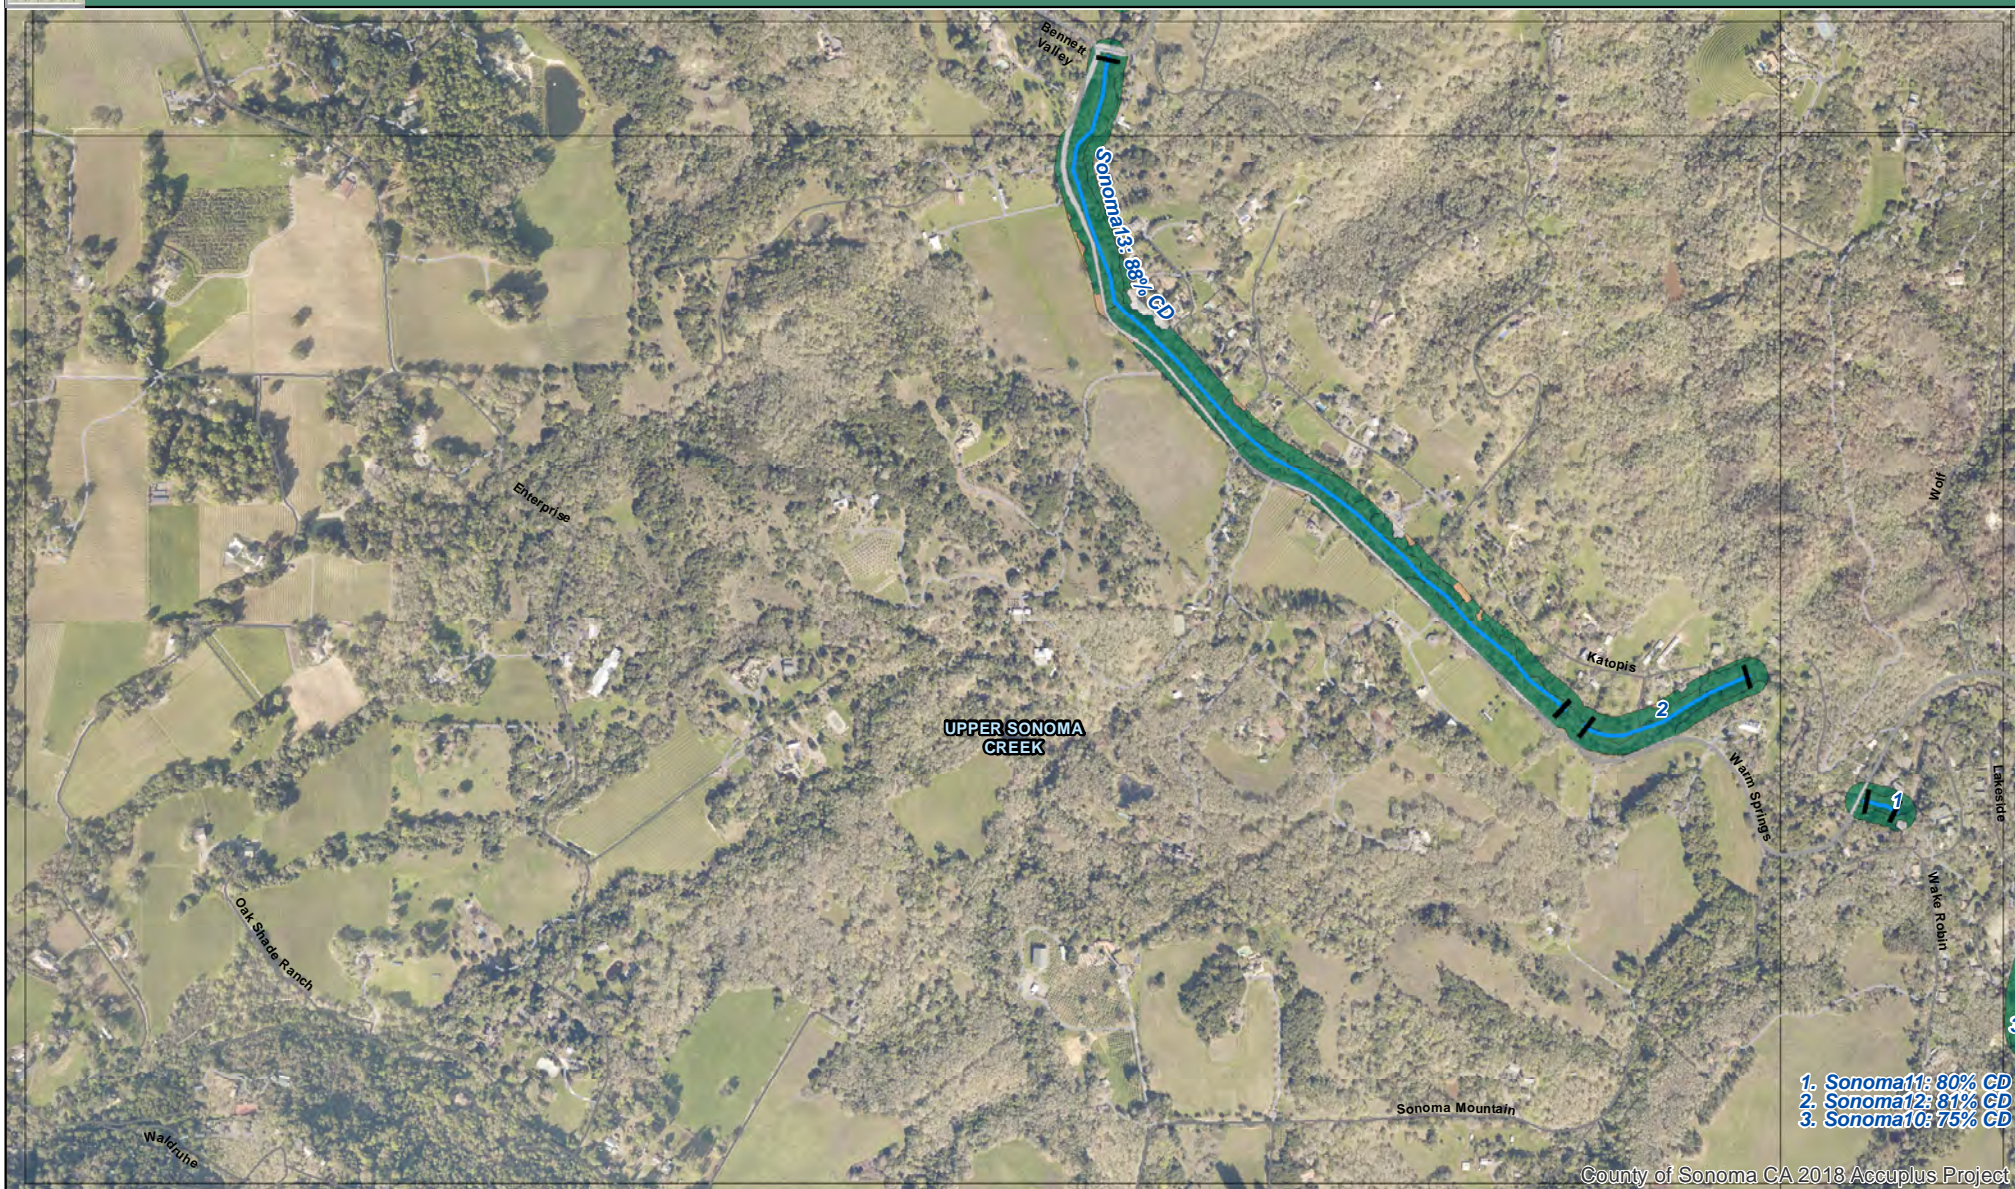
Figure C-99  
Reaches and Vegetation  
Upper Sonoma Creek

Sources: Sonoma County Water Agency; Sonoma County GIS  
Note: % CD = Percent Canopy Density (as of August 2019); 0% CD indicates that data is unavailable for the particular reach.

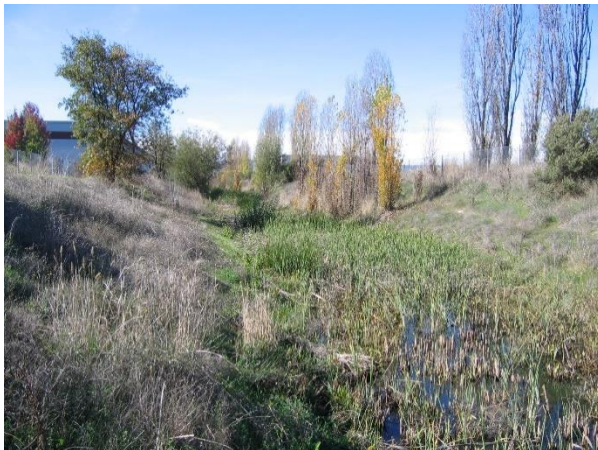
(b) Near the top of the reach looking downstream. Notice the engineered trapezoidal channel configuration and abundance of cattails growing across the flat channel bottom. Although this reach has very little riparian growth, plant poplars and oaks as well as willows appear to be thriving along a small section of creek (see photo c) (May 13, 2008).

Management considerations for Airport Creek Reaches 1 and 2 focus on vegetation removal throughout the reach and sediment removal near the Skylane Blvd culvert crossing. Due to lack of sinuosity, complexity, and shade, a number of treatments could be used to improve habitat conditions and reduce in-channel emergent vegetation growth. Aggressive planting with riparian species to provide shade and habitat would help control cattail growth and increase the value of these reaches as a migration corridor.

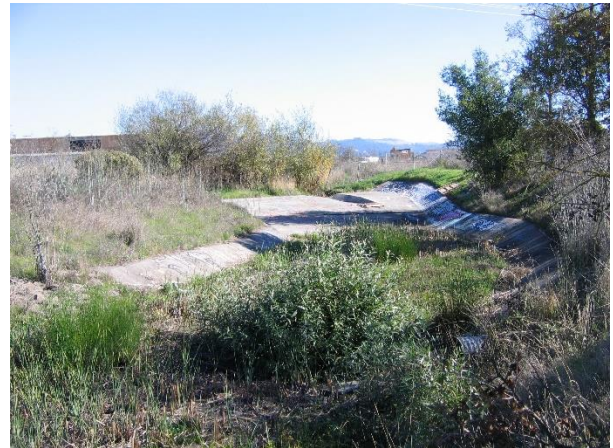
(a) Upper Reach 2 looking upstream to concrete apron that marks the beginning of SCWA's easement. Area upstream of apron channel appears more like a shallow swale across the lower plain. Broad and wide channel. Note recently cut cattails in the channel re-growing and entering culvert in the lower right (May 13, 2008).

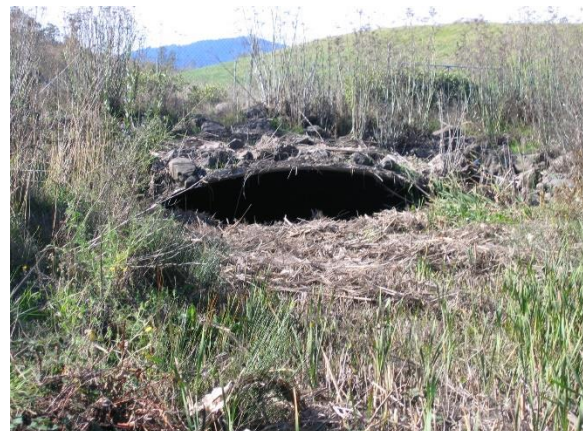
(d) Looking downstream at the culvert under Skylane Blvd. This aluminum arch is heavily impacted (as of 11/07) by sediment and cattail growth. It looks as though the culvert has lost at least ¾ of its capacity and the road bed is within a few feet of the top of the culvert. There is also a large sediment wedge on the downstream side of the culvert (May 13, 2008).

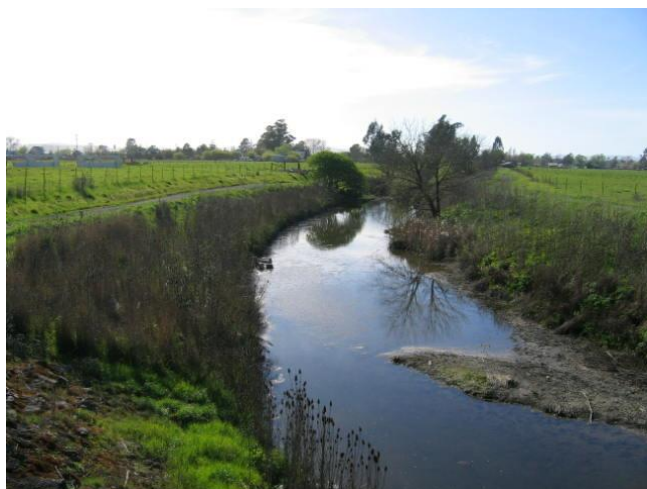
(b) Reach 4 looking downstream from first bend at railroad crossing; note wide channel, 10-12 ft below banks, with small point bar forming at inside of meander bend; riprap seen along outside bank (lower left); flow depth is 1-2 ft deep (March 14, 2007).

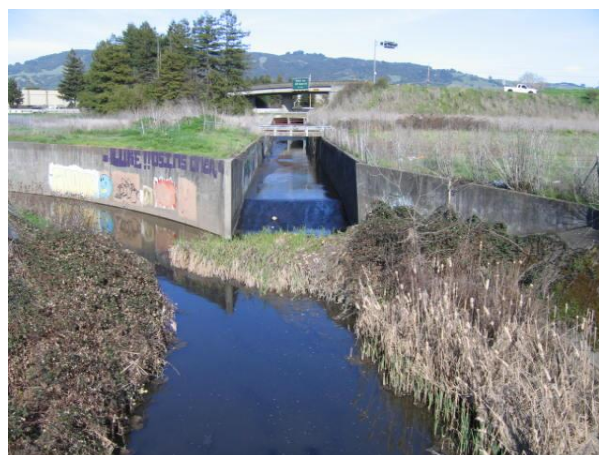
(a) Upper end of Reach 4, looking upstream to Todd Cr Reach 1 (left) and Wilfred Cr (at center); note drop structure at base of Wilfred Cr. and sediment wedge at confluence (March 14, 2007).

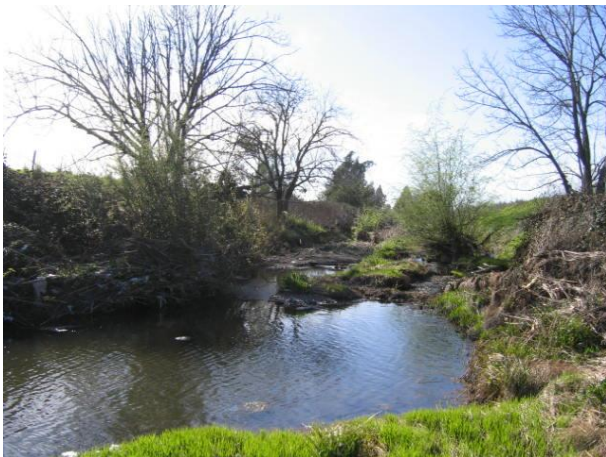
(c) Mid Reach 4 looking downstream; note pool formed by large sediment and debris wedge blocking flows. Pool depths are in excess of 6 ft (March 14, 2007).

Management considerations and opportunities for Bellevue-Wilfred Reach 4 are not extensive. There is a large sediment and debris blockage in the middle of the reach (photo c) but this dam and pooling do not appear to be creating any immediate flow hazard. This blockage should be monitored and may eventually require some clearing. Upper Reach 4 appears to have a steeper gradient than the lower Reach 4. The upper reach has some sinuosity and stream velocities under lower-flow conditions appear to be adequate to prevent settling and enable transport of finer sediments downstream. Besides the potential removal of sediment/debris at the blockage noted above, another opportunity includes enhancing the woody riparian corridor which is often lacking. Planting of riparian trees along the upper banks could benefit water quality and enhance habitat for a suite of species. Trash, plastic and other debris are observed in the lower reach and may need removal.

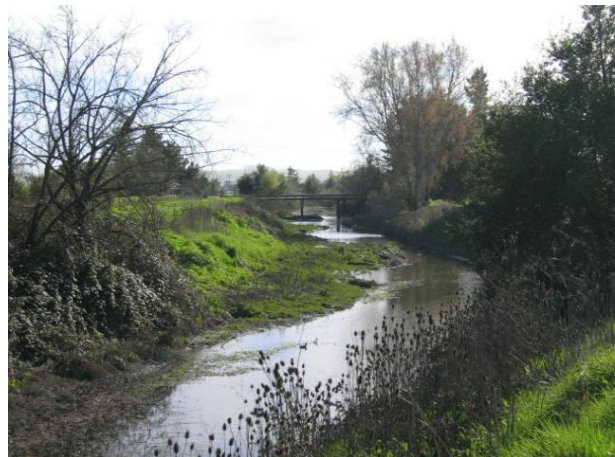
(d) Lower Reach 4 looking downstream to Millbrae Avenue; note large "D-shaped" bar along base of left bank where sediments collect on inner bend of channel (March 14, 2007).

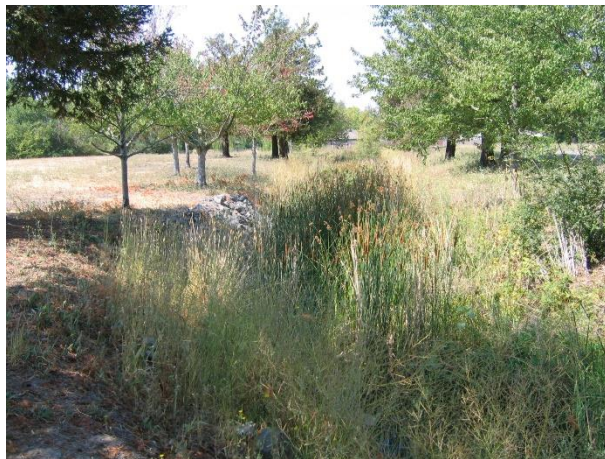
(b) Upper Reach 7 looking downstream: linear, trapezoidal channel is dry and choked with rushes and grasses. Several recent additions of rip-rap along banks (see left bank below the second tree) (August 2008).

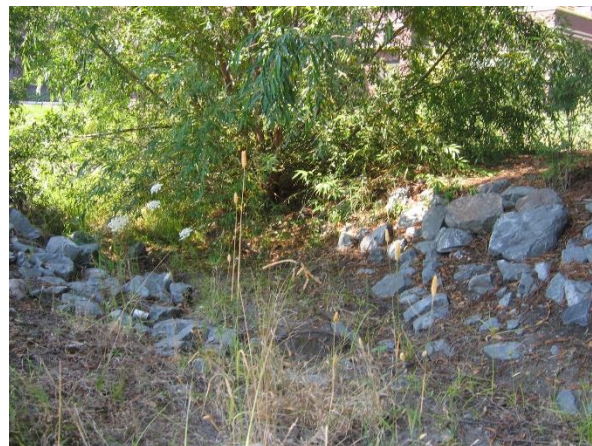
(a) Piner Cr. Reach 8 looks more like a seasonal swale than a typical flood control channel. Reach 8 was mostly dry in Aug 2008 with stands of cattails where the channel was still wet. The narrow channel includes rip-rap on the bed and banks (August 2008).

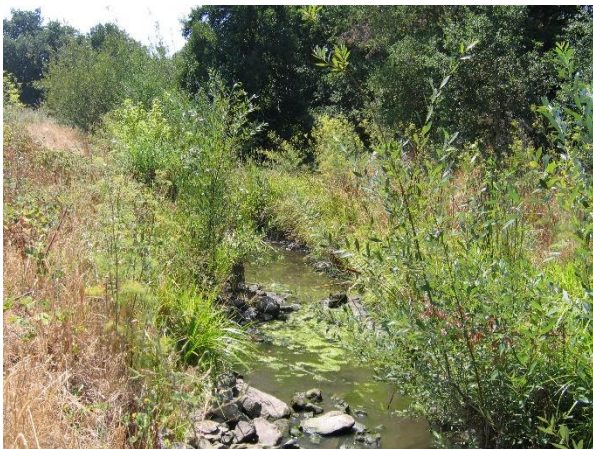
(c) Lower Reach 7 looking upstream. Eroded rip-rap extends into channel; several rip-rap banks appear unstable in many locations; water quality appears poor with brown stagnant water and extensive algal growth (August 2008).

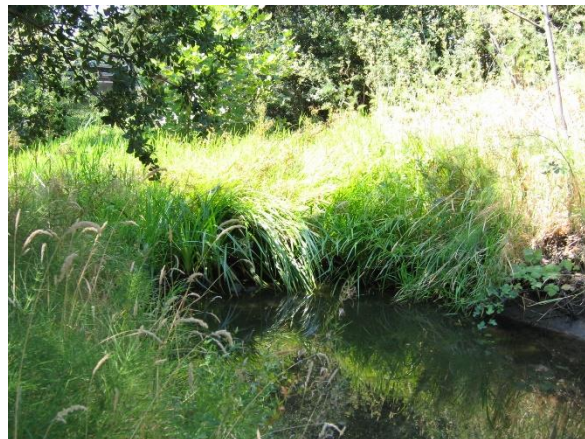
(d) Lower Reach 7 looking downstream toward the Hopper Avenue Bridge. Photo shows transition between an open water pool and a large, vegetated (with grasses) sediment wedge approx 2-3 ft high; this deposit stretches from the Hopper Ave Bridge 75 ft. upstream (August 2008).

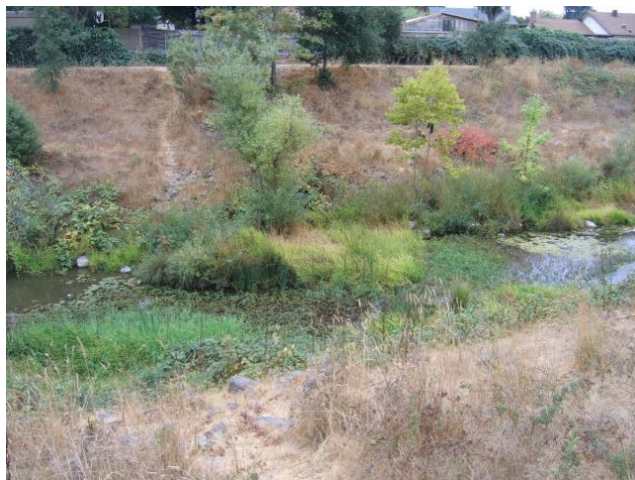
(b) Reach 3, looking across the channel upstream from College Creek confluence. Notice how the dense riparian vegetation along the banks in photo (a) has been replaced by ruderal grassland type vegetation and the presence of a d-bar constricting flow to a small 2-3 wide vegetated channel with large open channel segments both upstream and downstream (9/29/08).

Management considerations for Reach 3 are currently limited to vegetation management along the toe of slope to reduce dense arroyo willow growth and to enhance other riparian canopy species. Small bars forming in Reach 3 should be watched for impacts to conveyance and/or capacity, but current conditions do not appear to warrant major in-channel maintenance. Reach 2, on the other hand, appears to be heavily impacted by the presence of large bars/wedges increasing in size and frequency moving downstream. These bars are large enough to support robust populations of arroyo willows and create the potential for significant flood control issues. One example is the large set of bars within a ~200 ft segment of stream upstream of the Willowside Road Bridge. Willows were removed from this bar in 2005 and by August 2008, the bar was covered completely obscured by a dense thicket of 20-30 ft tall willows. The key for successful management of these bars will be determining how much material and vegetation needs to be removed to provide safe flood conveyance while encouraging the passive restoration or re-naturalization of the aquatic environment. Finally, since any sediment mobilized from these bars will eventually be re-deposited in the Laguna de Santa Rosa, particular attention needs to be paid to managing sediment in these reaches to reduce future sediment deposition into the Laguna.

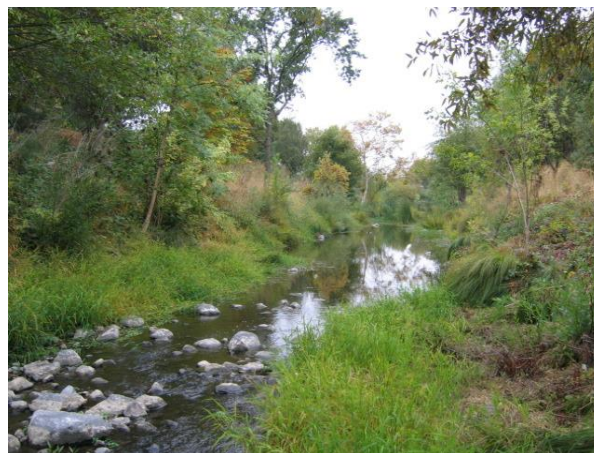
(a) Reach 3, looking downstream from just below the Marlow Road Bridge. Note the rip rap and swiftly flowing water observed in September 2008. Sediment deposition appears to be limited to small margin bars (both banks), and a moderate channel gradient leading to an open uniform channel geometry (9/29/08).

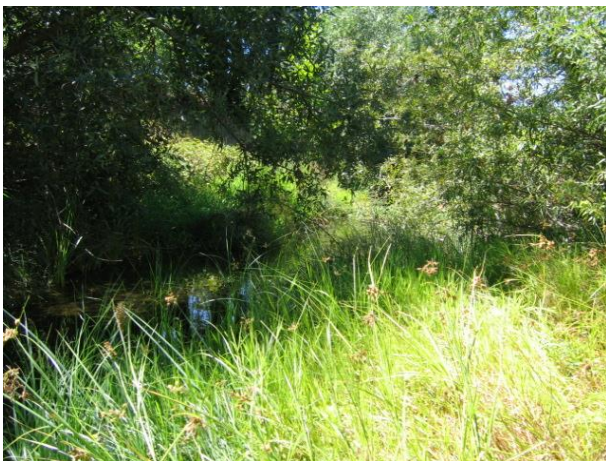
(c) Reach 2, about 500 ft downstream of Fulton Road Bridge, looking across the channel from a large vegetated bar to another large bar just downstream. At this location, the low flow channel has gone from being about 25 ft wide to about 8 ft wide due to confinement between alternating d-bars (8/21/08).

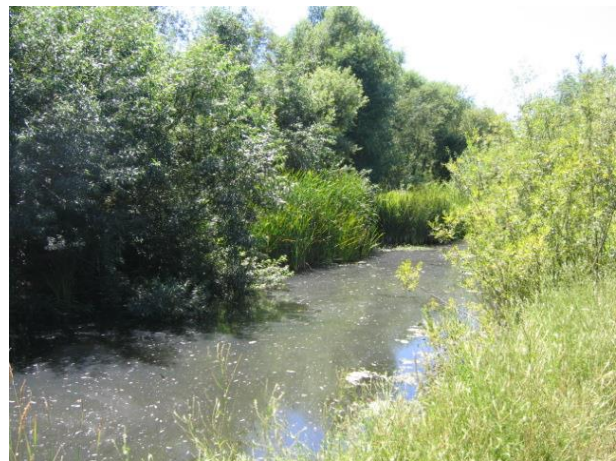
(d) Lower Reach 2, looking downstream from just upstream of the Abramson Creek confluence. Notice the large stand of cattails in the background and the stagnant “pool” in the foreground. Beyond the photo the cattail bar reduced the low flow channel from ~ 20 ft wide to ~6 ft wide creating a significant flow impediment and creating the stagnant conditions upstream. This photo is typical of the pool and wedge/bar geometry common to Reach 2 (8/21/08).

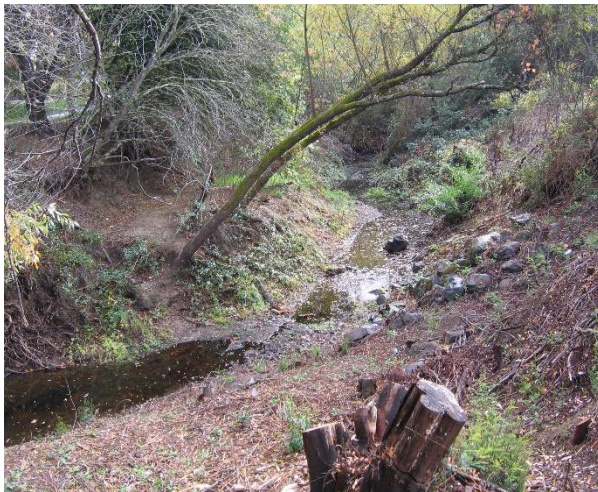
(a) Upper Reach 4, looking downstream, right bank shows widespread bank erosion with an area of failure approximately 50-75 ft long. The sands from this eroding bank appear to be the source of numerous bars forming in and along the channel downstream. (November, 2008)

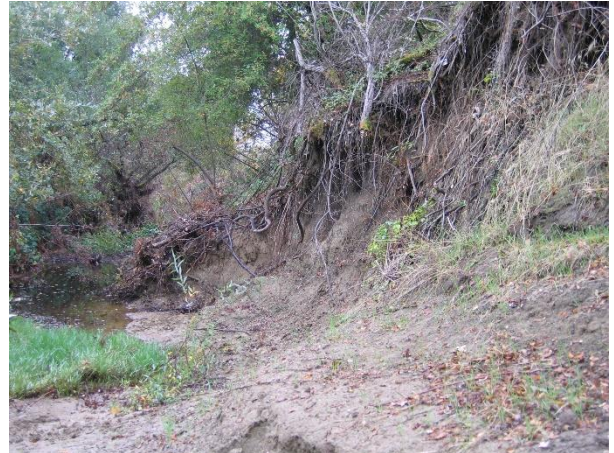
(b) Mid Reach 4, looking downstream. Note cut stump in foreground, this section of Reach 4 has experienced recent vegetation thinning and removal. Channel morphology includes pool and riffle sequences throughout Reaches 4 and 3. (November, 2008)

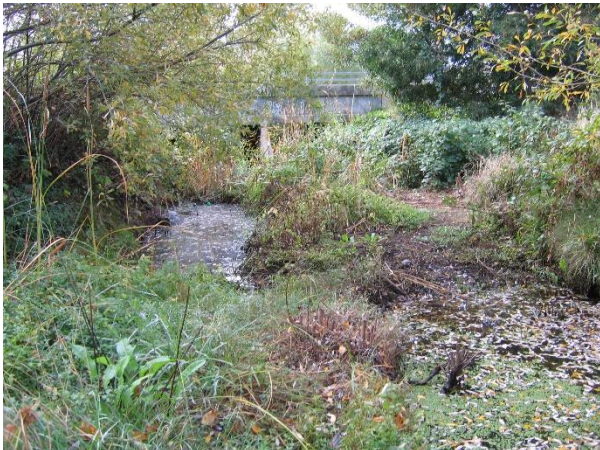
(c) Bottom of Reach 4, looking downstream to Natalie Dr. crossing. Note large bar in the foreground on the left and background on the right. Reach 4 is dominated by numerous areas of bank instability and increasing bar formations

Management considerations for Reach 4 focus on addressing chronic bank failures, especially the large slip approximately 50 ft downstream from Brooks Rd. Management in Reach 4 should also address the large sediment wedges that have built-up upstream of the Natalie Dr. crossing. This series of bars and wedges extends at least 50 ft upstream from the crossing and is between 1-2 ft above the baseflow water surface elevation. There are also a number of localized sediment wedges in Reach 3 (generally behind rock features) that should be monitored. Based on existing channel capacity, planting to create a canopy in Reach 3 would benefit a wide array of wildlife species and possibly create conditions conducive to supporting steelhead.

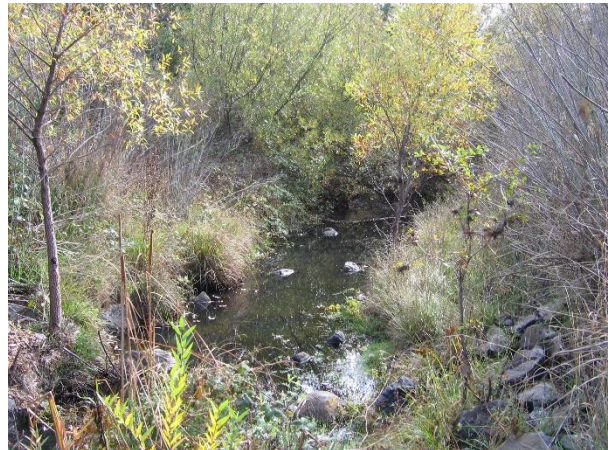
(d) Middle of Reach 3, looking downstream. Notice that the banks from the toe to the top are composed of large ungrouted rip-rap. This rip-rap is also found across the channel in many locations and appears to be functioning as grade control, and trapping and retaining sediments.

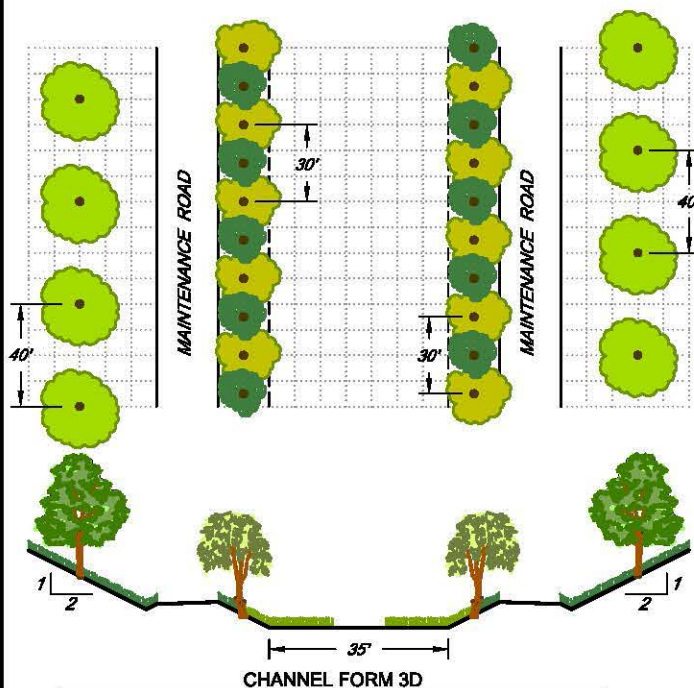
- PERMANENT TOE TREES AT 30' SPACING.
- TEMPORARY TOE TREES AT 15' SPACING.
- TREES MAY BE IN THE BOTTOM OF THE CHANNEL DEPENDING UPON WIDTH.

- ALTER TREE SPACING AND LOCATION BASED ON THE SLOPE OF BANKS, EXISTING RIPARIAN HABITAT, OR SITE CONDITIONS.
- LOCATE UPPER BANK TREES 3' TO 4' BELOW TOP OF BANK FOR MOWING.
