Technical Addendum ASR Pilot Testing at TW-6A

March 2020

GEI Consultants
2868 Prospect Park Drive, Suite 400
Sacramento, CA 95670

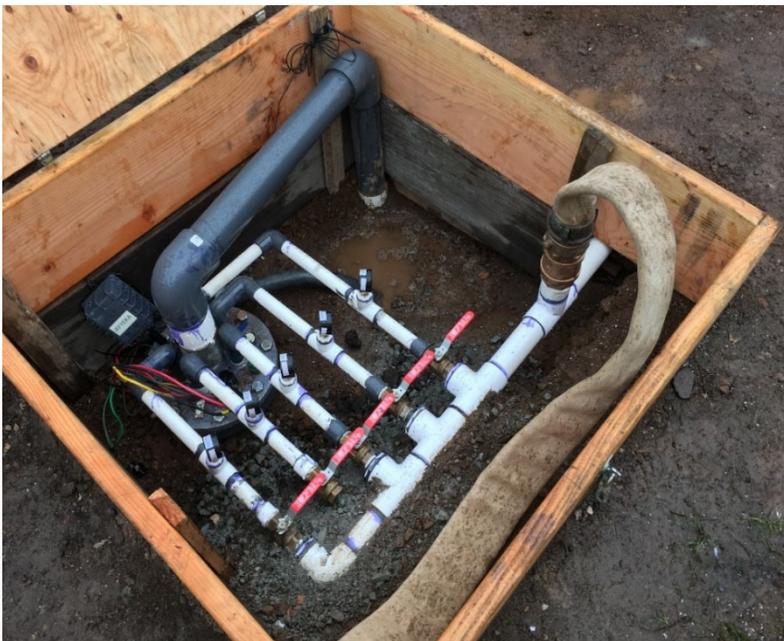
Figure 2. Wellhead Modifications

The City furnished and installed the injection and discharge water piping from the wellhead, two flow meters, valves, pressure gages, and other appurtenances. In addition, the City replaced the small Christy Box with a 16-square foot wooden enclosure large enough to house all infrastructure at the wellhead. The 1-inch diameter injection tubes were connected to a 2-inch diameter PVC manifold that was connected to piping to the nearby Sonoma Water potable water supply pipeline. The manifold also included a connection to a 2-inch diameter fire hose in the event the

injection piping needed flushing. Pressure gages were installed at the wellhead on each injection tube and at the connection to the potable supply pipeline. Valves were installed on each injection tube upstream of the pressure gage and both upstream and downstream of the flow meter. A pressure gage and sampling port was installed on the injection piping near the connection to the potable supply pipeline. **Figure 2** and **Figure 2** show the completed wellhead modifications and the equipment at the connection to the supply pipeline, respectively.

(Pump-to-waste via flexible hose.)

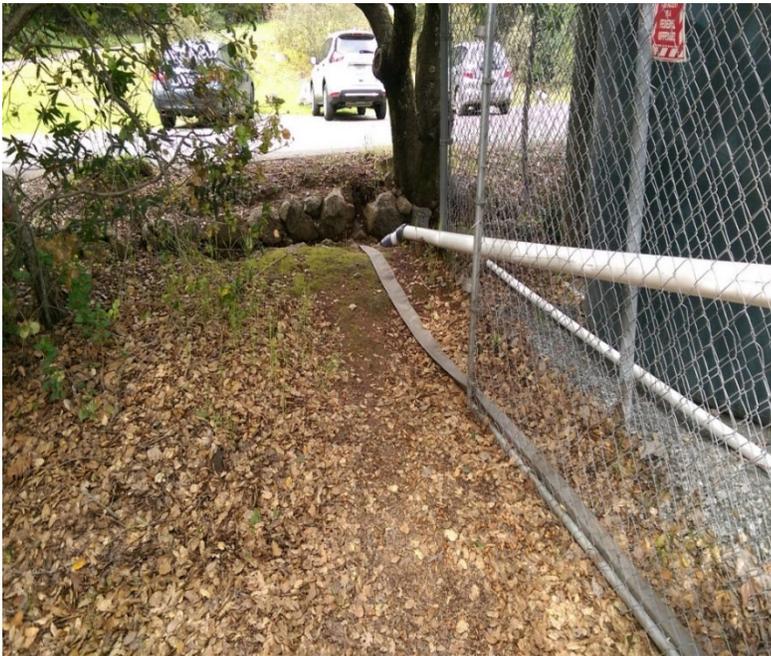
Figure 4. Discharge Piping from Settling Tanks

The City also installed discharge piping from the wellhead to the two (2) interconnected 6,000-gallon settling tanks with PVC piping installed from the second settling tank to the adjacent drainage channel. **Figure 4** shows the discharge piping along with the settling tanks.

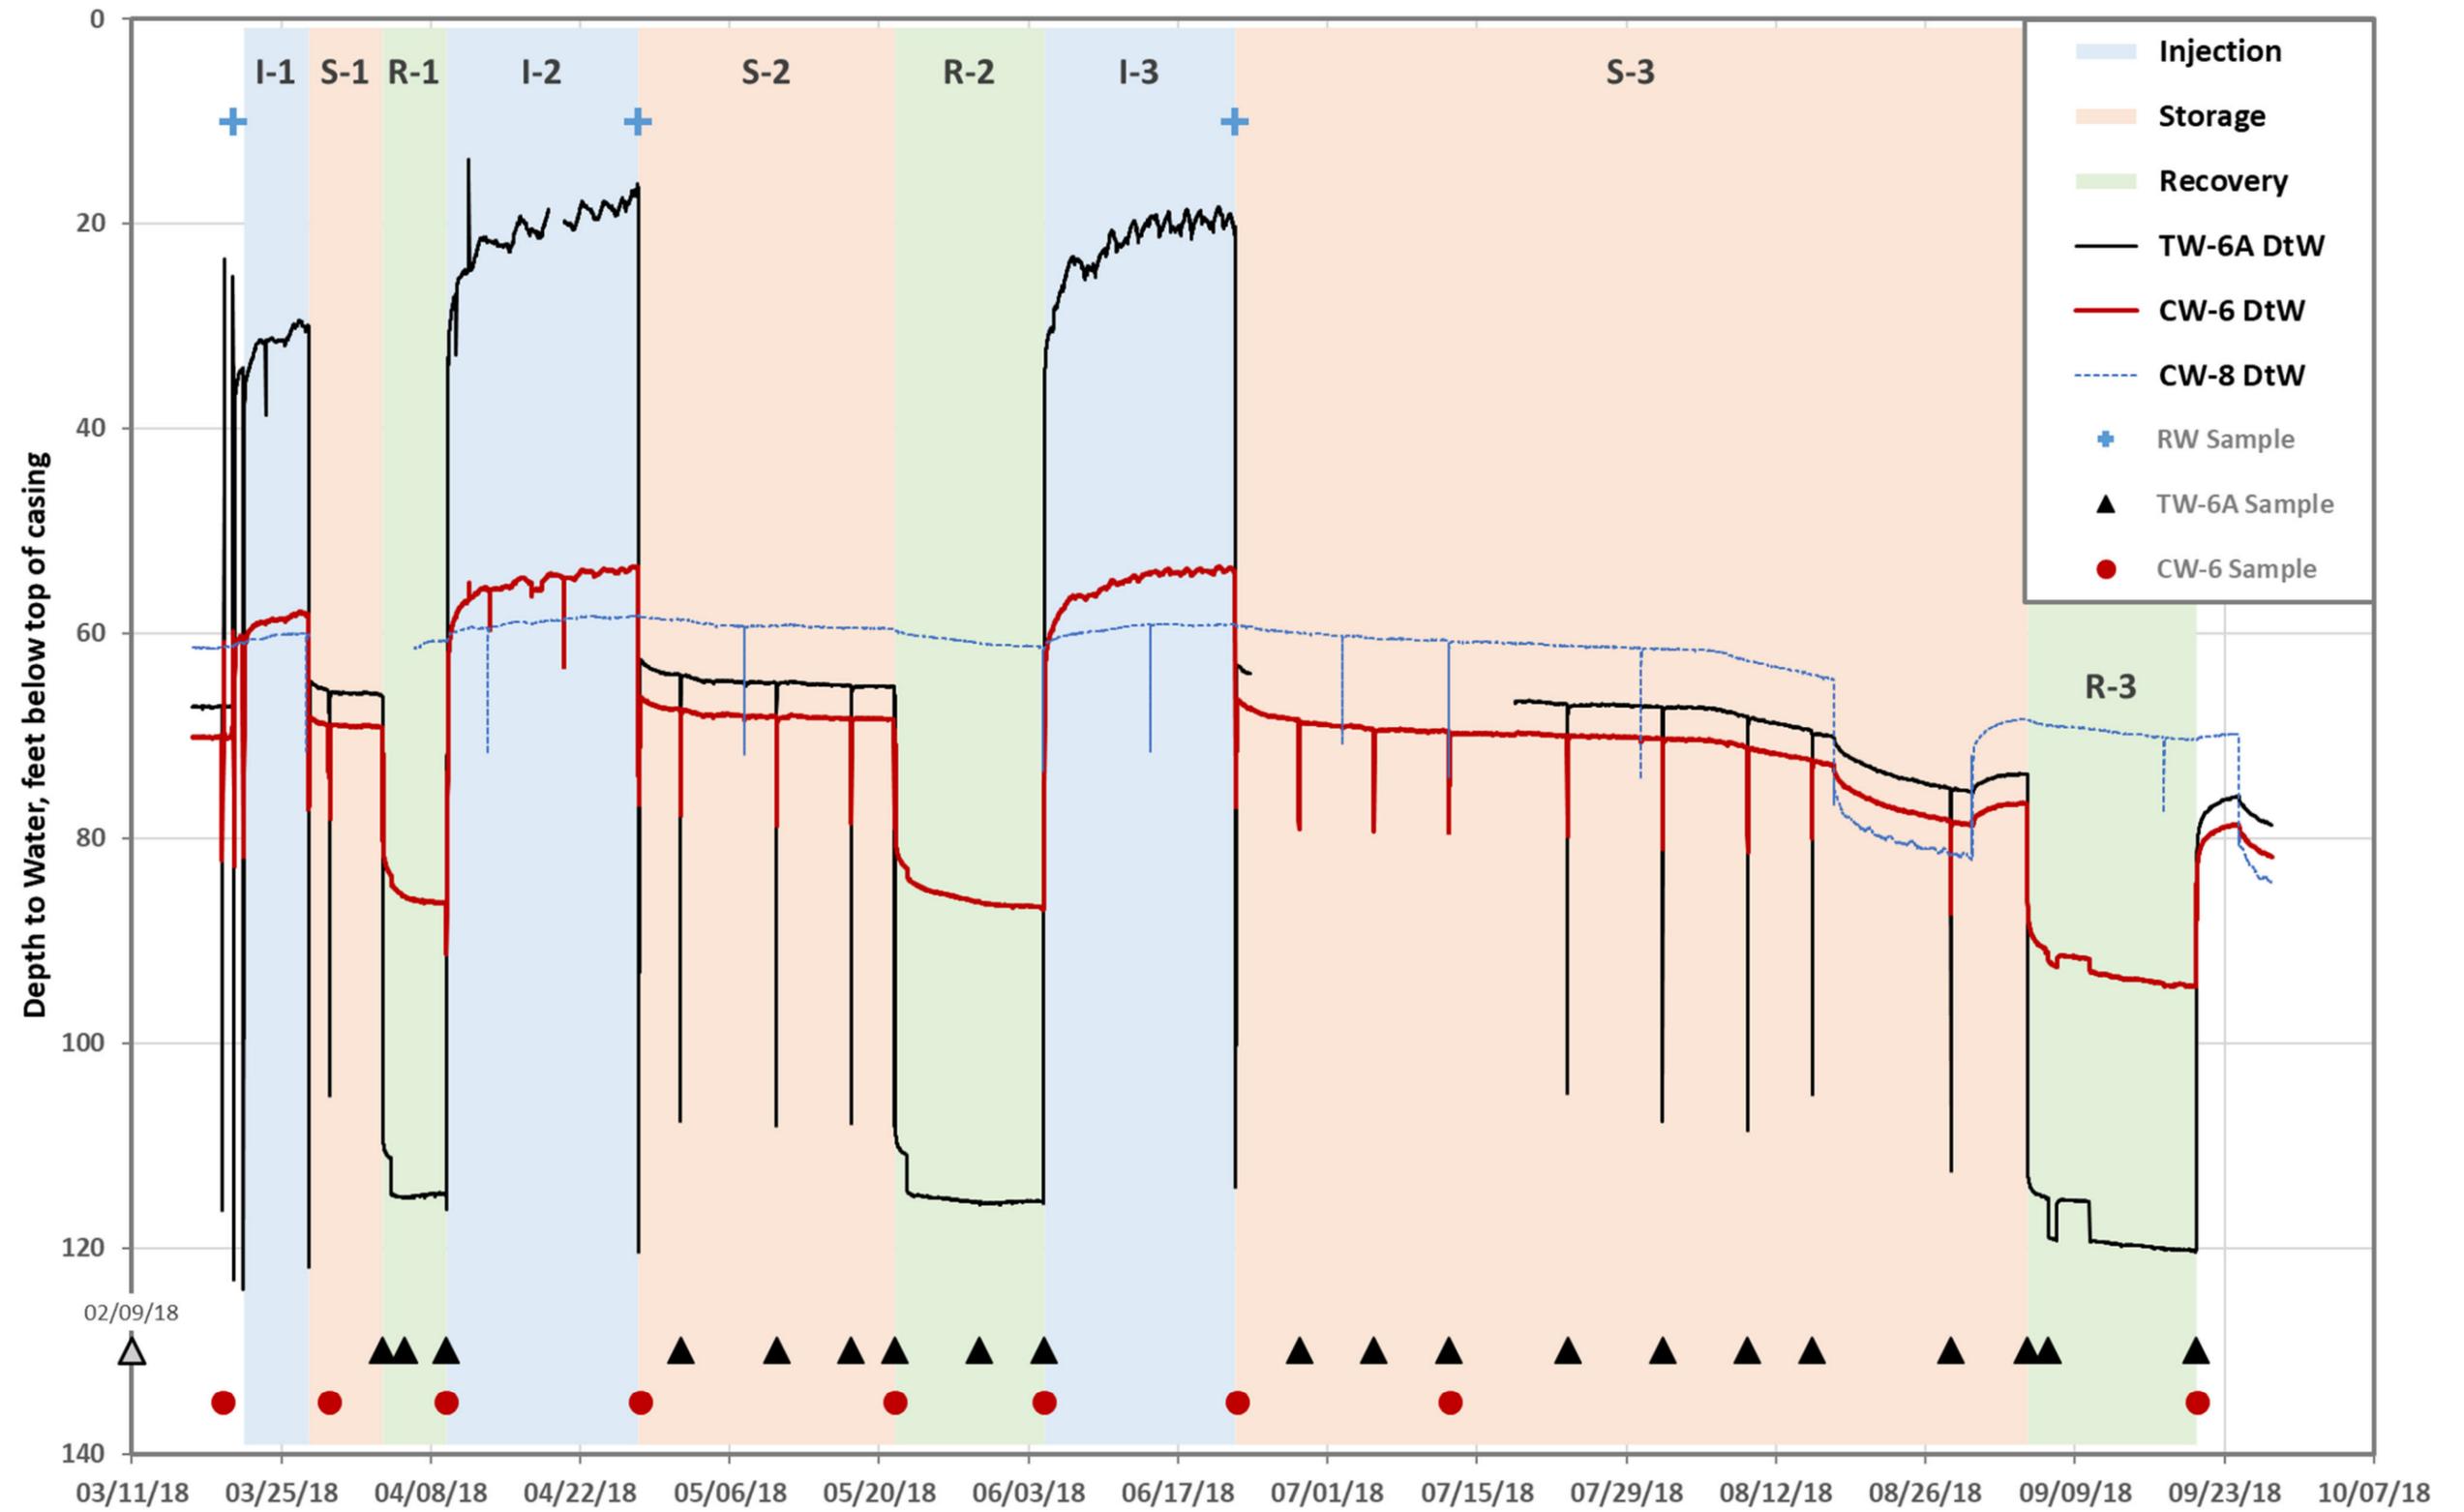
Figure 6. Hydrograph for Wells TW-6A, CW-6, and CW-8

Figure 6 appears to be a complicated illustration but is really a repetition of three sets of conditions that can be described as follows. Each ASR cycle is composed of an injection period (blue shading), a storage period (orange shading) and a recovery period (green shading). Groundwater level (WL) depths are shown by a black line for TW-6A and by a red line for CW-6.

The hydrograph starts on the left with three horizontal lines of static WLs and is followed by a brief period of erratic WLs at TW-6A and CW-6 during the initial calibration testing of the ASR equipment. The WLs for the first and second ASR cycles are similar even though the duration and injection volume of the second cycle are three times longer.

During the third ASR cycle, TW-6A WLs rose to 20 feet bTOC by the end of the 18-day injection of over 1.8 M-gallons of water at an average flow rate of 71 gpm. CW-6 WLs rose to a depth of 54 feet bTOC and CW-8 rose to a depth of 59 feet. After 45 days of storage, WLs had declined in each well: 67 feet at TW-6A, 70 feet at CW-6, and 62 feet at CW-8 bTOC – about the same depths at the start of the pilot test, when the downward slope of the WL trends increased slightly in the three wells. The cause of this slope change is not readily apparent but could be due to pumping at a distance well.

Brief WL drawdowns occurred during the transition between injection and storage periods due to backflushing and specific capacity testing of TW-6A and sampling of CW-6; and during the storage periods due to periodic sampling of TW-6A and also for the sampling of CW-6. During the backflushing, testing, and sampling, WLs varied between 50 and 122 feet bTOC at TW-6A and between 59 and 77 feet bTOC at CW-6. During storage sampling, TW-6A drawdown varied from 35 to 43 feet (median: 40 feet) for 9 of 12 events, depending on pumping rate and duration, which caused drawdown at CW-6 that varied between 6 and 11 feet (median: 10 feet) for 12 events. The CW-6 sampling drawdown was about 5 feet for two storage sampling events, which caused a 2-foot drawdown at TW-

WLs were measured for seven days after termination of the ASR pilot test. During the first four days WLs rebounded normally to about 76 feet bTOC at TW-6A, 79 feet bTOC at CW-6, and 70 feet bTOC at CW-8 – nearly 9 feet deeper than the pre-test levels. The operation of CW-8 caused the WLs to decline by about 3 feet at TW-6A and CW-6 during the last three days of the post-test period, and by 14 feet at CW-8.

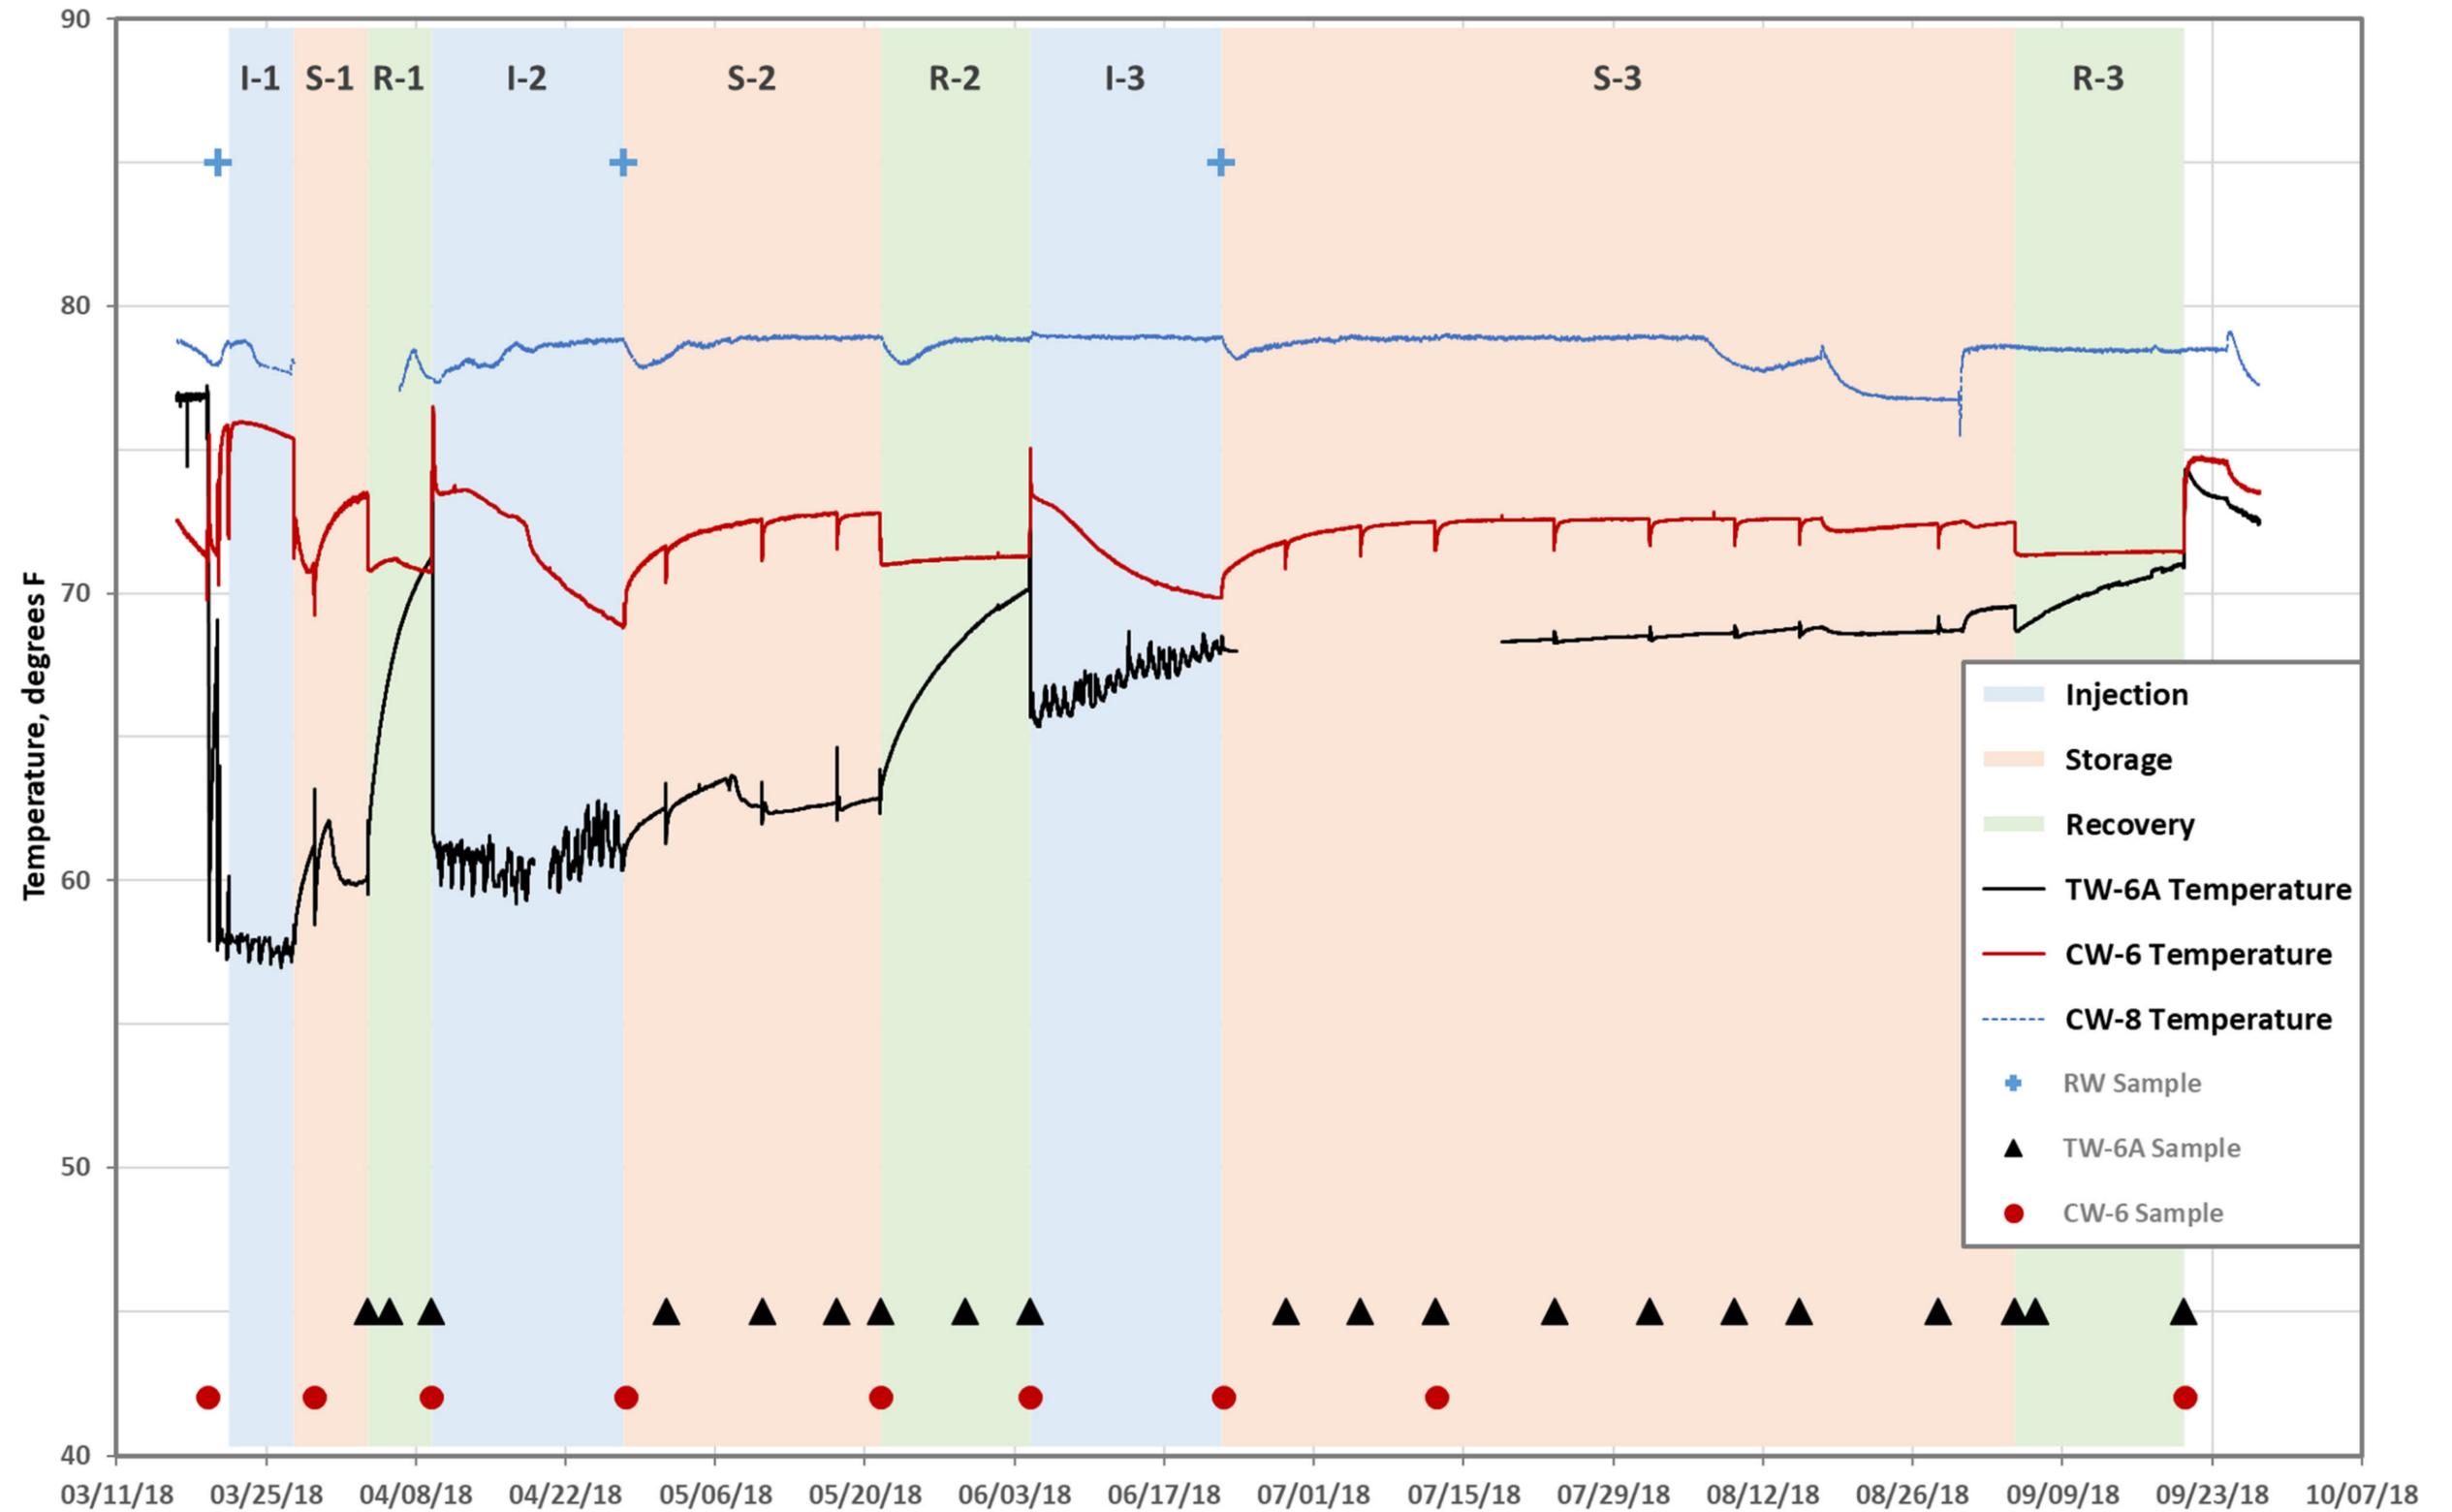
Figure 7. Groundwater Temperature at Wells TW-6A and CW-6

The water temperature data are also complicated but displayed repetitious conditions during much of the three period of each ASR cycle, similar to the WL data. In general, the temperature differences between TW-6A and CW-6 were greatest at the start of the pilot test but decreased during the progression of the test – overall and for each period. This convergence was likely due to overall increase in volumes and durations of each cycle and the variable conditions of starting the test in early spring and preceding until late summer. The temperature of CW-8 was several degrees higher than CW-6 and TW-6A and showed the least variation in temperature but the temperature of the well did respond to the ASR activities occurring 840 feet away, as discussed below.

Pre-ASR test conditions start on the left with relatively steady warmer temperatures (77° F) for TW-6A compared to declining, cooler temperatures (71° F) at CW-6. Conversely, temperatures at CW-8 are warmer (78° F) but declining prior to ASR activities. The temperature differences prior to ASR activities are notable and the reasons for these differences are not known but are likely related to location and well construction. During the pre-test calibration activities, the temperature of TW-6A was variable but dropped by nearly 20° F due to the use of the colder injection water, which was subject to ambient temperature conditions. Conversely, the variable temperature of CW-6 rose about 4° F, which

may have been due to relatively warmer water between the two wells being pushed toward CW-6 by the injection of water at TW-6A.

During each injection period, the TW-6A temperature data declined substantially from the previous period and were cyclic during the injection period as the overall temperatures were increasing, from the high 50s during March to the high 60s during June. These diurnal cycles and the overall increase were due to the ambient conditions of the supply pipeline. The daily range of temperatures varied up to 1° F during the first injection period in March, between 1.4 and 2.3° F during the second injection period in April, and between 0.7 and 1.9° F during the third injection period in June. The overall temperature at TW-6A decreased during the first injection period and during the first half of the second injection period at similar rates, whereas the overall temperature of the second half increased at twice the rate, presumably due to warmer weather in late April. The overall temperature at TW-6A continued to increase during the third injection period in June.

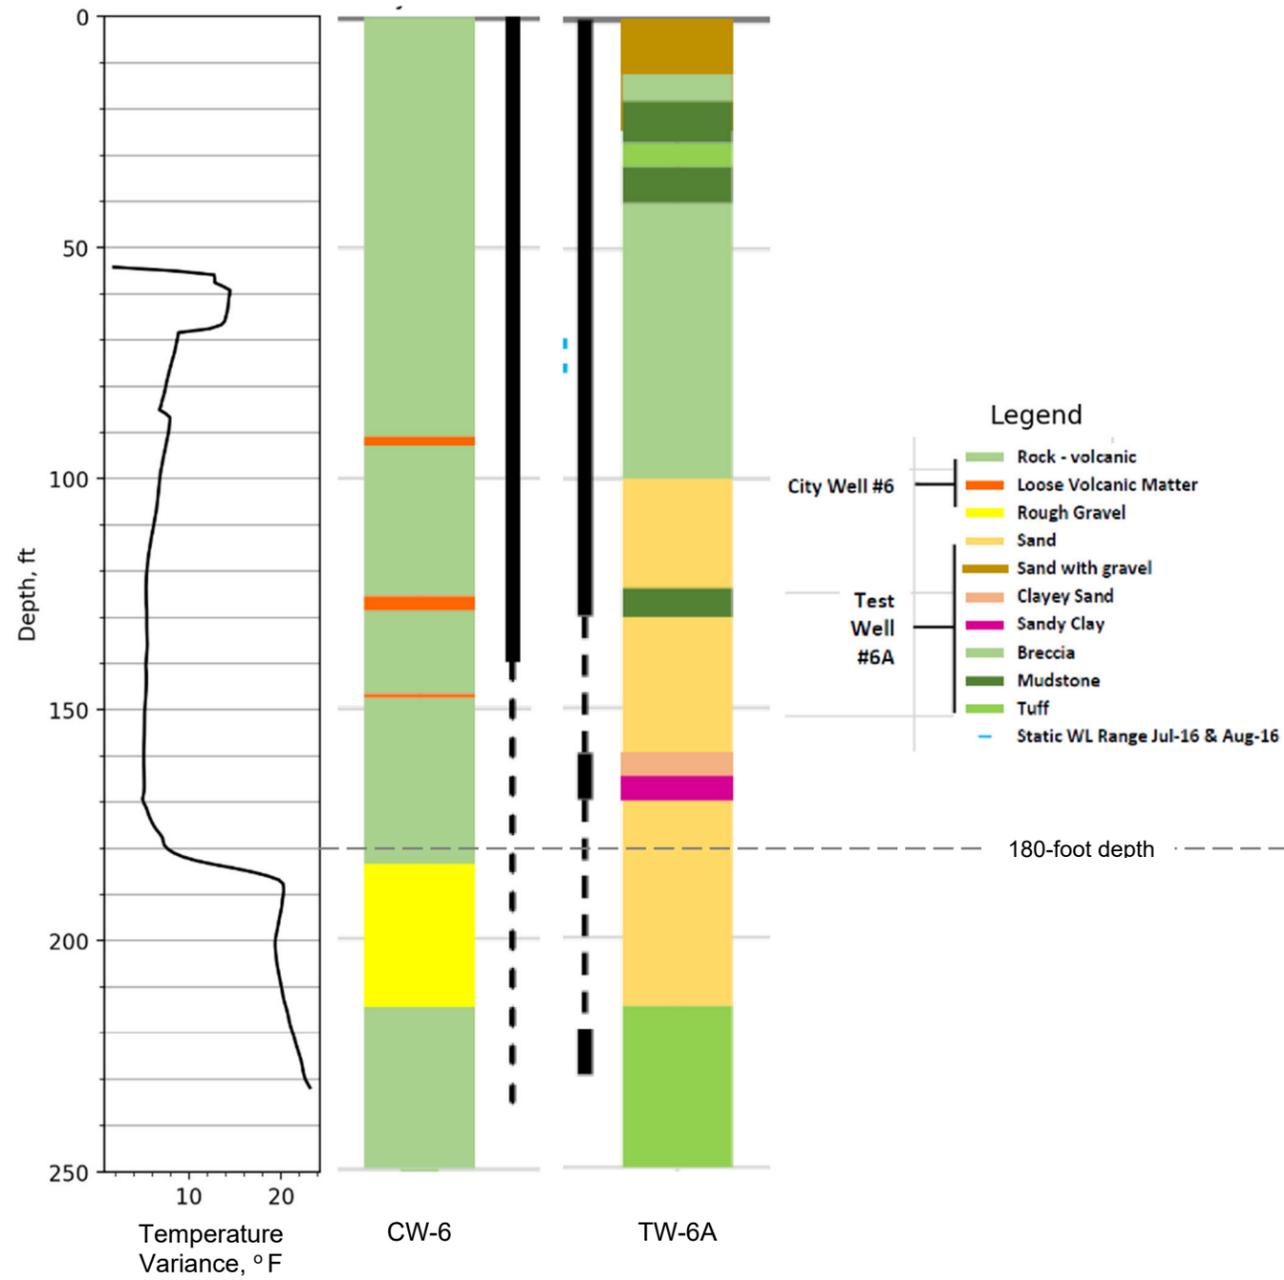
Figure 8A displays the relative temperature variance with depth over the entire DTS monitoring period and provides clearer evidence that the vast majority of thermal transport (and groundwater movement) occurs within the 180- to 230-foot depth horizon. This depth interval corresponds with a zone of “rough gravels” identified on the log for CW-6 and the lower interval of medium to coarse-grained sands (volcaniclastic) identified at TW-6A.

A. Relative Temperature Variance with Depth at CW-6, Late March to Early June 2018

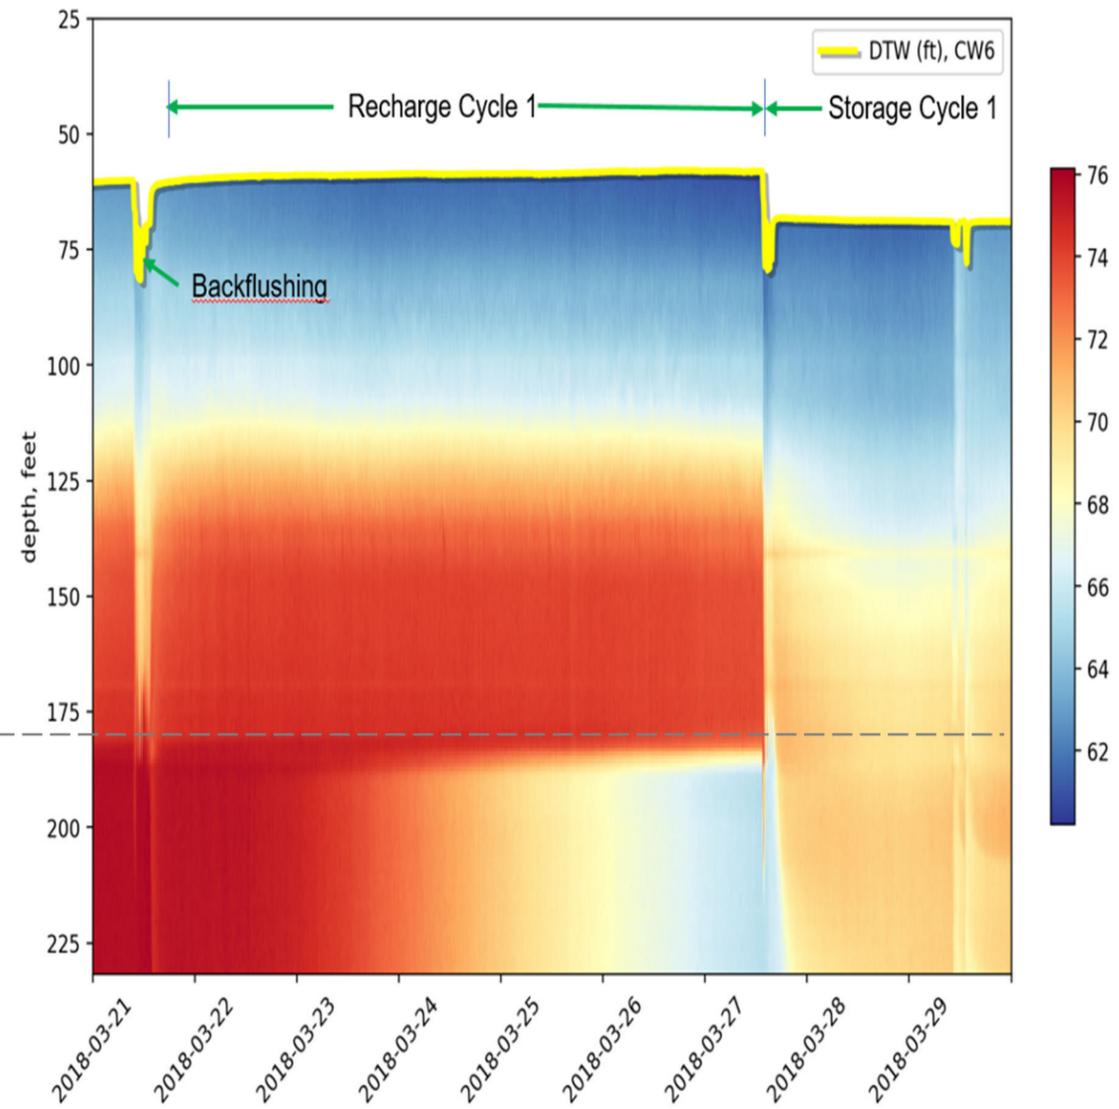
As shown in Figure 8B, the strong temperature contrast between the cooler recharge water and warmer native groundwater, coupled with high resolution data collection by the DTS, was utilized to identify any preferential zones for flow within the aquifer system and help constrain the thickness and depths of those zones. The perforations at CW-6 are continuous between 140 and 236 feet and the log for the well has very limited lithologic information. However, results from the DTS indicate that temperatures initially ranged up to 75° F within CW-6 consistent with the temperature sensor data described above. As shown in Figure 8B, the temperature change (decrease) observed within CW-6 during recharge cycles is most striking between the depths of approximately 180 and 230 feet and correlates with the lower screened interval of TW-6A. During recharge cycle 1, the temperature between the depths of 180 and 230 feet at CW-6 began decreasing approximately two days after the onset of recharge due to the influence of the cooler water being introduced at TW-6A, while the temperatures above that depth interval remained relatively stable throughout the entire recharge cycle. During backflushing and recovery events, the entire vertical water column initially cools down before warming again as the cooler recharge water is extracted and replaced with warmer native groundwater. The gradual warming during the later stages of recovery periods is also much more pronounced between the depths of 180 and 230 feet. The less pronounced vertical variation in water temperature during the short-term backflushing events and early stages of recovery may be due to the turbulent nature of backflushing and the onset of pumping, which causes vertical mixing within the well casing.

B. Temperature (°F) Distribution at CW-6, March 21 to 29, 2018

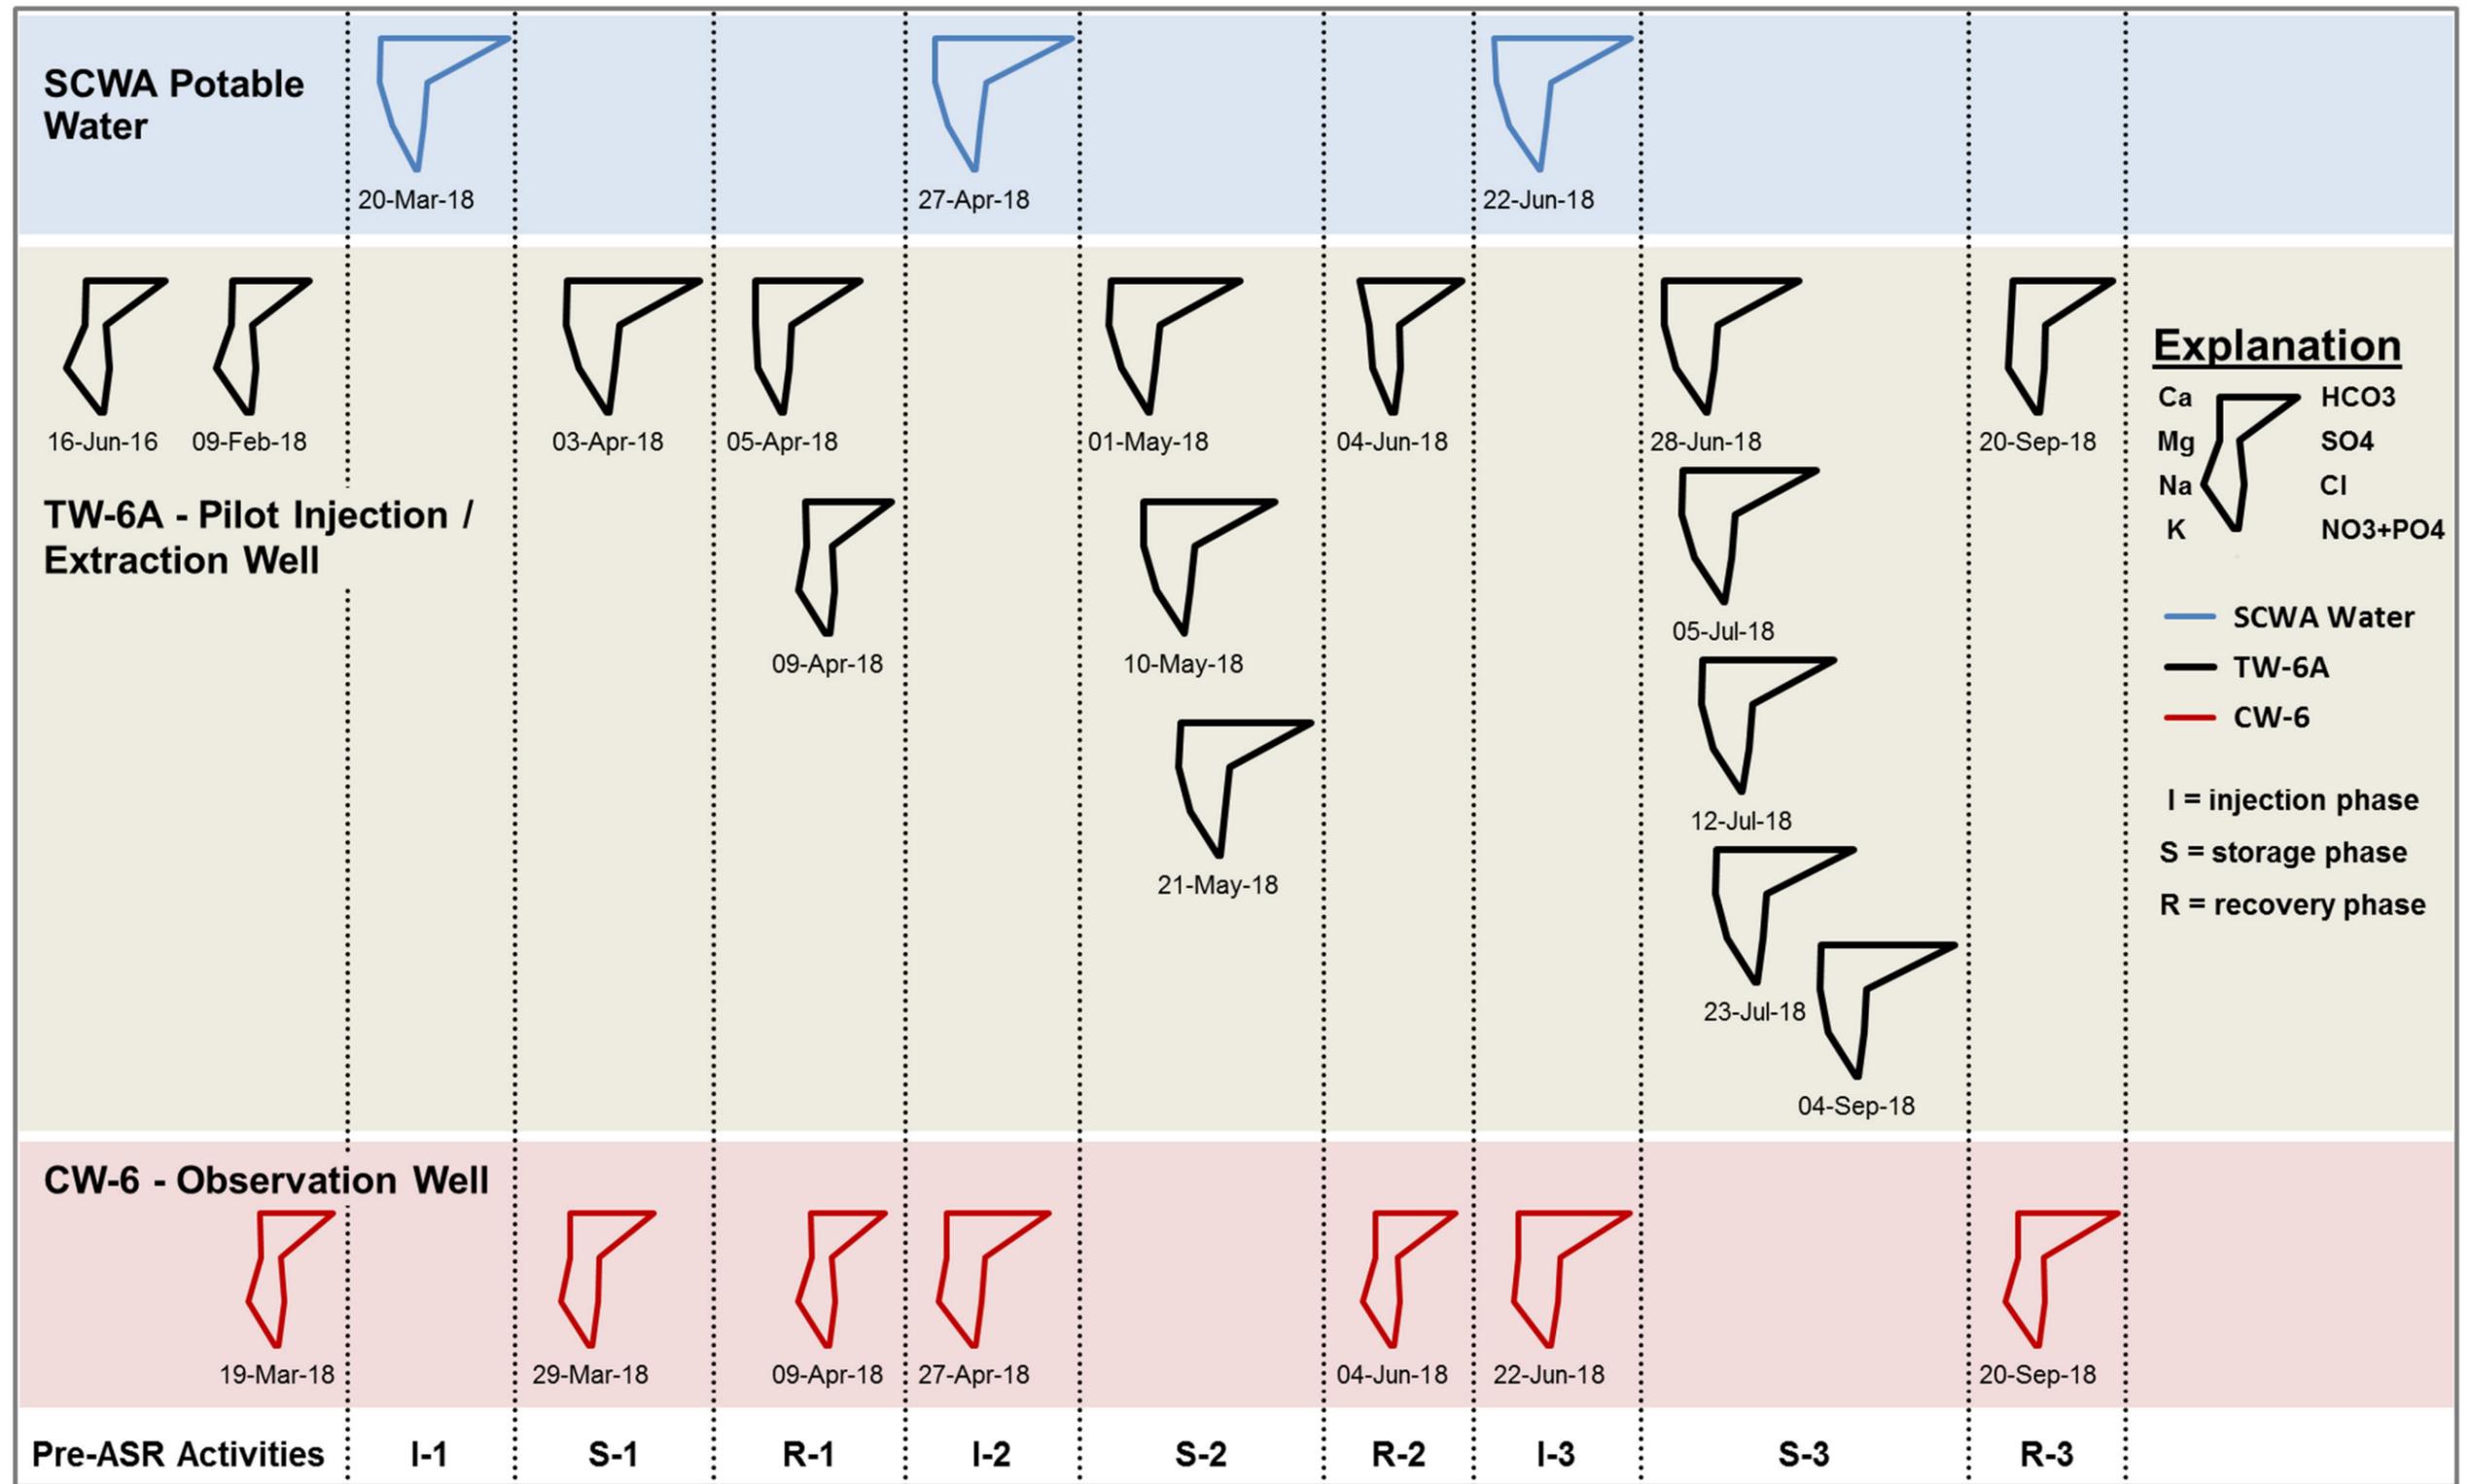
Figure 8. Stiff Patterns for Anion / Cation Data

During the first storage (S-1) period, the shape for TW-6A is quite similar to the RW shape because over 0.48 M-gallons of recharge water were injected to the well. Whereas, the shape for CW-6 has not changed significantly but appears to be slightly larger, which indicates minimal impact from the RW injection. During the first recovery (R-1) period, the first shape for TW-6A is smaller and midway between the two end-members after the recovery of more than 0.2 M-gallons. At the end of R-2, the shapes for TW-6A and CW-6 are quite similar to their starting shapes due to the recovery of more than 0.72 M-gallons of groundwater from TW-6A, including a relatively small volume for sampling. This recovery volume is 50% greater than the injection volume

For the second injection (I-2) period, the shape for CW-6 is clearly intermediate between its original shape and the RW shape after injecting over 1.73 M-gallons. During the second storage (S-2) period, the shape for TW-6A is quite similar to the size and shape for recharge water, and then shifts to an intermediate shape by the end of the second recovery (R-2) period, indicating a residual presence of the recharge water.

The CW-6 shape is slightly larger but similar to the original shape, which indicates a smaller residual. Only about 1.66 M-gallons were recovered during the second cycle, including sampling, which is about 4% less than the injection volume.

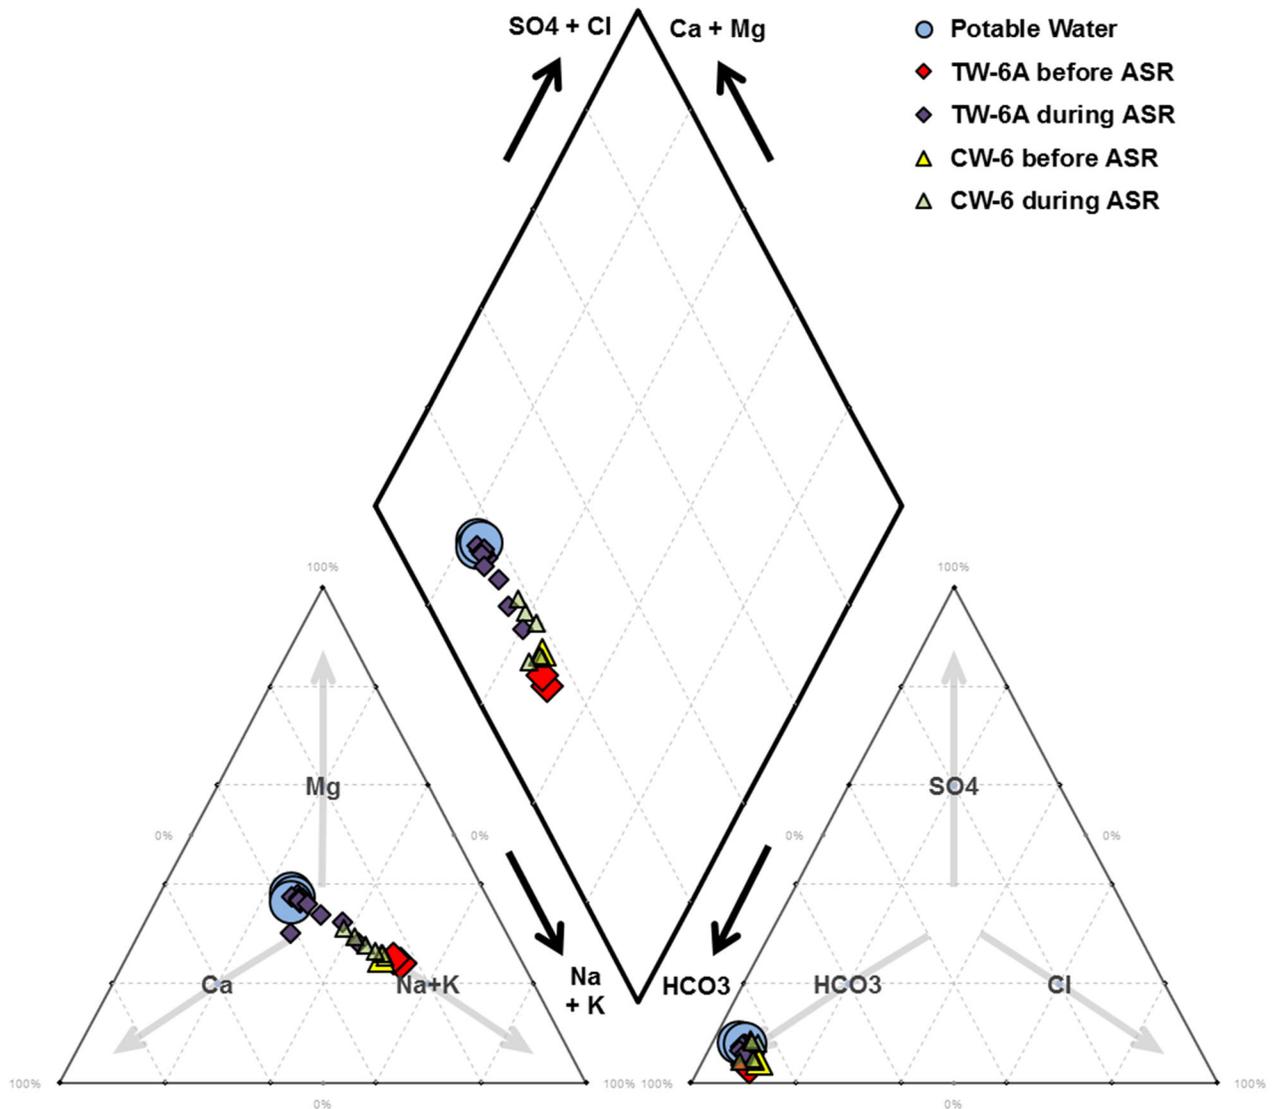
Figure 9. Piper Diagram of Anion / Cation Data

The purple diamonds represent TW-6A at various times during the ASR pilot test and, similarly, the green triangles represent CW-6. As expected, these symbols plot in a line between the two end-members. The purple diamonds extend all the way to the blue circles because the recharge water replaces the native groundwater at TW-6A at different times during the test. Whereas, the green triangles only extend partway to the blue circles because a mixture of native groundwater and recharge groundwater remained at CW-6.

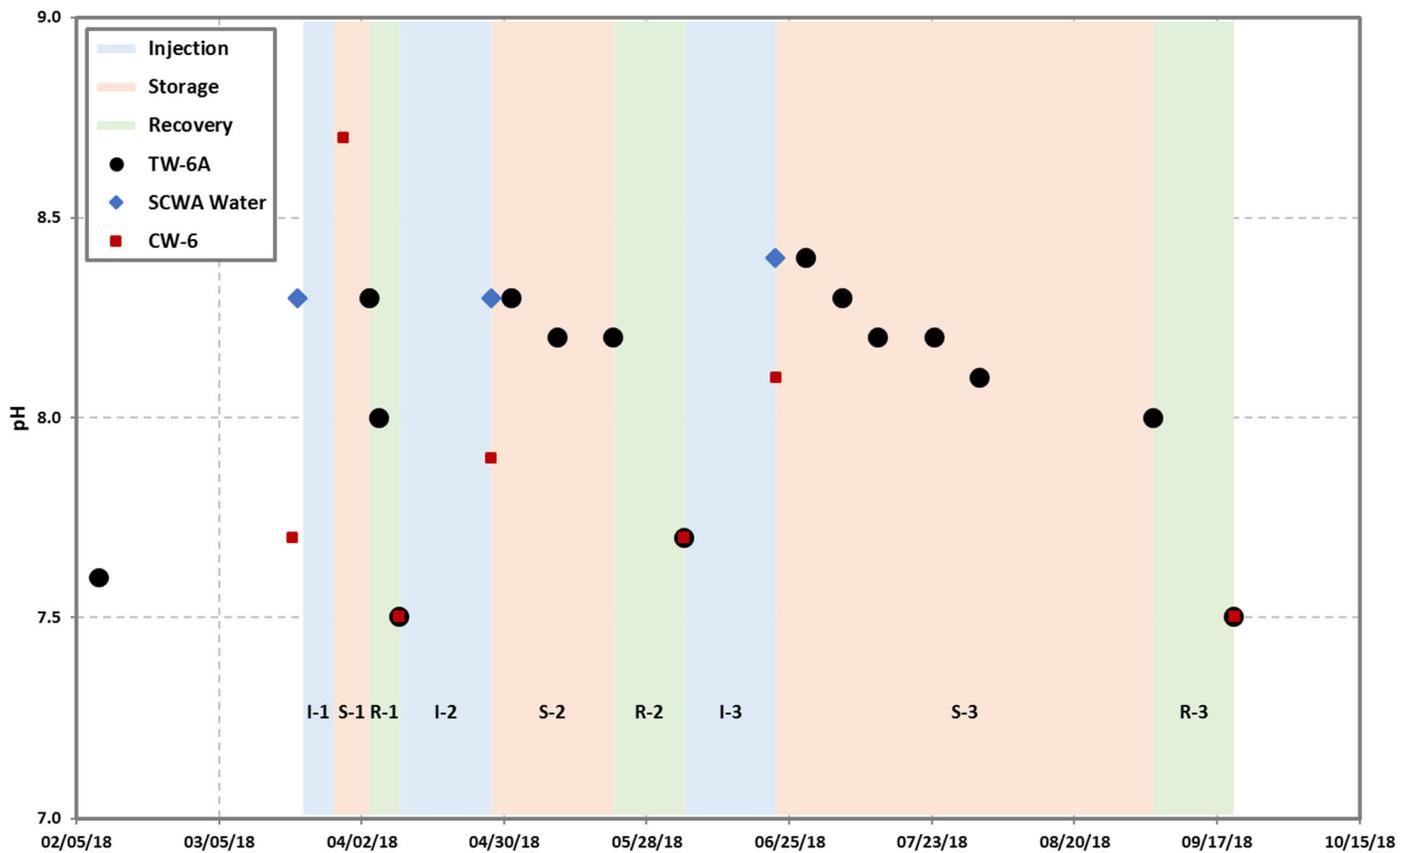
Figure 10. Recharge Water pH versus Native Groundwater pH

Figure 10 shows a relatively steady pH – 8.3 to 8.4, for recharge water during the ASR pilot test, while the pH values of native groundwater were less than 8.0 before the test. The pH of the two wells were found to be higher, generally greater than 8.0, at the end of the injection periods, during the storage periods, and during the early recovery periods. At the end of each recovery period, the pH values of the wells were similar to or lower than the pre-test values.

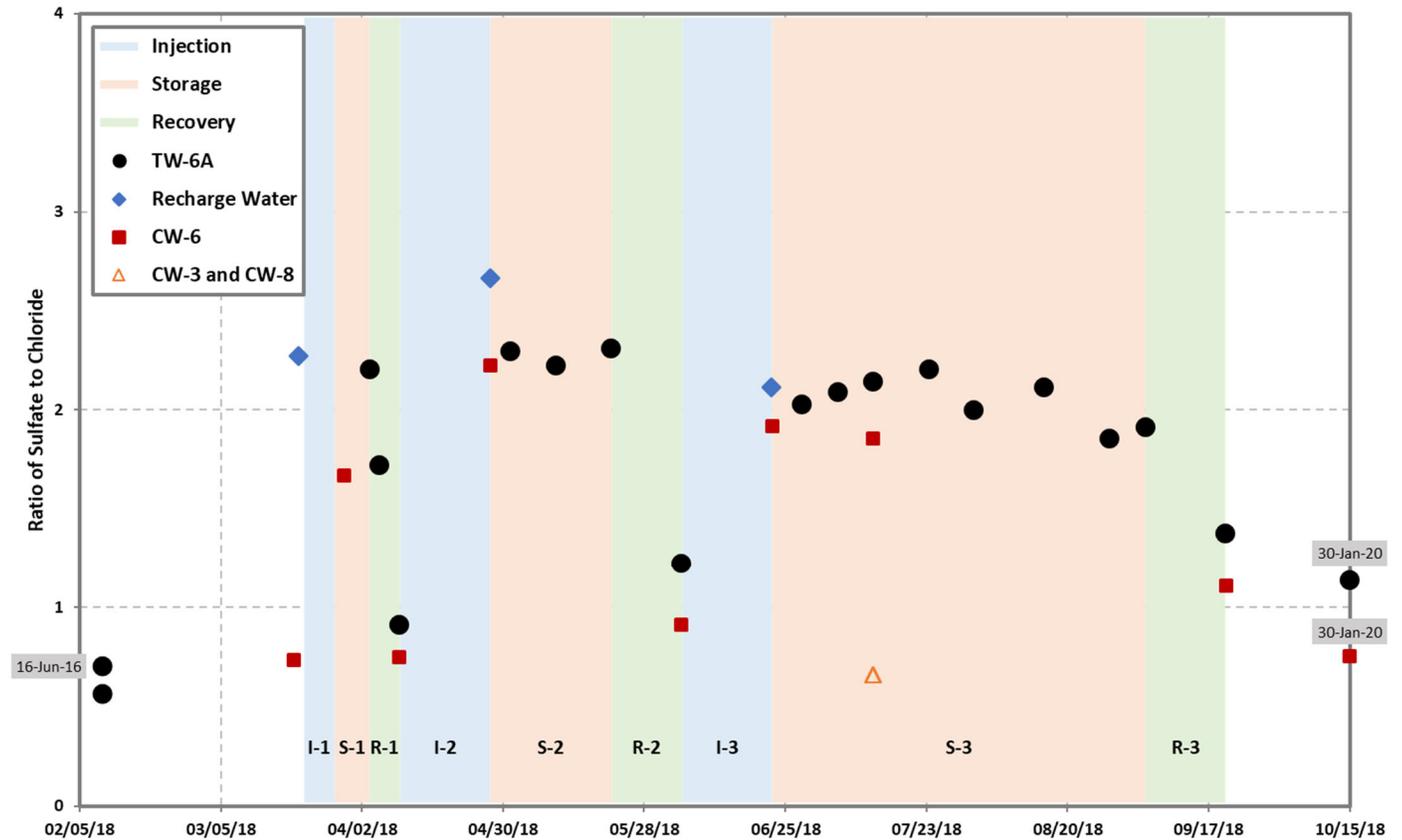
Figure 11. Sulfate-Chloride Ratio for Recharge Water and Native Groundwater

Figure 11 illustrates the sulfate-chloride ratios during the pilot test and shows that the recharge water ratio is greater than 2 – sulfate concentrations are twice chloride concentrations. Prior to the ASR pilot test, the ratios for native groundwater were less than 1, and were found to increase to between 1.6 and 2.3 during the storage and early recovery periods. These native groundwater ratios were much lower at the end of the recovery periods – less than 1 for both wells after the first cycle but higher than the pre-test ratio, especially for TW-6A (0.9 versus 0.6, respectively) which indicates a residual of recharge water. The respective ratios for CW-6 were 0.7 and 0.8, also suggesting a slight residual. For the

second and third recovery cycles, the respective ratios were 1.2 and 1.4 for TW-6A and 0.9 and 1.1 for CW-6, -- indicative of residual of recharge water.
