Technical Addendum ASR Pilot Testing at TW-6A

March 2020

GEI Consultants
2868 Prospect Park Drive, Suite 400
Sacramento, CA 95670

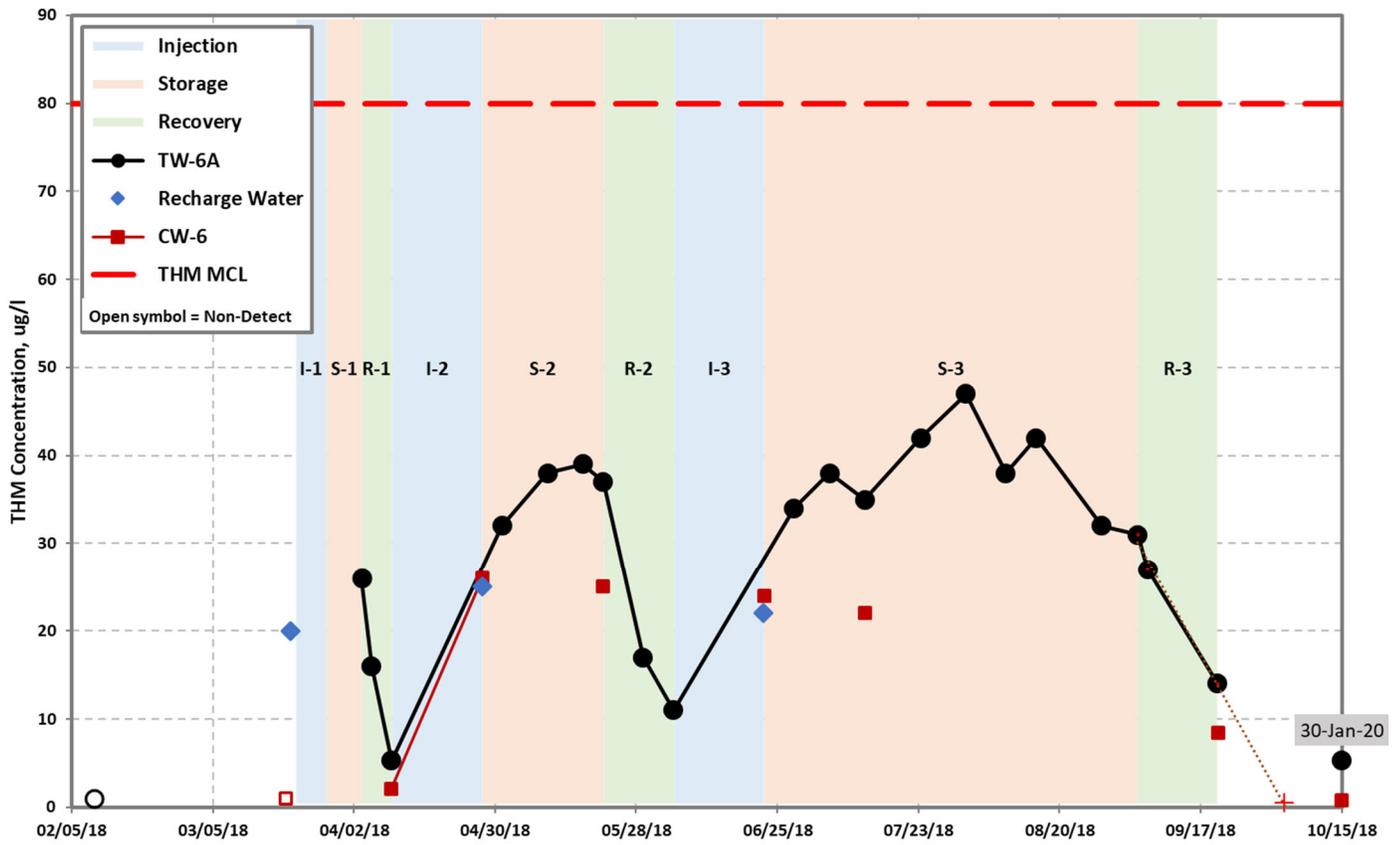
Figure 12. Total Trihalomethane Concentrations

Figure 12 is a plot of THM concentrations during the pilot test and shows that THM concentrations were relatively steady for the recharge water – 20 to 25 ug/l, and THMs were not detected in the native groundwater. During the first injection and storage periods, THMs formed rapidly at TW-6A with the initial concentration (26 ug/l) at the onset of the recovery period exceeding the initial RW concentration (20 ug/l). Thereafter, the THM concentrations decreased rapidly but THMs were still detected at the end of first recovery period at TW-6A (~5 ug/l), and at CW-6 (~2 ug/l).

During the second cycle, THM concentrations increased from 32 ug/l at the beginning of the storage period to 39 ug/l at the end and then decreased to 11 ug/l by the start of the third injection period. Only two samples were collected at CW-6 – at the beginning and end of the storage period, and the THM concentrations were 26 and 25 ug/l. Additional sampling at CW-6 would likely have found THM concentrations following a subdued trend consistent with the TW-6 trend.

During the third cycle, the THM concentrations at TW-6A appeared to be increasing at the end of the planned 30-day storage period so the duration of period was extended (+44 days) to better define the THM characteristics at TW-6A. The THM concentrations increased from 34 ug/l to 47 ug/l by the middle of the extended storage period and then decreased to 31 ug/l by the end of storage period. The THM concentration decreased to 14 ug/l at the end of the third and final recovery period. A projection of the last three THM values indicates that an additional 13 days of groundwater recovery would have been required to reduce the THM concentration to non-detect, based on a linear decline. This latter assumption is probably not valid and groundwater recovery might have extended well into October to

achieve non-detect THM data. Additional samples were not collected at CW-6 but THMs would probably have trended similar to the TW-6A trend but at lower concentrations. The two wells were sampled again during late January 2020 for THMs, chloride, and sulfate, and one THM (chloroform) was detected at low concentrations – 5.3 ug/L at TW-6A and 0.8 ug/L at CW-6.

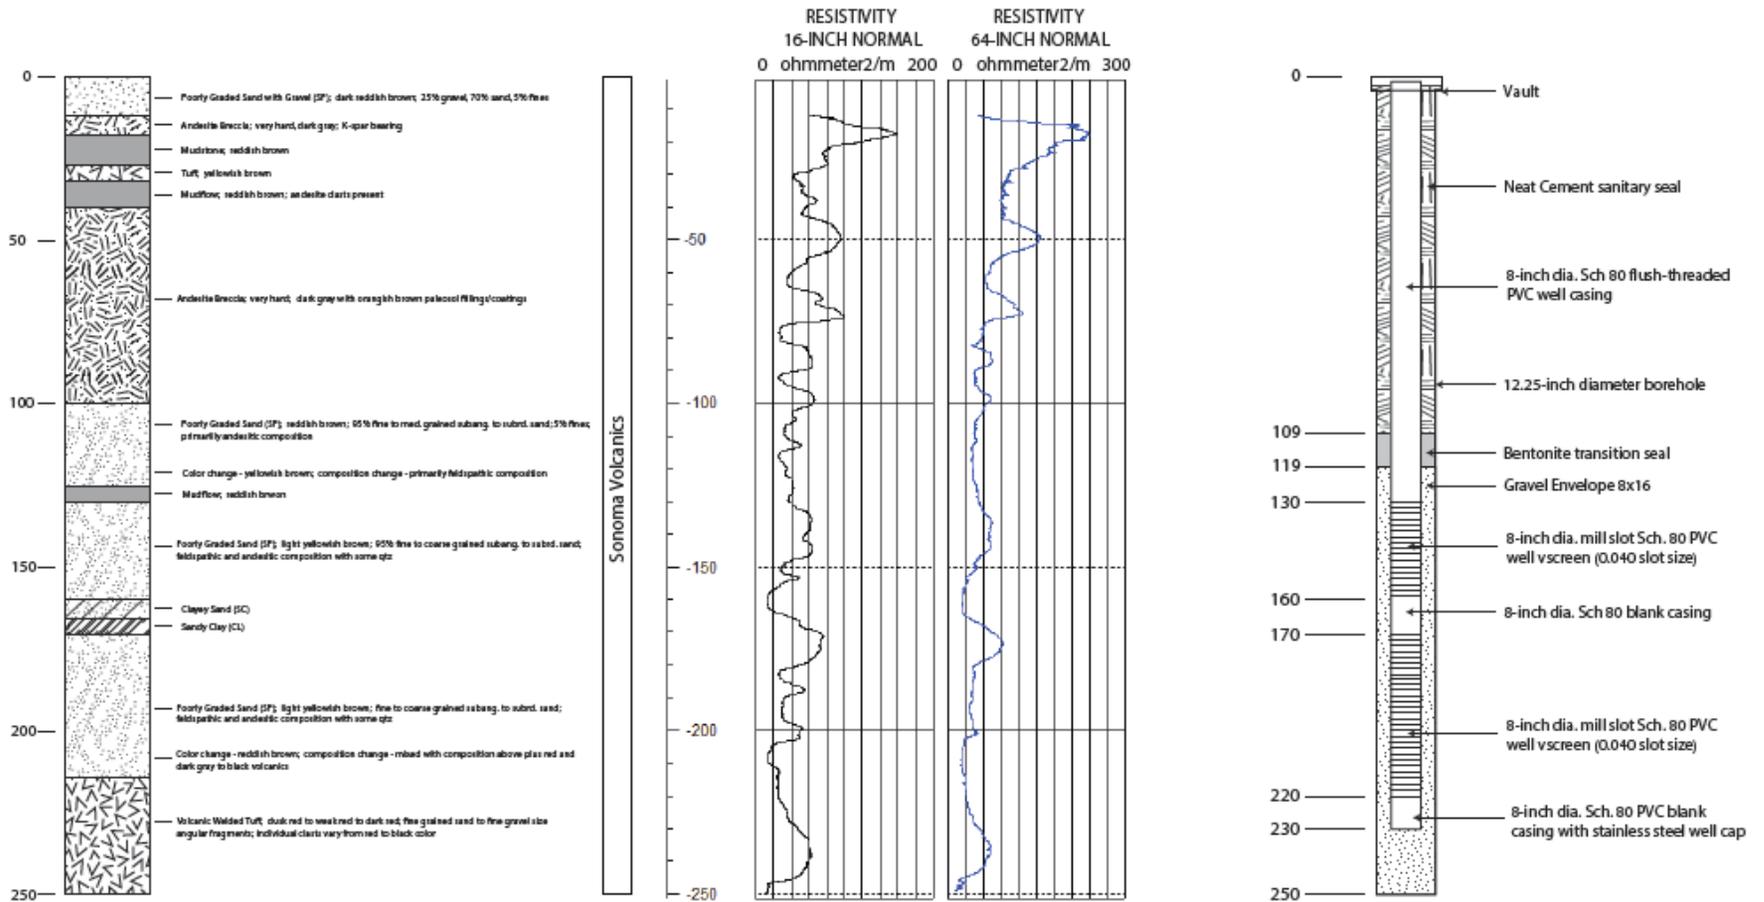
**FIGURE 1. GRAPHIC LOGS AND AS-BUILT COMPLETION
Sonoma TW-6A ASR Pilot Test Project
GEI Consultants, Inc. / Sonoma County Water Agency**

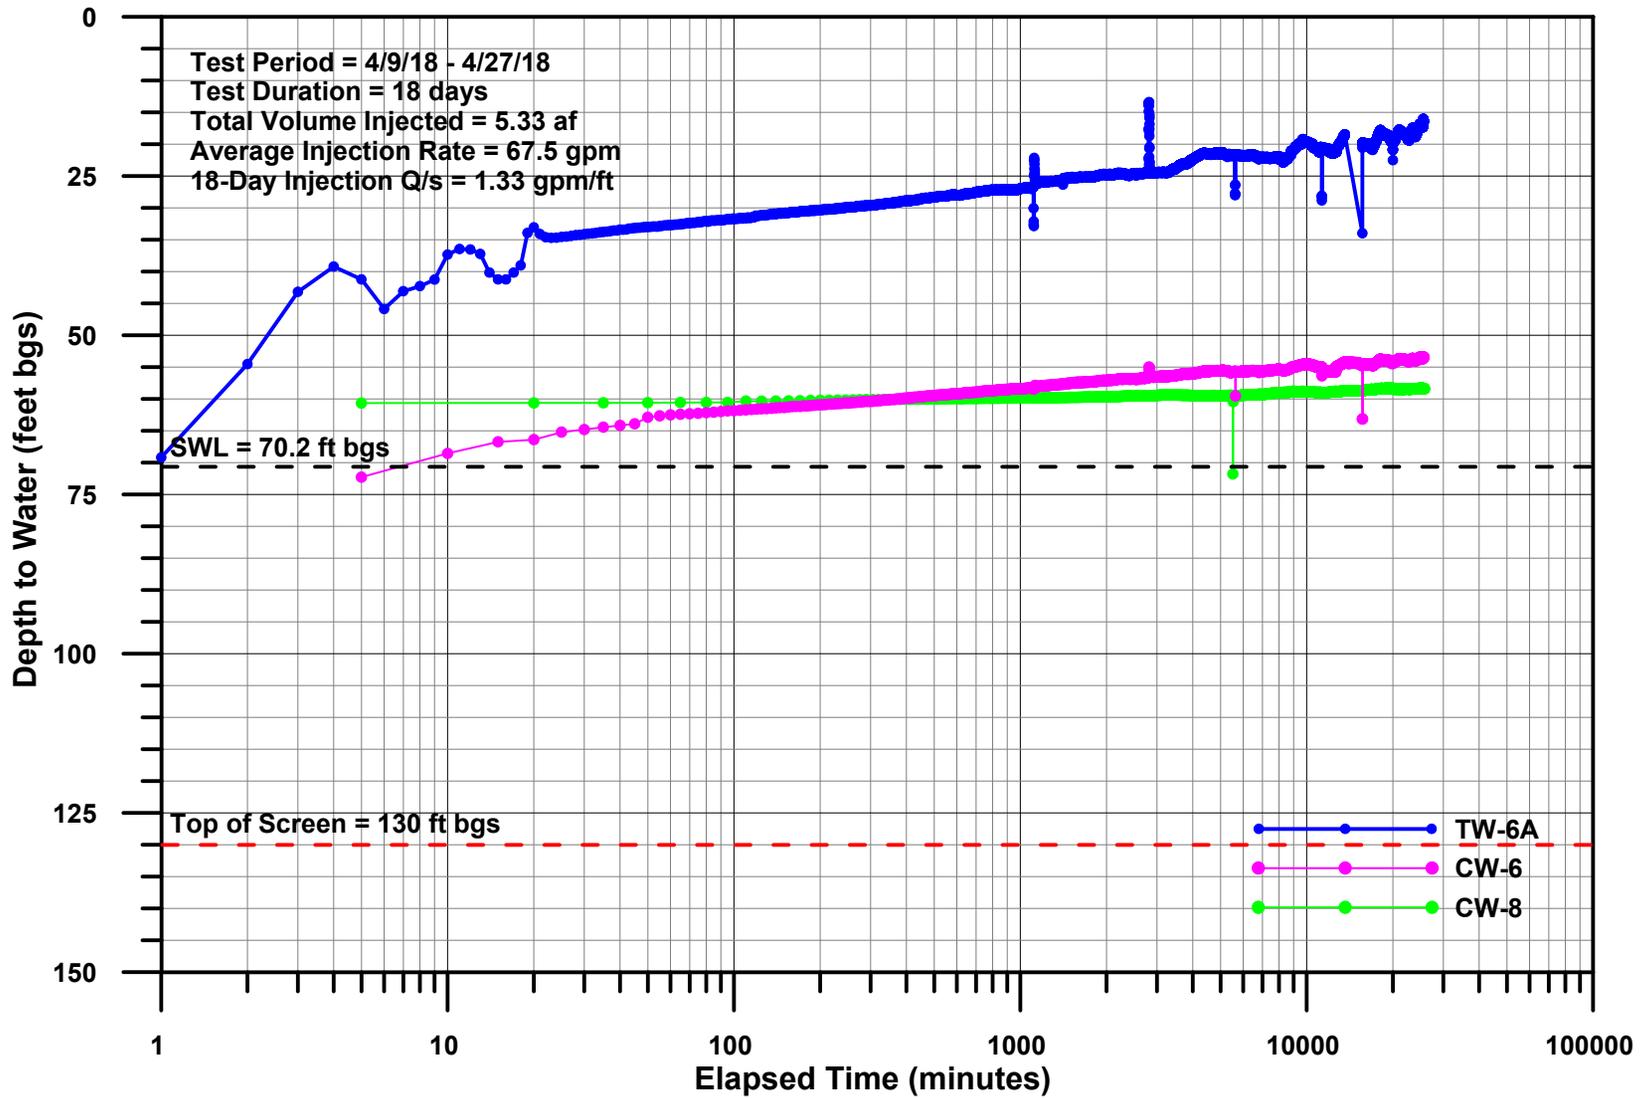
FIGURE 8. ASR CYCLE 2 - INJECTION
Sonoma TW-6A ASR Pilot Test Project
GEI Consultants, Inc. / Sonoma County Water Agency

Water-level data for ASR Cycle 2 Injection Test are graphically presented on **Figure 8**. As shown, the static water level in the well prior to injection was 70.2 feet bgs. It is noted that the static water level had not fully recovered after ASR Cycle 1 Recovery pumping prior to initiating ASR Cycle 2 Injection (i.e., the well was not left idle for a period of 6 days following termination of pumping) but did recover adequately to a level of approximately 95 percent. During injection, drawup in the well was approximately 43.3, 48.3 and 53.9 feet after 1000 minutes, 6 days and 18 days of injection; respectively, corresponding to specific injectivities of approximately 1.55, 1.39 and 1.24 gpm/ft, respectively. These 1000-minute and 6-day specific injectivity values are approximately 10 percent less than those observed during the Cycle 1 injection test, indicating that the increased injection rate resulted in slightly greater hydraulic losses.

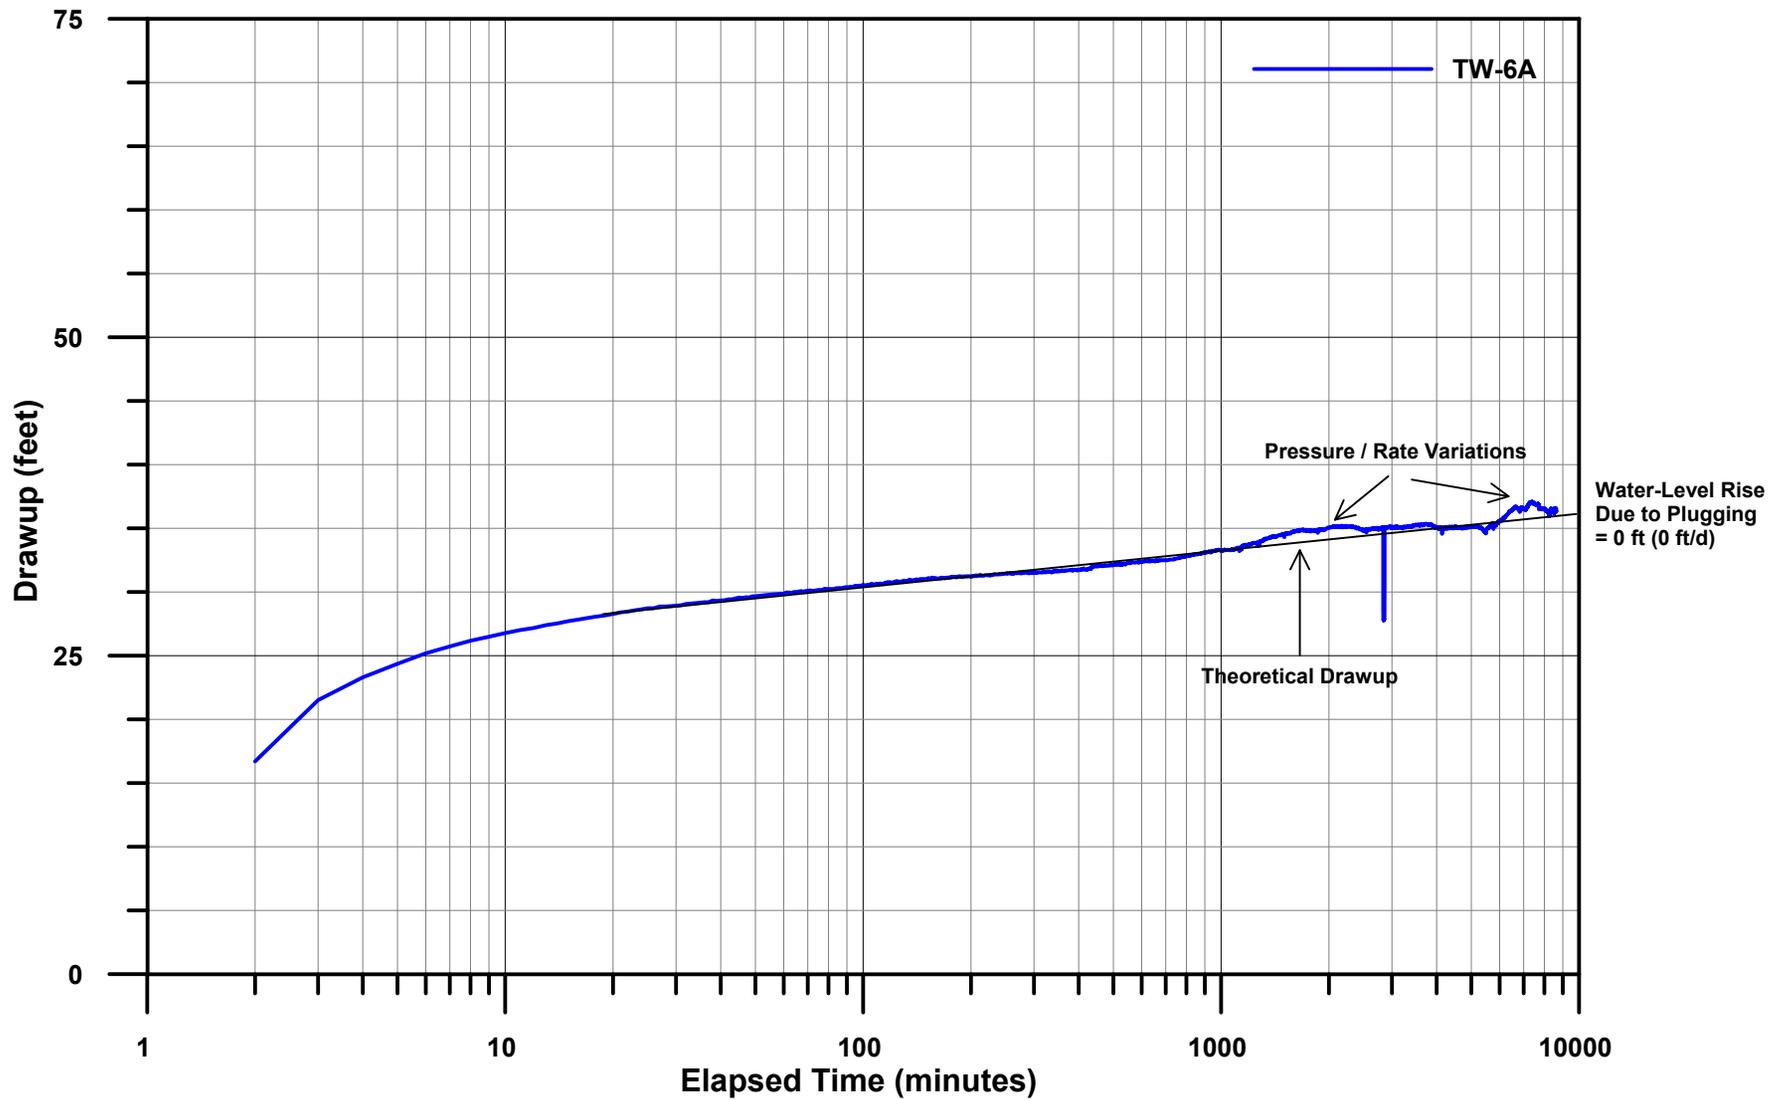
FIGURE 13. ASR CYCLE 1 - INJECTION PLUGGING RATE ANALYSIS
OBSERVED VS. THEORETICAL DRAWUP METHOD
Sonoma TW-6A ASR Pilot Test Project
GEI Consultants, Inc. / Sonoma County Water Agency

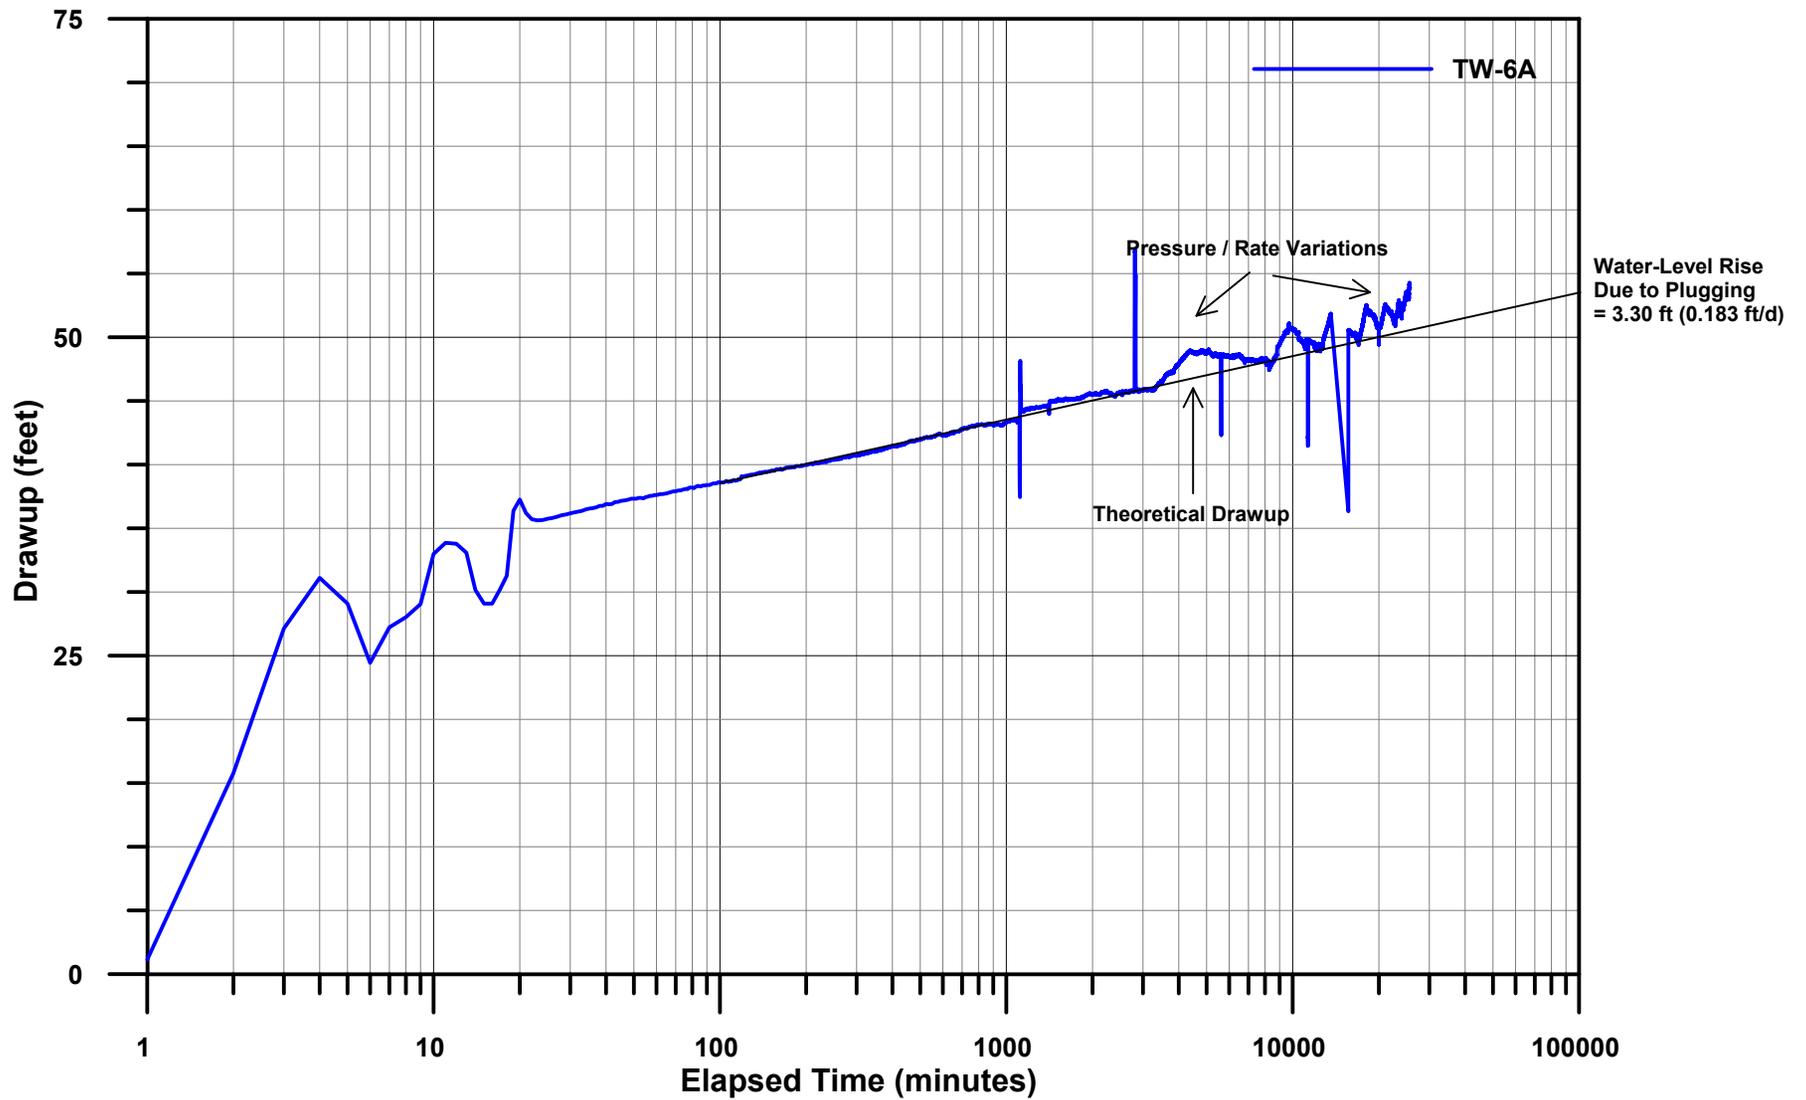
FIGURE 14. ASR CYCLE 2 - INJECTION PLUGGING RATE ANALYSIS
OBSERVED VS. THEORETICAL DRAWUP METHOD
Sonoma TW-6A ASR Pilot Test Project
GEI Consultants, Inc. / Sonoma County Water Agency

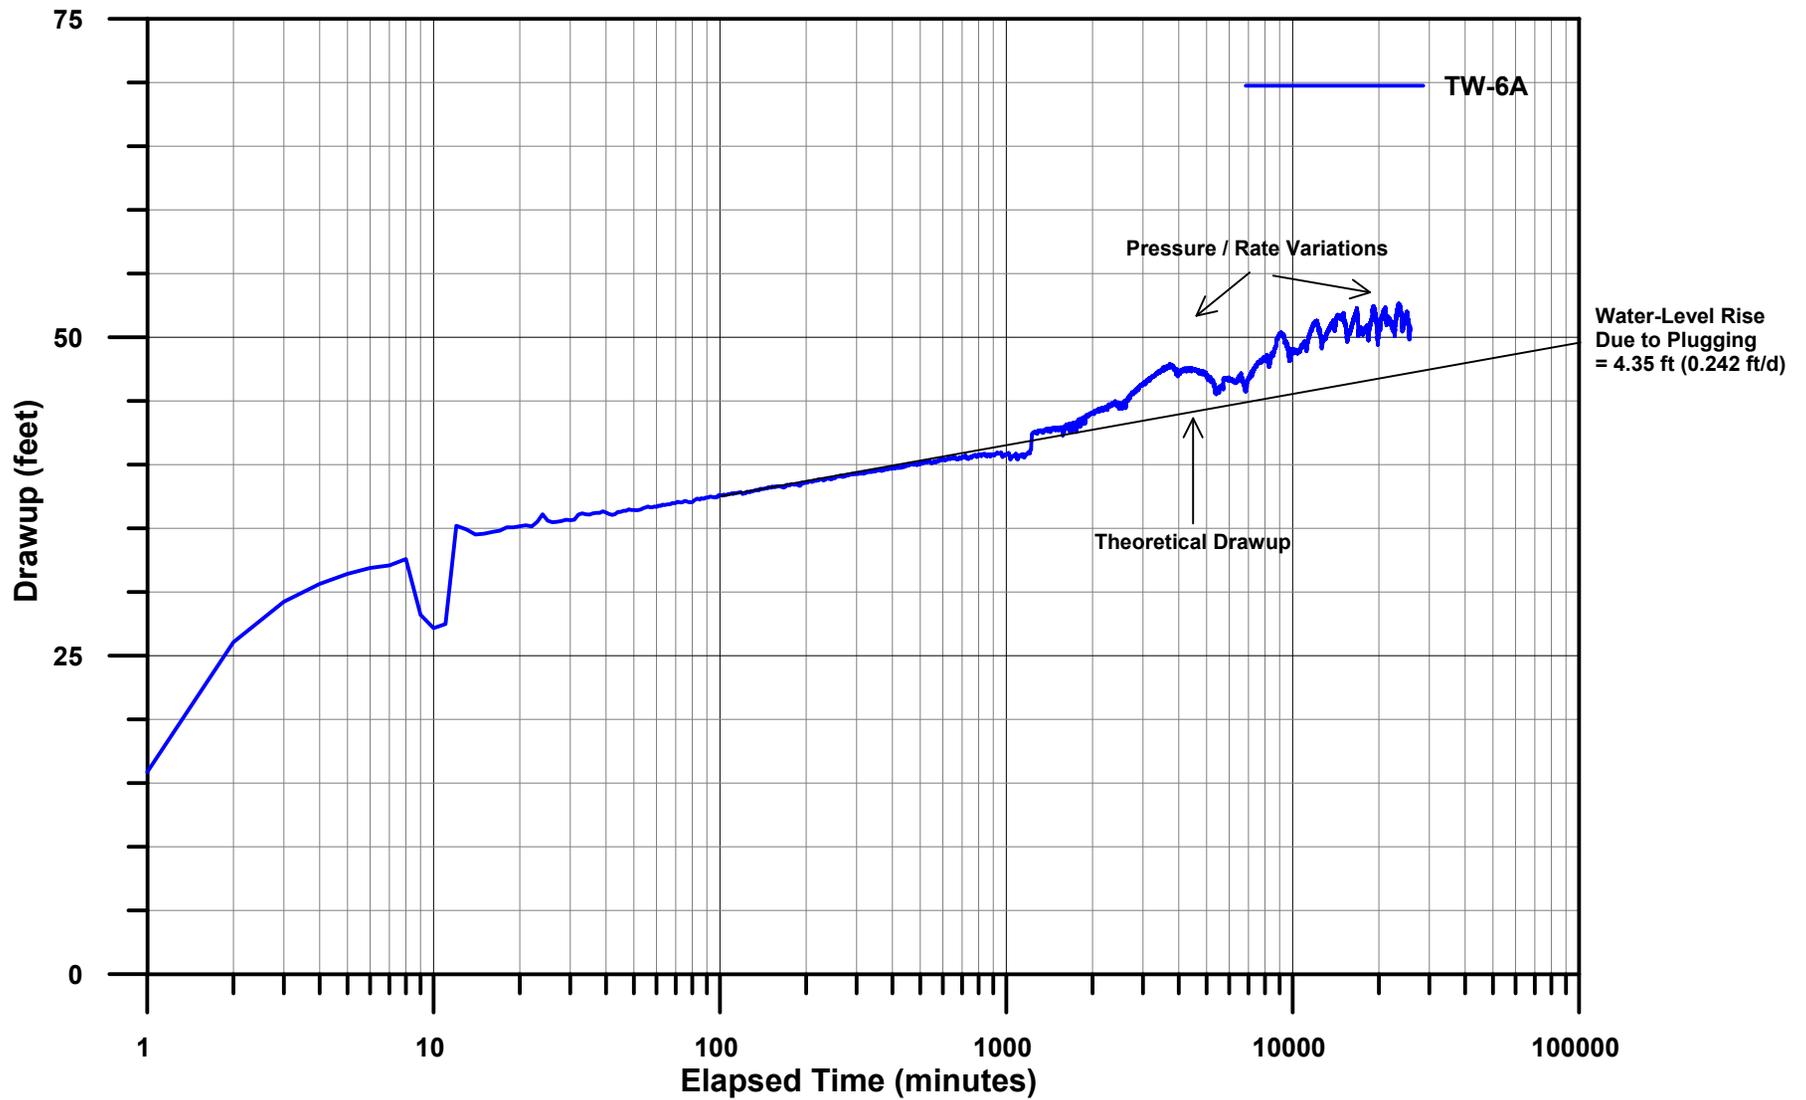
FIGURE 15. ASR CYCLE 3 - INJECTION PLUGGING RATE ANALYSIS
OBSERVED VS. THEORETICAL DRAWUP METHOD
Sonoma TW-6A ASR Pilot Test Project
GEI Consultants, Inc. / Sonoma County Water Agency

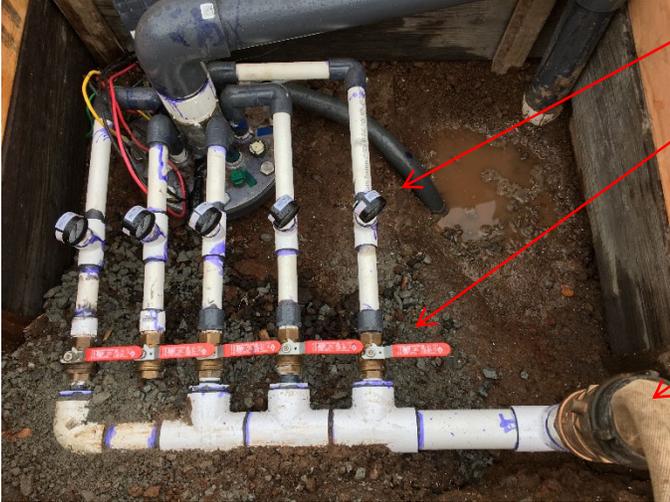
Test Well TW-6A with recharge manifold (pressure gauges, valves, and pump-to-waste hose)

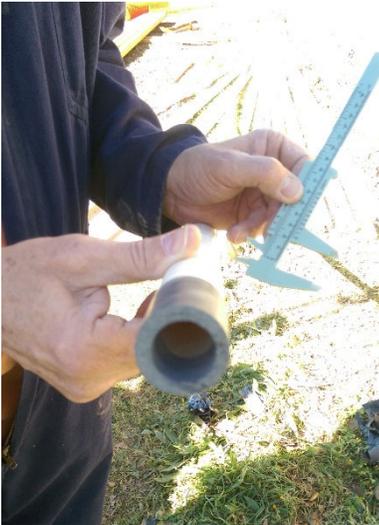
Recharge (injection) tube with 3/4-inch orifice

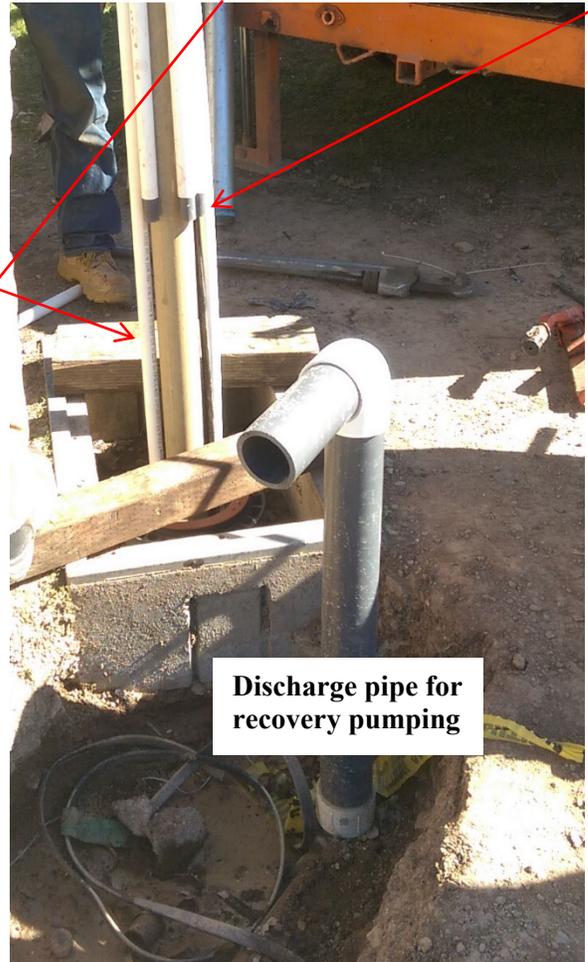
Installation of injection tubes with orifices and sounding tubes around pump column.

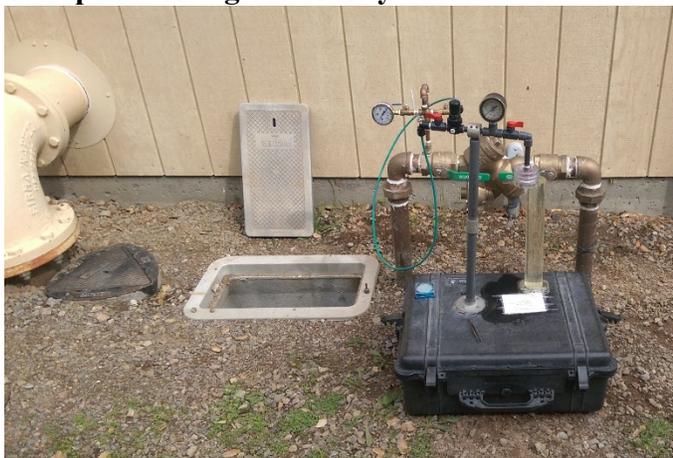
Set-up for testing silt density index

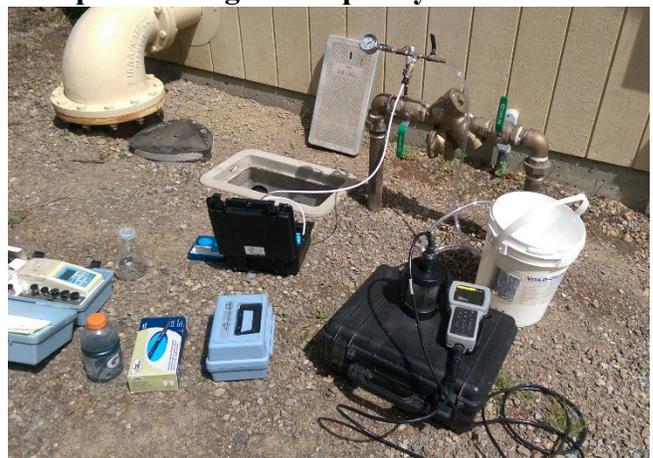
Set-up for testing water quality

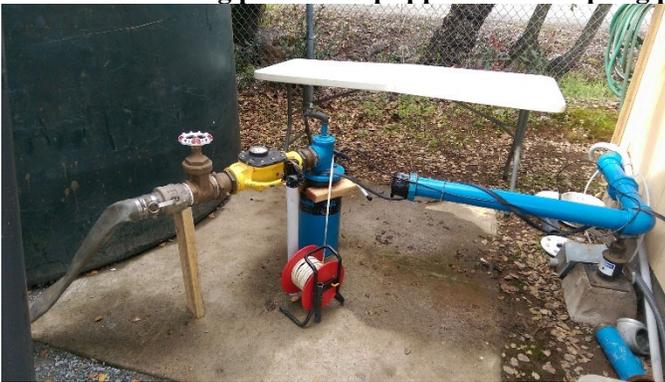
Well CW-6 during pilot test equipped with sampling pump, flow meter, water level gauge, and storage tanks
