Sonoma County Water Agency 2023 Watershed Sanitary Survey

**Sonoma County Water Agency Watershed Sanitary Survey
Fourth Update
FINAL REPORT
December 2023**

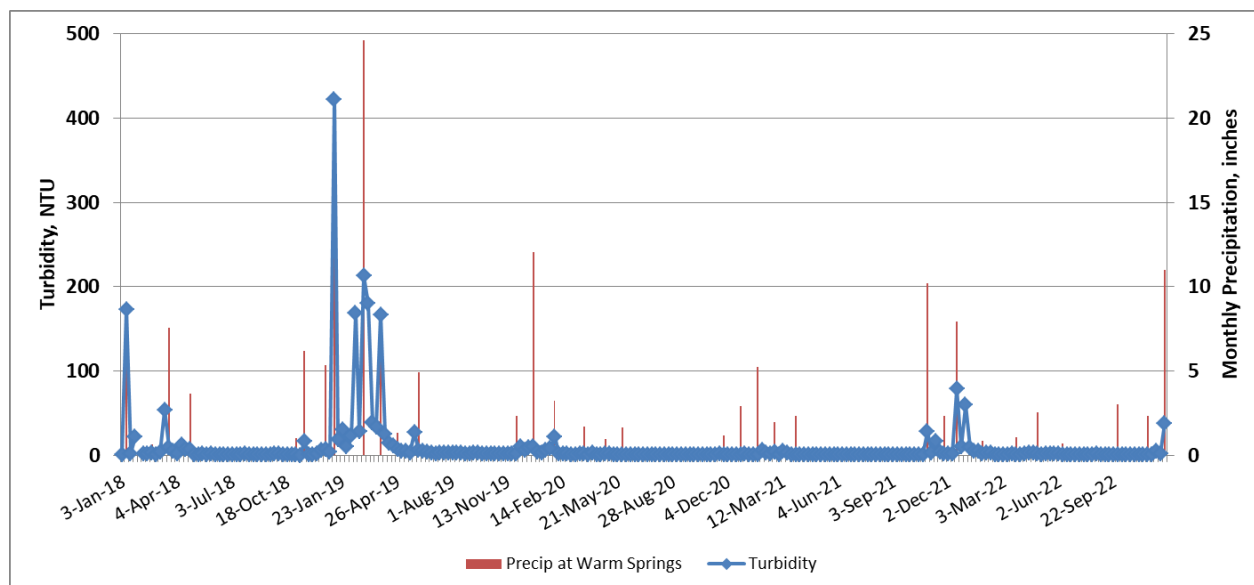
Figure 3-5. Weekly Turbidity Data in the Russian River at the Diversion Location, 2018 to 2022

as required by the operating permit. However, in most cases, a 2.0 NTU reading at Collector 5 is related to start-up of the well. Sonoma Water Operations would monitor the turbidity closely, and would shut off Collector 5 if it did not decrease to below 1.0 NTU within 30 minutes.

- Turbidity levels in the Russian River at the diversion location are quite variable, ranging from less than 2.0 to over 400 NTU. The highest levels are typically found during the wet season when Radial Collector Well 5 is not being used as a water supply source.

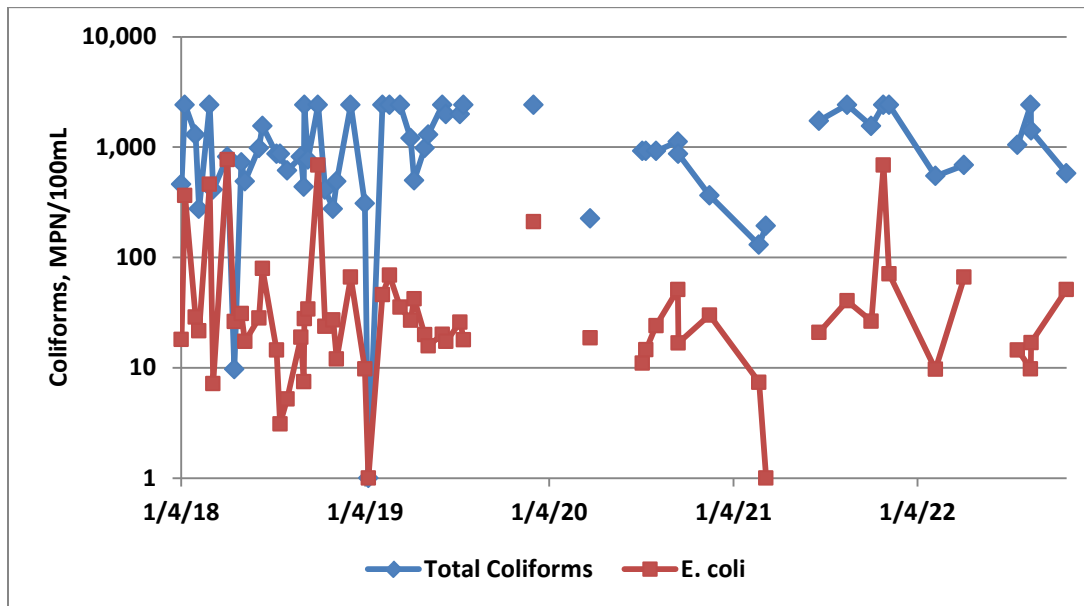
Figure 3-6. Total Coliform and *E. coli* Levels in the Russian River, 2018 to 2022

Total coliforms and *E. coli* were also analyzed in samples collected from Radial Collector Well 5 prior to disinfection, when it was operating. Total coliforms were found detectable two times, at 1.0 and 3.1 MPN/100 ml. *E. coli* was never detected.

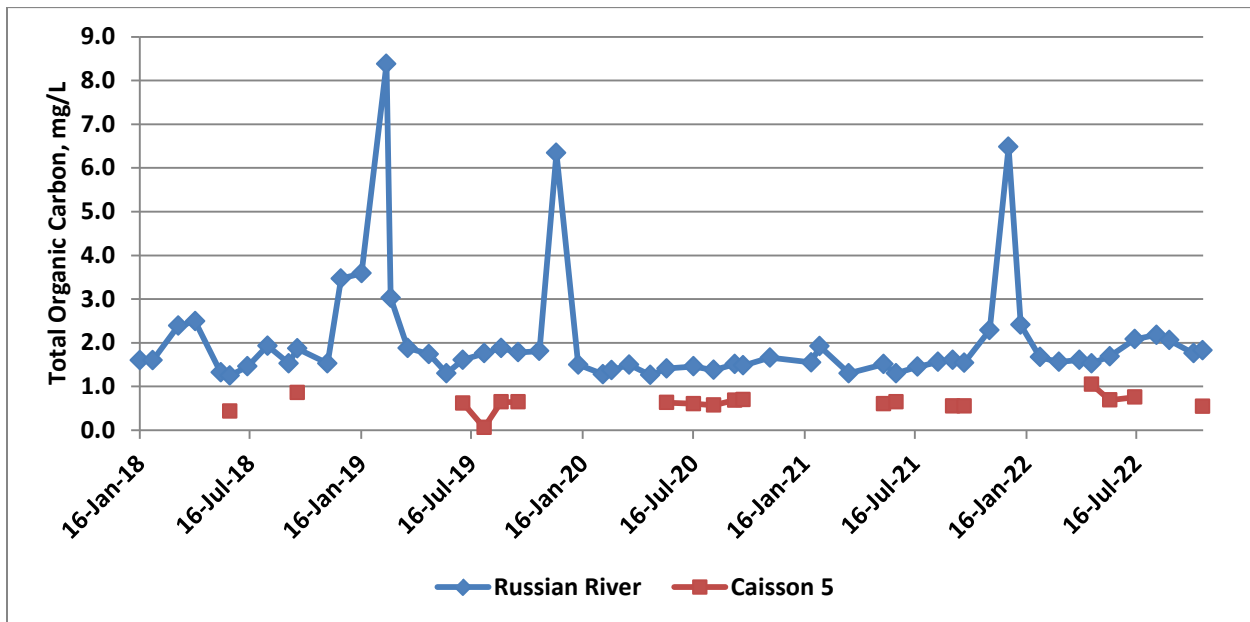
Figure 3-7. Total Organic Carbon Concentrations in the Russian River and Collector 5, 2018 to 2022

The Water Agency collects total organic carbon (TOC) samples on a monthly basis from the diversion location, and occasionally at Collector 5. **Figure 3-7** presents TOC in the Russian River and at Collector 5. TOC in the river ranged from 1.3 to 8.4 mg/L, with an average of 2.0 mg/L. TOC in Collector 5 was much lower, ranging from 0.1 to 1.1 mg/L, with an average of 0.6 mg/L.

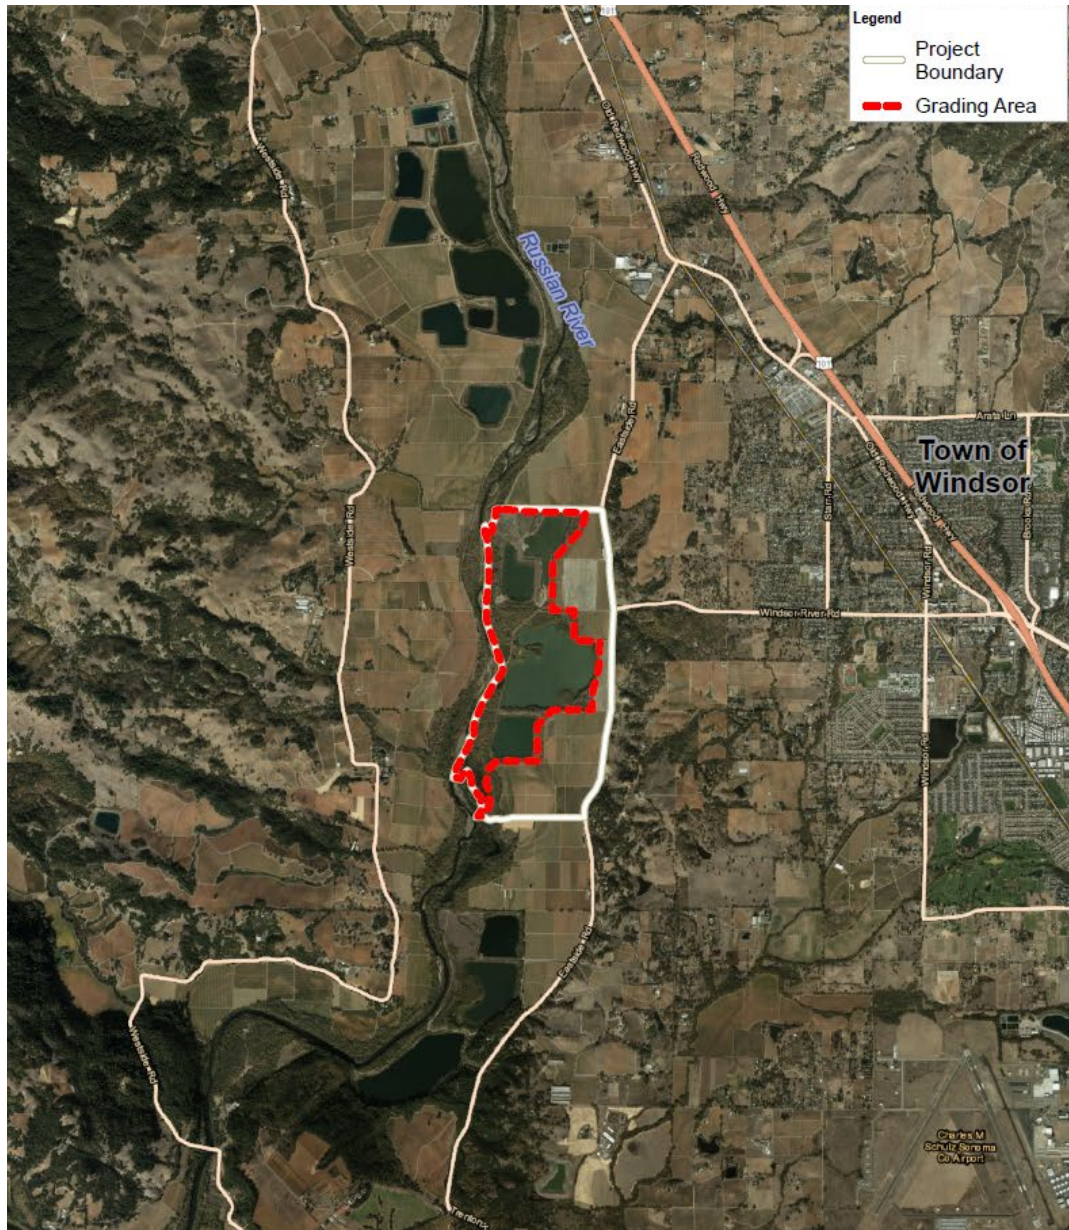
Figure 4-1. Hanson Pits Restoration Project

There are two former terrace pit sites upstream of Wohler Bridge: the Hanson pits and the SYAR pits. These are terrace pits that are outside the active channel, but within the floodplain of the Russian River. **Figure 4-1** shows the Hanson Pits. A use permit for reclamation of the Hanson Pits was submitted in August 2023. Reclamation would involve filling the ponds and removing internal levees, roads and mining infrastructure. The floodplain would also be reconfigured to reestablish the natural floodplain topography and function.

According to the Sonoma County PRMD, it will take two years to approve the use permit for the Hanson Pits, which includes the required CEQA environmental

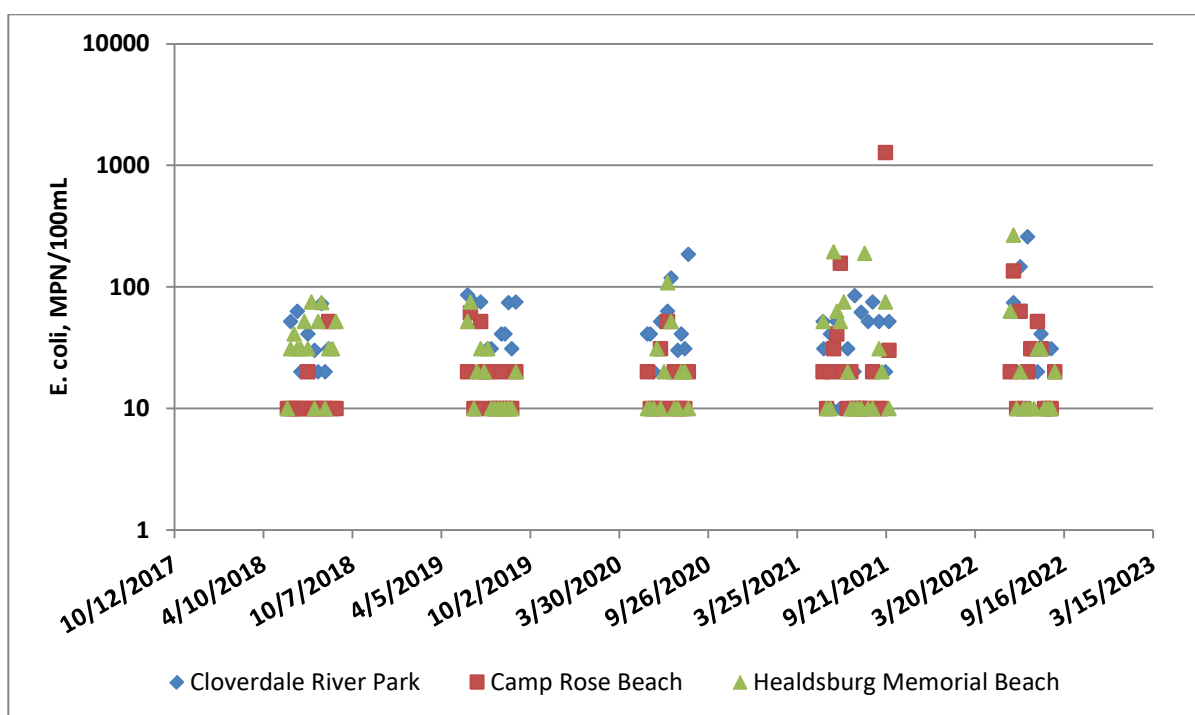
Figure 4-5. *E. coli* Beach Monitoring Data from 2018 to 2022

The Sonoma County Department of Health Services, in cooperation with the North Coast Regional Water Quality Control Board and the Sonoma County Water Agency, monitors bacterial levels in the water at beaches on the Russian River. Sampling is conducted regularly between Memorial Day and Labor Day. *E. coli* data for Cloverdale River Park Beach, Camp Rose Beach, and Healdsburg's Veterans Memorial Beach from 2018 to 2022 is shown in **Figure 4-5** and **Table 4-9**. **Figure 4-5** shows that *E. coli* levels at the Cloverdale River Park are slightly higher compared to Camp Rose and Healdsburg Veterans' Memorial Beach, which is reflected in a higher median of 31 MPN/100mL at Cloverdale River Park.

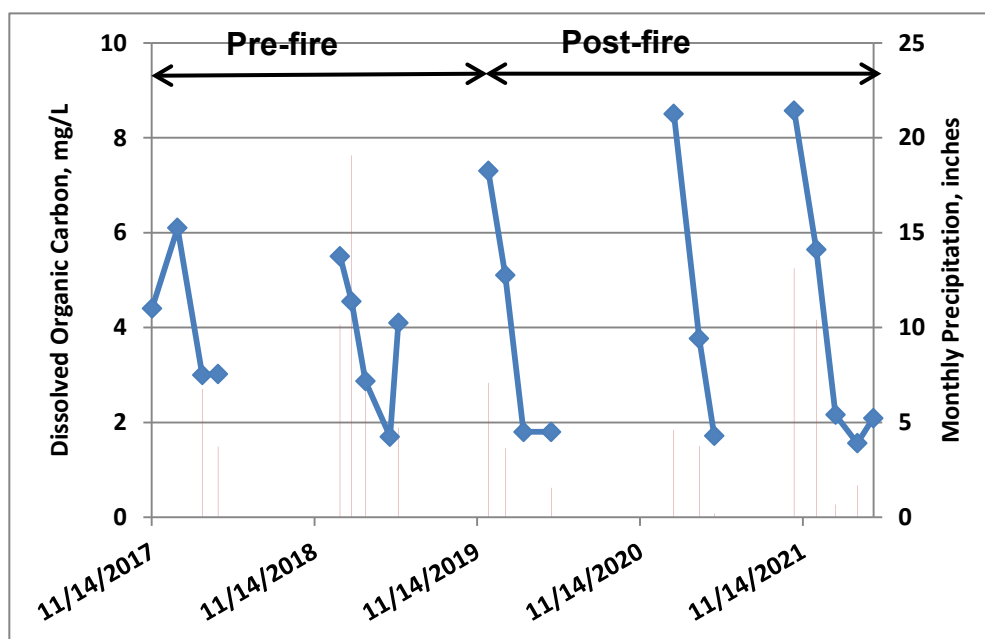
Figure 4-7. Dissolved Organic Carbon at Franz Creek (FRACR) before and after the Kincade Fire

As a result of the wildfires, the Water Agency conducted baseline and post-storm monitoring at 15 locations. The Franz Creek monitoring location was within the burn area for the 2019 Kincadee fire. Samples collected by the Water Agency were analyzed for nutrients, salinity, physical, organic carbon, and metals. Metals were not analyzed in any of the post-fire samples for Franz Creek. The highest dissolved organic carbon (DOC) peak in the pre-fire period was 6.1 mg/L, and the highest DOC peak in the post-fire period was 8.6 mg/L, indicating a 41 percent increase. The highest nitrate peak in the pre-fire period was 1.26 mg/L, and the highest nitrate peak in the post-fire period was 1.58 mg/L, indicating a 25 percent increase. There were no notable increases in ammonia, alkalinity and specific conductance in comparing pre and post fire samples.

The post-fire monitoring conducted by the Water Agency after the Kincadee and Walbridge fires did show a post-fire impact with higher concentrations of DOC and nitrate in the tributaries within the burn area. Additionally, increases in iron and phosphorus were seen in tributaries within the burn area of the Walbridge fire. These increases may have been higher with higher monthly precipitation totals (similar to February 2019). As these tributaries flow to the Russian River, there is a direct impact to the Russian River. However it is difficult to precisely quantify the impact due to the distance from the burned area to Collector 5, as dilution occurs within the river. This assessment indicates the vulnerability for source water quality impacts due to fires is medium/high.

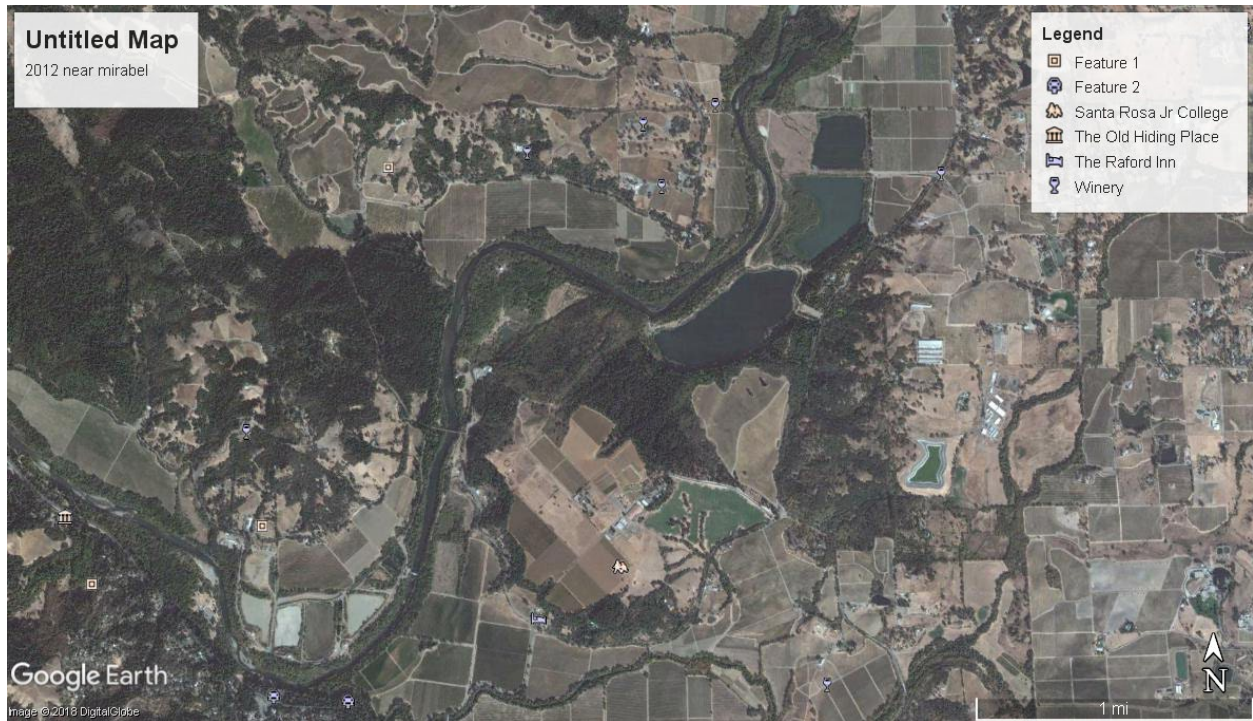
Photo #1. Mirabel/Wolher Area 2012

Google Earth photos along the river corridor from Healdsburg to Radial Collector Well 5 were reviewed from 2012 to 2018 to 2023. Overall, there appears to be very little change along the river corridor. As shown in **Attachment C**, photos #1, #2 and #3 shows the Mirabel/Wohler area in 2012, 2018, and 2023 respectively. Photos #3, #4, and #5 shows from Mirabel/Wohler area to the Healdsburg WWTP, in 2012, 2018 and 2023, respectively. Photos #5, #6 and #7 show the Healdsburg area in 2012, 2018 and 2023, respectively. There is a new housing development on the west side of Windsor, along Windsor River Road as shown on Photo #6.
