## TECHNICAL MEMO

Date: October 30, 2017  
To: Mary Ann King, Trout Unlimited  
From: Lauren Hammack, Prunuske Chatham, Inc.  
Subject: Mill Creek Dam Fish Passage Monitoring – Post-construction

### Introduction

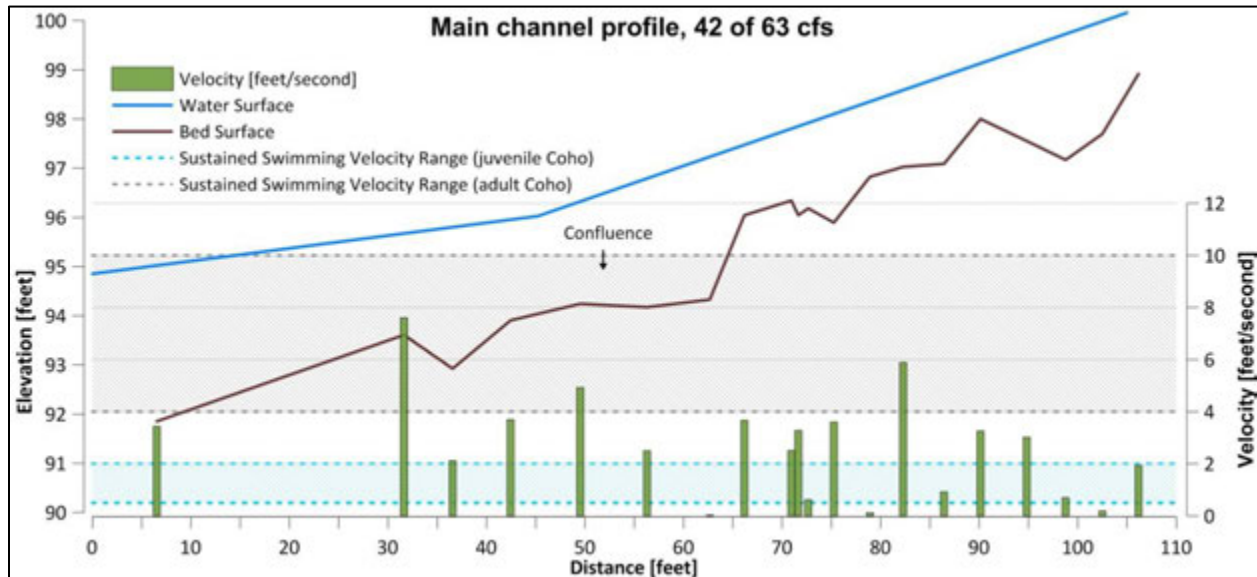
Figure 7. Measured depths and velocities in the main channel on March 1, 2017.

The profile graphs (Figure 7 and Figure 8) show that point specific velocities vary from near 0 fps to over 4 fps in both the main and side channels, which is due to the chute-pool nature of the bed form and flow patterns. Channel slope does not appear to significantly influence velocity. Velocities at or above 6 fps were measured in the 6% and 8% sloped sections, while the 3% side channel's maximum measured velocity was 4.5 fps. The profile points were taken to represent a fairly straight-line swim path for adult fish to take near the center of the channel. The profile data does not represent the path a juvenile fish would likely take if migrating upstream. Velocities near the channel margins are typically much lower than the center channel, as shown in the cross section plots (Figure 9). The cross-channel velocity variation is similar in scale to the longitudinal variation. However, multiple locations at each cross section had velocities within the preferred range for juvenile coho and had zones of calm water. The zones of calm or low velocity waters are larger in extent in the 3% side channel (Figure 10) than they are in the main channel where the slopes are 6-8% (Figure 11).

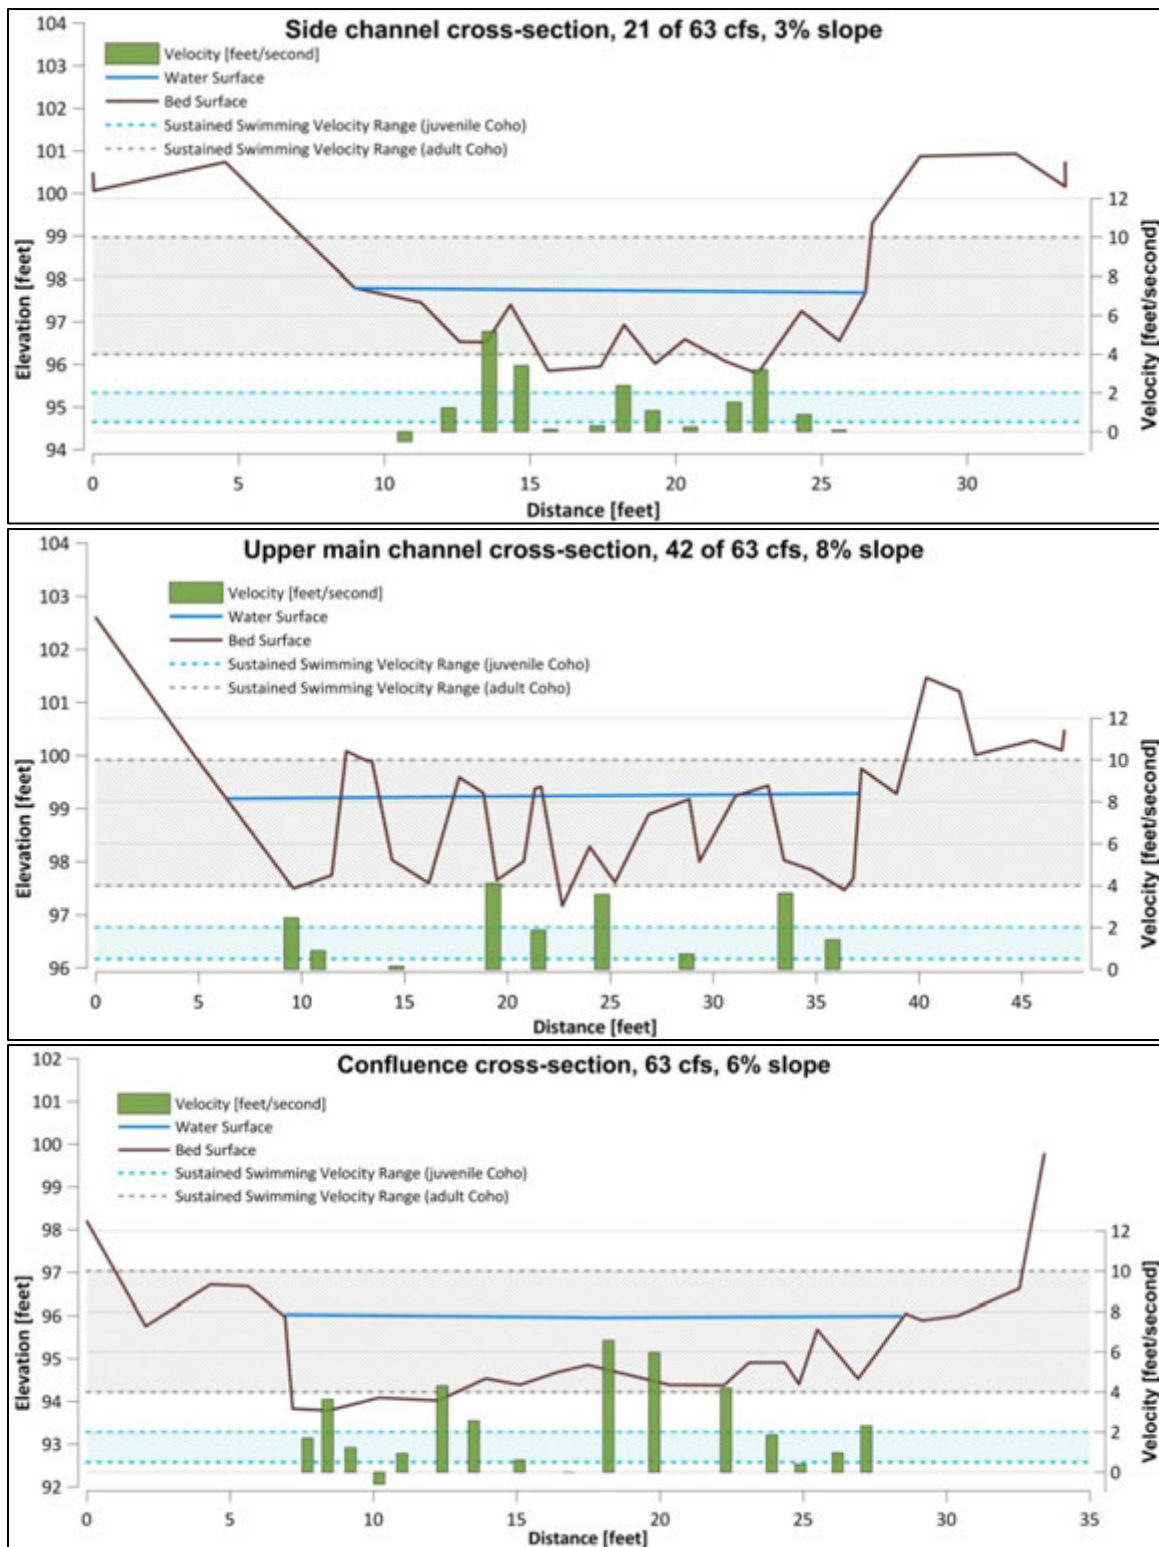
Figure 9. Fish passage conditions in cross sections during the mid-range flow measured on March 1, 2017.

During the mid-range flow event on March 1, 2017 all measured sections and profiles had average velocities that were well below the fish passage guidelines for adult salmonids (<6.0 fps) as shown in Table 3. The average velocities were all above the 1.0 fps threshold for juvenile passage. Average depths measured in the reach were all greater than one foot, meeting minimum depth requirement for both adult and juvenile salmonids.

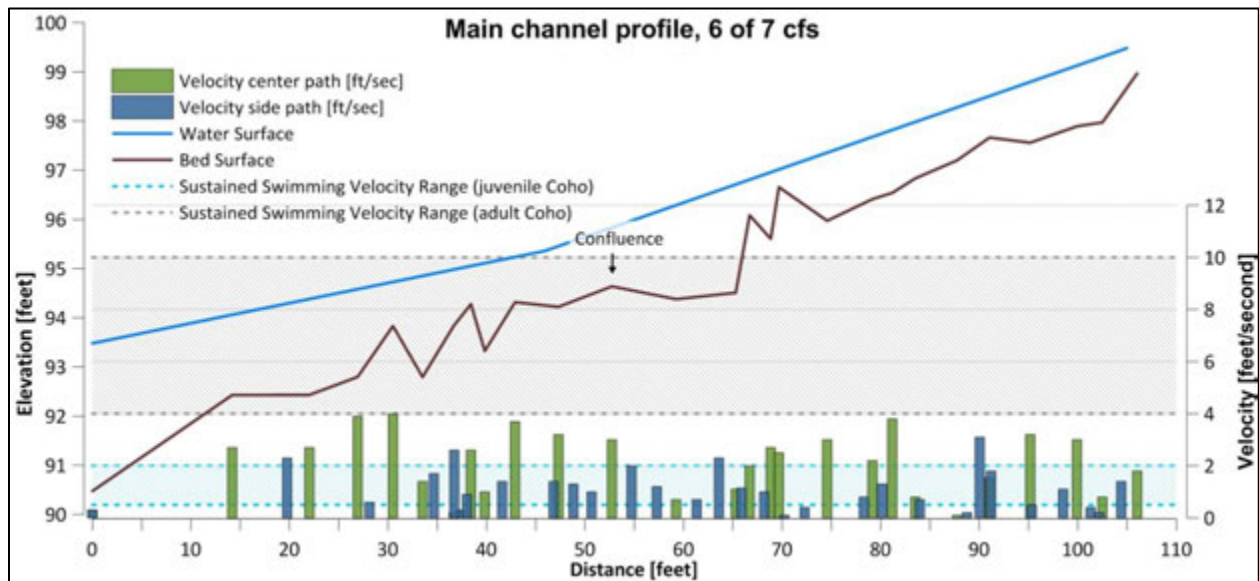
Figure 12. Measured depths and velocities in the main channel on May 30, 2017.

As for the mid-range flow, velocities during low flow vary longitudinally and cross channel (Figure 12, Figure 13, and Figure 14). At the low adult and juvenile flow represented by the May 30<sup>th</sup> measurements velocities do not exceed 4 fps anywhere in the channels and are within the preferred velocity range for juveniles in many locations. The edge profile up the main channel shows more favorable passage conditions than the center path profile does, as would be expected. The side channel appears to have only a few points where velocities are above the preferred sustained swimming velocity range for juvenile coho.

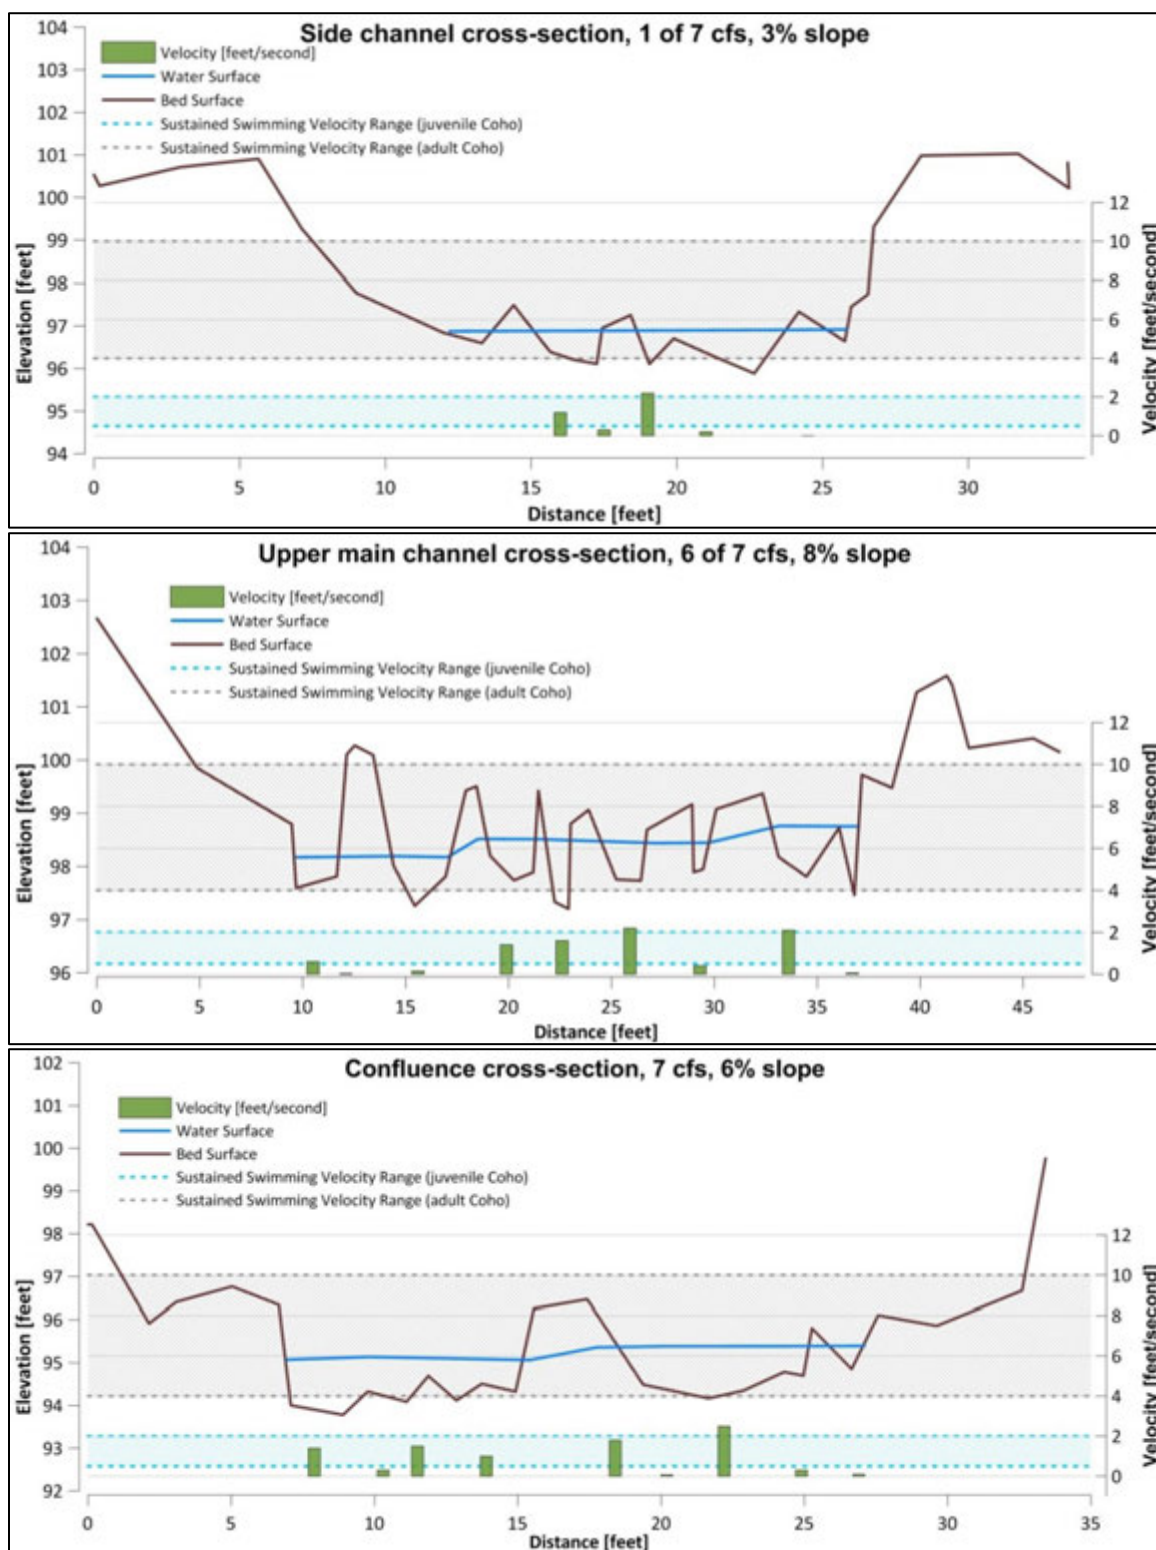
Figure 14. Fish passage conditions at the cross sections during the low flow on May 30, 2017.

Based on the cross section velocity and depth data it is expected that juvenile coho and steelhead can navigate the Project and migrate upstream between early spring storm events and when flows recede in the late spring through early summer (see 2017 hydrograph, Figure 6). The side channel provides abundant low velocity and calm water zones with gravel and meandering flow paths between the boulders. The main channel, with its steeper slope, has less defined flow paths and calm-water resting zones. In the main channel below the dam the interstitial gravel and cobble was largely scoured out, which left small drops and chutes between the boulders that may make navigating the main channel more difficult for juvenile coho (Figure 15).
